Erosion and redeposition pattern on the W7-X graphite test divertor unit tile

A set of plasma-facing components was retrieved from the W7-X vessel after OP1.2b campaign with an inertially cooled Test Divertor Unit (TDU) and analyzed postmortem to provide data on the plasma-surface interactions processes in the complex device geometry. In the present study, the lower TDU horizontal target (HT) graphite tile HM19TM400hTE2 exposed to the plasma during both OP 1.2 campaigns was examined. The surface modification of the material caused by the plasma-wall interactions was determined. The study employed several microscopy methods including SEM, FIB, STEM, TEM, EDX, and optical profilometry which showed that (i) distinct erosion zone was located at the inner HT strike line position, (ii) the area covered by a pronounced deposit was located adjacent the erosion zone, (iii) the target finger substructures positioned close to the outboard side was unaltered, and (iv) significant changes to surface roughness values along the length of the plate occurred.

In the presented study, the fine graphite horizontal target tile designated as HM19TM400hTE2 from the lower TDU module 1, which was subject

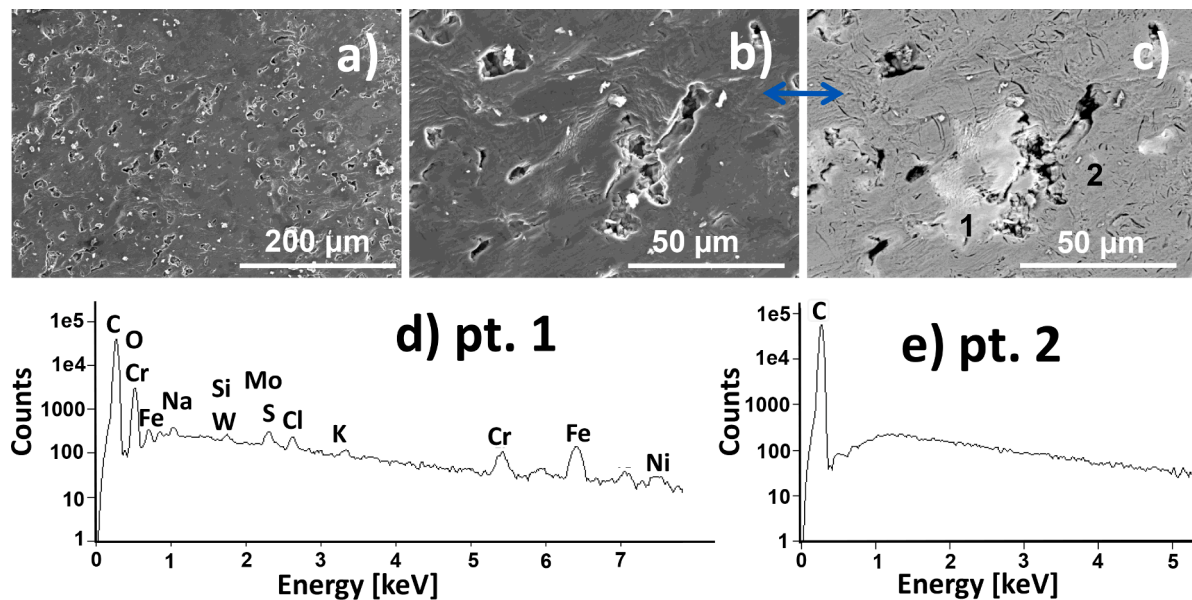
The erosion zone was observed on samples P5, P6T1, and P7. Micrographs that displayed surface features of this area in conjunction with EDX spectra are shown in Fig. 3. The surface of the material in this region was smoothed with traces of impurities in the shallow cavities at the surface (shadowed areas). This effect was also observed in the eroded areas of the graphite limiters from the TEXTOR tokamak [24]. EDX spectra showed only a carbon peak at the eroded zones (Fig. 3e), whereas peaks related to oxygen and small ones from other elements

(like Fe, Cl, S) were observed inside the shallow cavities (visible in bright contrast in the backscattered electrons (BSE) image) (Fig. 3d). This peak erosion zone was located at approx. $s = 150 \text{ mm}$, at the location of the inner strike line in standard divertor configuration (with s coordinate origin at the pumping gap of the horizontal target on sample P0 in the middle).

Fig. 3. SEM images of sample P6T1 morphology (a–c) with corresponding EDX spectra (d–e) at points 1 and 2 marked in (c), from the erosion zone. Point 1 is located in the shallow cavity, while point 2 is at the flat surface. Images 3c and 3d show the same location imaged in SE and BSE modes, respectively.

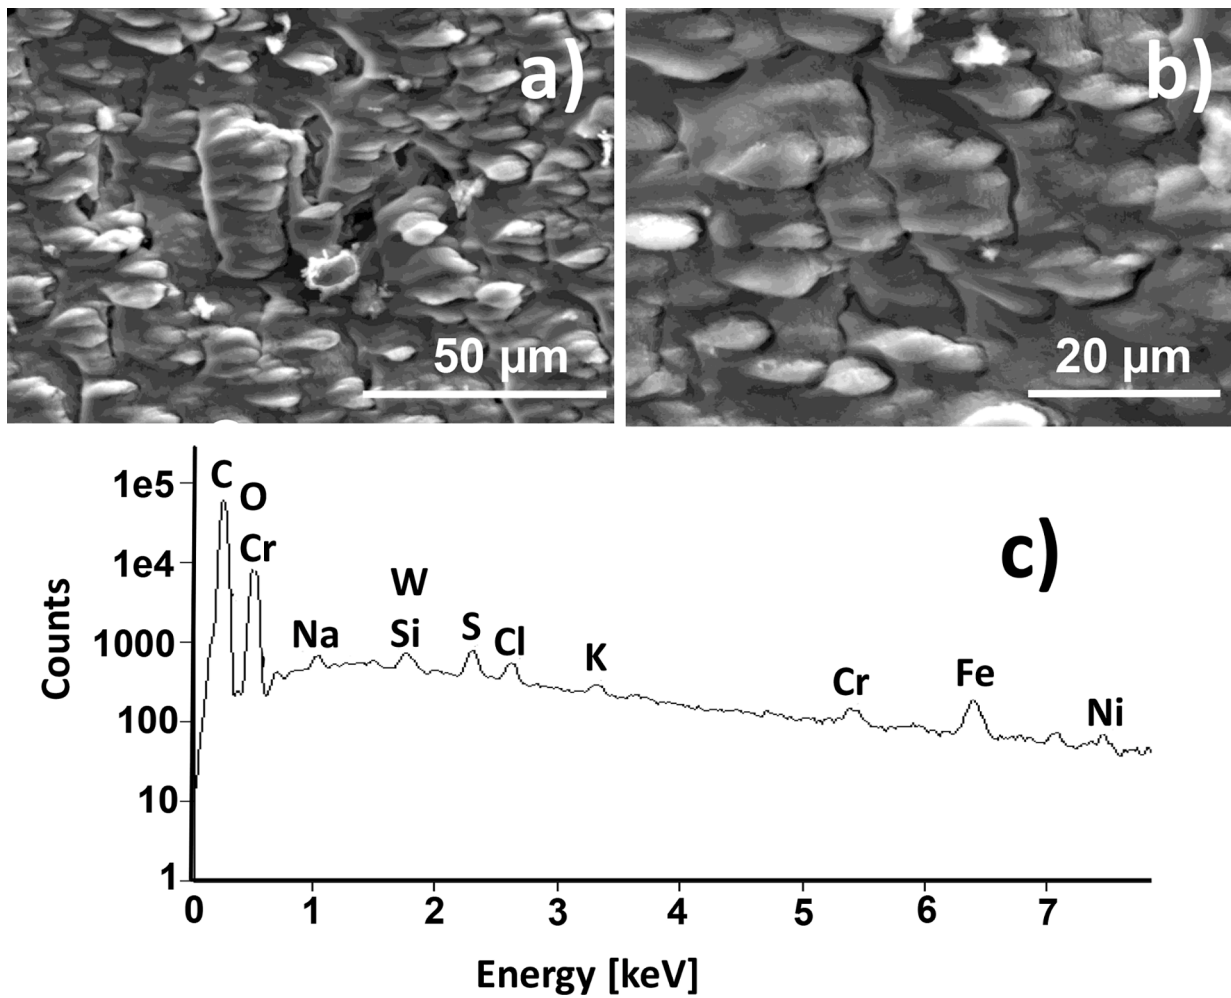
The deposition zone was located adjacent to the erosion zone. As shown in Fig. 4a–b, the surface of samples P8 and P9T1 were covered with a distinct, thick, scale-like deposit. In the case of sample P10, a relatively flat and thinner scale was observed. The registered EDX spectra proved that the main deposit constituents were carbon and oxygen. Additionally, the deposit included a small amount of iron and other steel components along with other impurities (S, Cl, and Na). It should be noted that S and Cl were not determined as exogenous impurities but were found in the deposits of the limiters after OP1.1 campaign [25].

Fig. 4. SEM images of sample P9T1 morphology (a-b) with corresponding EDX spectrum of area (c), in the deposition zone.

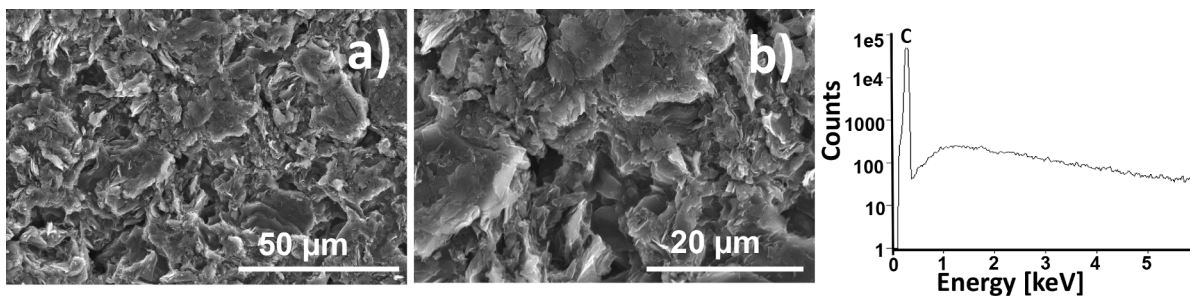
It was found that the target finger substructures located close to the outboard side did not show any evidence of redeposition or erosion (samples P17–P22). As shown in Fig. 5a–b, sample P21 possessed a tile surface in this zone, which was strongly developed, porous, and without characteristic directionality. The obtained EDX spectra showed only the presence of C signal (Fig. 5c). Hence, it was assumed that the morphology of the material in this area was similar to the original plate surface.

Fig. 5. SEM images of sample P21 morphology (a-b) with corresponding EDX spectrum of area (c), located in the region without direct plasma contact.

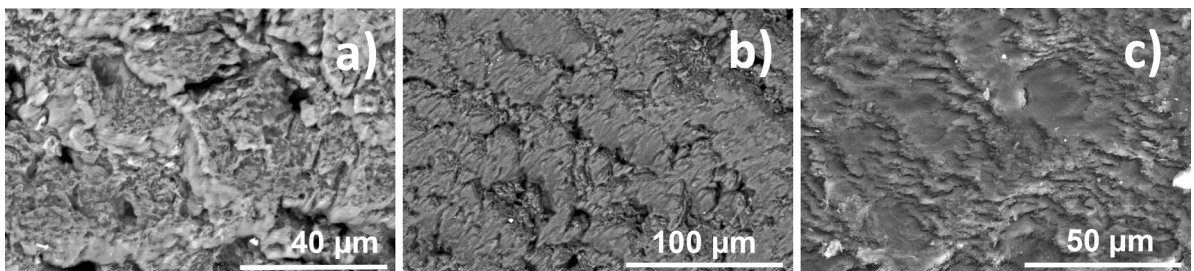
Fig. 6. SEM images of the surface morphology in the first transition zone: (a) sample P0, (b) sample P1, (c) sample P3.

side, and (ii) on the right from the region with strong redeposition. The first transition zone comprised of samples P0–P4. It should be noted that the surface morphology in this region was diversified (Fig. 6). In the case of sample P0, neither a clear layer of deposit nor a strongly eroded surface was detected. However, at the edges of the pores/surface cavities, a concentration of impurities was observed. Sample P1 was covered by a deposit. Sample P2 was partially eroded, although EDX measurements confirmed the presence of impurities on the surface indicating redeposition. Sample P3 showed another type of morphology, where the surface appeared to be trimmed with a razor. Part of sample P4 surface was significantly eroded, whereas another part had similar morphology to sample P3. In all cases, the characteristic surface directionality (the same direction as for the eroded areas) was determined.

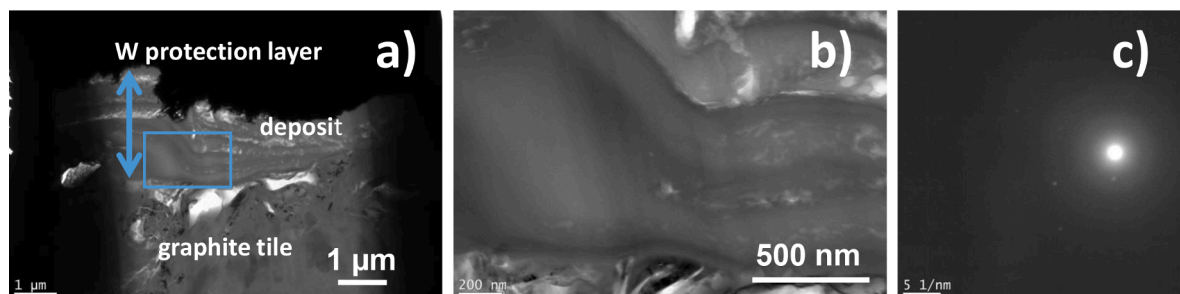
TEM images showing the structure of deposit grown on the surface of sample P9T1 and the corresponding electron diffraction pattern are presented in Fig. 7. The structure of the deposit was inhomogeneous and contained areas with significantly different porosity. Additionally, the layered structure of the deposit material was obvious. The deposit layer thickness was determined by TEM images and reached $2.7 \mu\text{m}$. The electron diffraction pattern shown in Fig. 7c, displays weak, diffused rings that indicated the material's amorphous structure.

Fig. 7. TEM images of the deposit structure (a-b) with the corresponding electron diffraction pattern (c), sample P9T1. Fig. b shows an enlarged image of the deposit marked with a frame in Fig. a.

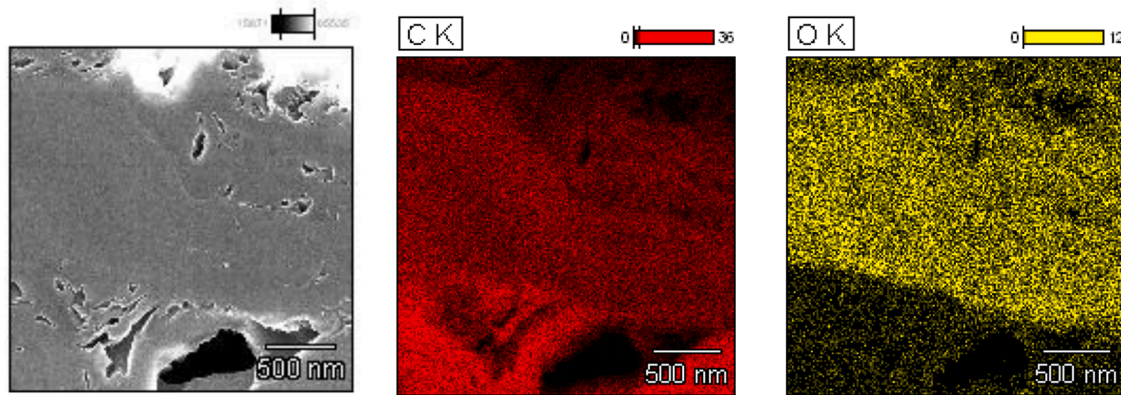
TEM analysis was complemented by EDX elemental mapping shown in Fig. 8, which displays the distribution of the main deposit constituents, carbon and oxygen, and revealed the enrichment of the deposit layer with oxygen. A comparable increase was reported previously [12]. The obtained result was consistent with the measurements carried out in the micro-areas on the surface.

Fig. 8. Distribution of carbon and oxygen in the deposit area, thin foil, sample P9T1.

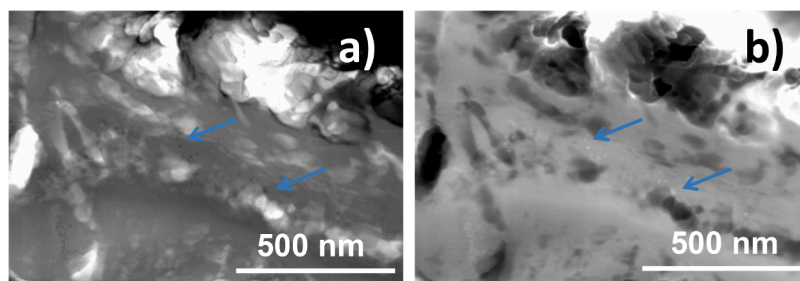
The bright and dark field STEM images recorded at 30 kV shown in Fig. 9 revealed that a certain amount of small particles were located in the porous layers of the deposit, but their precise identification was difficult. However, we supposed that these particles may be Fe-enriched regions. The iron enrichment was revealed in the iron profile of the redeposition zone at the divertor target (Fig. 14 in Sereda et al. [15]). The observed increase was related to He glow-discharge cleaning being performed frequently before boronization.

Fig. 9. STEM images of the deposit structure on sample P9T1, recorded in (a) bright and (b) dark field. The arrows indicate the deposited particles.

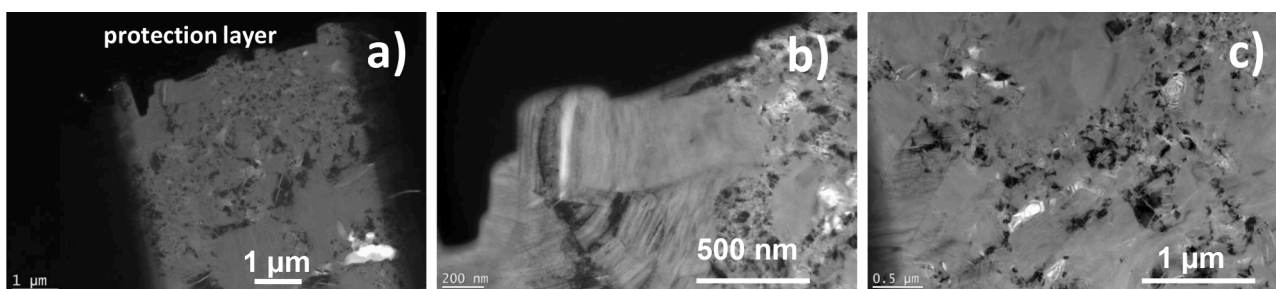
To examine the subsurface structure of the samples from the unchanged zone located close to the outboard side, a thin foil was cut out for TEM observation of sample P19T1. Images shown in Fig. 10 display both the sub-surface and graphite matrix structure. No deposit on the surface of the material was observed.

Fig. 10. TEM images of the structure of the material cut out from sample P9T1 from the region without direct plasma contact.

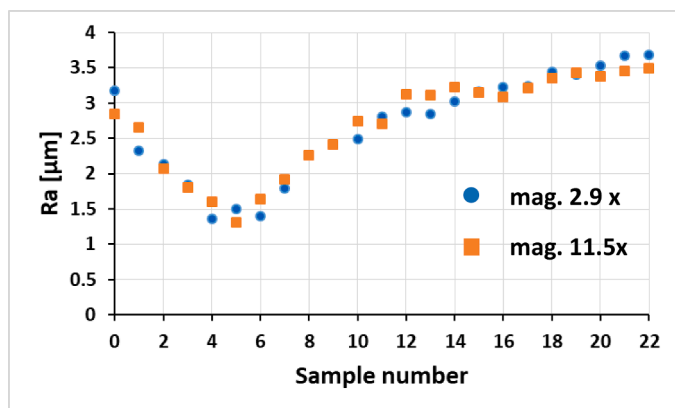
The image shown in Fig. 11 described changes in the surface roughness along the length of the tile at two magnifications $2.9 \times$ and $11.5 \times$. For the executed series of measurements, the values of standard deviation were relatively small and therefore were excluded from the graph. These amounted to 0.06 and $0.13 \mu\text{m}$ on average for magnifications of $2.9 \times$ and $11.5 \times$, respectively.

The obtained results showed very good agreement for the roughness distribution for both magnifications. The study revealed significant differences in surface roughness values along the length of the tile. Ra parameter for the strongly eroded zone reached the lowest level of 1.6 – $1.9 \mu\text{m}$ (mag. $11.5 \times$). The value showed a slight increase for the area with a deposit (2.3 – $2.5 \mu\text{m}$), whereas the areas that did not show significant surface damage were characterized by relatively high surface roughness, exceeding $3 \mu\text{m}$.

Fig. 11. Changes in surface roughness, Ra along the length of the tile. Measurements carried out at the magnifications of 2.9 and 11.5 show good agreement.
