Tube failure during long-term exposure to flowing lead-bismuth eutectic (LBE)

Carsten Schroer, Olaf Wedemeyer, Aleksandr Skrypnik, Josef Novotny, Jürgen Konys

INSTITUTE FOR APPLIED MATERIALS – MATERIAL PROCESS TECHNOLOGY (IAM-WPT)

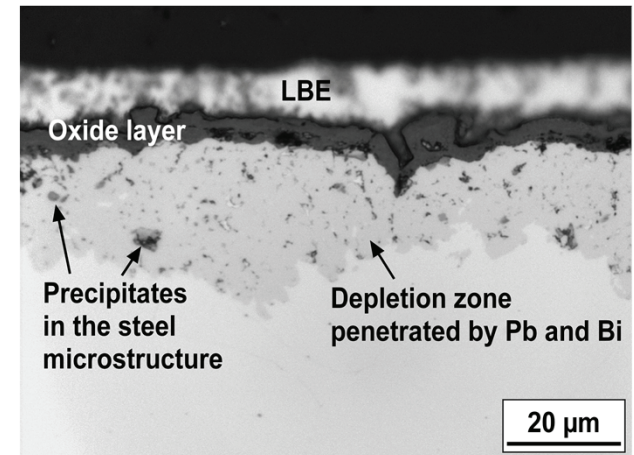
- Typical scale observed for some of the tube samples from the CORRIDA loop

Tube sample taken from the CORRIDA loop after exposure for ~23,000 h to flowing oxygen-containing LBE at 550°C

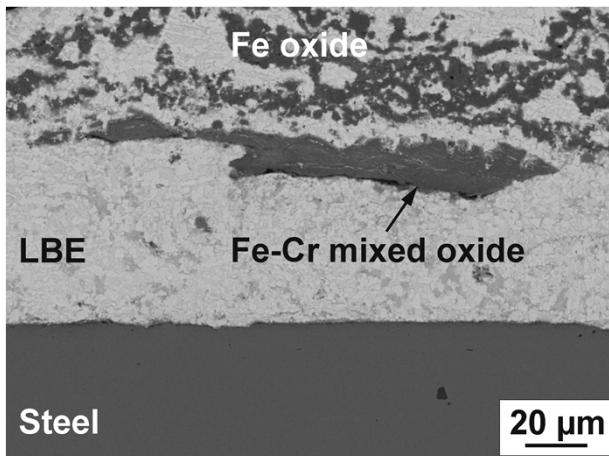
□ Sample T5 after 40,000 h at 385°C

- Position after the cooler, before magnetic trap
- No significant change in wall thickness after the long-term exposure
- Oxide deposits in adherent solidified LBE, but only in some distance from the tube wall
- Neither deposits nor significant amounts of oxide on the surface

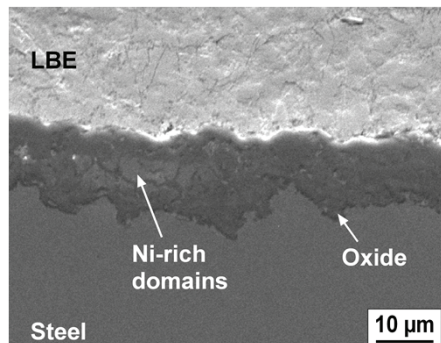
Oxide scale on T3

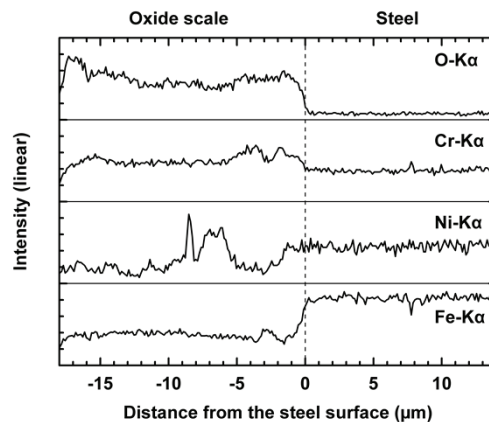
- T3 (6000 h) and T4 (40,000 h) mainly show oxidation; T3 was not pre-oxidised
- T1 (23,000 h) and T2 (29,000 h) show significant selective leaching

Corrosion scales typically observed on T1 and T2

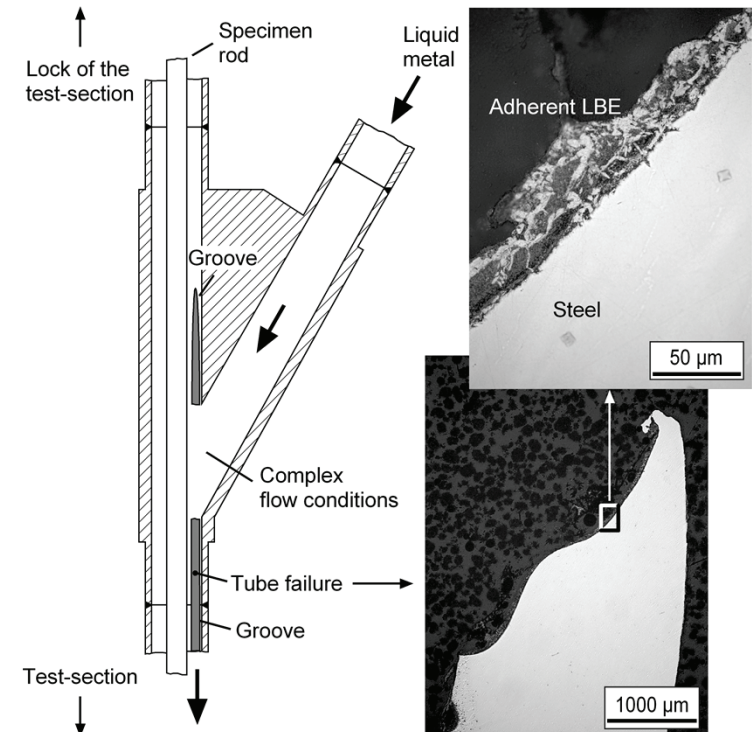
❑ After 29,000 h, at the inlet of the second test-section

- ❑ Hole the size of a pinhead in the straight bottom part of the approximately Y-shaped inlet piece
- ❑ Failure occurred inside a vertical groove that is interrupted at the junction where the liquid metal enters the test-section tube
- ❑ Adherent LBE observed inside the groove, but none of the corrosion scales typical for the steel
- ❑ Erosion caused by the complex liquid-metal flow in the inlet piece was identified as main reason for tube failure
- ❑ Replacement of the inlet piece by a re-designed part
- ❑ Inlet piece of the first test-section was operated for 66,000 h without major damage

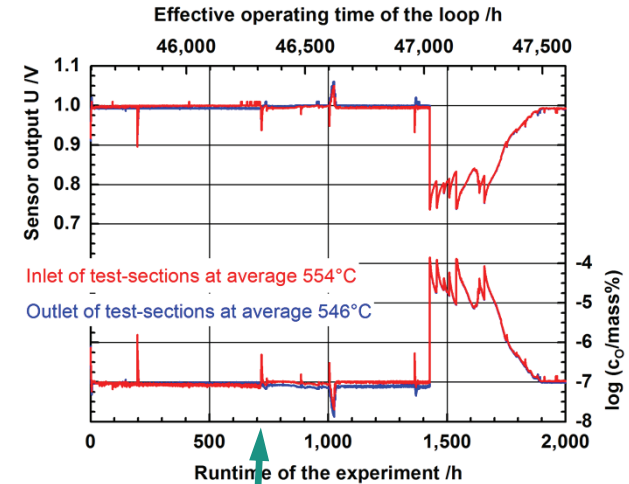
❑ Tubing of the first test-section after 66,000 h

- ❑ During experiment at 550°C/10⁻⁷ mass% O
- ❑ Prior to that, experiments at 450°C and 550°C/10⁻⁶ mass% O and pre-conditioning for 550°C/10⁻⁷ mass% O
- ❑ Ø10 mm leak in Position C that corresponds to the bottom end of the specimen rod
- ❑ **The particular specimen in this position (9Cr steel) was heavily corroded!**
- ❑ Up- and down-stream specimens inconspicuous
- ❑ Oxygen sensors did not indicate excessive oxygen consumption in the test-sections
- ❑ Problems with maintaining constant flow and sudden release of oxygen into the LBE

Tube failure after 715 h of the experiment at 550°C/10⁻⁷ mass% O

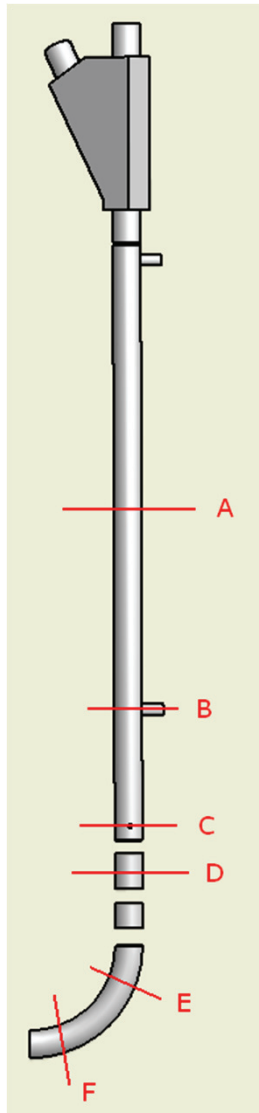
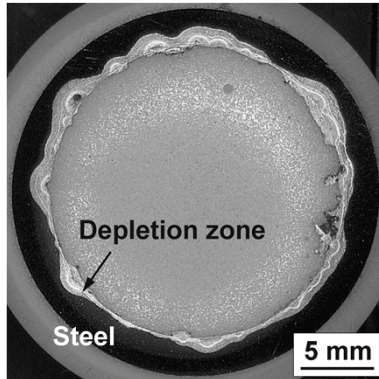
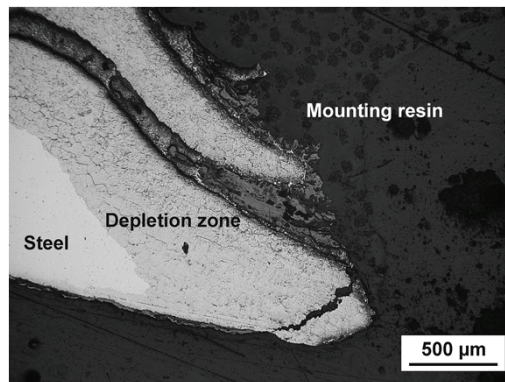
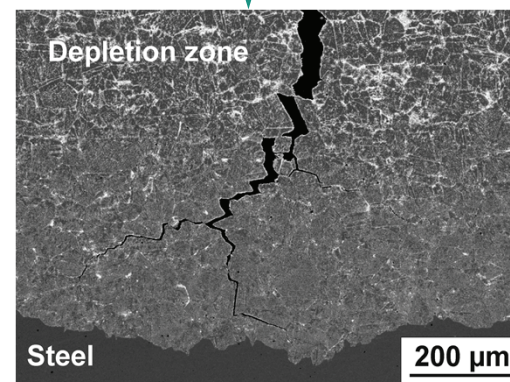
Cross-section in Position A

Site of failure

Positions A, B, C

- Severe selective leaching along nearly the complete inner tube surface
- Depletion zone locally reaches outer tube surface
- Cracking of the mechanically unstable depletion zone probably is the ultimate cause of failure in Position C

In a cross-section nearby the site of failure

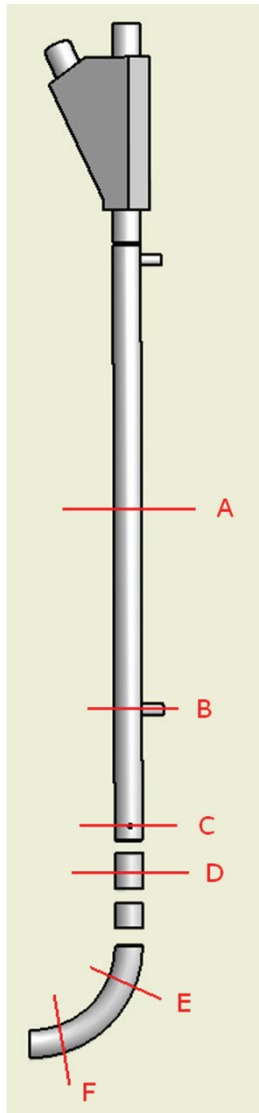
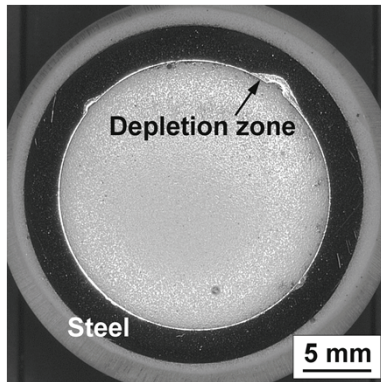
Cross-section in Position D

Positions D, E, F

- Severe selective leaching is a local rather than general phenomenon
- Qualitatively similar in overall appearance to tube samples T1 (23,000 h) and T2 (29,000 h)
- Absence of specimens inside the tube is the obvious difference to Positions A, B, C
