First results of the QUENCH-17 bundle test on debris formation

SARNET2: WP5-COOL Review Meeting

Objectives of the QUENCH-17 test

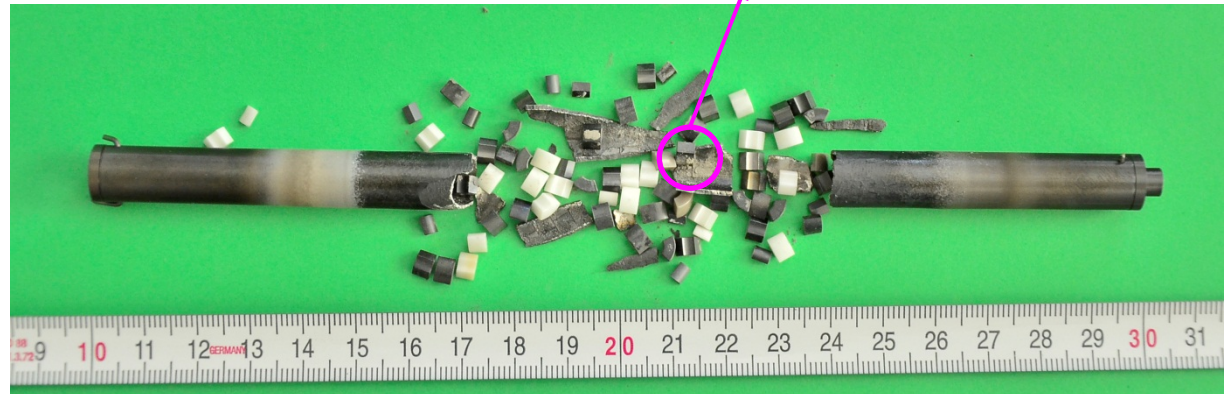
sample was destroyed during handling

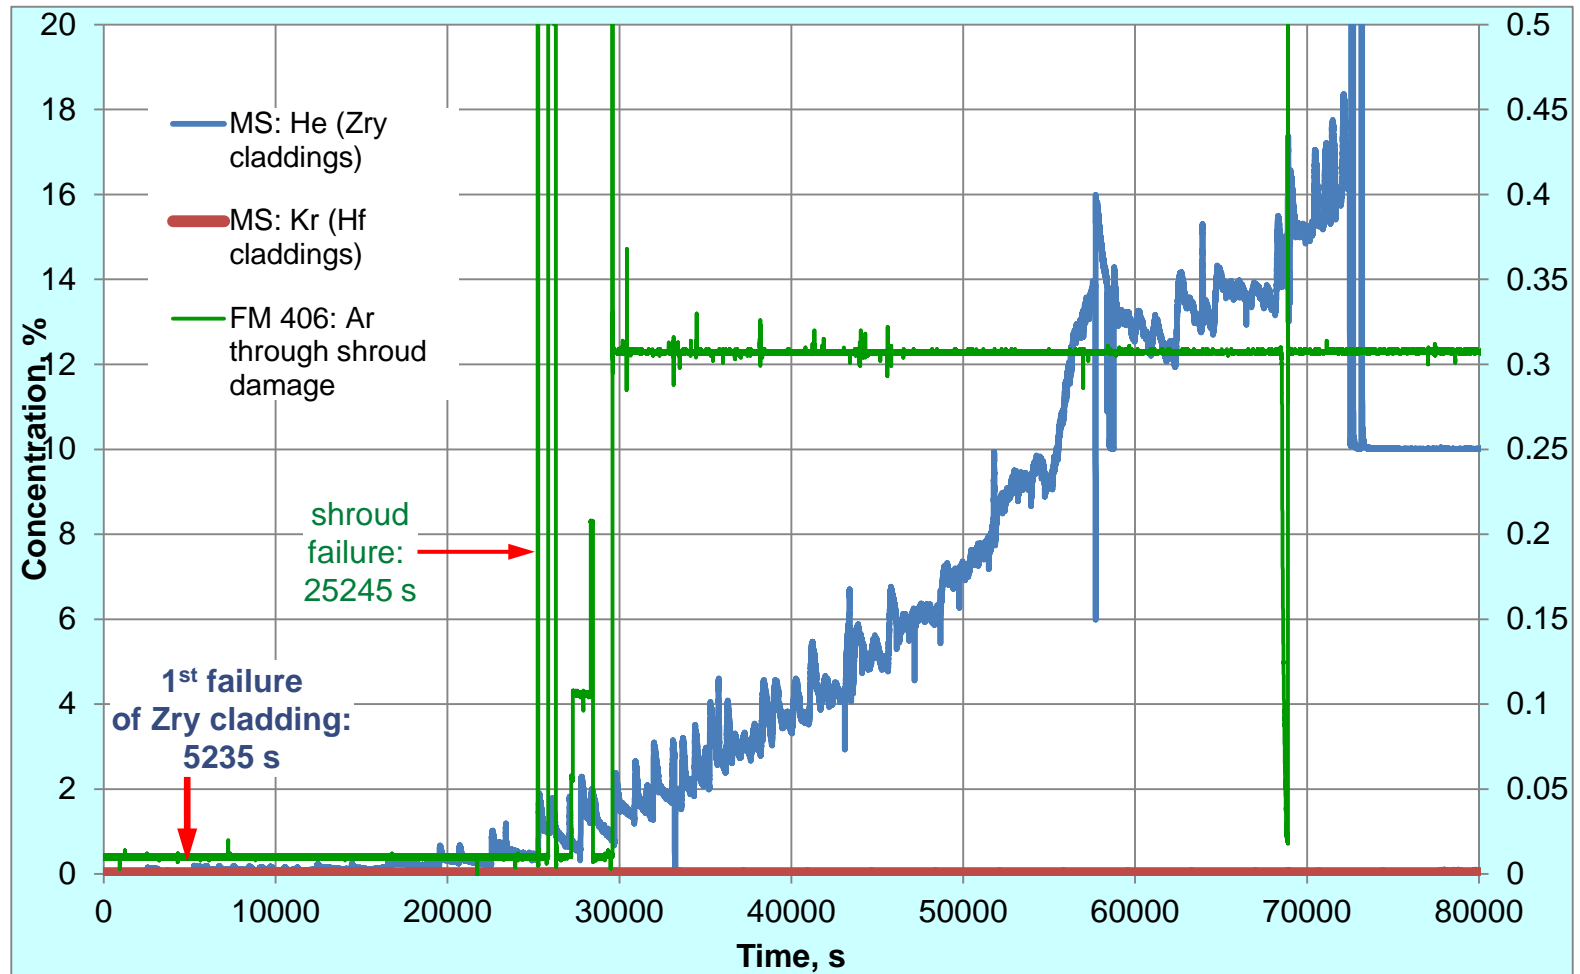
Failures of Zry claddings and Hf shroud

no failure of Hf claddings was registered

- Hf claddings of heated rods were intact during whole test, Hf shroud was failed at 850 mm after 25000 s.
- First failure of Zry-4 cladding was registered at 5500 s. Noticeable internal oxidation was observed at upper bundle elevations.

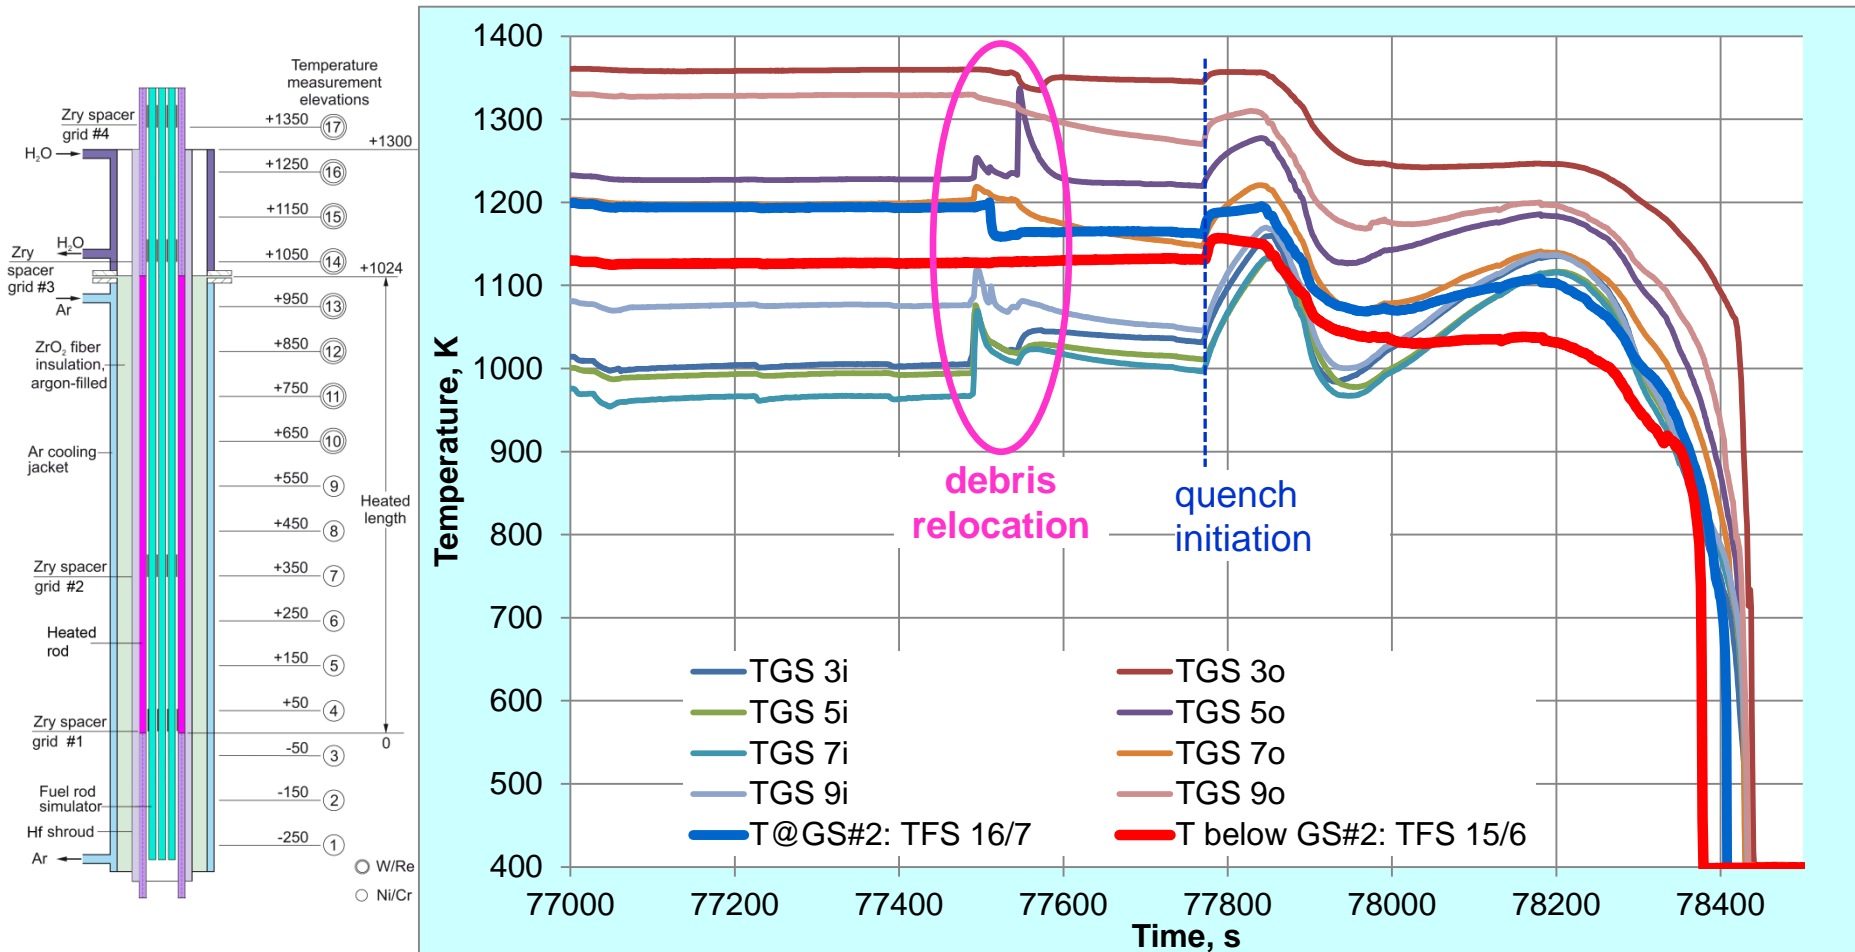
Indication of debris relocation to GS#2 (reaction of thermocouples TGS installed at the top of GS#2)

- Mechanical impact on the end of pre-oxidation caused debris relocation to grid spacers at 1050 mm and 350 mm.
- Steam production rate was stagnated during propagation of flooding water through the debris collected above grid spacers at 350 mm.

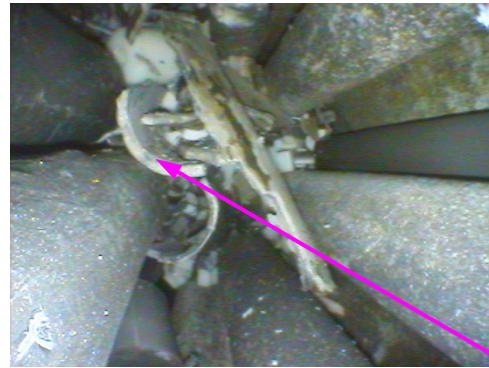
debris of oxidised cladding and pellets on the top of GS#3

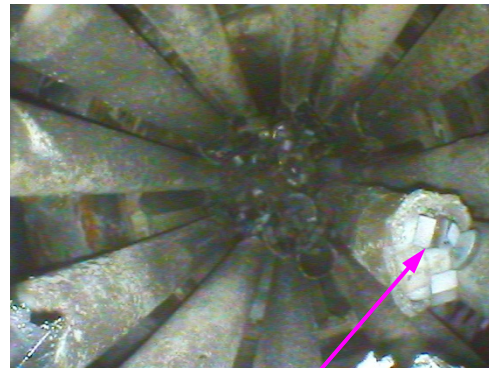
1200 mm: segmented pellets inside remnant of rod #8

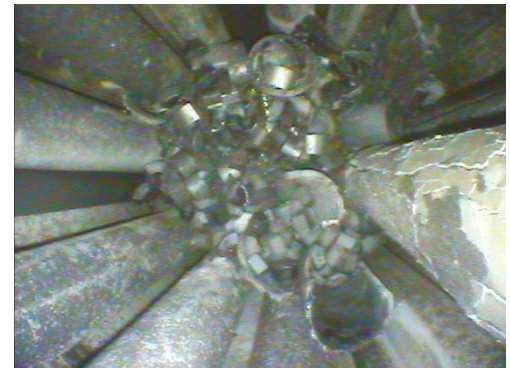
1100 mm: debris relocated downwards from removed nine test rods

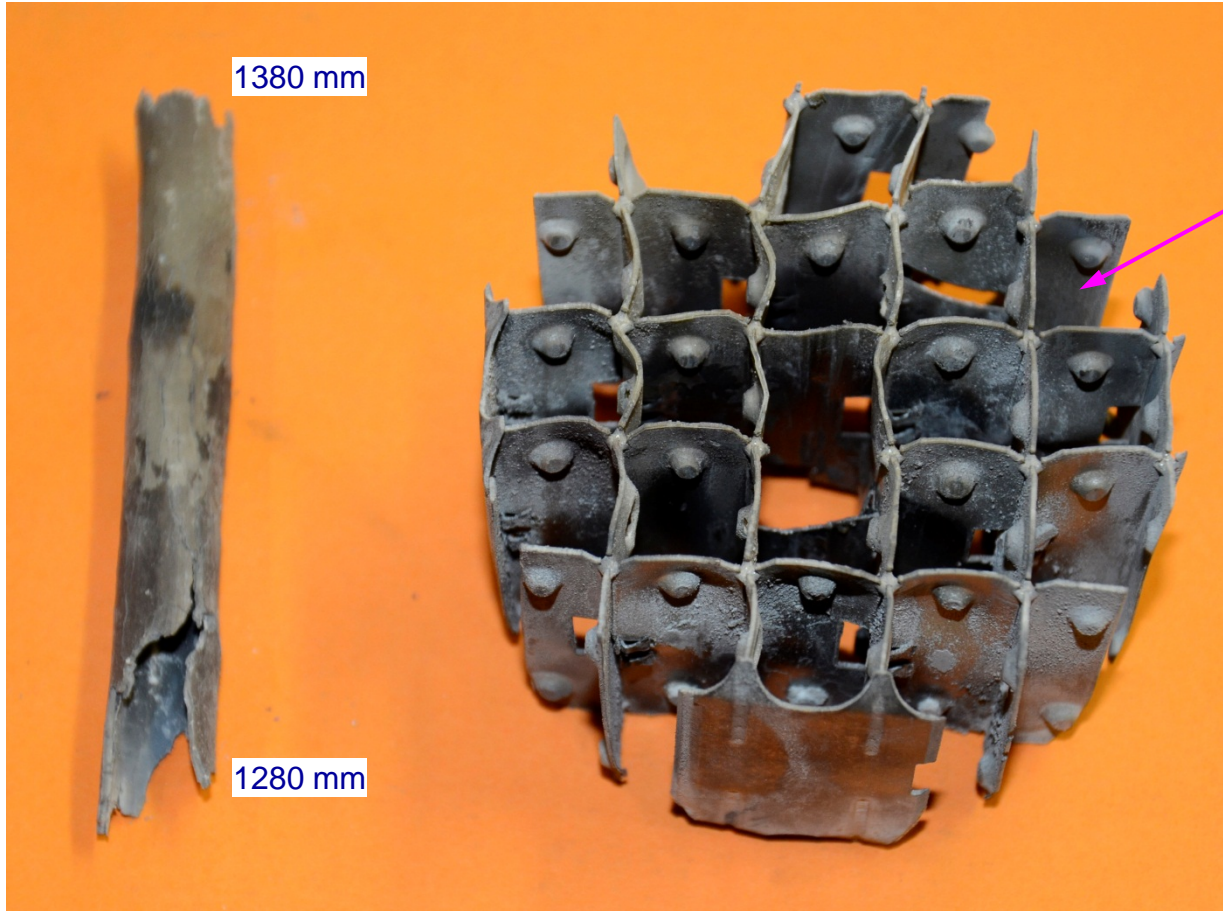
Withdrawn grid spacer #4 (1350 -1390 mm) and remnant of cladding relocated downwards from spacer

remnant of rod #8:
significantly oxidised

GS #4:
completely oxidised

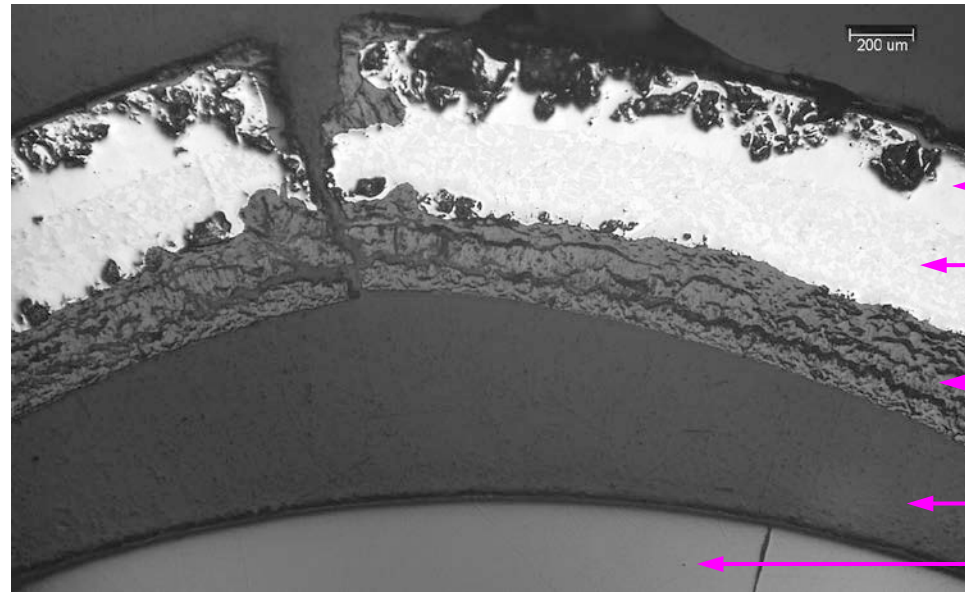
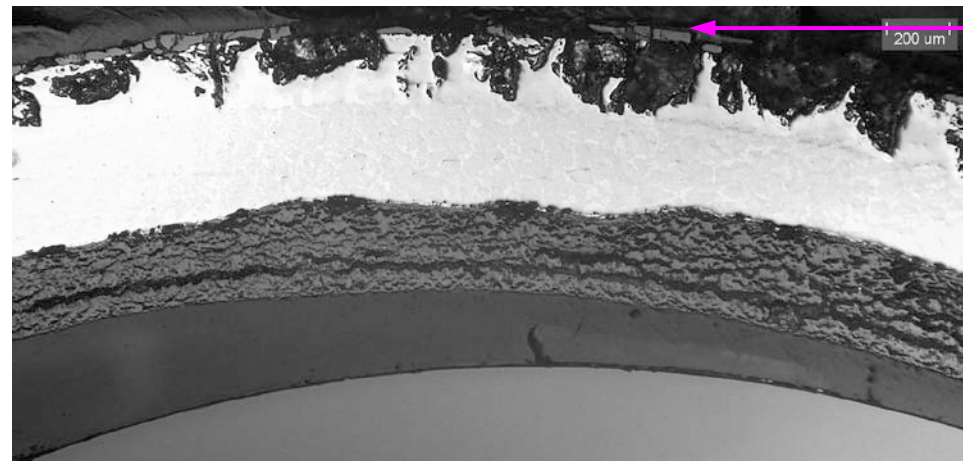
Structure of oxidized Zry cladding at 1328 mm, T ≈ 1000 K. Stab #7.

thick inner
oxide layer

thin outer ZrO₂
(starvation, spalling?)

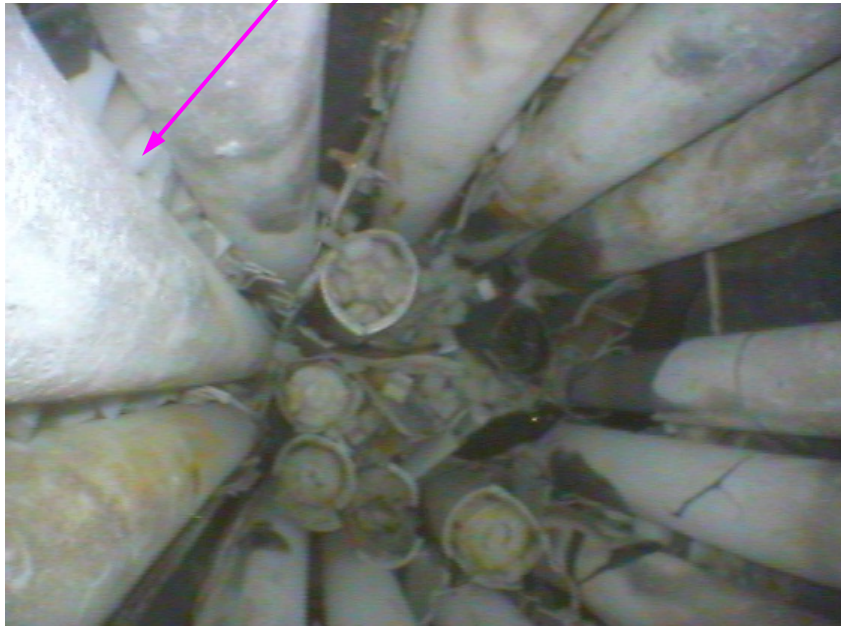
Top view of grid spacer #3 (1090 mm)

pellet segments
between heated rods

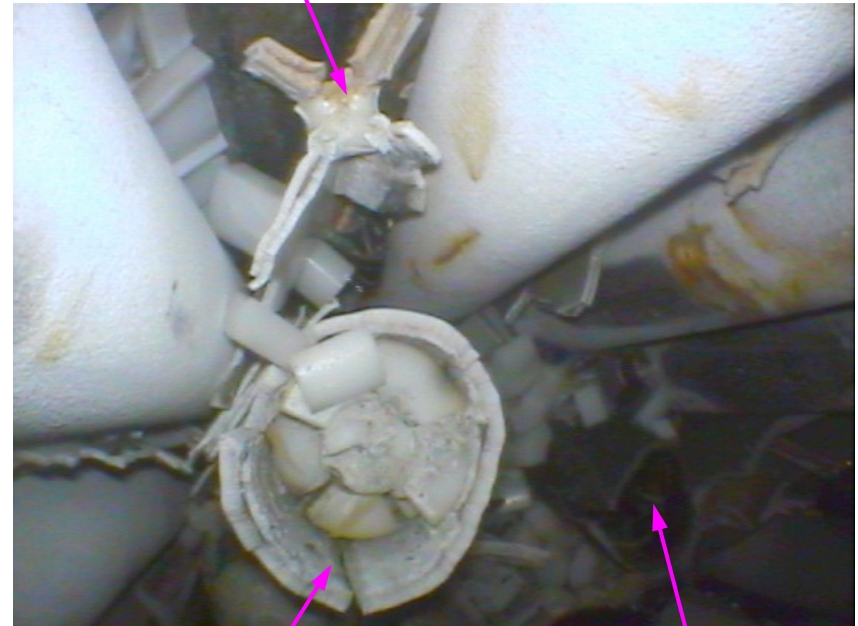
completely oxidised GS #3

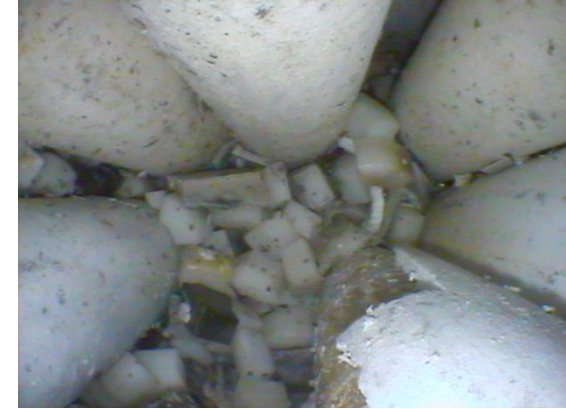
blockage at elevation 910 mm

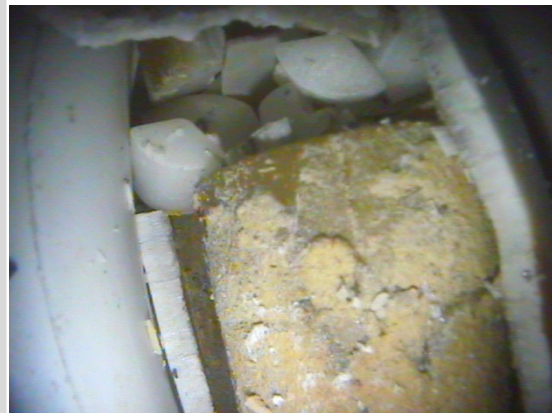
sintered pellets at 950 mm

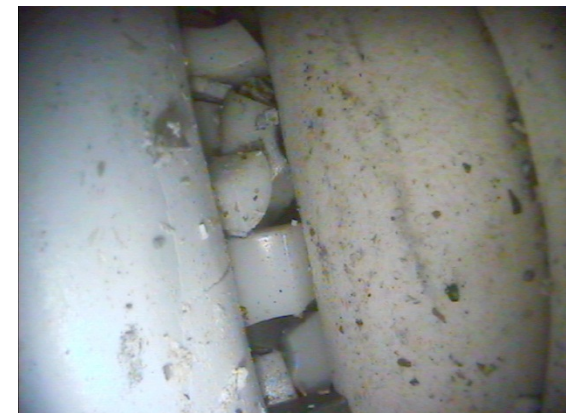
pellet segments at 920 mm
between Zry and Hf claddings

- Some Zry-4 claddings were not significantly damaged; the pellet segments relocated from the failed rods were captured between corresponding neighbour rods.

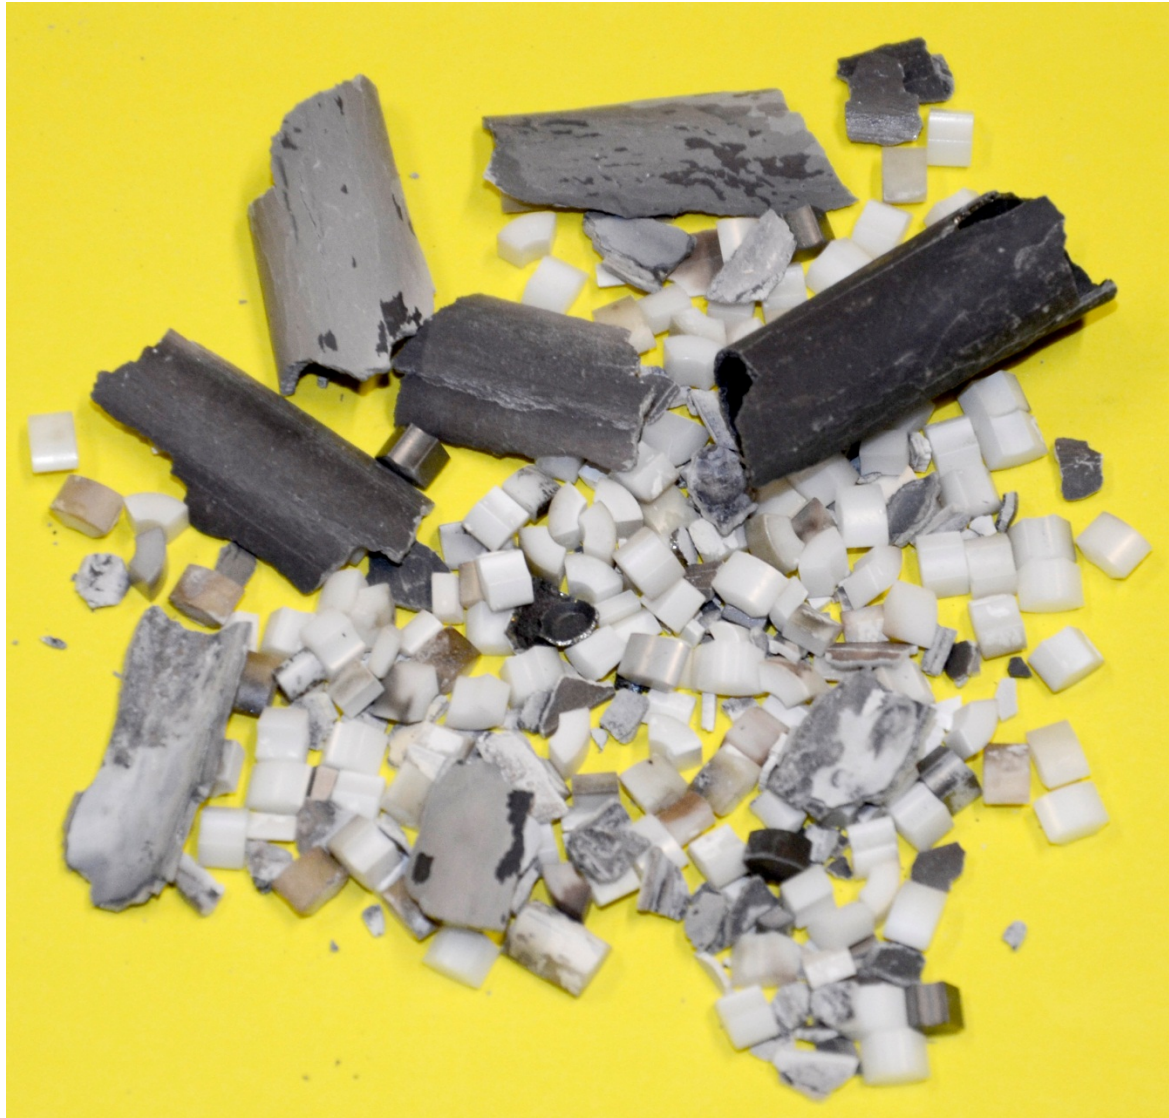
Debris collected at the top of grid spacer #3 (1090 mm)

- Ceramics debris collected at the top of spacer at 1050 mm consist of separate pellet segments and relatively large cladding segments.
- Tomographical and metallographical investigations of region above grid spacer 350 mm should give detailed information on the degree of bundle degradation.
