KfK 3769
August 1986

Post Test Investigation of the Bundle Test ESBU-1

**On Temperature Escalation in PWR Fuel
Rod Simulator Bundles due to
the Zircaloy/Steam Reaction**

**S. Hagen, H. Kapulla, H. Malauschek,
K. P. Wallenfels, B. J. Buescher**
**Hauptabteilung Ingenieurtechnik
Projekt Nukleare Sicherheit**

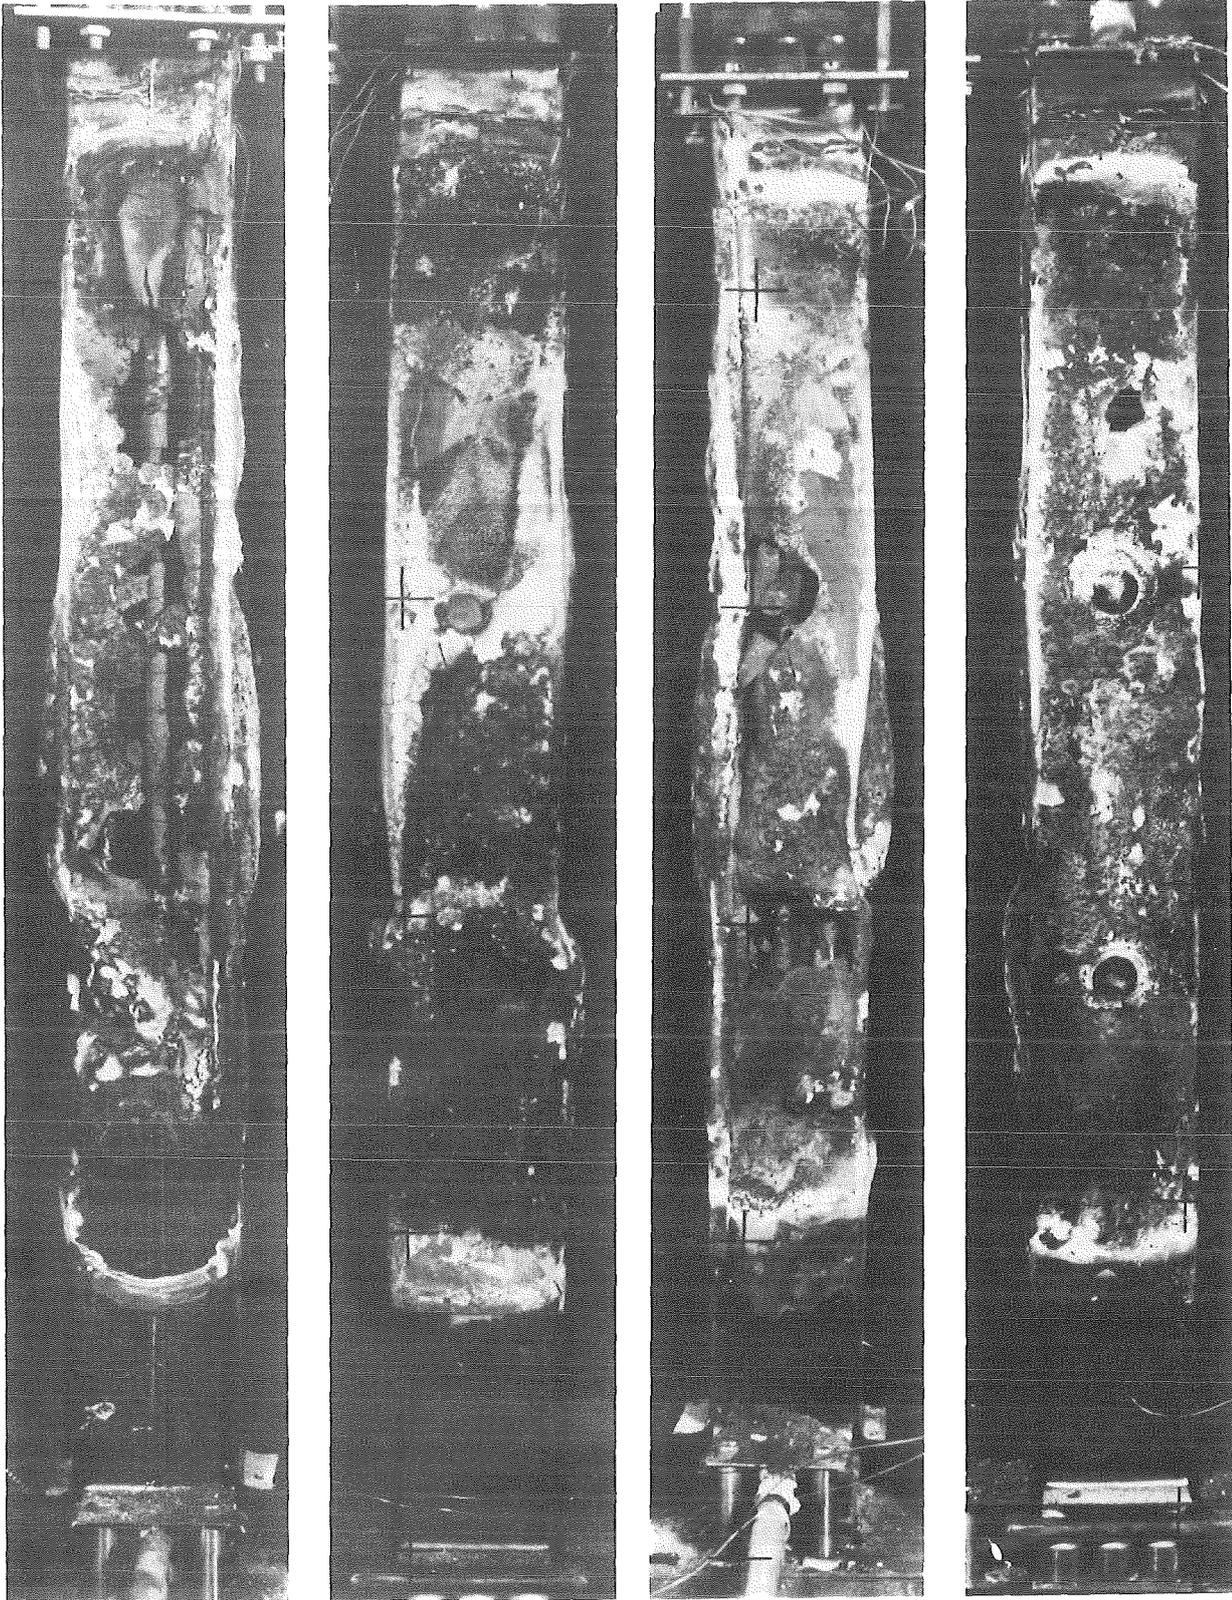
FIGURE 4: FOUR ORIENTATIONS OF THE ESBU-1 SHROUD AFTER REMOVAL OF THE INSULATION

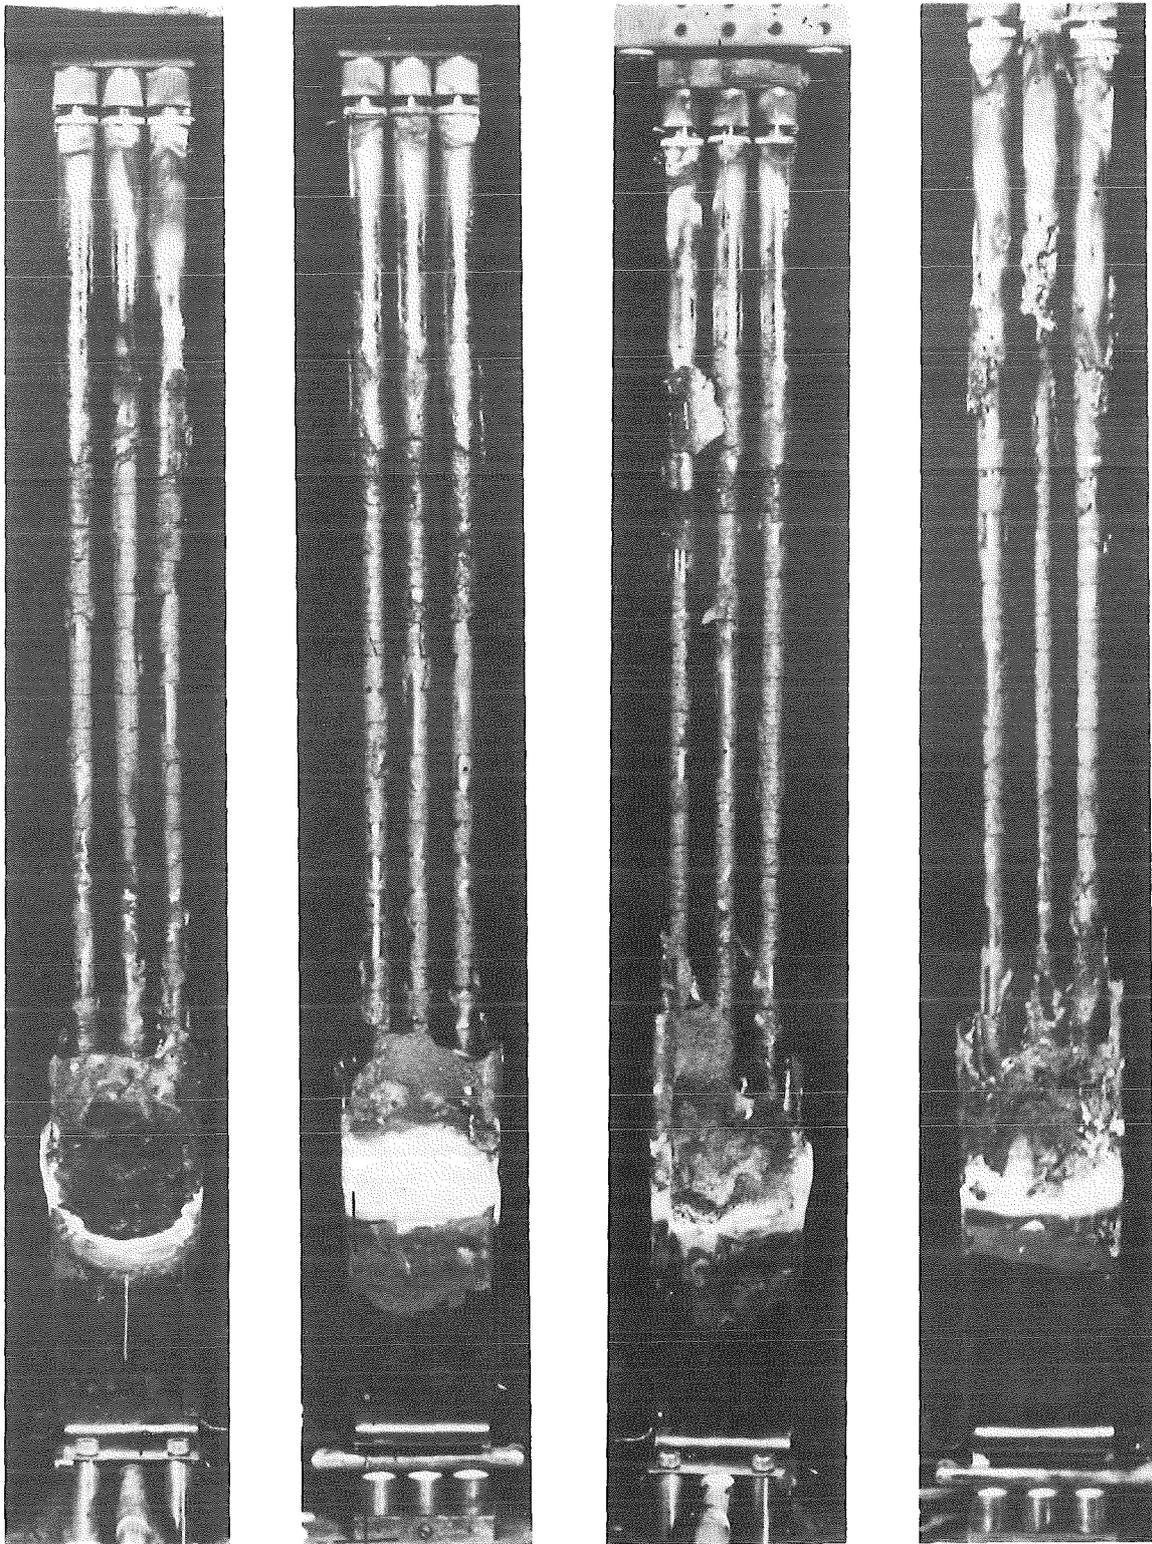
Figures 5 and 6 show the fuel rod simulators after removal of the shroud. The cladding from all nine rods has melted over the center portion of the bundle, liquefied some of the UO_2 fuel and formed a molten mixture which flowed down the rods. The molten mixture has frozen in a solid mass near the bottom of the bundle which substantially blocks the coolant flow channels. The upper end of the bundle contains intact but oxidized zircaloy cladding. In the middle region, only a thin layer of UO_2 and some fragments of pellets stuck to the tungsten rod can be seen. Figure 6 shows the lower part of the bundle after removal of the shroud from above and below the blockage. In this figure one can see metallic looking zircaloy near the steam inlet changing to oxidized zircaloy near the blocked region.

FIGURE 5: 3x3 BUNDLE OF ESBU-1 AFTER REMOVAL OF THE UPPER PART OF THE SHROUD

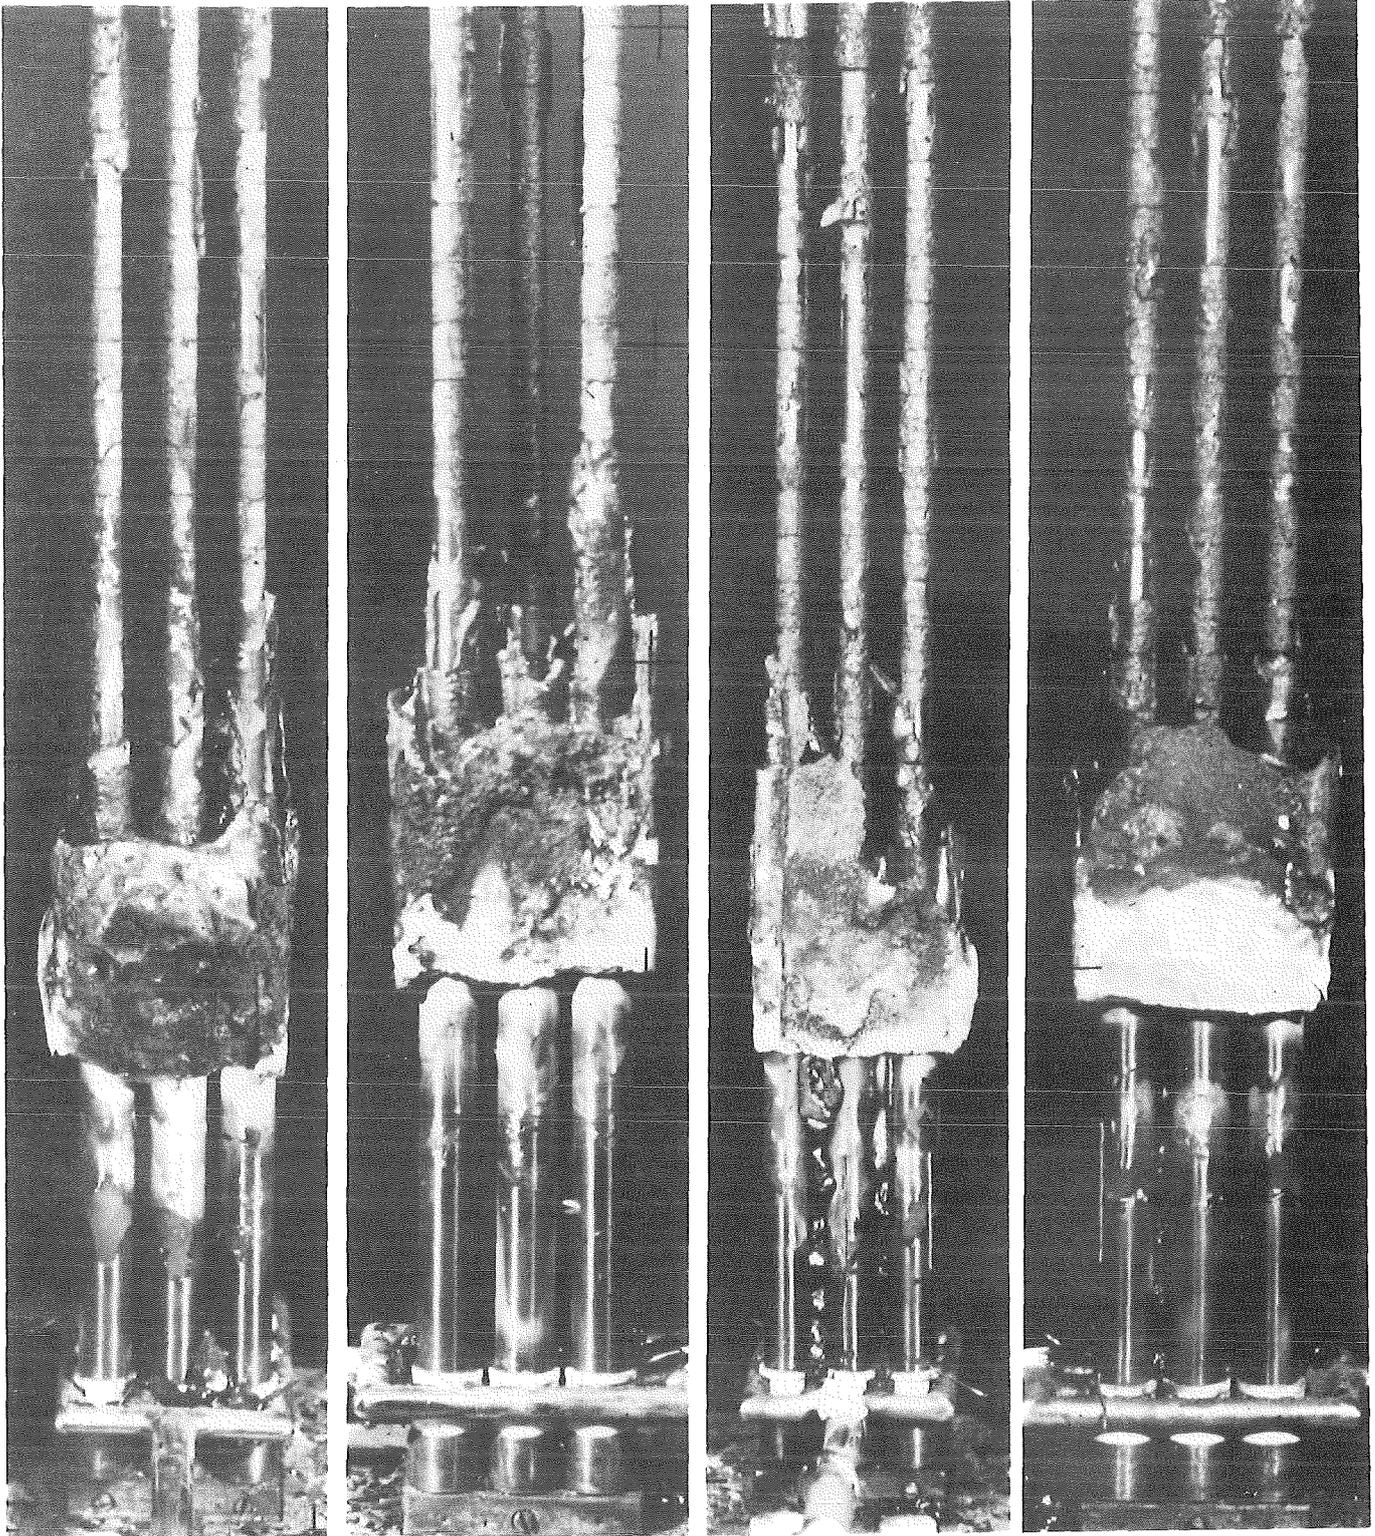
FIGURE 6: LOWER REGION OF ESBU-1 AFTER REMOVAL
OF THE SHROUD

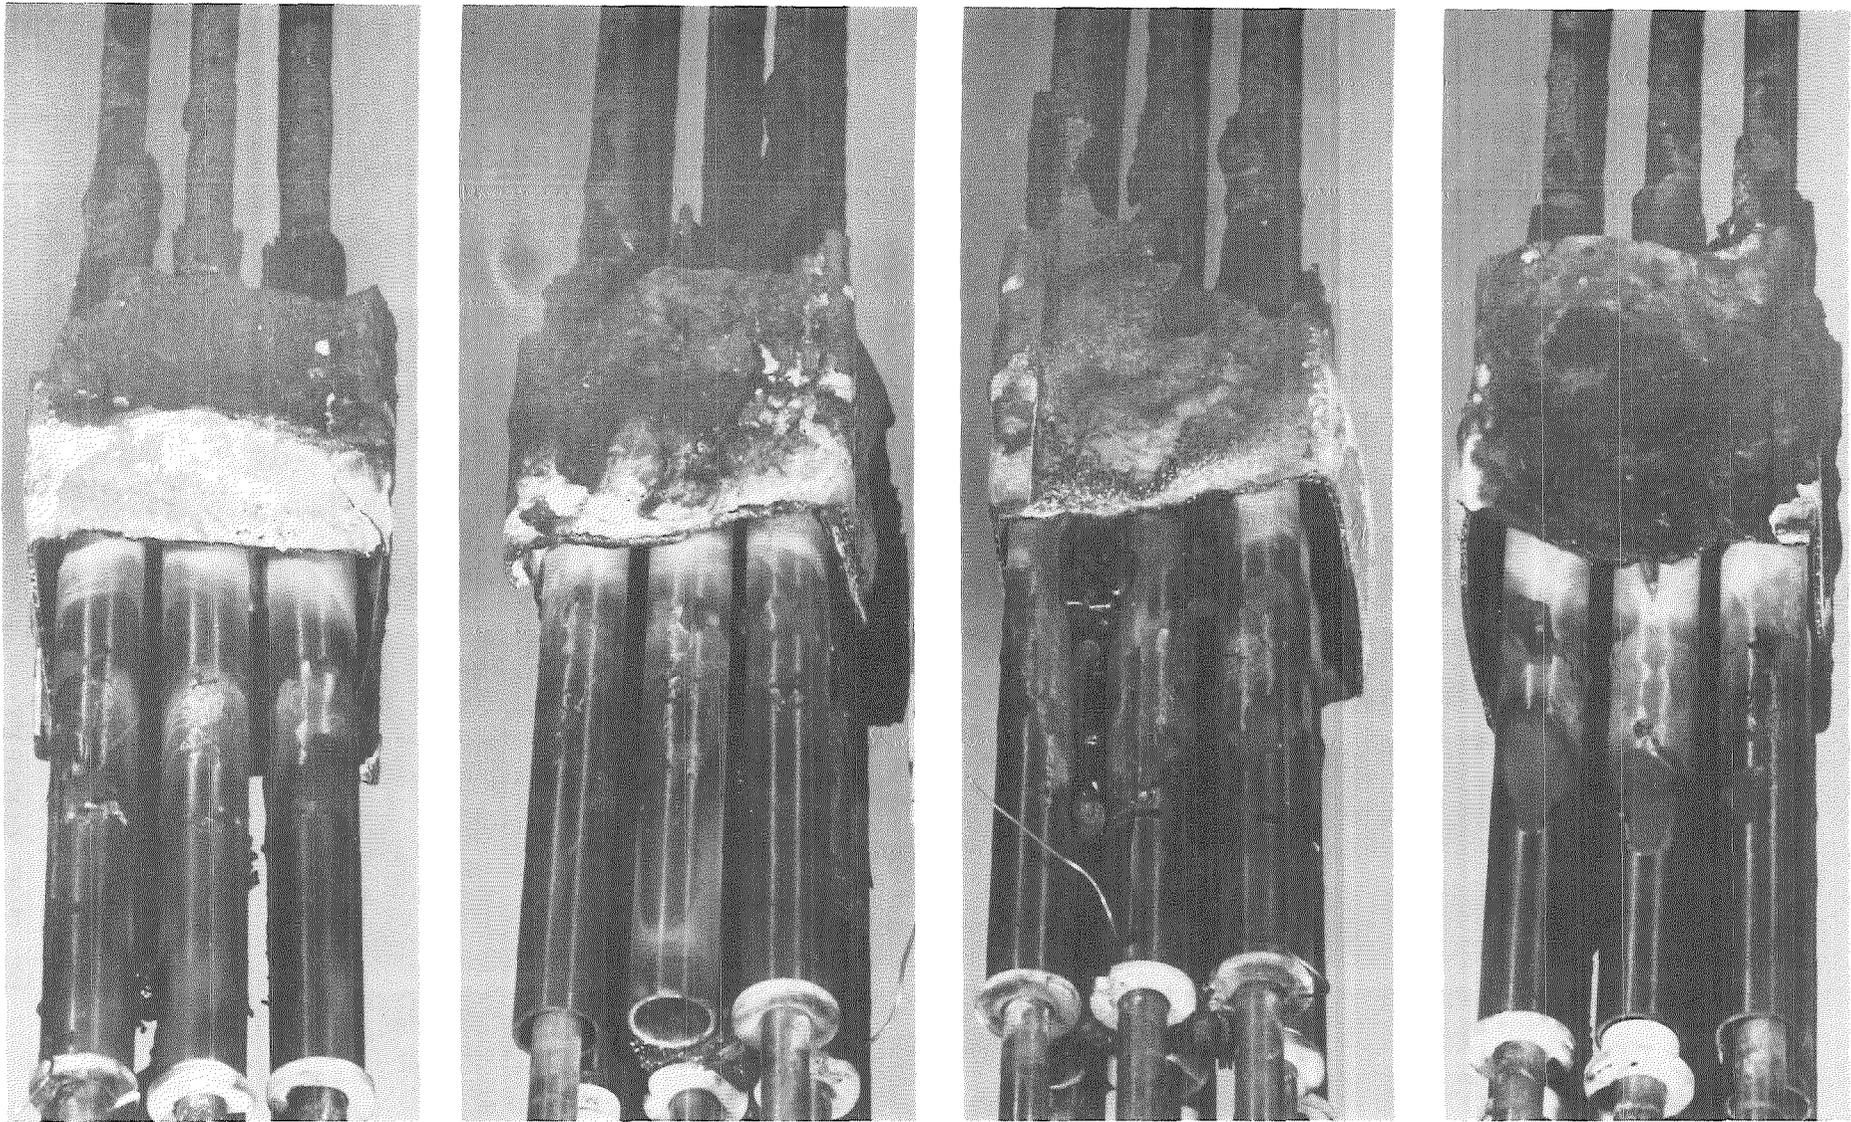
Figures 7 and 8 show the detail of the lower bundle region as seen from below. Oxide spalling is evident as are refrozen drops of liquefied material. The frozen melt shows poor wetting of the solid surface as indicated by the large wetting angles and small contact areas. Melt viscosity, oxygen content, and the relatively cold fuel rod simulators probably influenced the behaviour in this region.

FIGURE 7: APPEARANCE OF THE BLOCKED REGION OF ESBU-1 AS SEEN FROM BELOW

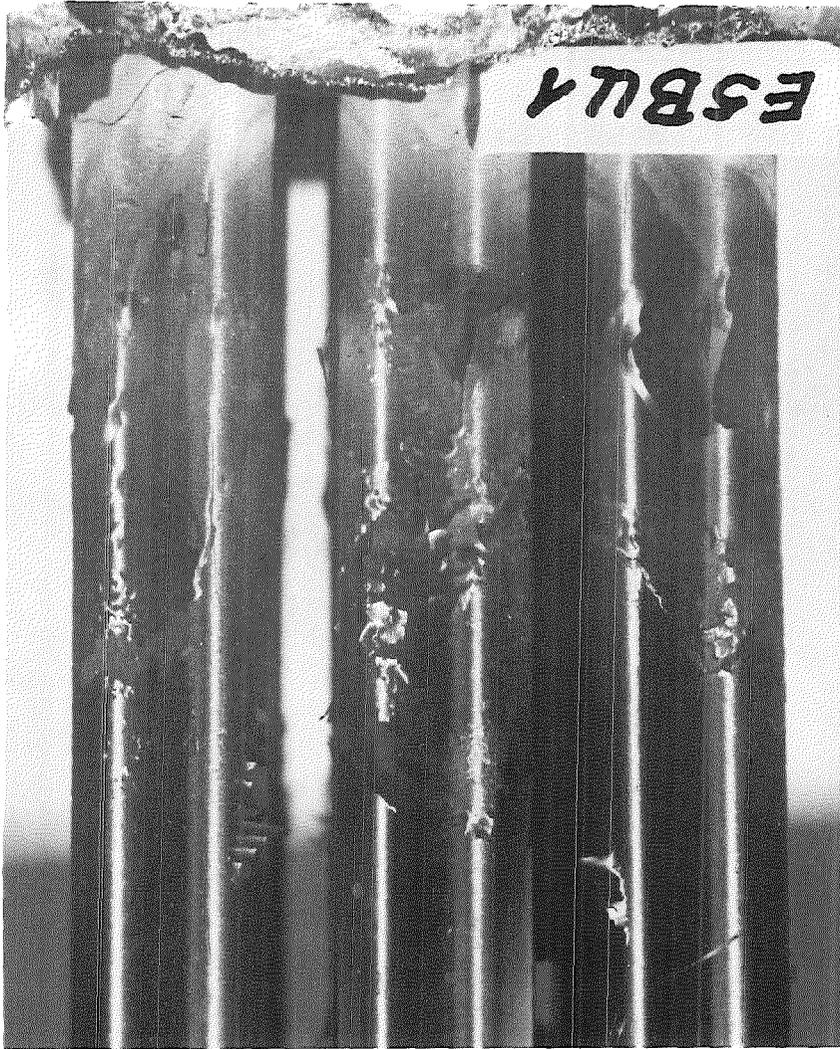
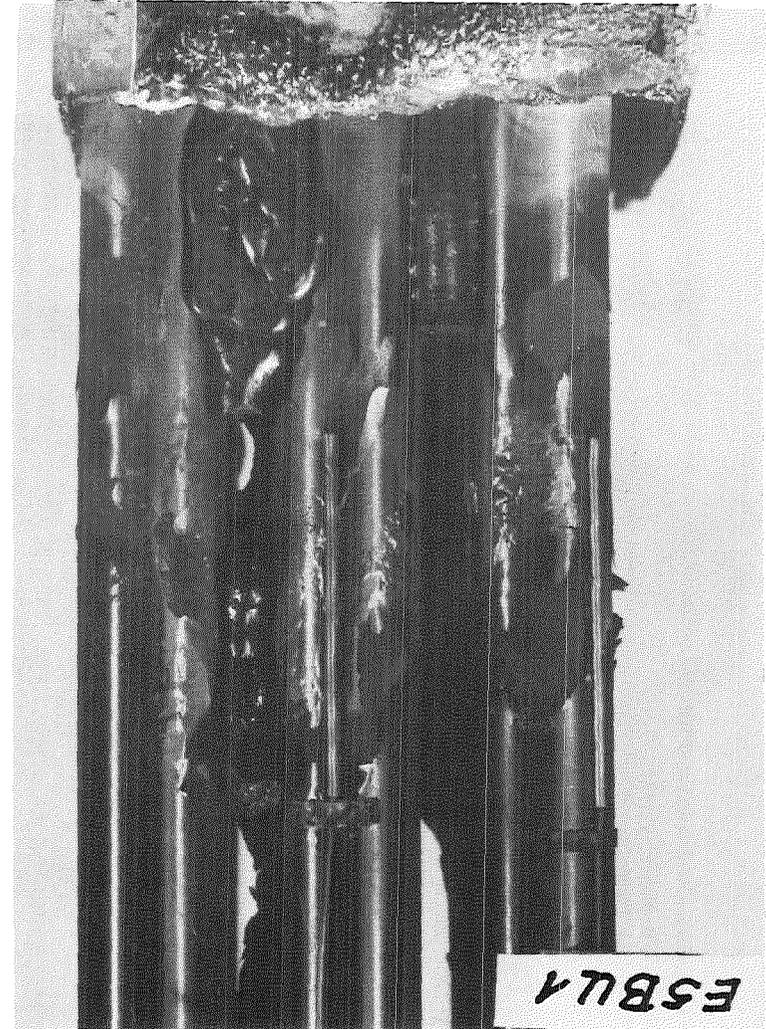
FIGURE 8: DETAILS OF OXIDE SPALLING AND REFROZEN MELT OF ESBU-1 BELOW BLOCKED REGION

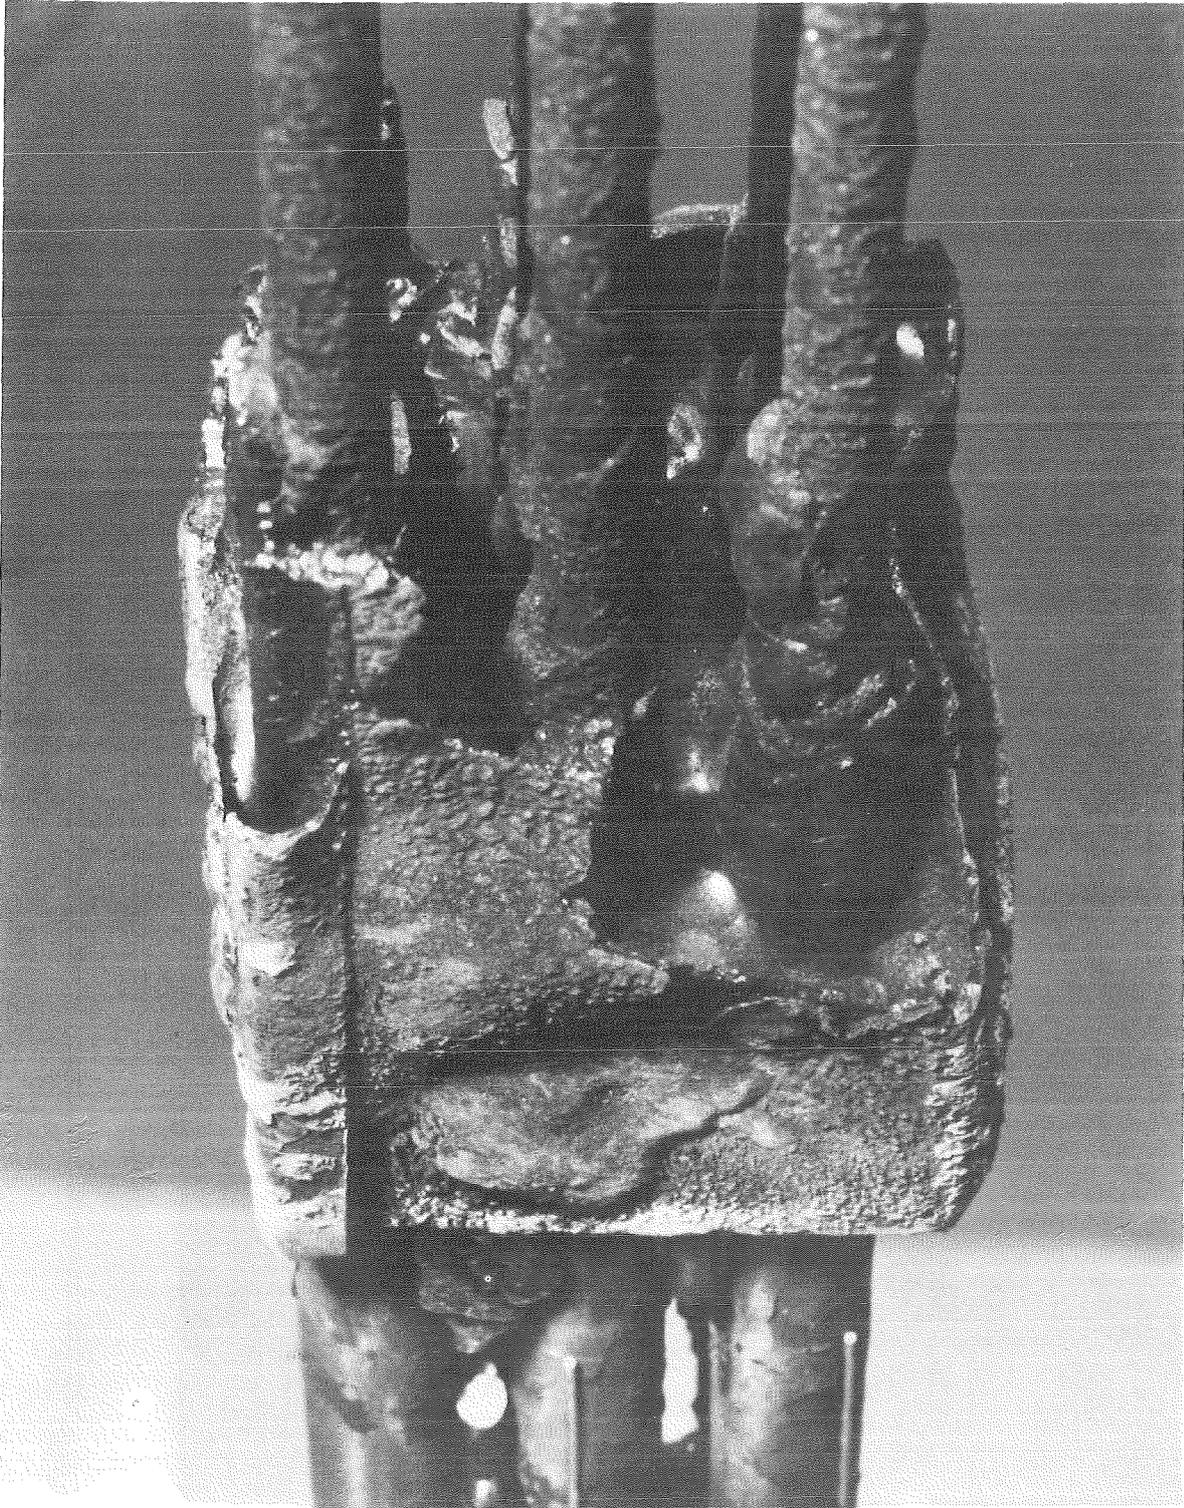
The appearance of the blocked region from above is shown in Figures 9 through 11. The frozen melt has a smooth surface and has wet what is remaining of the simulators rather well (small wetting angle and large contact surface). This is clear evidence of an interaction of the melt with the oxidized fuel rod simulators. The composition of the melt and these interactions are the primary subject of the posttest examination. A large amount of powdery rubble, not shown in these photographs, was found on top of the blockage.

The smooth upper surface of the blocked region (Fig. 11) with loose powder lying on top of the blockage indicates that the powder must have fallen down onto the melt after it was frozen and that the fragmentation of the upper part of the bundle happened during cooldown.

FIGURE 11: ENLARGEMENT OF THE BLOCKED REGION OF ESBU-1
ILLUSTRATING THE WETTING BEHAVIOR OF THE MELT

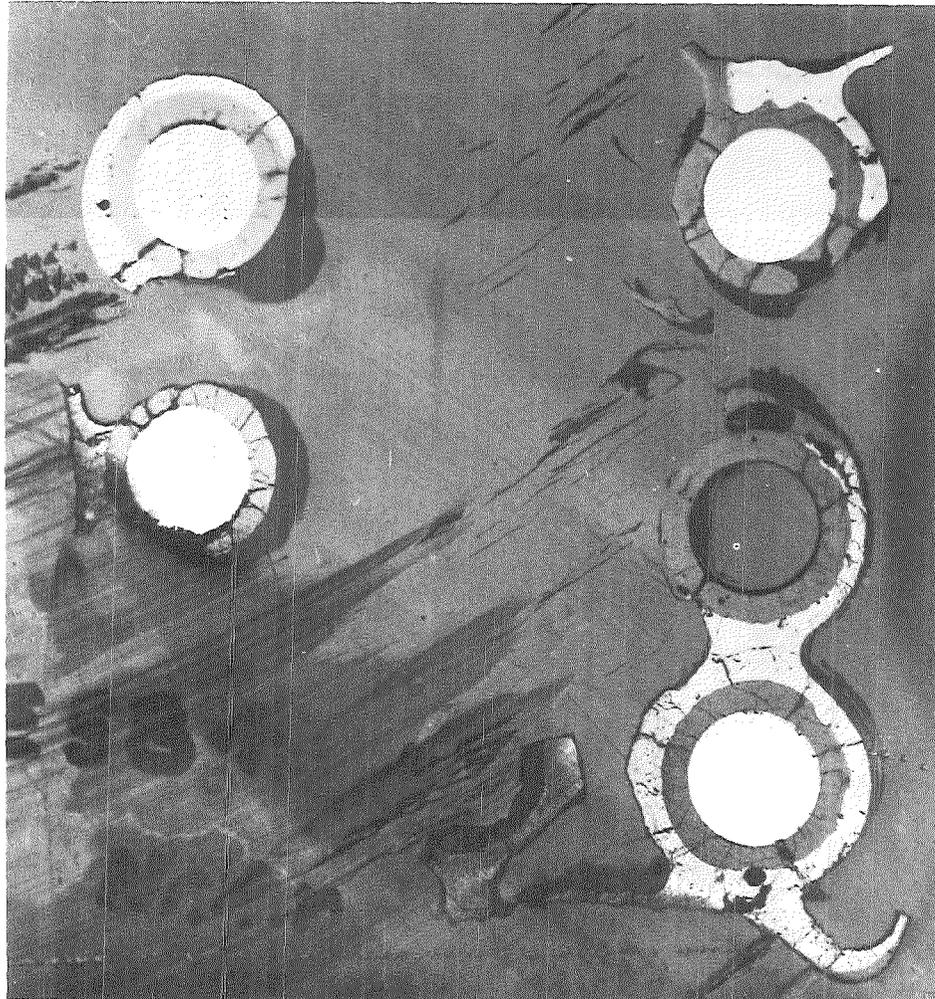
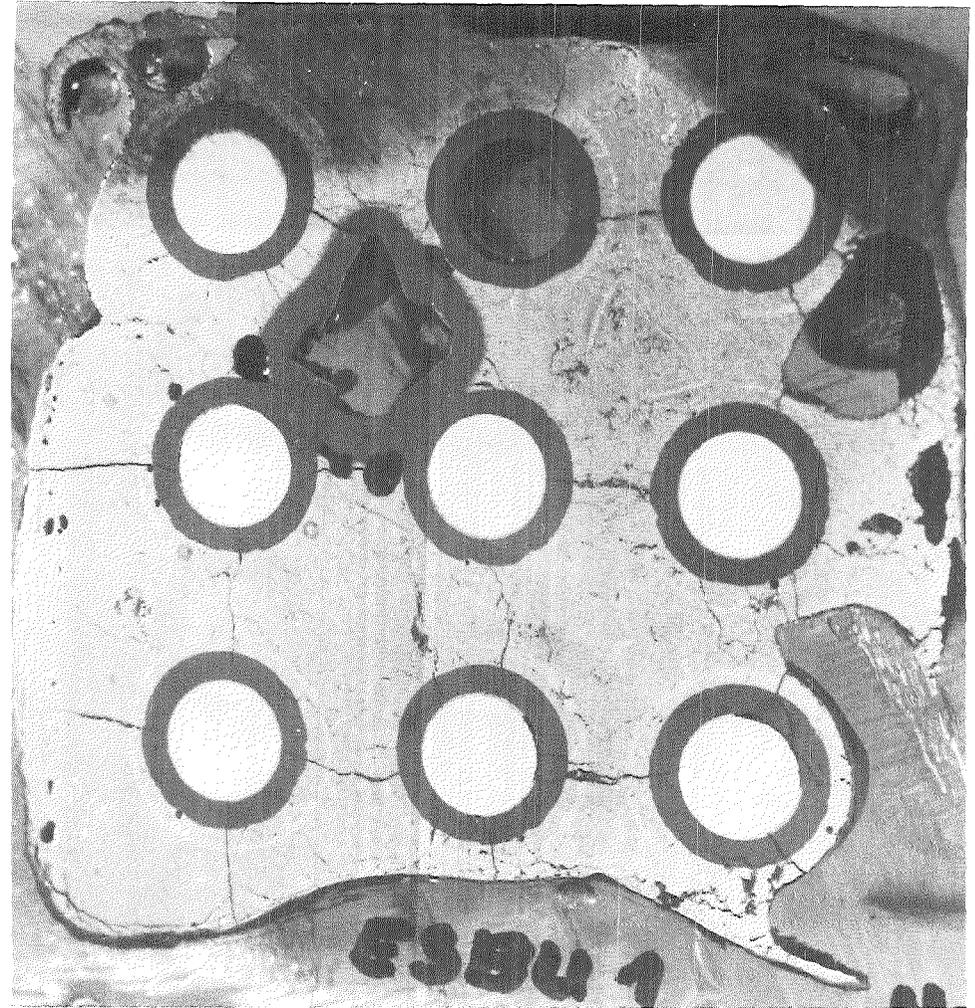
The right hand photograph in Figure 15 shows the cross section at 119 mm, corresponding to the bottom of section 2. The cross section is less than 10 mm below the upper surface of the refrozen melt. The white circular areas are the tungsten heaters, surrounded by black UO₂ ring pellets. The outer radius of the UO₂ ring pellets have been reduced to about 4.2 mm from 4.6 mm, indicating dissolution of UO₂ by liquid zircaloy. The cladding has essentially disappeared and only faint rings at the original cladding boundaries can be recognized for some rods. A large coherent lump of frozen melt has filled the space between pellets and shroud.

FIGURE 15: CROSS SECTIONS OF ESBU-1 AT 129 AND 119 MM ABOVE THE BOTTOM OF THE BUNDLE

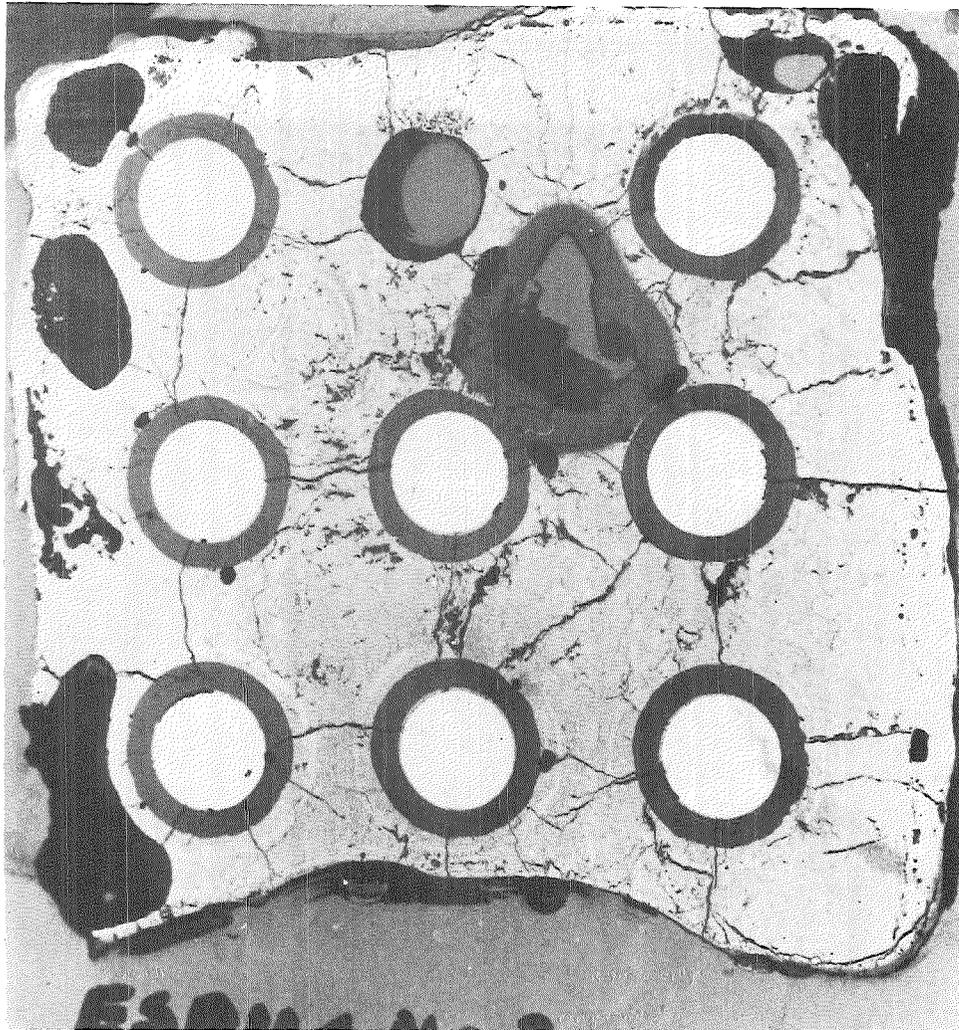
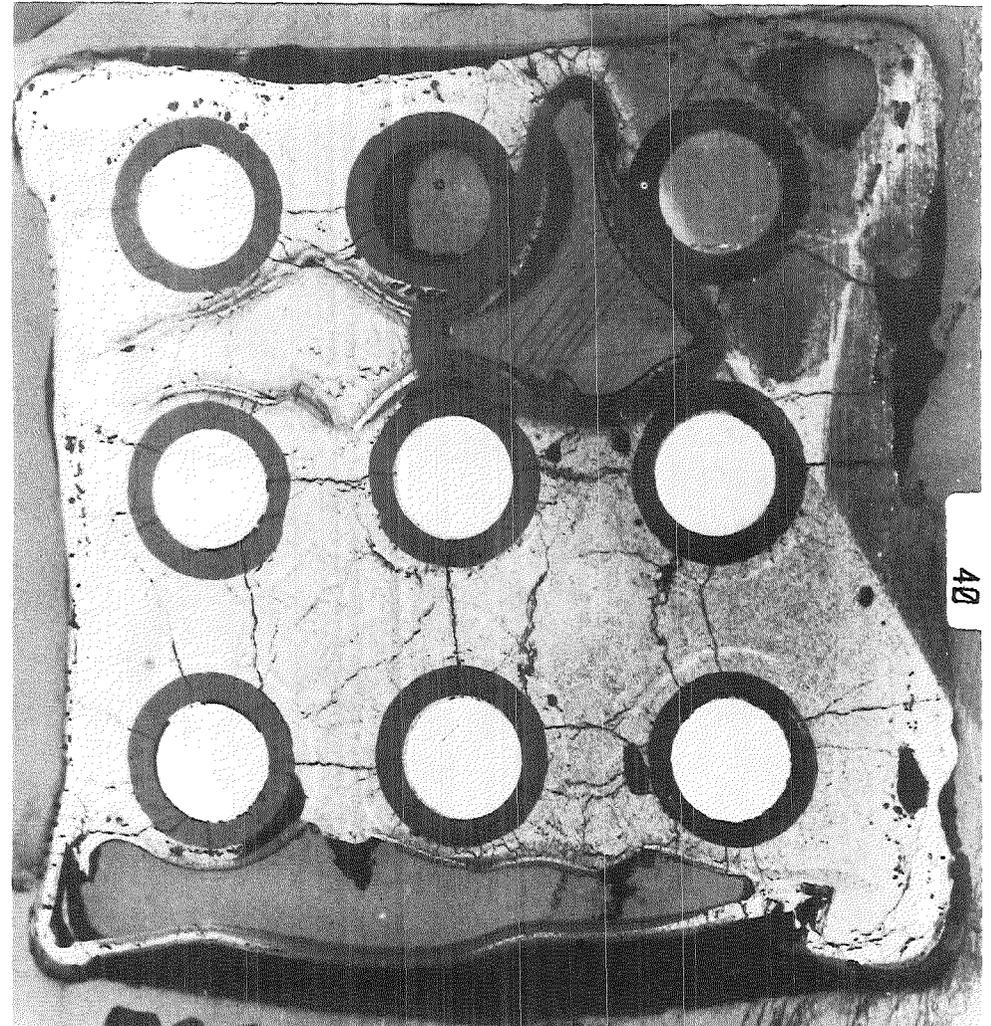
FIGURE 16: CROSS SECTIONS OF ESBU-1 AT 116 AND 106 MM ABOVE THE BOTTOM OF THE BUNDLE

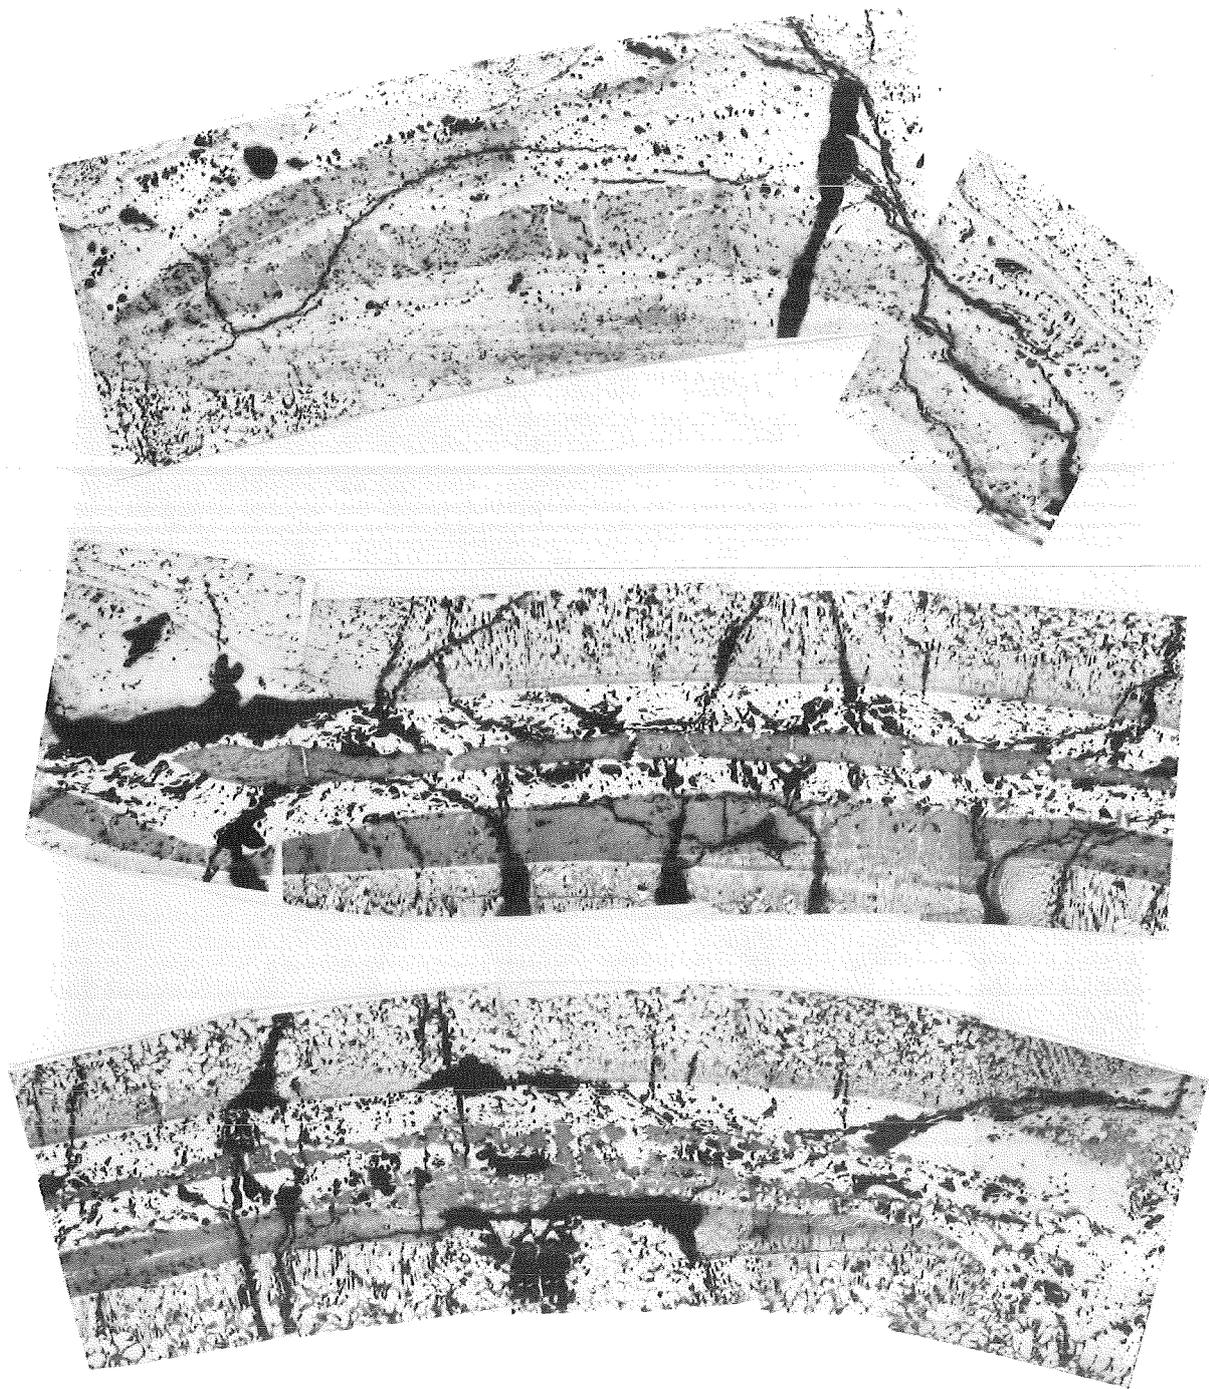
In the enlarged view of the ZrO_2 remnants from rods A, B, C, D in Figures 70 and 71 one can see the attack of the melt on the oxide. These figures clearly show the penetration of the oxide along the cracks. In the light microscope pictures here, the oxide appears darker than the metallic phase.

Fig.70 Enlarged View of former cladding region A of the cross section at 106mm above the bottom of the bundle. (ESBU-1)

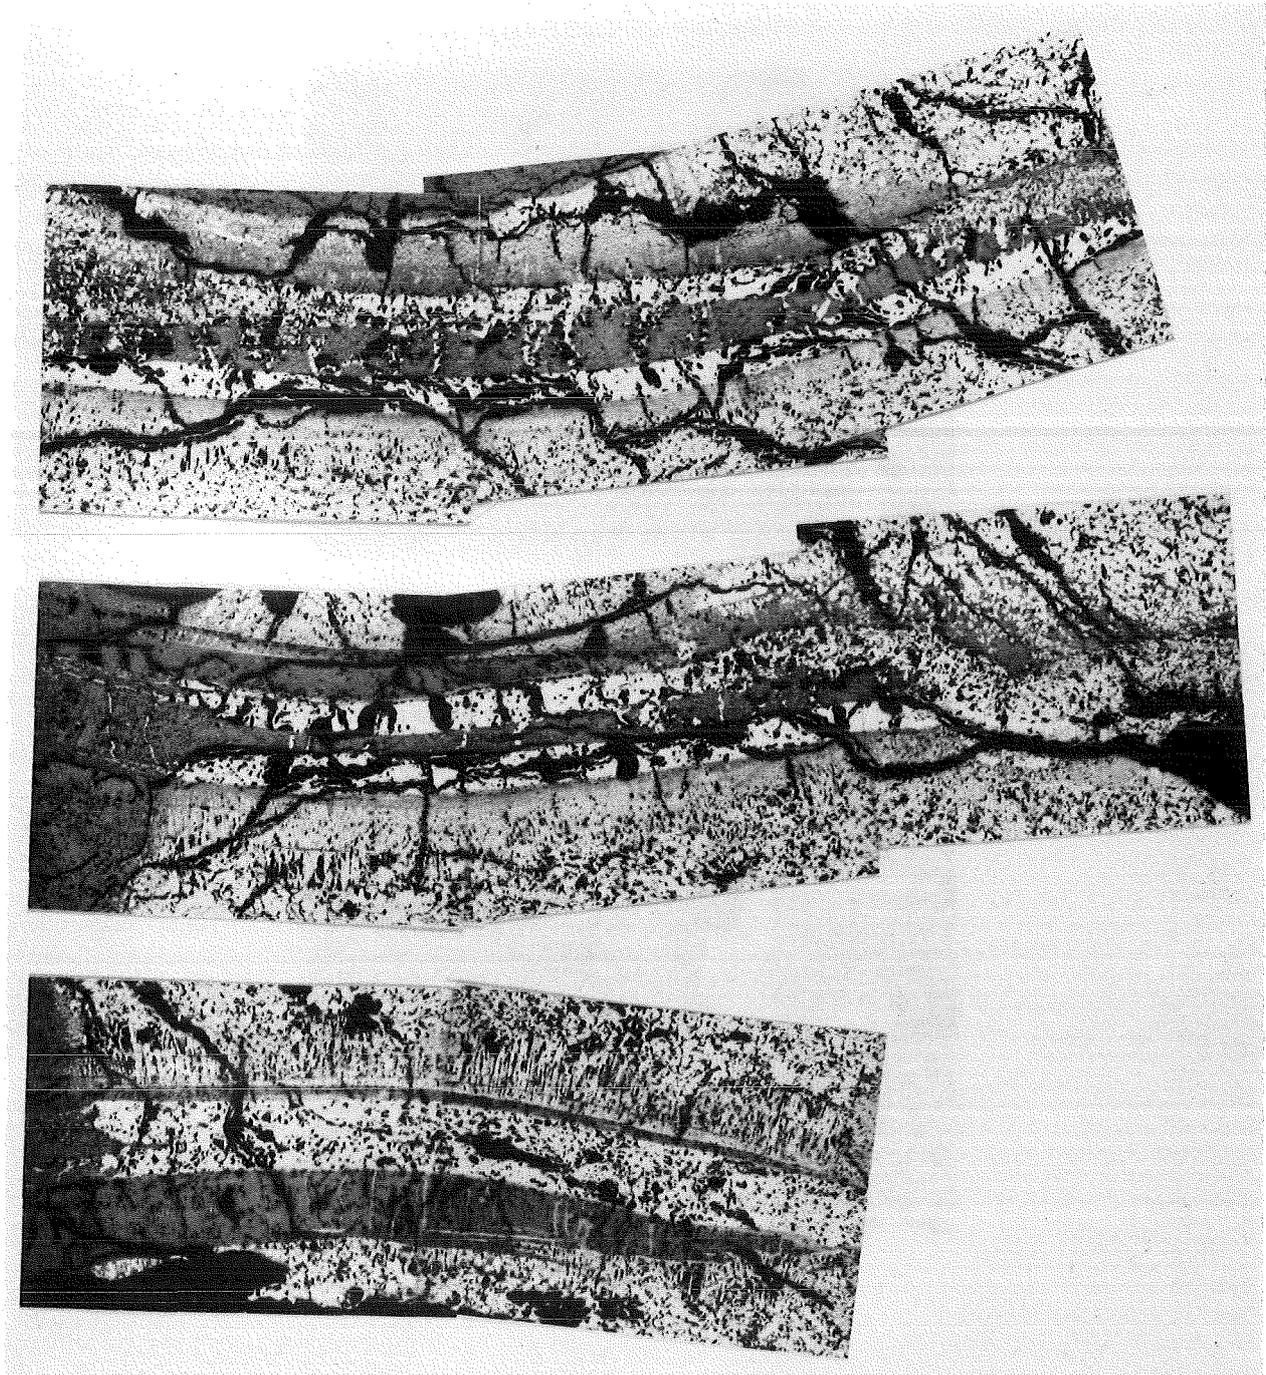
Fig.71 Enlarged Views of former cladding regions B, C, D of the cross section at 106mm above the bottom of the bundle (ESBU-1)

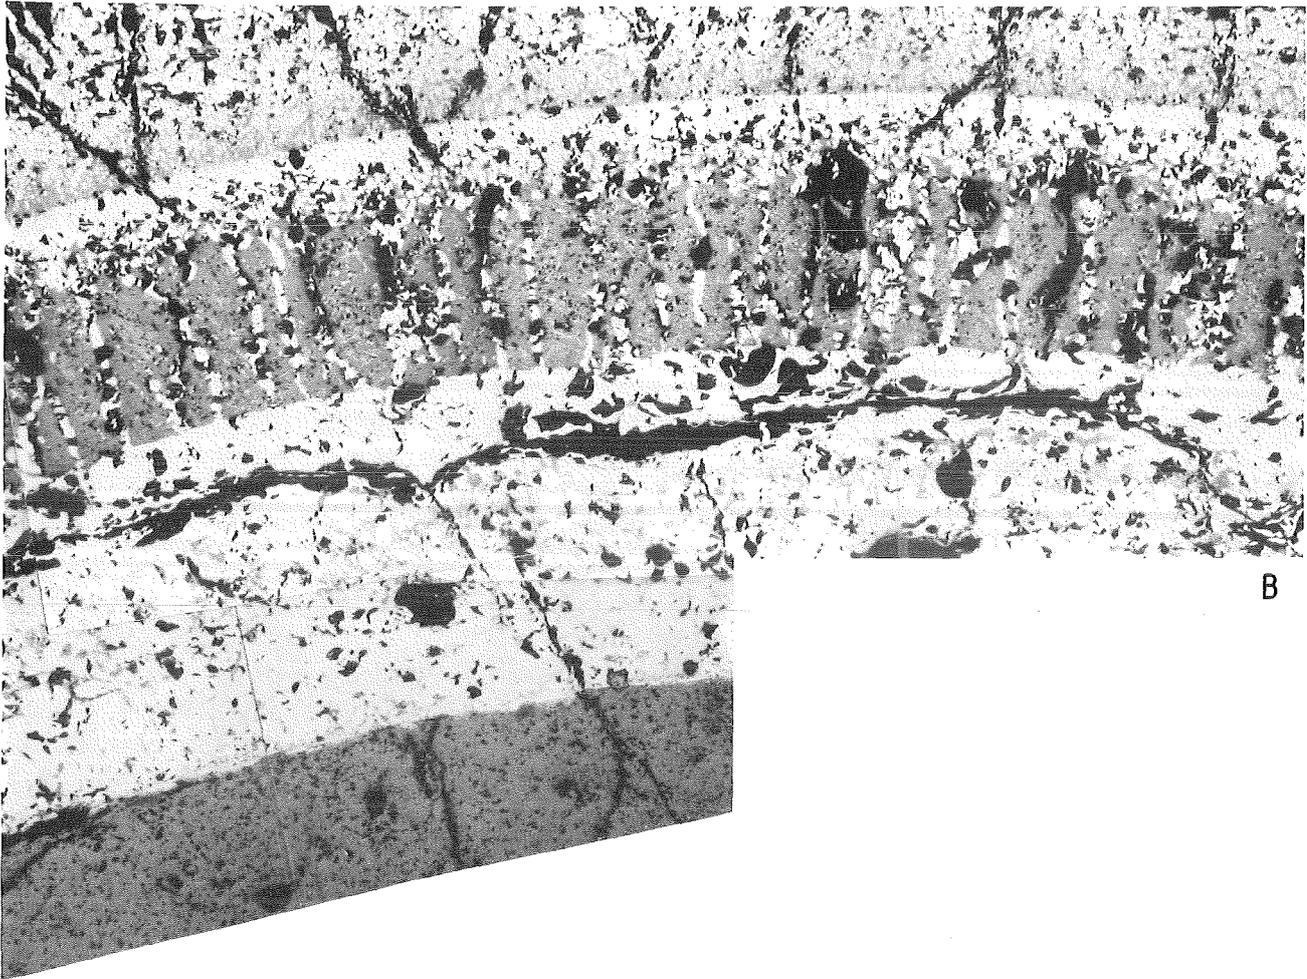
The attack of the melt on the ZrO_2 can also be clearly seen from the comparison of different locations on the same rods. These locations were selected as they had the same oxidation history, until one of the regions was covered with melt. This is seen in the cross section at 86 mm elevation. The overview of this cross section is given in figure 72. The comparison of 4 rods at this elevation is found in figures 73 to 76. This comparison clearly demonstrates the attack of the melt on the ZrO_2 at the macroscopic scale.

FIG. 74 : COMPARISON OF OXIDIZED PARTS OF CLADDING FROM SAME ROD. MELT COVERED REGIONS (B) AND UNCOVERED REGIONS (E) SHOWN FROM CROSS SECTION AT 86 MM ESBU-1. FIG.
