KfK 3769
August 1986

Post Test Investigation of the Bundle Test ESBU-1

**On Temperature Escalation in PWR Fuel
Rod Simulator Bundles due to
the Zircaloy/Steam Reaction**

**S. Hagen, H. Kapulla, H. Malauschek,
K. P. Wallenfels, B. J. Buescher**
**Hauptabteilung Ingenieurtechnik
Projekt Nukleare Sicherheit**

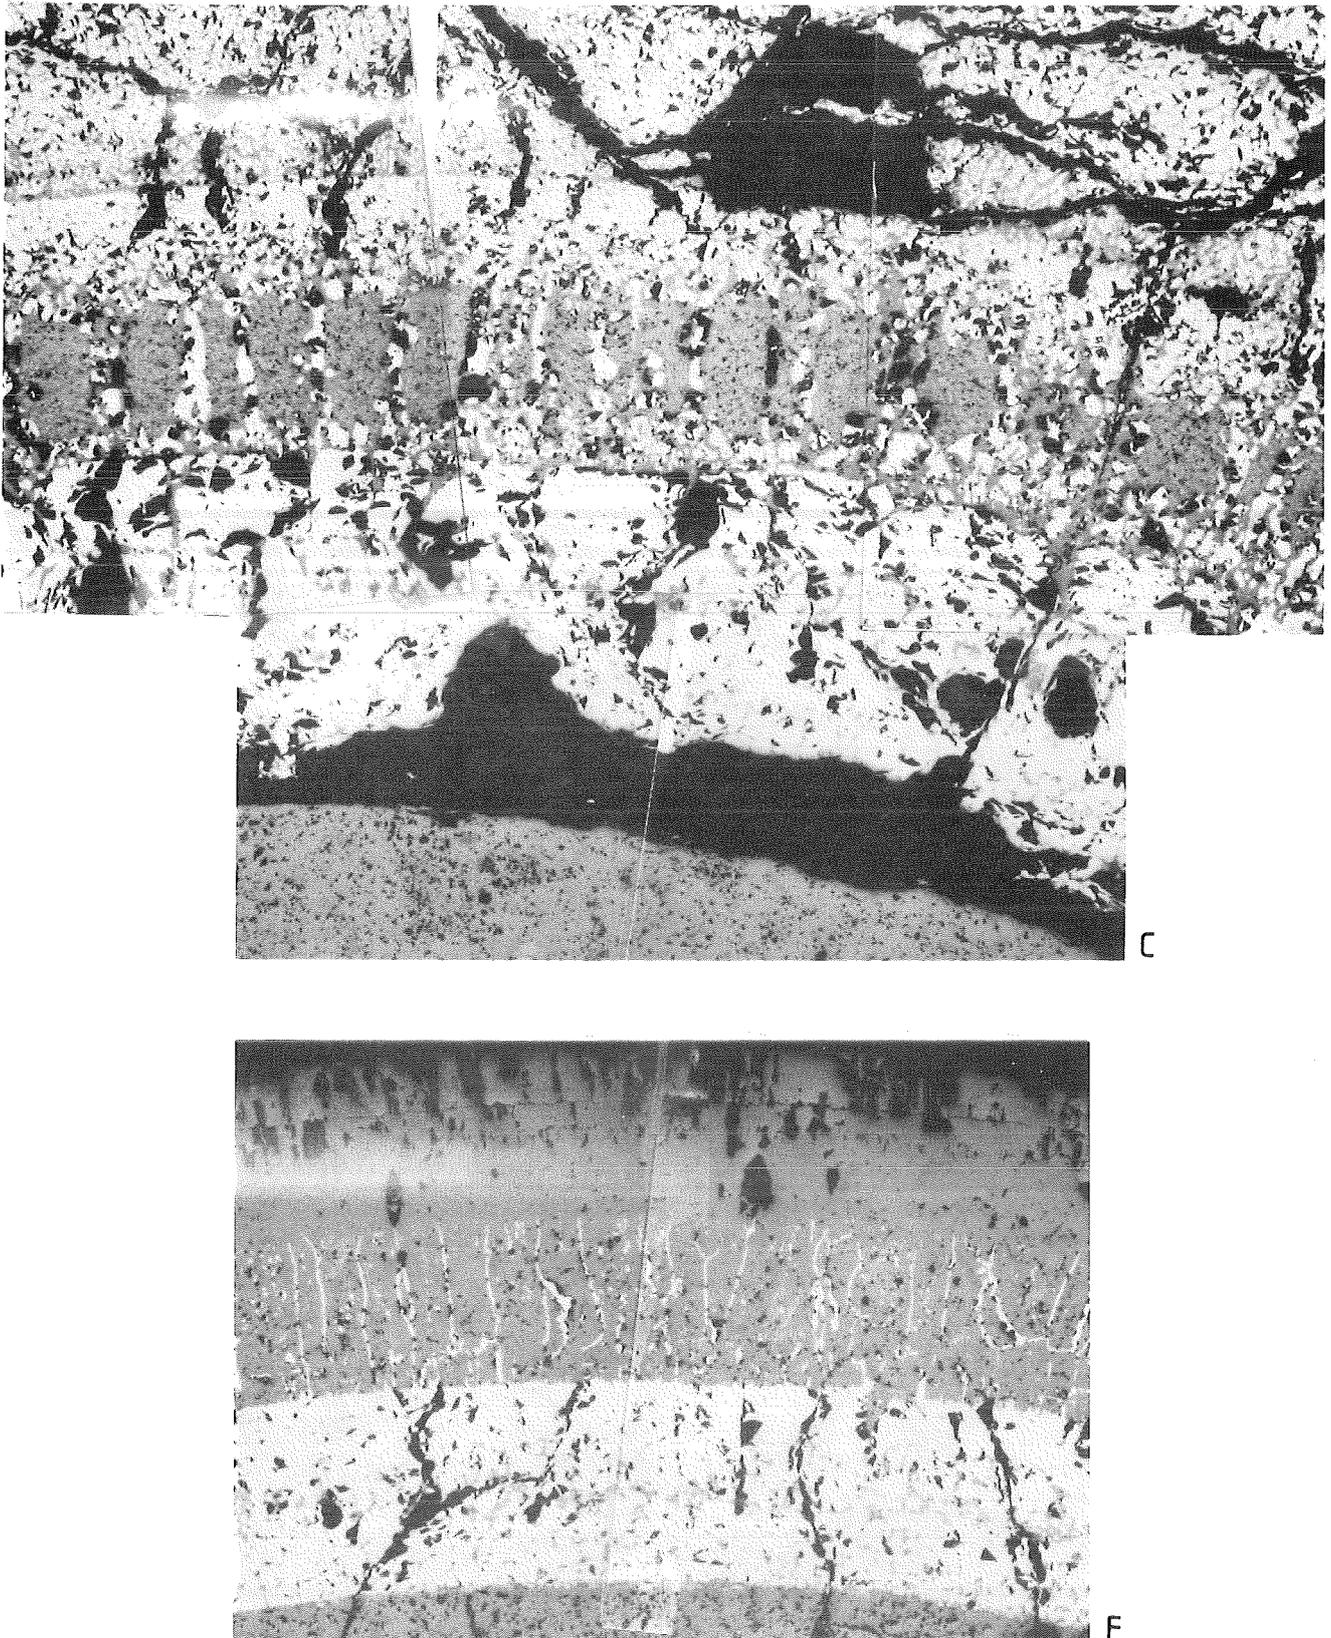
The attack of the melt on the ZrO_2 can also be clearly seen from the comparison of different locations on the same rods. These locations were selected as they had the same oxidation history, until one of the regions was covered with melt. This is seen in the cross section at 86 mm elevation. The overview of this cross section is given in figure 72. The comparison of 4 rods at this elevation is found in figures 73 to 76. This comparison clearly demonstrates the attack of the melt on the ZrO_2 at the macroscopic scale.

FIG. 75 : COMPARISON OF OXIDIZED PARTS OF CLADDING FROM SAME ROD. MELT COVERED REGIONS (C) AND UNCOVERED REGIONS (F) SHOWN FROM CROSS SECTION AT 86 MM ESBU-1. FIG.

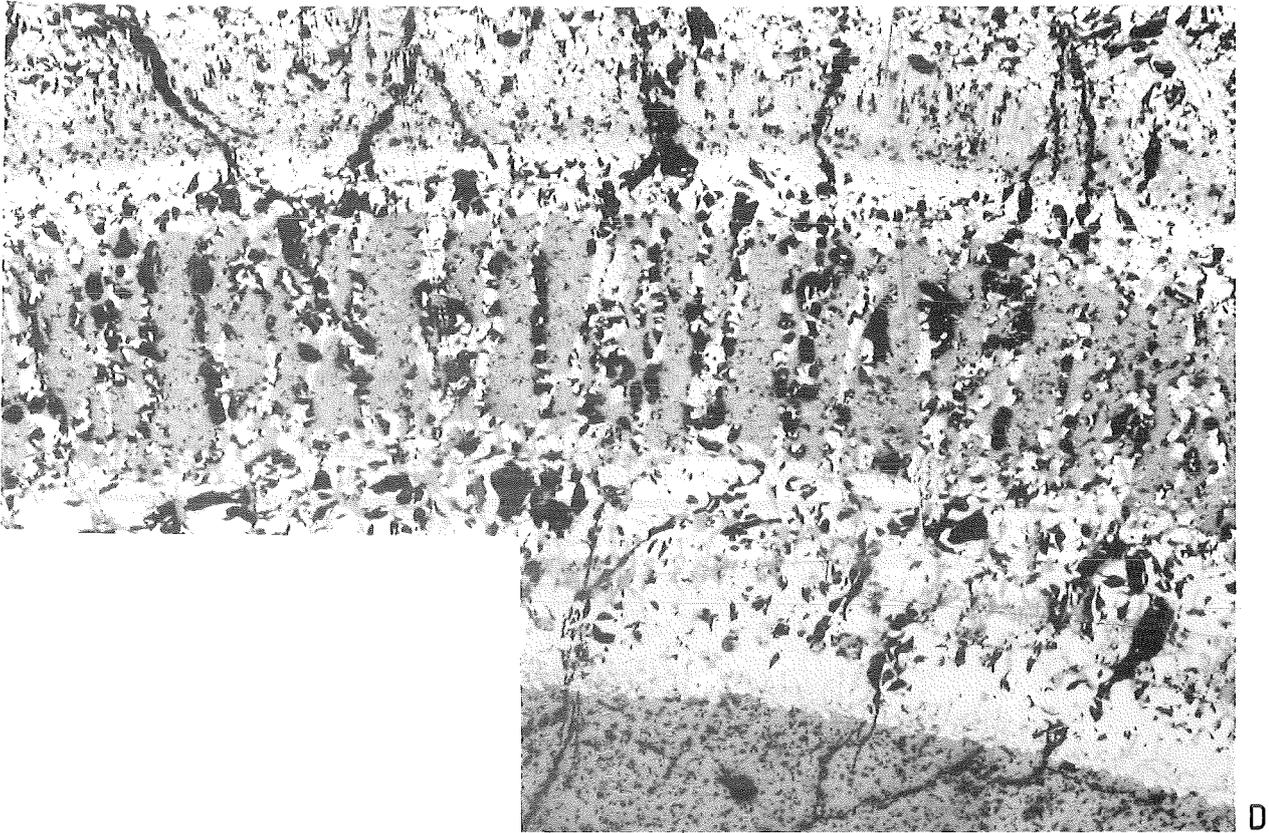
FIG. 76 : COMPARISON OF OXIDIZED PARTS OF CLADDING FROM SAME ROD. MELT COVERED REGIONS (D) AND UNCOVERED REGIONS (H) SHOWN FROM CROSS SECTION AT 96 MM ESBU-1. FIG.

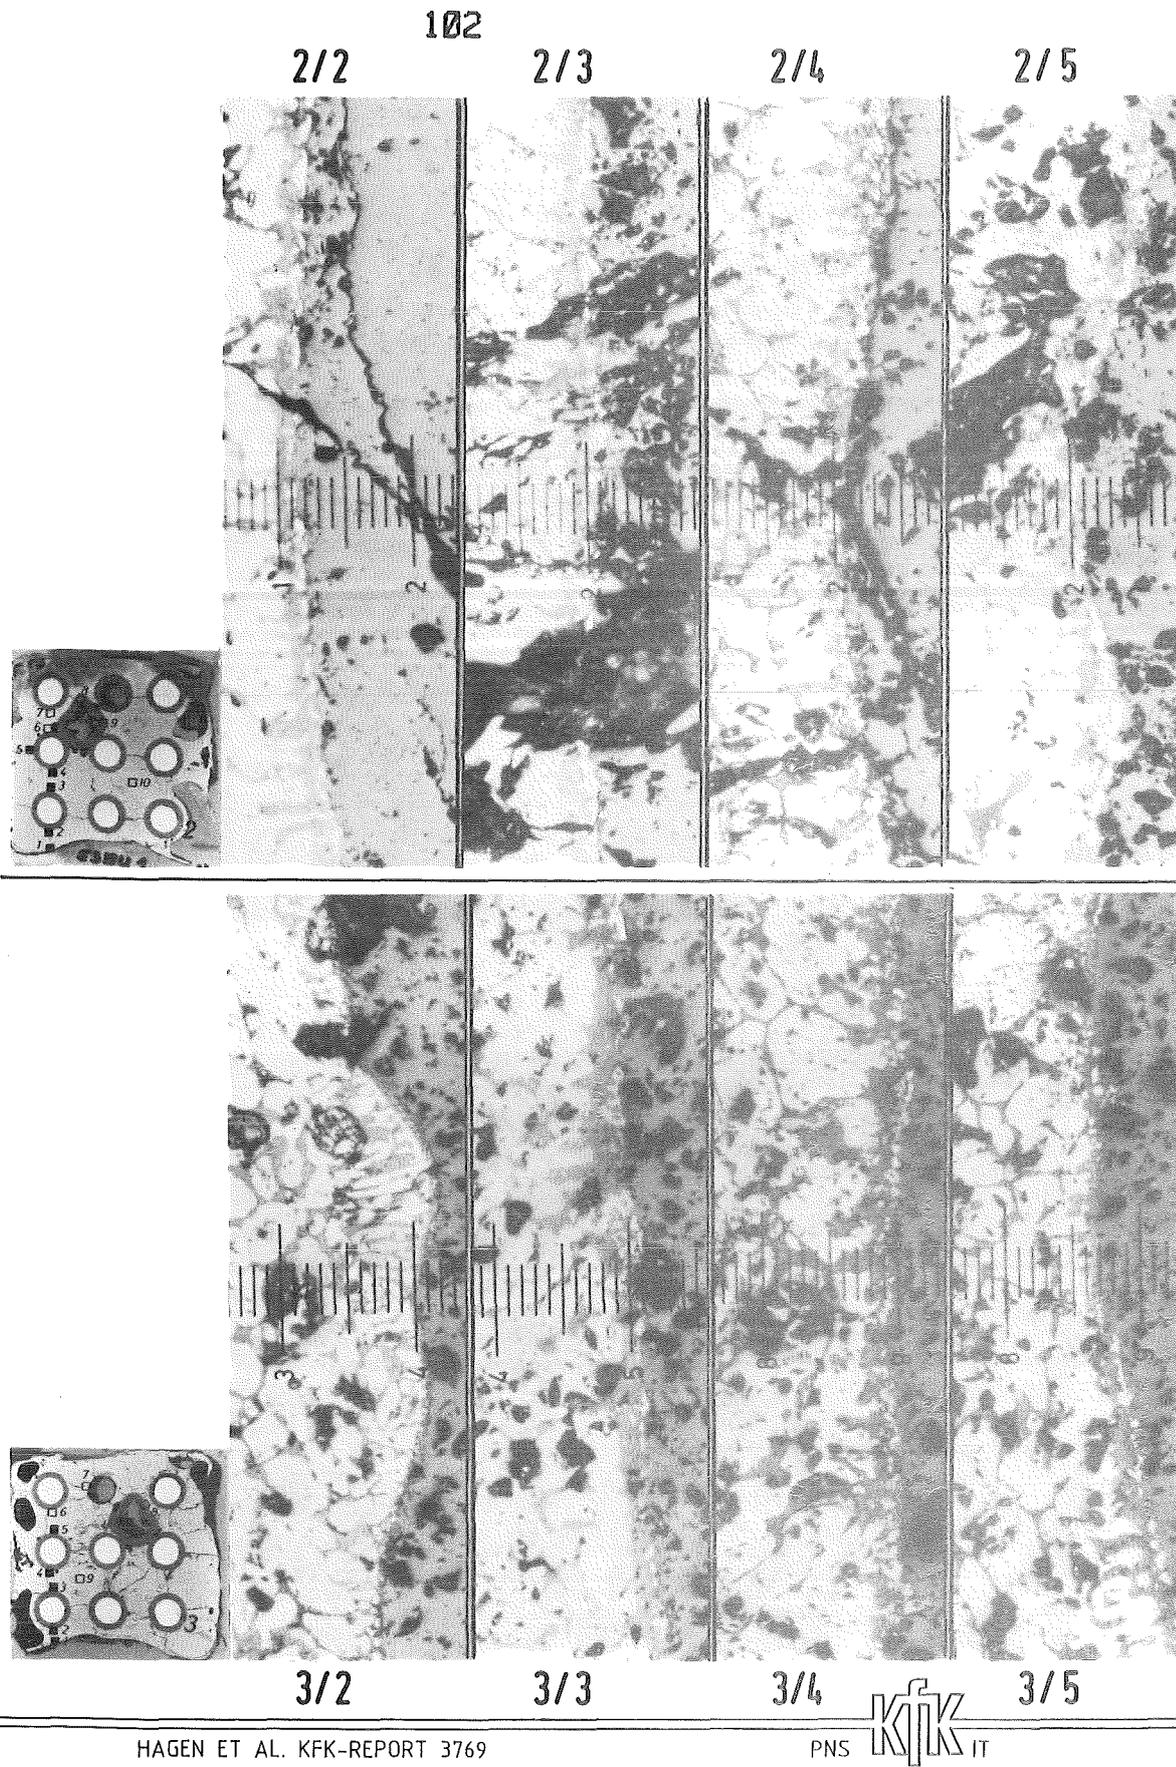
Under high temperature conditions, UO_2 is not stable in contact with zircaloy. Zircaloy reduces UO_2 to form oxygen stabilized α -Zr(O) and metallic uranium. The process of UO_2 dissolution has been investigated in detail in separate effect tests by P. Hofmann /3/. Dissolution of the UO_2 by molten zircaloy occurred in test ESBU-1 and the dissolution process is shown in figures 77 and 78. In these figures the molten zircaloy is seen penetrating into cracks at the UO_2 surface. The UO_2 is reduced by the molten zircaloy and forms metallic uranium along the grain boundaries of

Fig.77 Dissolution of UO_2 by molten ZrO_2 for different positions of cross sections 2 (119mm) and 3 (109mm). (ESBU-1)

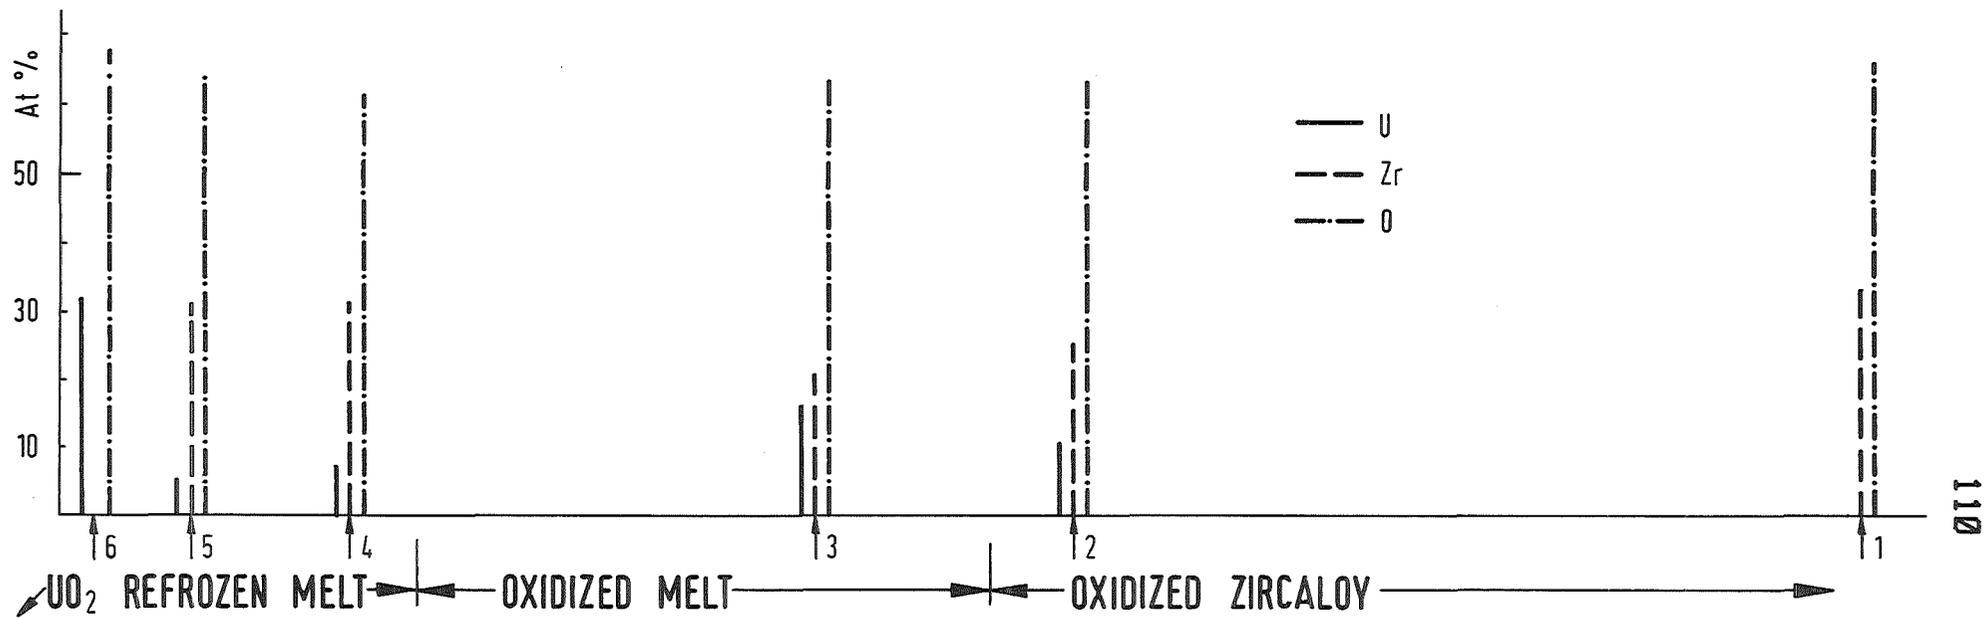
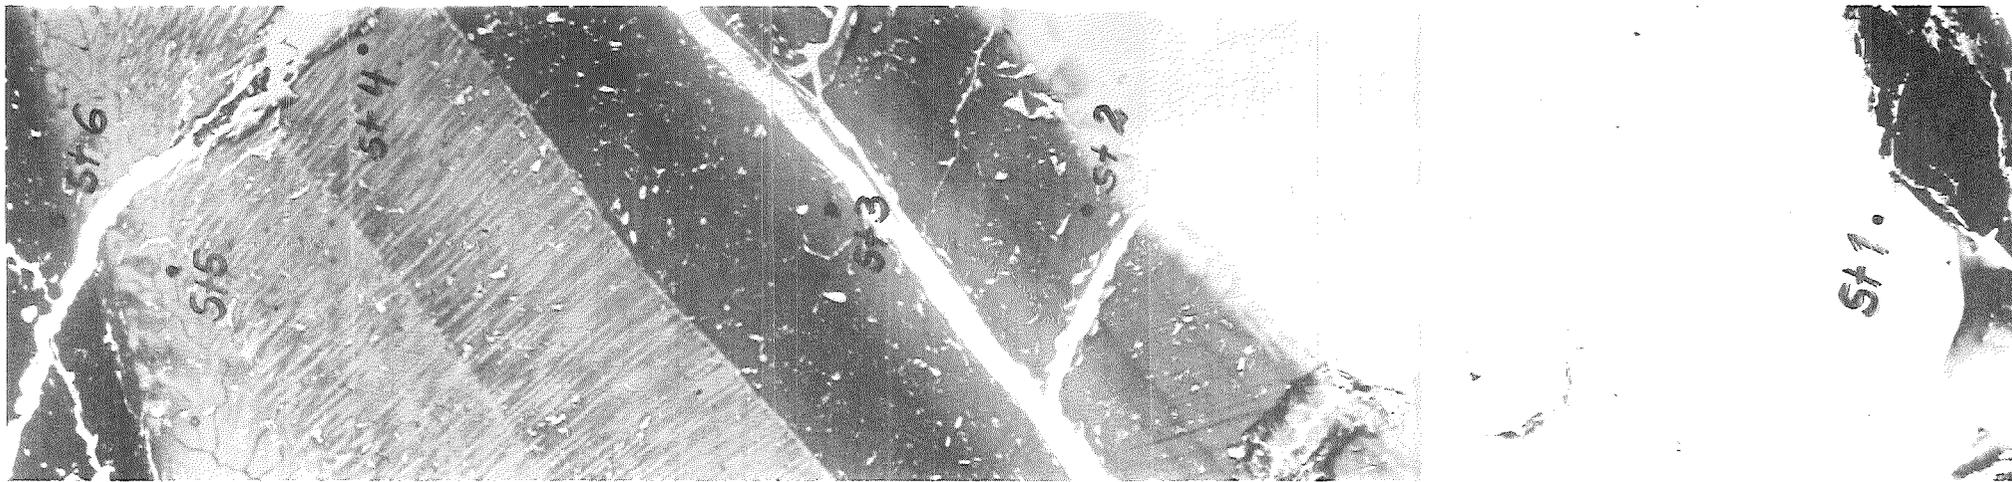
Figures 84 to 86 show the SEM pictures from oxidized regions under different conditions. In fig. 84 region 1 from fig. 81 is investigated. This cavity was blocked from above and only stagnant steam was available, which left primarily hydrogen after reaction with the zircaloy. If we start from the right side of Figure 84, the outer layer consists of ZrO_2 (St2) with some α -Zry incursions (St1).

FIG. 84 : OXIDATION IN STAGNANT STEAM

ESBU - 1: LOCATION 1 OF CROSS SECTION 4 (106 mm) UNCORRECTED O-VALUES; SEE FIG. 81

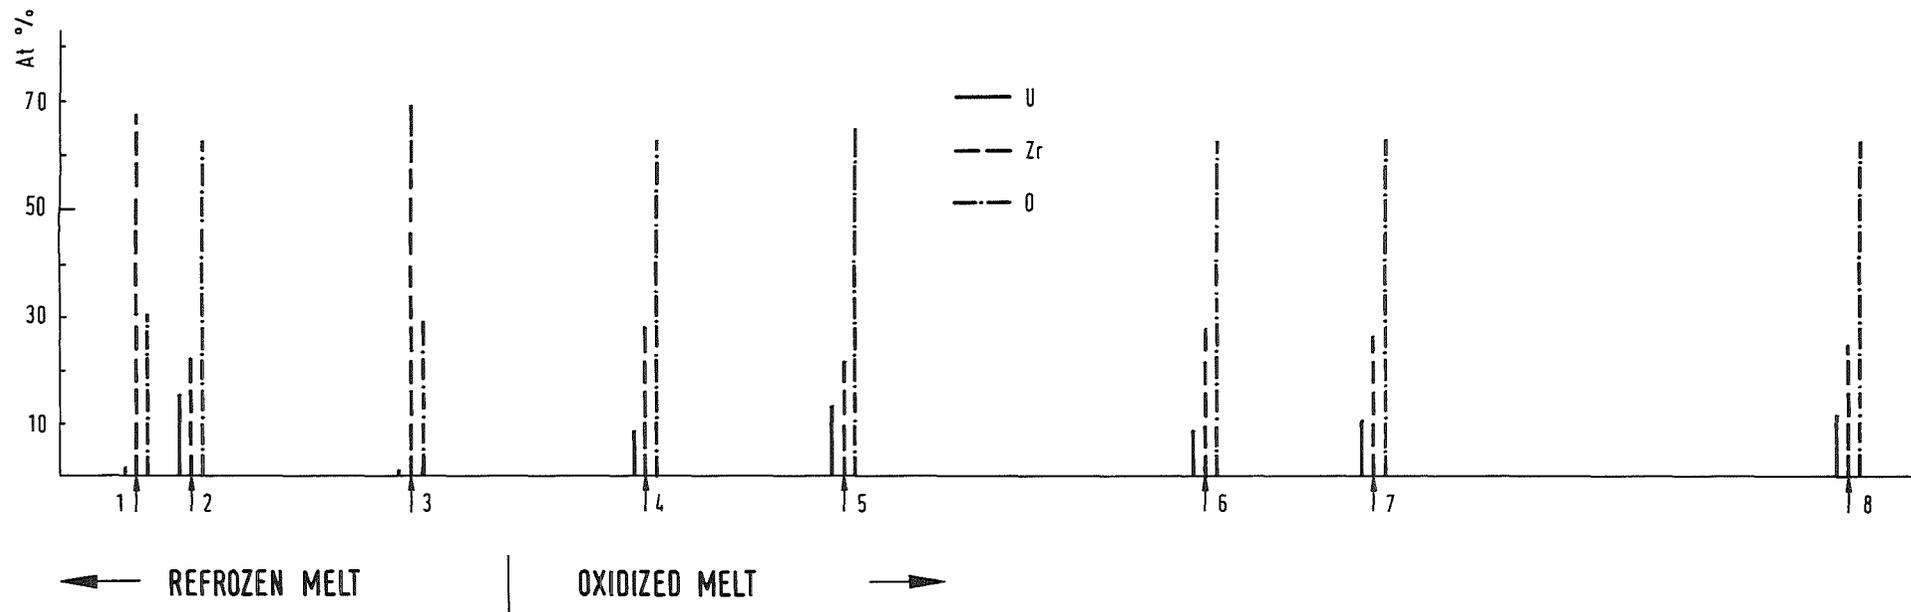
FIG. 85: OXIDATION OF CLADDING IN CONTINUOUS STEAM FLOW

ESBU-1: LOCATION 4 OF CROSS SECTION 4 (106mm); SEE FIG.81

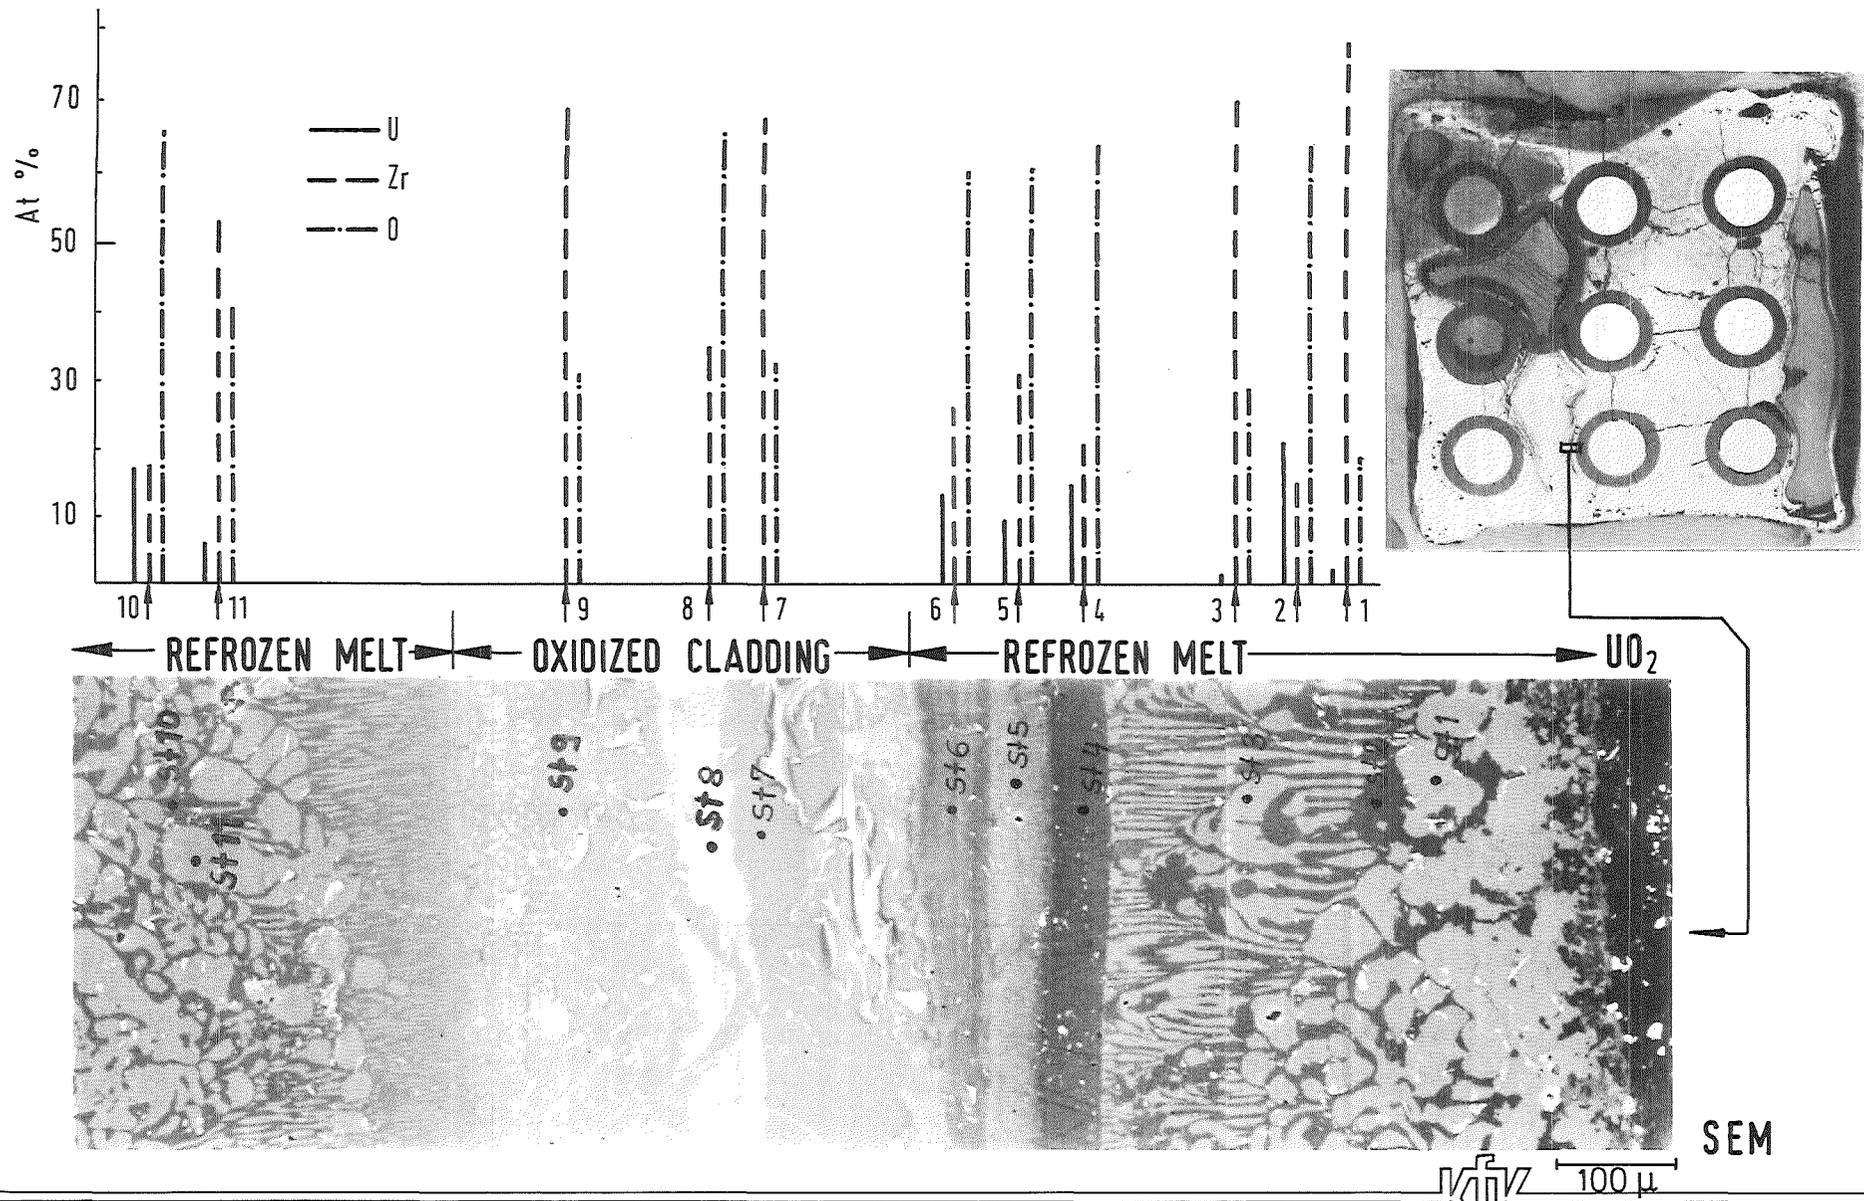
FIG. 87:
MICROPROBE ANALYSIS OF REMAINING OXIDIZED CLADDING IN CONTACT WITH REFROZEN MELT
 ESBU-1: LOCATION 3 OF CROSS SECTION 4 (106mm ABOVE BOTTOM), UNCORRECTED O-VALUES

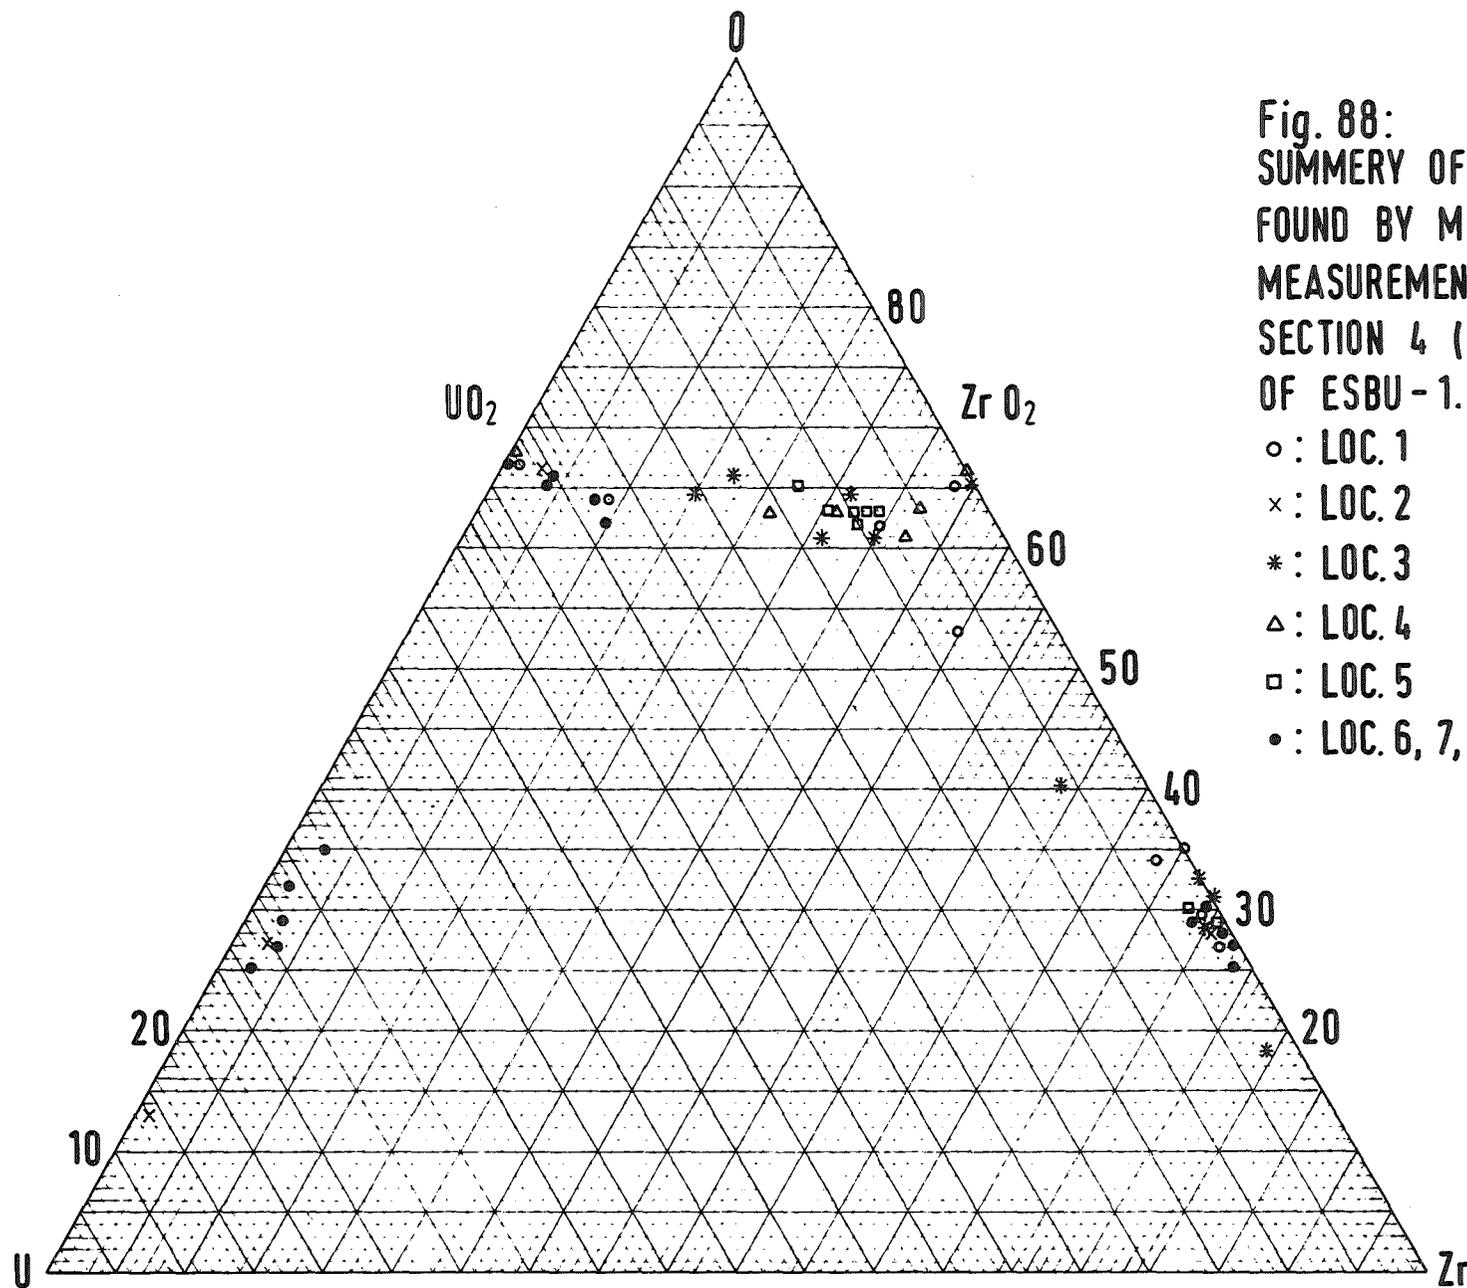
In Figure 88, the results of the point analysis are represented in a (U, Zr,O) diagram. One sees that the oxides lie in the neighbourhood of the line connecting UO_2 and ZrO_2 . The zircaloy rich phase is found in the neighbourhood of the $\alpha-Zr(O)$. The uranium rich alloy has an unexpectedly high oxygen content. It appears that for this phase the measurement was influenced strongly by oxygen contamination of the surface.

Fig. 88:
SUMMERY OF COMPOSITIONS
FOUND BY MICROPROBE
MEASUREMENTS AT CROSS
SECTION 4 (160 MM)
OF ESBU-1.
