**Sliding Bearing Test Methods and Apparatus**

**Test Procedure and Results**

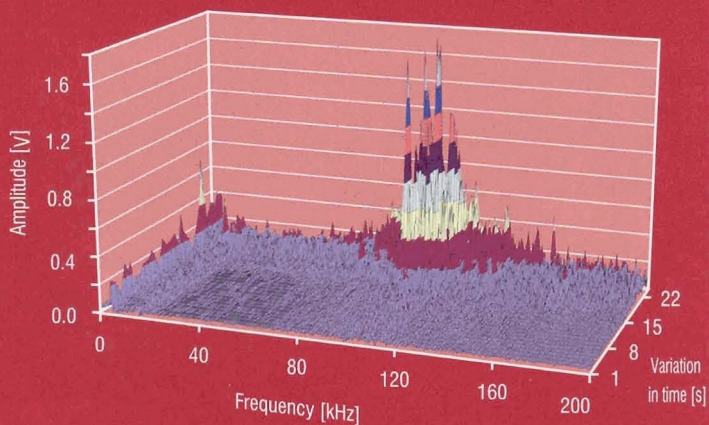
Figure 5. Time Variation of the Frequency Spectra

To document the progress of the bearing failure, the acoustic signal was measured and evaluated continuously every second. The result of the measurement using a Glyco 40 half-shell under slowly increasing continuous load, with a speed of 3,000 rpm, is represented in Figure 5. The lubricant for this test was preheated to 53°C. In Figure 5, the variation in time of every frequency spectral analysis is properly arranged. The progress of the bearing damage can be clearly observed. At the beginning of the measurements, the same frequency pattern is consistent with those seen in Figure 4. Starting at the 16th test series, the amplitude in the range between 80 to 140 kHz is clearly pronounced, showing the beginning of metallic contact between shaft and shell, and eventually leading to a bearing failure.
