# Behaviour of Prefabricated Timber Wall Elements Under Static and Cyclic Loading

Patrick Schädle, Hans Joachim Blaß

Lehrstuhl für Ingenieurholzbau und Baukonstruktionen

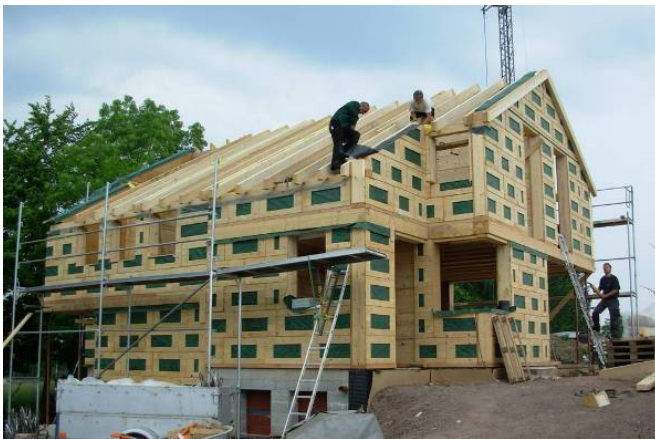
Fig. 1 Building made of Prefabricated Timber Wall Elements

The main feature of PFTE is prefabricating wooden “brick” elements primarily out of the residues of a saw-mill. The brick-like elements can be easily transported to the building site and are easy to handle even for beginners under the guidance of a site foreman. The mass of a single element is less than 25 kg, it can be moved by hand and walls can be built without a crane. Thus the system can be cost-saving. In Germany a technical approval for up to three - storey buildings was issued in Sept. 2007.

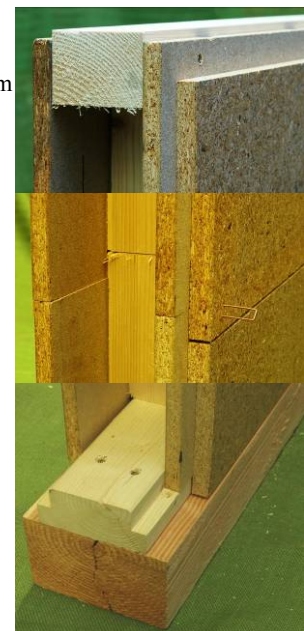
- Top rail on top element, fixed with:
  - vertical screw 6 x 140 mm every 2nd column
  - Horizontal screw 5 x 60 mm – spaced 250 mm solely on chipboard side
  - Horizontal staples 64 mm – dist. 50 mm solely on chipboard side

- Basic elements, overlap connected with staples 32 mm – spaced 50 mm solely on chipboard side

- Douglas fir wall plate with spruce element, connected via screws 6 x 160 mm spaced 250 mm
- First line connected to spruce element via 1 BMF-Angle per wall element
- First-Line elements connected with staples 64 mm – spaced 50 mm solely on chipboard side

Fig. 4 Details of Prefabricated Timber Wall Element System

a wall plate is fixed to the foundation. The first row of the elements is installed by fixing each element to the wall plate via one BMF 90 x 90 mm angle connector. When the wall height is reached, a continuous vertical stud is inserted from the top at least every 3 m of wall length. The vertical studs transfer the in-plane up-lift forces to the foundation, and

they provide bending stiffness for loads perpendicular to the wall plane, e.g. wind loads. At the top of the wall the top rail is put into position and the vertical studs as well as the top rail are connected to the elements via self-drilling screws. Normally the spaces between the vertical columns are filled with insulation. The tests, however, were performed without insulation. All the connections described in Fig. 4 are of prime importance for the behaviour of the wall under the different loading conditions.

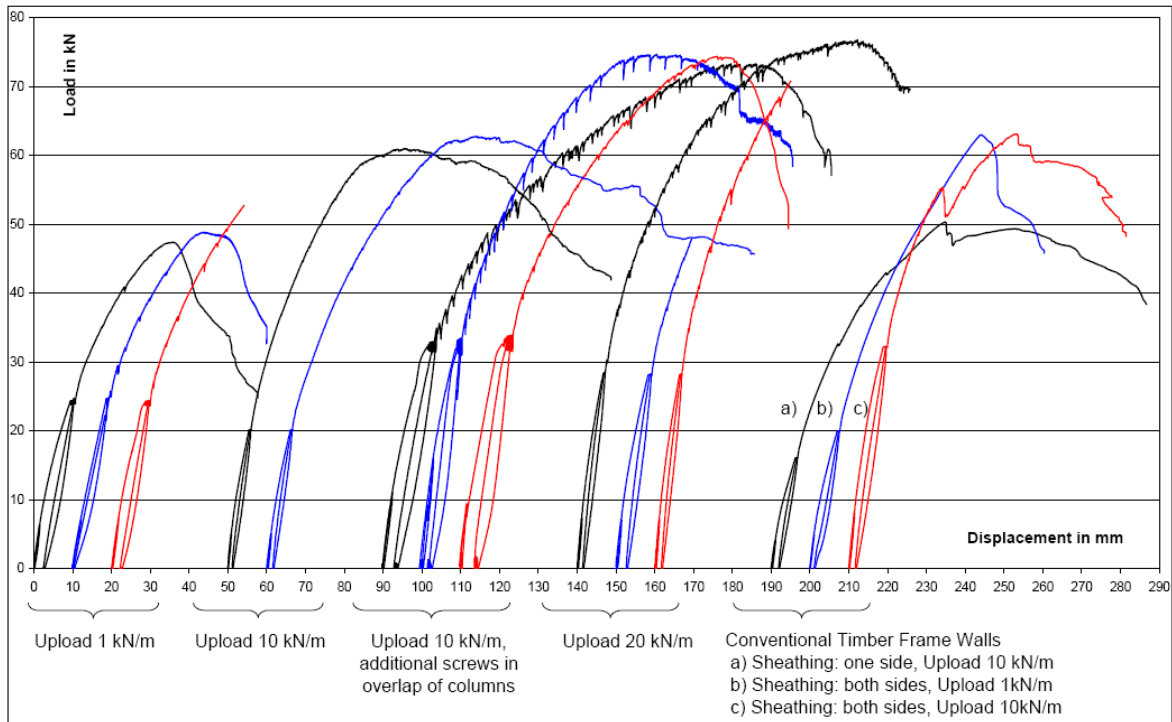
Fig. 8 Load-displacement curves of monotonic (Push-Over) Tests

The test results with vertical load 10 kN/m using no additional screws (PO\_10\_4 and PO\_10\_5) are shown at position 50 and 60 mm in Fig. 8. The test configuration was nearly the same as in the tests with no vertical load, only the steel plate as an additional connection between the lower elements and the wall plate was left out. Compared to the tests with no additional vertical load, the horizontal load capacity increased to about 62 kN while the stiffness only slightly increased. Ductility of the wall raised, as can be seen from the displacements at 80% of  $F_{max}$ : while being about 44 mm in the case with no additional vertical load, it rose to about 93 mm with a vertical load of 10 kN/m. This is a result

Since PFTE wall elements are connected by staples on the chipboard side only, a continuous sheathing only exists on one side of the wall. The first tests similarly were carried out with timber framed walls sheathed on one side. The results of the monotonic test can be seen in Fig. 8 and Table 1. The load bearing capacity increased due to the additional screws to about 74 kN compared to the 62 kN in the tests without screws. While the maximum horizontal load for a PFTE wall is about 62 kN, the timber frame wall achieves a maximum load of about 50 kN at a displacement of approx. 50 mm.

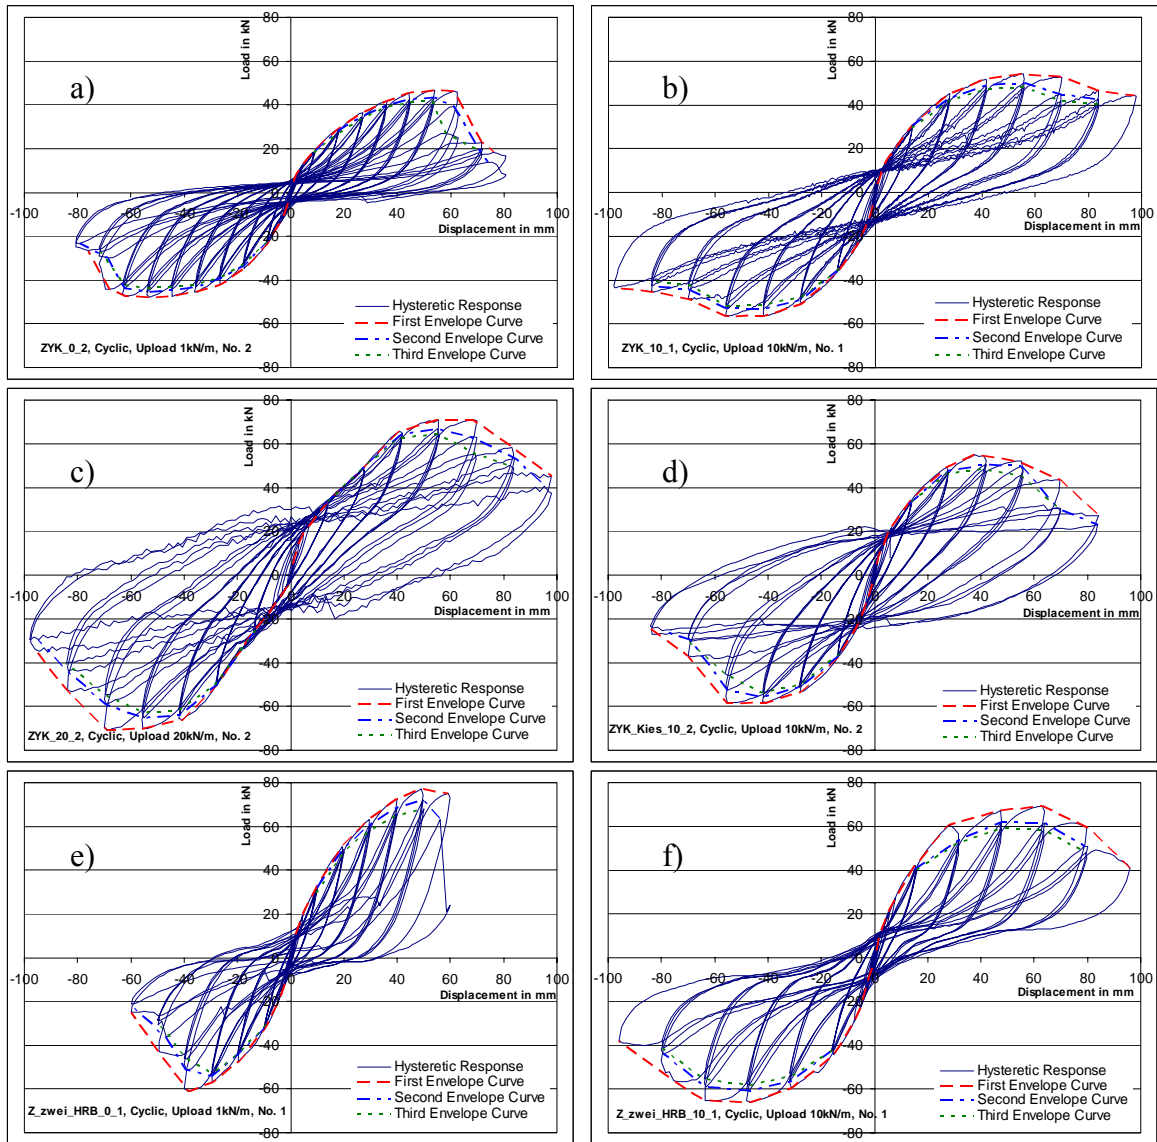
Fig. 11 Hysteretic responses of tested walls

The multiple element connections with a large number of mechanical fasteners and the friction between the elements should lead to a favourable behaviour under cyclic loading. The staples used for the connections are very slender fasteners which bend easily. The subsequent plasticity of the staples as well as the timber under embedding lead to a ductile behaviour and a large energy dissipation during the repeated cycles. The friction between the elements cause additional energy dissipation. In ISO/CD 21581 [3] there is no approach to determine the energy dissipation of the wall, but it is noted that in future there may be a need to determine such additional properties. To gain some information about the energy dissipation of the tested walls, the equivalent hysteretic damping  $v_{ed}$  according
