Results of the commissioning bundle test QUENCH-L0 performed under LOCA conditions

J. Stuckert, M. Große, C. Rössger,
M. Steinbrück, M. Walter

Report-Nr. KIT-SR 7657

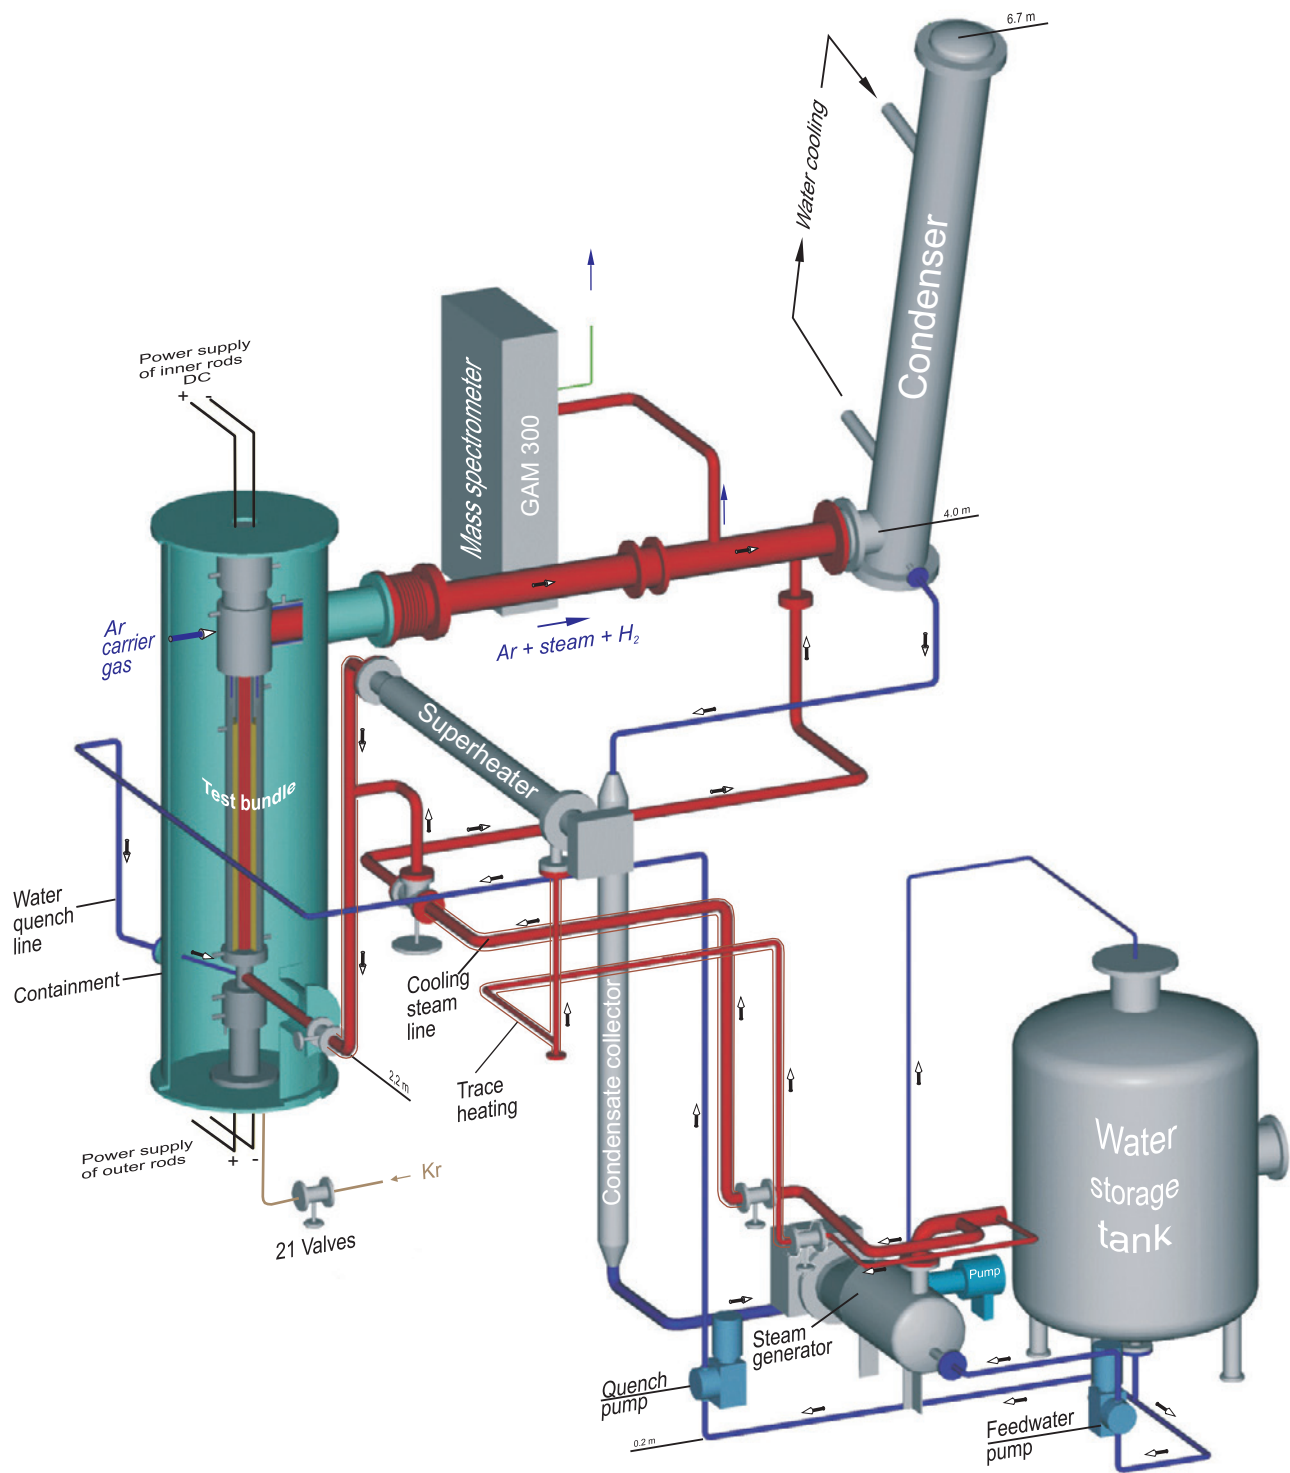
Fig. 2: QUENCH Facility - Main components.

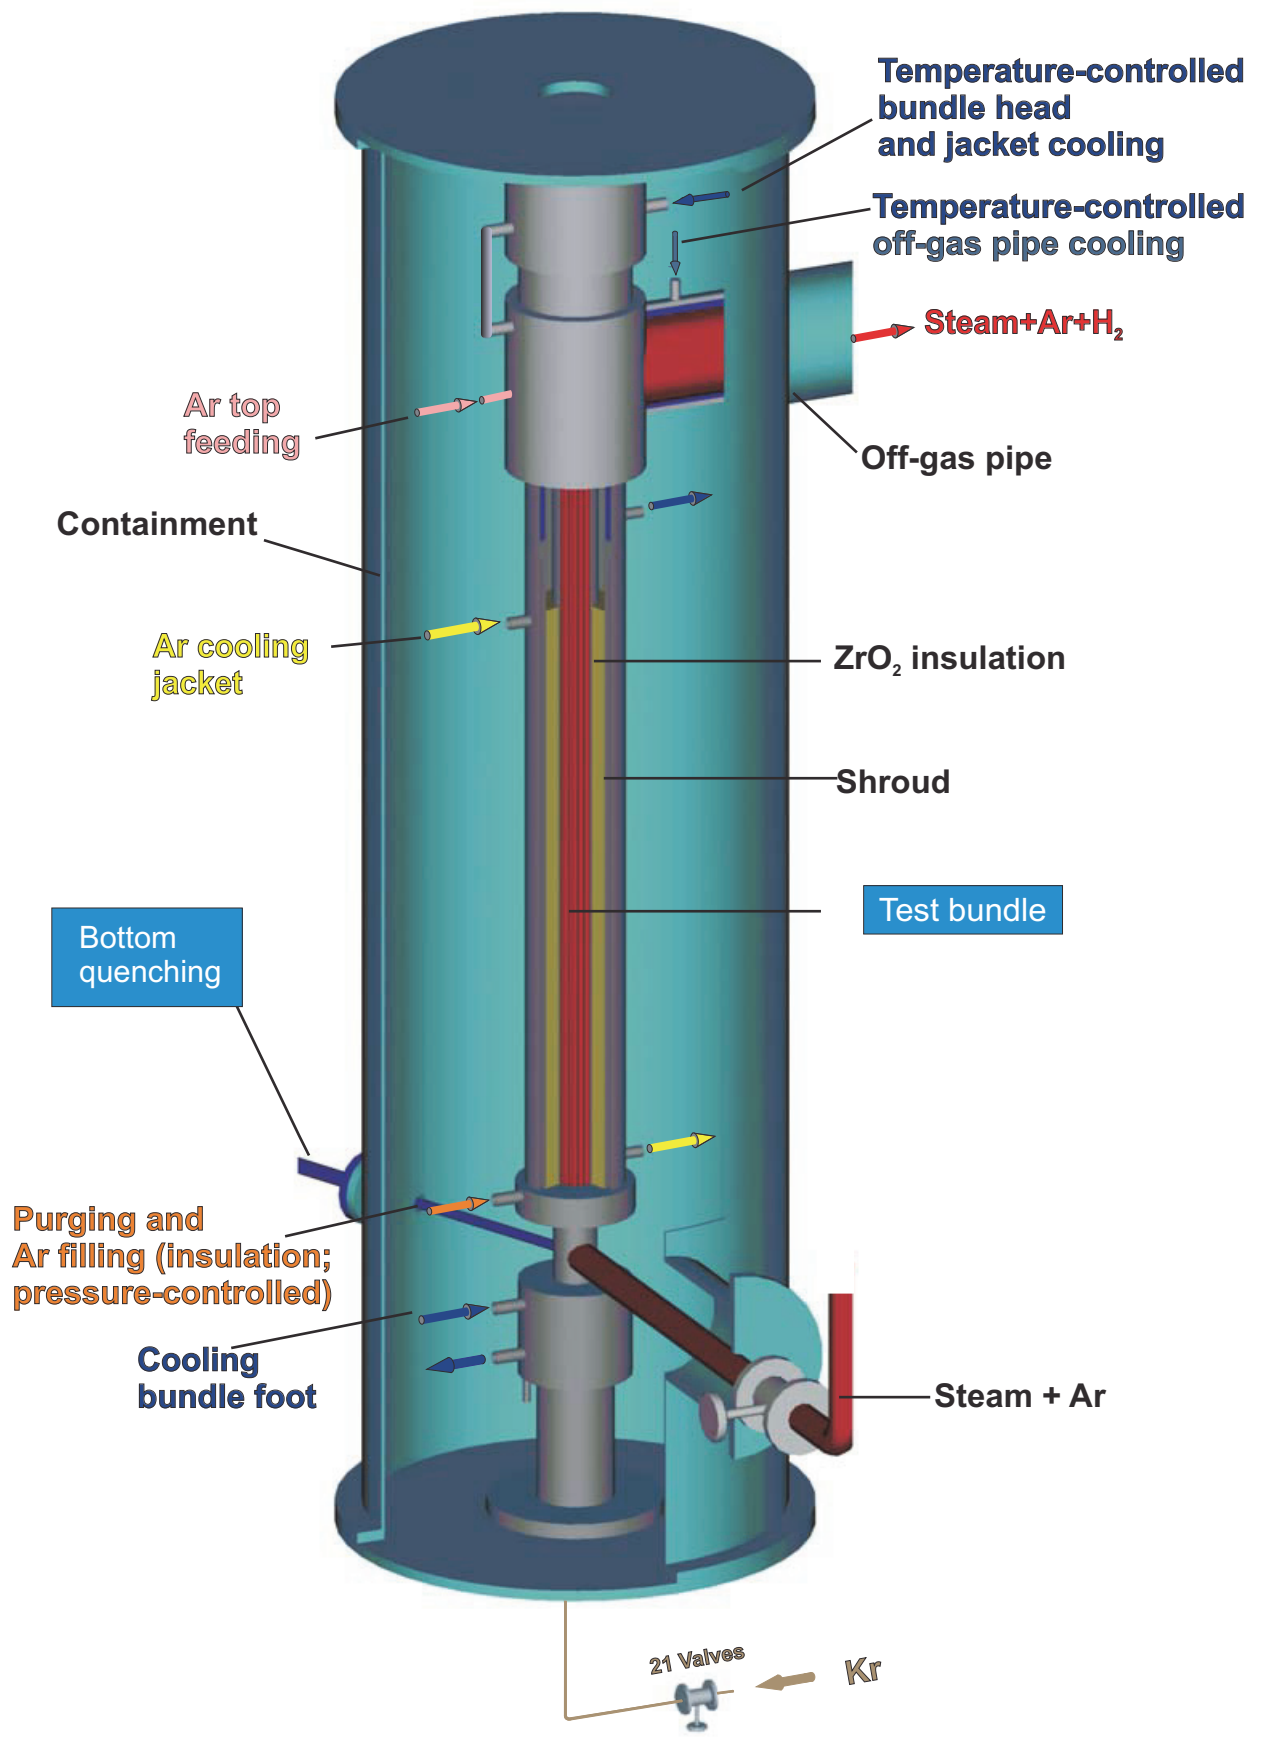
Fig. 3: QUENCH Facility; Containment and test section.

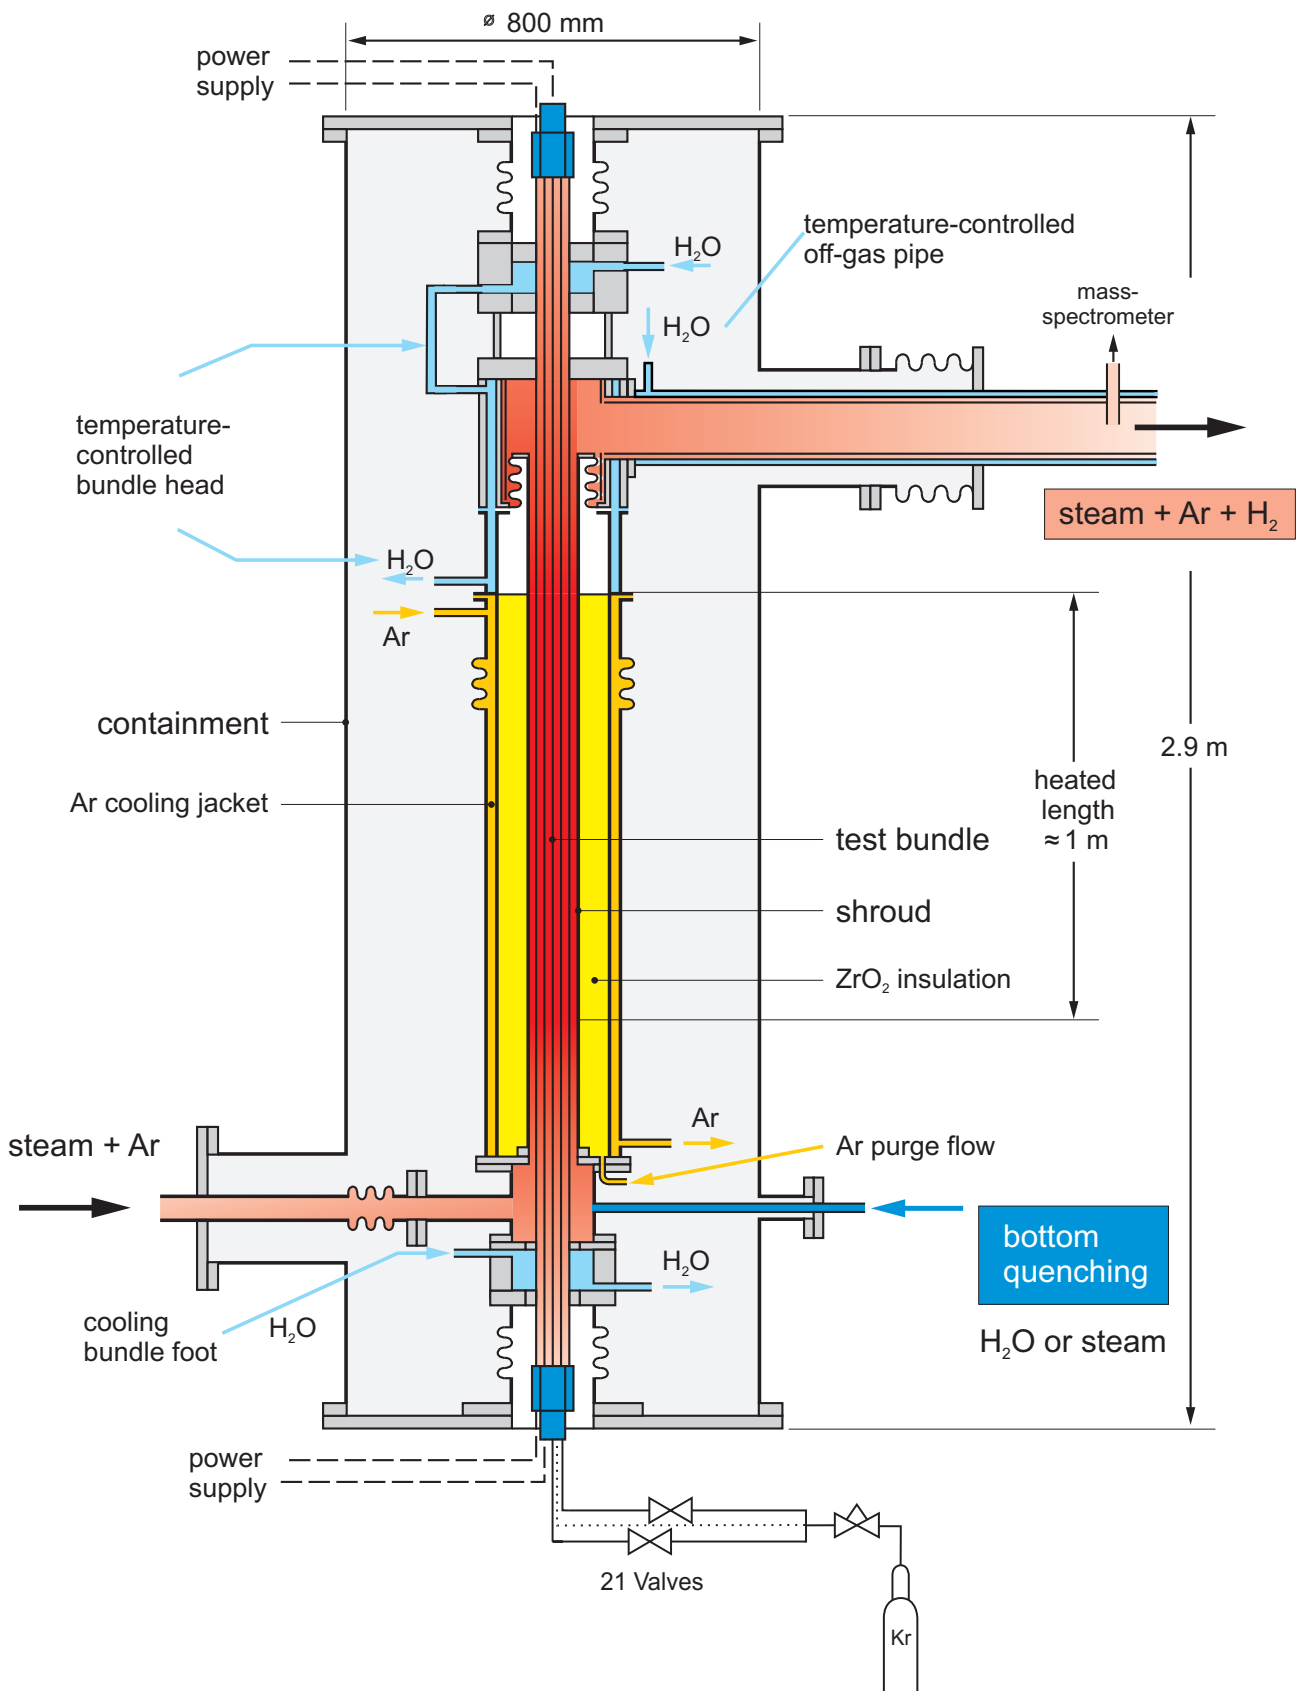
Fig. 4: QUENCH-L0; Test section with flow lines.

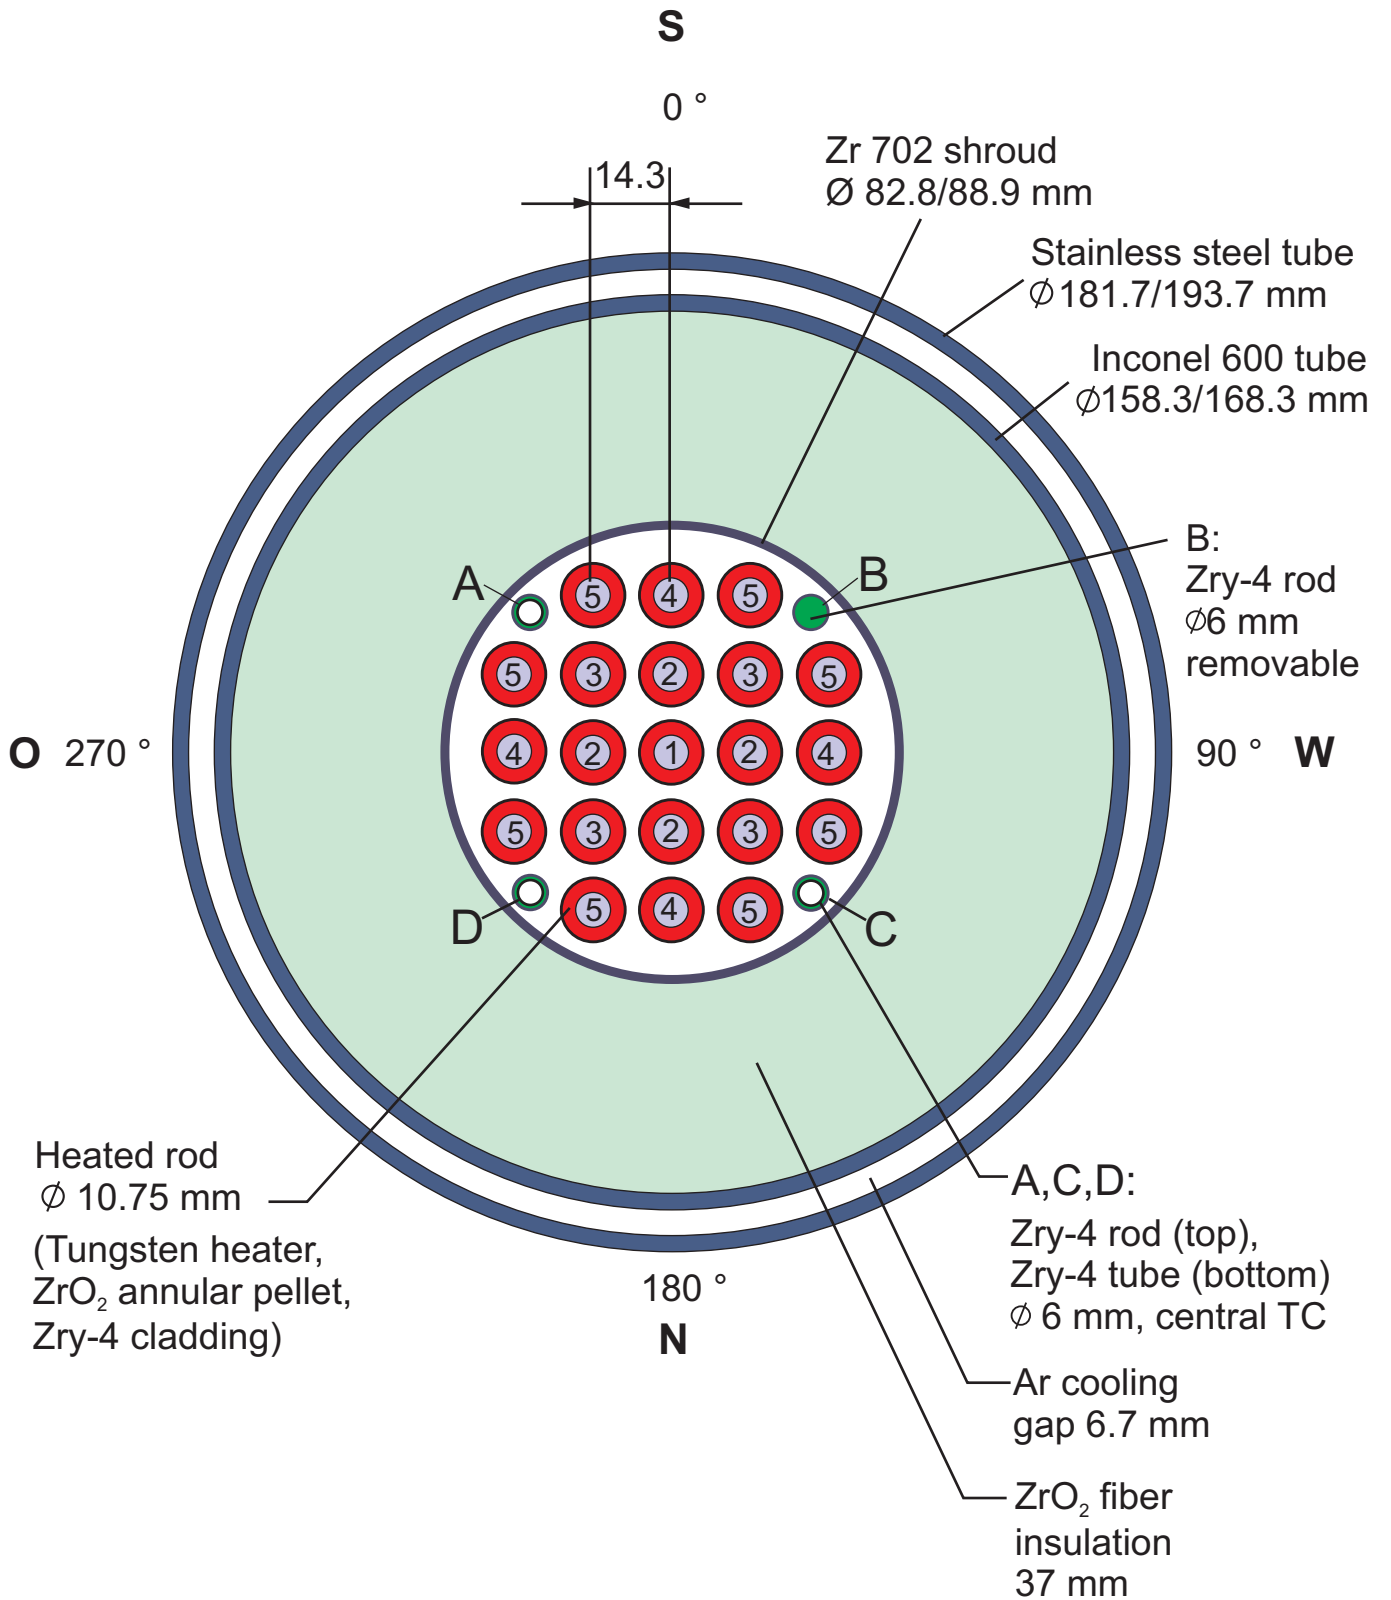
Fig. 5: QUENCH-L0; Fuel rod simulator bundle (cross section, top view) including rod type indications corresponding to table "List of Instrumentation".

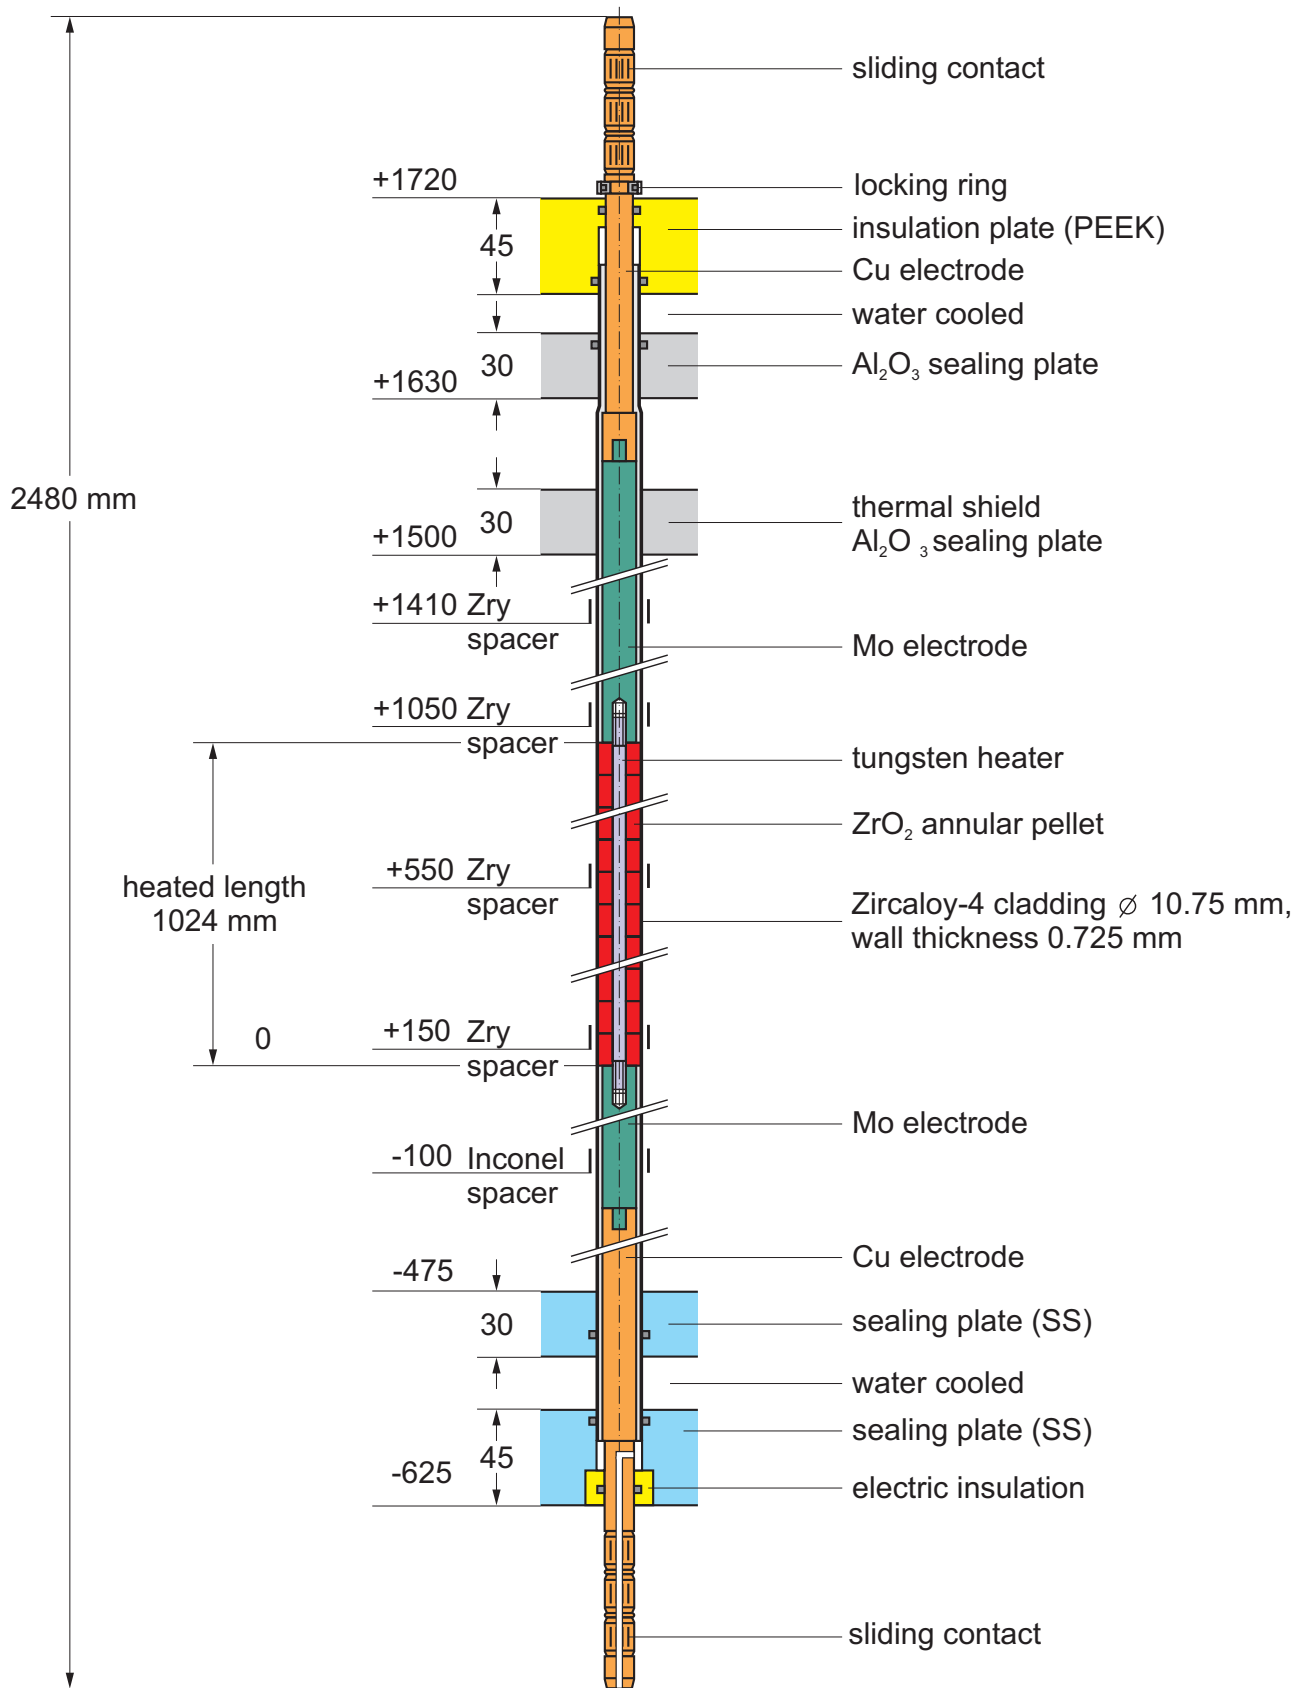
Fig. 6: Heated fuel rod simulator.

The lower boundary for the lower cooling chamber is a sealing plate made of stainless steel with plastic inlays for electrical insulation, sealed toward the system by O-shaped rings. The upper boundary of the lower cooling chamber is a sealing plate of stainless steel. An insulation plate made of plastic (PEEK) forms the top of the upper cooling chamber, and a sealing plate of Al₂O₃, functioning as a heat-protection shield, is the lower boundary of the upper cooling chamber (see Fig. 6).

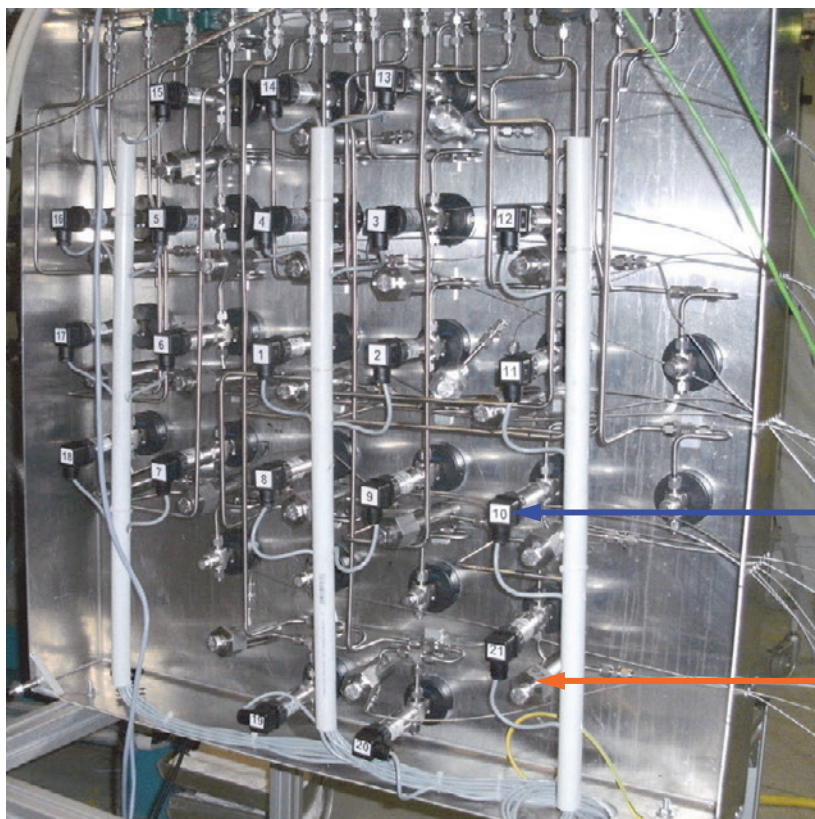
Fig. 7: QUENCH-L0; Rod pressure control and measurement panel.

Front side with:
21 pressure valves

precise pressure control

Rear side with :
21 capillary tubes
to test bundle
21 pressure
transducers
21 adjustable
compensation volumes
to setting of original
volume value
of 31.5 cm^3

According to LOCA scenarios the fuel rod simulators were loaded by inner pressures. The gas supply system ([Fig. 7](#)) for individual pressurization of rods consists of pressure controller, 21 valves, 21 pressure transducers, and 21 justified compensation volumes for setting of original volume value of 31.5 cm³ (the compensation is needed because of the absence of empty plenums inside the rod simulators). The gas supply is connected with capillary tubes (with inner diameter 1 mm, length ca. 1.2 m) to each rod at its lower end with drilled copper electrode ([Fig. 8](#)). The gas gap under the cladding is: 0.15 mm in the region of Cu/Mo electrodes and 0.075 mm in the region of W-heater/ZrO₂-pellets. Before gas filling the rods and gas supply system were evacuated.

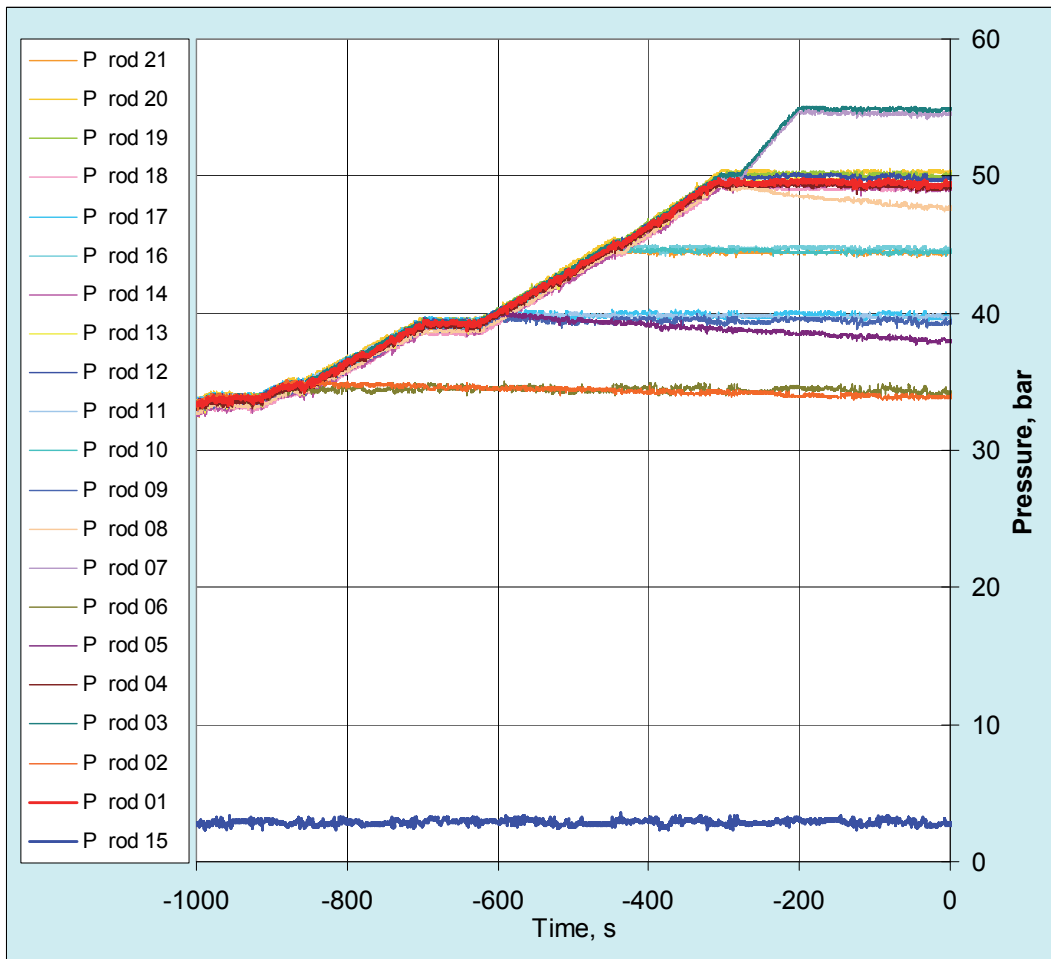
individual rod pressurization with Kr
at max cladding temperature $T_{pct}=520^{\circ}\text{C}$

Fig. 9: QUENCH-L0; Rod pressurization process.

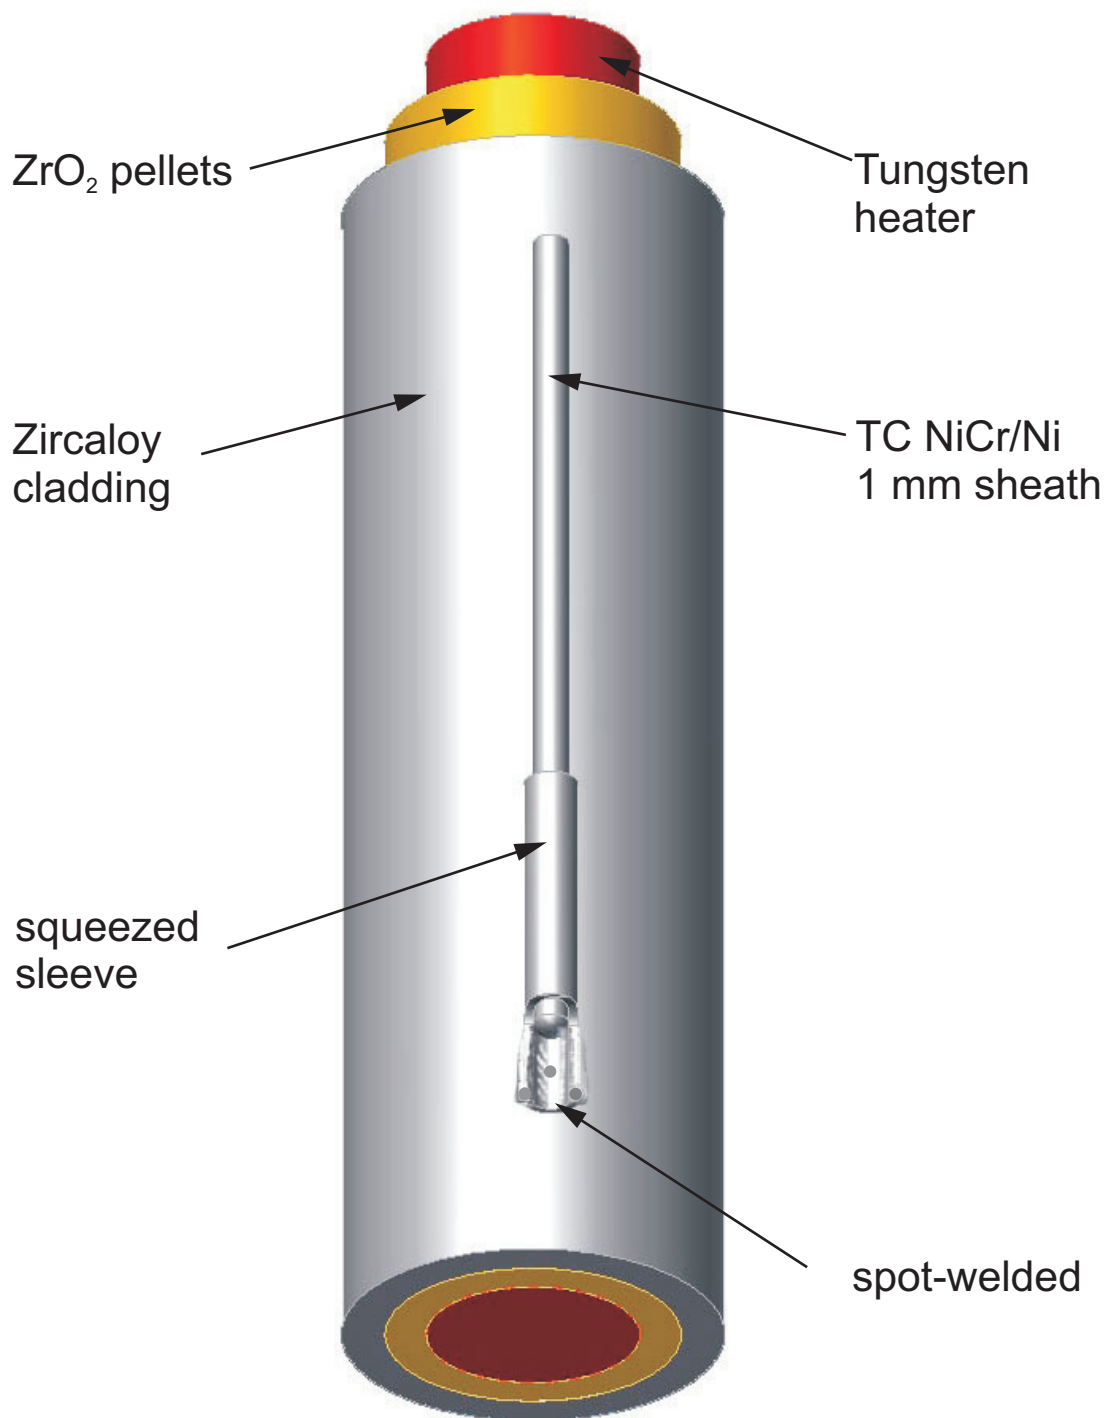
Fig. 10: QUENCH-L0; Concept for TC fastening at the test rod.

The test bundle was instrumented with sheathed thermocouples (TC) attached to the rod claddings ([Fig. 10](#)) at 17 different elevations between -250 mm and 1350 mm and at different orientations according to [Figs. 11 and 12](#). The NiCr/Ni thermocouples (1 mm diameter, stainless steel sheath 1.4541 (X6CrNiTi18-10), MgO insulation) are used for temperature measurement of rod cladding and shroud outer surfaces. The TC tip is held in place by a Zr ferrule welded to the surface. The compensation leads of the thermocouples from the -250 mm to the 850 mm level leave the test section at the bottom of the test section whereas those of the TCs above 850 mm are routed out of the top of the test section to prevent TC cables to pass the hot zone. The thermocouples attached to the outer surface of the rod cladding are designated "TFS" for all heated rods. The shroud thermocouples (designation "TSH") are mounted at the outer surface between -250 mm and 1250 mm. The thermocouples that are installed inside the Zry-4 instrumentation rods at the three corner positions of the bundle (positions A, C and D) are designated "TIT" (see [Fig. 13](#)). The thermocouples of the cooling jacket are installed inside the wall of the inner cooling tube (from -250 mm to 1150 mm, designation "TCI") and at the outer surface of the outer cooling tube (from -250 mm to 950 mm, designation "TCO").

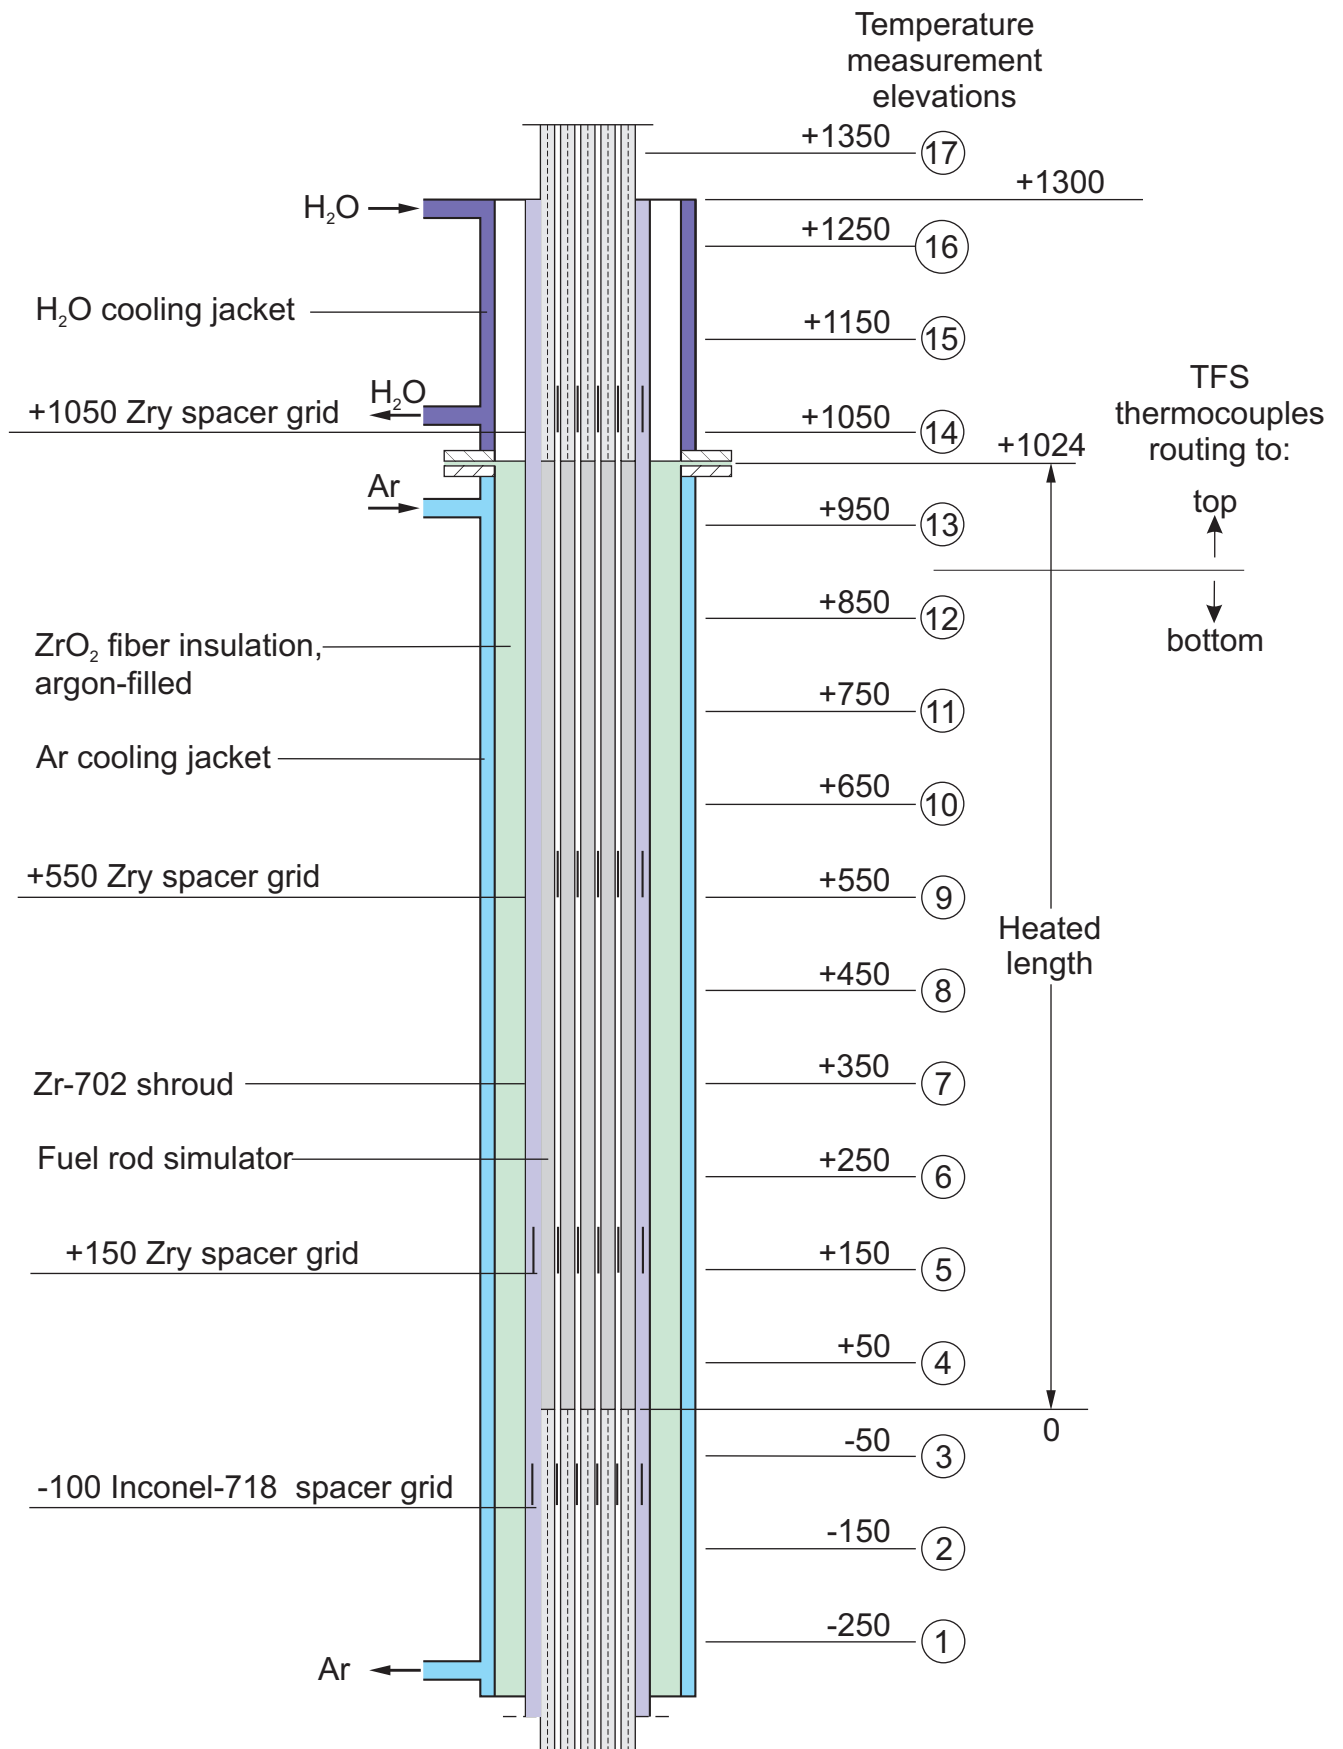
Fig. 11: Axial temperature measurement locations in the QUENCH-L0 test section.

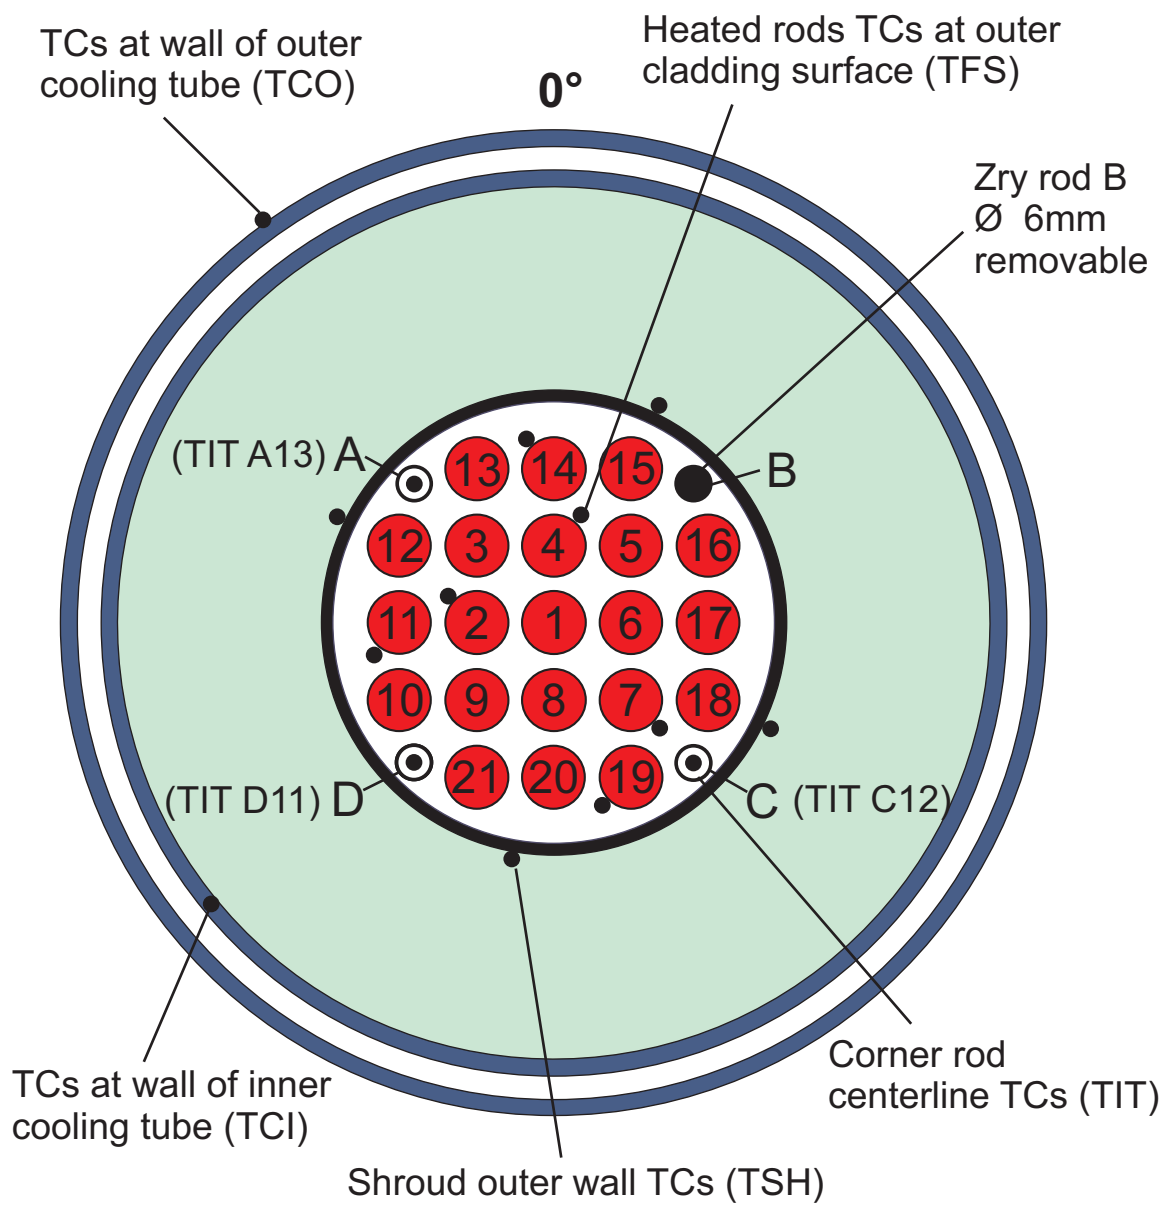
Fig. 12: QUENCH-L0; Test bundle; TC instrumentation and rod designation (top view).

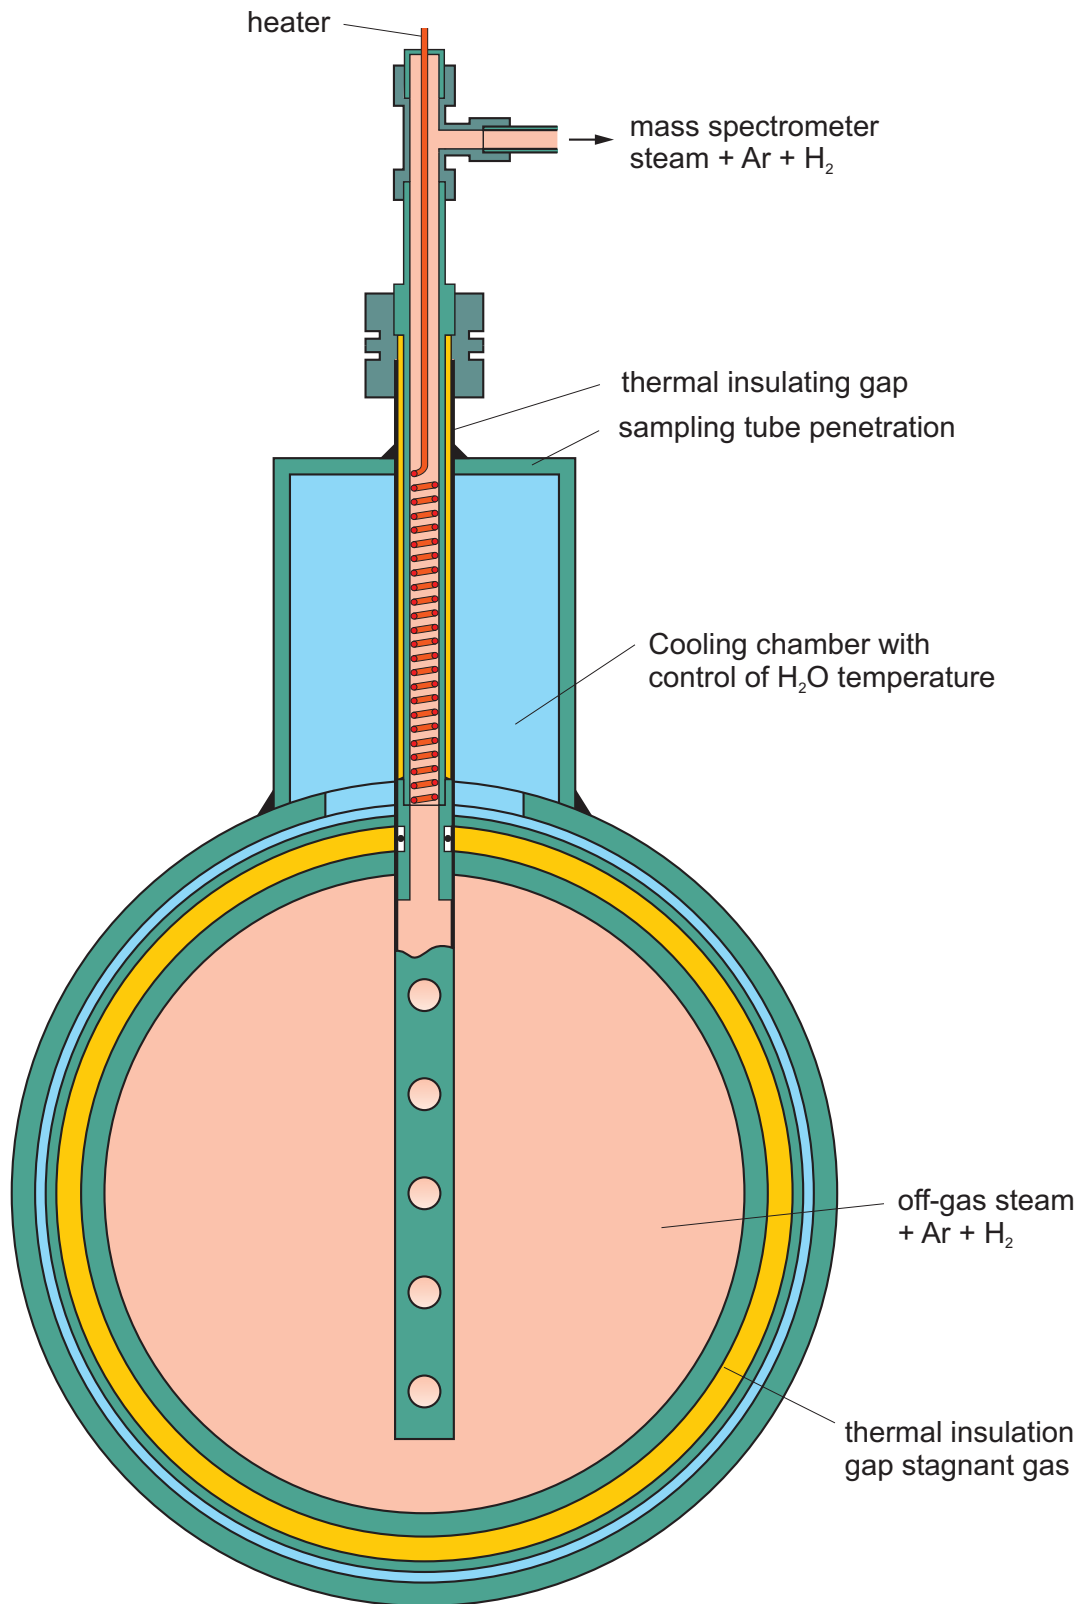
Fig. 15: Mass spectrometer sampling position at the off-gas pipe of the QUENCH test facility.

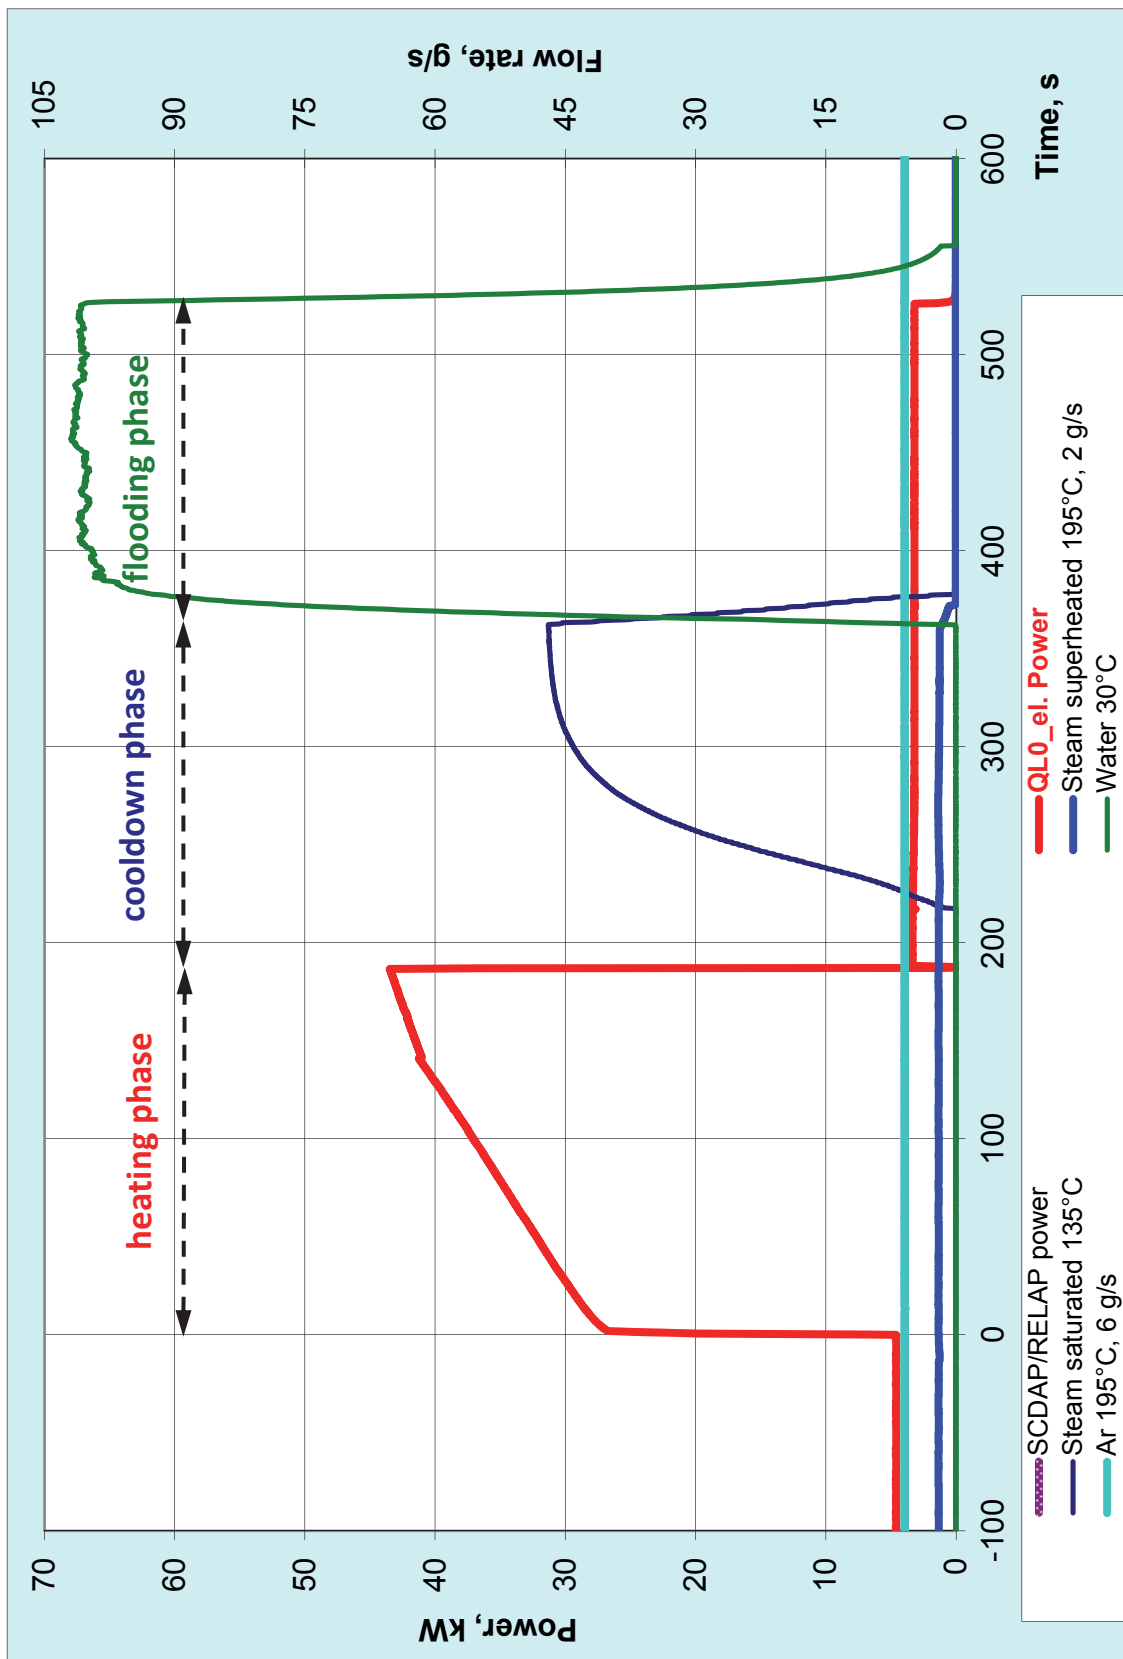
Fig. 16: QUENCH-L0; QLO test progression.

The sequence of the test events is represented in [Table 9](#). The experiment started ([Fig. 16](#)) by stabilizing the bundle conditions with an application of electrical bundle power of 4.6 kW (corresponded the linear heat rate of ~ 1 W/cm) in argon - superheated steam mixture (with rates of 6 g/s argon and 2 g/s steam, or specific rates 0.2 g/s/(effective rod) and 0.07 g/s/(effective rod) correspondingly) resulting in maximum bundle temperatures of 800 K. Due to limitation of the maximal electrical current of the DC generators the heating rate of 2.5 K/s was realised only ([Fig. 17](#)).
