Results of the commissioning bundle test QUENCH-L0 performed under LOCA conditions

J. Stuckert, M. Große, C. Rössger,
M. Steinbrück, M. Walter

Report-Nr. KIT-SR 7657

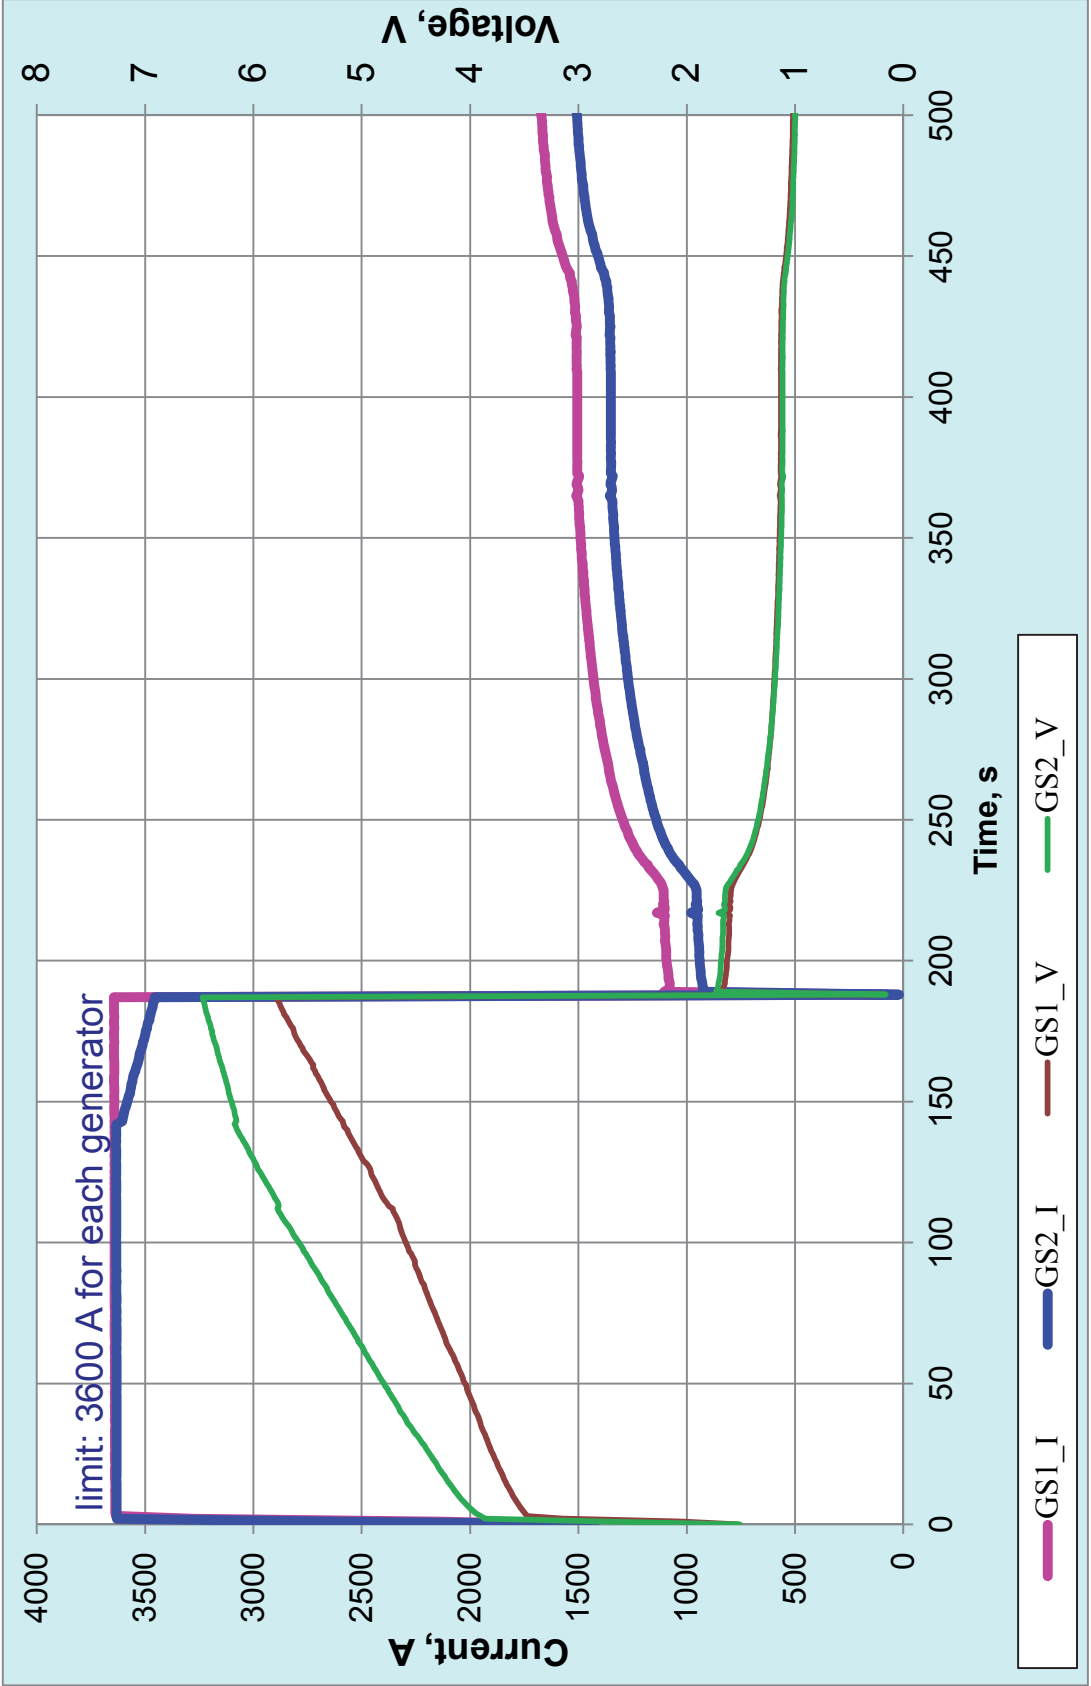
Fig. 17: QUENCH-L0; current limitation of DC generators.

The sequence of the test events is represented in [Table 9](#). The experiment started ([Fig. 16](#)) by stabilizing the bundle conditions with an application of electrical bundle power of 4.6 kW (corresponded the linear heat rate of ~ 1 W/cm) in argon - superheated steam mixture (with rates of 6 g/s argon and 2 g/s steam, or specific rates 0.2 g/s/(effective rod) and 0.07 g/s/(effective rod) correspondingly) resulting in maximum bundle temperatures of 800 K. Due to limitation of the maximal electrical current of the DC generators the heating rate of 2.5 K/s was realised only ([Fig. 17](#)).

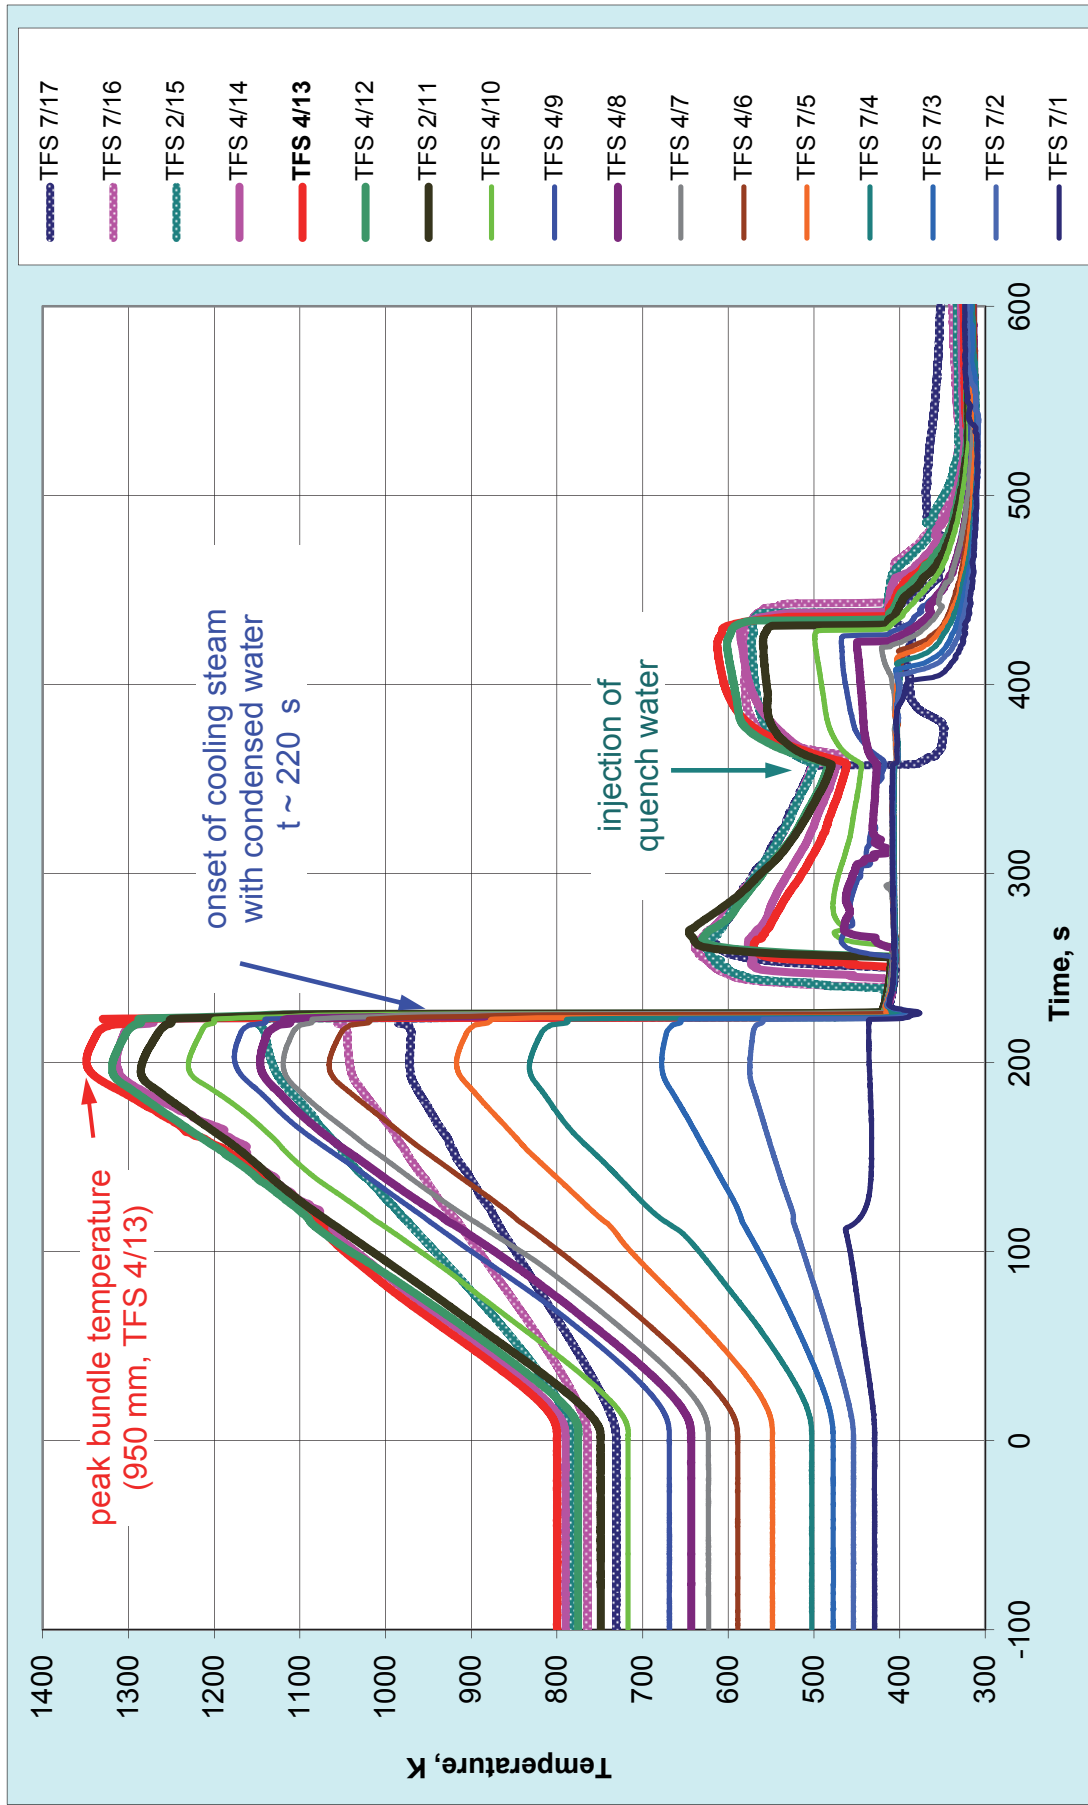
Fig. 18: QUENCH-L0; Rod-surface thermocouple readings at 17 elevations between -250 und 1350 mm.

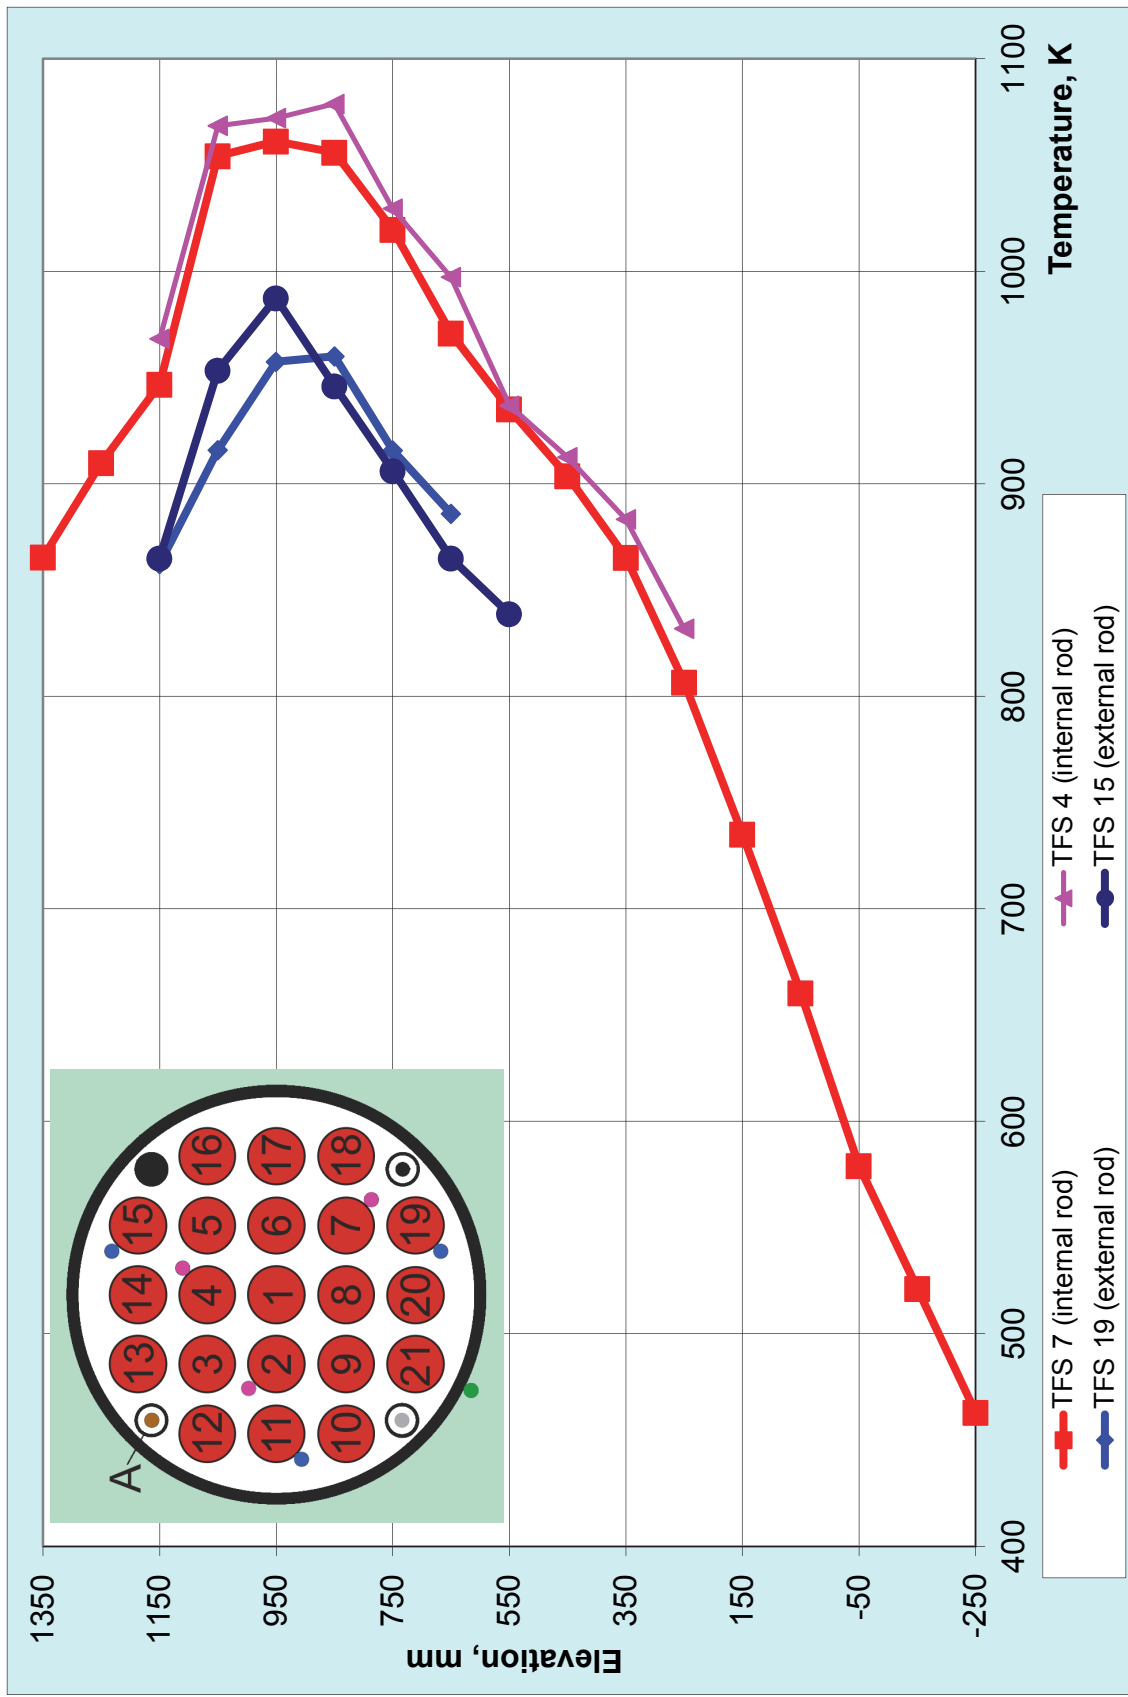
Fig. 37: QUENCH-L0; Axial and radial temperature distribution on time of the first burst case.

Two groups of curves are clearly separated in the diagram: a more oxidized inner rod group of the bundle and a less oxidized outer group together with the corner rod. Irregular thickness changings were observed inside of the axial zone with the pronounced ballooning of gas loaded tubes due to deviation of cladding thickness from this parameter for the original calibration sample. Only the unloaded cladding #15 and the solid corner rod show regular axial distribution of the oxidation degree. The most oxidized region is between 850 and 1050 mm, what corresponded to the axial temperature profile (Fig. 37).

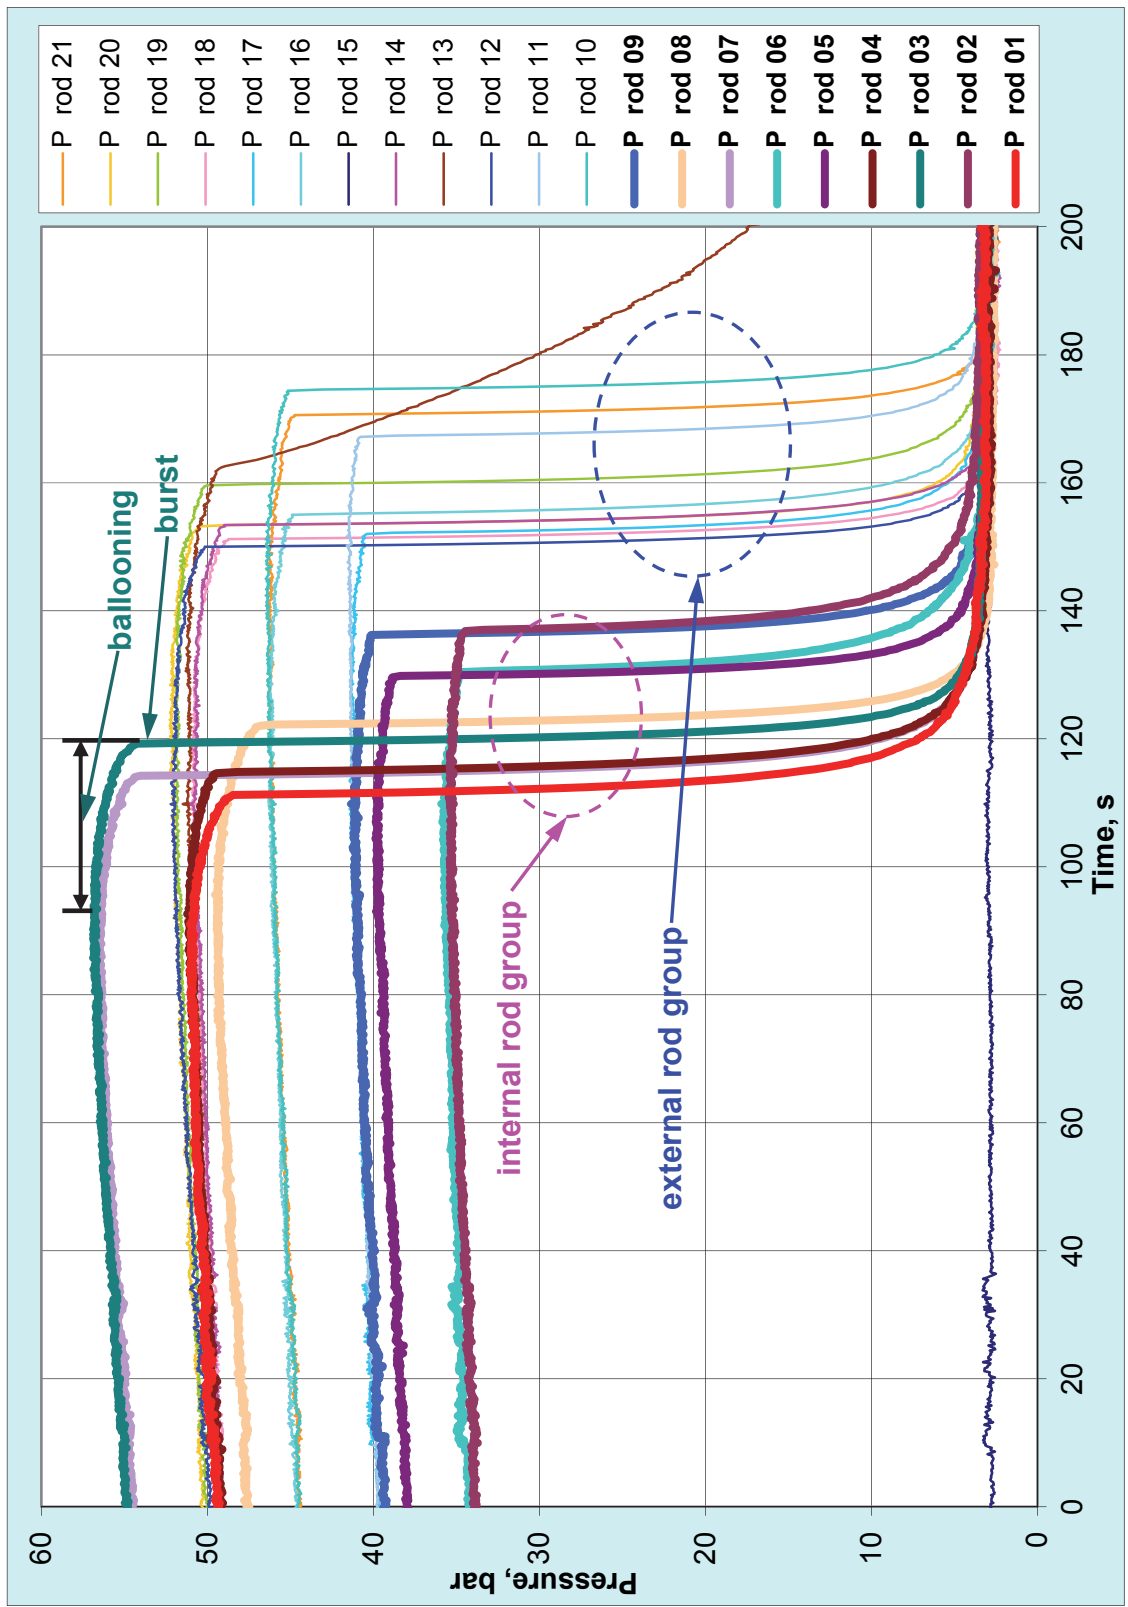
Fig. 44: QUENCH-L0; Pressure changing during heating phase; ballooning and burst.

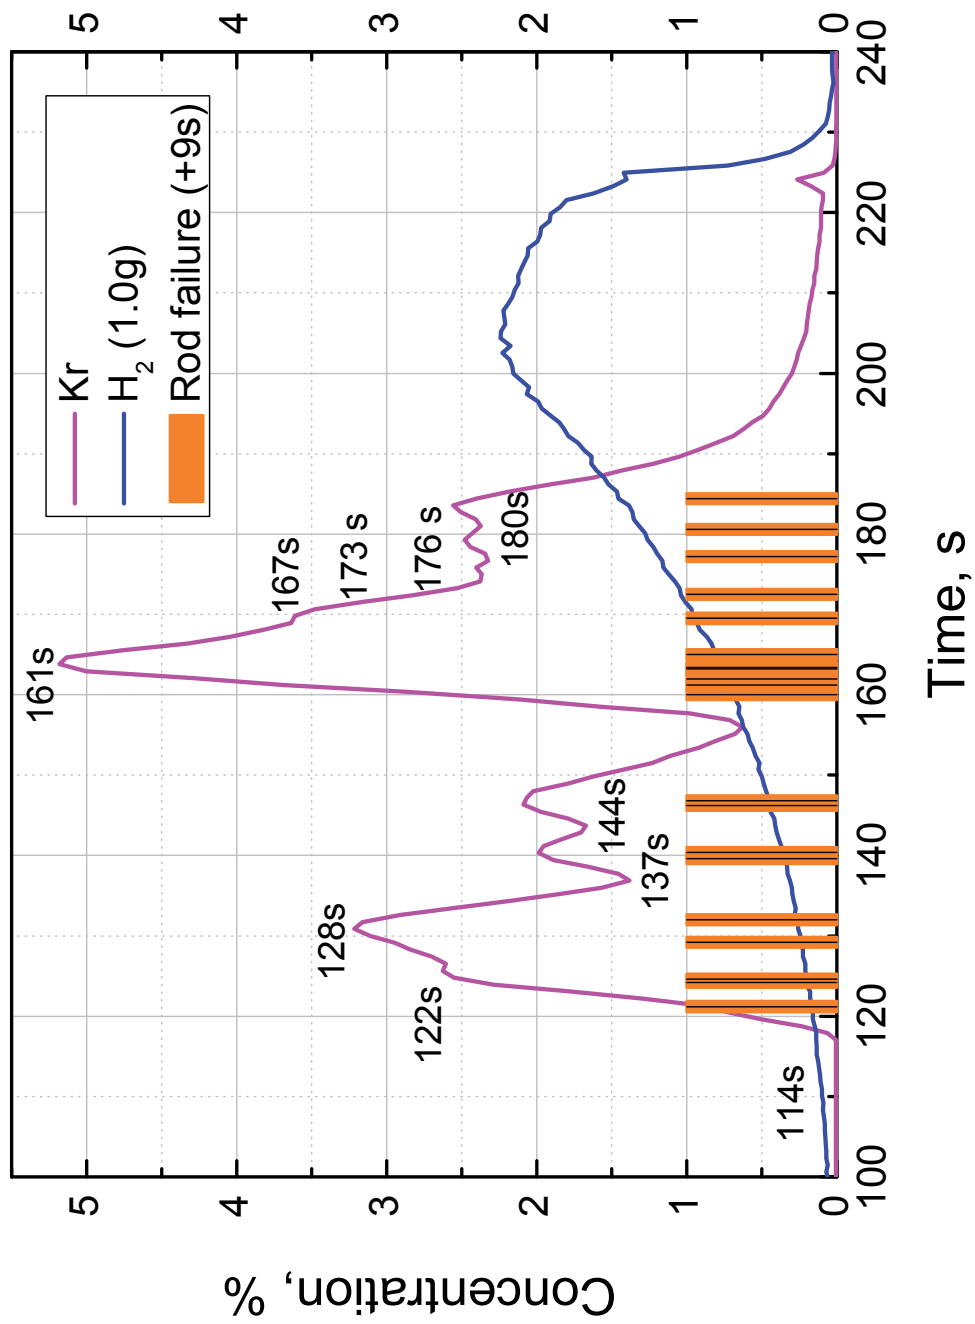
Fig. 45: QUENCH-L0; Mass spectrometer measurements: Krypton as burst indicator.

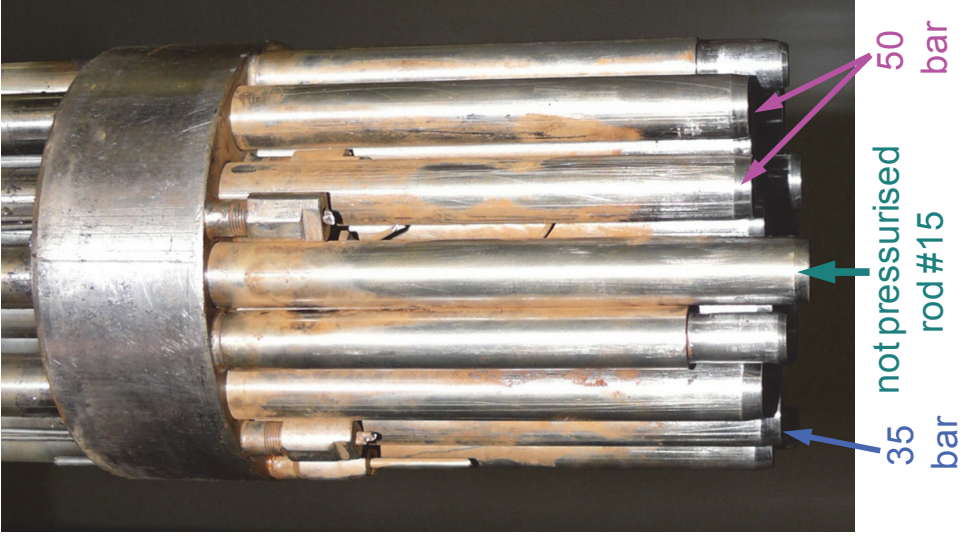
Fig. 46: QUENCH-L0; Consequences of ballooning.

side view at 30°:
axial shrinkage of claddings
due to Zry anisotropy

The decreased yield strength and increased ductility of claddings during the transient phase resulted in a progressive ballooning and consequent burst of all of the pressurized rods ([Table 10](#)). The first burst occurred 111 s after initiation of the transient phase at about 1069 K at rod 1 which was pre-pressurized to 50 bar. All 20 pressurized rods failed within 63 s ([Fig. 44](#)). The individual rod failures were indicated by internal pressure readings and precisely correlated with krypton peaks measured in the off-gas pipe by mass spectrometer. Two peaks of Kr release indicate failure of inner and outer rod groups ([Fig. 45](#)). The first failed rod was the central rod #1, the last one was the peripheral rod #10. The temperature range for bursts is estimated from thermocouple readings to be between 1049 and 1141 K. The burst time is mainly controlled by the rod temperature, which has a much stronger influence on the burst time than the internal pressure. All pressurized rods revealed axial contraction by ~10 mm due to Zircaloy anisotropy ([Fig. 46, right](#)). No significant rod bending was observed.

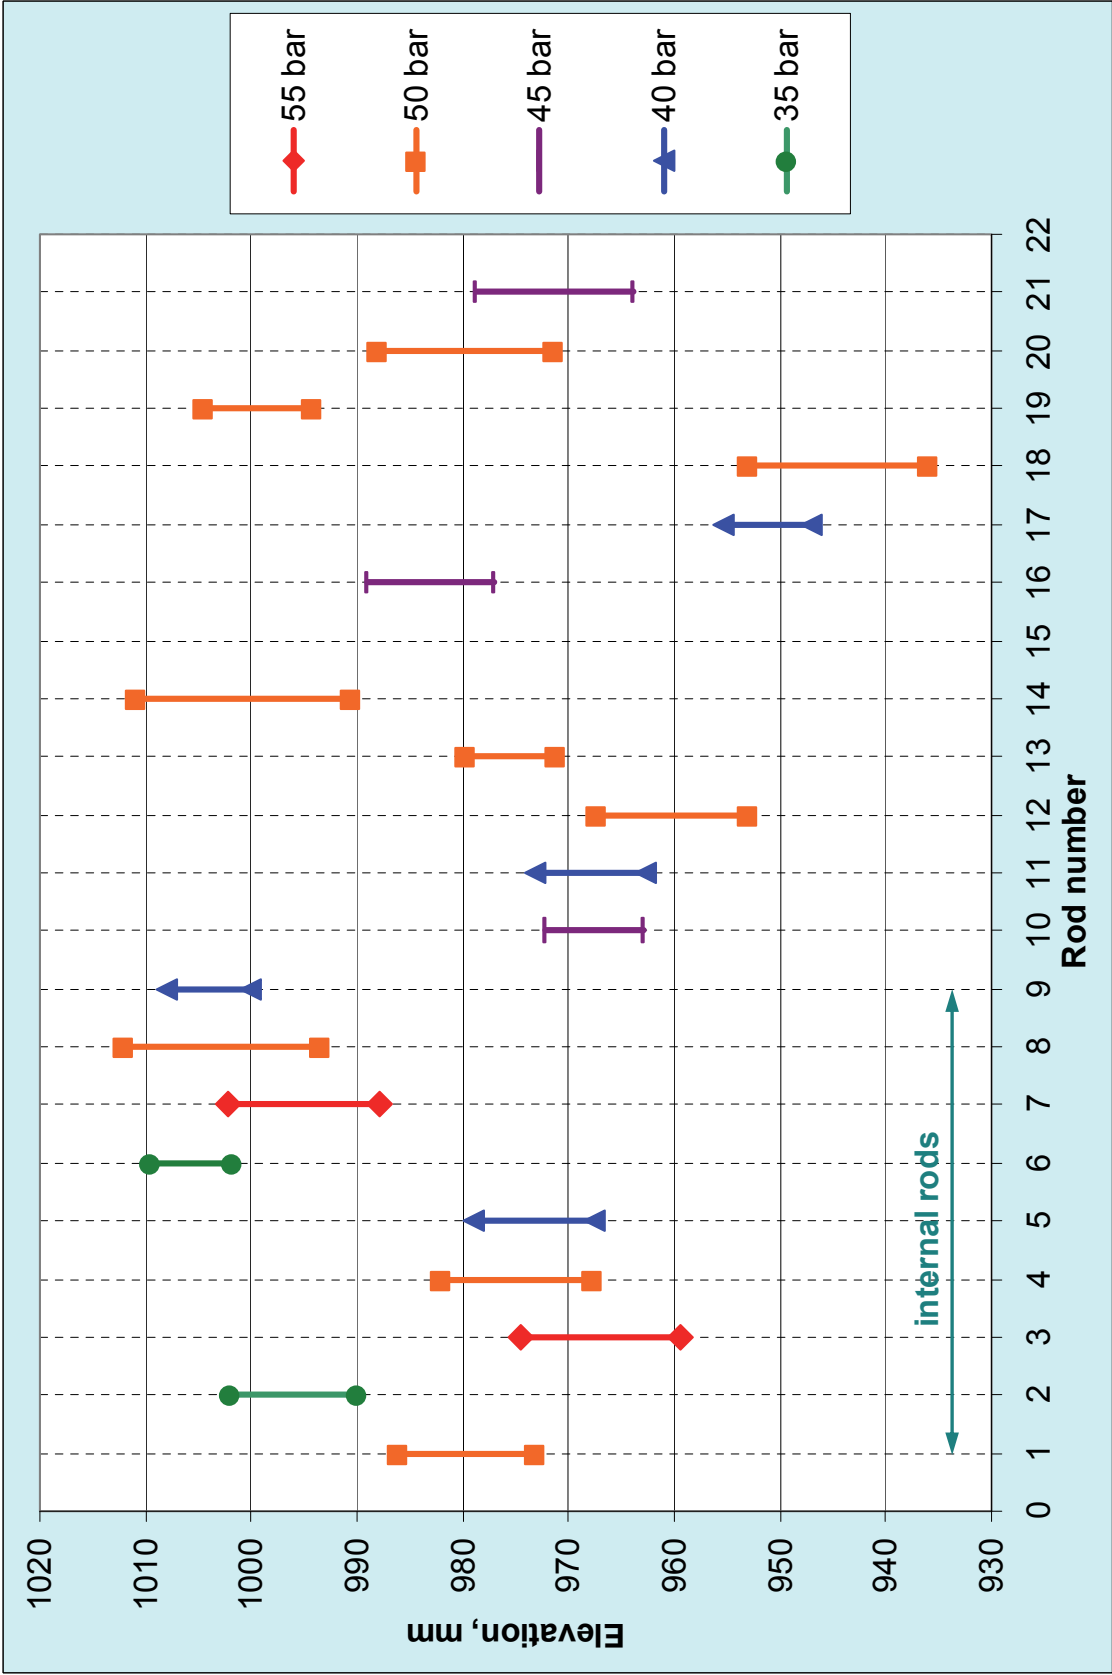
Fig. 48: QUENCH-L0; Axial burst positions.

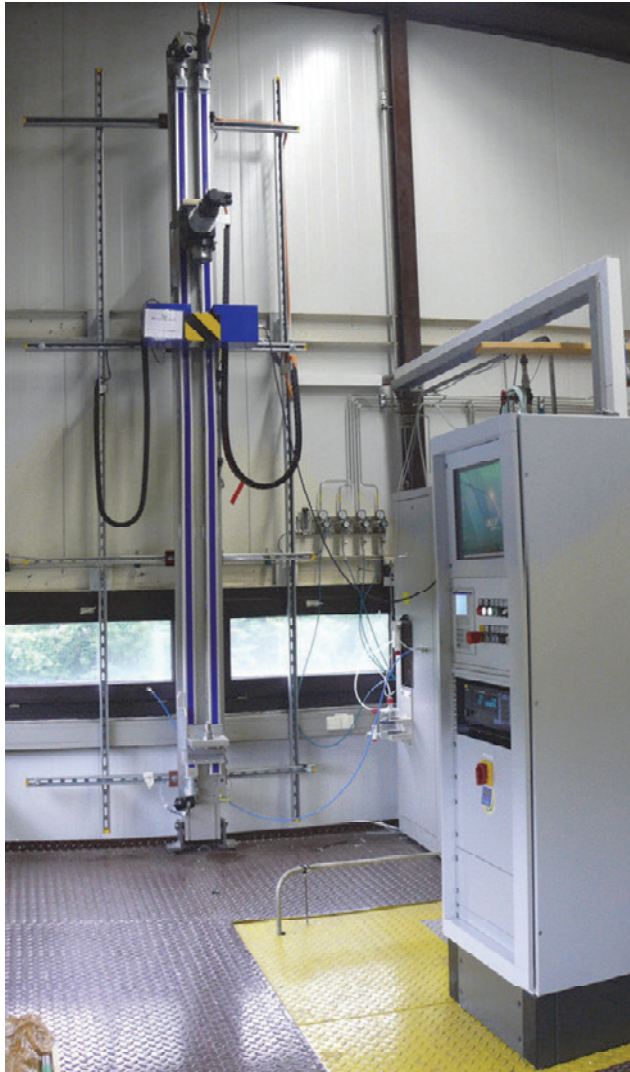
scanner facility

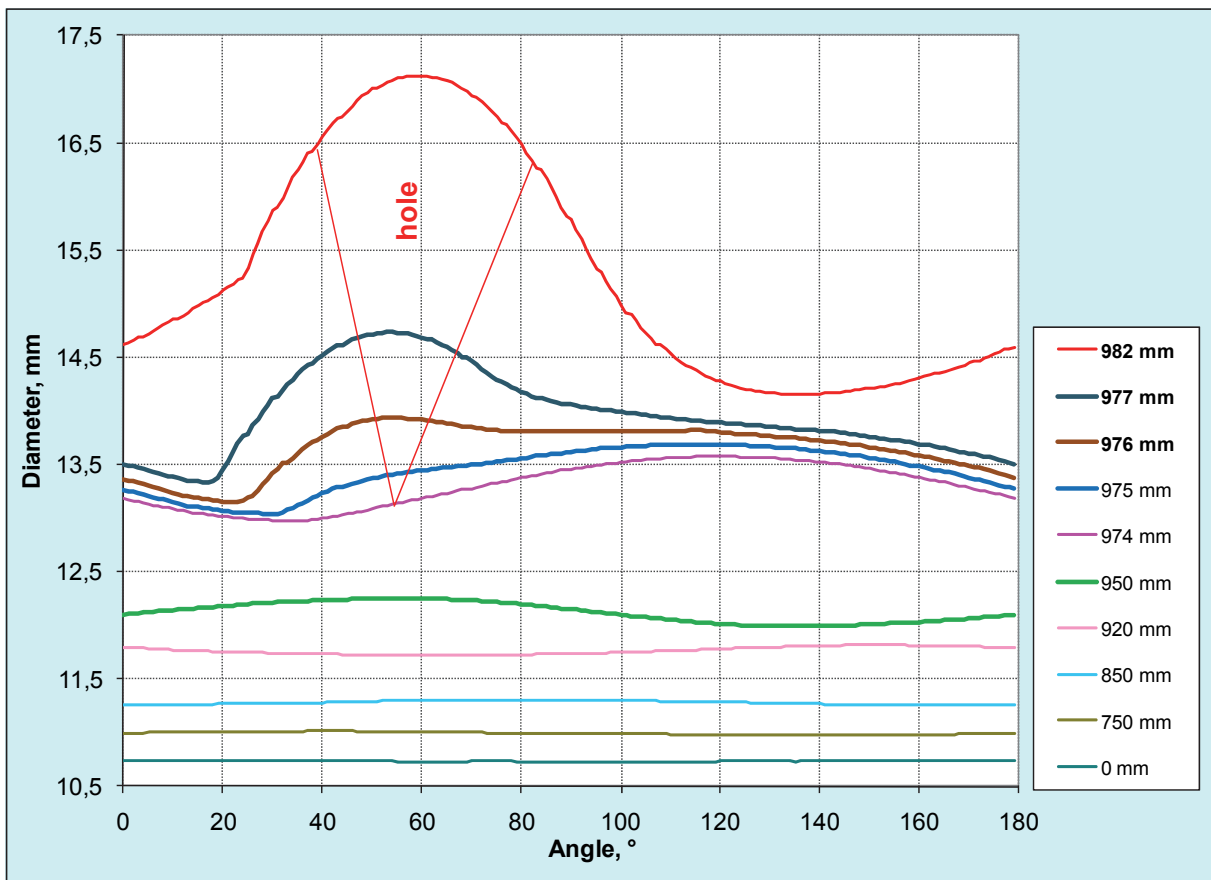
Fig. 50: QUENCH-L0, rod #1; longitudinal circumferential strain changing (top); azimuthal diameter changing downwards from burst (bottom).

Also based on these scans, the circumferential strains can be calculated (Table 11), which are depicted on Figs. 50-69, top. There is a clear correlation of the burst mean location and the temperature distribution on the longitudinal axis. Maximum strain of 49% was observed on the inner rod #8, minimum strain of 25.3% was observed on the inner rod #10.

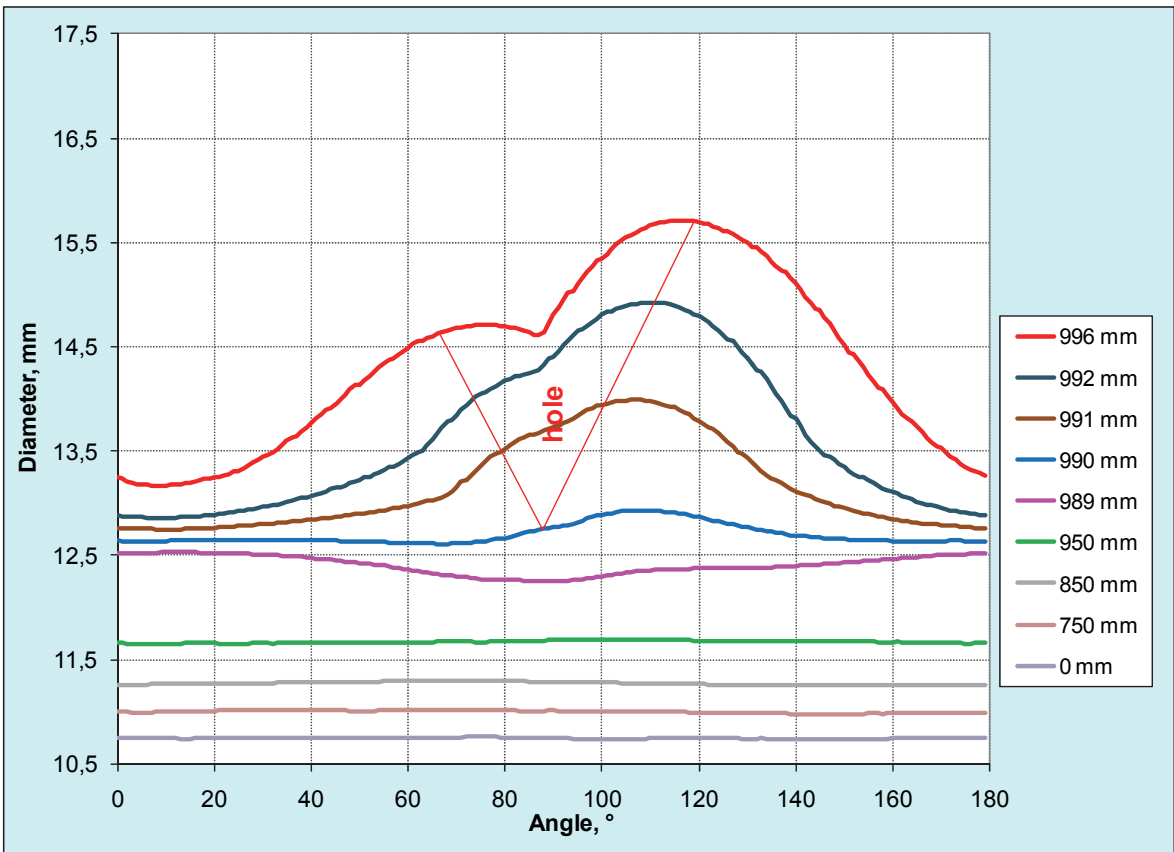
Fig. 51: QUENCH-L0, rod #2; longitudinal circumferential strain changing (top); azimuthal diameter changing downwards from burst (bottom).

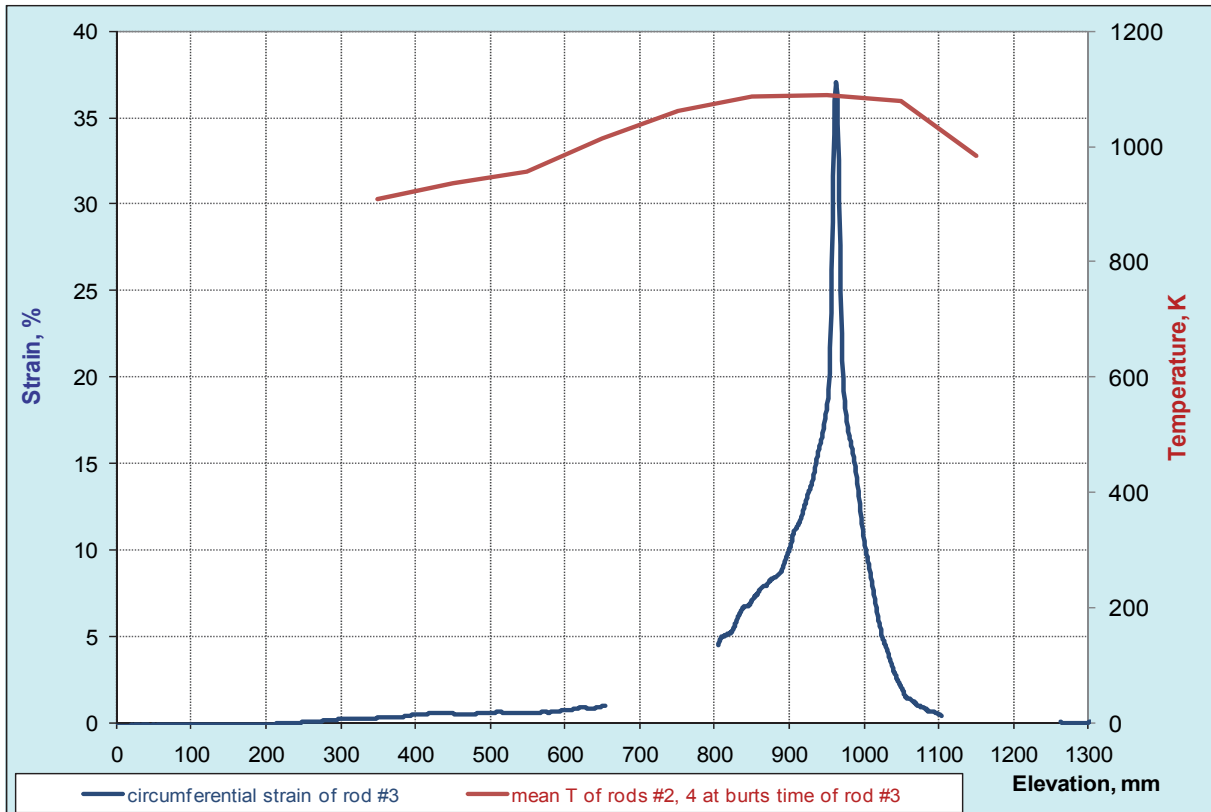
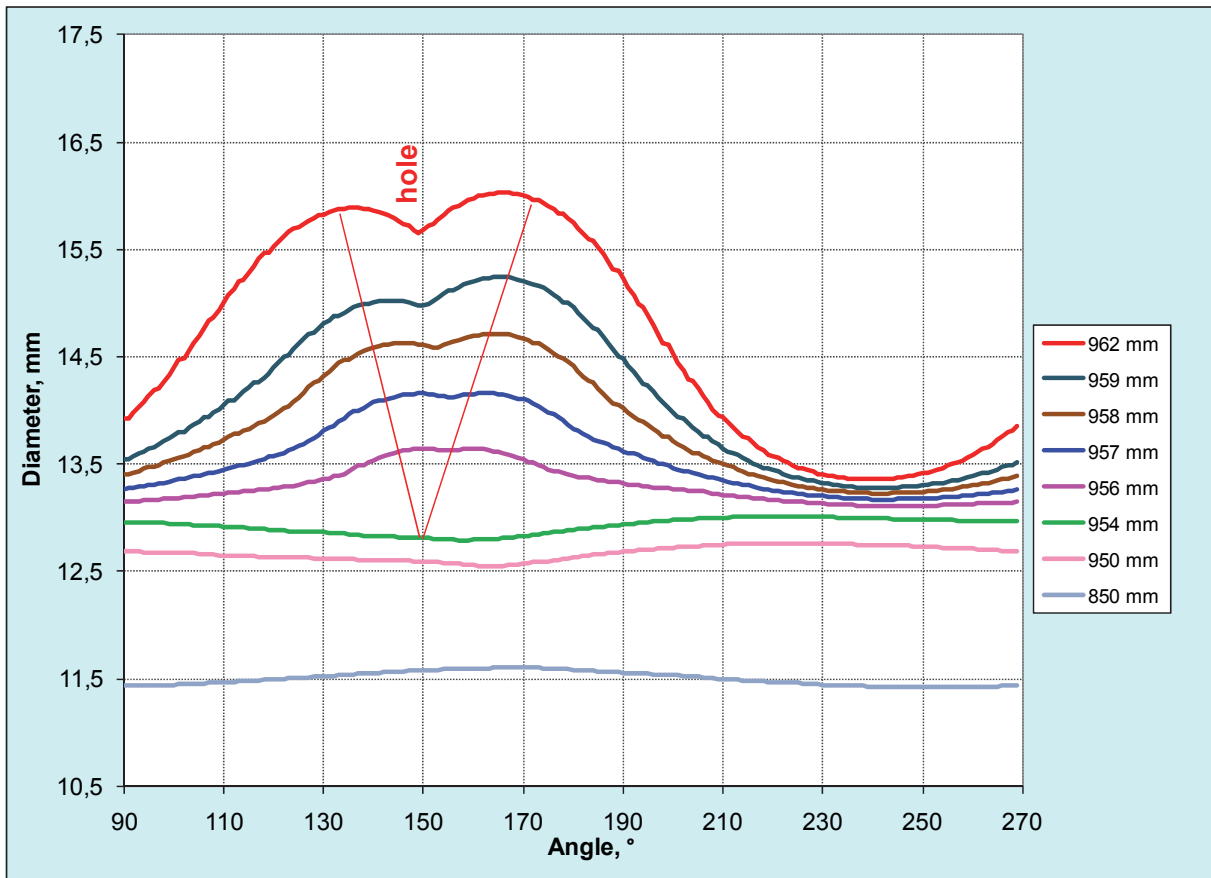
Fig. 52: QUENCH-L0, rod #3; longitudinal circumferential strain changing (top); azimuthal diameter changing downwards from burst (bottom).

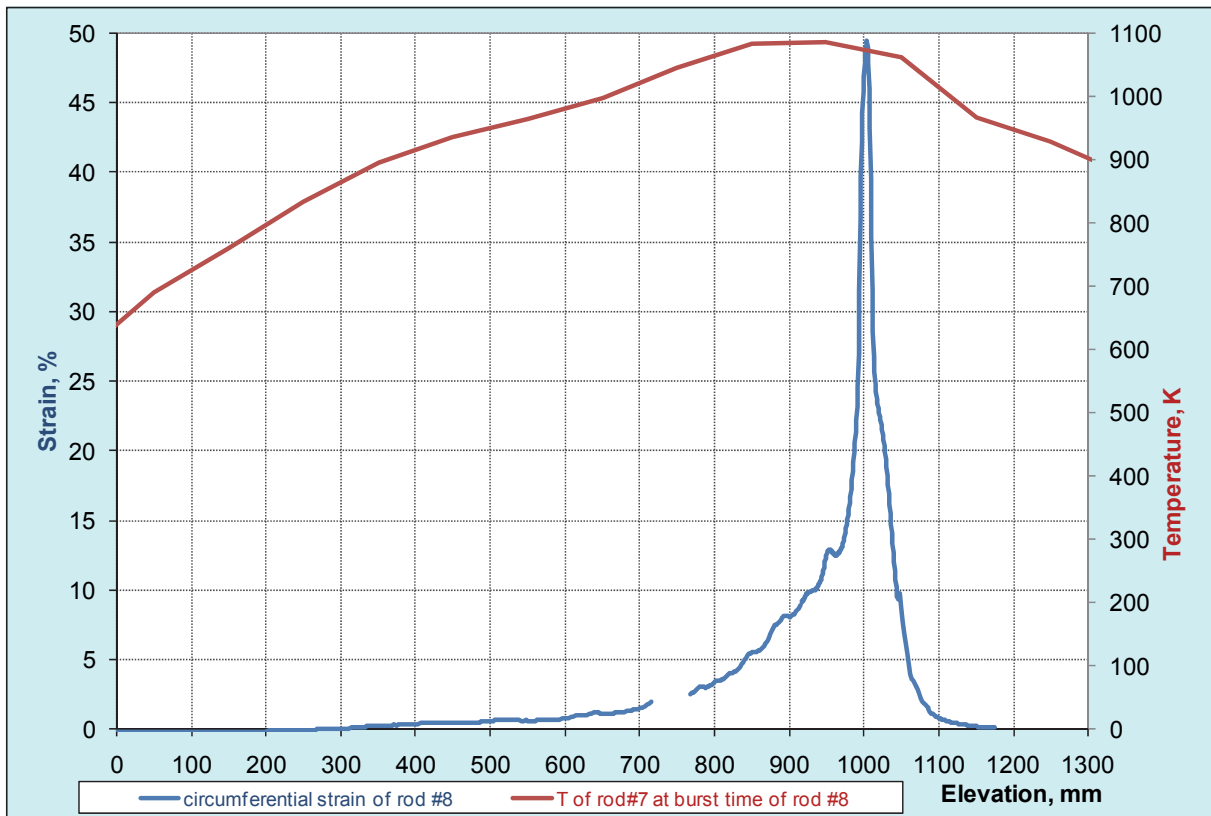
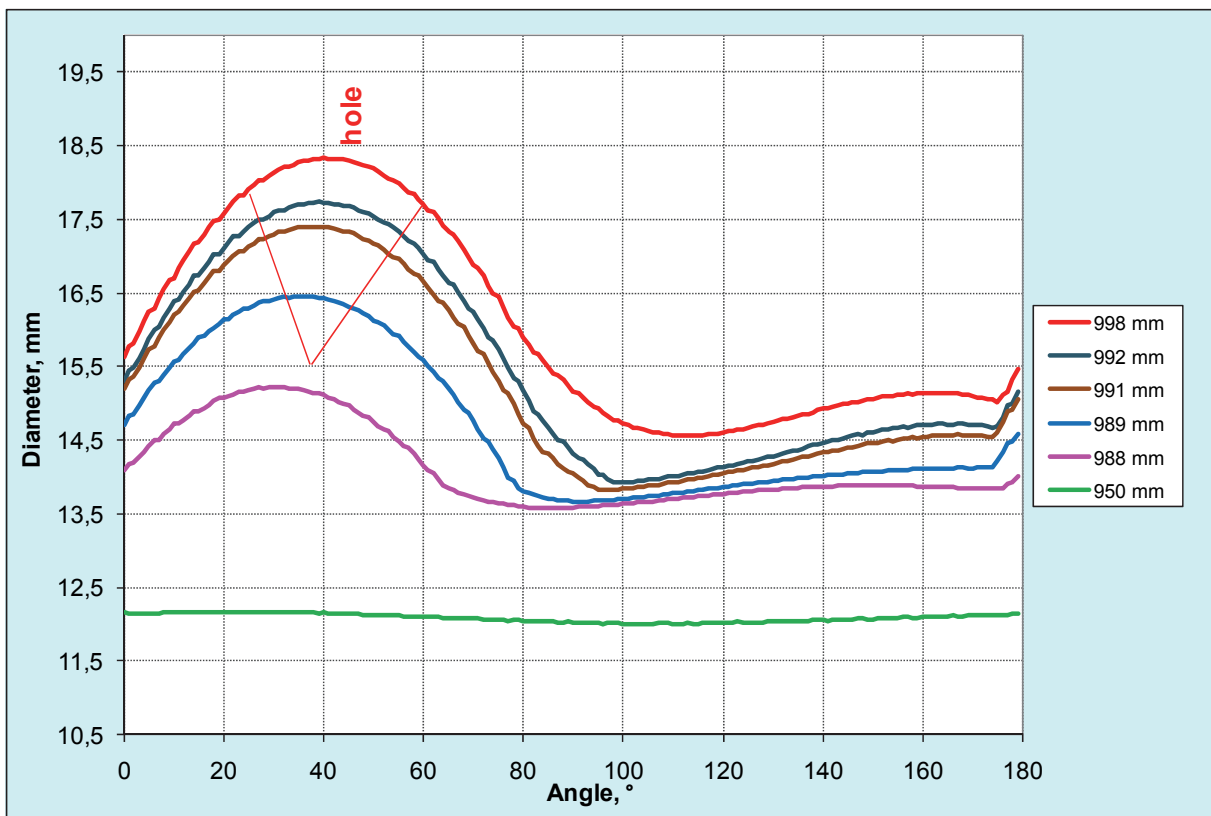
Fig. 57: QUENCH-L0, rod #8; longitudinal circumferential strain changing (top); azimuthal diameter changing downwards from burst (bottom).

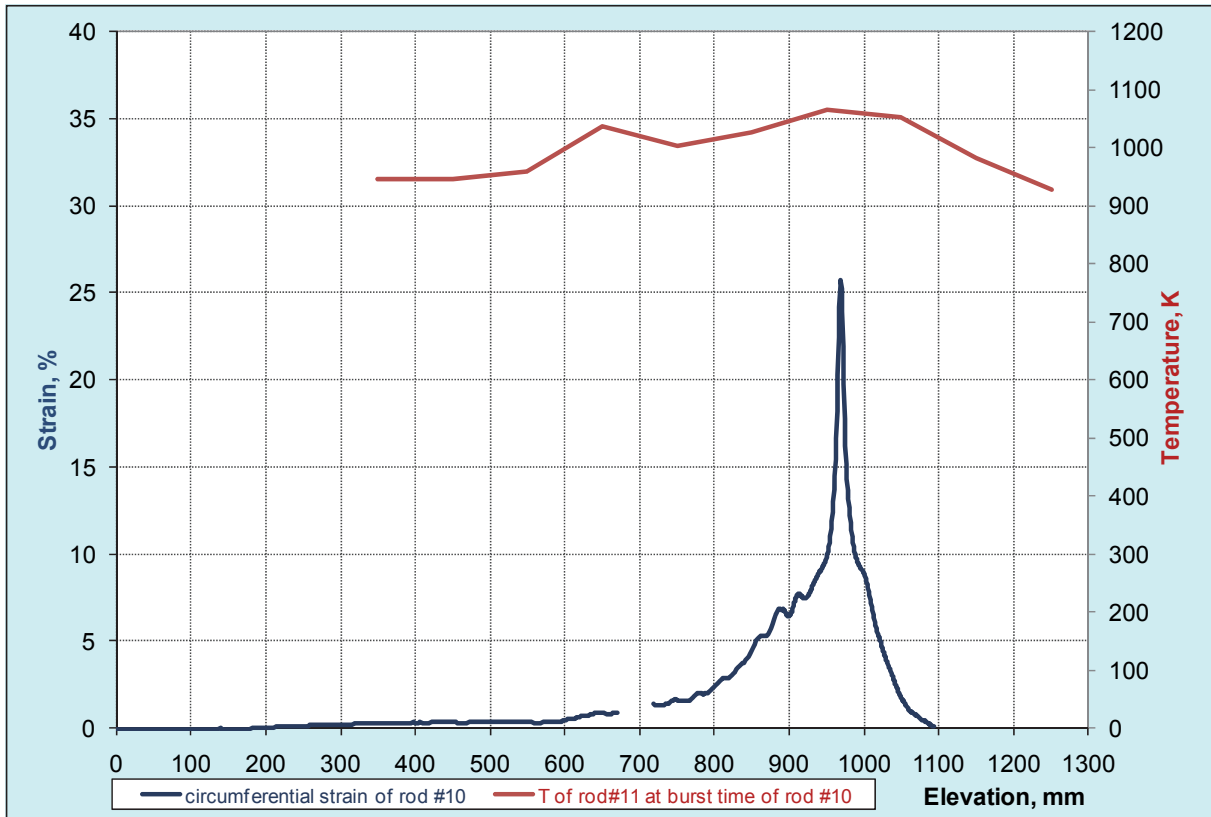
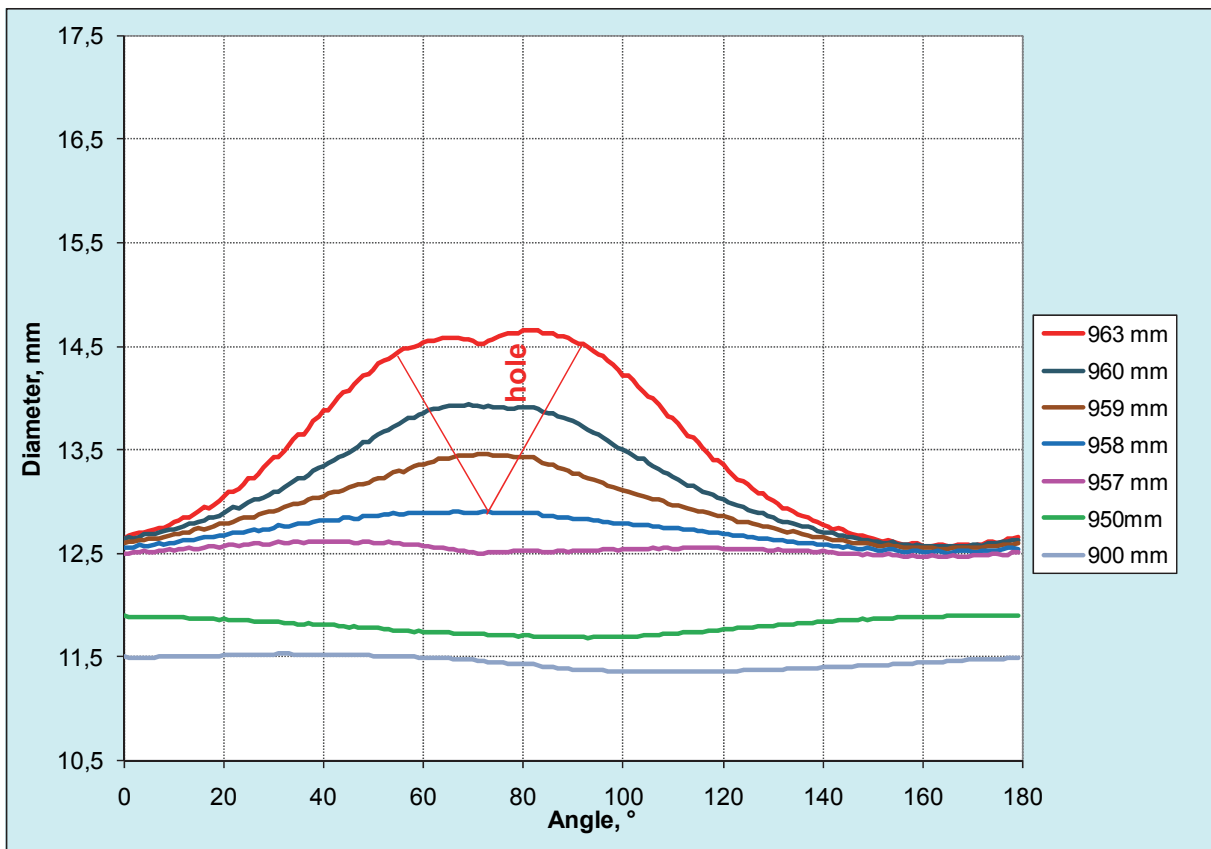
Fig. 59: QUENCH-L0, rod #10; longitudinal circumferential strain changing (top); azimuthal diameter changing downwards from burst (bottom).

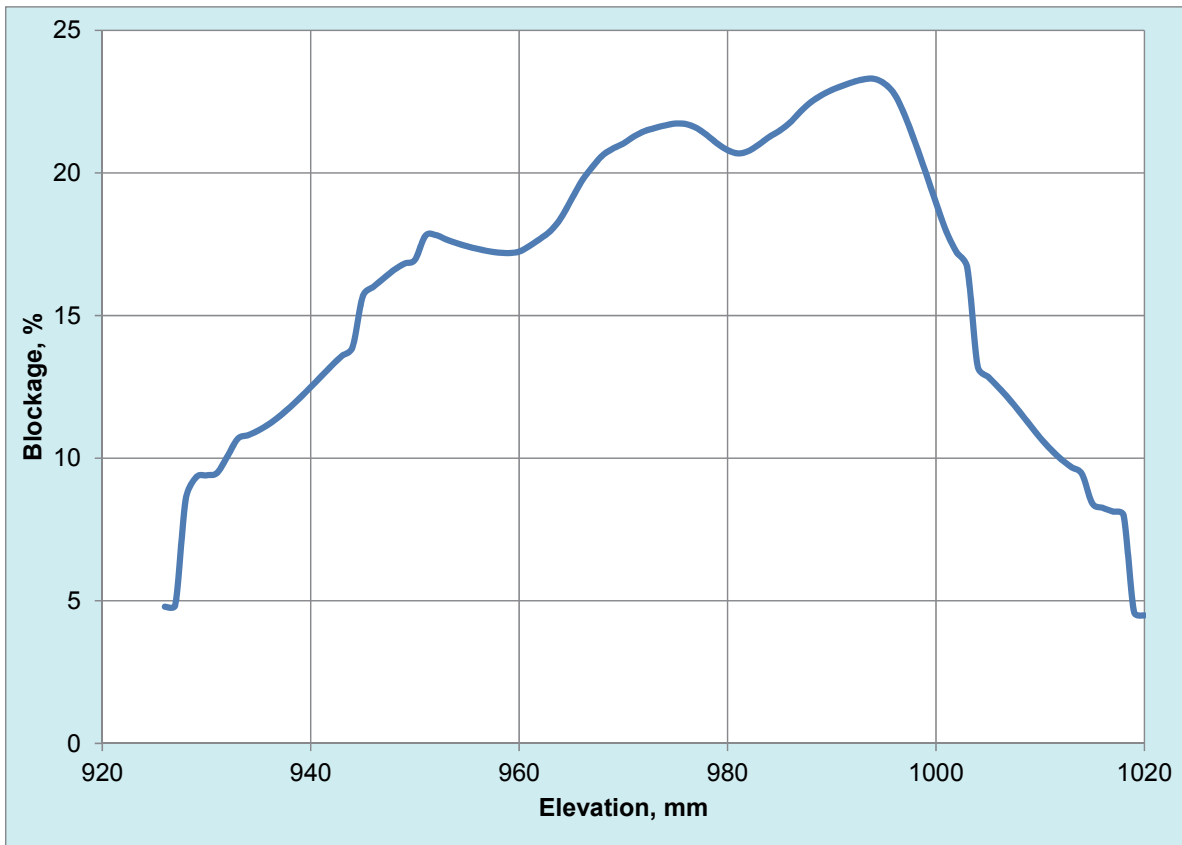
Fig. 70: QUENCH-L0; Blockage of coolant channel.

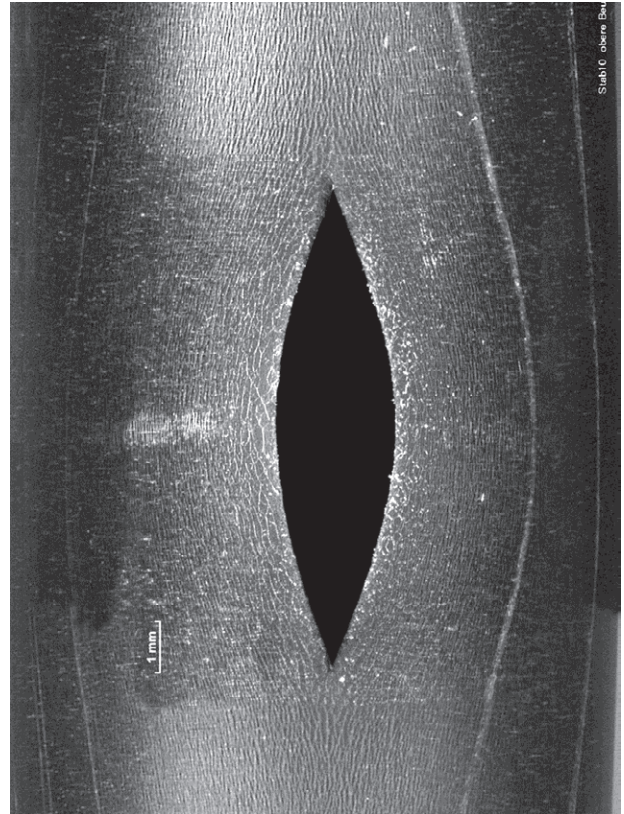
Rod #10 at 77°; $p=45$ bar, $A_{burst}=13$ mm²

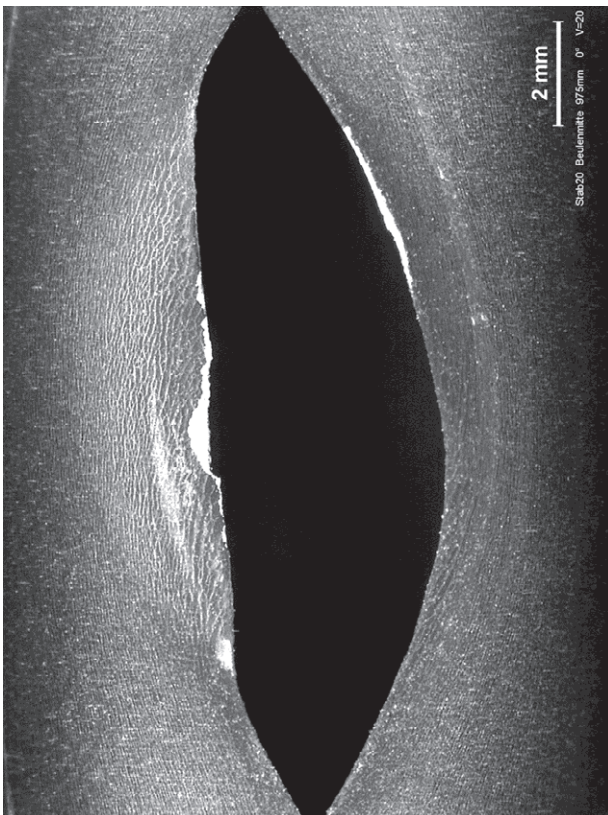
Rod #20 at 325°; p=50 bar, $A_{burst}=53 \text{ mm}^2$
