Results of the commissioning bundle test QUENCH-L0 performed under LOCA conditions

J. Stuckert, M. Große, C. Rössger,
M. Steinbrück, M. Walter

Report-Nr. KIT-SR 7657

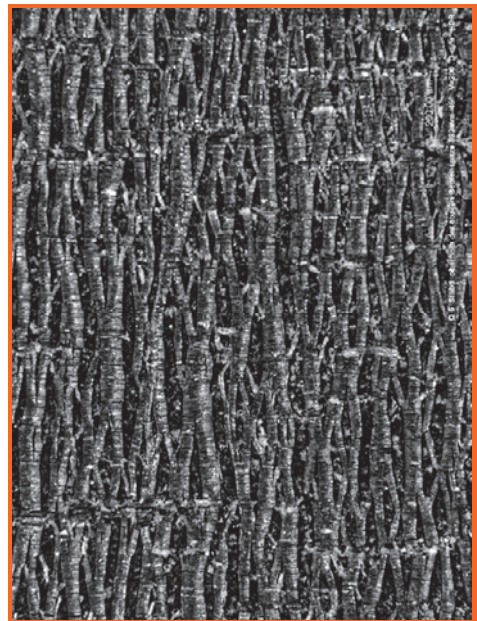
Fig. 78: QUENCH-L0; Overview of cladding surface along burst line (azimuth 60°) of rod #1.

Elevation 992 mm

Observations of cladding surface were performed with a Keyence digital microscope equipped with a macroscopic objective. The form of burst openings and the structure of oxidized cladding surface near to openings are shown in [Figs. 72-77](#). It can be seen that the cladding surface is covered with a network of crossed longitudinal cracks developed during the ballooning process. [Figs. 78-87](#) show regions of this “tree bark” structures in details. Large scale cells of crack network are located near to the burst opening, whereas small scale cells are typical for the cladding side opposite to burst (e.g. Fig. 84 for rod #6, two upper pictures right). It is illustrated in Figs. 79 and 80 for rod #1. The rod #2 has more linear (not cell) structure of cracks (black linear structures in Figs. 81 and 82); the distance between these black lines decreased with the relative azimuth increase. But mostly the crack structure in oxide is the celled structure as for rods #3, #6, #10, #17, and #21 (Figs. 83 – 87 correspondingly). The cell size changed not only circumferentially, but also longitudinally: cell size decreased with increase of the distance to the burst location. The cracks are disappeared practically at distances between 50 and 60 mm from the burst position – accordingly to the sharp strain decrease in upper diagrams of Figs. 50-69. The cell size strongly depends on strain: The higher the strain the larger are the cells.

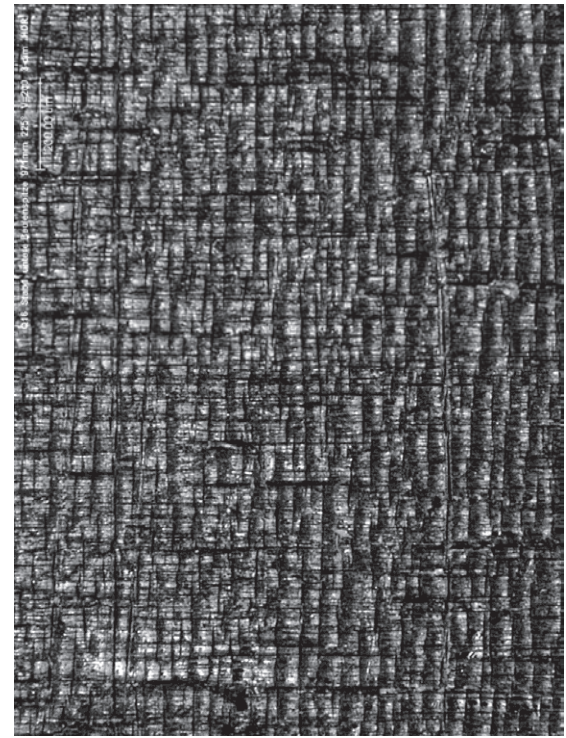
Fig. 79: QUENCH-L0; Overview of cladding surface around burst position of rod #1.

Elevation 971 mm, azimuth 240°

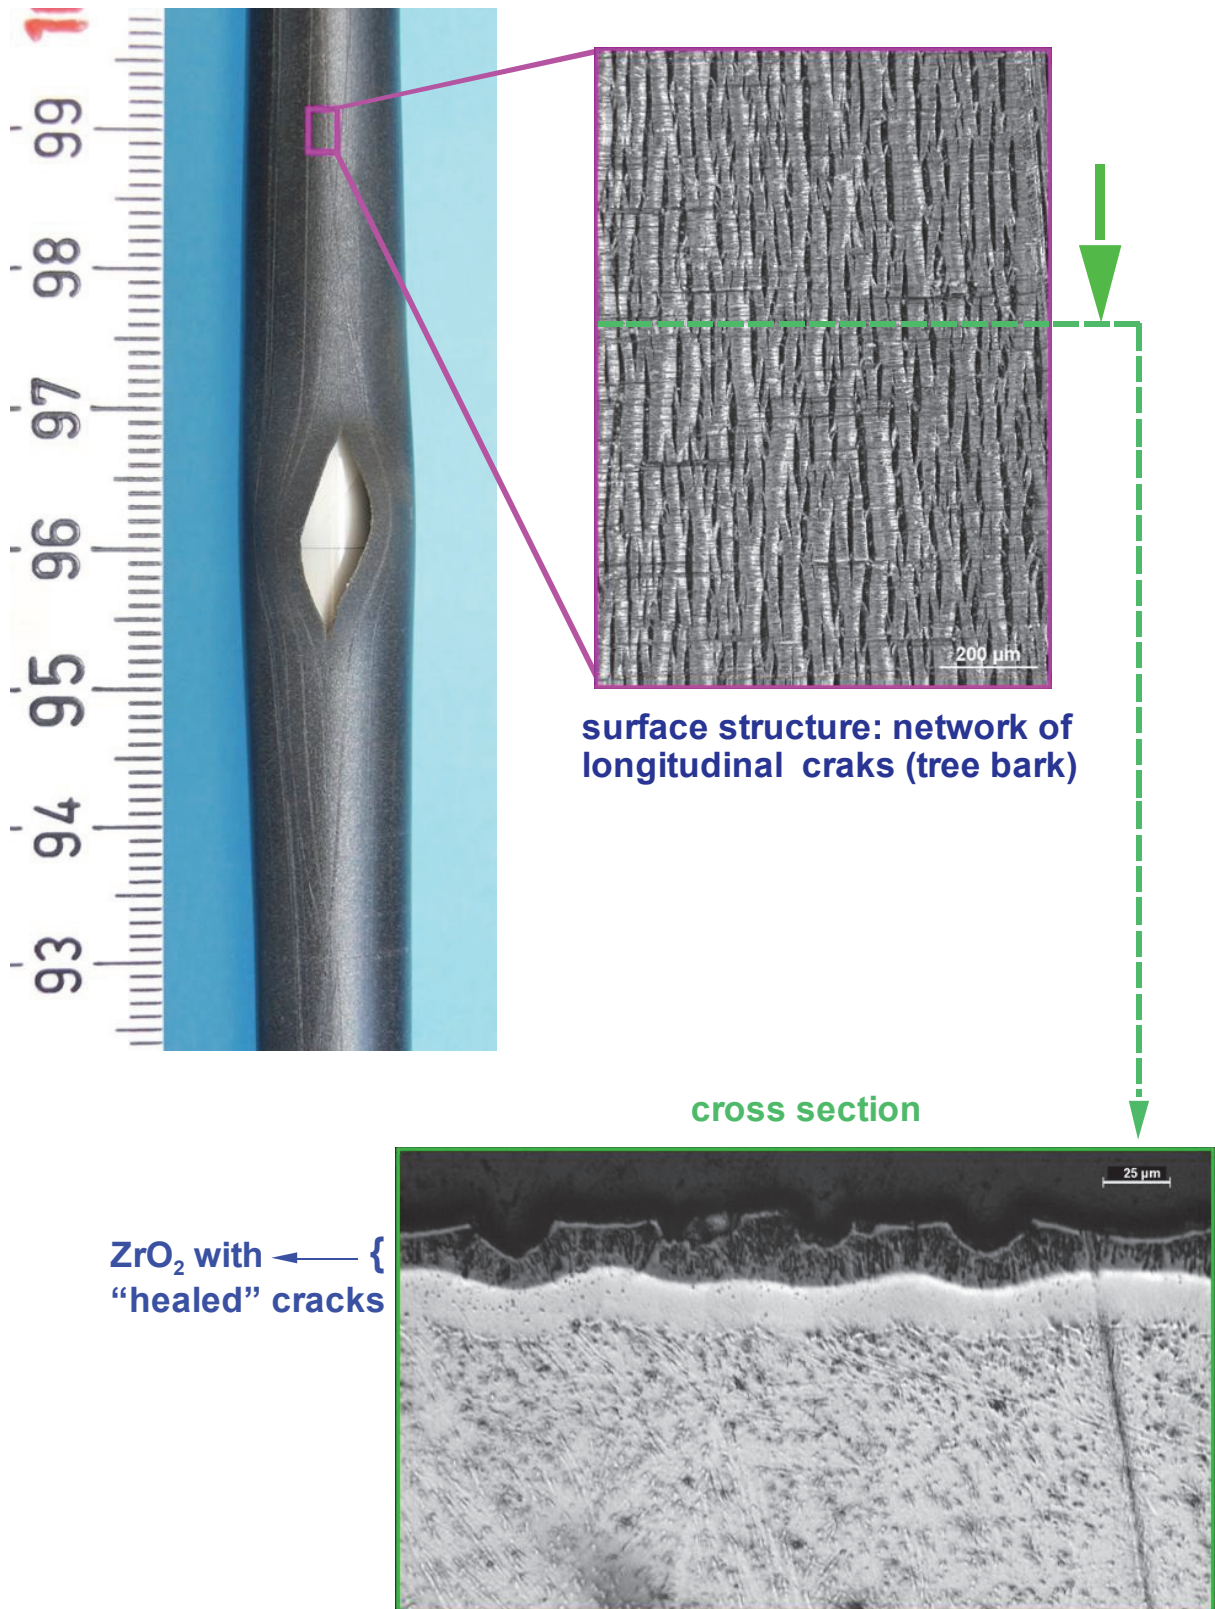
Fig. 88: QUENCH-L0; "Self-healing" surface cracks developed during ballooning rod #3 (55 bar), angle 140°.

Large magnification ($\times 1000$) micrographs made by the Keyence microscope at the cladding cross sections evidence waved structure of ZrO_2 and α -Zr(O)-layers ([Fig. 88](#)): the cracks, growing during the ballooning process, are self-healed due to continuous oxidation in steam. The average azimuthal distance between pits varied between 20 and 50 μm , whereas a typical longitudinal distances are 100 – 150 μm ([Fig. 89](#)).

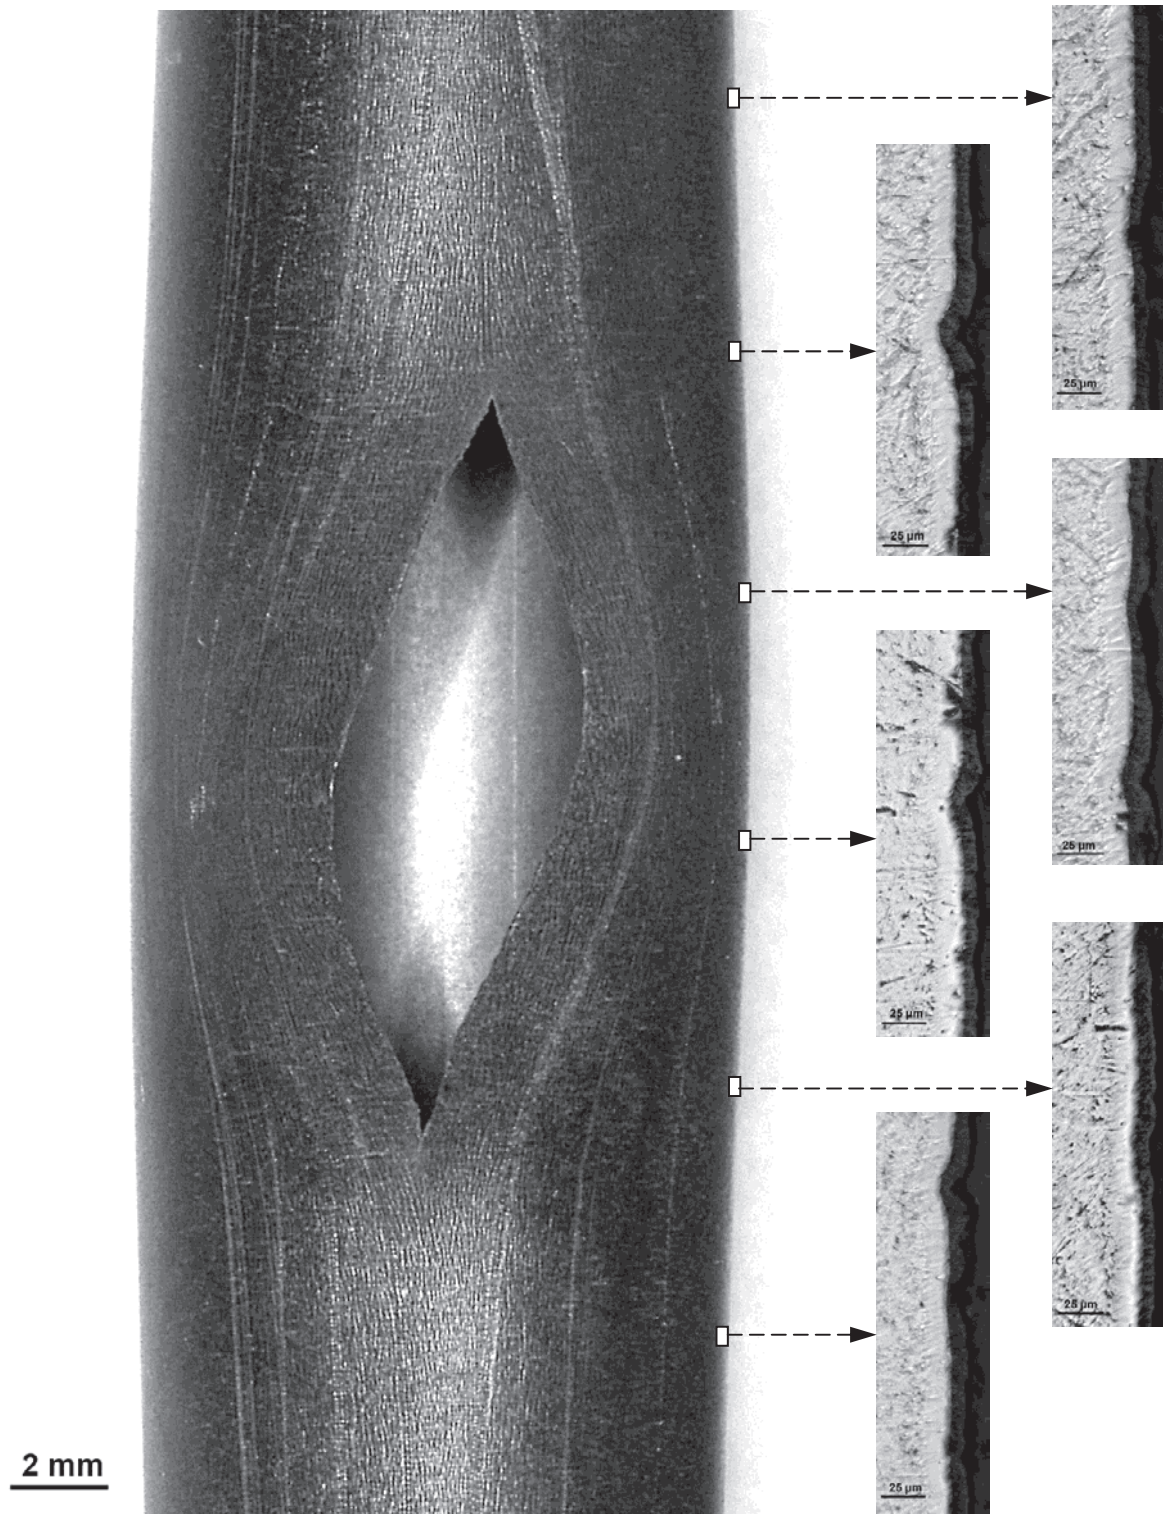
Fig. 89: QUENCH-L0; Longitudinal sections at outer surface of rod #3 at azimuth shifted with 90° to the burst position.

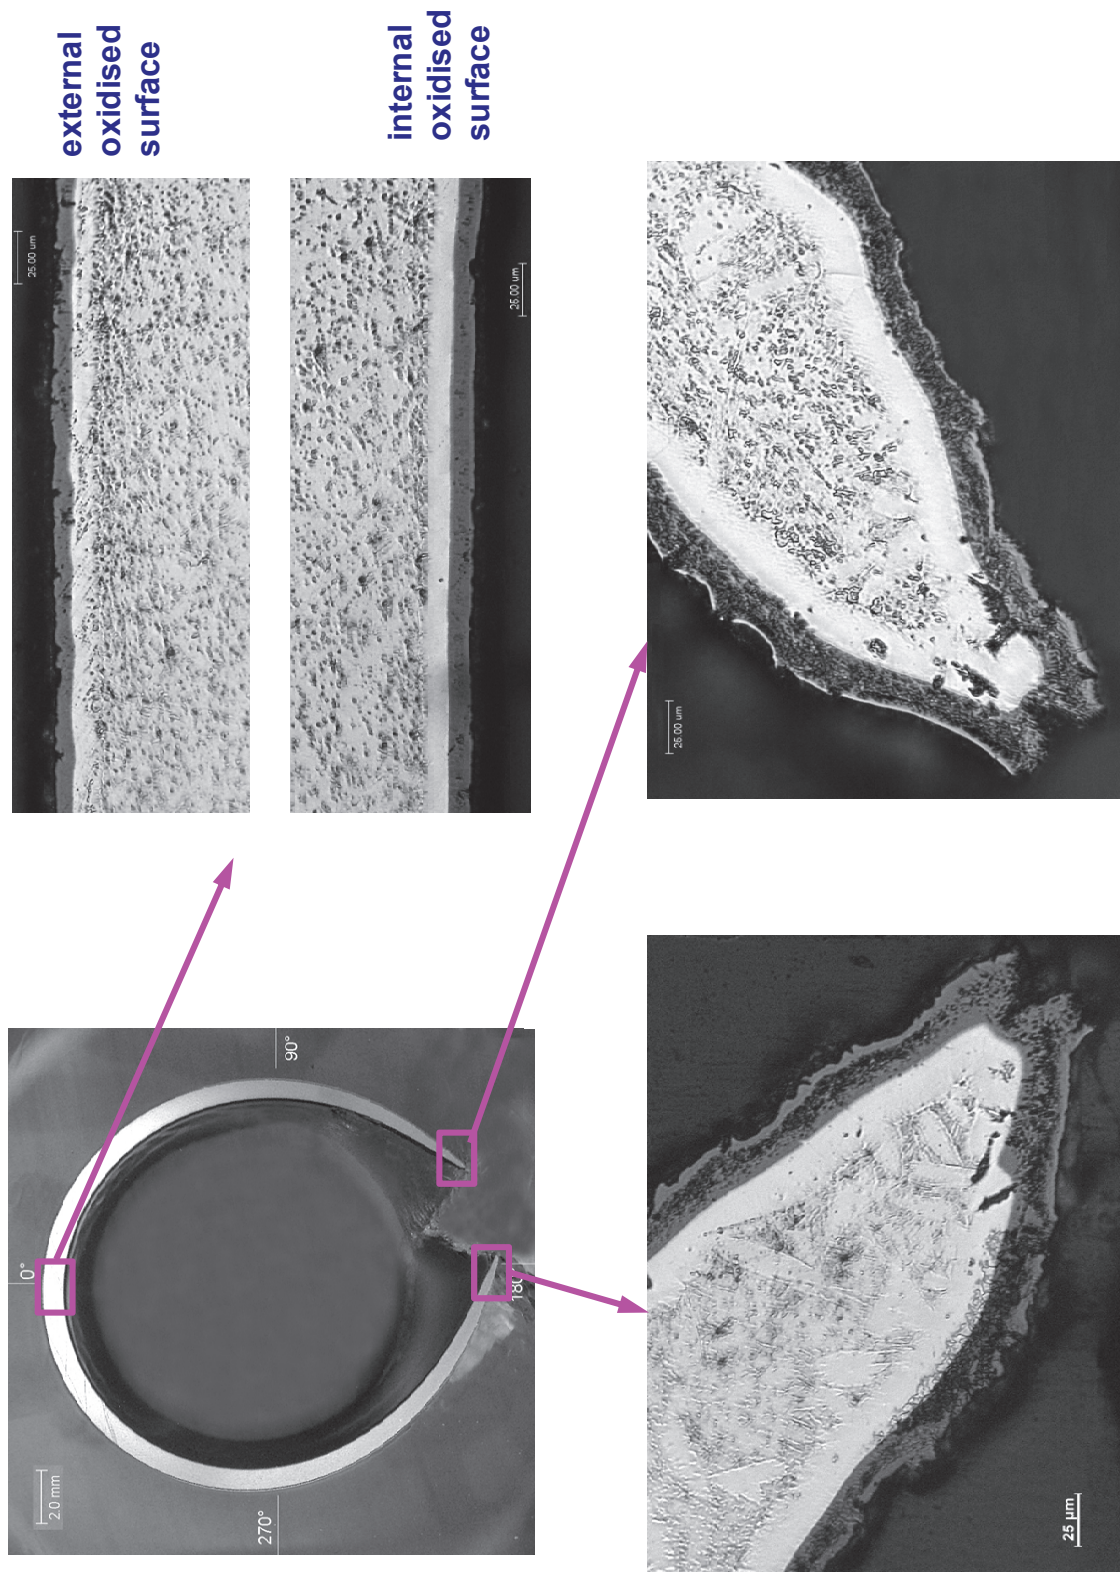
Fig. 90: QUENCH-L0; Similar internal and external oxidation degree at burst elevation rod #3 (55 bar).

The metallographic investigation of the cross section of rod #3 at the elevation of the burst middle (962 mm) evidences oxide layer growth at the outer cladding surface as well as oxidation of the inner surface ([Fig. 90](#)). The averaged maximal outer oxide thickness of 12 μm and corresponding α -Zr(O) thickness of 16 μm was reached at elevation of 947 mm (oxide thickness at some azimuth positions reached 15 μm). The thickness of the inner oxide layer decreases axially, and at the elevation of 982 mm (i.e. 13 mm above the burst opening edge) no inner oxide layer was observed at the azimuth of the burst line ([Fig. 91](#)).

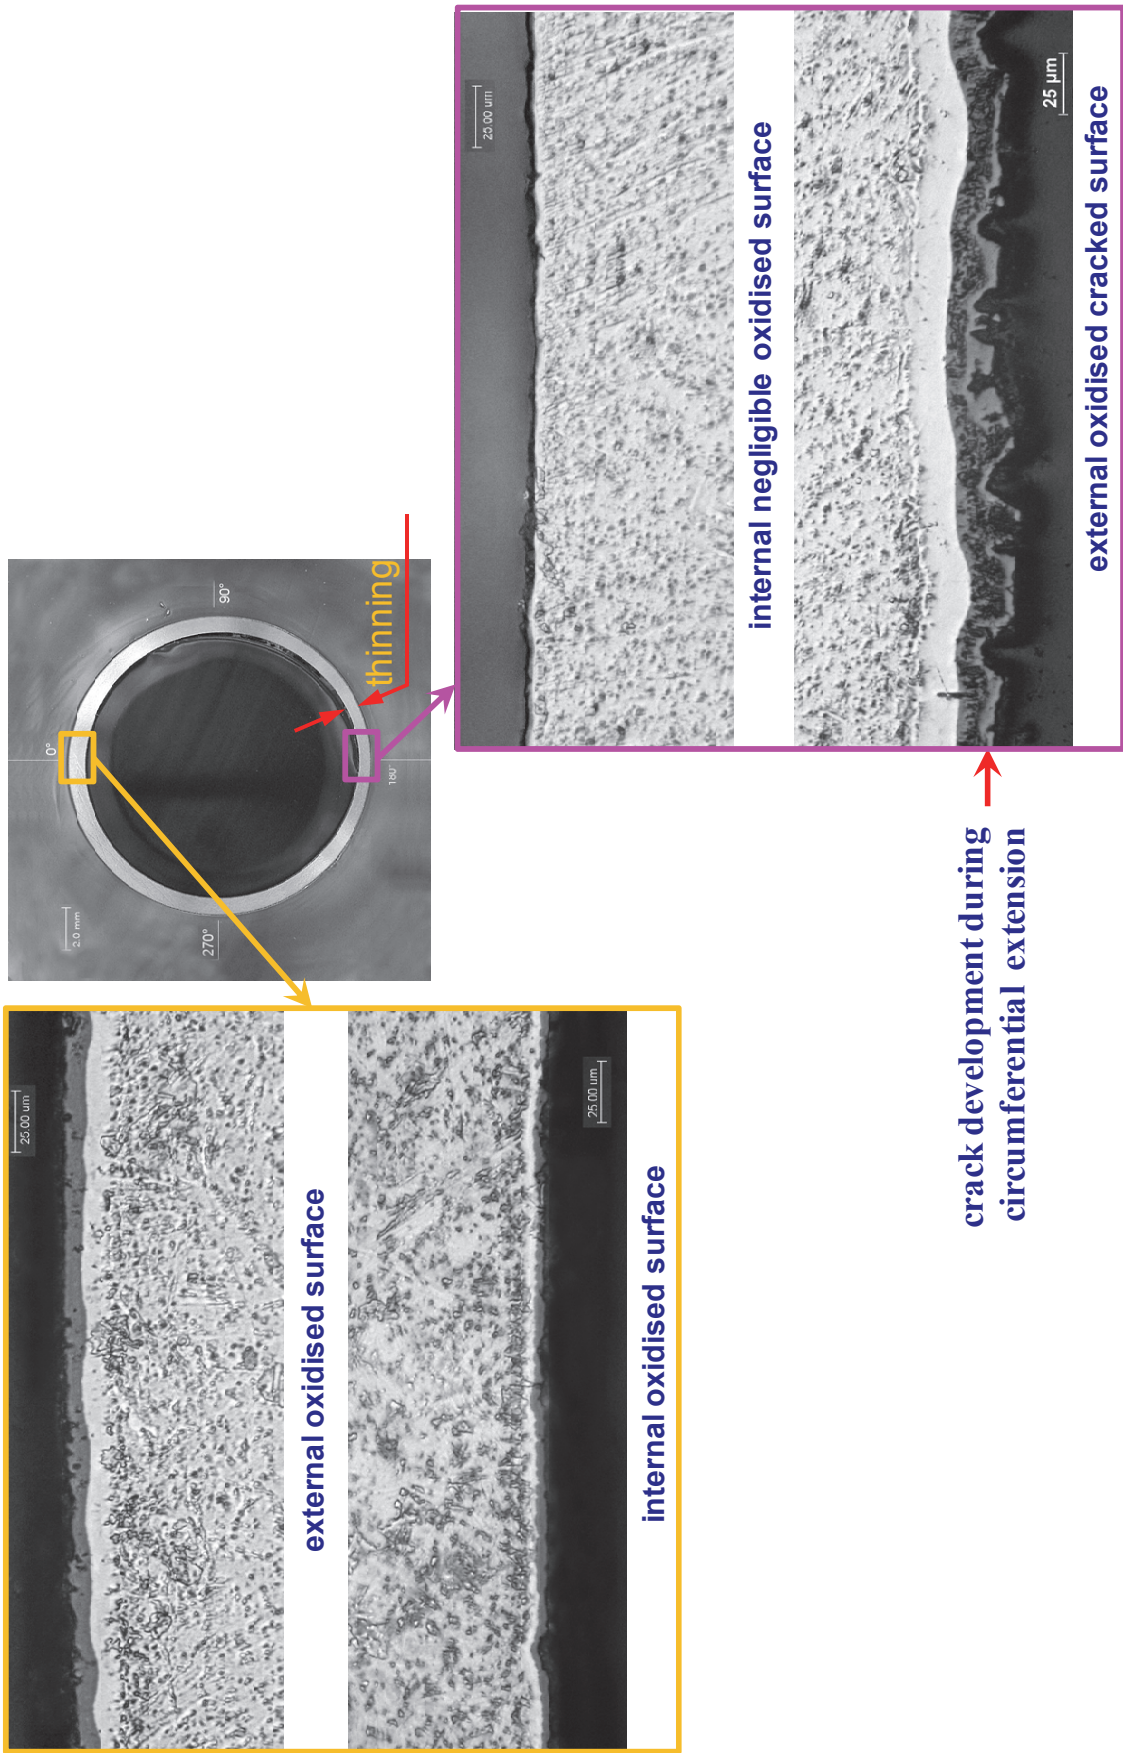
Fig. 91: QUENCH-L0; Different internal and external oxidation degree outside burst elevation rod #3 (55 bar).

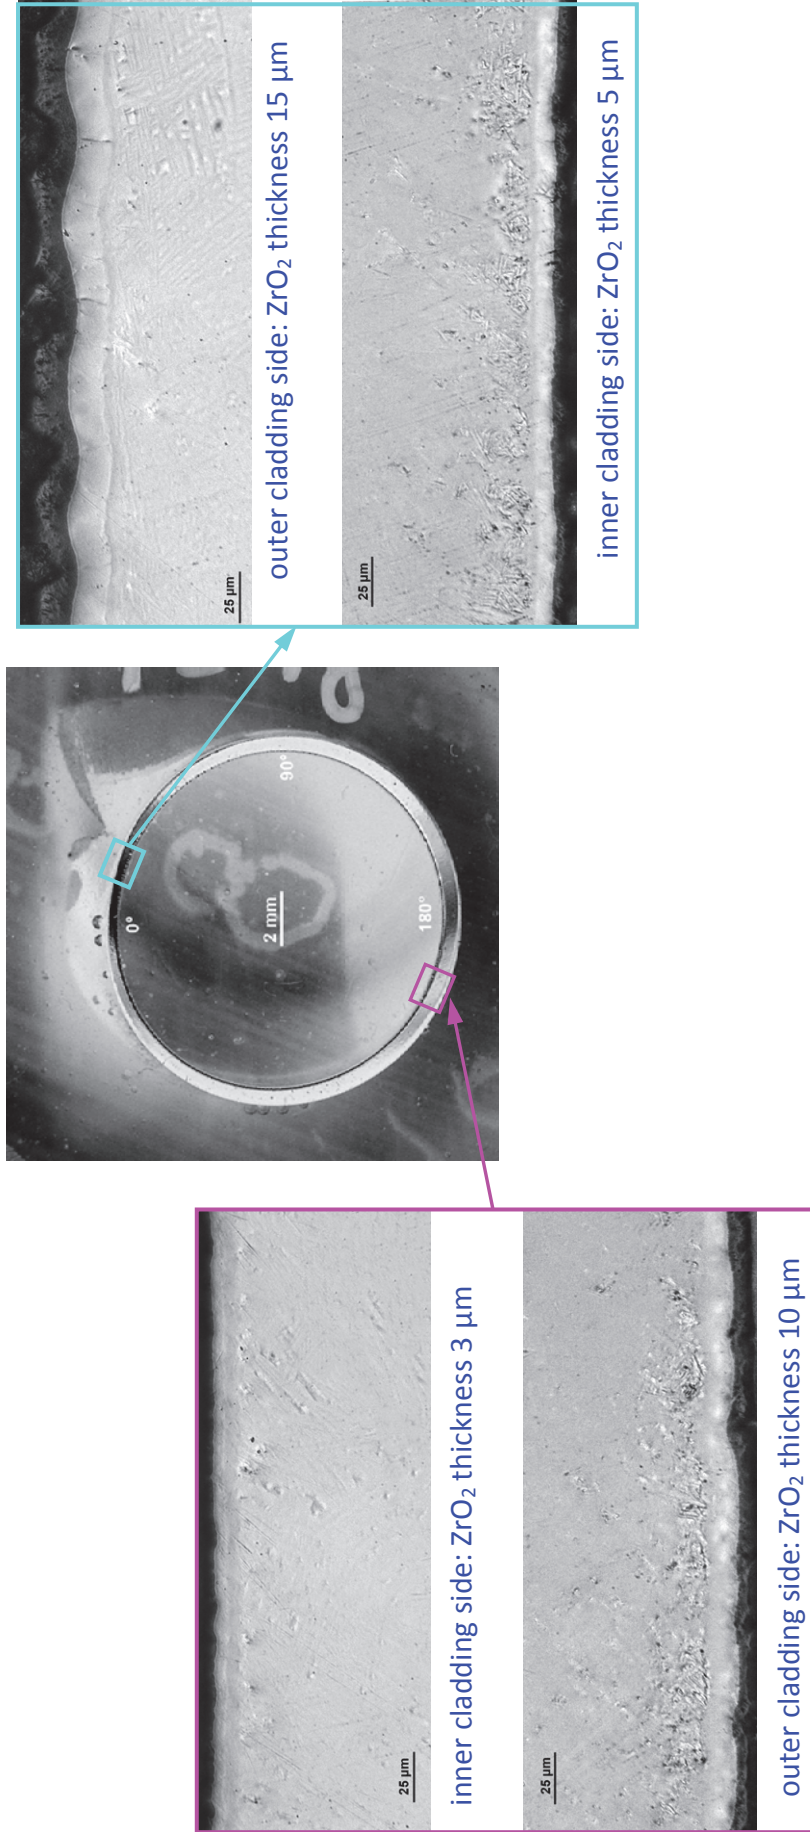
Fig. 93: QUENCH-L0; Top view of cross section of rod #8 at elevation 1018 mm. Very thin internal oxide layer at inner cladding surface.

Only very thin inner oxide layer was observed opposite to the burst line for rod #8 at the elevation 1004 mm, corresponding to the middle of the burst opening ([Fig. 92](#)). The axial extension of internal oxidation is about 11 mm from the burst opening edges, what can be seen with metallographic investigation of corresponding cross sections ([Fig. 93](#) shows layer structures at the elevation of 1018 mm).

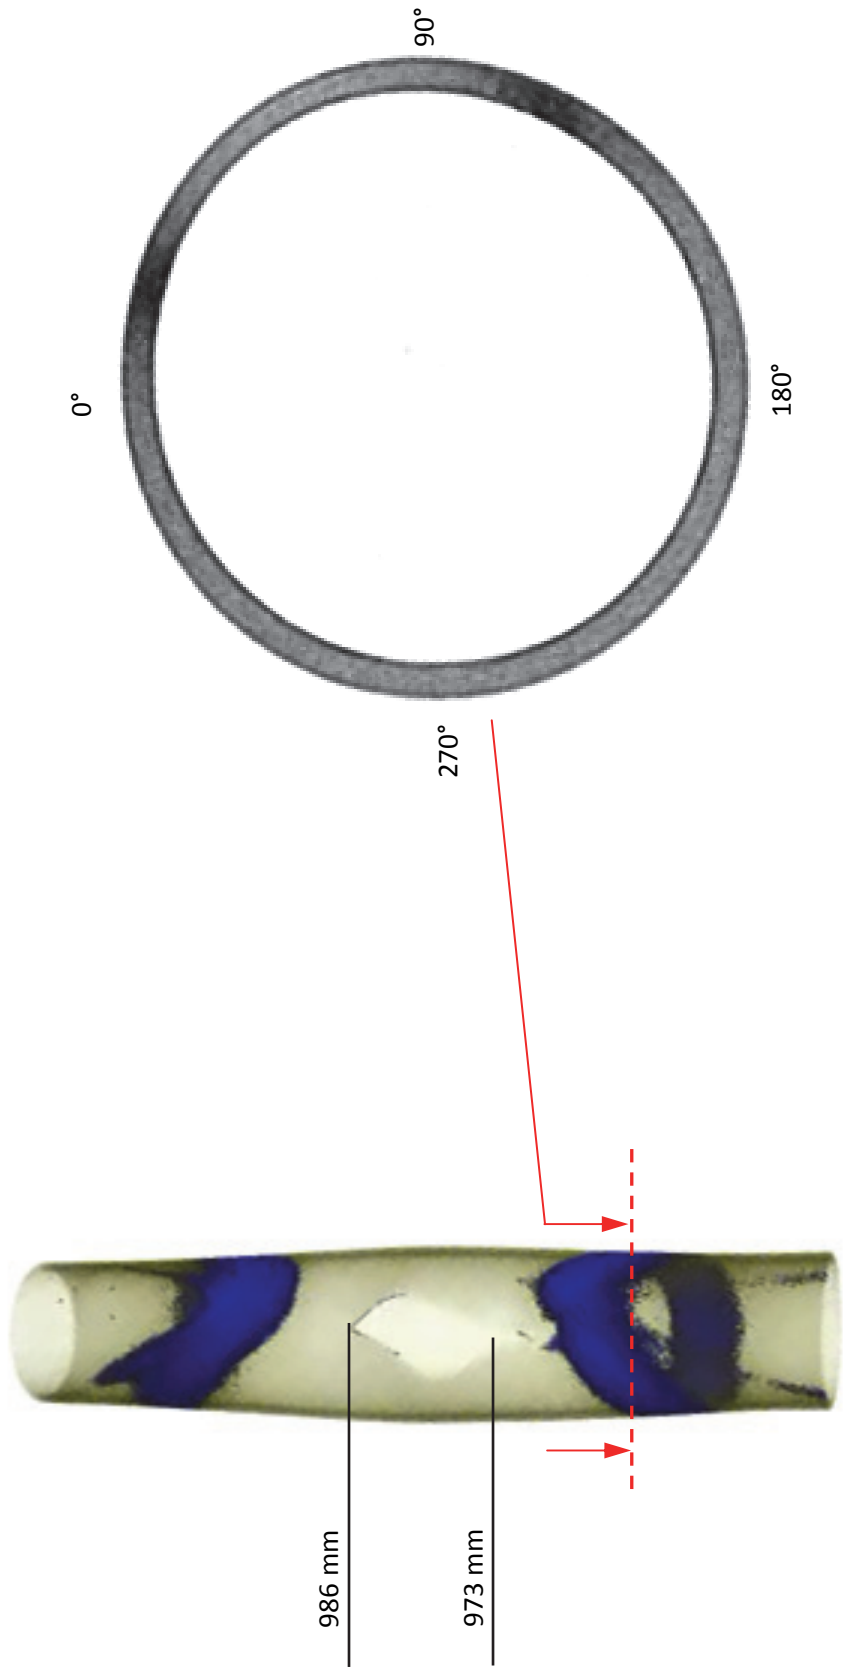
Cladding part with hydrogen bands (blue). Hydrogen concentration in bands about 1330 wppm. Cross section of tomography image at 960 mm: black segments evidence high hydrogen concentration

Fig. 105: QUENCH-L0; Neutron tomography of rod #1.

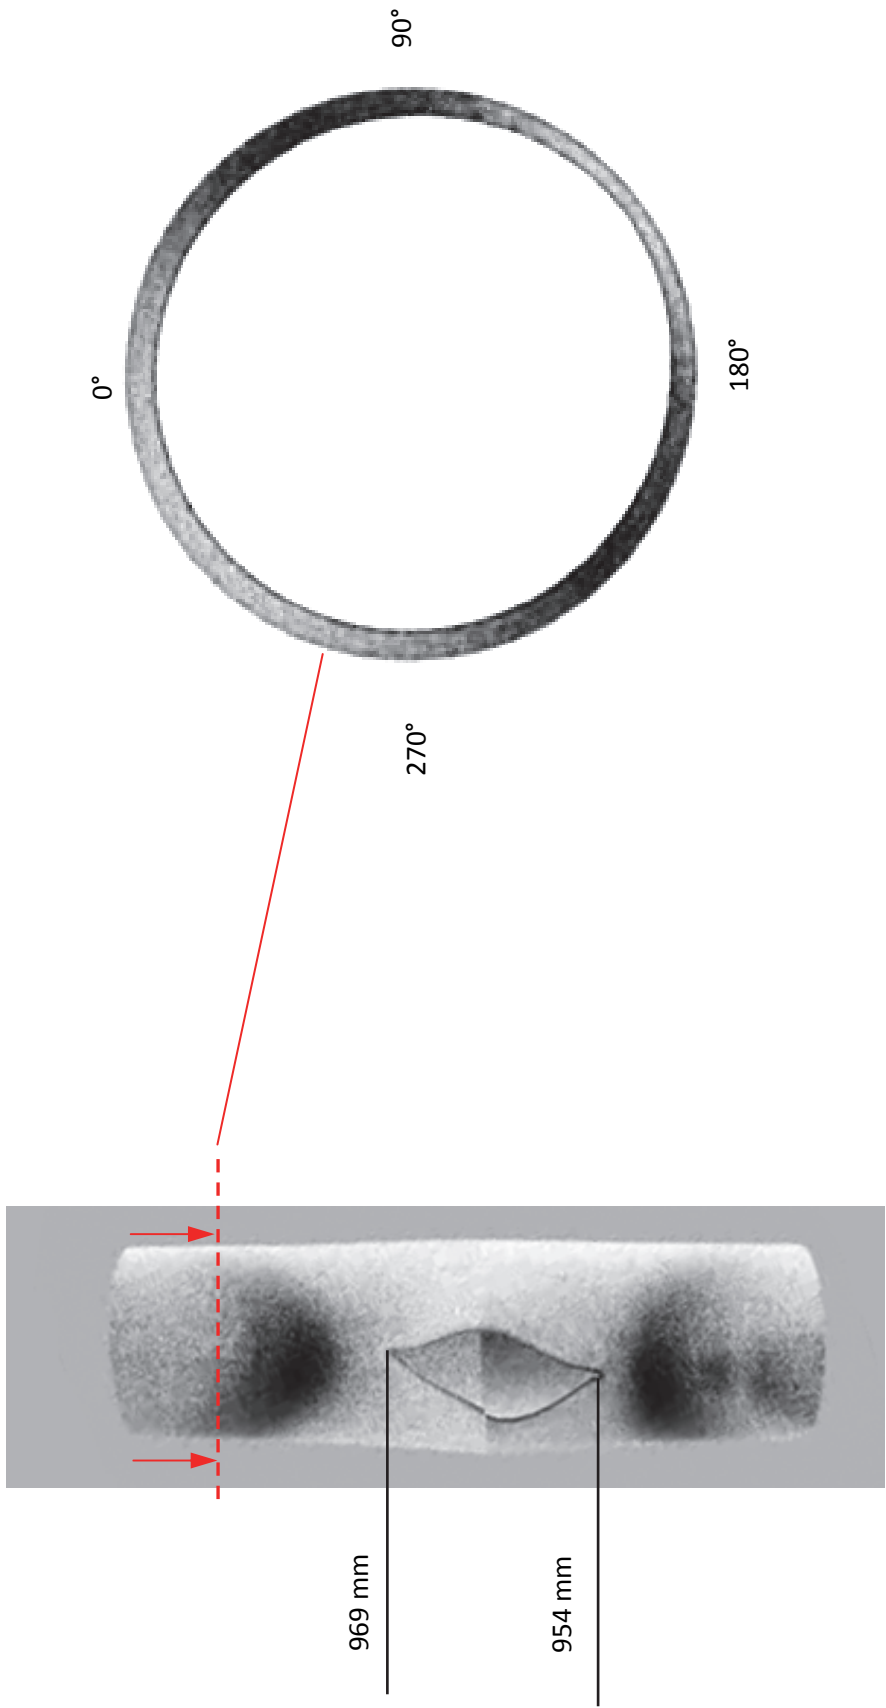
Cladding part with hydrogen bands (black). Hydrogen concentration in bands about 1300 wppm. Cross section of tomography image at 980 mm: black segments evidence high hydrogen concentration

Fig. 106: QUENCH-L0; Neutron tomography of rod #3.

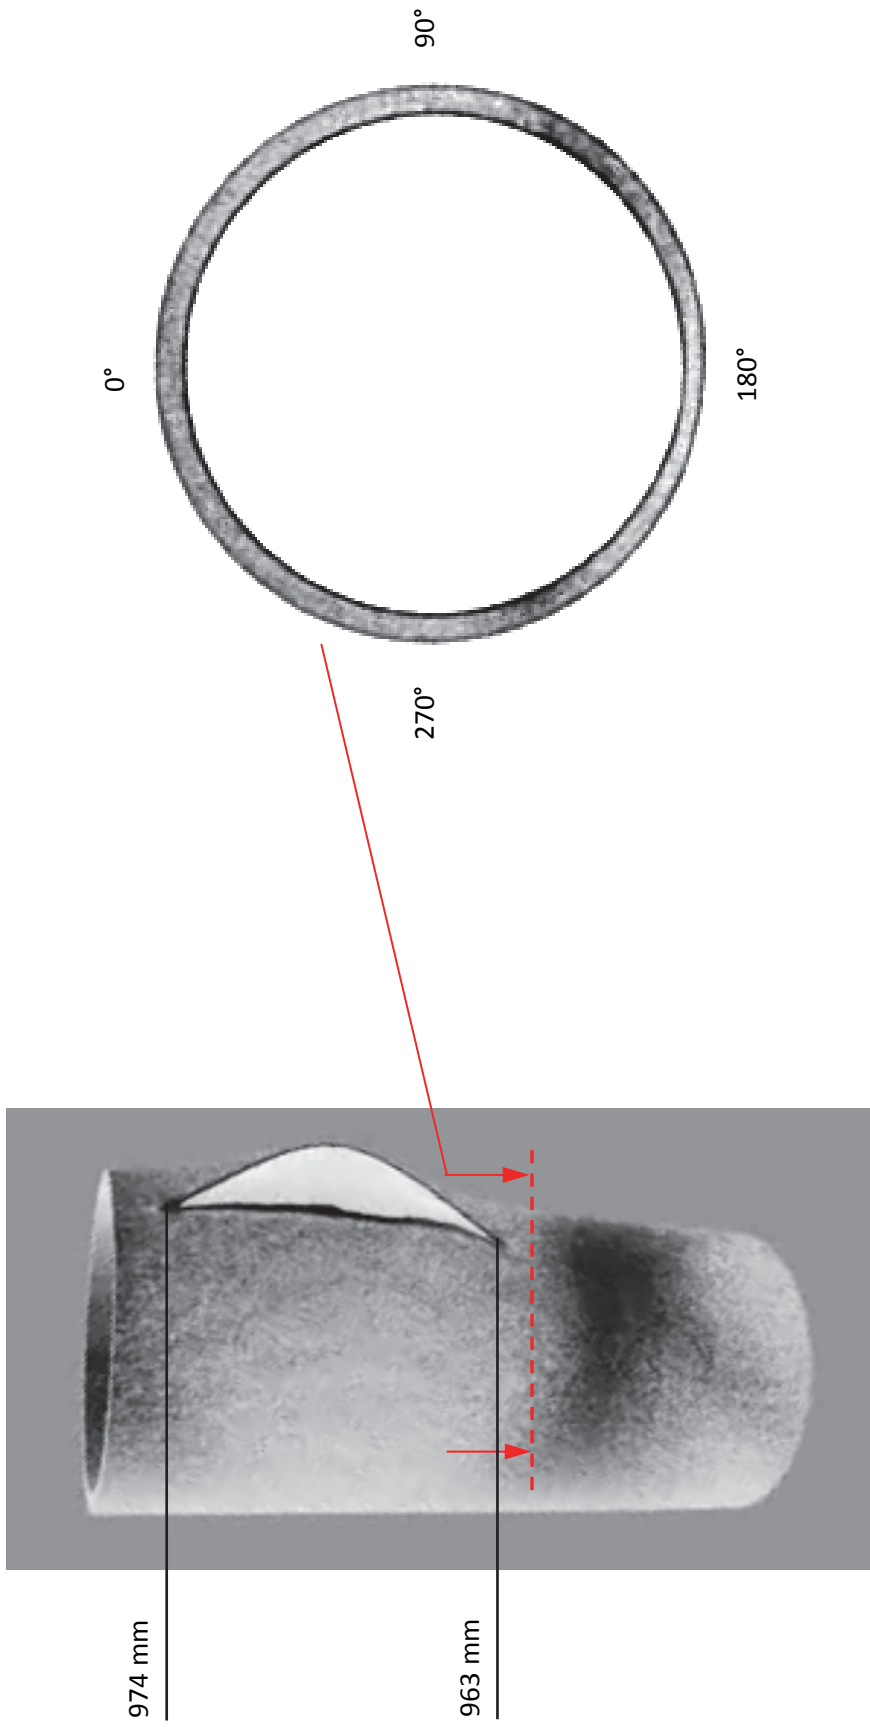
Cladding part with hydrogen bands (black). Hydrogen concentration in bands about 1060 wppm. Cross section of tomography image at 960 mm: black segments evidence high hydrogen concentration

Fig. 107: QUENCH-L0; Neutron tomography of rod #5.

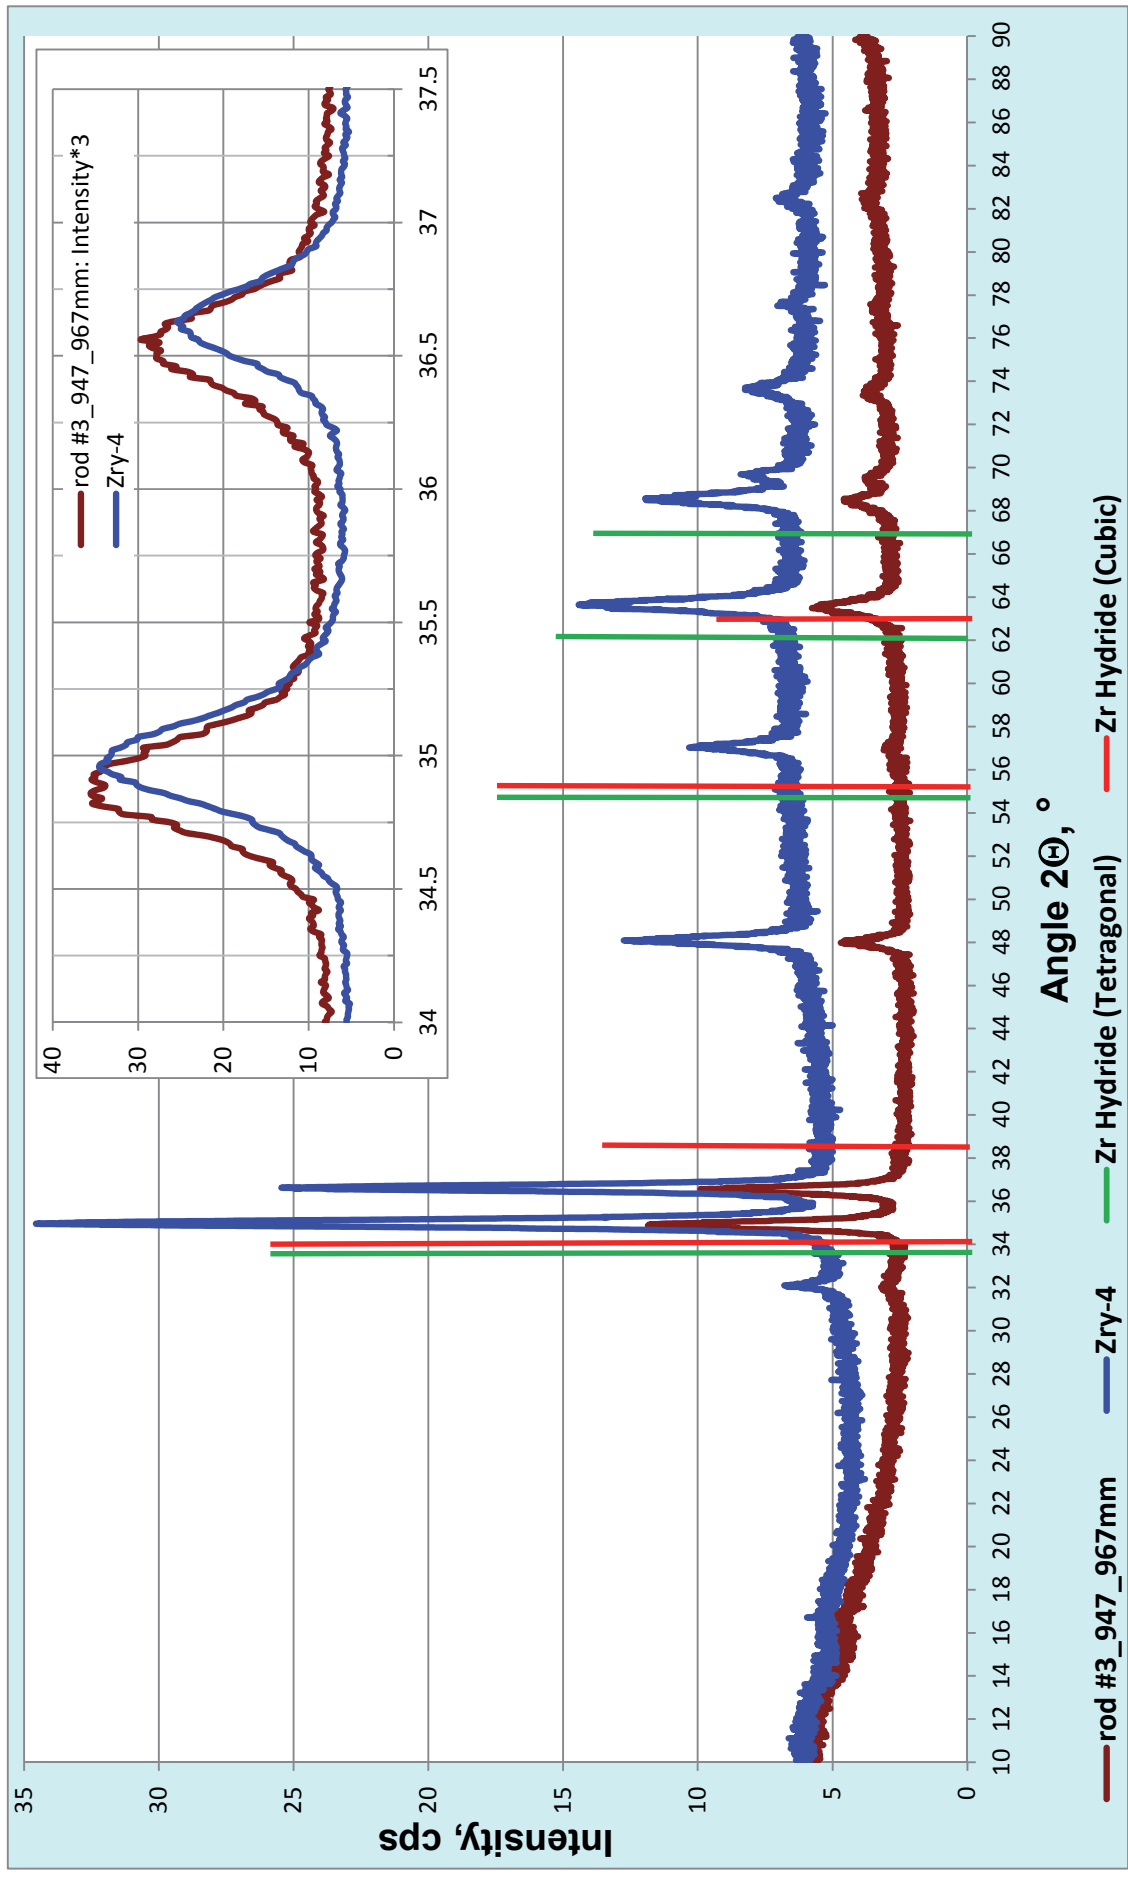
Fig. 108: QUENCH-L0; Results of X-ray diffractometry for the rod #3 at the hydrogen band.

In both of the obtained diffraction pattern only metallic zirconium was detected (Fig. 108). The agreement with the JCPDS card 5-665, corresponding to pure metallic zirconium, revealed to fit almost perfectly, despite the presence of 1.5 wt% tin and the intrinsic crystallographic texture of the samples extracted from the rods. The line shift of $\approx 0.1^\circ$ between the pattern obtained from the as-received specimen and the specimen from the hydrogen enriched zone was observed. This indicates that hydrogen is at least partially dissolved in the α -Zr lattice.

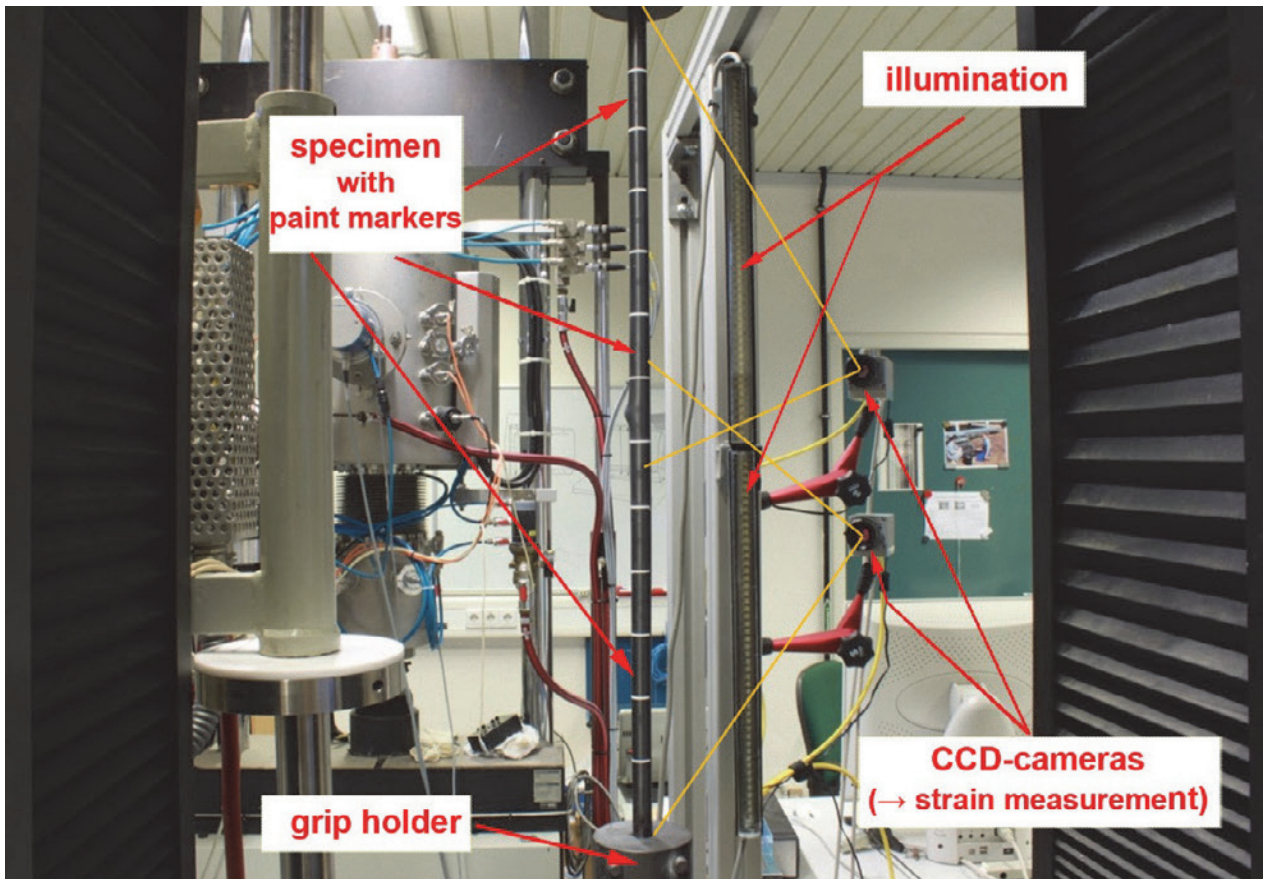
Fig. 113: QUENCH-L0; Testing facility for tensile tests.

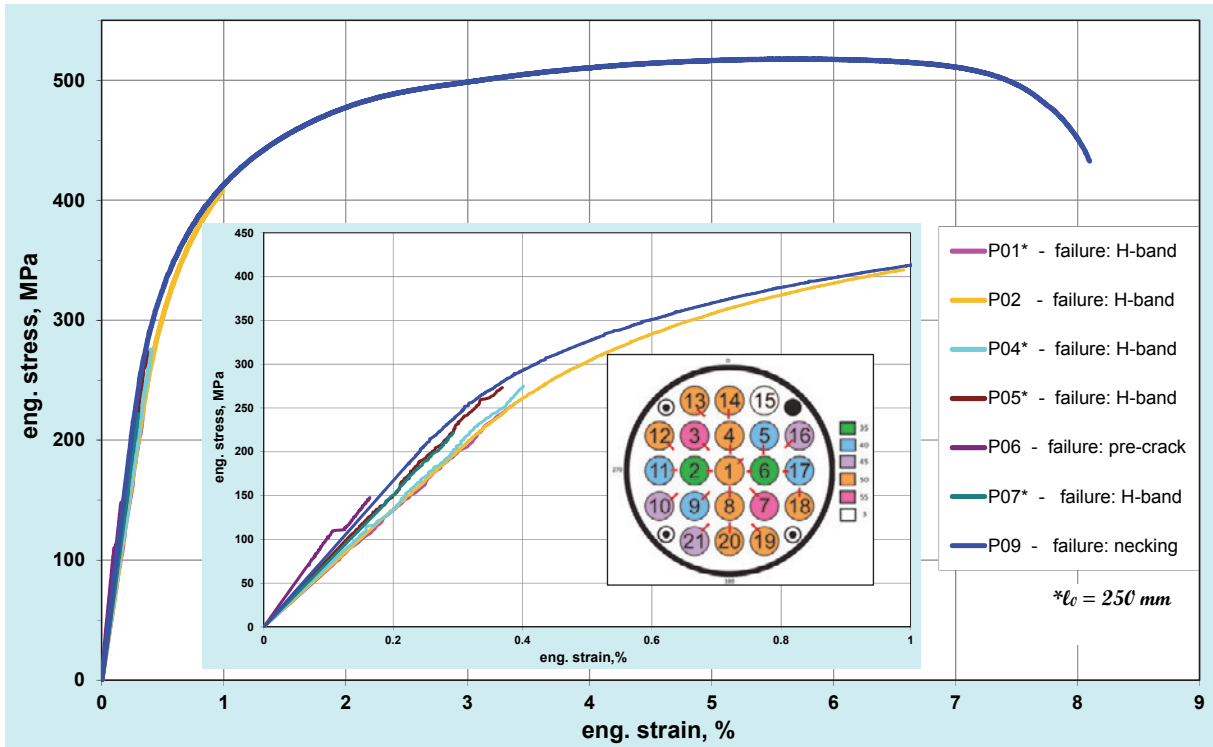
Fig. 118: QUENCH-L0; Results of the tensile tests: claddings from the inner group of the bundle.

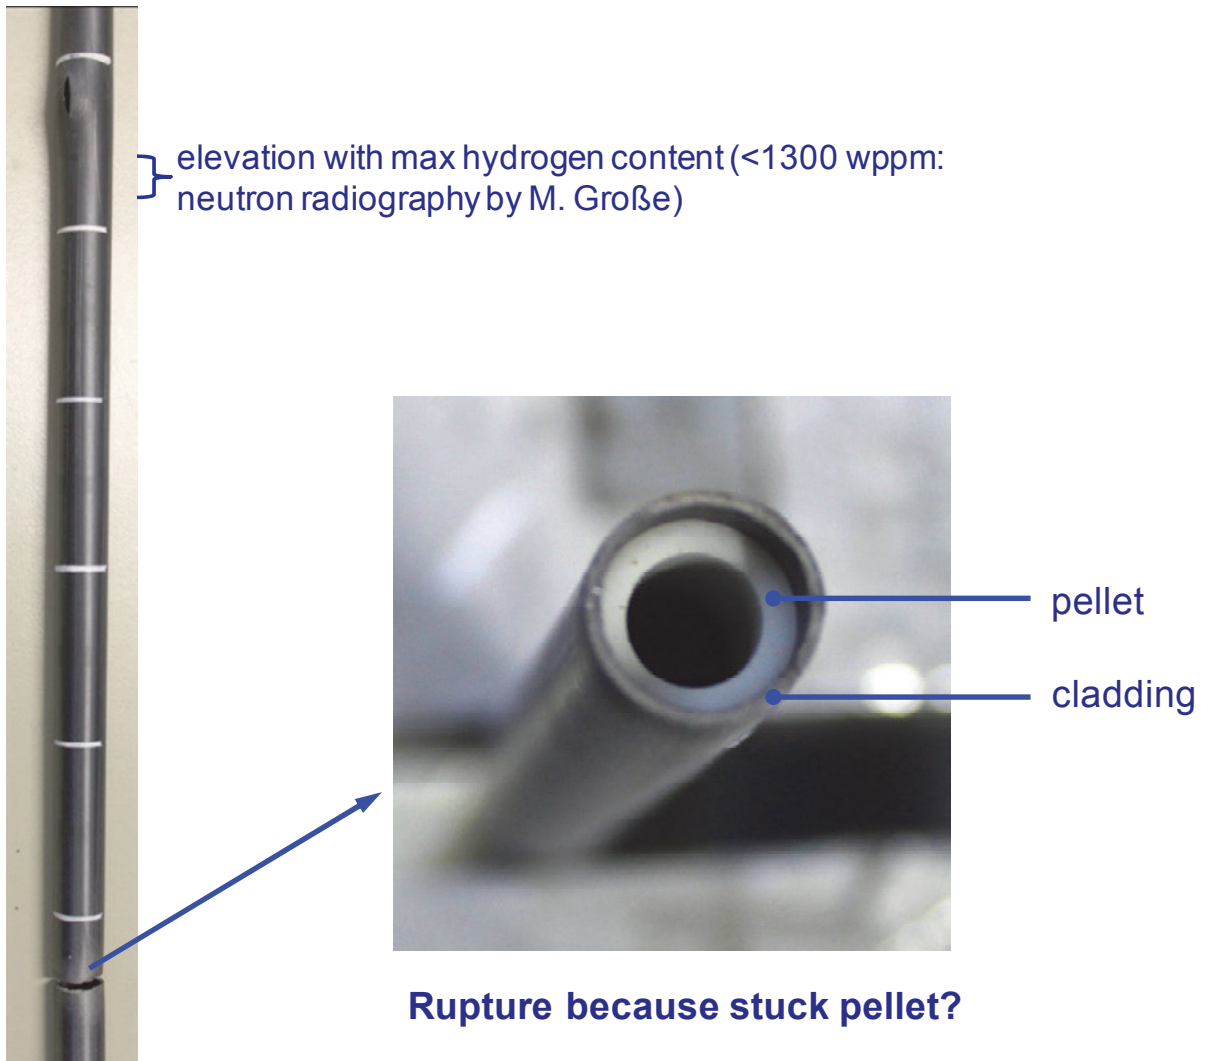
Fig. 120: QUENCH-L0; Rupture position outside ballooning rod #17 (40 bar).

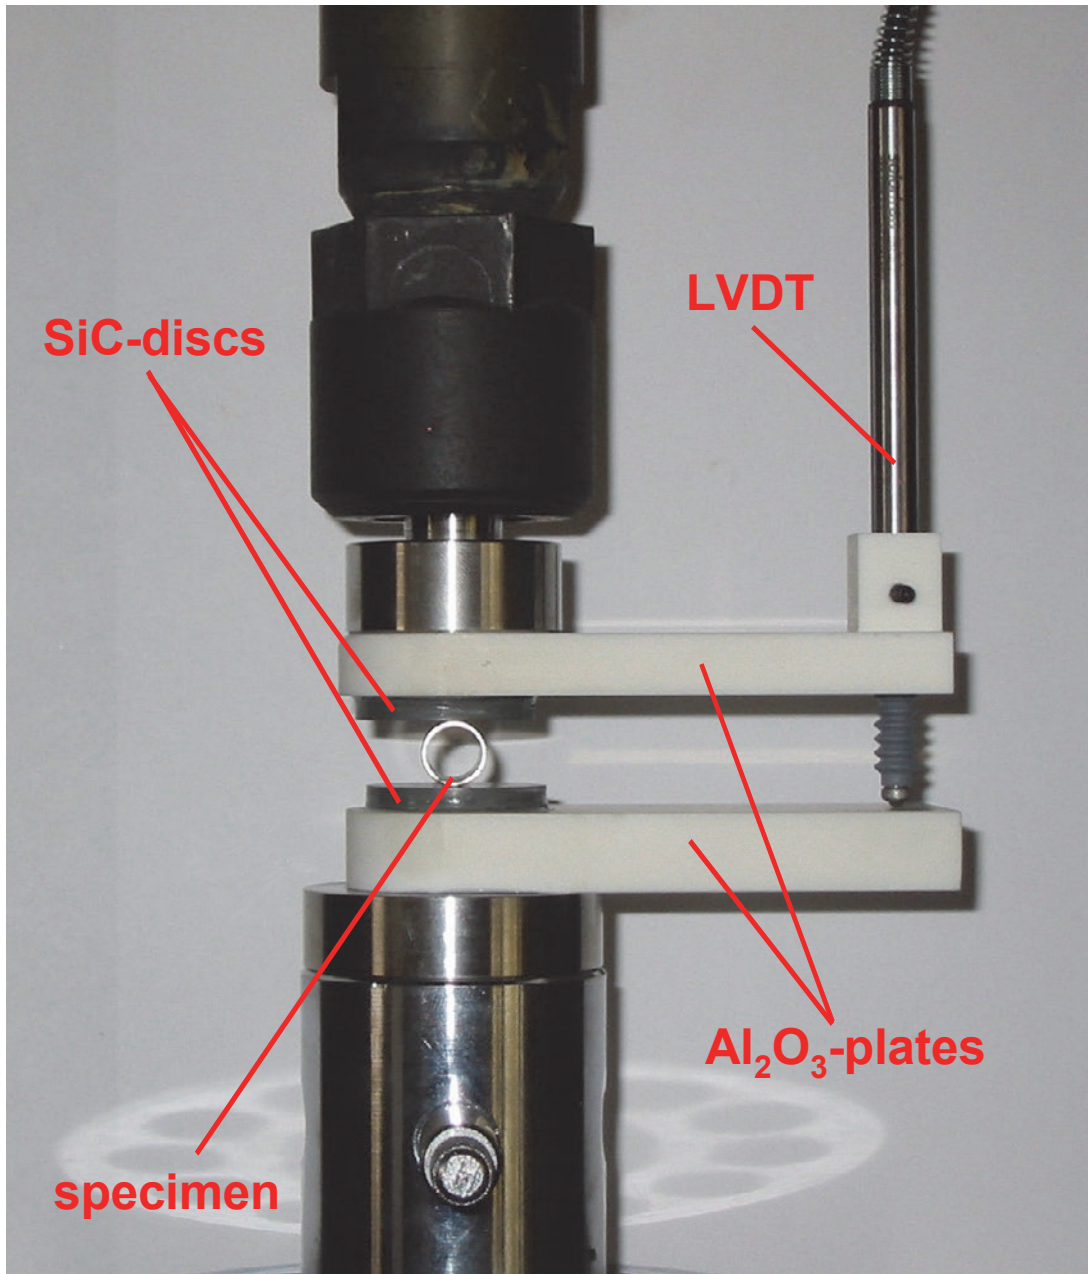
Fig. 121: QUENCH-L0; Test setup machine for the ring compression tests.
