Results of the commissioning bundle test QUENCH-L0 performed under LOCA conditions

J. Stuckert, M. Große, C. Rössger,
M. Steinbrück, M. Walter

Report-Nr. KIT-SR 7657

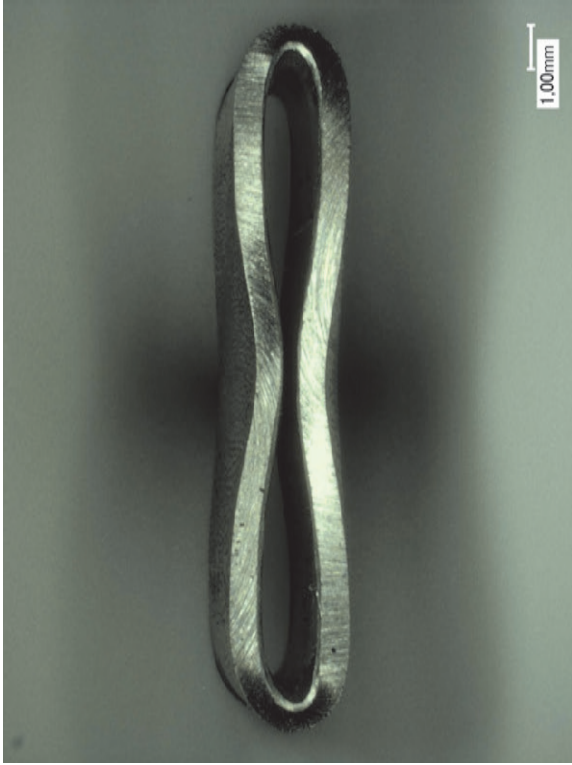
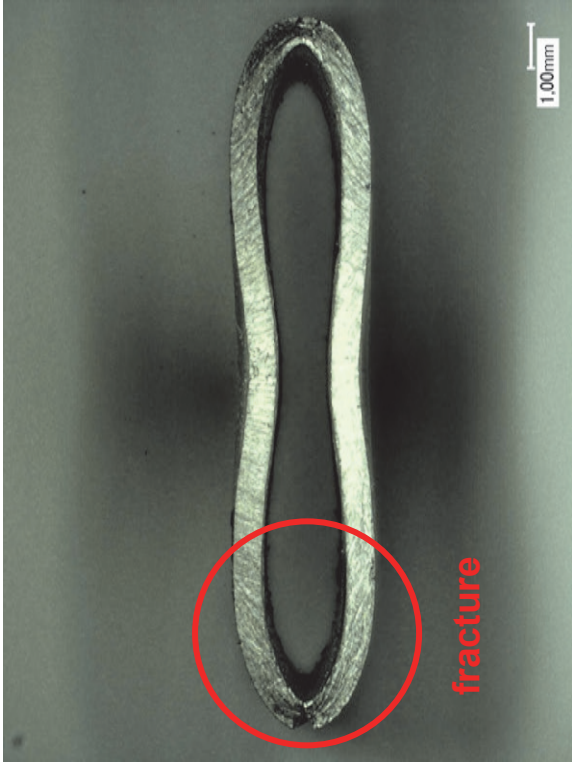
failure caused by plastic instability

failure caused by fracture

Fig. 122: QUENCH-L0; General failure behaviour of the rings.

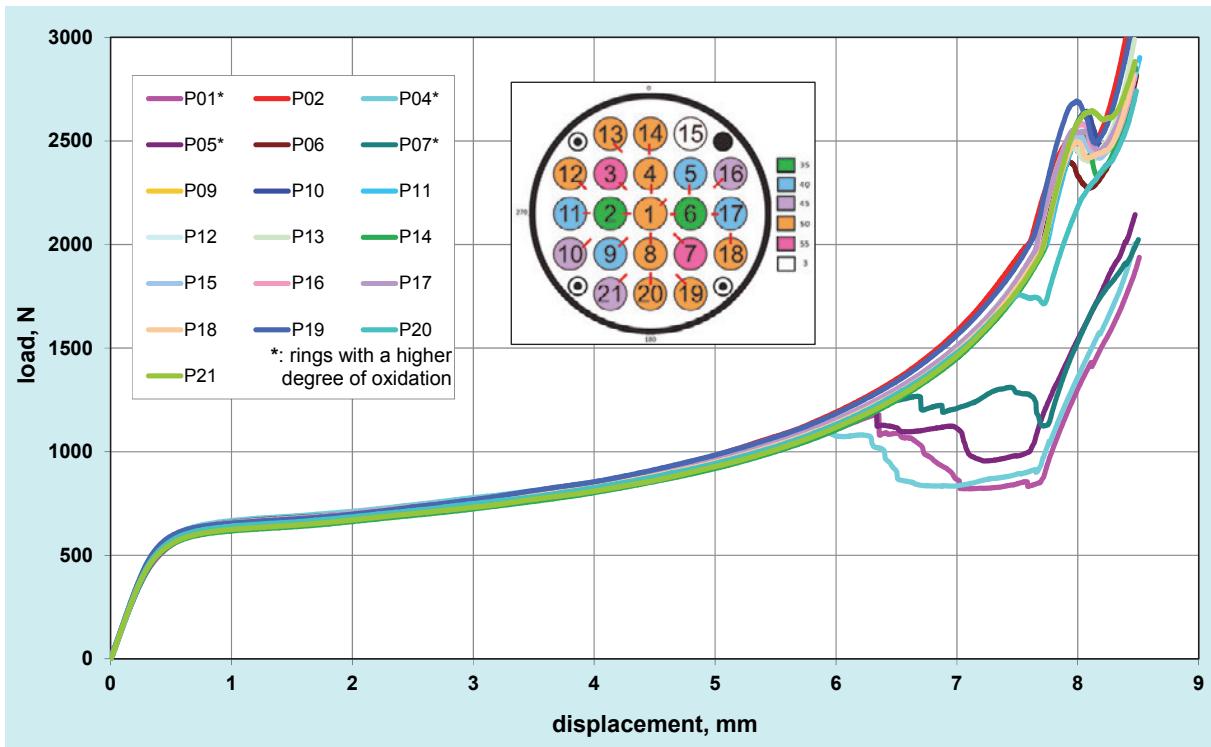
Fig. 123: QUENCH-L0; Results of the ring compression tests: rings of the upper part of the claddings.

Due to the axial gradient of the oxidation degree along an entire cladding, the less oxidized rings from the upper section in general showed clearly better mechanical properties than the more oxidized rings from the lower section. All samples from above the burst region failed ductile, based on plastic instability (buckling). In contrast, half of the specimens from below
