Article

Fatigue Behavior of Ultrafine-Grained Medium Carbon Steel with Different Carbide Morphologies Processed by High Pressure Torsion

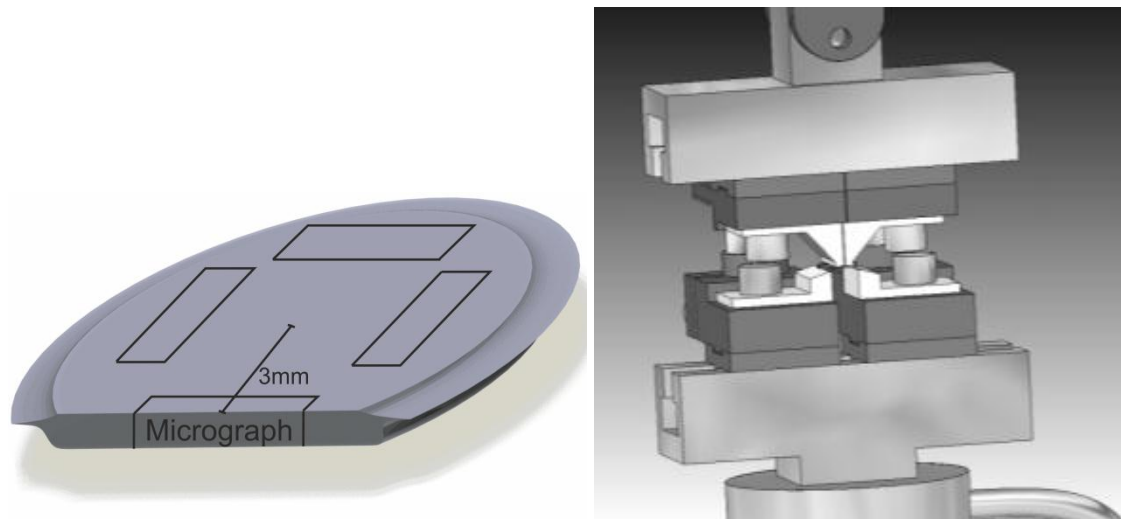
Figure 1. (a) HPT disc with indicated specimen extraction areas. (b) cyclic four-point-bending test fixture.

Four rectangular fatigue samples with dimensions of 4 mm \times 1 mm (w) \times 0.6 mm (h) were cut with their center at a distance of 3 mm from the center of every 10 mm \times 0.6 mm cylindrical HPT disk as illustrated in Figure 1a. The fatigue samples were ground into the final shape and polished to 1 μ m grid size. Hardness measurements were carried out with an ASMEC UNAT 2 Nanoindenter (ASMEC GmbH, Radeberg, Germany) and a proof force of 200 mN on a surface polished with colloidal SiO₂.

Cyclic four-point-bending tests were performed on a BOSE ELECTROFORCE 3230 electrodynamic testing machine at a frequency of 40 Hz under stress control. They were conducted with a load ratio of $R = 0.1$ at room temperature. The mountings are shown in Figure 1b with a lower mounting distance of 3.2 mm and an upper one of 1.6 mm. To determine the endurance limits, the staircase method [20] was used with different step sizes, depending on the fatigue limit to be expected by a linear correlation with the hardness. Stress calculations were carried out for the controlled force F considering the specimen geometry, using Equation (2):

In this case, $d = 0.8$ mm is the distance between the upper and lower mounting rollers. The parameter σ_{edge} specifies the edge stress as real stress in longitudinal direction in the lowest tension fiber when linear-elastic material behavior is assumed.

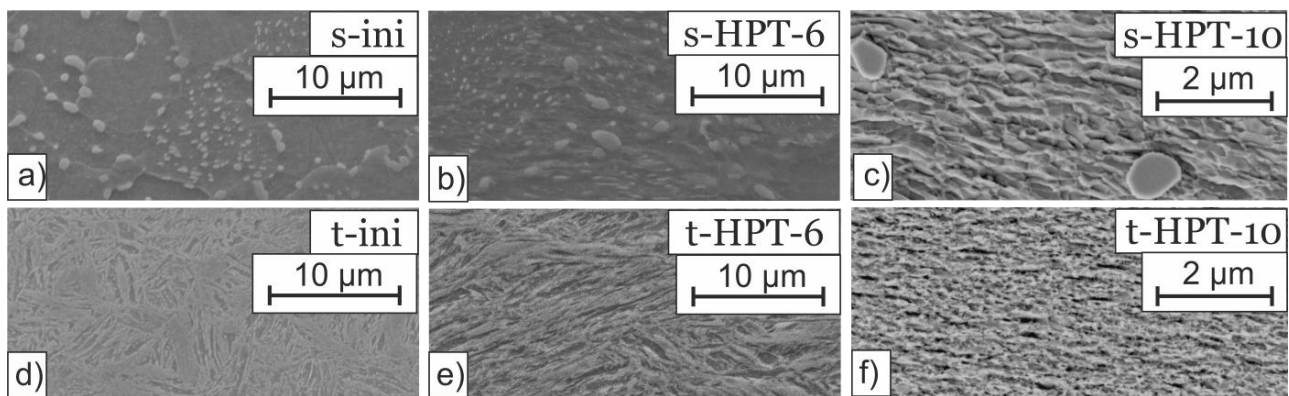
Figure 2. Etched surface microstructures prior to the fatigue tests (a) initial state after soft annealing containing spheroidal carbides (b) after 6 HPT rotations (c) after 10 HPT rotations (d) initial state with tempered microstructure (e) after 6 rotations (f) after 10 rotations.

The microstructure of C45 steel after spheroidizing annealing (S state) is shown in Figures 2a and 3a,b.

The soft annealed state contains spheroidal carbides distributed in a uniform coarse grained microstructure with well-defined grain boundaries (Figures 2a and 3b). The grains are micrometer sized ($\sim 15 \mu\text{m}$) and initial hardness is 169 HV. This state will be referred to as s-ini. Typical images of the S state after warm HPT for six and ten rotations (these states will be referred to as s-HPT-6 and s-HPT-10) are shown in Figures 2b,c and 3c–f. After six rotations, the microstructure is refined and new grain boundaries appear (Figures 2b and 3c). The grain size shrinks to approximately $0.8 \mu\text{m}$ and the grains show a slight elongation along the HPT shear direction (Figure 3c) with a hardness of 289 HV. After ten rotations, the ferrite grain size decreases further to approximately $0.2 \mu\text{m}$ and the elongation is more pronounced (Figure 3e,f). Hardness rises to 511 HV. The continuous grain refinement is best visible in Figure 3a,c,e.

Needle-shaped microstructures are visible in Figures 2d and 4a,b for C45 steel after tempering (T state). Carbides are finely dispersed between the needles (Figure 4b). The samples have an initial hardness of 388 HV before HPT. This state will be referred to as t-ini. After six HPT rotations (t-HPT-6), the needles become slightly refined (Figures 2e and 4c), their long axis is oriented along the shear direction and the formation of new low and high angle grain boundaries is visible. The hardness increases to 457 HV in t-HPT-6. After ten rotations (t-HPT-10), the microstructure shows strong refinement by SEM (Figure 2f) with no visible needles anymore. ACOM-TEM reveals an ultrafine grained structure with elongated grains and the cementite is finely dispersed in the ferrite matrix. The final hardness at the fatigue samples extraction point is 758 HV. However, the microstructure and hardness show variations along the radius of the HPT disk due to the shear strain variation (compare Equation (1)). The cementite distribution is most homogeneous after 10 rotations.

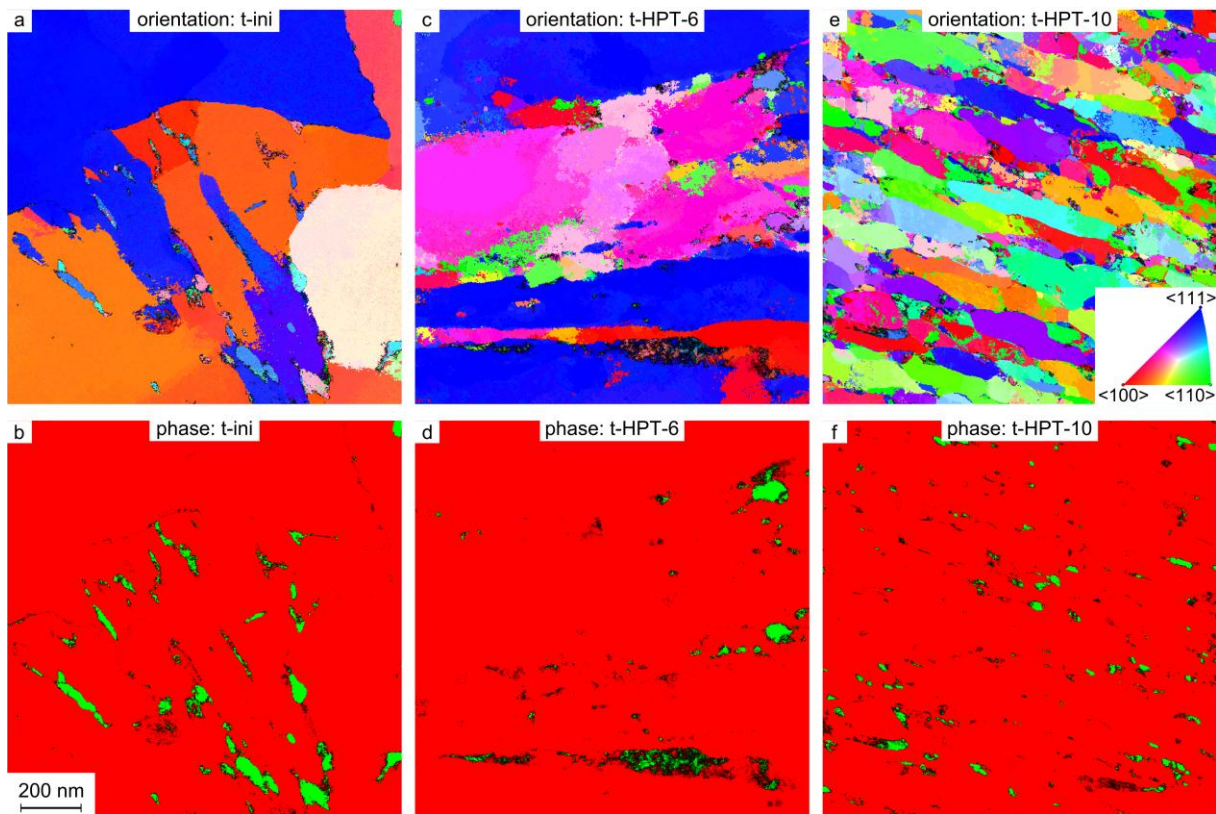
Figure 4. Orientation (a,c,e) and phase (b,d,f) maps (ACOM-TEM) overlaid with the reliability of the tempered microstructures (a,b), after 6 (c,d) and 10 HPT rotations (e,f) all prior to the fatigue tests. The color code of the orientation maps is given in (e). The projection direction is normal to the paper plane. The Fe phase is given in red and green represents the carbide phase. The reliability is given in black for both types of maps.

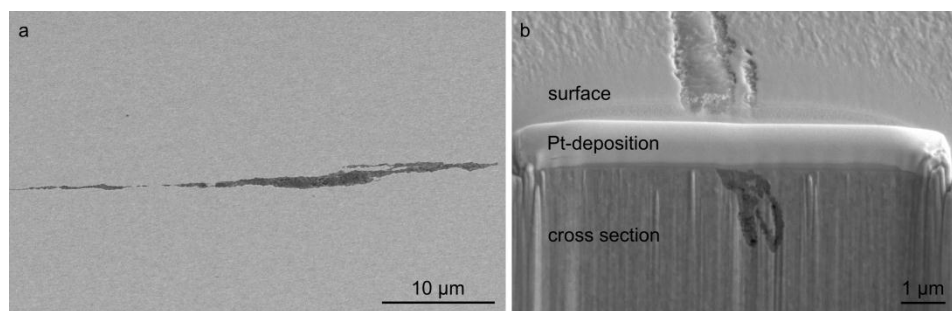
Figure 5. SEM images of a sheared non-metallic inclusion on the (non-etched) surface of t-HPT-10: (a) top view; (b) FIB cut through the inclusion.

After HPT, shear bands are visible by optical microscopy on the surface, fracture surface, and cross section of all specimens. Such shear bands have been reported earlier for HPT processed nanocrystalline metals such as palladium [25]. Interesting to notice is that, in the present case of the C45 steel, non-metallic inclusion were sometimes sheared by the shear bands as seen in the FIB cross-section in Figure 5.

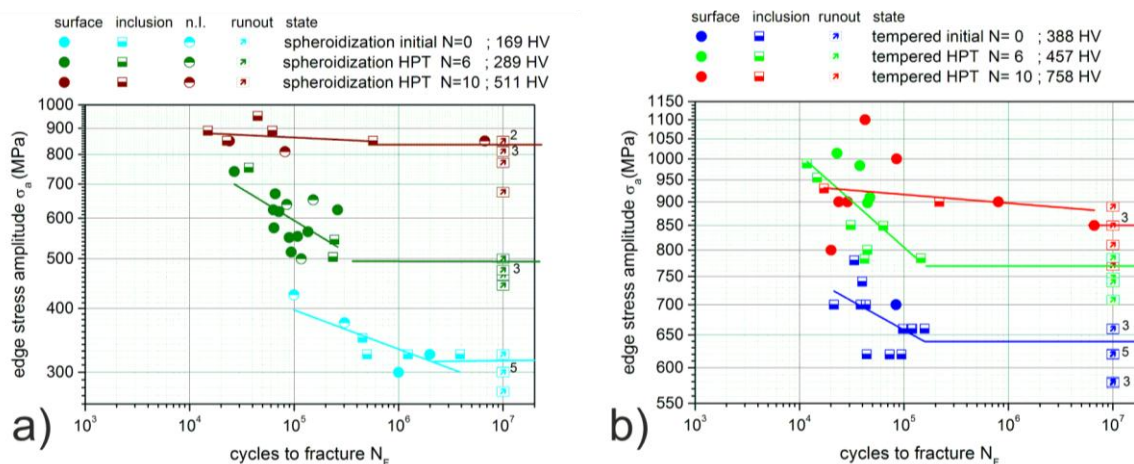
Figure 6. S-N curves of (a) CG and UFG spheroidized SAE 1045 revealing endurance limits of 316 MPa, 493 MPa and 837 MPa and of (b) UFG and CG tempered SAE 1045 showing endurance limits of 640 MPa, 769 MPa and 850 MPa.

Four-point-bending fatigue tests were carried out with both carbide morphologies in the initial coarse grained (CG) and the HPT deformed states (Figure 6). The edge stress amplitude was plotted against the number of cycles to fracture for both initial carbide morphologies. The arrows in the squares indicate runouts after 10^7 cycles. The small numbers beside the arrows show the number of overlapping runout-points. The crack initiation site type is indicated on top of the diagrams. A few specimens could not be investigated (n.I.) after fatigue, e.g., because they did not break completely.

Figure 6a shows the values for the spheroidizing annealed state in the CG (s-ini) and the UFG (s-HPT-6 and s-HPT-10) condition. For the s-ini state, a fatigue limit of 316 MPa was determined by the staircase method. Fractured specimens were observed after more than 10,000,000 cycles at stress amplitude of 325 MPa, while at stress amplitude of 300 MPa only one specimen fractured. In contrast, s-HPT-6 with a hardness of 289 HV showed fatigue fracture at lifetimes below about 400,000 cycles. The endurance limit (494 MPa) was significantly higher compared to s-ini. Crack initiation was mainly at the surface as indicated in the diagram. After 10 HPT rotations, resulting in a hardness of 511 HV, the fatigue limit further increased to 837 MPa. One specimen failed at 800,000 cycles, all other either failed within the first 80,000 cycles or ran out. Below 800 MPa, no fatigue failure was observed for s-HPT-10. The crack initiation site changed with an increasing number of HPT-rotations from the surface without non-metallic inclusions for s-HPT-6 to crack initiation at non-metallic inclusions at the surface in s-HPT-10 (see also Figure 7).

Figure 6b shows the S-N-curves for t-ini, t-HPT-6 and t-HPT-10. A fatigue limit of 640 MPa was determined for t-ini, corresponding to a hardness of 388 HV. In this case, crack initiation mostly occurred at non-metallic inclusions at the surface. With an increased hardness of 457 HV, the fatigue limit of t-HPT-6 rose to 769 MPa. For higher fatigue loads, a specific crack initiation location could not be identified. The exceptions are cyclic edge stresses between 780 MPa and 900 MPa, where all cracks initiated at non-metallic inclusions. For the t-HPT-10 specimens, offering the highest shear strain and hardness, the S-N curves and the crack behavior seem to be completely different. In contrast to the initial state and t-HPT-6, where specimens either failed before 200,000 cycles or ran out, many t-HPT-10 samples failed at a higher number of cycles. In addition, this state also revealed a number of very early cracks, which reduced the fatigue limit to a value of 850 MPa, lower than expected for a hardness of 758 HV, when considering a linear correlation between hardness and fatigue limit. Cracks were mostly initiated at the surface of the t-HPT-10 specimens.

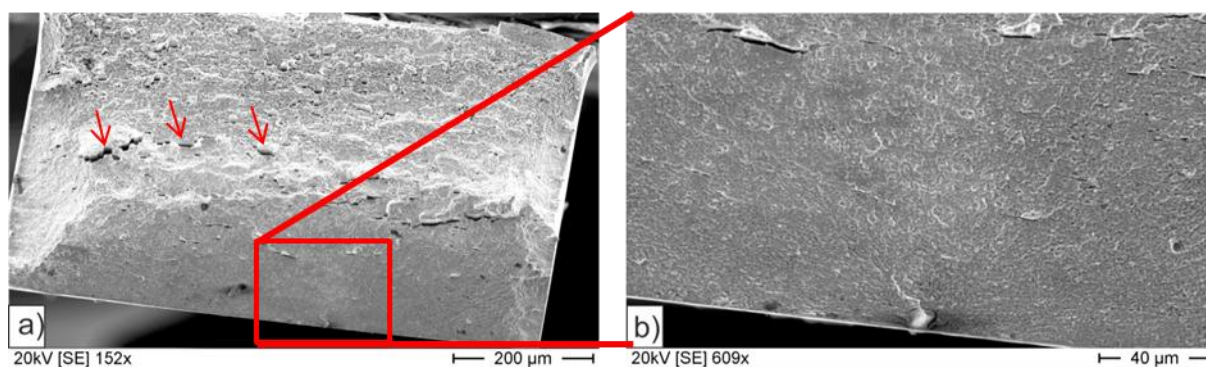
Figure 7. Fracture surface of s-HPT-10 (a) whole fracture surface (b) fatigue fracture surface; some shear bands resulting from HPT are shown with arrows.

Figure 7a shows the fracture surface of one of the s-HPT-10 specimens after a fatigue load of 850 MPa. A large fatigue fracture surface (Figure 7b) is visible, which is larger than typically found in conventional high strength materials. The fatigue fracture surface shown in Figure 7b is very homogeneous and appears smooth. The crack initiation occurred at a non-metallic inclusion. In the transition area between fatigue and residual fracture surface, some short cave-like shear bands are visible. Such shear bands are observed in fracture surfaces of HPT processed materials, for example in nanocrystalline palladium after HPT [25]. In this specimen, shear bands seem not to have influenced the crack initiation or early fatigue crack growth because they are observed only in the late fatigue crack growth areas well as in the residual fracture area.

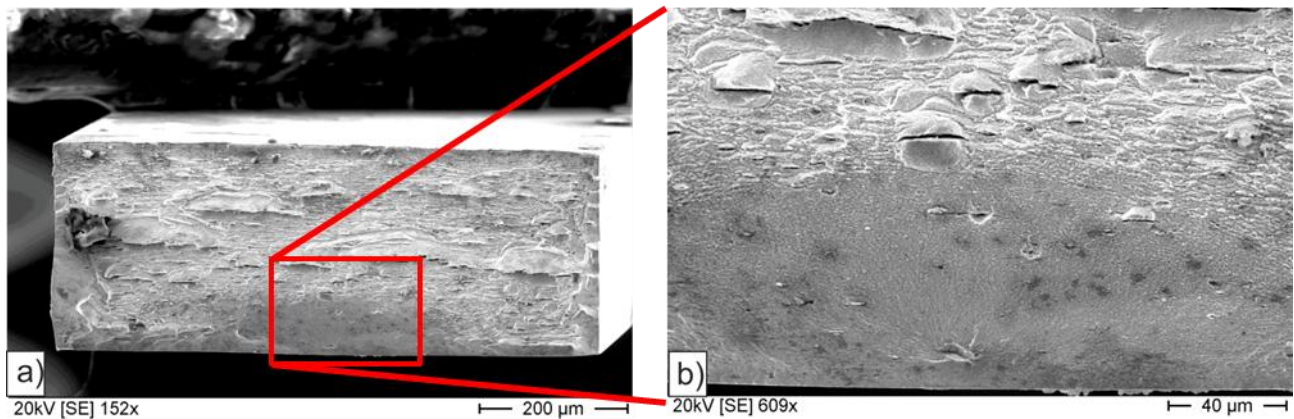
Figure 8. Fracture surface of t-HPT-10 (a) whole fracture surface (b) crack initiation area at the surface without nonmetallic inclusion and fatigue fracture surface.

Figure 8 illustrates the fracture surface of a t-HPT-10 sample loaded at a stress of 900 MPa. SEM investigations reveal shear bands in the fracture surface. The cave-like characteristics appear over the whole residual fracture surface. With a length of up to 200 μm , they seem to be larger than those in the spheroidizing annealed state, which are only up to 40 μm long. The fatigue fracture surface in Figure 8b is smaller than in the s-HPT-10 state although the sample was loaded at nearly the same stress level. We also observe crack initiation at a non-metallic inclusion. The fracture appearance is rather homogenous with a flat fatigue fracture surface. In addition, some shear bands are visible in the fatigue fracture surface but similar to the spheroidizing annealed state, they do not influence the crack initiation or propagation.

Comparing Figures 8 and 11, the fracture surfaces of t-HPT-10 do not appear as uniform as those of s-HPT-10. The main difference is that while the fatigue fracture surface in Figure 8 is not affected by

However, an open question is: why do early cracks or cracks at low stress amplitudes occur in some specimens of t-HPT-10? This can be explained comparing Figures 8 and 11, which both show shear bands in the fracture surface. Shear bands represent inhomogeneities, which, in combination with a brittle material, are detrimental to the fatigue performance, as shown in Figure 14. However, when comparing fracture surfaces of late and early failure, it is visible that the specimens with the worst fatigue properties exhibit a rotation of the shear bands, which is not parallel to the nominal HPT-shear planes. Unusually turbulent flows, manifesting themselves in the appearance of whirls observed at the macroscopic [30] and microscopic [31] scale in severely deformed materials, are most likely the reason for this rotation. This effect seems to increase the influence of the shear bands on fatigue failure.

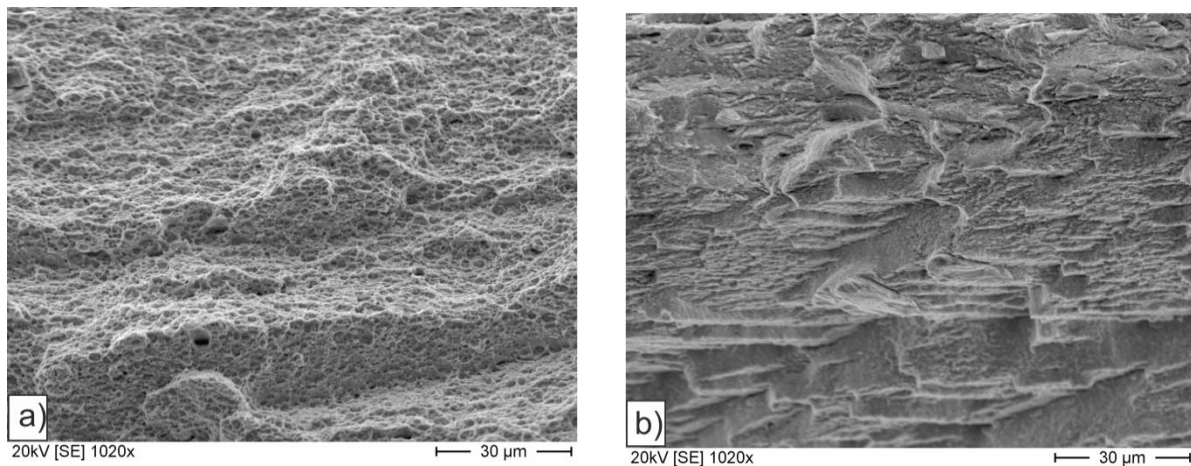
Figure 9. Residual fracture surface of (a) s-HPT-10 and (b) t-HPT-10.

Figure 9 shows a comparison of the residual fracture surfaces of the two states with tempered and spheroidizing annealed microstructure after HPT. There are significant differences in the morphology. In Figure 9a, s-HPT-10 shows well-defined dimples, which indicate a homogeneous ductile fracture behavior.

In contrast, Figure 9b reveals a rather rough residual fracture surface with sharp edges, which are common for this material state and indicate a brittle material behavior. Most likely, these sharp edges are shear steps from shear banding. Figure 10a,b show an FIB cross-section of the t-HPT-residual fracture surface at a characteristic cave, which was formed by a shear band. This indicates a correlation between shear bands observed at the fracture surface and the microstructure underneath. The shear band at the fracture surface is connected to a line-shaped inhomogeneity inside the microstructure. A similar line pattern is also visible in a polished and Nital-etched cross section of the HPT specimen in Figure 10c prior to fatigue loading. These lines are extended along the shear direction during HPT and become visible after etching in SEM in this case in the t-HPT-10 state. However, similar shear bands can also be seen in the micrographs of the s-HPT-10 states.

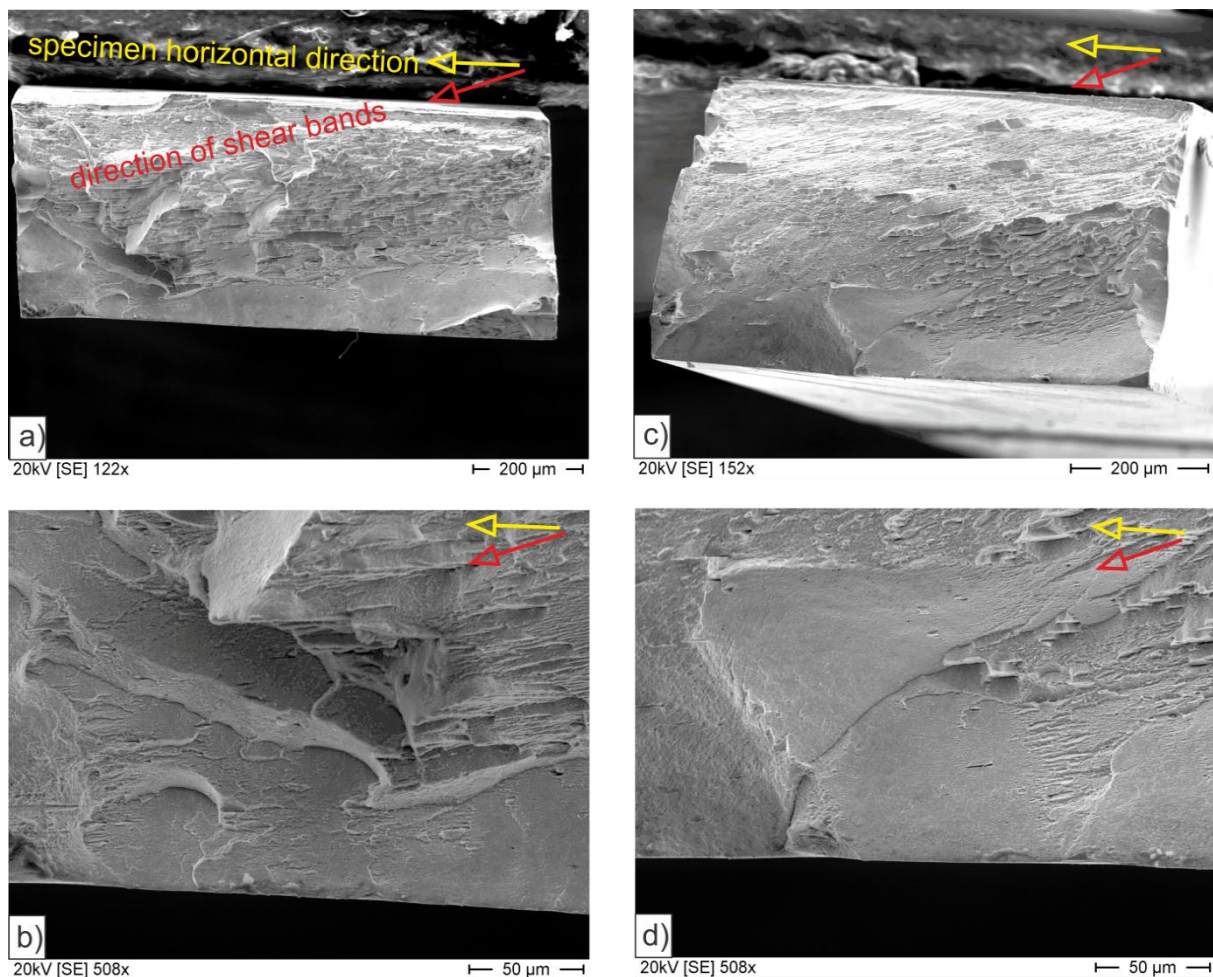
Figure 11. Fracture surface of t-HPT-10 state which shows shear bands (a,b) loaded at 900 MPa and (c,d) loaded at 850 MPa (red open arrows at the top indicate the direction of shear bands in correlation to the specimens surface indicated by the yellow open arrows. The crack initiation site is always at the bottom of the pictures).

The fracture surface of a tempered specimen after HPT, which failed very early at 900 MPa, is shown in Figure 11a,b. The picture shows a cliff-like fracture surface with a high topology in the residual and also in the fatigue fracture surface. The fatigue crack seems to change direction and jump between different levels. Usually, fatigue cracks grow mostly perpendicular to the tensile stress in one

defined direction, as visible in Figures 7 and 8. The fact that this is not the case here is an indication of some inhomogeneities inside the material prior to fatigue loading which affected the crack initiation site and the crack path. The whole fracture surface offers different characteristics of the shear bands compared to the fatigue samples with higher endurance limits. The shear bands seem to influence the crack growth and the lifetime of the fatigue sample because there is a link between the shear bands inside the residual fracture surface and the different levels and layers in the fatigue fracture surface.

A similar behavior is presented in Figure 11c,d, showing the fracture surface of a t-HPT-10 state sample, which cracked after 6,000,000 cycles. It is obvious that shear bands are present in the area of fatigue crack growth, especially at the crack initiation site, where an extension of a shear bands are points of multiple crack initiation. These shear bands have been produced during HPT and seem to have promoted the crack initiation during fatigue load. Further crack growth in the fatigue fracture surface is similar to that shown in Figure 11a,b, exhibiting a high topology. The fatigue crack growth is dominated by the shear bands (marked with red arrows in all pictures). The two arrows in each part of Figure 11 indicate that there is an angle of misorientation between the expected shear plane at HPT (yellow arrows) and the shear band plane in the respective specimen (red arrows). This is the case for both specimens, which both exhibited early failure during fatigue testing, and it establishes a significant difference in contrast to samples in the spheroidization annealed or tempered state, which offer a homogeneous fracture behavior in the S-N curve without early cracks (t-HPT-6). For both specimens shown in Figure 11, a complex structure of different fracture planes is visible in the fatigue fracture surface. The surface of each single plane itself seems to be very flat, as expected for fatigue failure in ultrafine grained materials, resulting in a strong topology with clustering in different spatial directions.

inhomogeneities, Figure 11 reveals a strong topology with fracture planes of different directions covering the whole surface, including the fatigue fracture surface. In both cases shown in Figure 11, the residual fracture surface has shear steps and no dimples indicating a brittle fracture behavior. In this context, Figure 10 provides an opportunity to understand the morphology of the shear bands prior to fatigue testing. Figure 10a shows an FIB cross-section of one of these cavities, which exhibits the typical fracture appearance of the shear bands [25]. There is a narrow plane-shaped inhomogeneity beneath the surface inside the microstructure. This could be a link to shear bands generated during HPT as similar stripes are present throughout the microstructure before fatigue loading, as visible in the optical micrograph in Figure 10c. This observation can be made not only in the brittle tempered state but similarly also in the ductile spheroidizing annealed microstructure with excellent fatigue properties. It follows that s-HPT-10 and t-HPT-10 do contain shear bands prior to fatigue testing but only in the tempered state they affect the fatigue properties. Therefore, the brittle behavior is the main reason for fatigue limits which are lower than expected in consideration of the hardness, because the brittle material has a more limited ability to reduce stress around process flaws owing to plastic flow. In this context, the s-HPT-10 state is an ideal material in respect of fatigue because it exhibits a high hardness and also a high ductility resulting in excellent fatigue performance with higher tolerance against crack initiation at inhomogeneities.

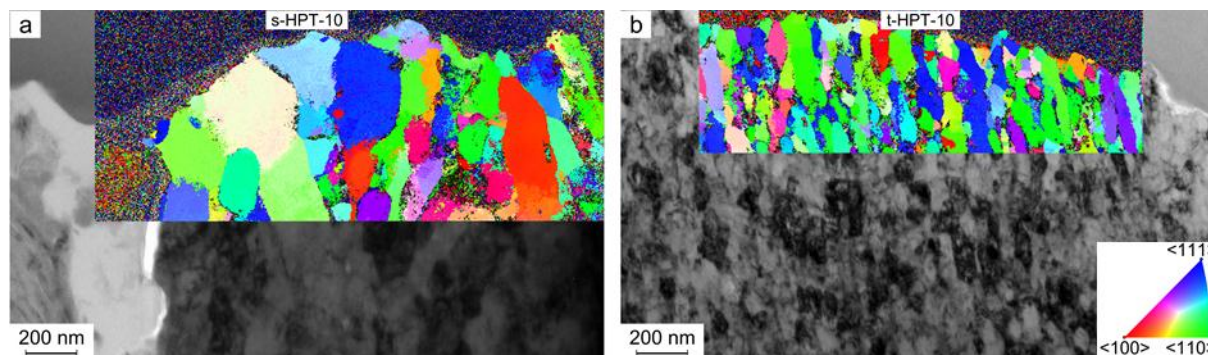
Figure 13. Cross section of the crack initiation (a) non-metallic inclusion for s-HPT-10 and (b) crack path near crack initiation from the surface for t-HPT-10. The overlays are orientation maps in projection direction normal to the paper plane with the reliability in black. The color code of the orientation maps is given in (Figure 3a).

Figure 13 shows cross sections of typical crack initiation sites for the HPT states after ten HPT rotations. BF-TEM and ACOM-TEM images were obtained to correlate the crack path, which is in both cases horizontal in the upper part of the images, with the microstructure underneath. In Figure 13a, a non-metallic inclusion, located on the left side of the shown area, was responsible for crack initiation in the s-HPT-10 state. Grain size and morphology close to the crack do not differ significantly from the pre-fatigue s-HPT-10 state.

Similarly, no significant grain coarsening or grain refinement has been observed for the t-HPT-10 state in Figure 12b. Nevertheless, in both cases, the crack path is influenced by the microstructure as it (partly) deviates from a straight crack front when crossing grain boundaries.

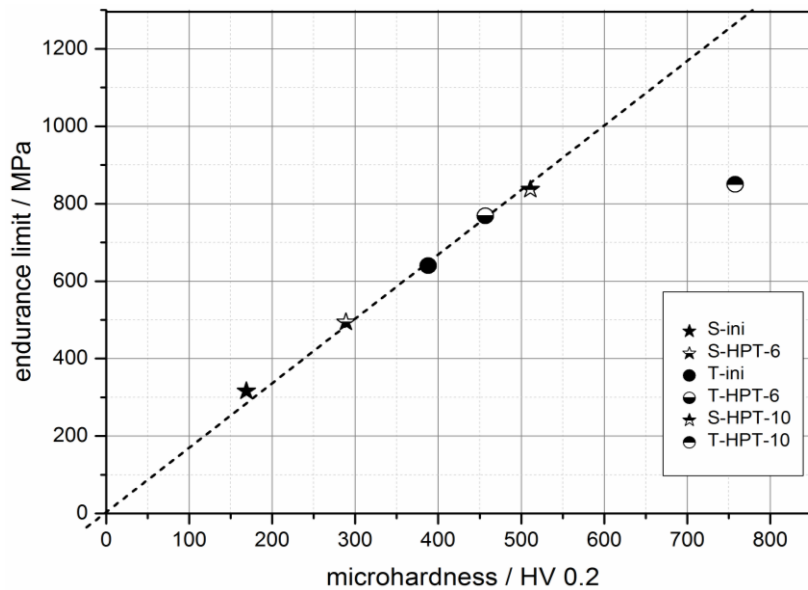
Figure 14. Relationship between hardness and endurance limit revealing a linear correspondence.

Figure 14 indicates the relationship between hardness and endurance limit in our investigations. It was created on the basis of the endurance limits presented in Figure 6. A linear correlation can be seen for the hardness range up to about 500 HV. The fatigue limit primarily correlates with the hardness which itself is strongly affected by the microstructure such as the carbide and grain morphologies. The initial and HPT-6 states fit this correlation very well. Following the investigation by Murakami [26], there must be a decrease of the fatigue limit with increasing hardness values over

Responsible for a deviation from the linear relationship are inherent material flaws such as non-metallic inclusions, which become more and more dominant at higher hardness. The subsequent decrease of the endurance limit, as suggested in Figure 14, depends on the material state and processing route. In high strength steels, the so-called process flaws resulting from the respective treatment are responsible for such behavior. For conventional steels, it is mostly the heat treatment which leads to process flaws. In our case, the HPT treatment replaces heat treatment for reaching a high strength. Thus, instead of the traditional process, flaws known from the literature, such as micro-cracks or weakened former austenite grain boundaries in carburized steels [28], here we are confronted with shear bands or cracks created during HPT, which act as process flaws. Other possible process flaws could not be clearly identified in the metallographic sections after the fatigue testing. Nevertheless, one result of the present investigation is that, in contrast to a material that only exhibits inherent or intrinsic flaws, here the process flaws in the material state with the highest hardness (t-HPT-10) lower the fatigue limit. The S-N curves already provide evidence for this, as contrary to our expectation, no non-metallic inclusions were responsible for crack initiation in the t-HPT-10 state, but the cracks mostly initiated from the surface. This is untypical for high strength steels and indicates that there must be something inside the microstructure that is more inhomogeneous or detrimental than the non-metallic inclusions.
