Lessons learned from the QUENCH-LOCA experiments

J. Stuckert, M. Große, M. Steinbrück, M. Walter, A. Wensauer

QWS-23, Karlsruhe 2017

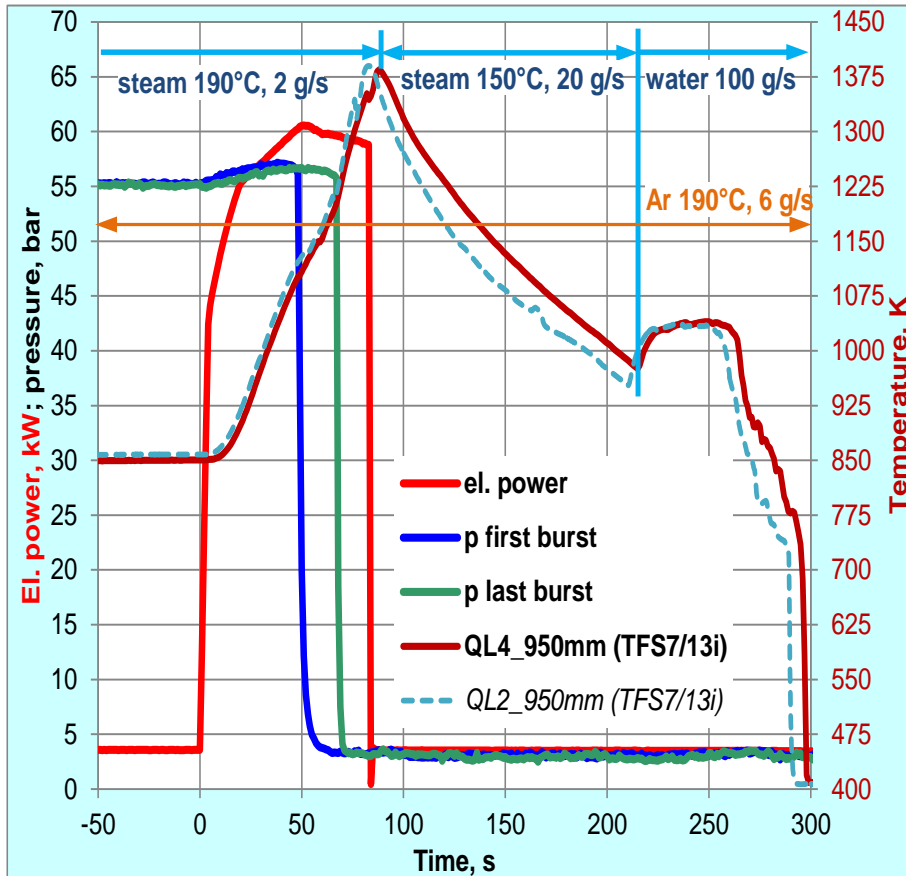
M5: QL-2, QL-4

Test progresses

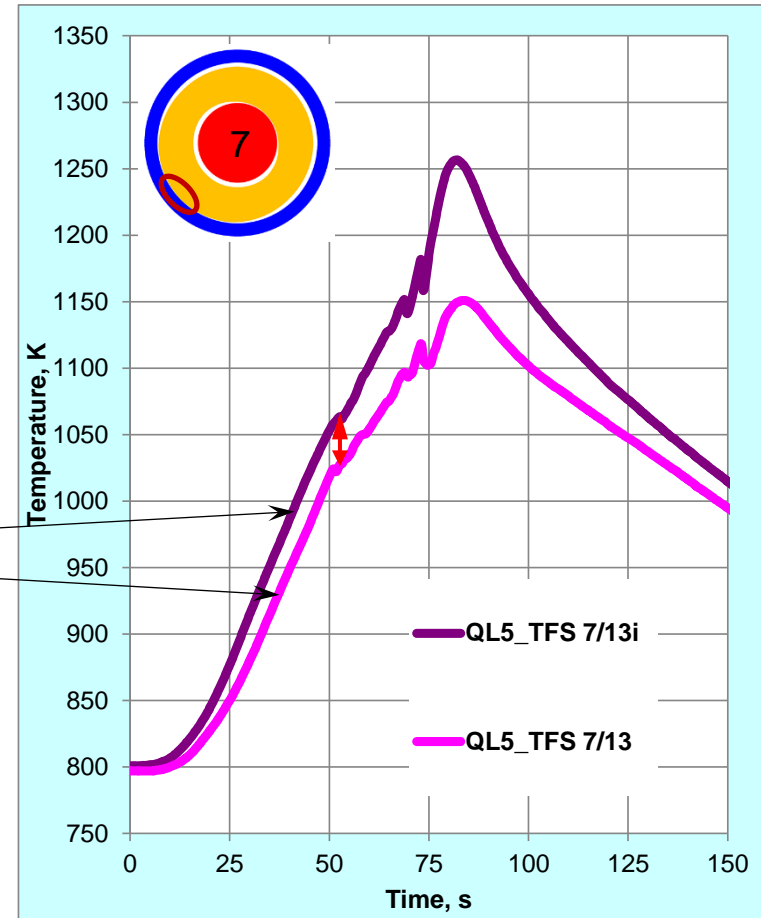
Dependence of radial temperature difference (for rod #7 of QL3 and QL5 bundles) from position of contact between pellet and cladding

**Superposition of two temperatures gradients:
global bundle gradient (from shroud to central rod) and local gradient inside rod**

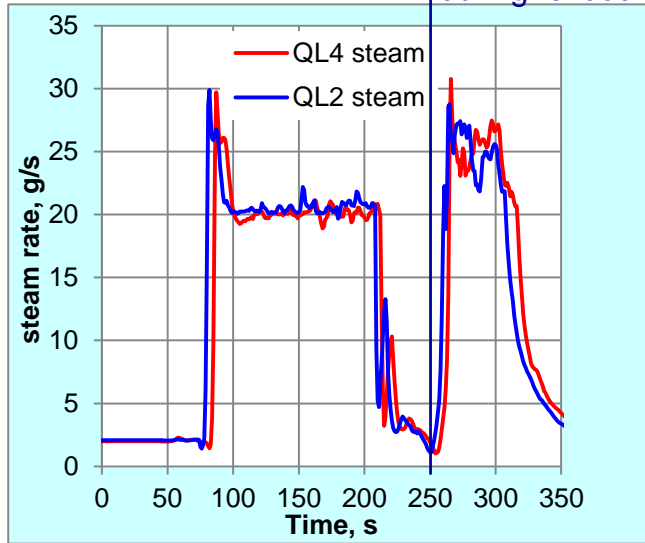
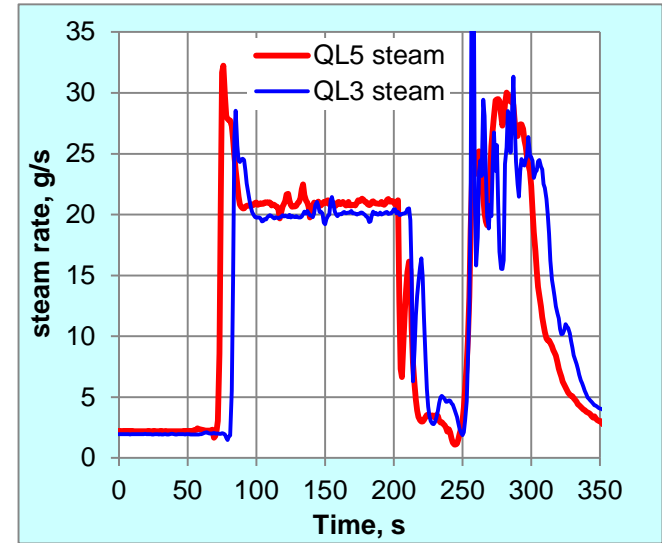
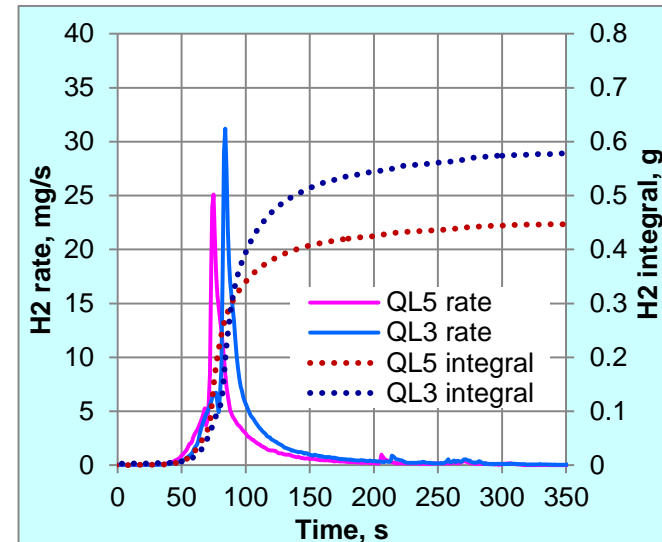
Off-gas mass spectrometer measurements: steam and H₂

steam release (25 g/s)
during reflow (100 g/s water)

H₂ increase during heat-up → H₂ peak at initiation of cool-down in 20 g/s steam

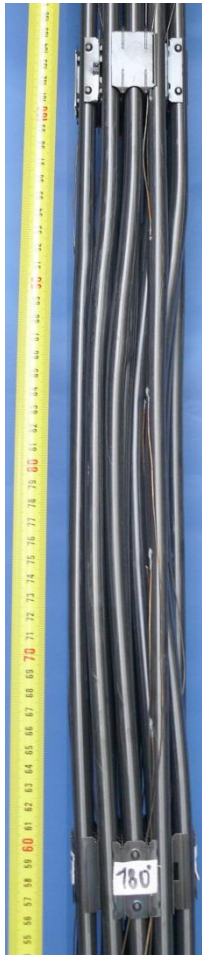
QL-1, view at 180°

Post-test views of different bundles in the burst region

**Increased bending of QL-0, QL-1, QL-2 and QL-3HT rods
due to limited axial heater expansion**

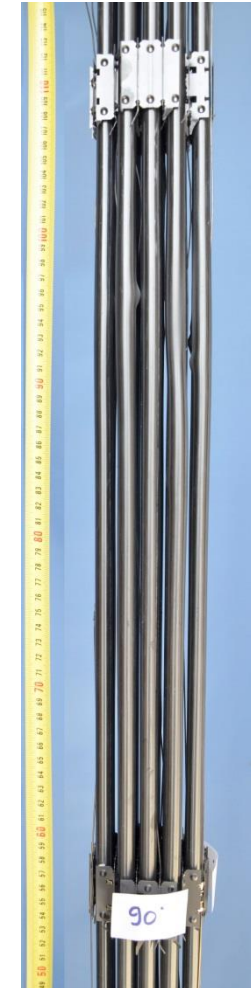
QL4, typical view for all QL-3, -4, -5 bundle positions

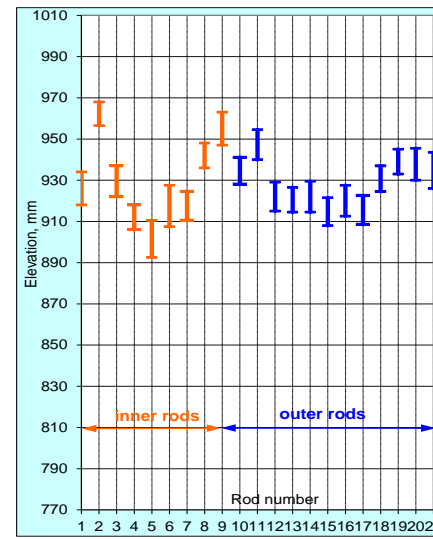
Radial and axial positions of burst openings

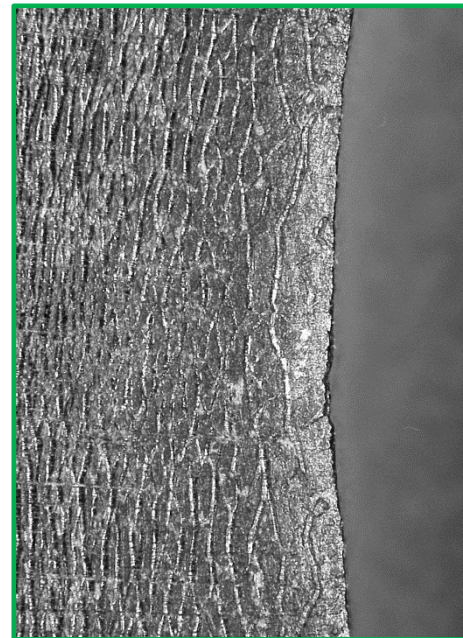
burst opening side,
 ≈ 20 cracks/mm

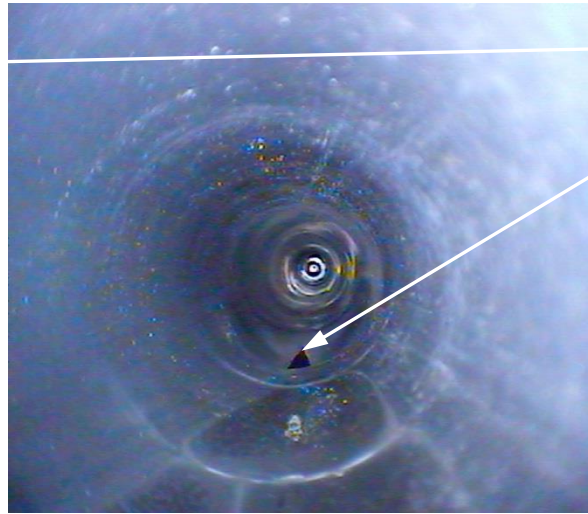
Videoscope observation of contact between pellet and cladding at inner cladding surface below burst opening

QL4, endoscopy of rod #1

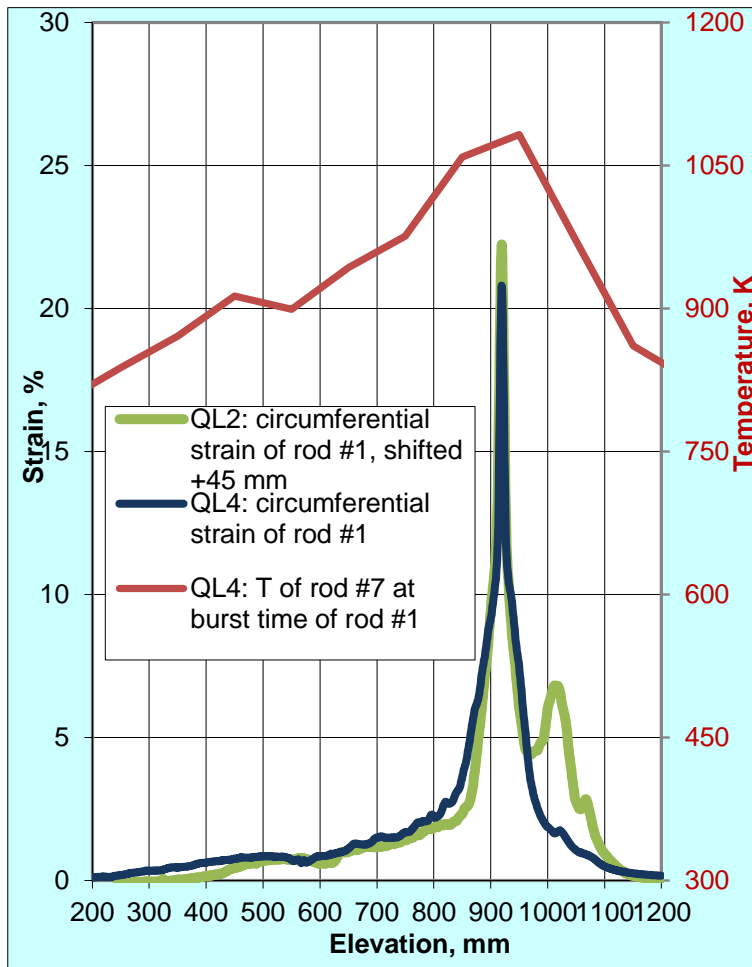
Results of laser profilometry: typical axial distributions of the circumferential strain of claddings

- additional ballooning peaks (alongside the main burst peak) formed during heat-up
- circumferential strain values in ballooning regions outside of burst opening are noticeably higher for the pre-hydrogenated claddings: cladding starts to creep earlier due to $\alpha \rightarrow \beta$ transformation around dissolving hydrides

- The detailed profilometry of the whole length of the rods showed formation of not only main ballooning area (with burst) but also, for several rods of each bundle, additional two or three ballooning regions. The reason should be the relatively long duration of the ballooning process at the main position and reaching of ballooning conditions ($T > 1000$ K) at other bundle elevations.

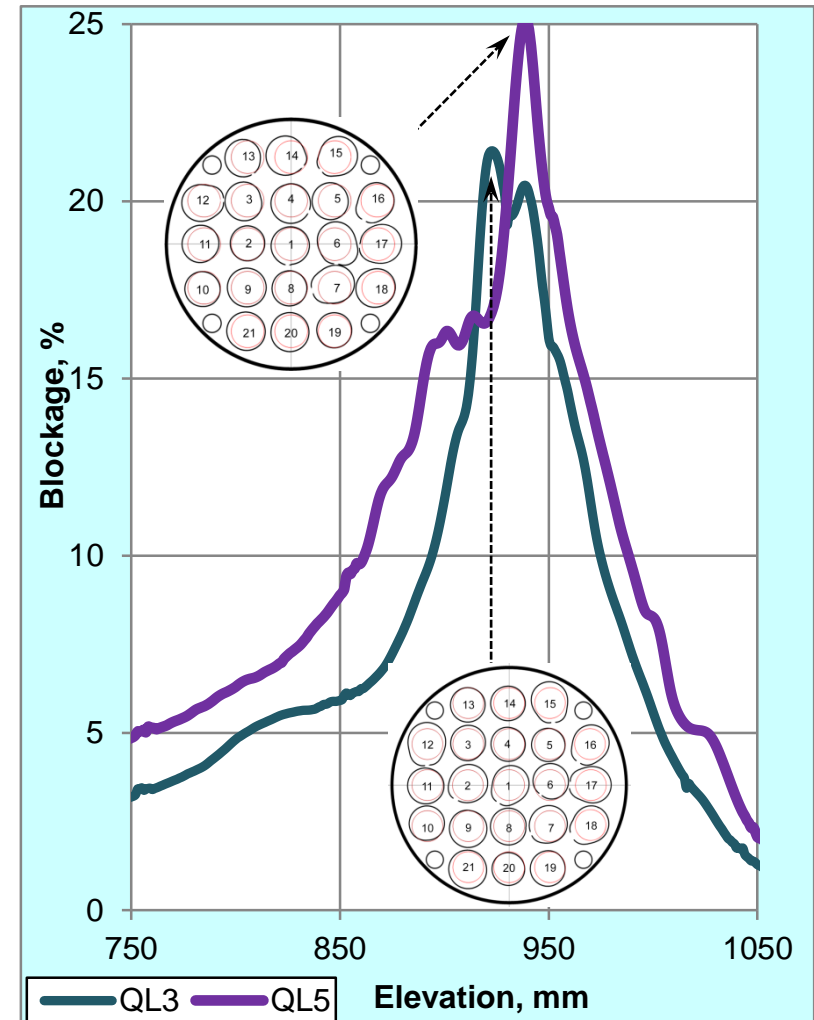
Results of laser profilometry: axial distribution of coolant channel blockages

- The maximal coolant channel blockage was less than 35% even for conservatively assuming coplanar ballooning. Due to this only moderate blockage, good bundle coolability was kept for all bundles.

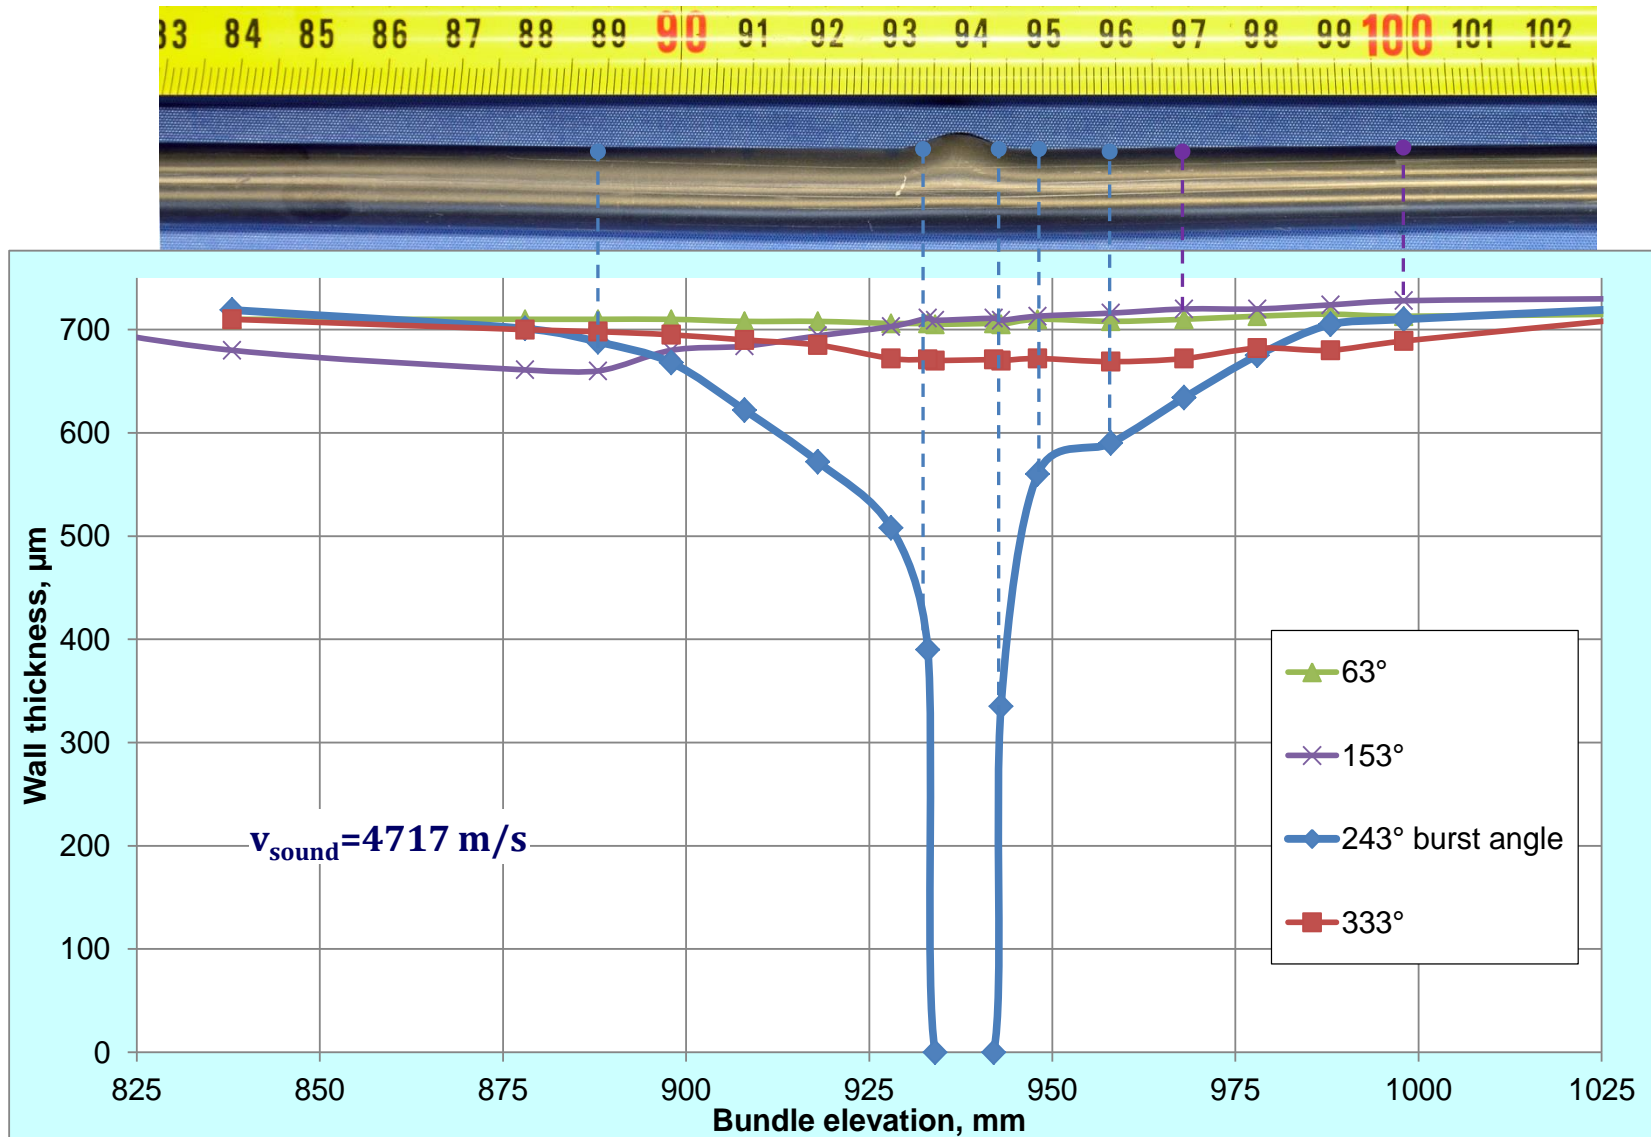
Ultrasound measurements: typical cladding wall thinning below and above the burst opening (rod #1, QUENCH-L5)

- Cladding wall thinning from 725 to 350 μm due to ballooning was observed at the burst side along 50 mm below and above burst opening. The maximal oxide thickness at the outer cladding surfaces was less than 15 μm . Surface cracks, penetrating both layers, were formed in vicinity of burst opening during ballooning.

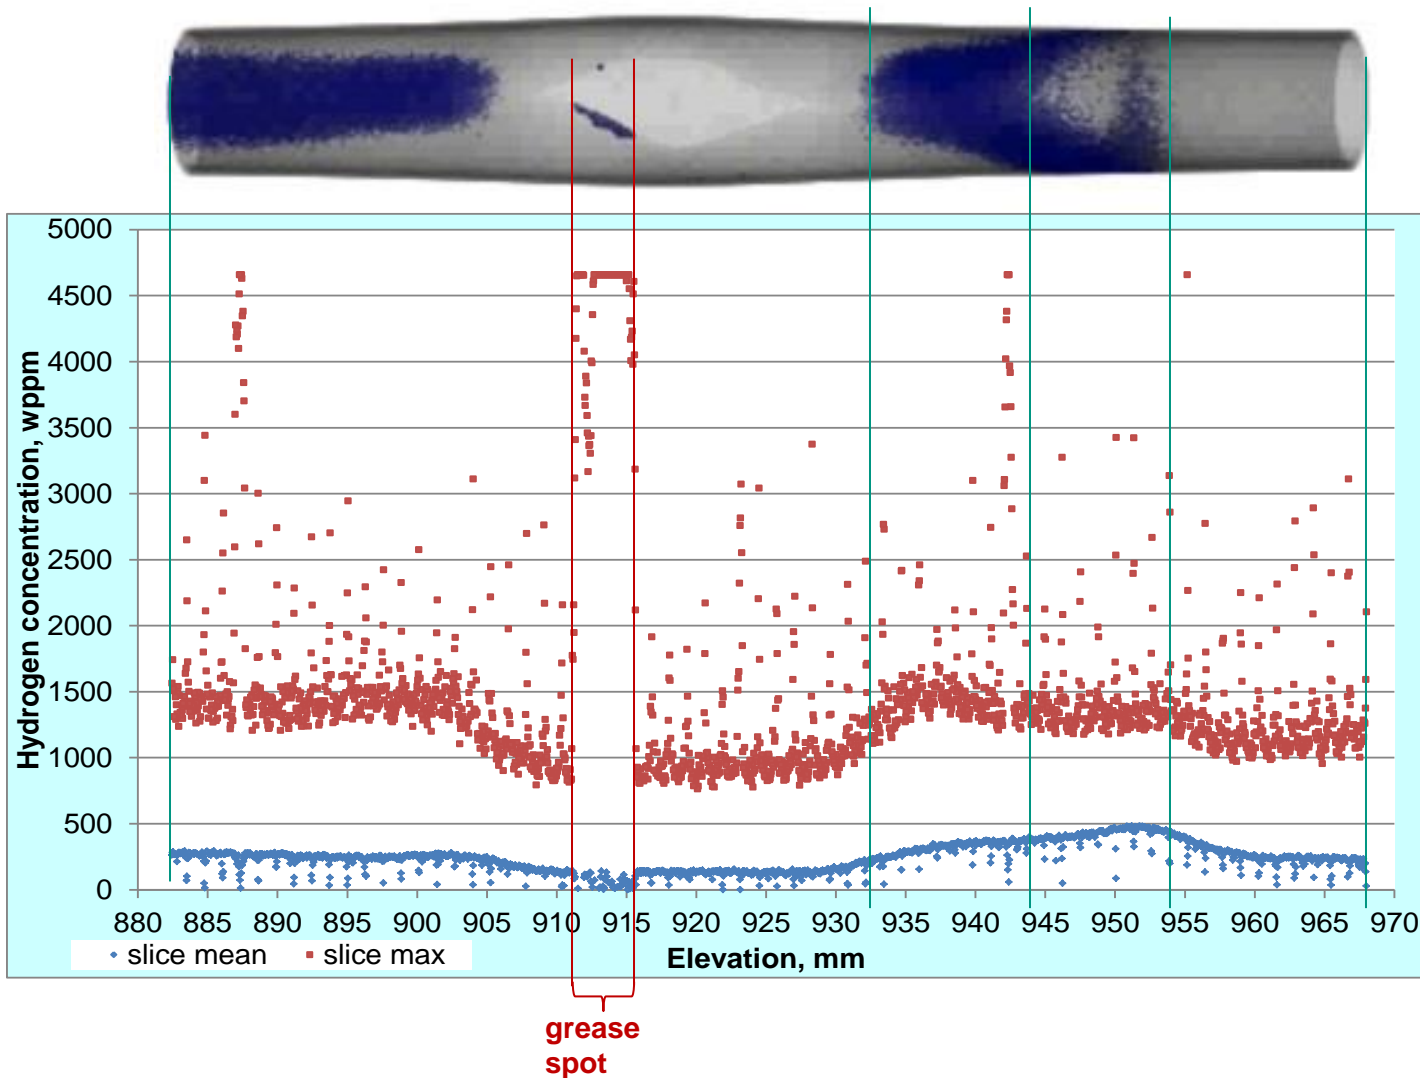
Neutron tomography: axial distribution of hydrogen (mean and max values for each elevation)

- Hydrogen enrichments of a quite complex 3D form were observed for inner rods having seen peak cladding temperatures of more than 1200 K.
- Neutron tomography analysis showed the maximal hydrogen concentrations inside the hydrogen bands less of 750 wppm (averaged through the cladding cross section).

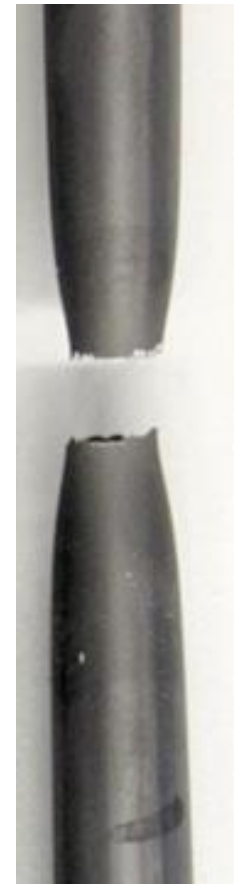
QL-3, clad #12
necking
far away from
burst region

- Tensile tests at room temperature evidenced fracture at hydrogen bands for several inner rods with local hydrogen concentrations about 1500 wppm and more. Claddings with lower hydrogen concentrations fractured due to stress concentration at burst opening edges. Other tensile tested claddings failed after necking far away from burst region.
