QUENCH - LOCA - REPORTS Nr. 5

**Results of the LOCA bundle test QUENCH-L4
with pre-hydrogenated M5[®] claddings (SR-7712)**

J. Stuckert, M. Große, A. Pshenichnikov , C. Rössger,
M. Steinbrück, M. Walter

Karlsruher Institut für Technologie

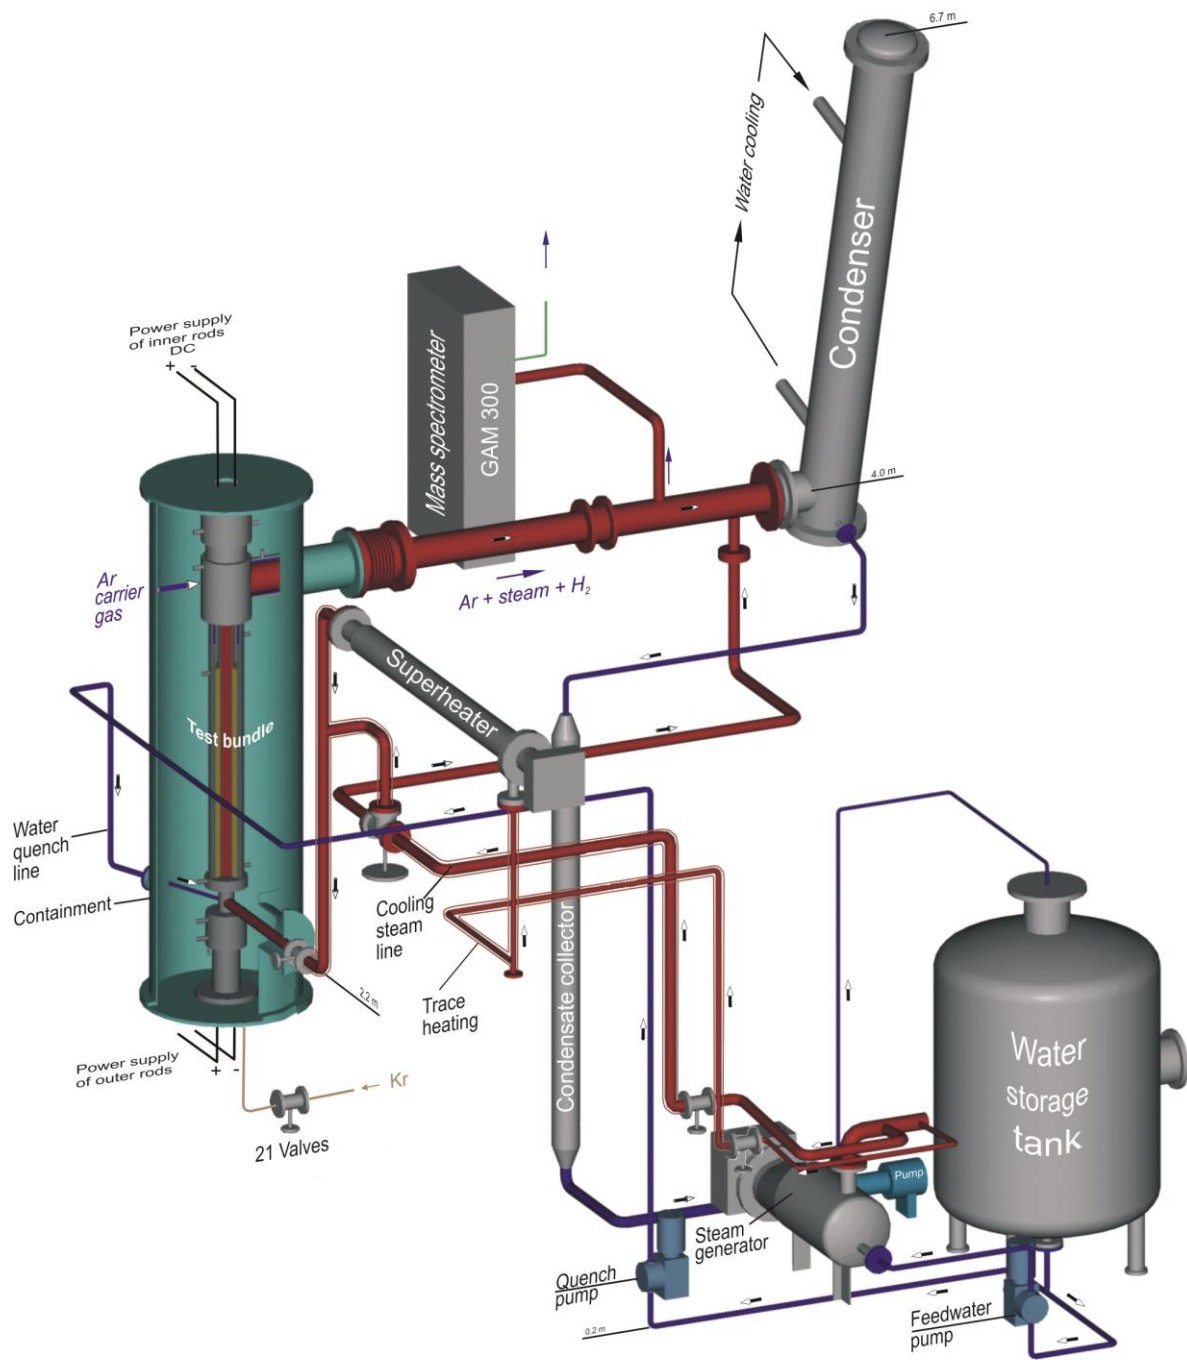
Figure 1 QUENCH Facility - Main components.

The QUENCH facility was constructed 1997 at KIT for the investigation of the hydrogen source term during reflood, i.e. of the measurement of hydrogen release during the reflood of an overheated reactor core. Since then 17 bundle tests were performed as under severe accident conditions ([Table 1](#)). The main components of the QUENCH test facility are presented in [Fig. 1](#). The test section is enclosed by a safety containment with a wall thickness of 5.6 mm and an inner diameter of 801.8 mm. The facility can be operated in two modes: a forced-convection mode depicted in the flow diagram of [Fig. 2](#) and a boil-off mode. In the forced-convection mode (relevant for QUENCH-L4) superheated steam from the steam generator and superheater together with argon as a carrier gas enter the test bundle at the bottom ([Figs. 3 and 4](#)). The system pressure in the test section for the QUENCH-LOCA tests is about 0.3 MPa. The argon, steam and hydrogen produced in the zirconium-steam reaction flow upward inside the bundle and from the outlet at the top through a water-cooled off-gas pipe to the condenser where the remaining steam is separated from the non-condensable gases argon and hydrogen. The water cooling circuits for bundle head and off-gas pipe are temperature-controlled to guarantee that the steam/gas temperature is high enough so that condensation at the test section outlet and inside the off-gas pipe can be avoided. The temperature of the cooling water in the bundle head is kept at 348 K, and the water flow rate is 250 g/s.

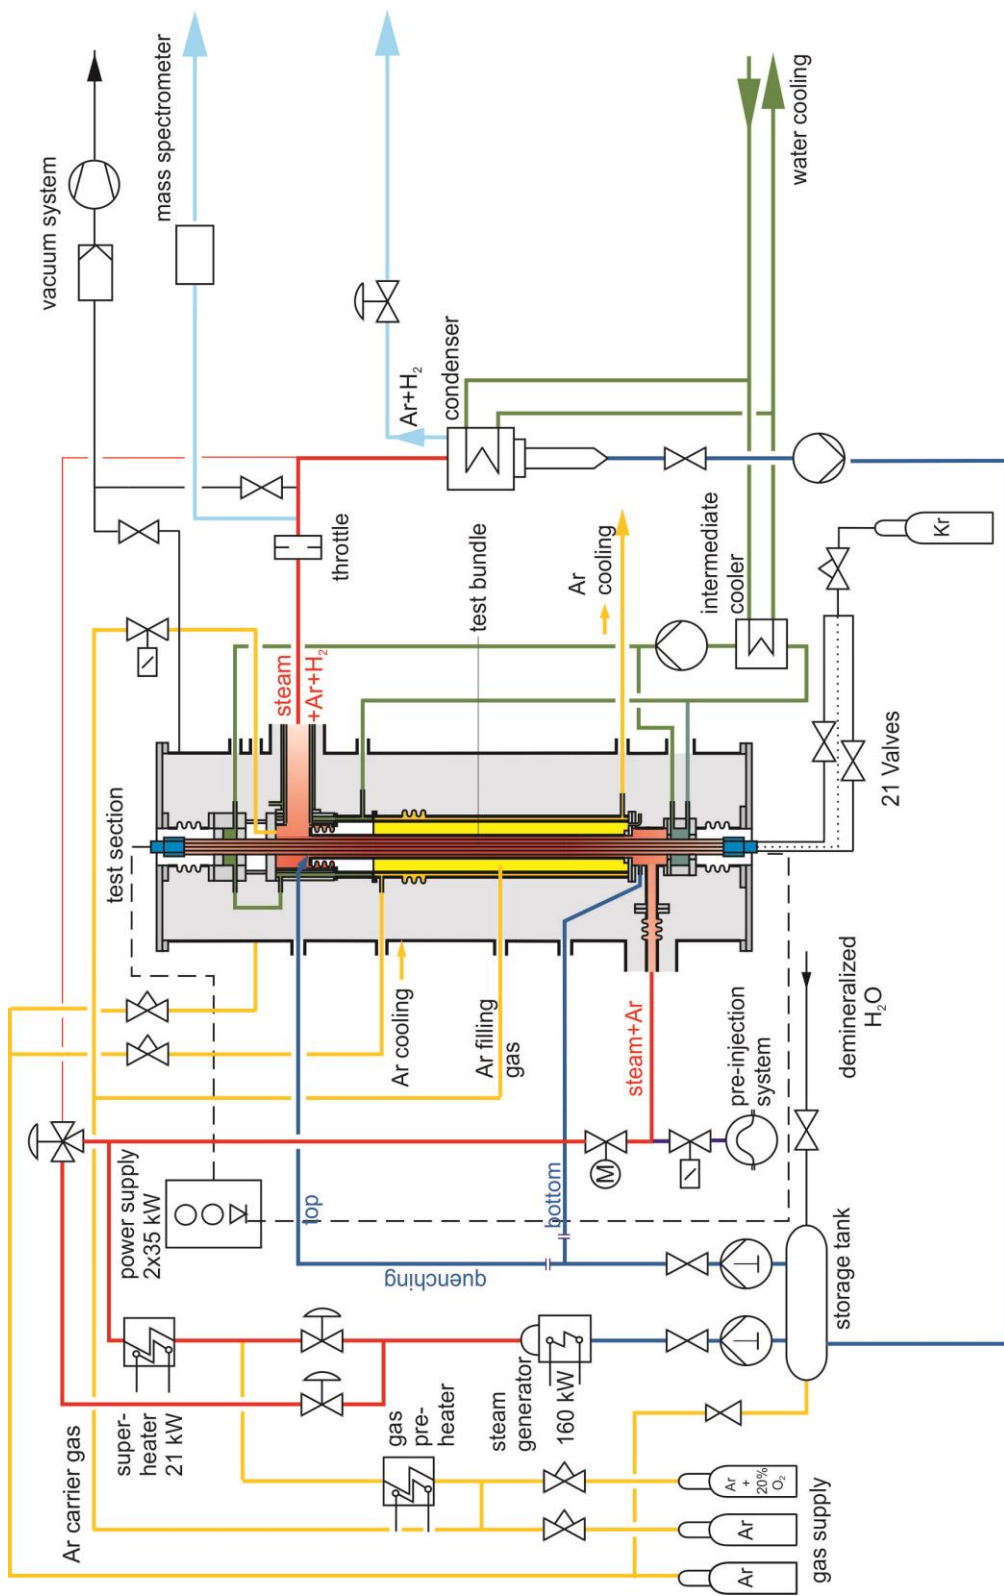
Figure 2 Flow diagram of the QUENCH test facility.

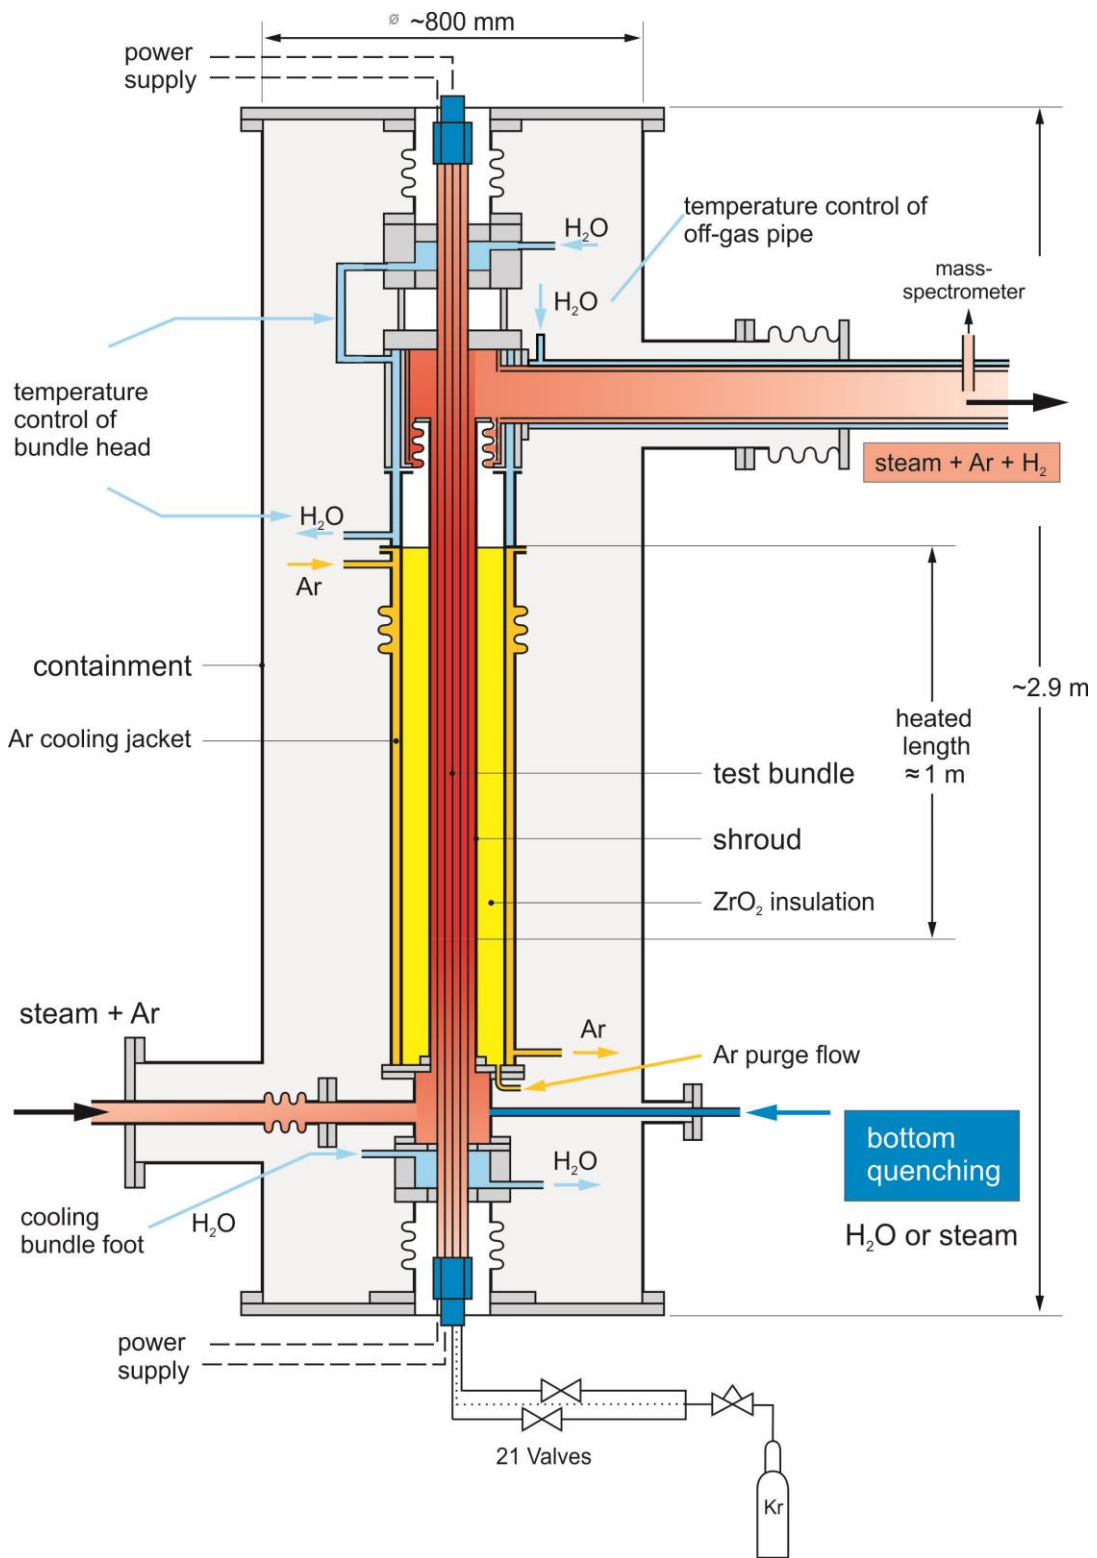
Figure 4 QUENCH-L4; Test section with flow lines.

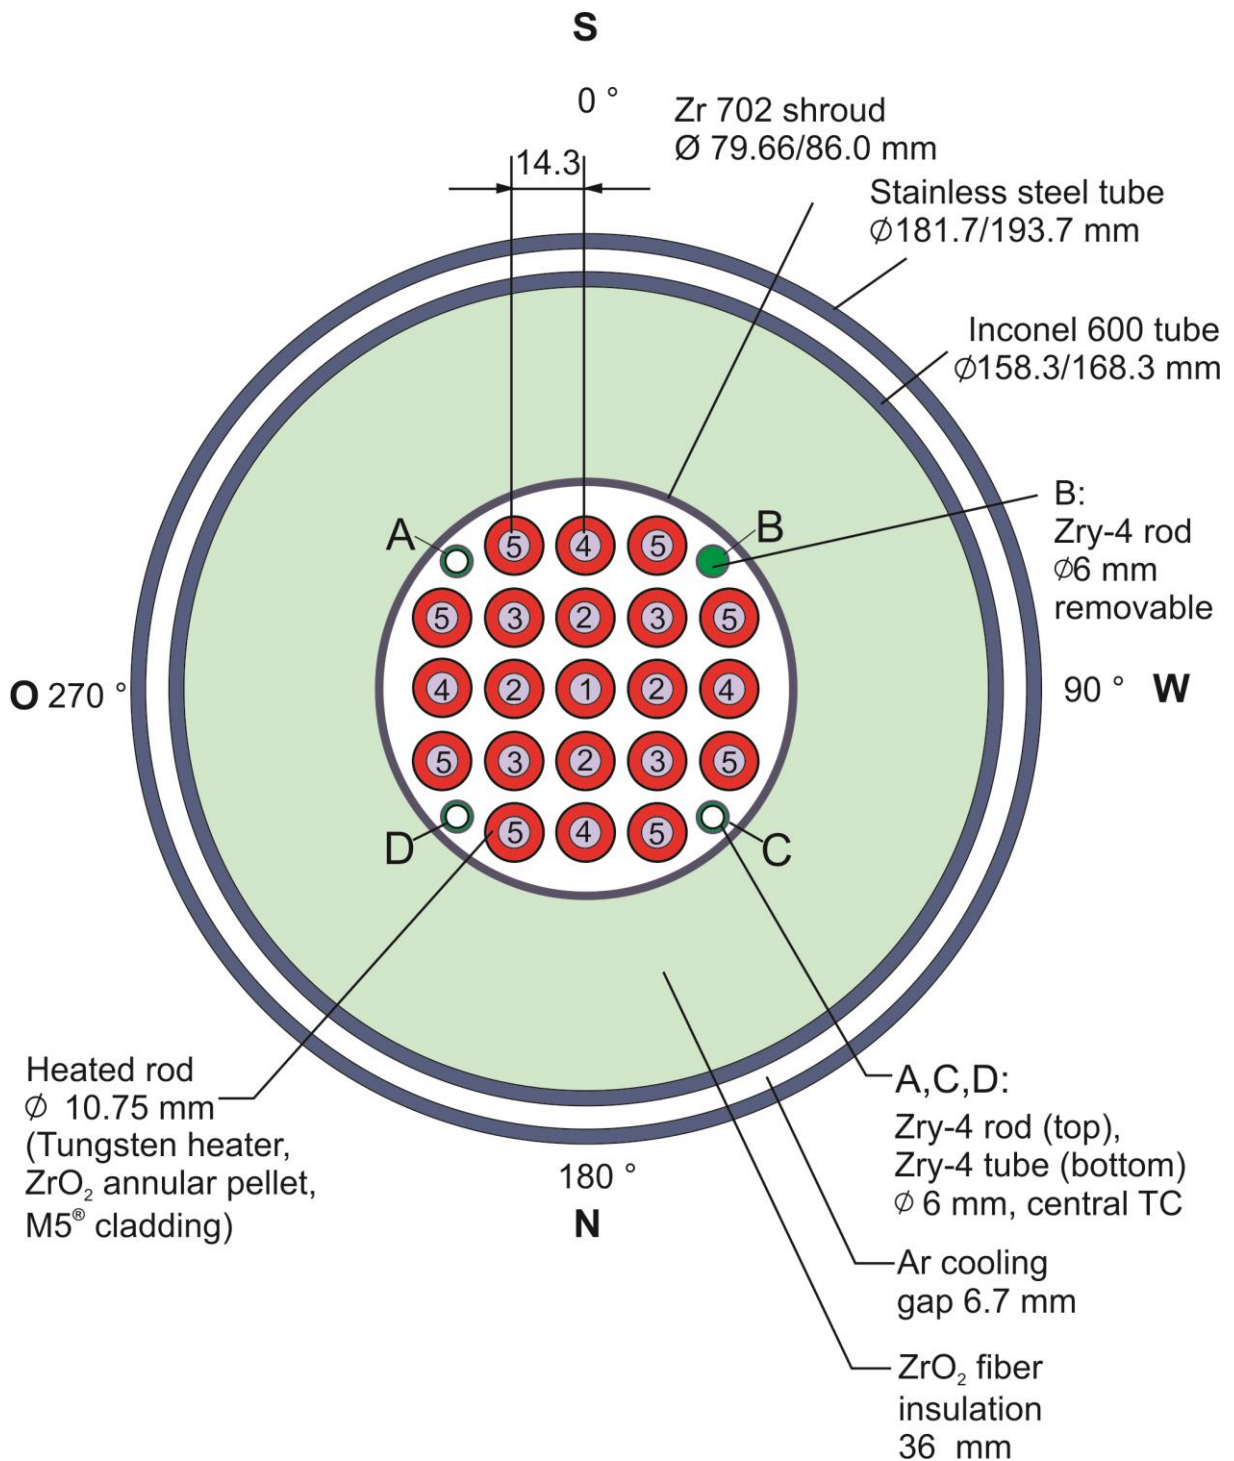
Figure 5 QUENCH-L4; Fuel rod simulator bundle (cross section, top view) including rod type indications corresponding to table “List of Instrumentation”.

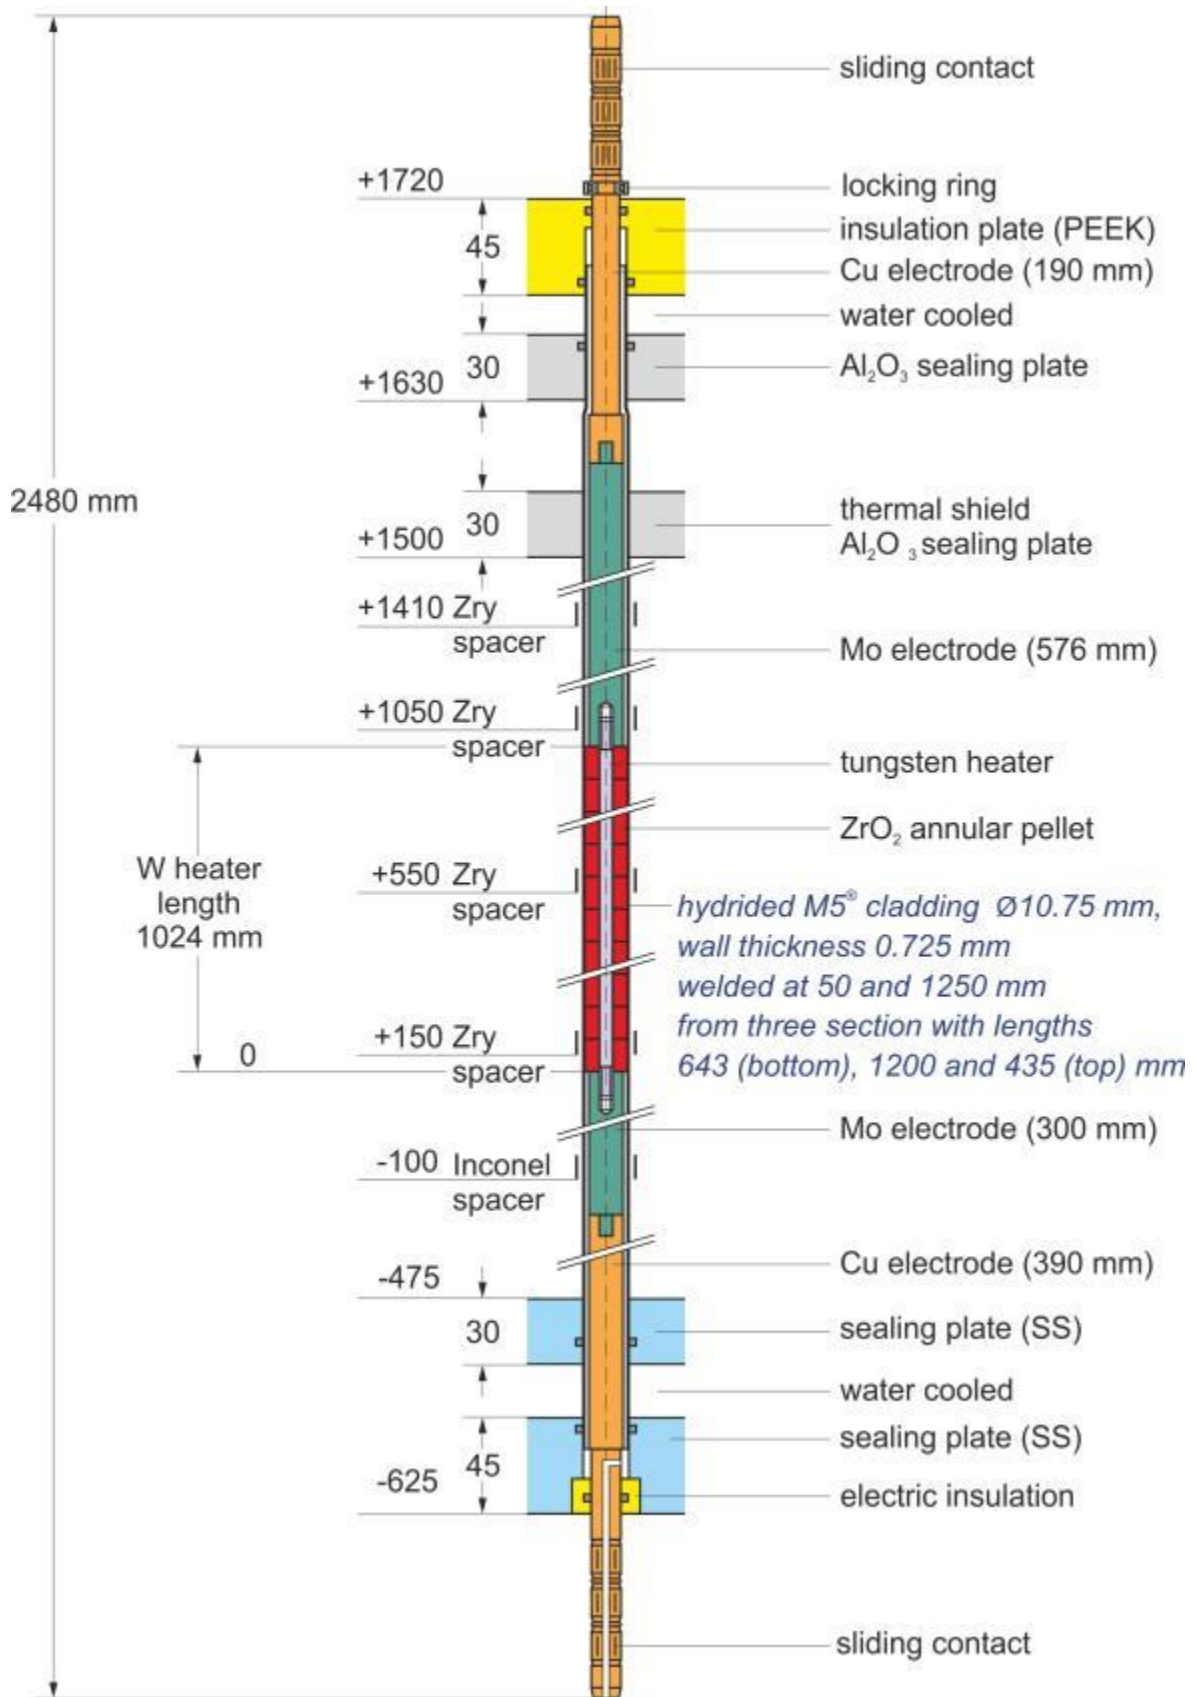
Figure 6 QUENCH-L4; Heated fuel rod simulator.

The lower boundary for the lower cooling chamber is a sealing plate made of stainless steel with plastic inlays for electrical insulation, sealed toward the system by O-shaped rings. The upper boundary of the lower cooling chamber is a sealing plate of stainless steel. An insulation plate made of plastic (PEEK) forms the top of the upper cooling chamber, and a sealing plate of Al_2O_3 , functioning as a heat-protection shield, is the lower boundary of the upper cooling chamber (see [Fig. 6](#)).

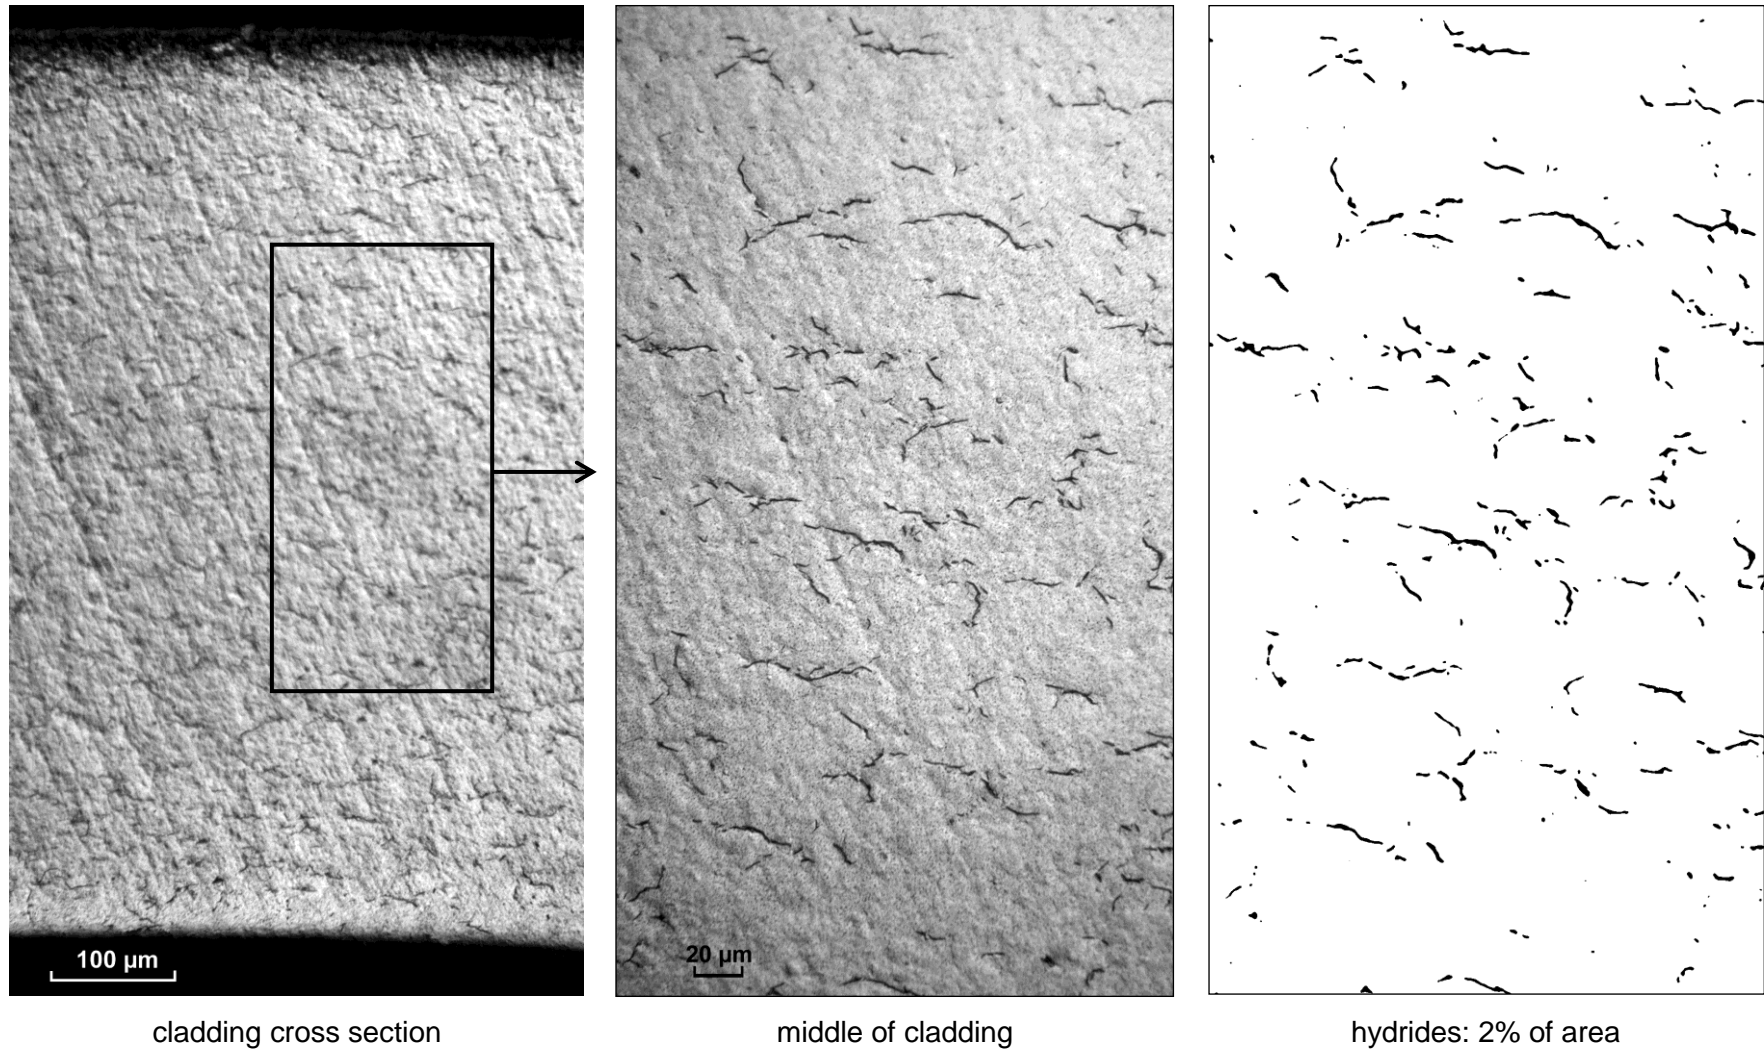
Figure 7 QUENCH-L4; Hydrides inside the prototype cladding with 100 wppm H (as etched).

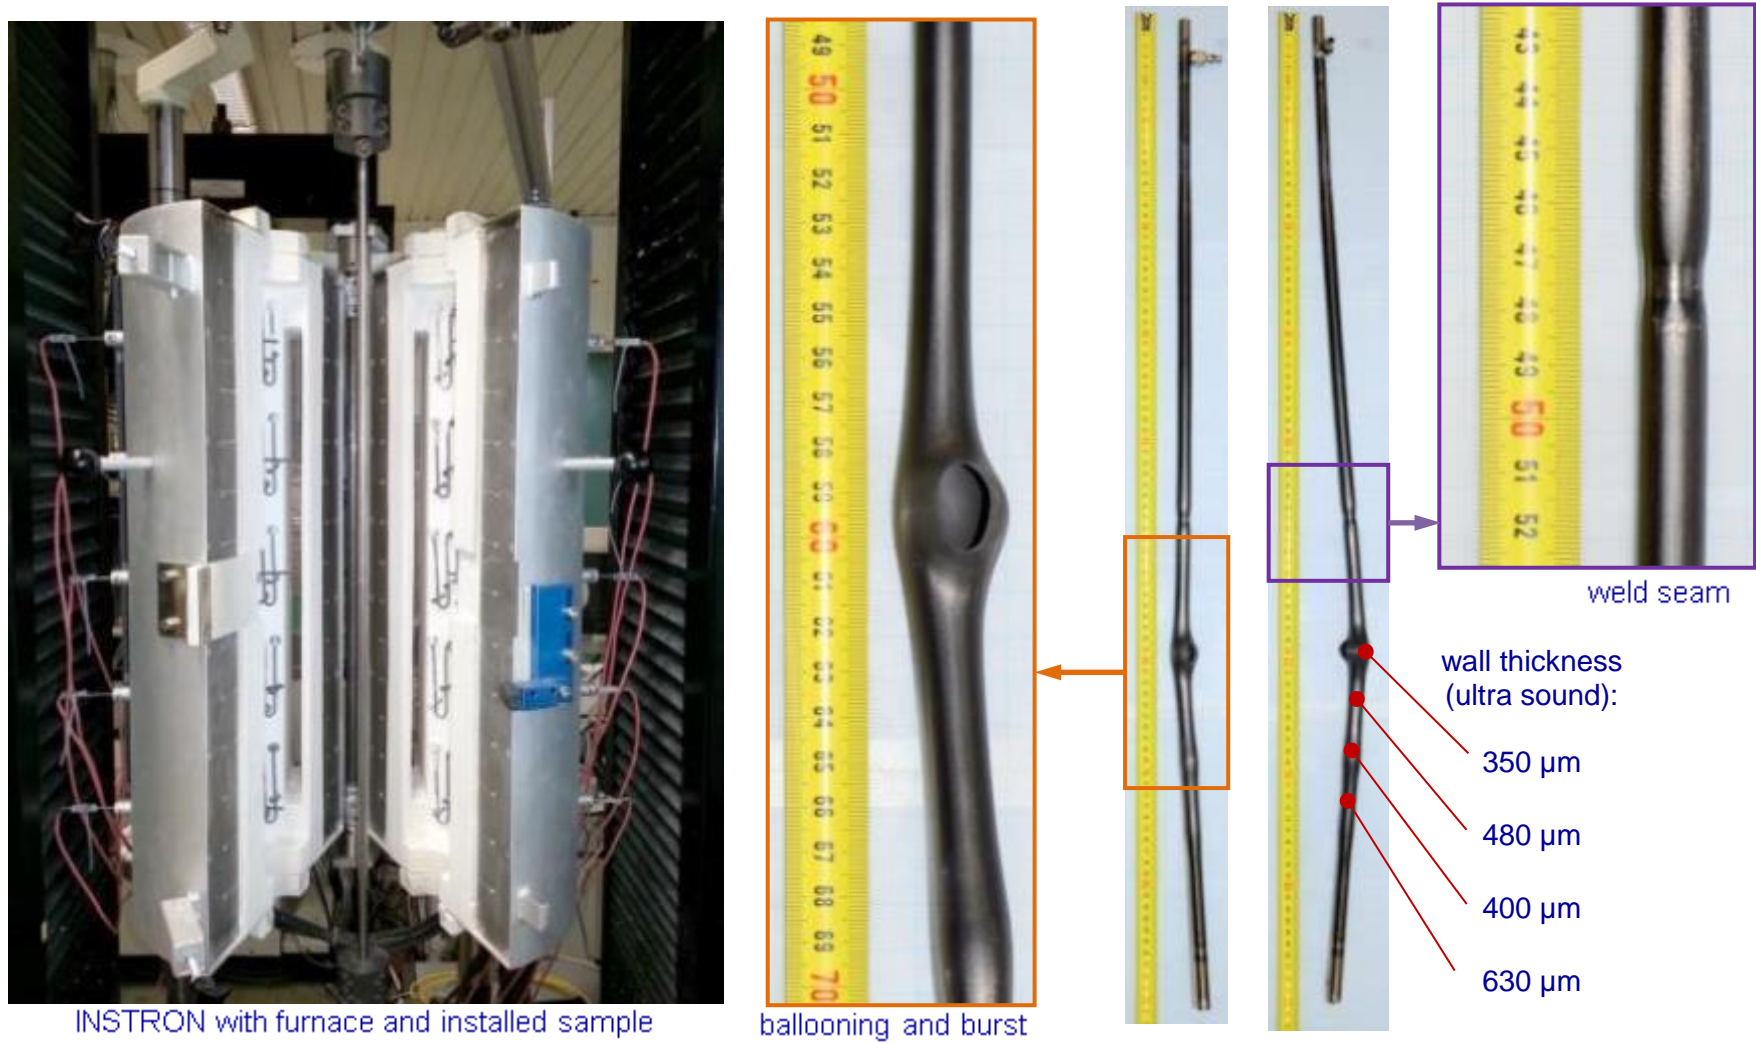
Figure 8 QUENCH-L4; Ballooning test of welded prototype cladding (both parts hydrogenated to about 100 wppm) pressurized to 55 bar; burst after 1 hour at constant $T=650\text{ }^{\circ}\text{C}$.

slightly axially loaded with tensile force of 10 N, heated to 650 °C, and pressurized with Kr to 55 bar. After 1 hour heating at constant temperature the sample was burst outside of weld position (Fig. 8). The upper part of the prototype was tested in tensile machine also at temperature of 650 °C, but with increased tensile stress and decreased inner pressure (from 55 bar to 4 bar after 1800 s holding time at temperature). The sample was fractured ductile outside of the weld seam (Fig. 9). The corresponding stress-strain curve is presented in Fig. 10. So, the tests with the prototype showed that failure of the cladding occurred outside of weld seams.

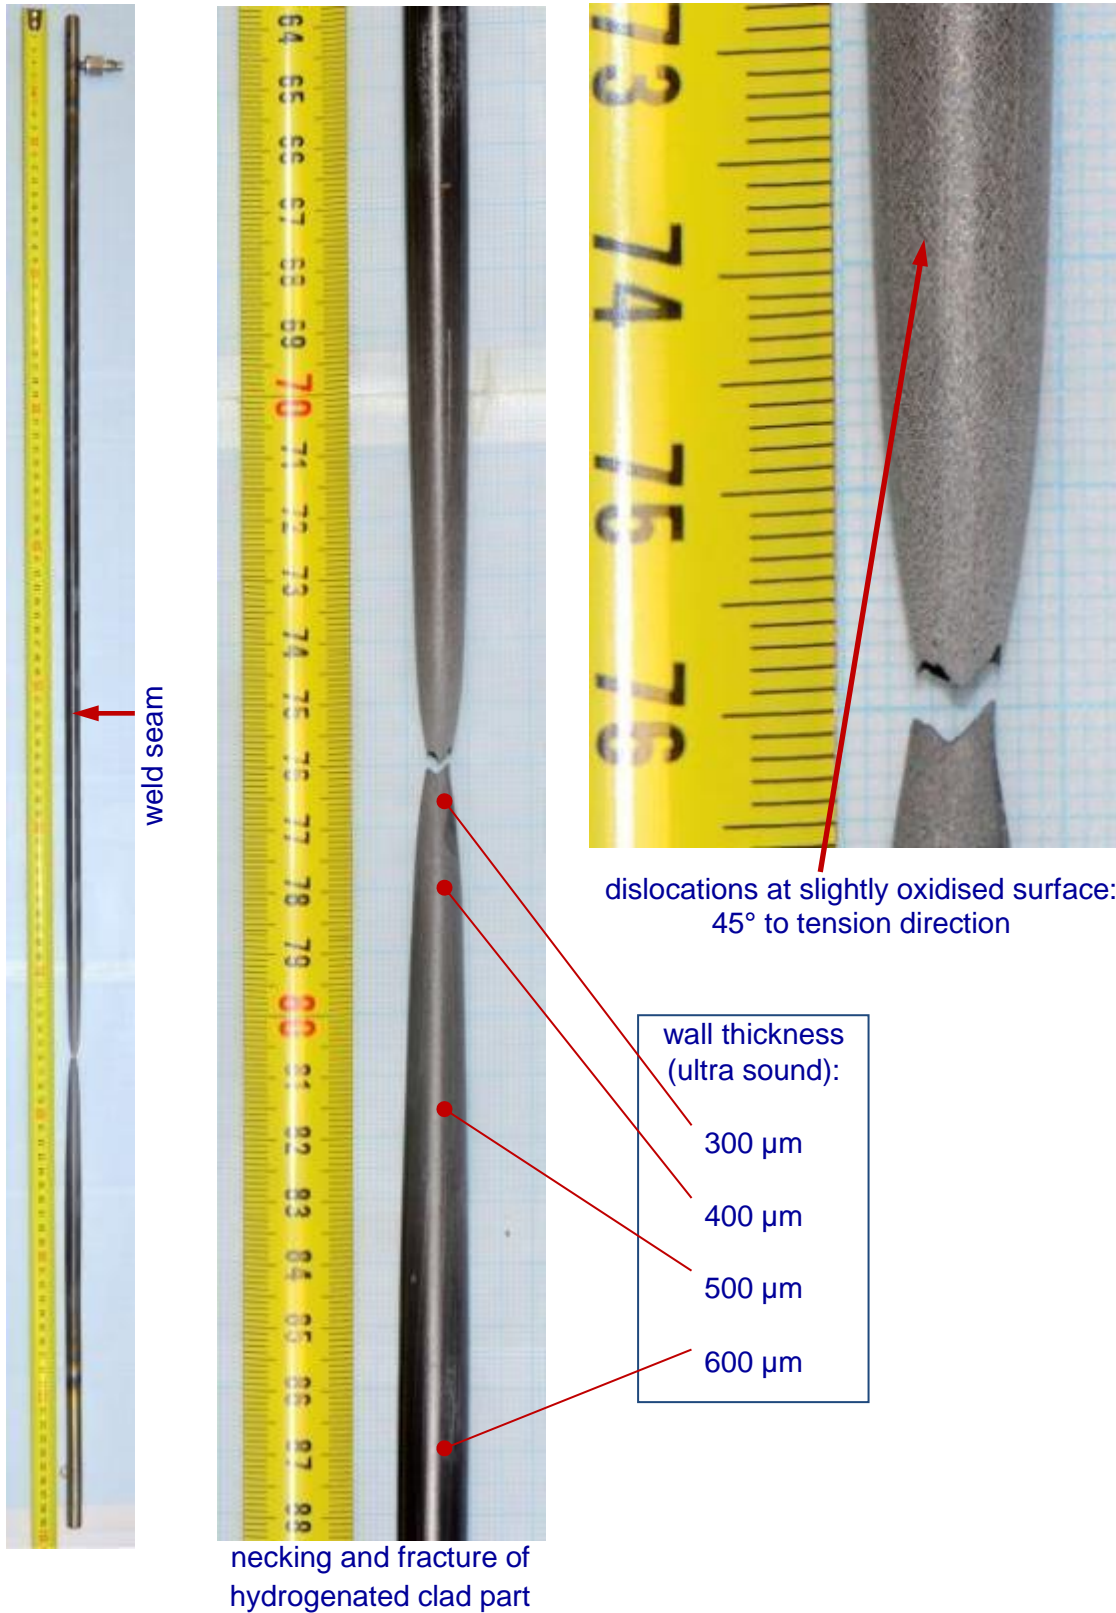
Figure 9 QUENCH-L4; Tensile test of welded prototype cladding (only lower part hydrogenated to about 100 wppm) at 650 °C; inner pressure was decreased from 55 to 4 bar after holding time of 1800 s at 650 °C.

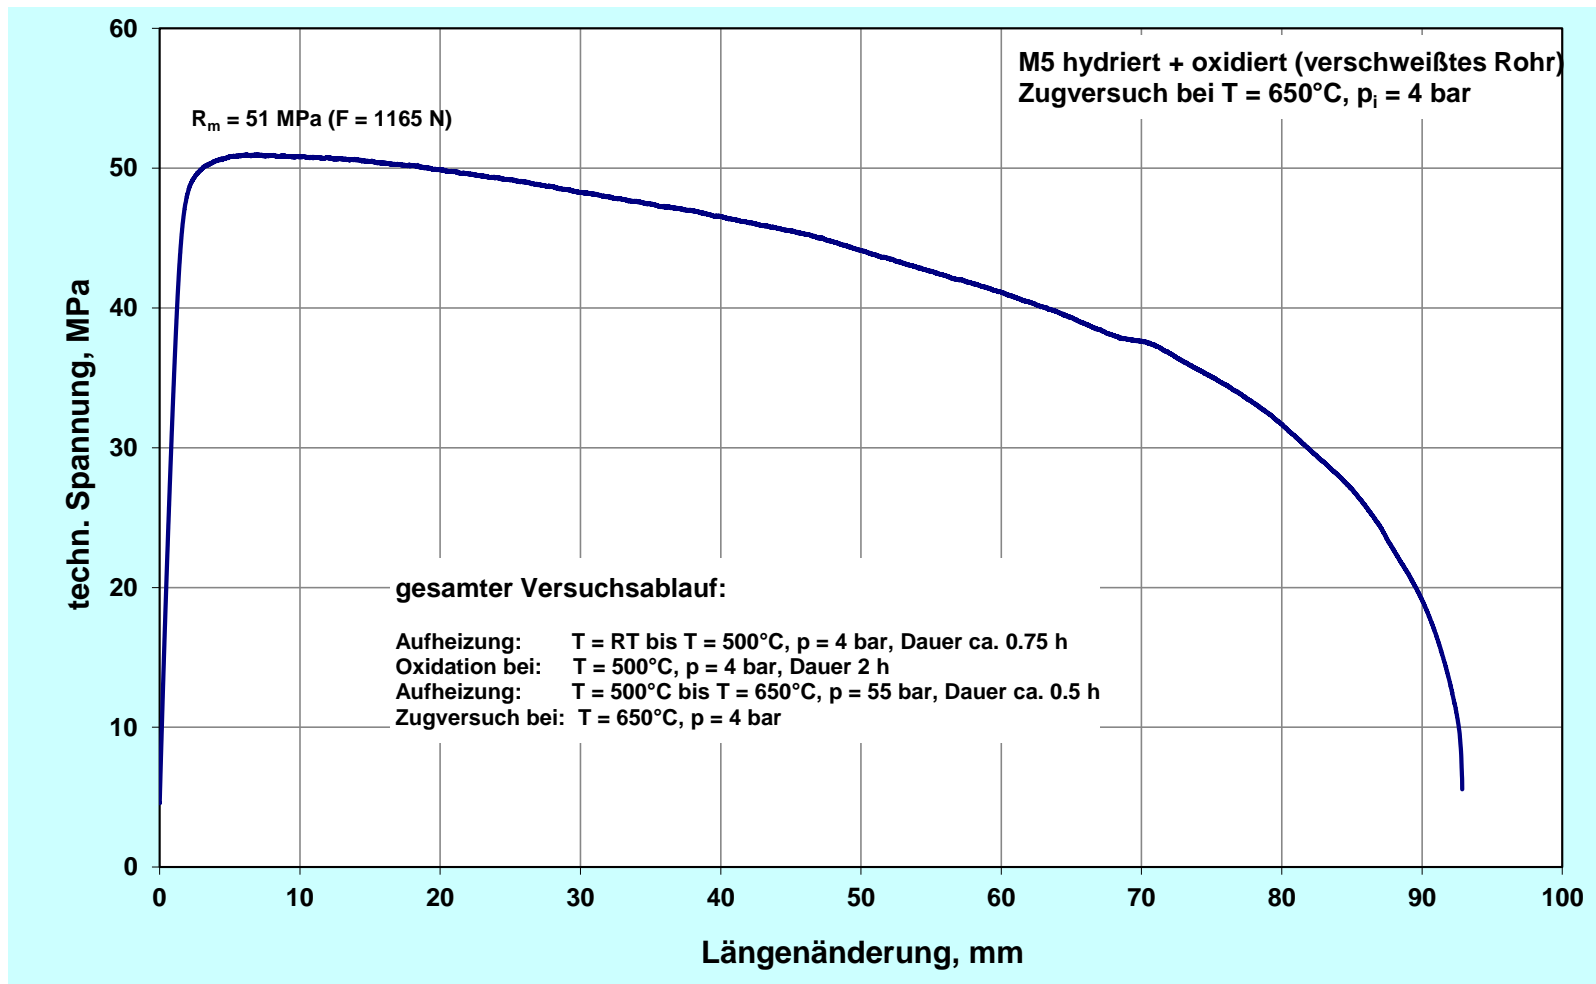
Figure 10 QUENCH-L4; Tensile diagram for prototype sample composed (welded) of hydrogenated and not hydrogenated claddings (shown in Fig. 9).

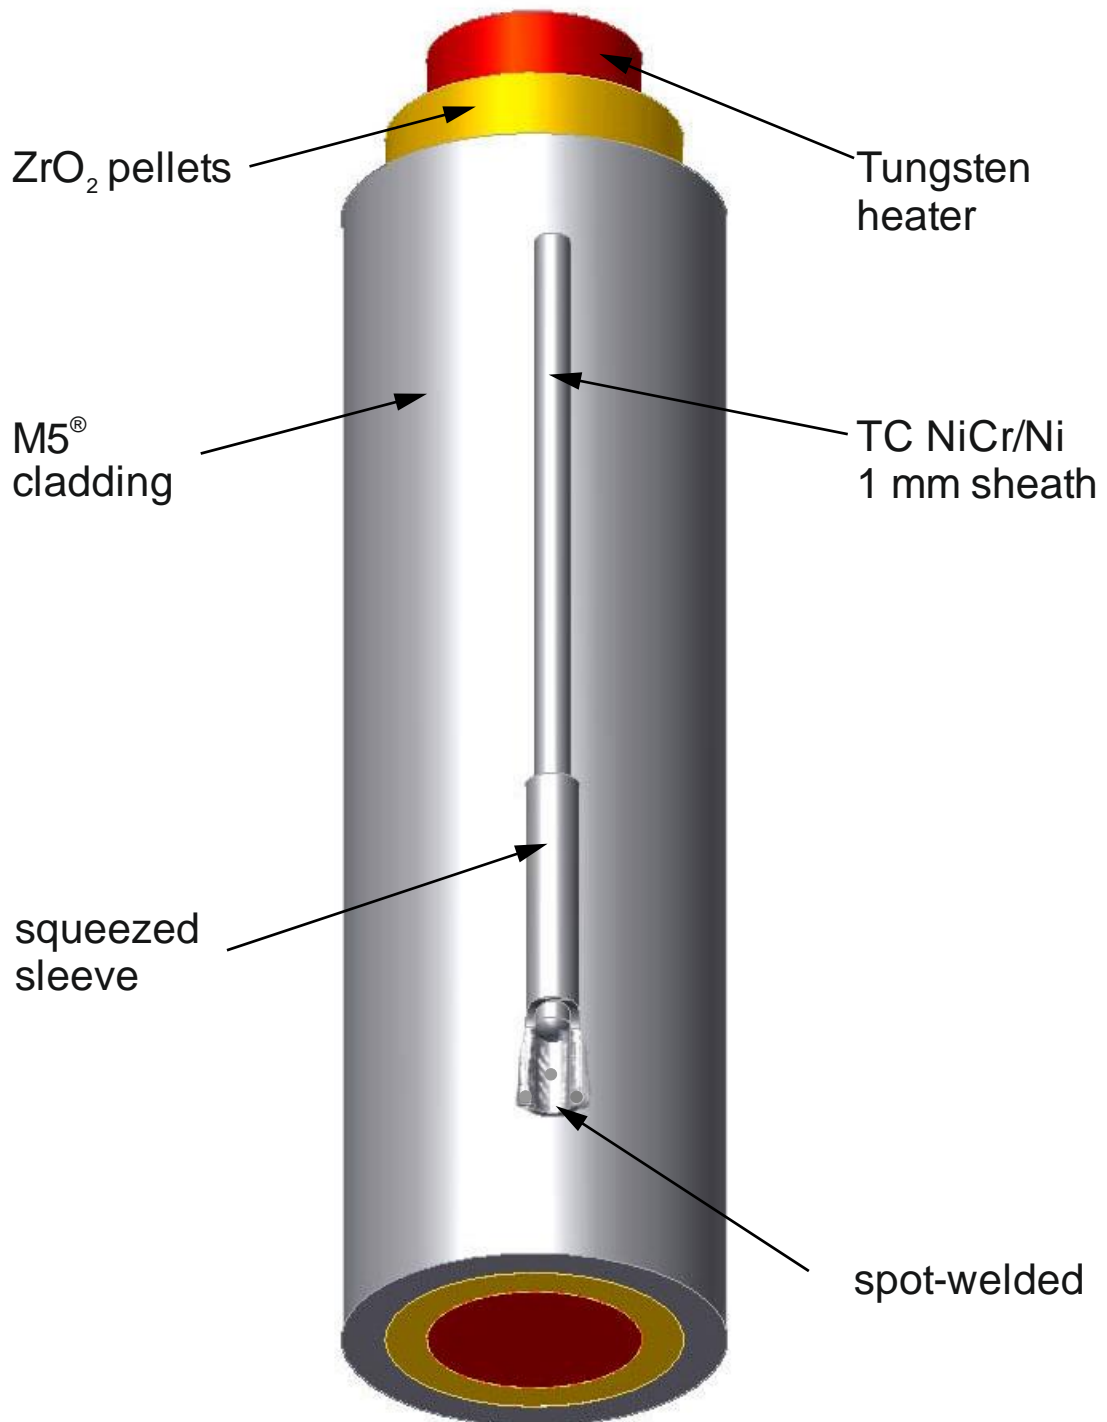
Figure 19 QUENCH-L4; Concept for TC fastening at the test rod.

The test bundle was instrumented with sheathed thermocouples (TC) attached to the rod claddings ([Fig. 19](#)) at 17 different elevations between -250 mm and 1350 mm and at different orientations according to [Figs. 20 and 21](#). The NiCr/Ni thermocouples (1 mm diameter, stainless steel sheath 1.4541 (X6CrNiTi18-10), MgO insulation) are used for temperature measurement at rod cladding and shroud outer surfaces. The TC tip is held in place by a Zr ferrule welded to the surface. The cables of the rod-thermocouples from the -250 mm to the 850 mm level leave the test section at the bottom whereas those of the TCs above 850 mm are routed out on the top of the test section to prevent TC cables passing the hot zone. For the same reason the cables of the shroud-thermocouples in this region are routed outside the insulation. The thermocouples are designated as following:

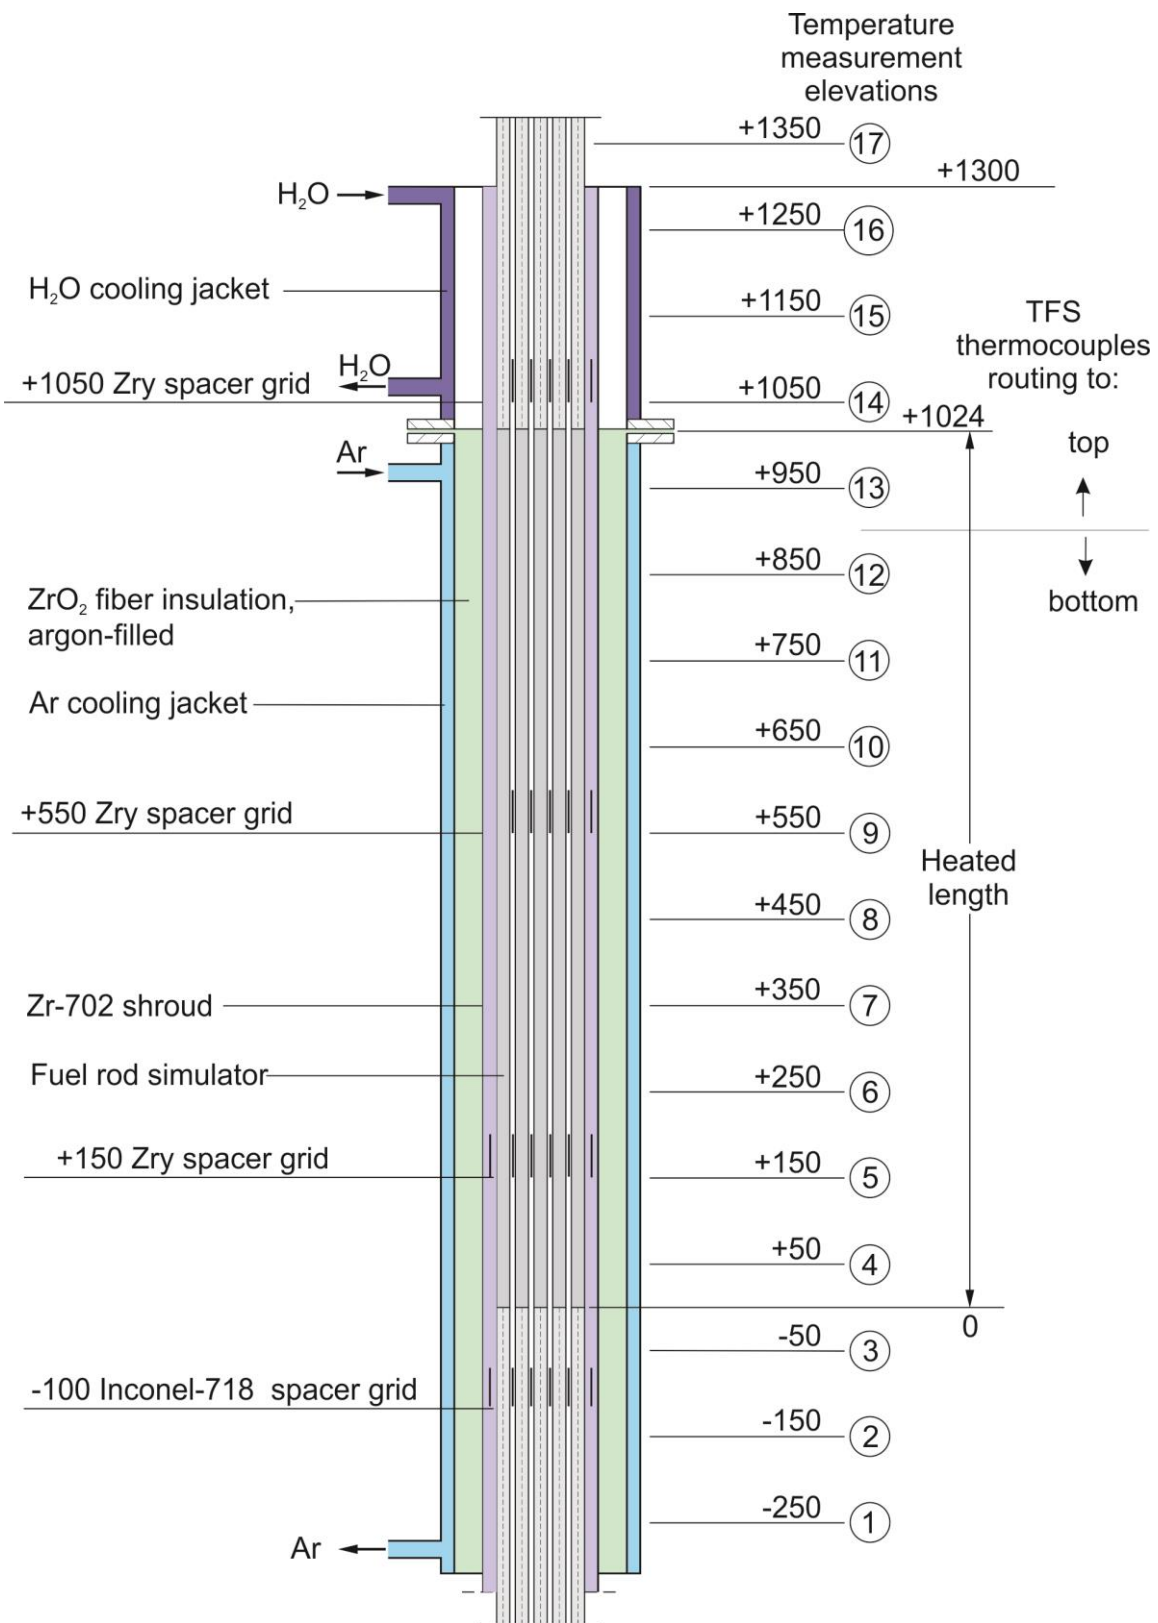
Figure 20 Axial temperature measurement locations in the QUENCH-L4 test section.

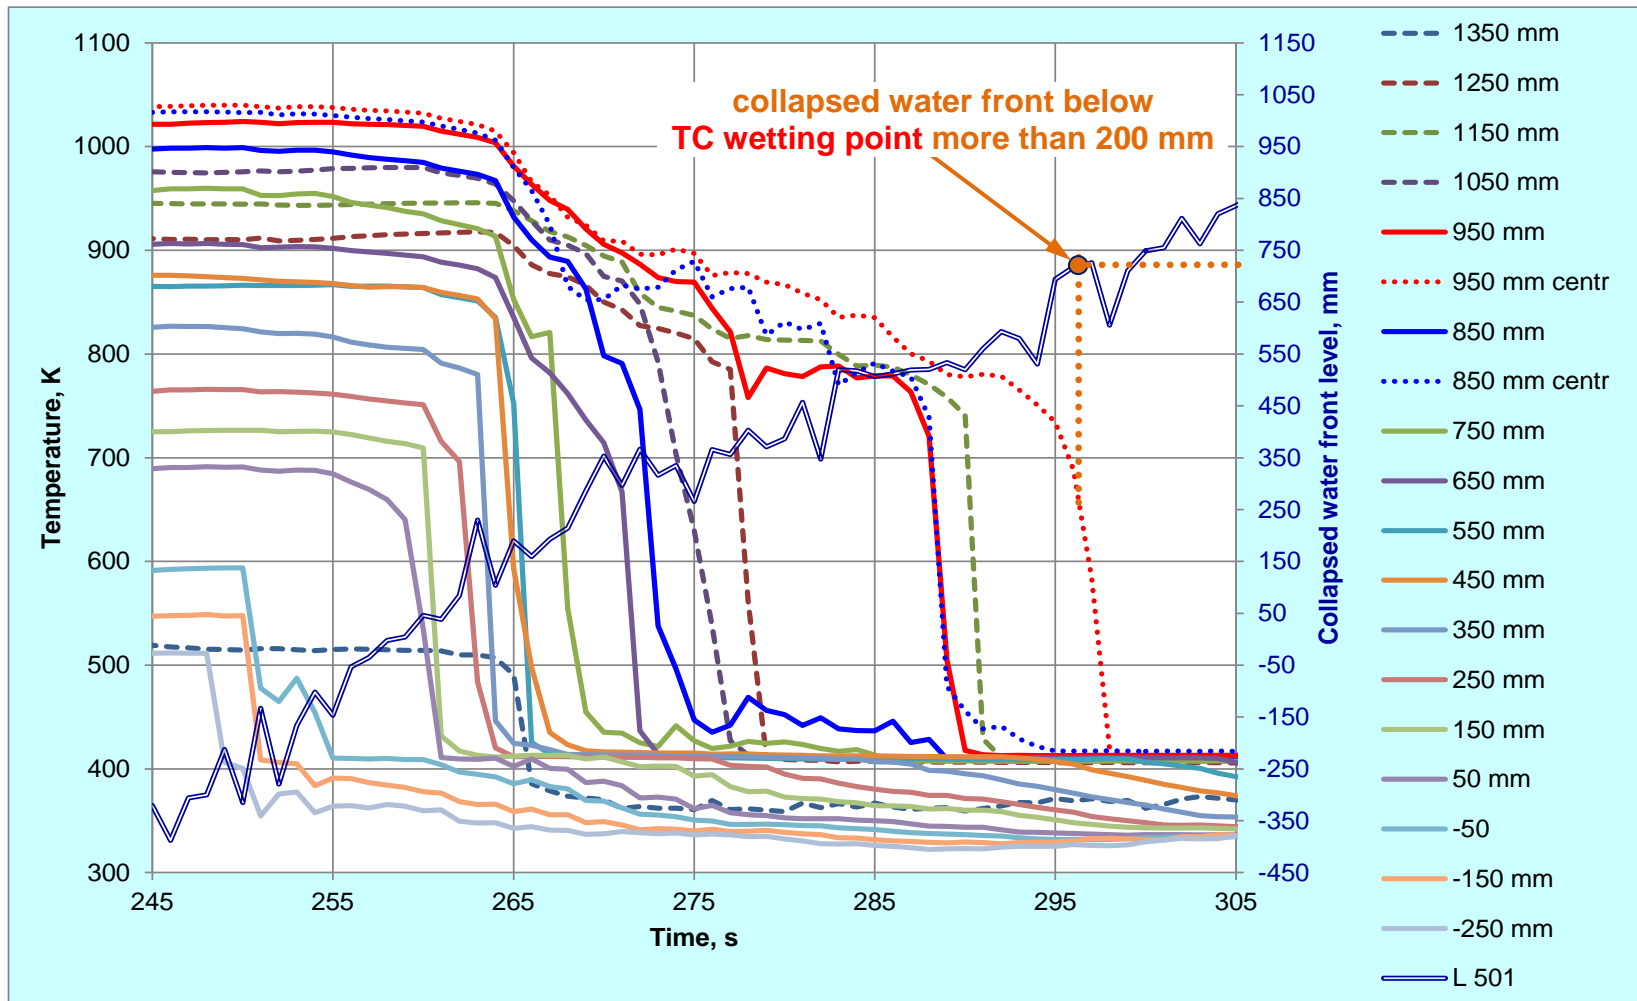
Figure 53 QUENCH-L4; Sequence of wetting of surface thermocouples for rod #7 by 2-phase fluid formed above collapsed water front (L 501).
