QUENCH - LOCA - REPORTS Nr. 5

**Results of the LOCA bundle test QUENCH-L4
with pre-hydrogenated M5[®] claddings (SR-7712)**

J. Stuckert, M. Große, A. Pshenichnikov , C. Rössger,
M. Steinbrück, M. Walter

Karlsruher Institut für Technologie

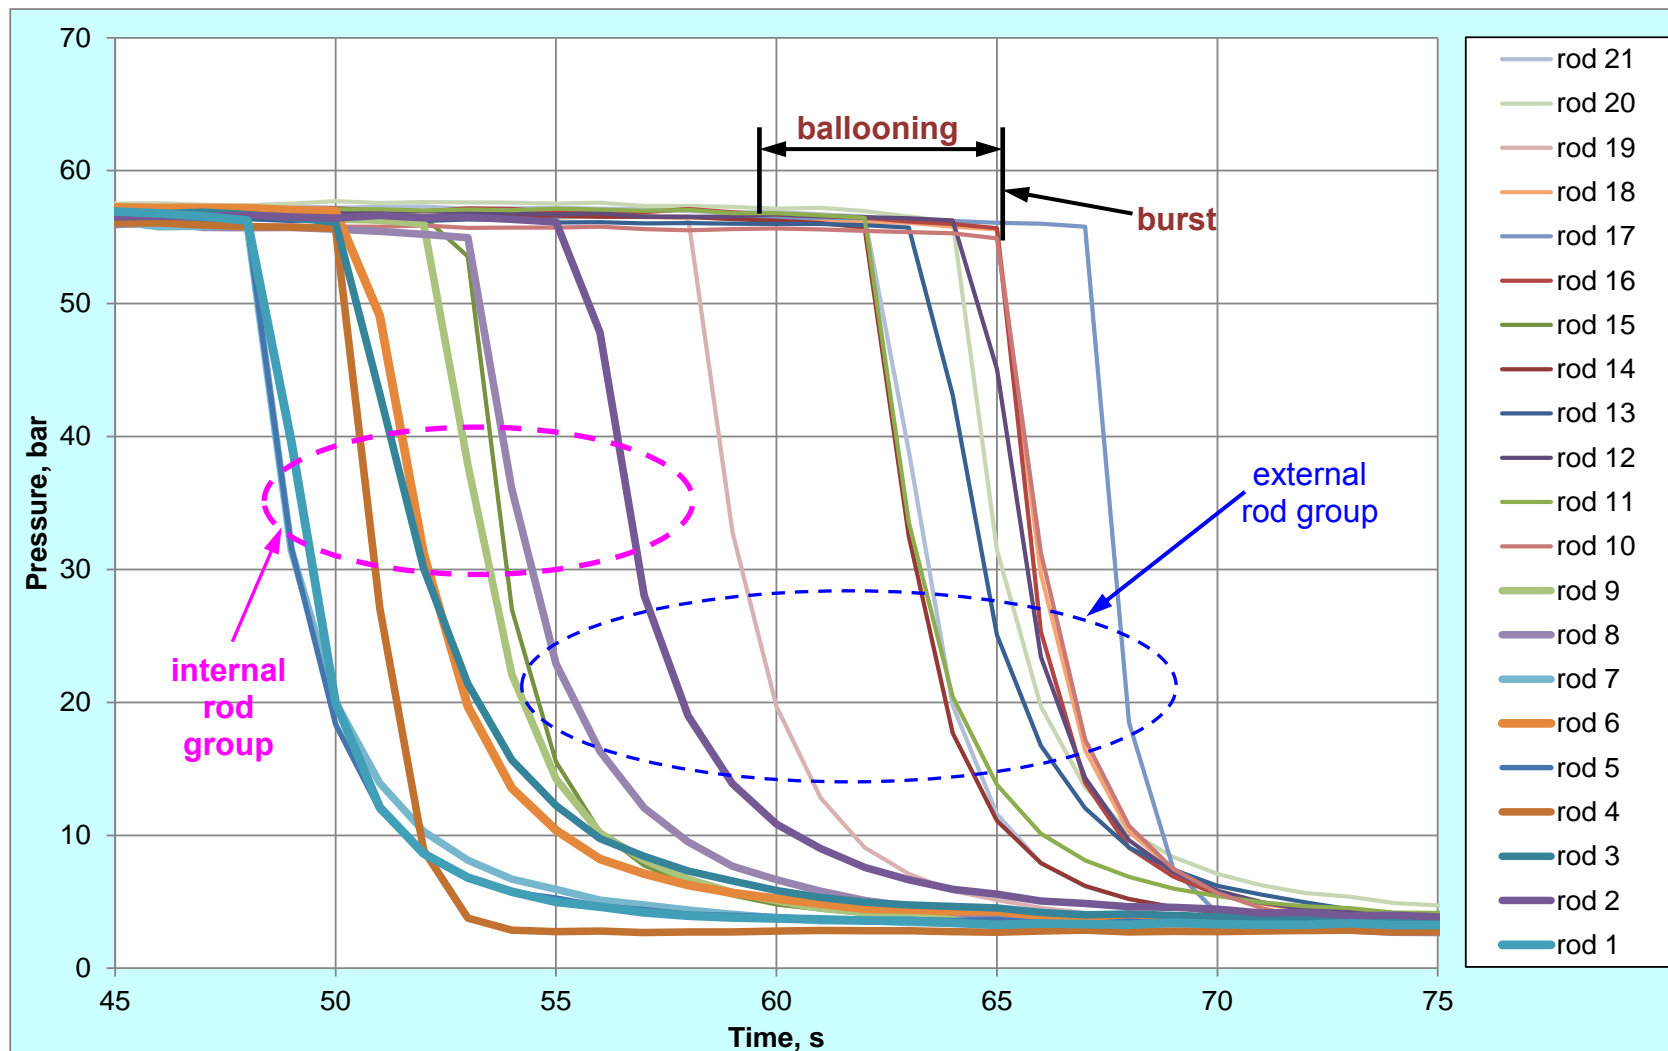
Figure 58 QUENCH-L4; Pressure change during the heating phase, cladding ballooning and burst.

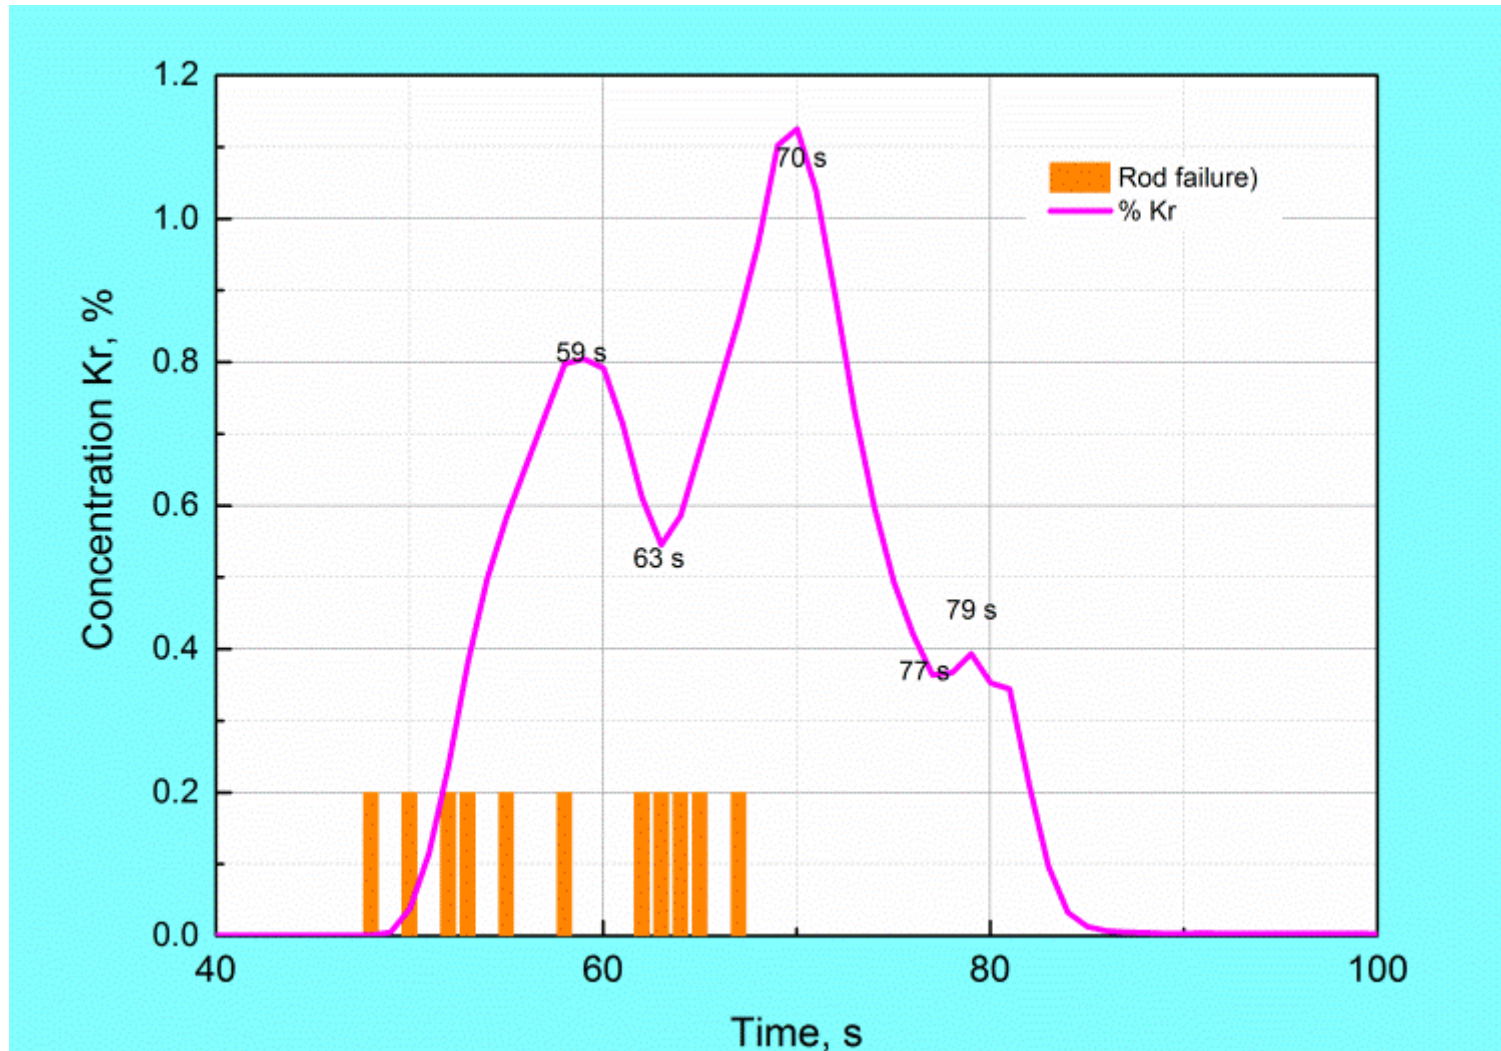
Figure 59 QUENCH-L4; Mass spectrometer measurements: krypton as burst indicator.

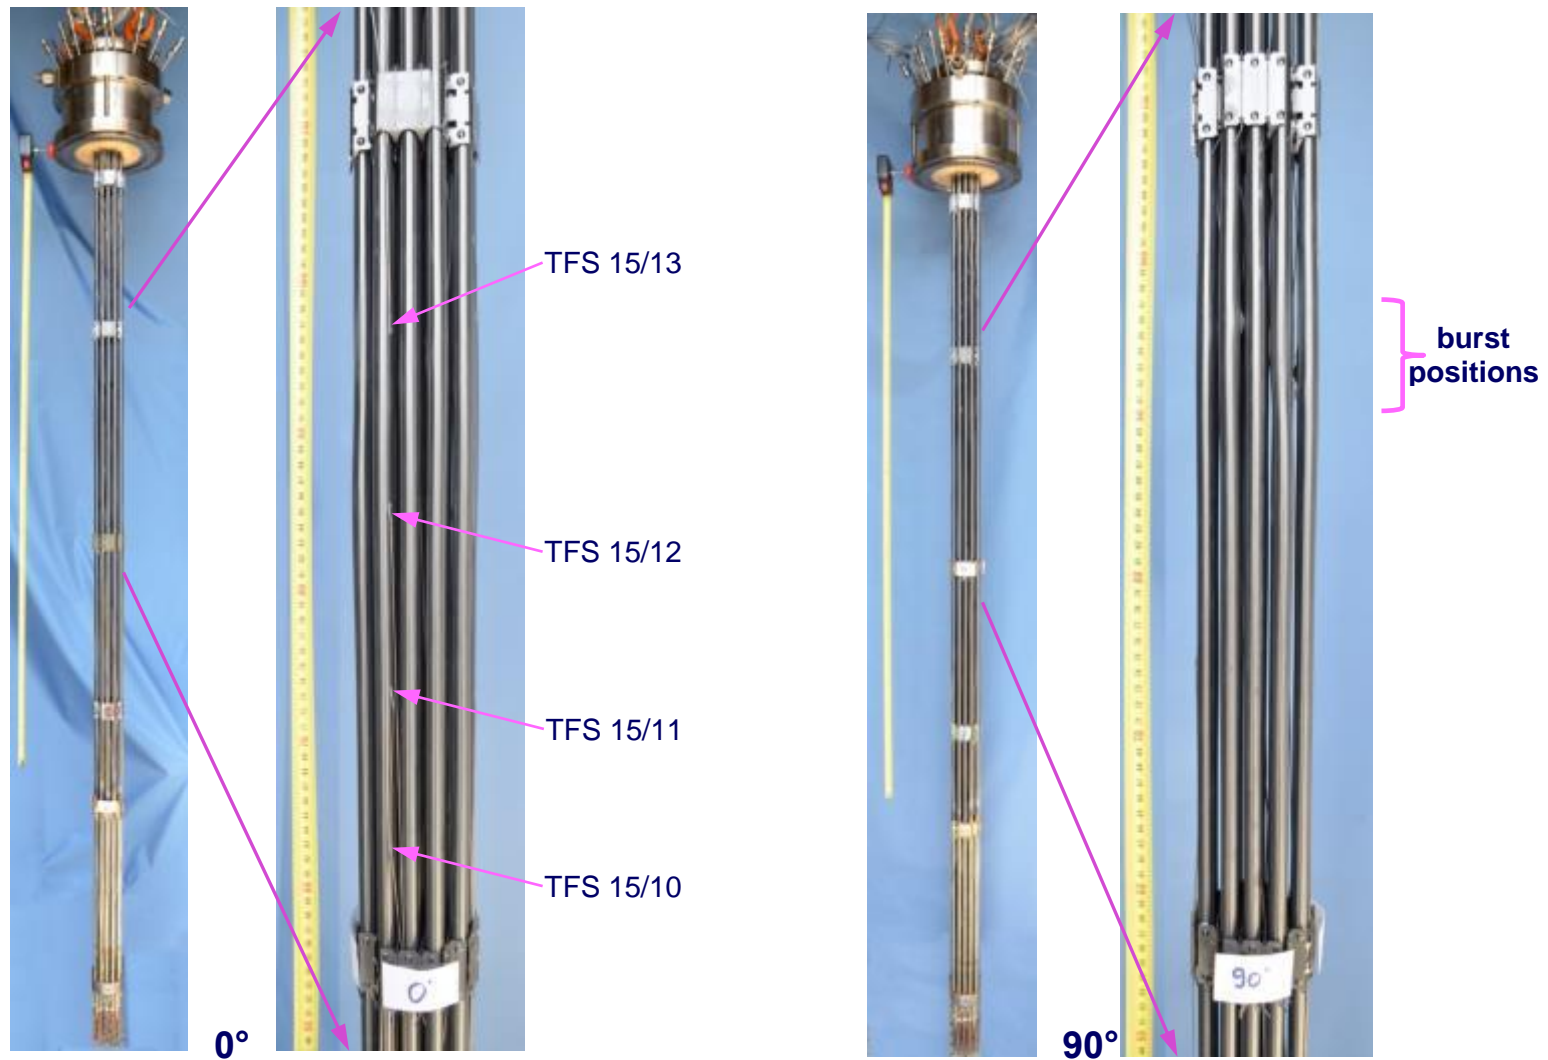
Figure 65 QUENCH-L4; Views of bundle at angle positions of 0° and 90°: negligible rod bending and intact thermocouples.

The bundle was withdrawn from the shroud for further investigations. No noticeable changes of bundle geometry were indicated (Figs. 65 and 66). Grid spacers were removed for the separation of the single rods. The surface of the claddings is mostly shining black, only the regions around the burst openings are matte black (Figs. 67 and 68) due to surface micro cracks (Fig. 79) formed during ballooning. No rod bending was observed in the plane with overhead view to burst opening. For the plane with the side view of openings only negligible rod bending was observed for the inner rods (Fig. 69) and some of the outer rods (Fig. 70) with values less of 3 mm deviation from original rod axis.

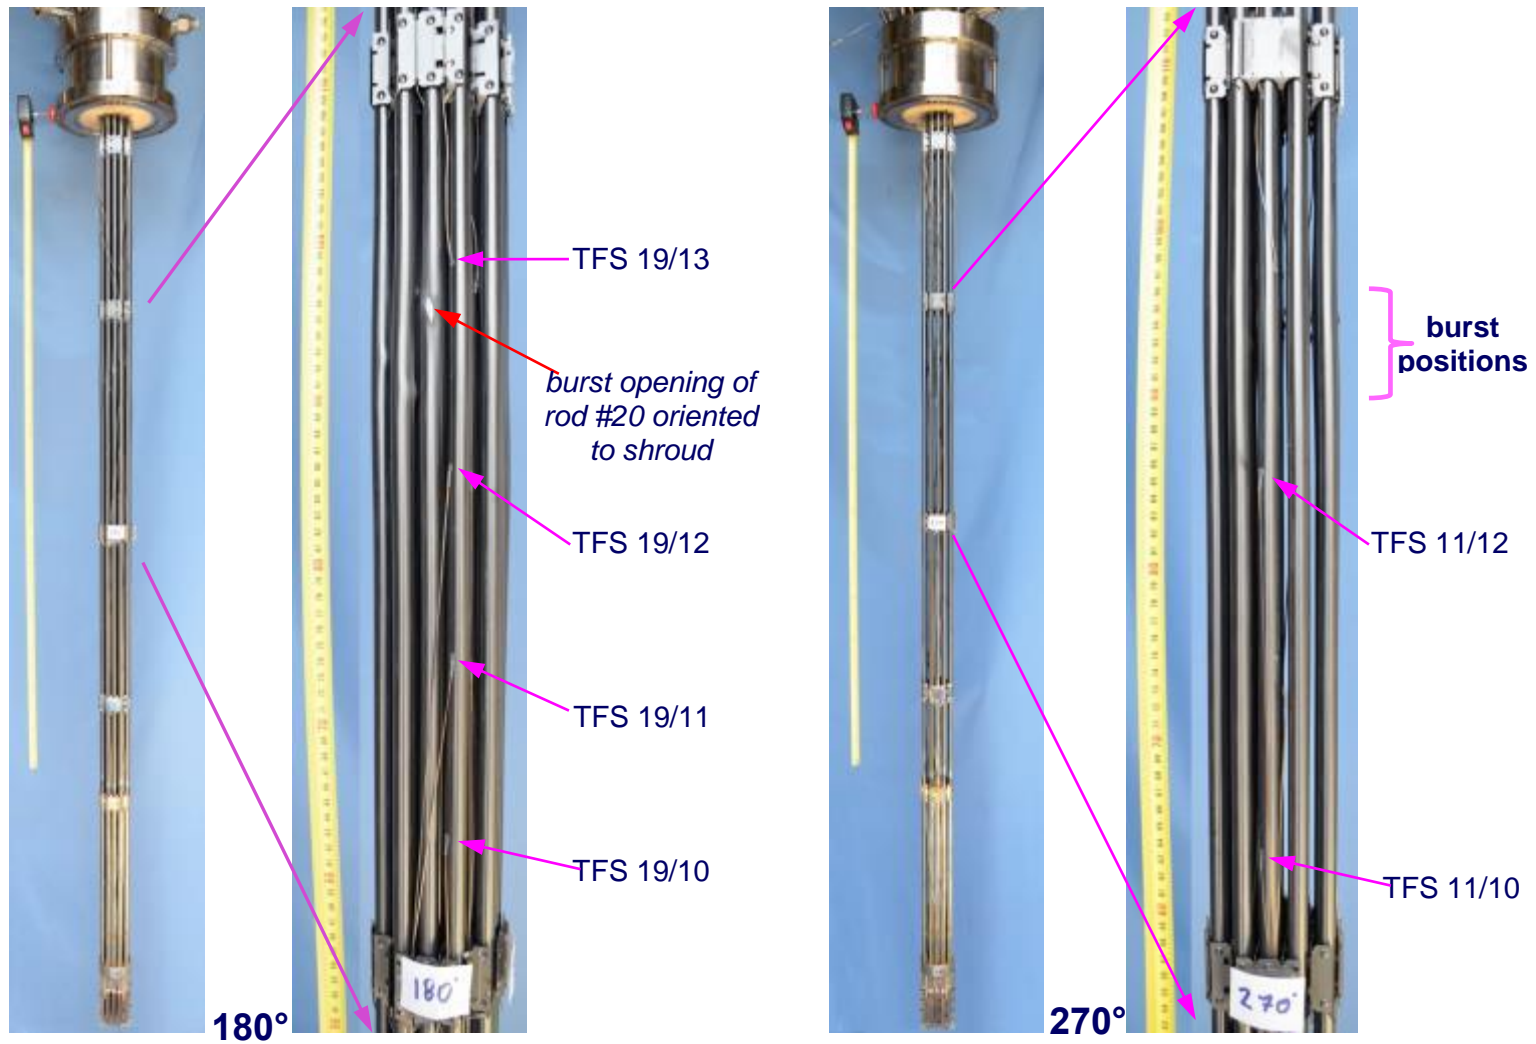
Figure 66 QUENCH-L4; Views of bundle at angle positions of 180° and 270°: negligible rod bending and intact thermocouples.

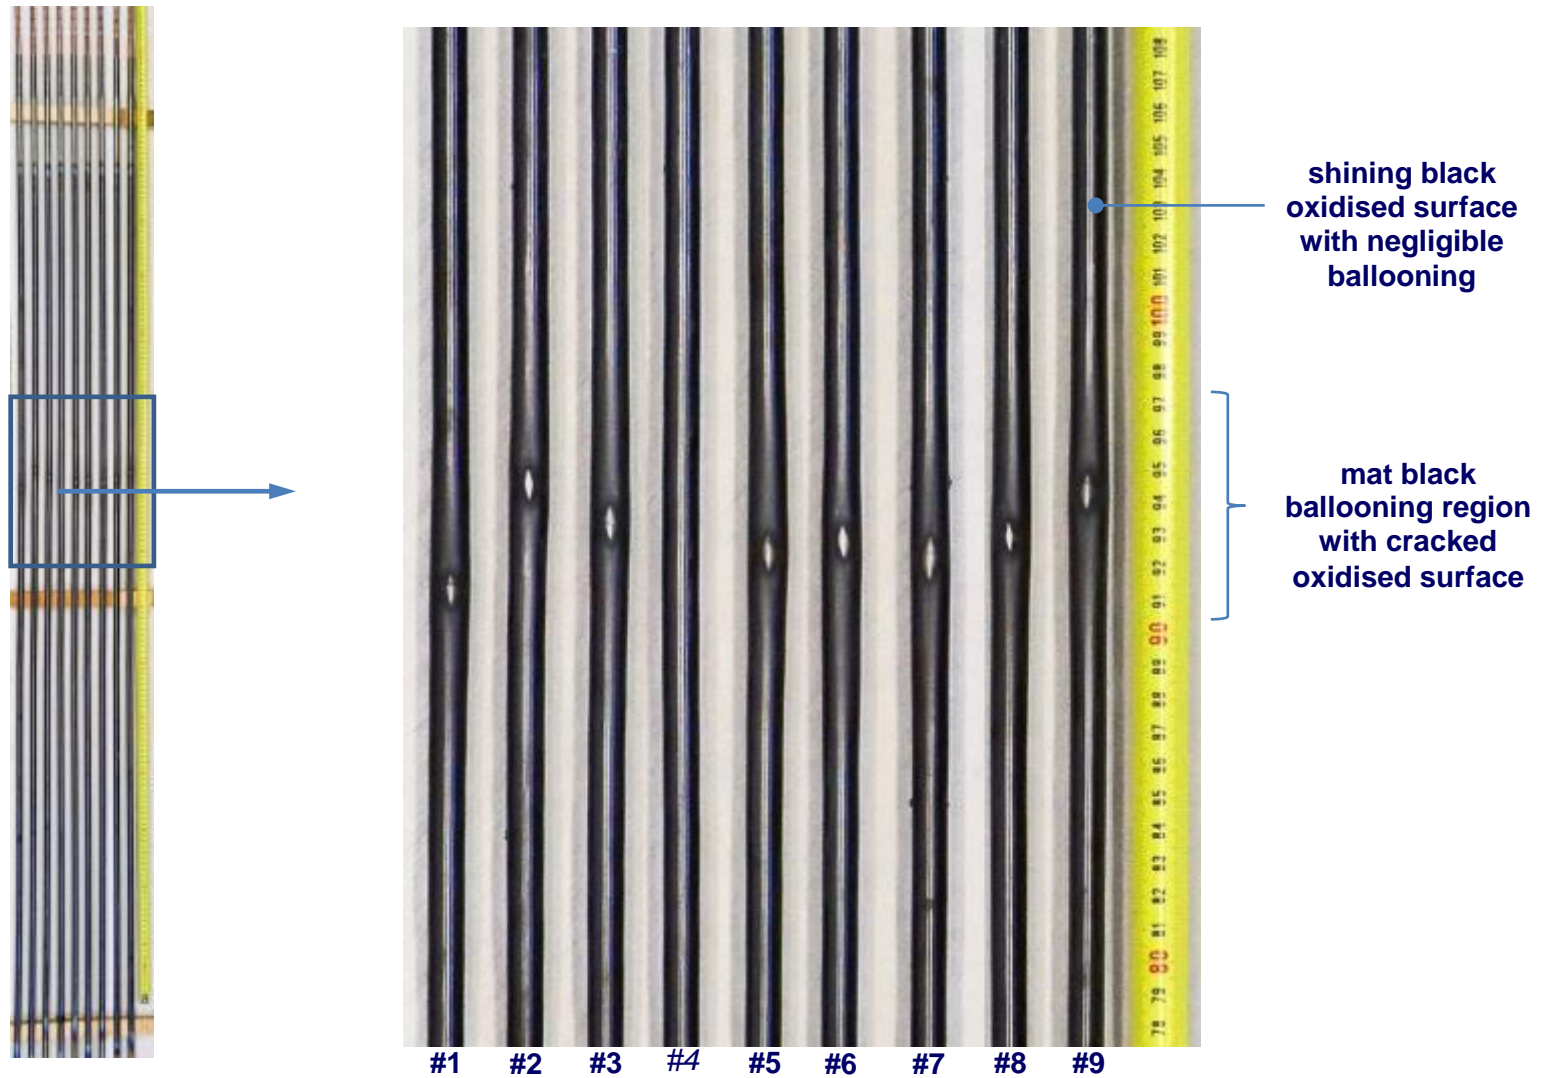
Figure 67 QUENCH-L4; Post-test overview of inner rods: no bending, localized ballooning region.

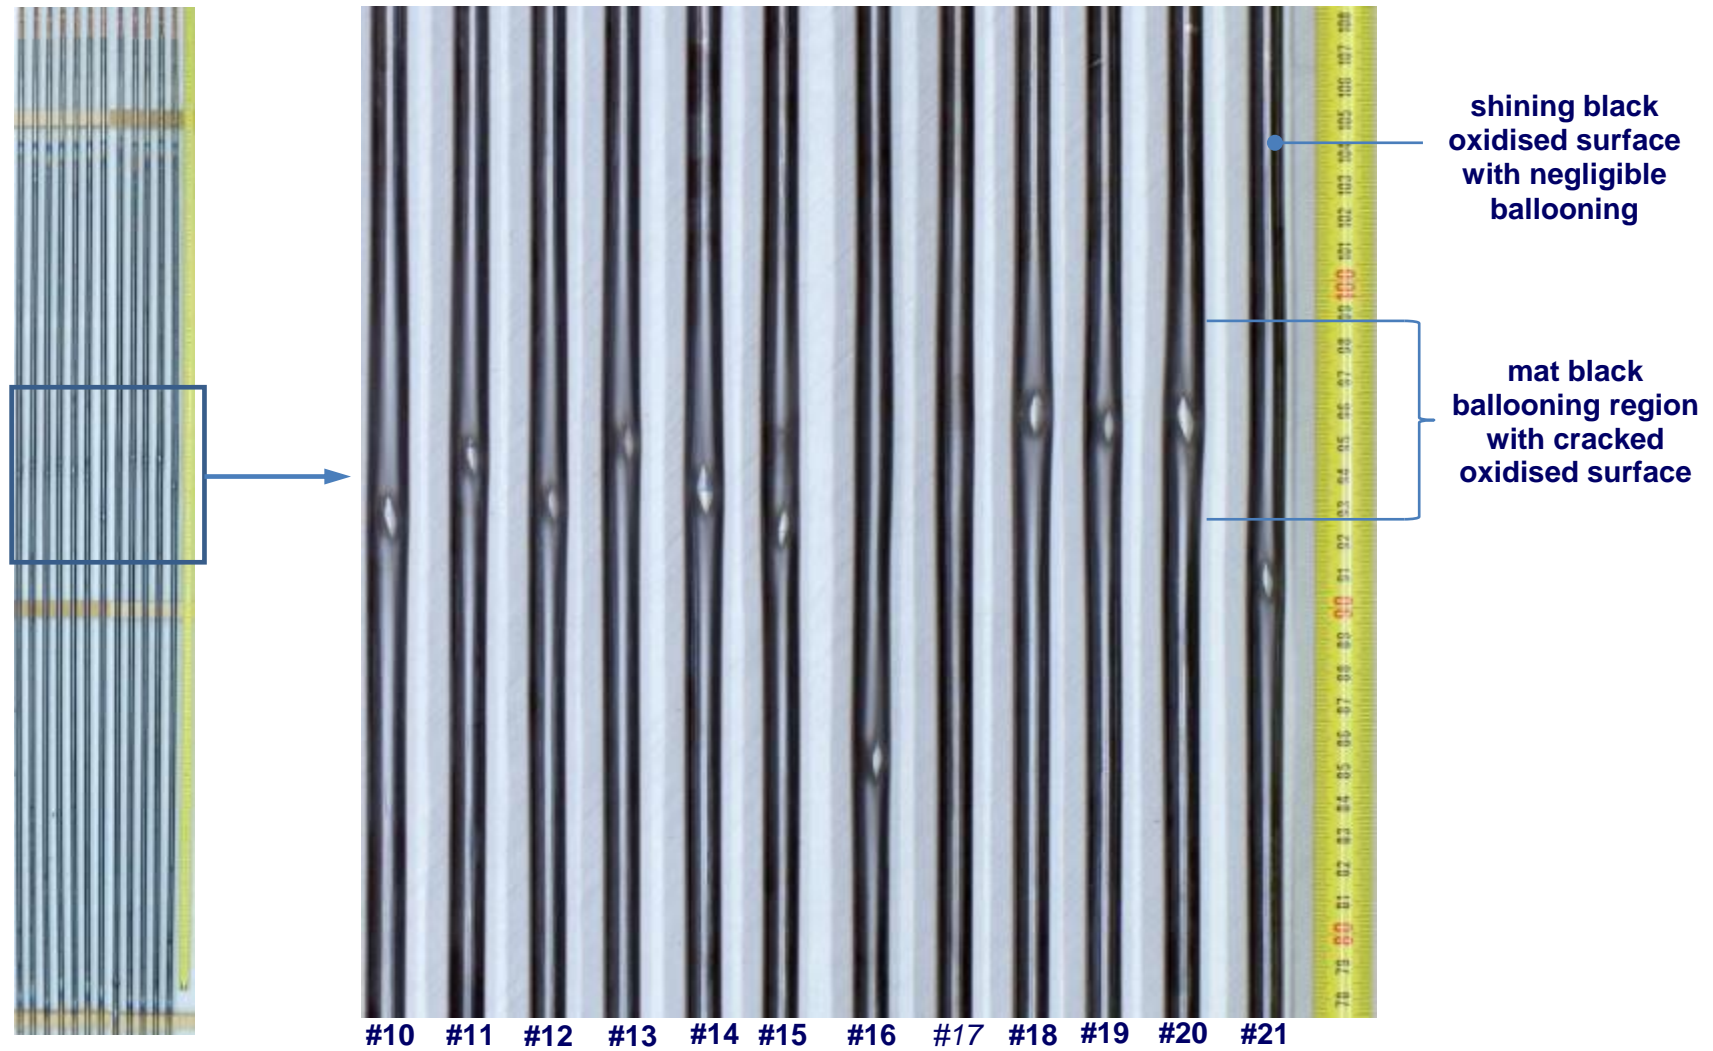
Figure 68 QUENCH-L4; Post-test overview of outer rods: no bending, localized ballooning region.

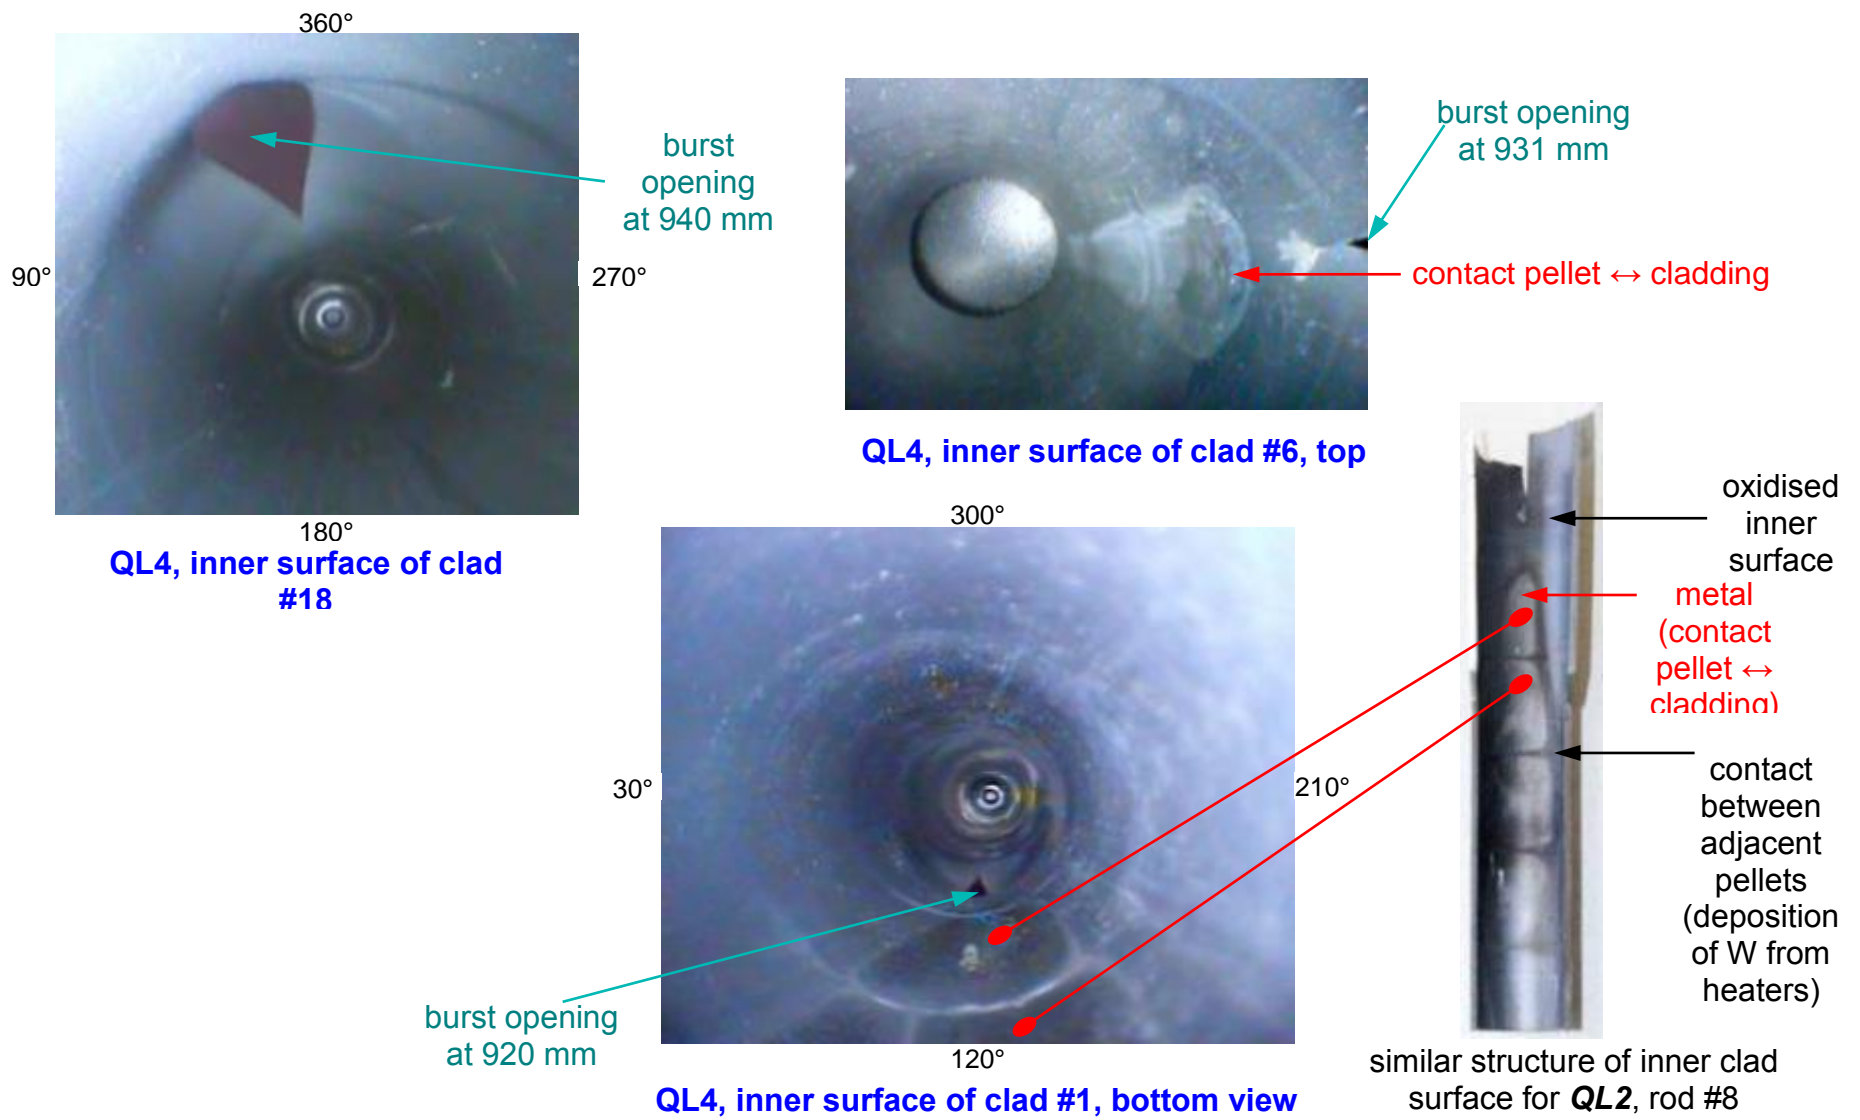
Figure 80 QUENCH-L4; Videoscope observations of cladding inner surface.

The inner surface of three claddings was investigated by videoscope (Fig. 80). For two claddings typical traces of contact between pellet and cladding slightly below the burst opening were observed. Similar observations were made previously also for some claddings of the QUENCH-L2 bundle and confirmed the early suggestions [4] that relatively often the burst occurs at the position of contact between pellet and cladding. Due to absence of the gas gap, the heat transport from pellet to cladding is at this circumferential position the highest. Concerning the gas penetration to these contact spots, the corresponding surface areas were not oxidised because access of steam was not possible to this area. Because the metal in these areas is not covered by oxide layer, the hydrogen, which has a higher diffusivity than steam penetrating very narrow gaps, can be absorbed at these contacts between pellet and claddings.

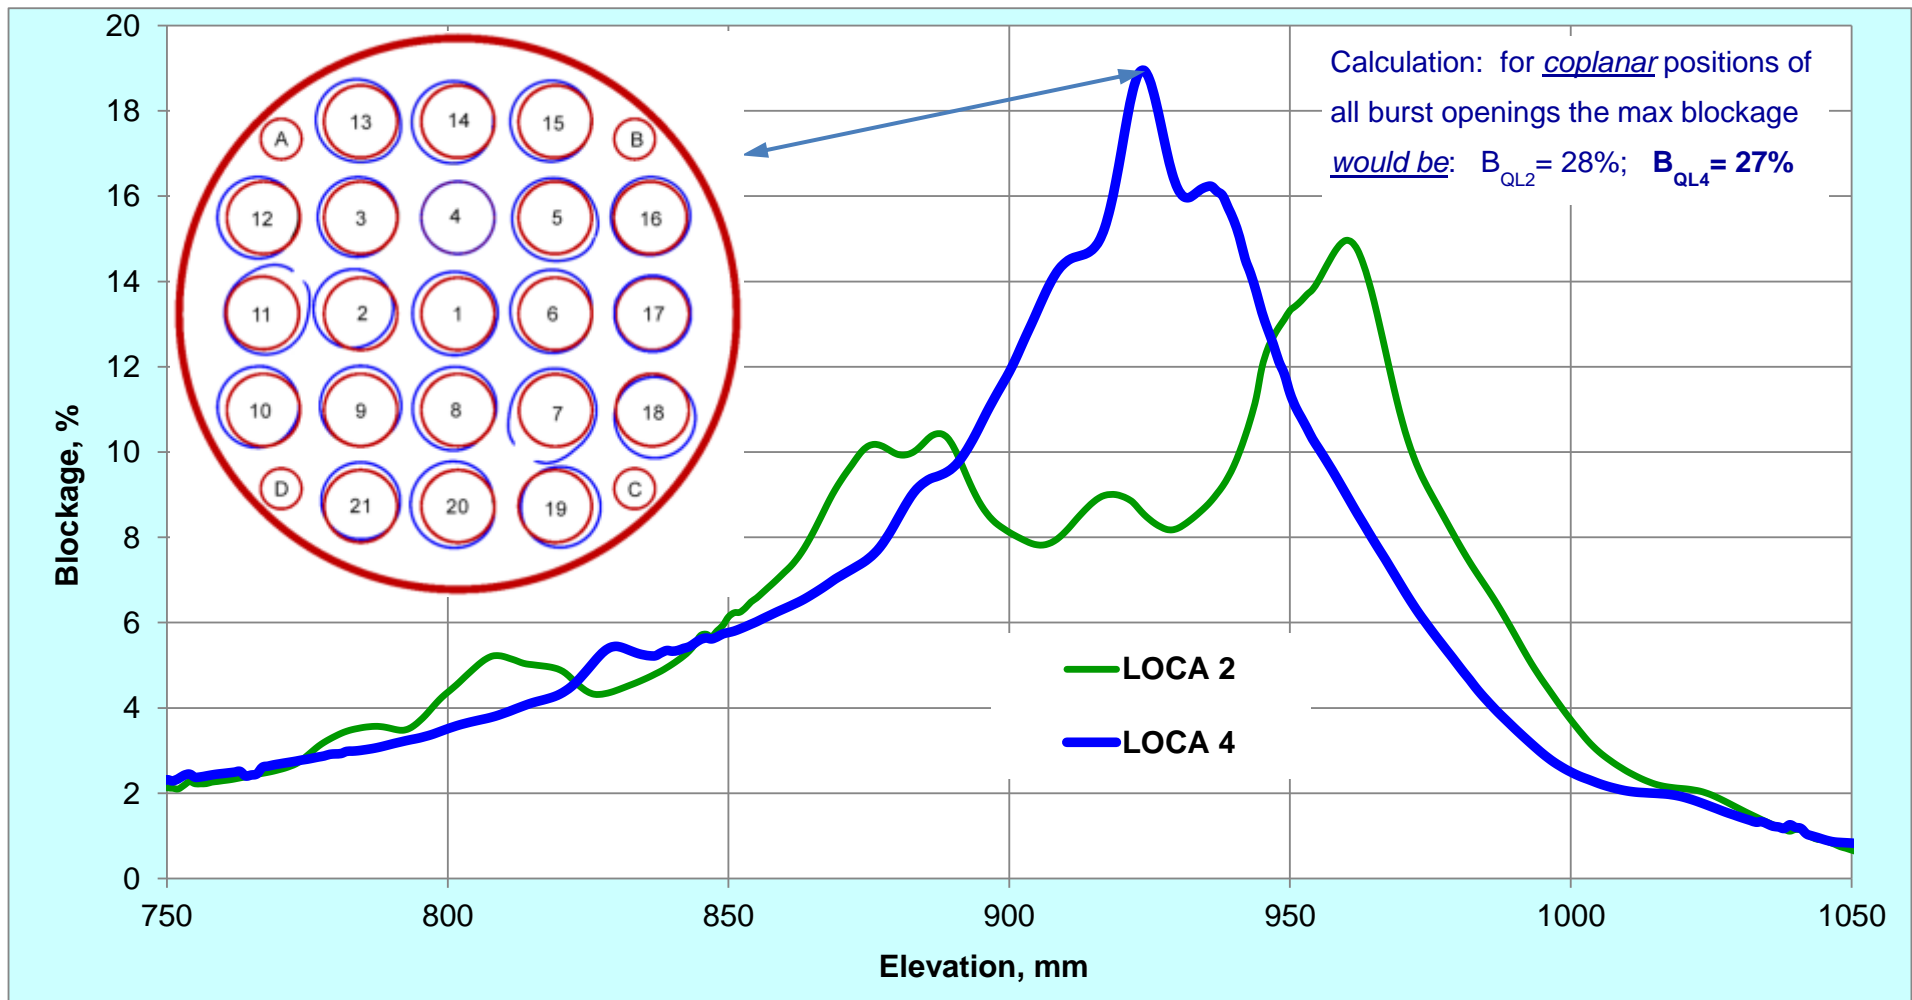
Figure 104 Axial distribution of coolant channel blockage for QUENCH-L2 and -L4 bundles. Cross section of QUENCH-L4 bundle corresponds to the bundle elevation 924 mm with a maximal blockage of 19% (blue lines - ballooned claddings; red lines - original claddings)

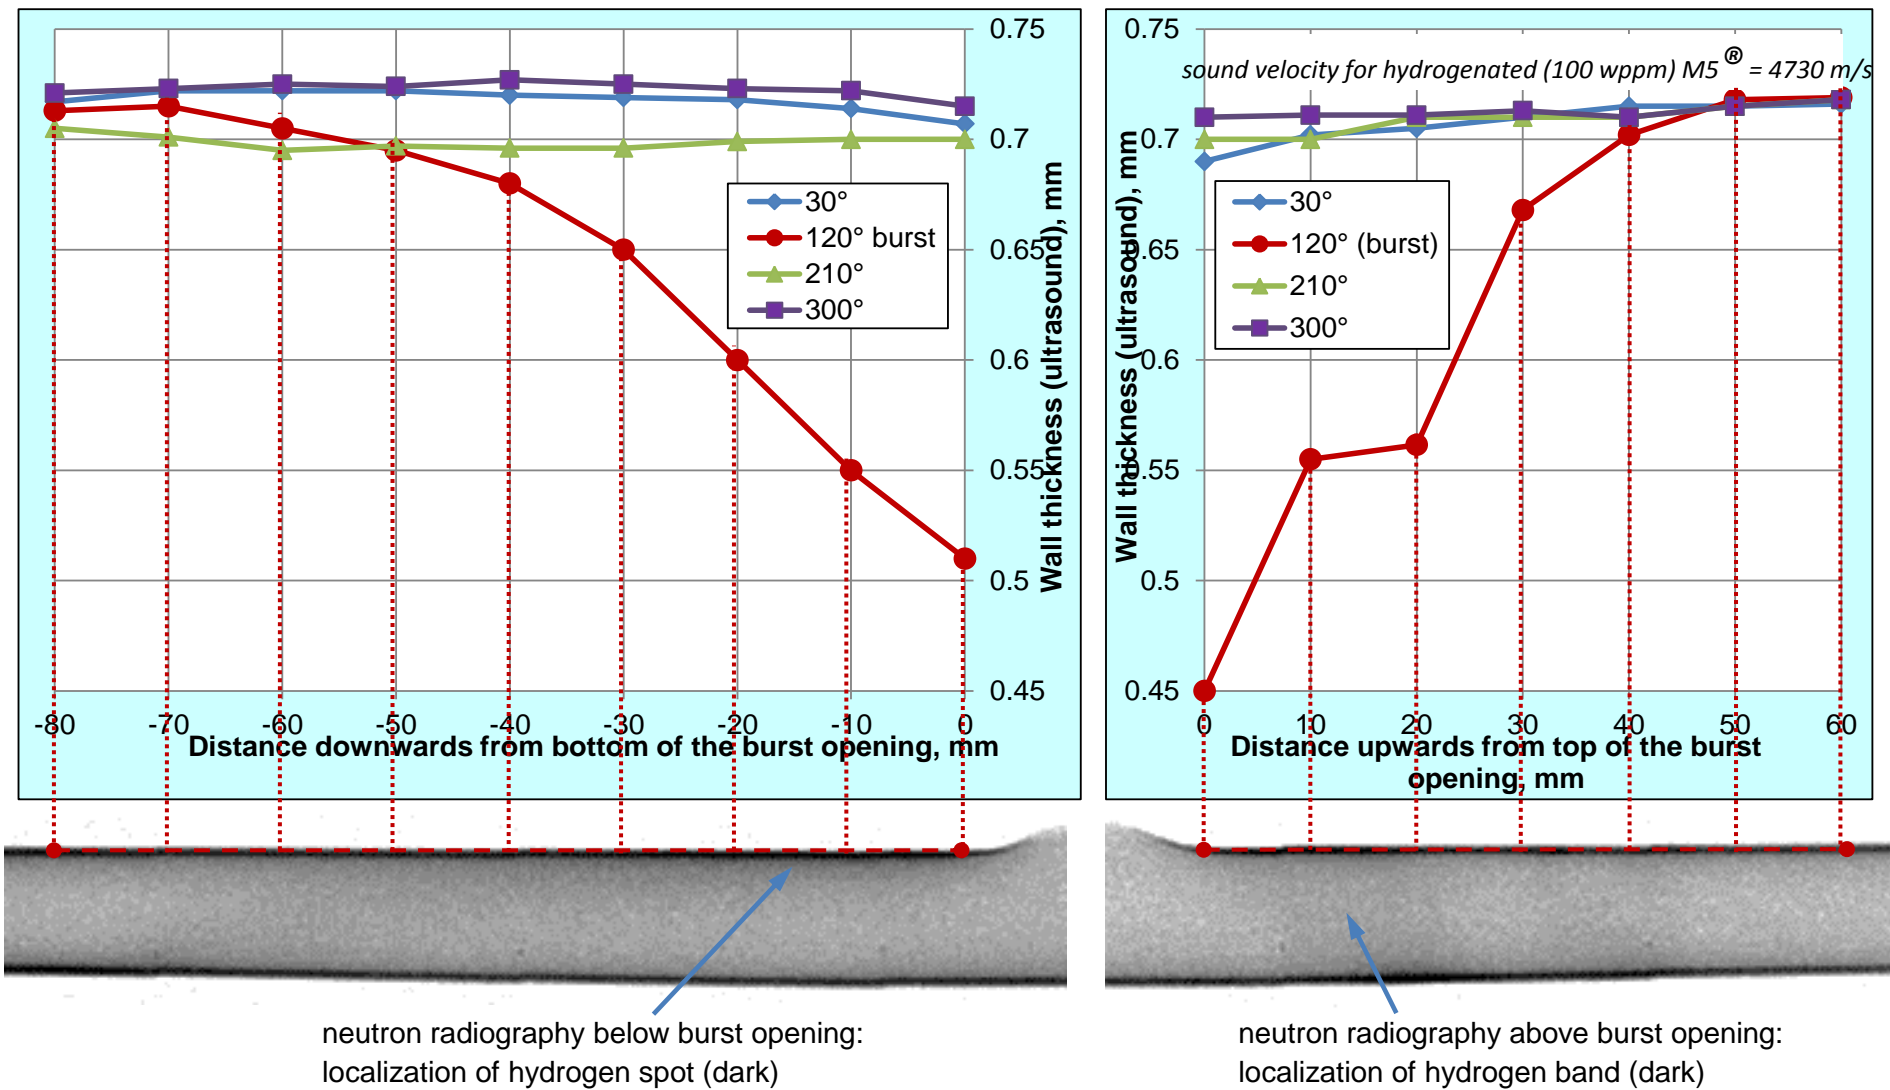
Figure 105 QUENCH-L4; Ultrasound measurement of wall thickness for rod #1 below and above the burst opening.

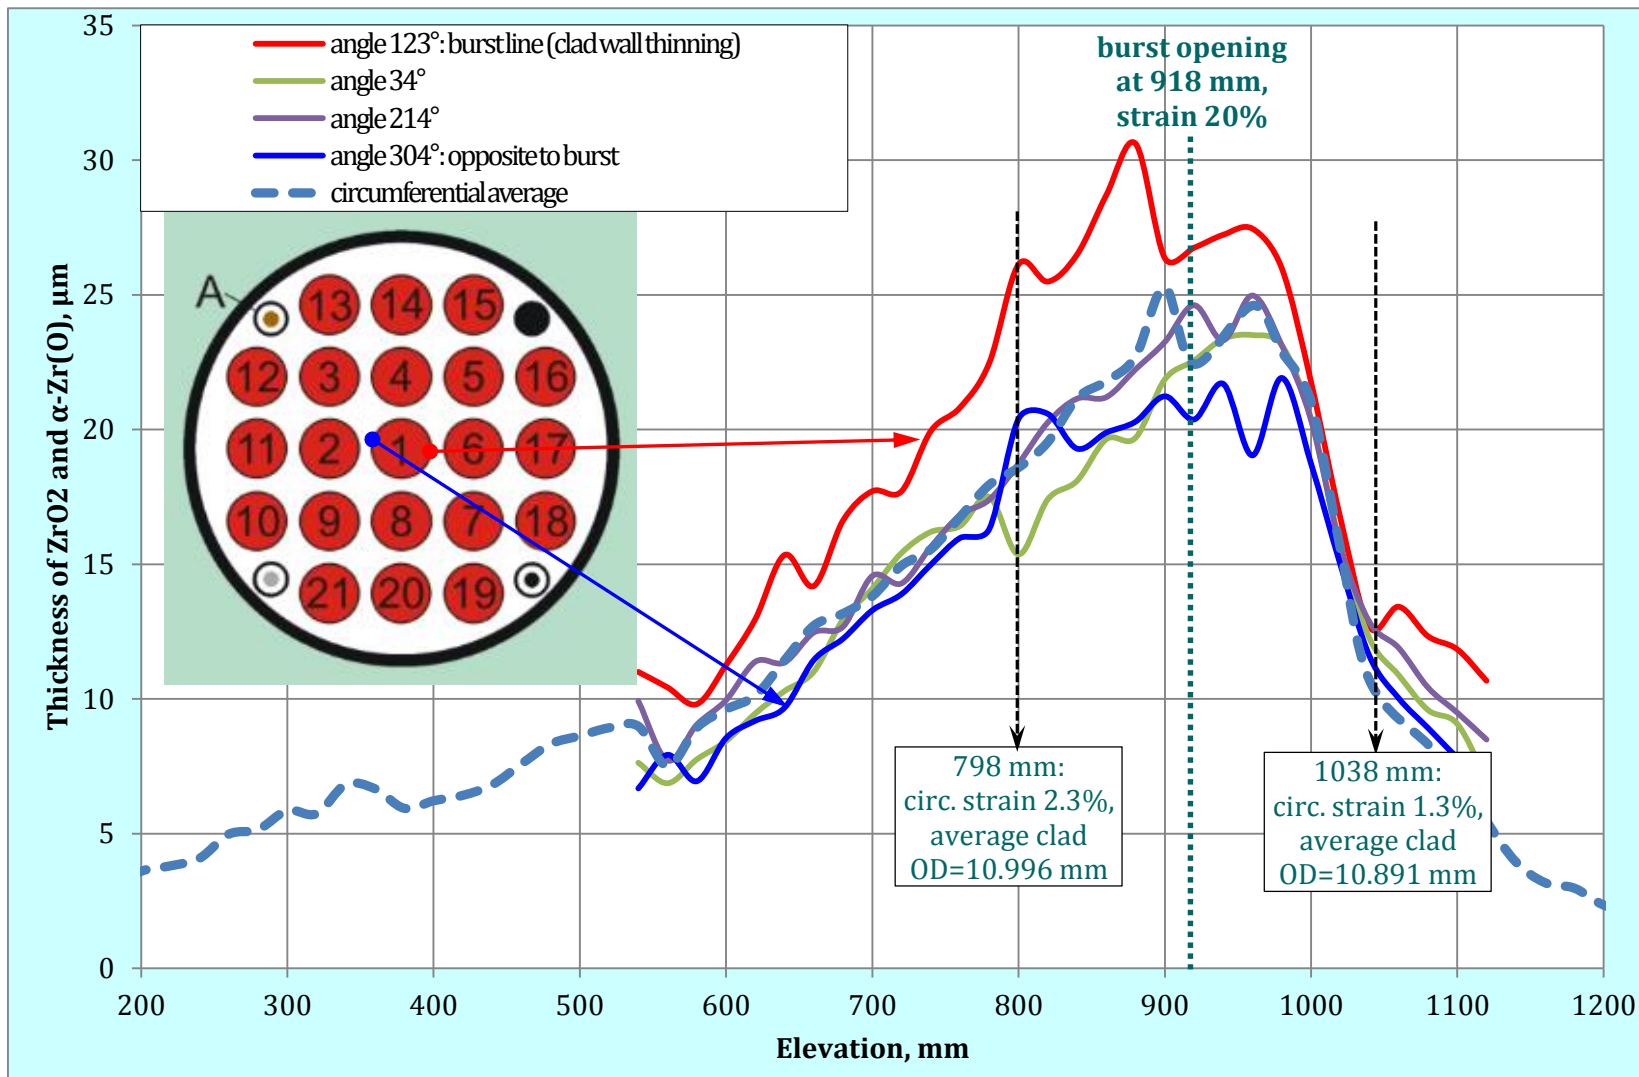
Figure 108 QUENCH-L4; Results of eddy-current measurements for different circumferential positions of rod #1.

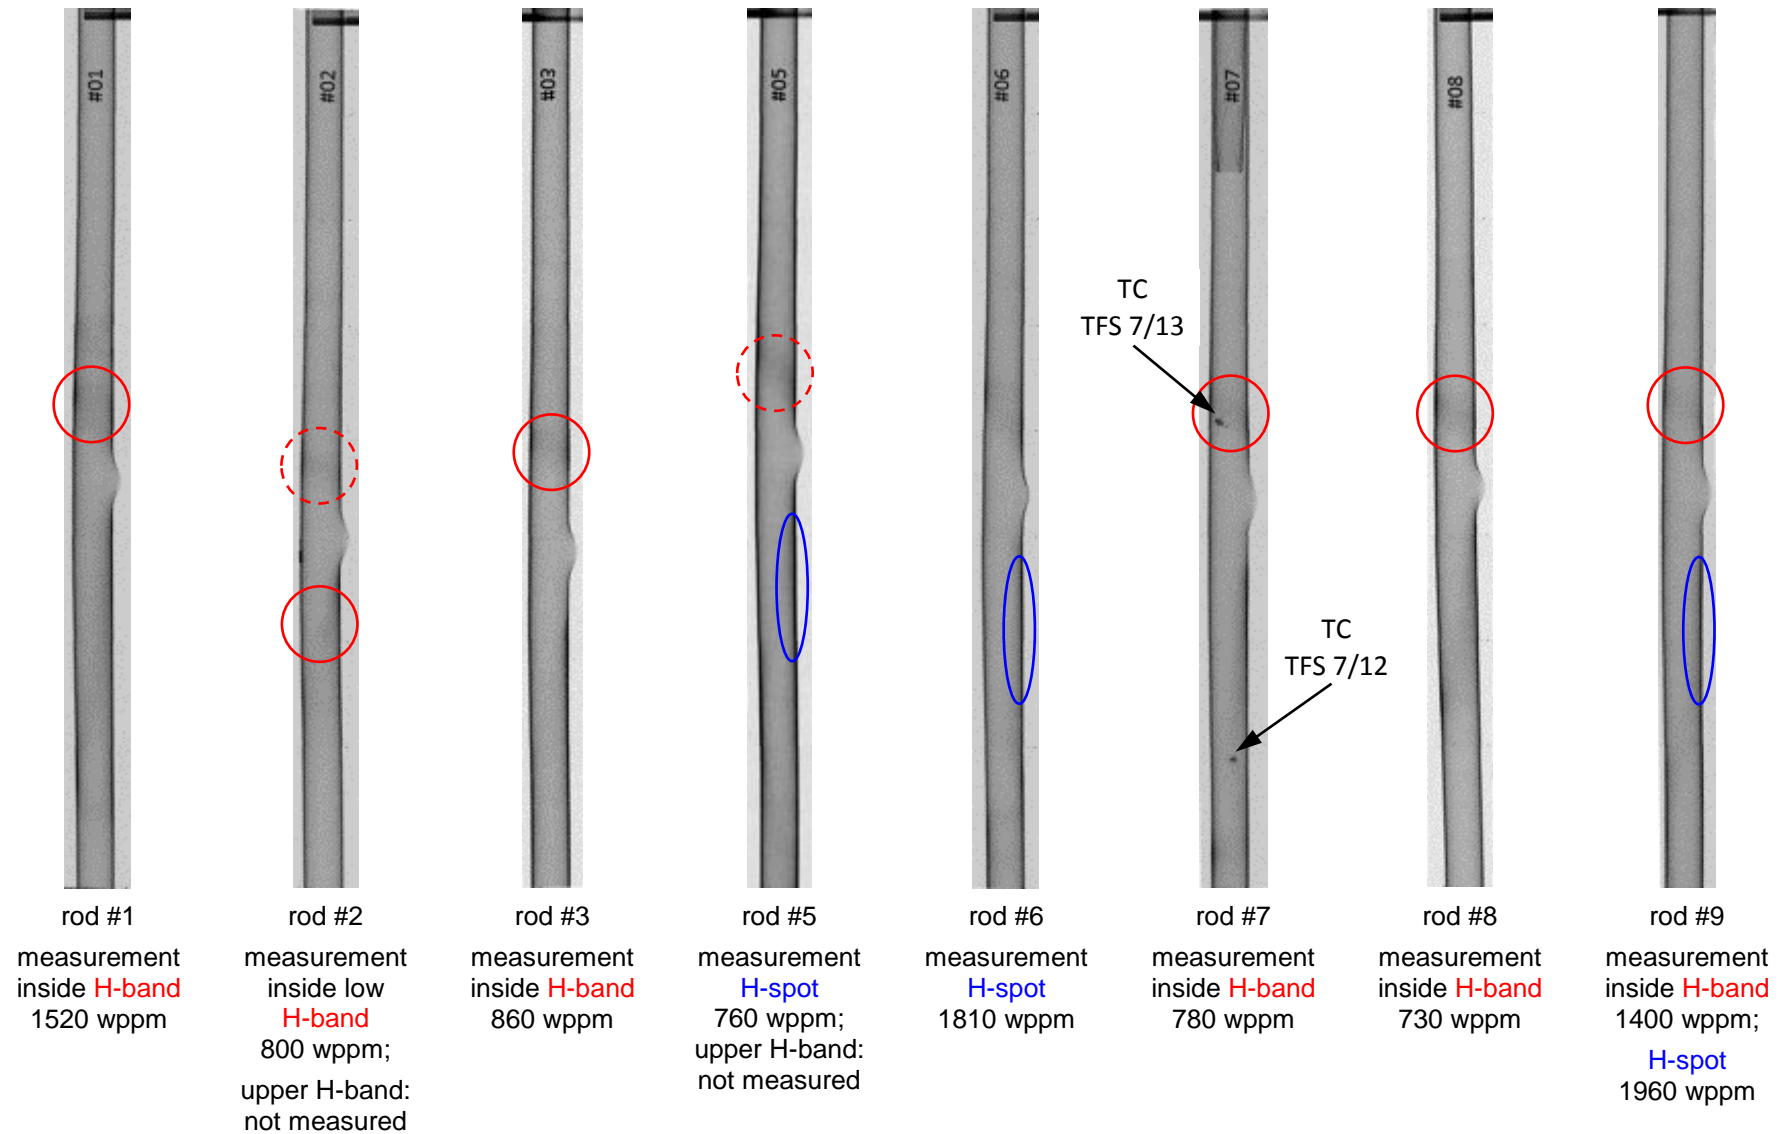
Figure 111 QUENCH-L4; Hydrogen bands on neutron radiographs of inner rods and maximum hydrogen content measured by neutron tomography.

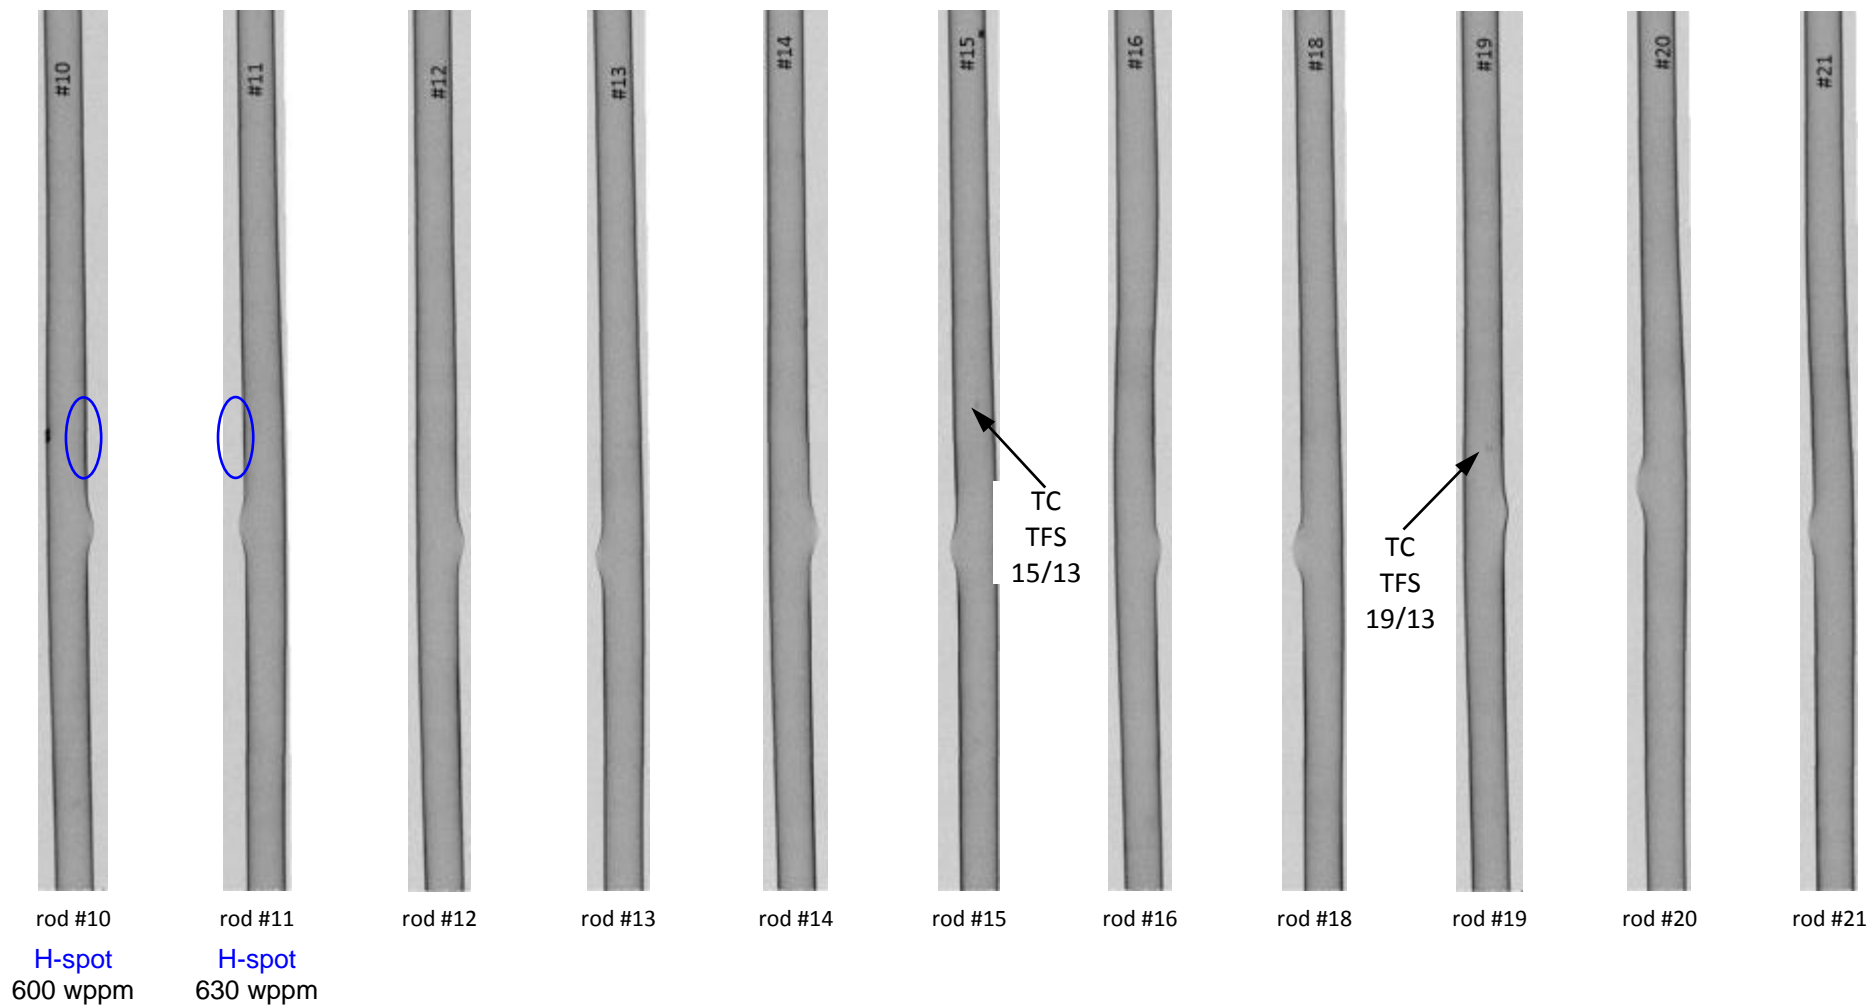
Figure 112 QUENCH-L4; Neutron radiographs of outer rods and maximum hydrogen content measured by neutron tomography.
