QUENCH - LOCA - REPORTS Nr. 5

**Results of the LOCA bundle test QUENCH-L4
with pre-hydrogenated M5[®] claddings (SR-7712)**

J. Stuckert, M. Große, A. Pshenichnikov , C. Rössger,
M. Steinbrück, M. Walter

Karlsruher Institut für Technologie

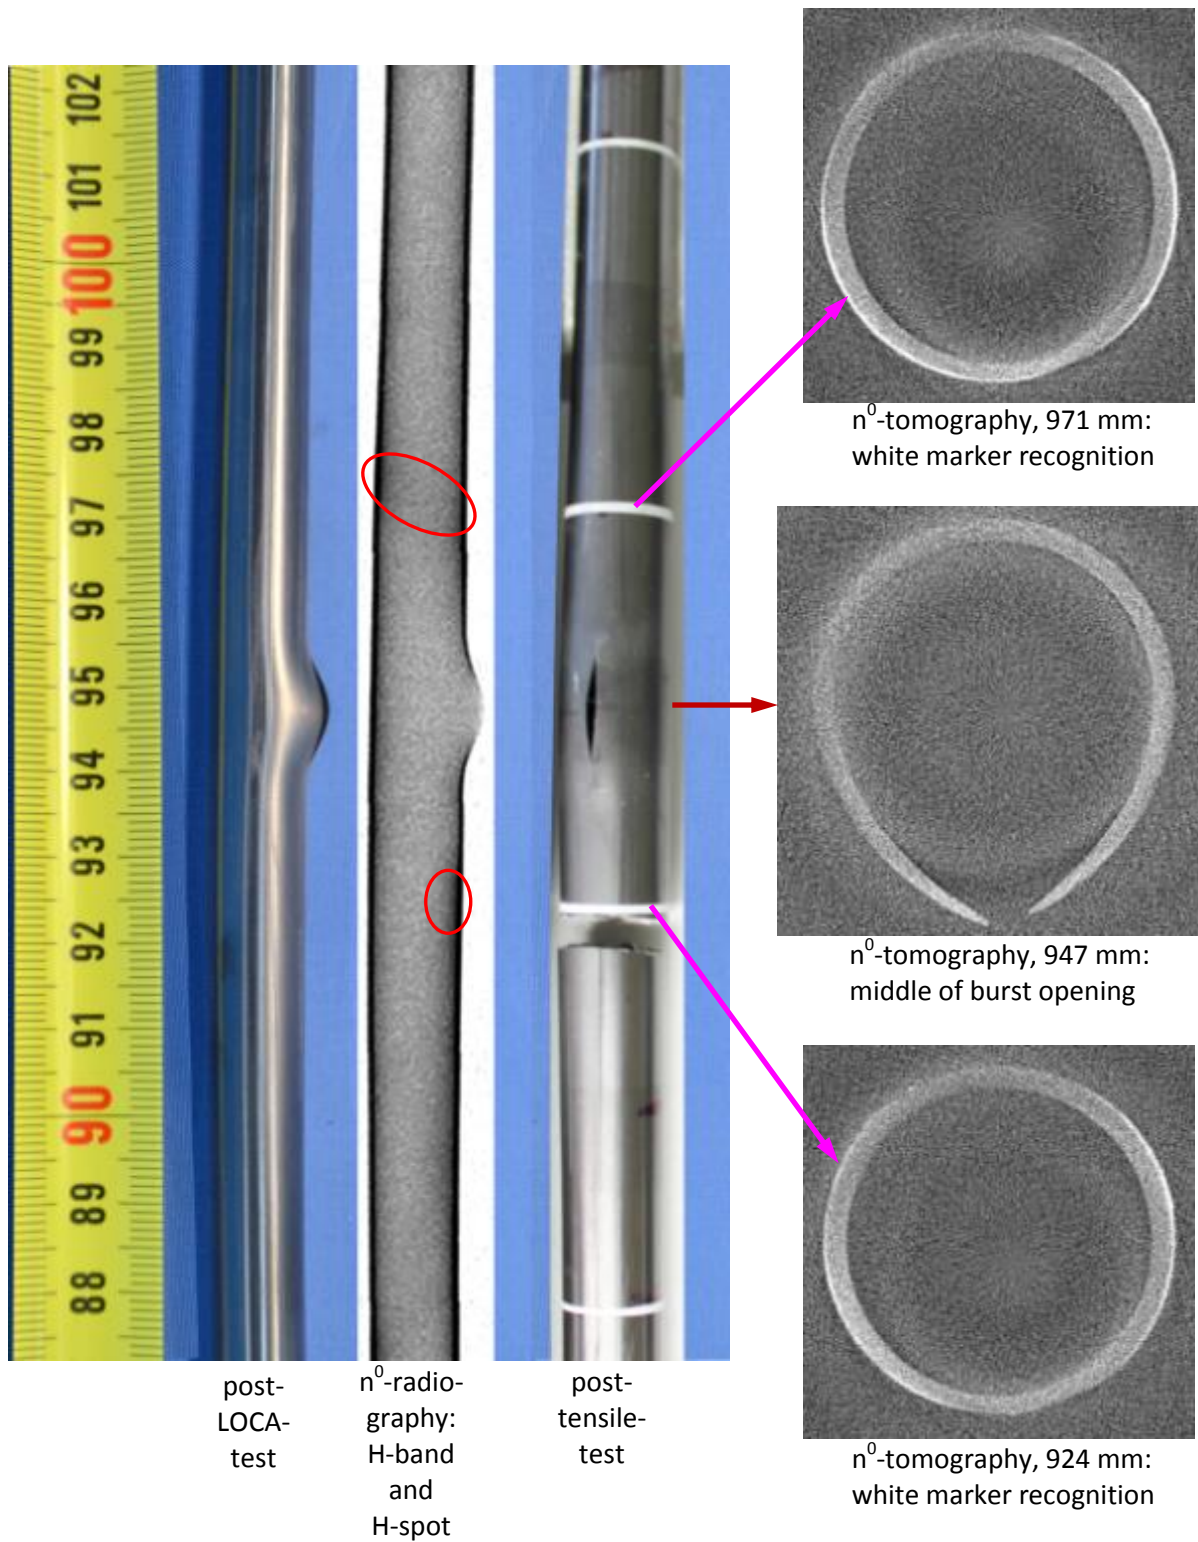
Figure 113 QUENCH-L4, Rod #9; results of n^0 -radio- and tomography.

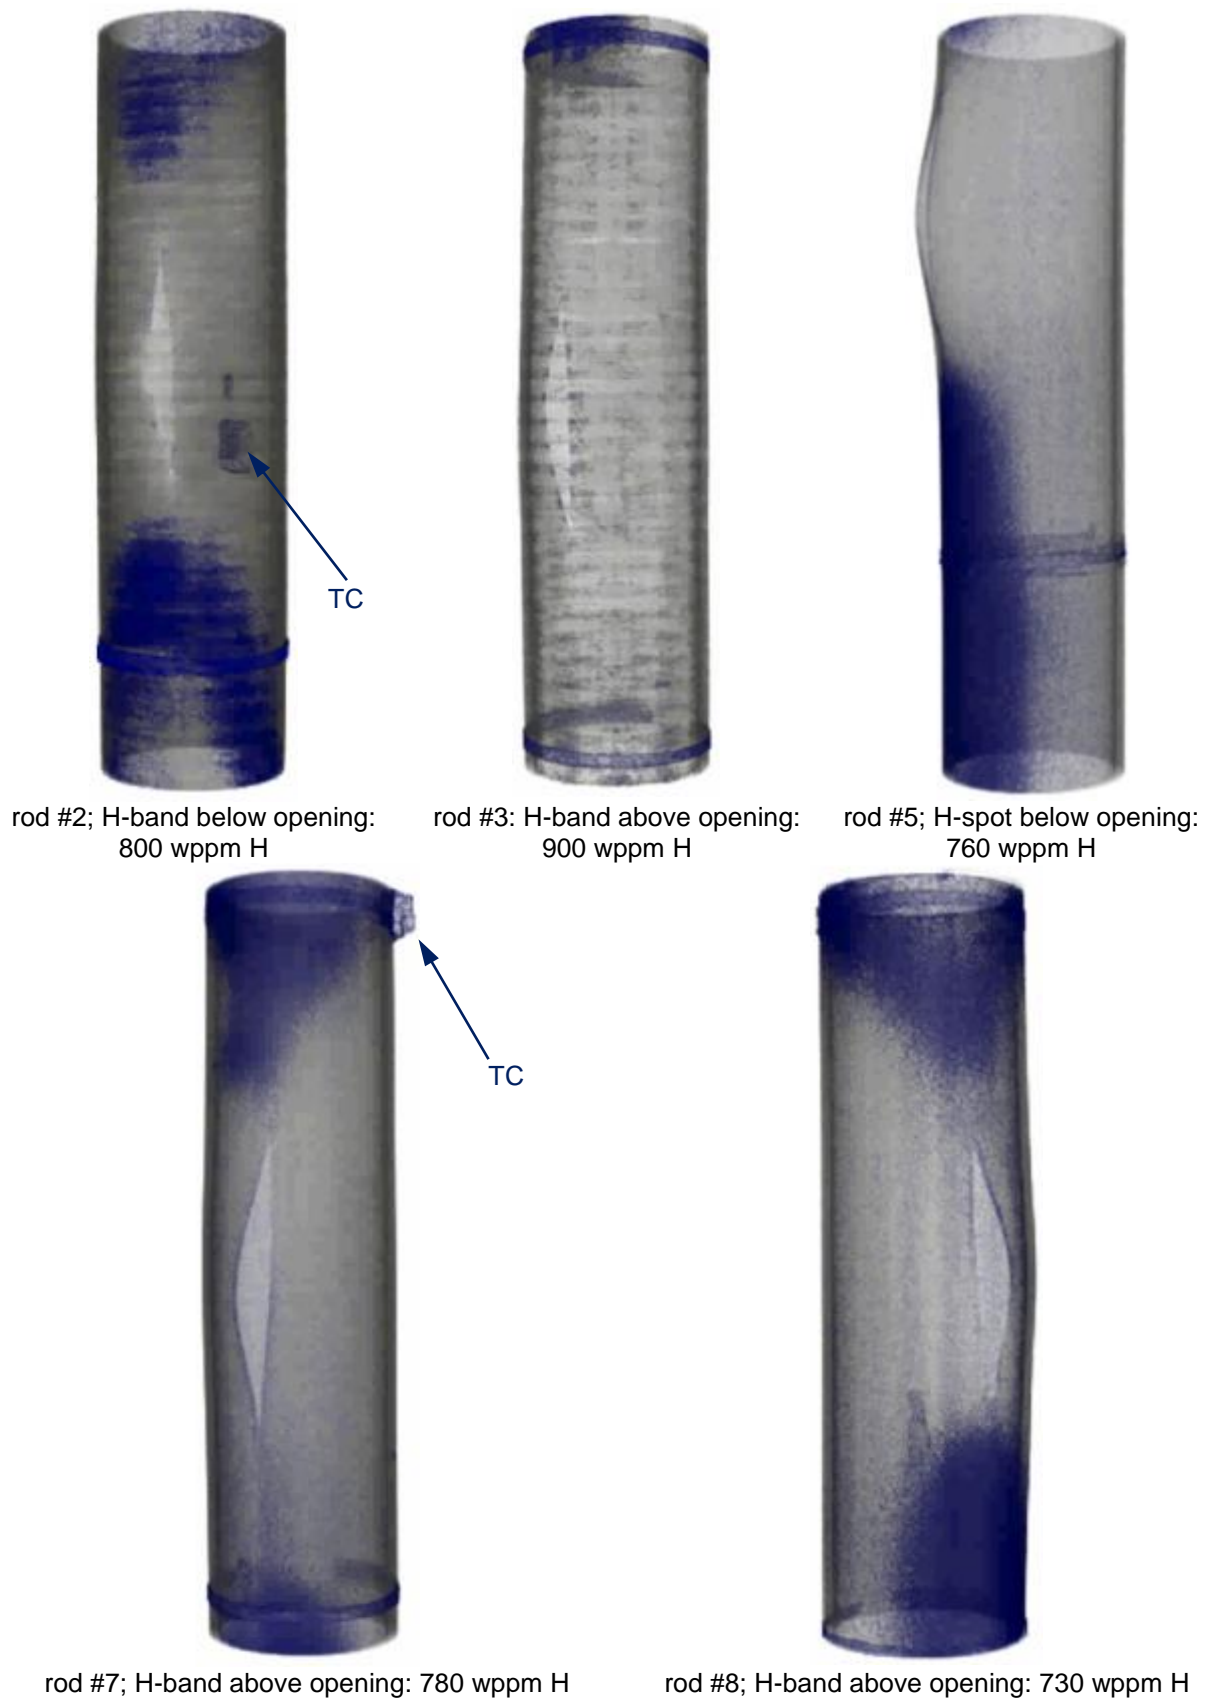
Figure 115 QUENCH-L4; Results of neutron tomography for internal rods fractured during the tensile tests by necking. Dark blue points correspond to hydrogen bearing material. Rings are colouring markers dished up before tensile tests. The values are local maximal hydrogen concentrations.

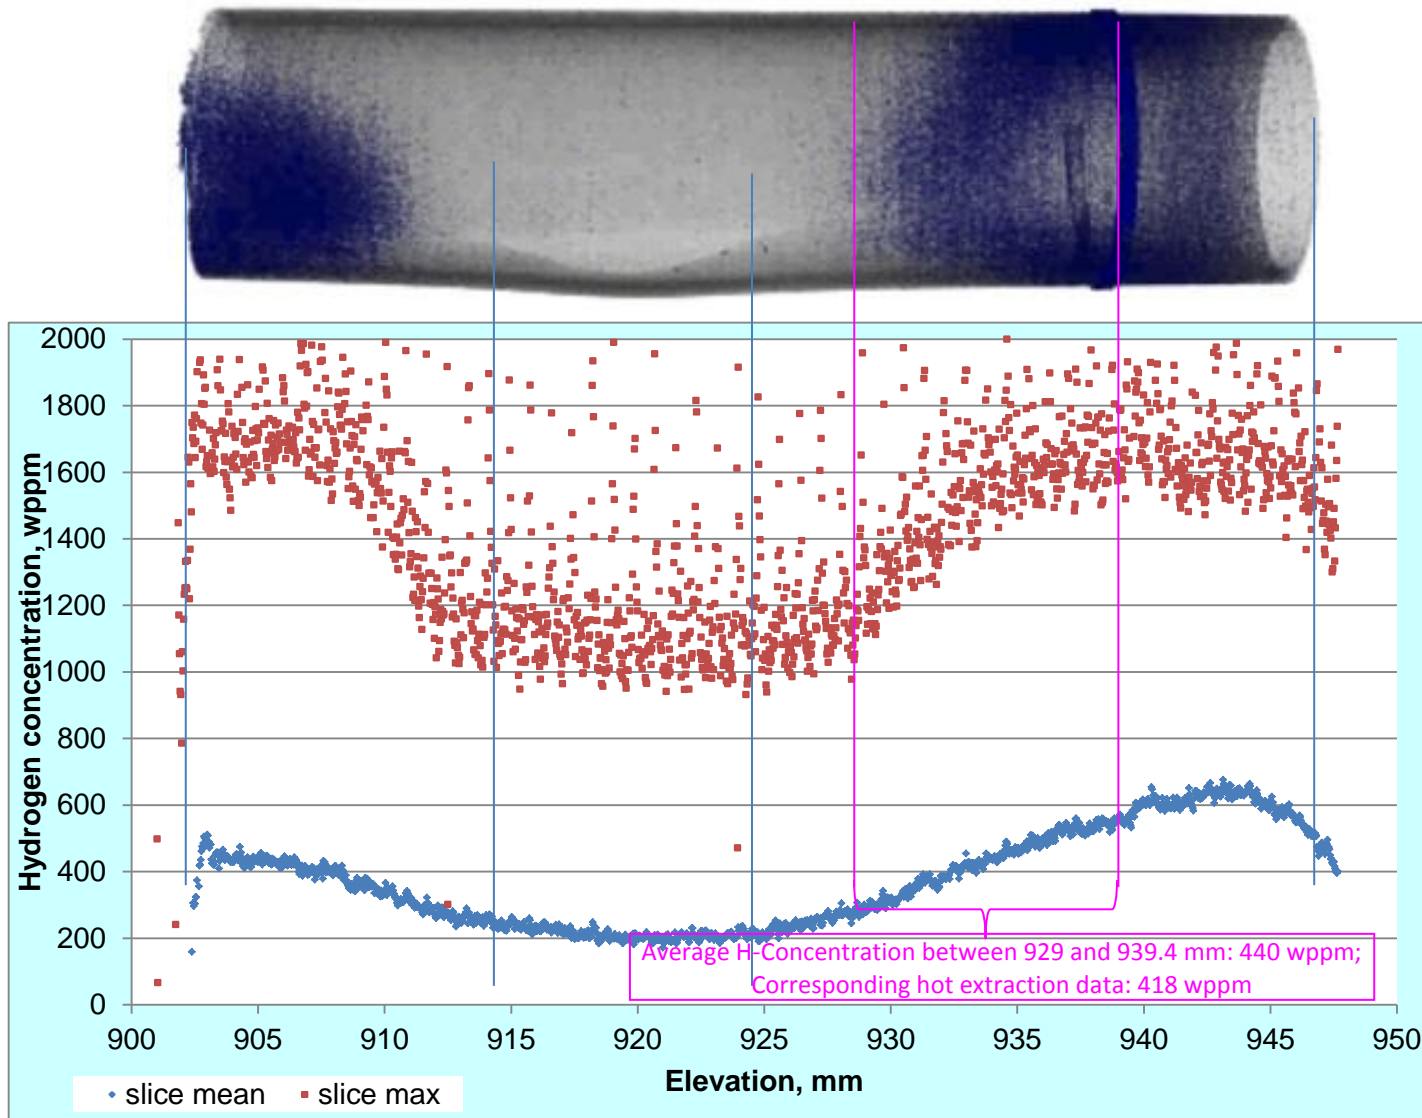
Figure 117 QUENCH-L4; correspondence between reconstruction of tomography image and plots of mean and maximal hydrogen concentrations (calculated for each cross section slice of 25.6 μm width) in rod #1: hydrogen band above and hydrogen spot below burst opening.

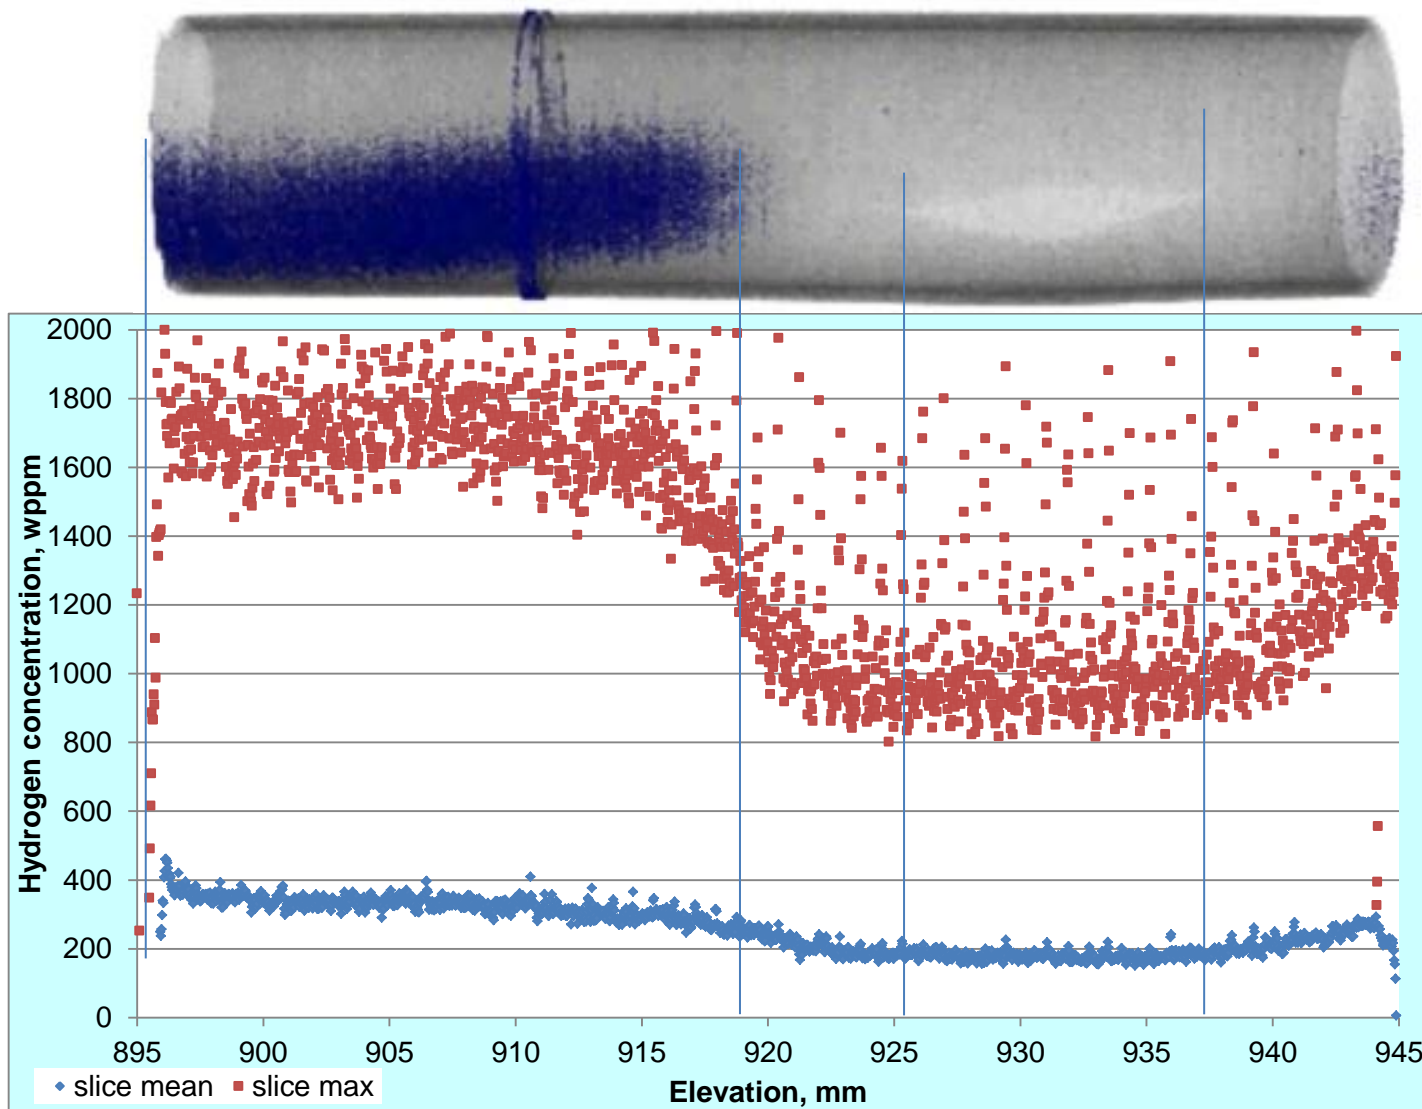
Figure 119 QUENCH-L4; correspondence between reconstruction of tomography image and plots of mean and maximal hydrogen concentrations (calculated for each cross section slice of 25.6 μm width) in rod #6: hydrogen spot below burst opening.

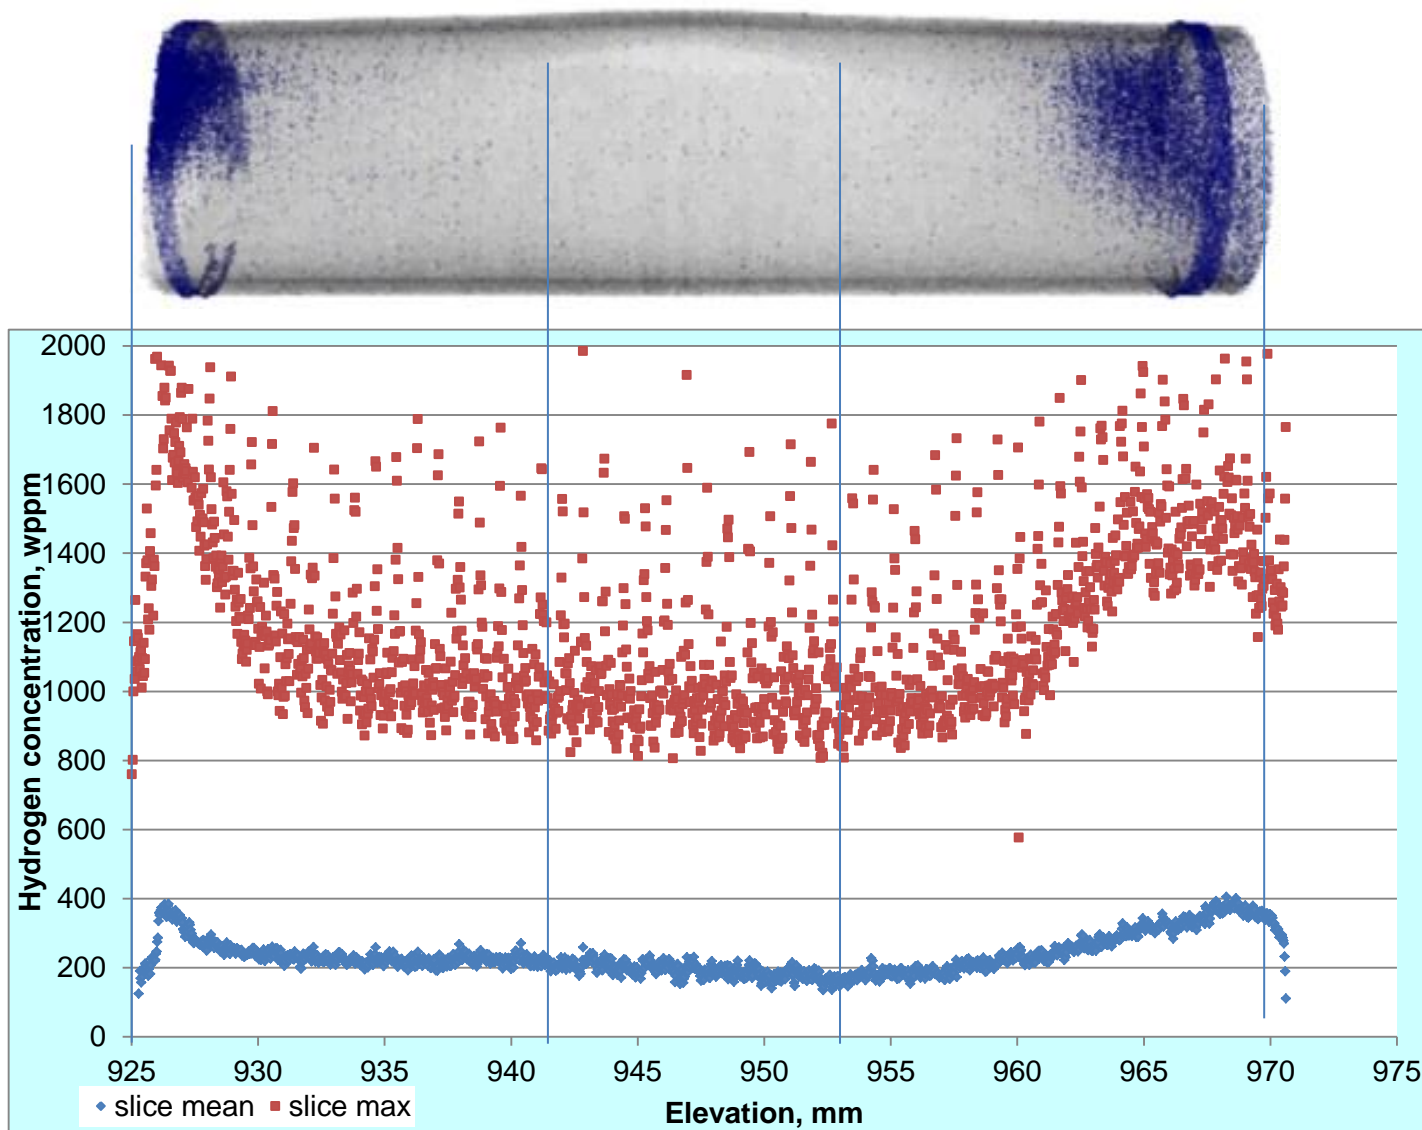
Figure 120 QUENCH-L4; correspondence between reconstruction of tomography image and plots of mean and maximal hydrogen concentrations (calculated for each cross section slice of 25.6 μm width) in rod #9: hydrogen band above and hydrogen spot below burst opening.

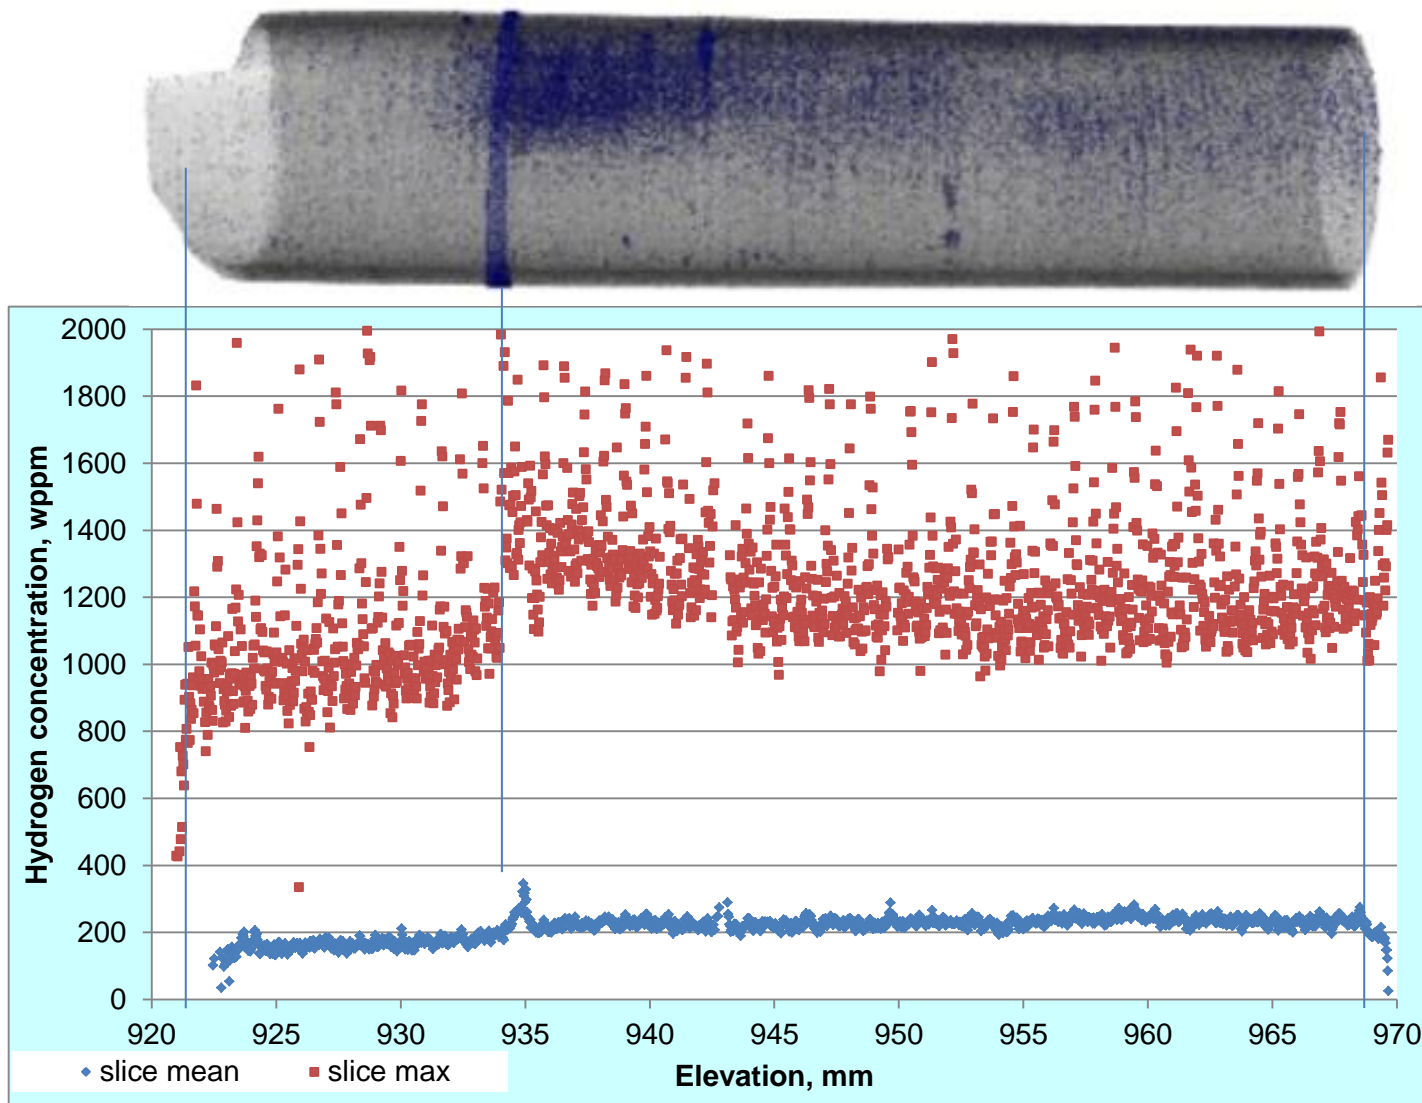
Figure 122 QUENCH-L4; correspondence between reconstruction of tomography image and plots of mean and maximal hydrogen concentrations (calculated for each cross section slice of 25.6 μm width) in rod #14: hydrogenated zone above burst opening, relative homogeneous axial distribution of hydrogen.

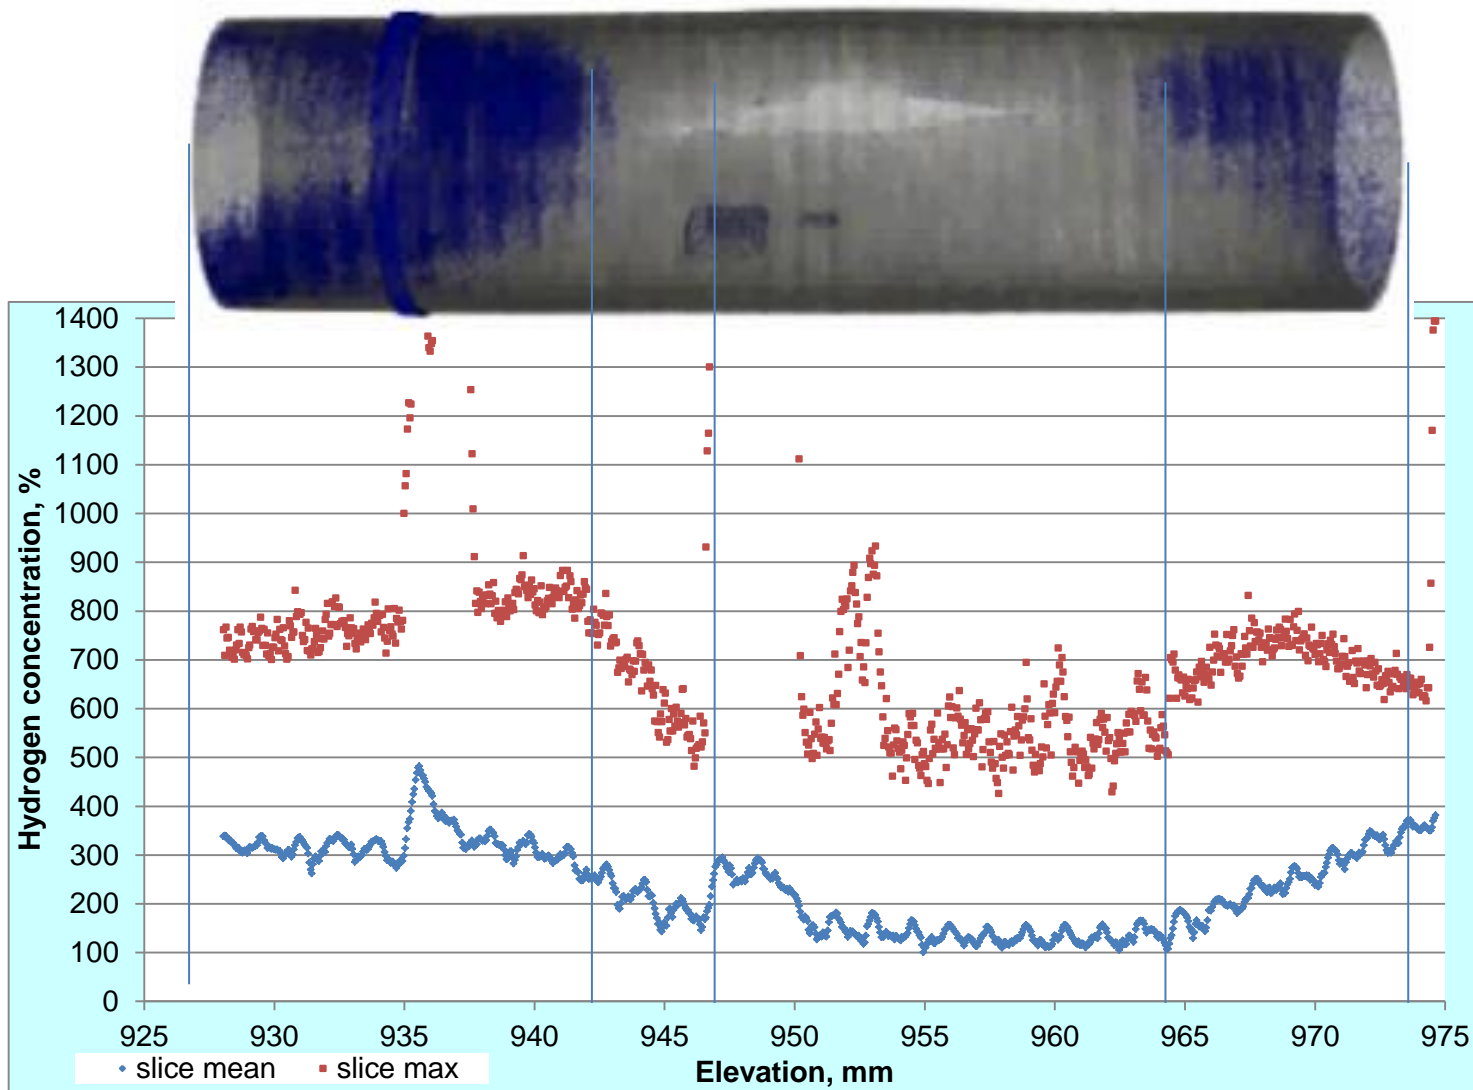
Figure 123 QUENCH-L4; correspondence between reconstruction of tomography image and plots of mean and maximal hydrogen concentrations (calculated for each cross section slice of 45.9 μm width) in rod #2: hydrogenated zone *below* burst opening.

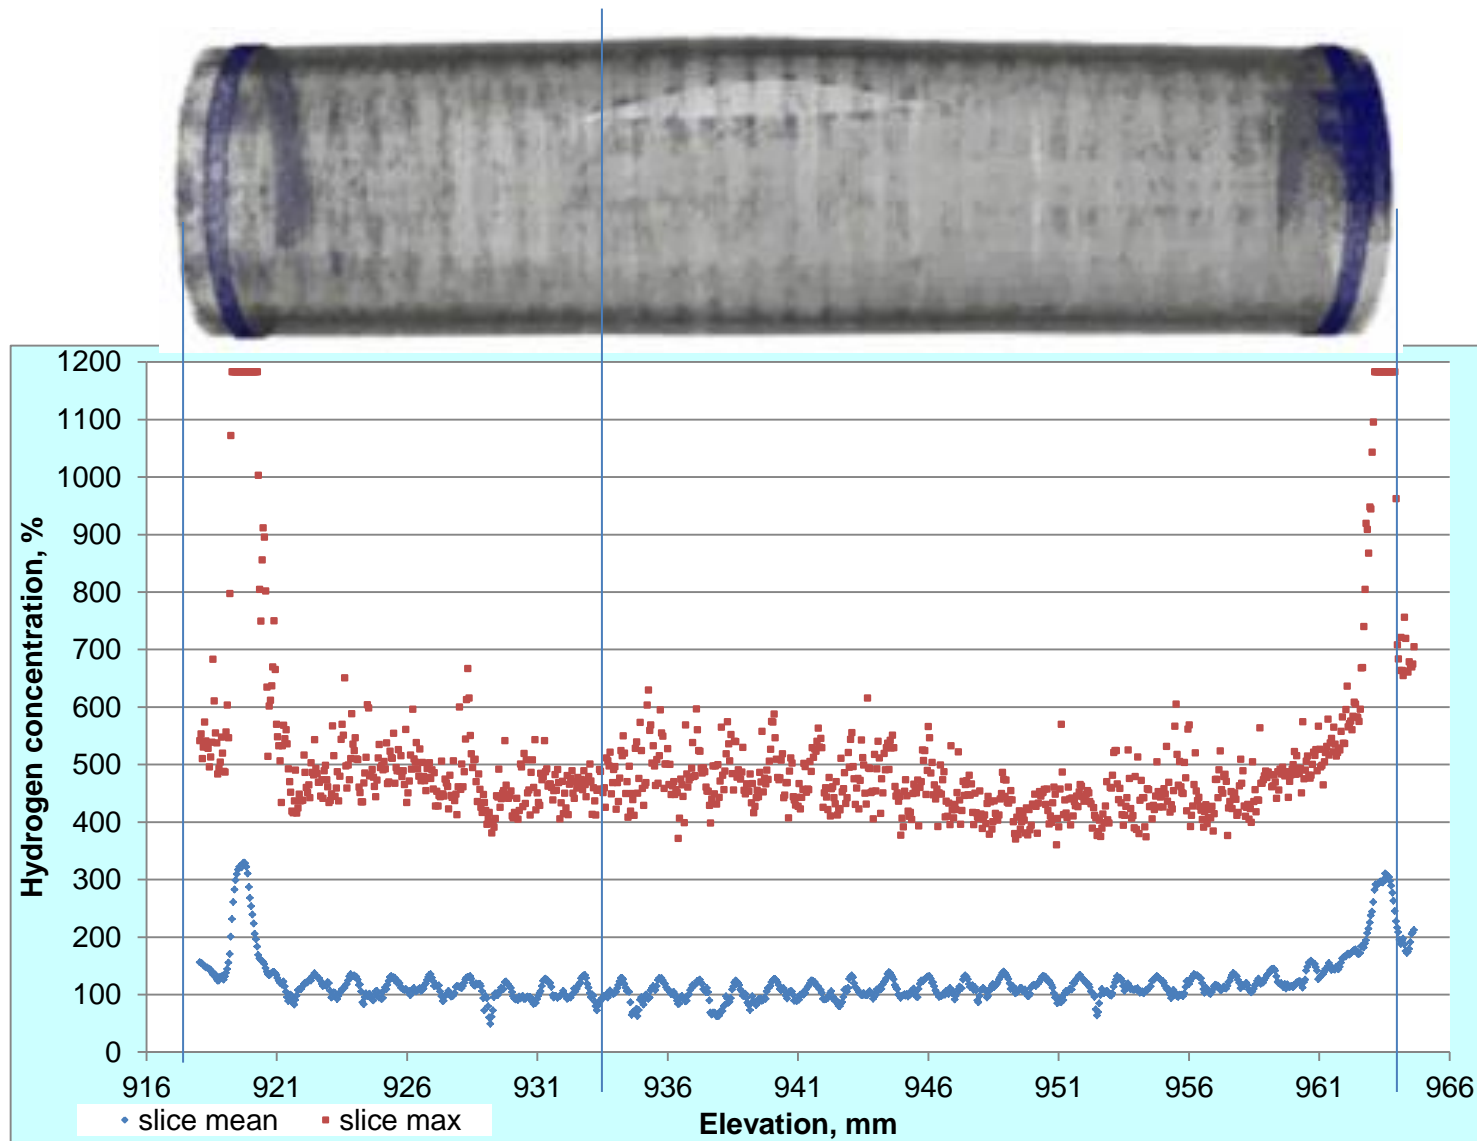
Figure 124 QUENCH-L4; correspondence between reconstruction of tomography image and plots of mean and maximal hydrogen concentrations (calculated for each cross section slice of 45.9 μm width) in rod #3: no hydrogenated zones.

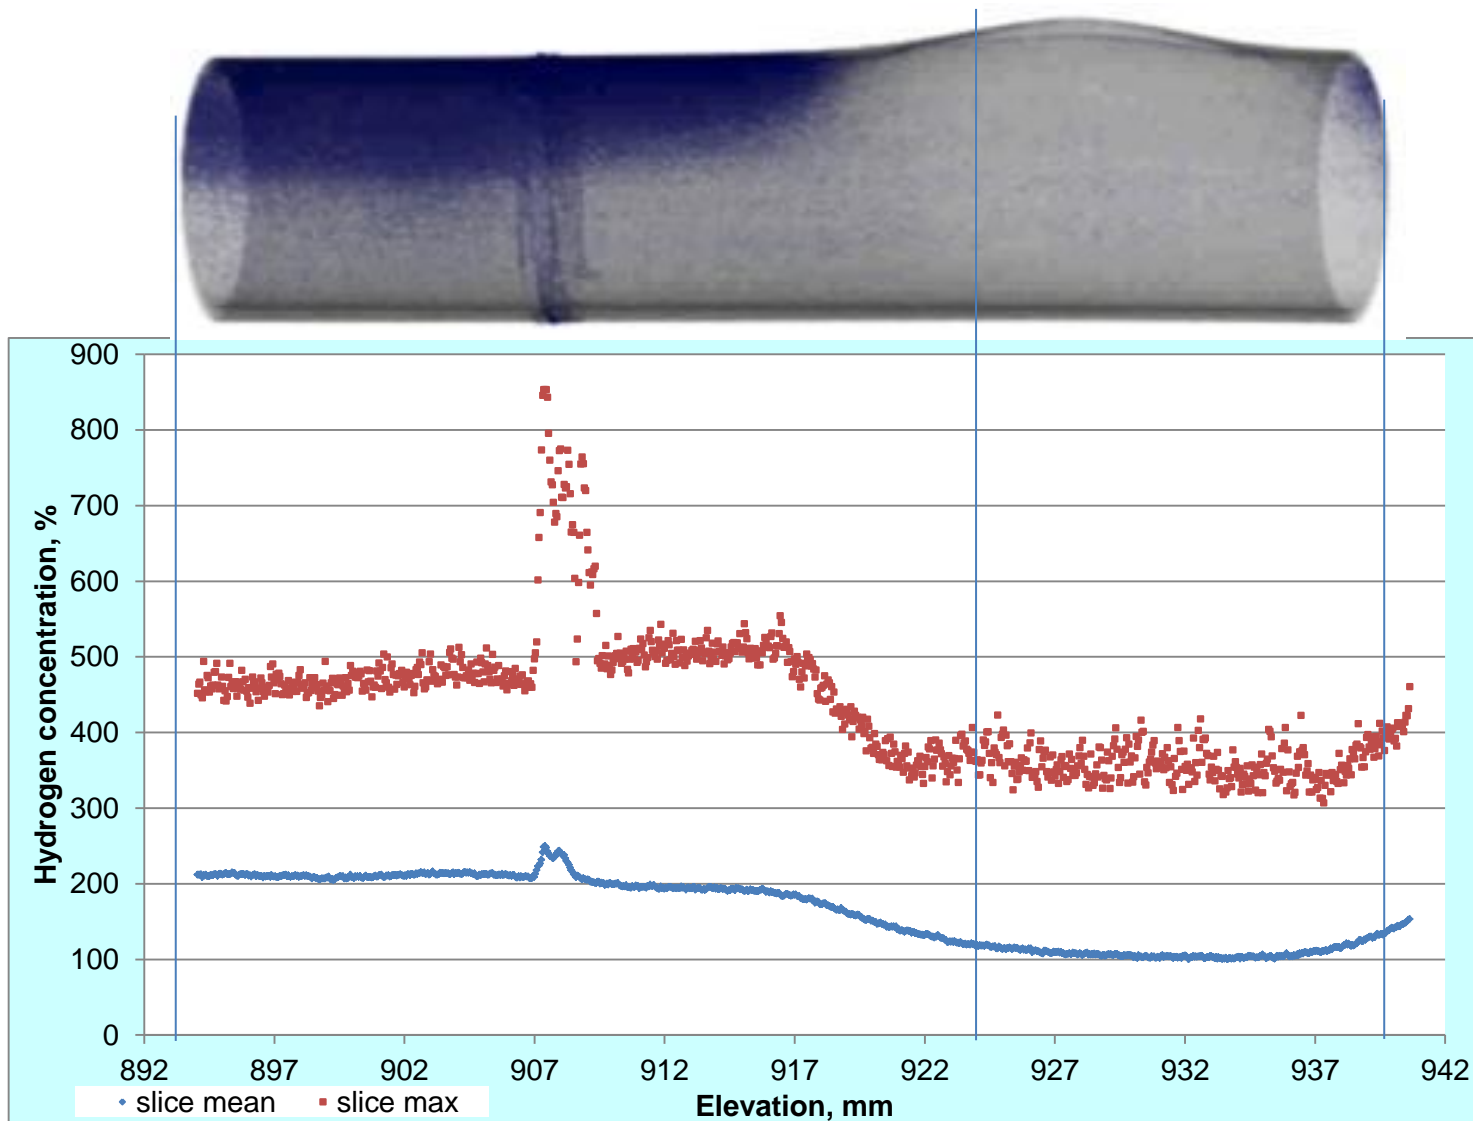
Figure 125 QUENCH-L4; correspondence between reconstruction of tomography image and plots of mean and maximal hydrogen concentrations (calculated for each cross section slice of 45.9 μm width) in rod #5: hydrogenated zone *below* burst opening.

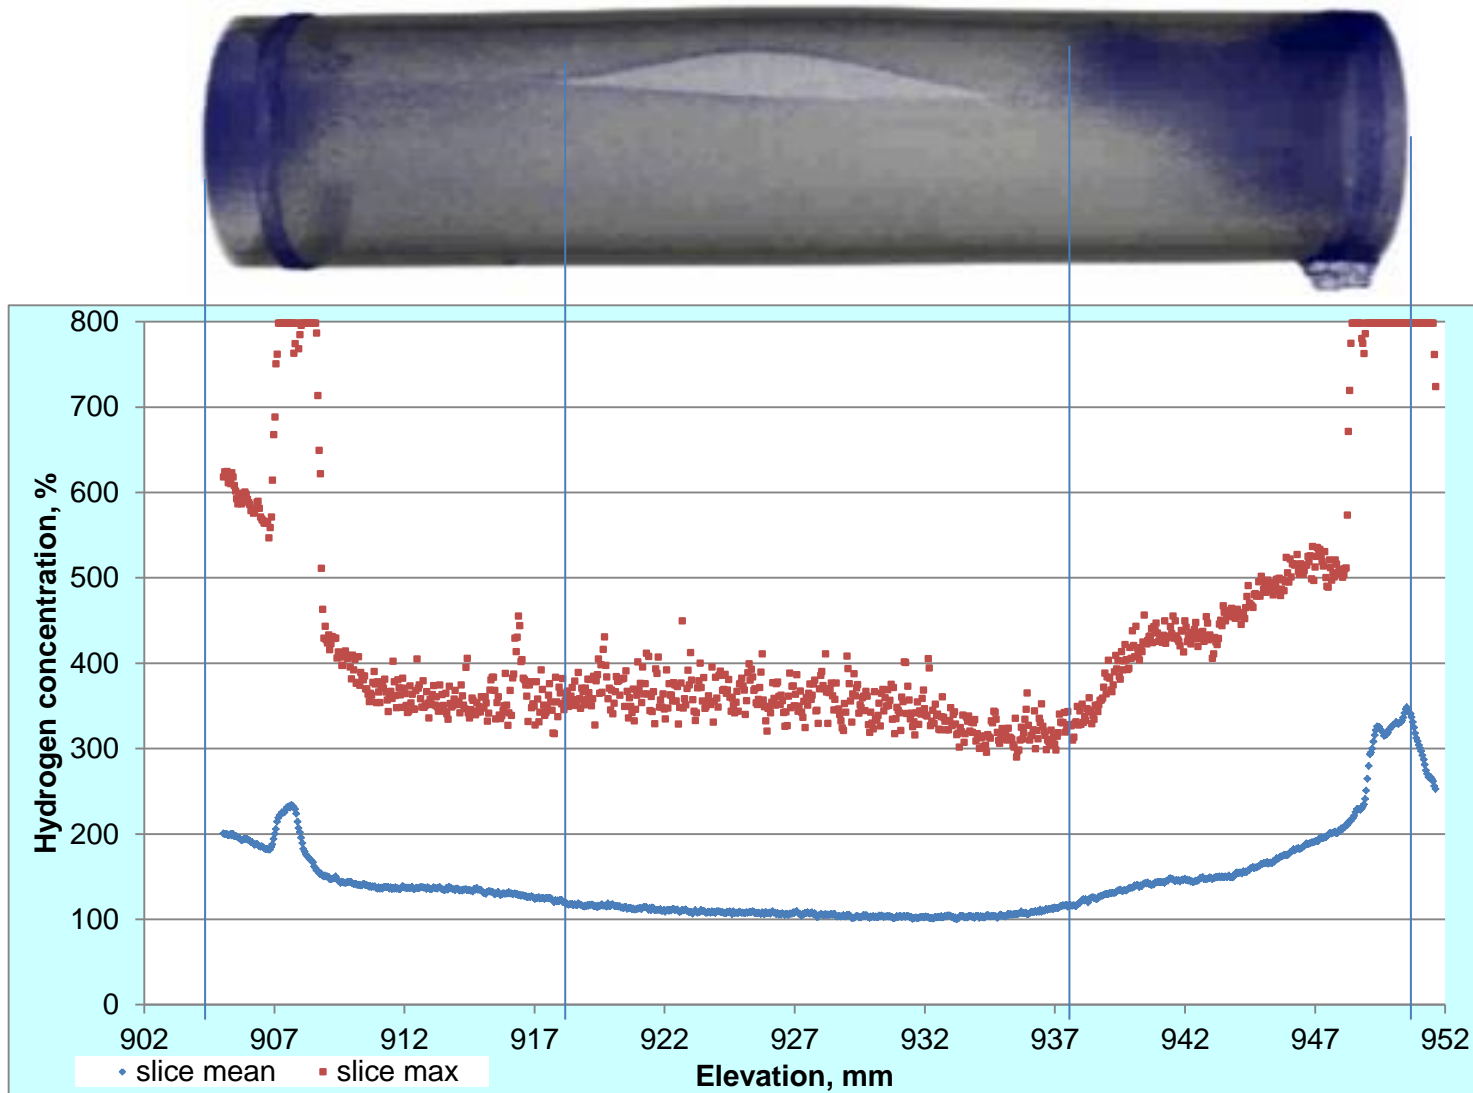
Figure 126 QUENCH-L4; correspondence between reconstruction of tomography image and plots of mean and maximal hydrogen concentrations (calculated for each cross section slice of 45.9 μm width) in rod #7: hydrogenated zone above burst opening.

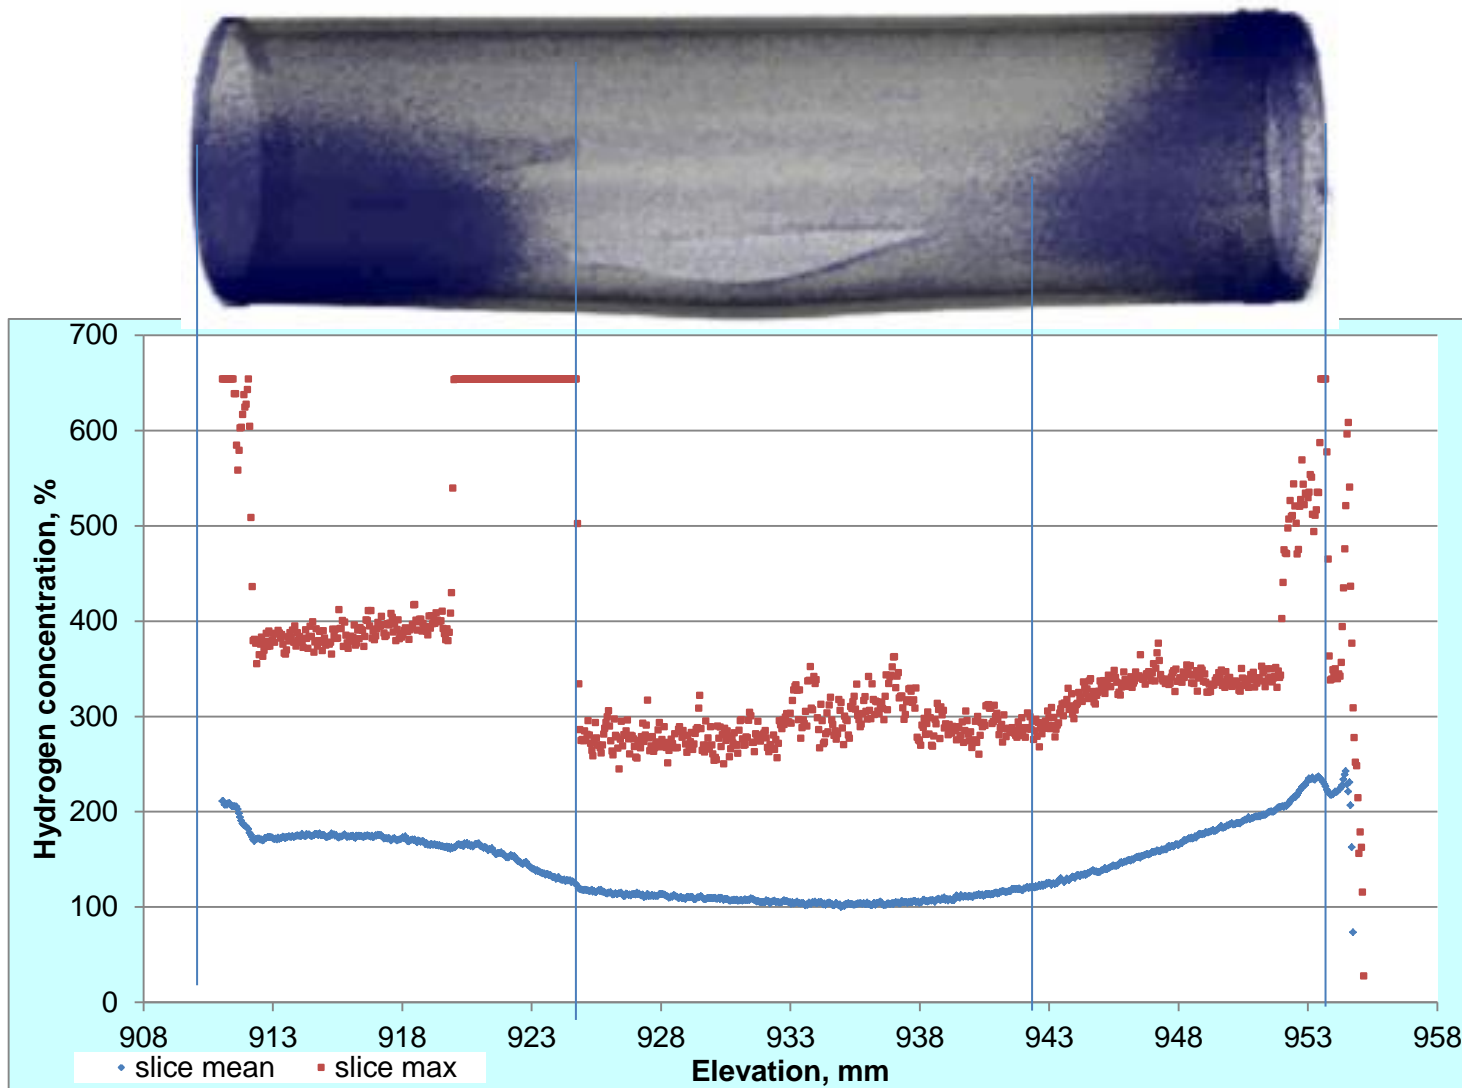
Figure 127 QUENCH-L4; correspondence between reconstruction of tomography image and plots of mean and maximal hydrogen concentrations (calculated for each cross section slice of 45.9 μm width) in rod #8: hydrogenated zones above and below burst opening.

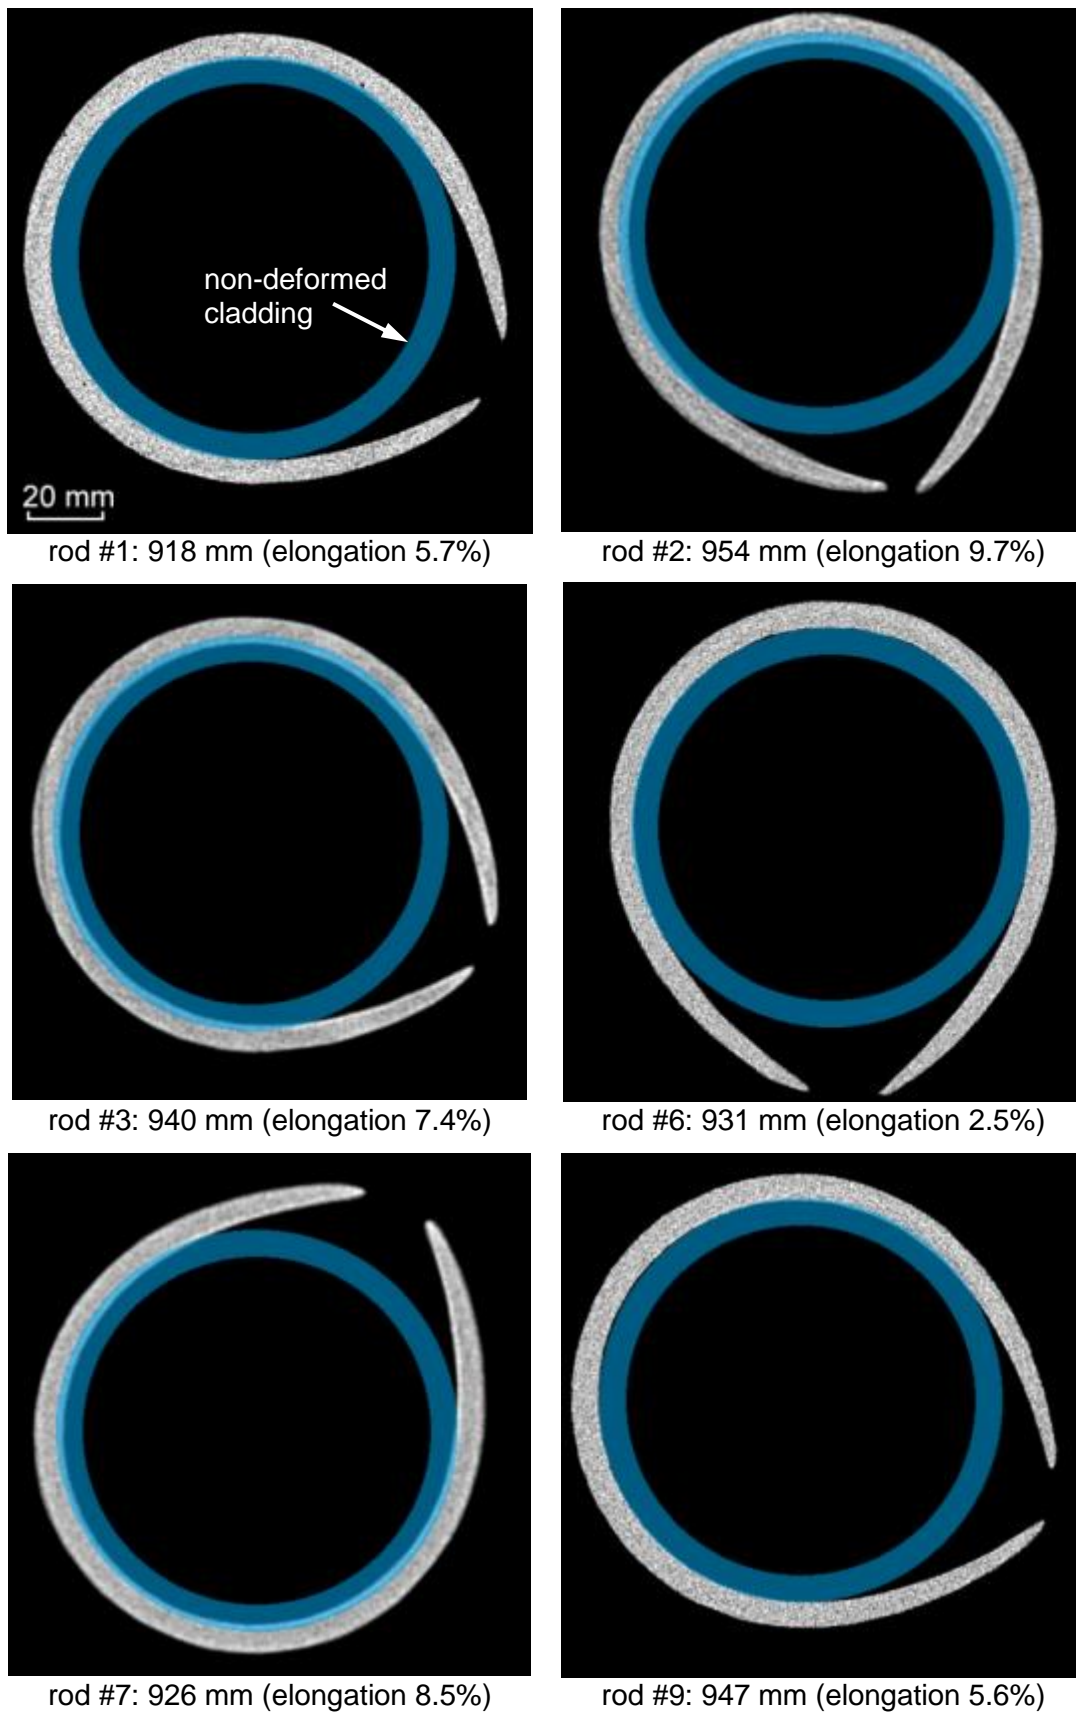
Figure 128 QUENCH-L4; Comparison of tomography images (made after tensile tests) at the axial middle of burst opening with initial (pre-test) cladding cross section (OD=10.75 mm; wall thickness 725 μm); elongation values point the deformation degree after tensile tests.

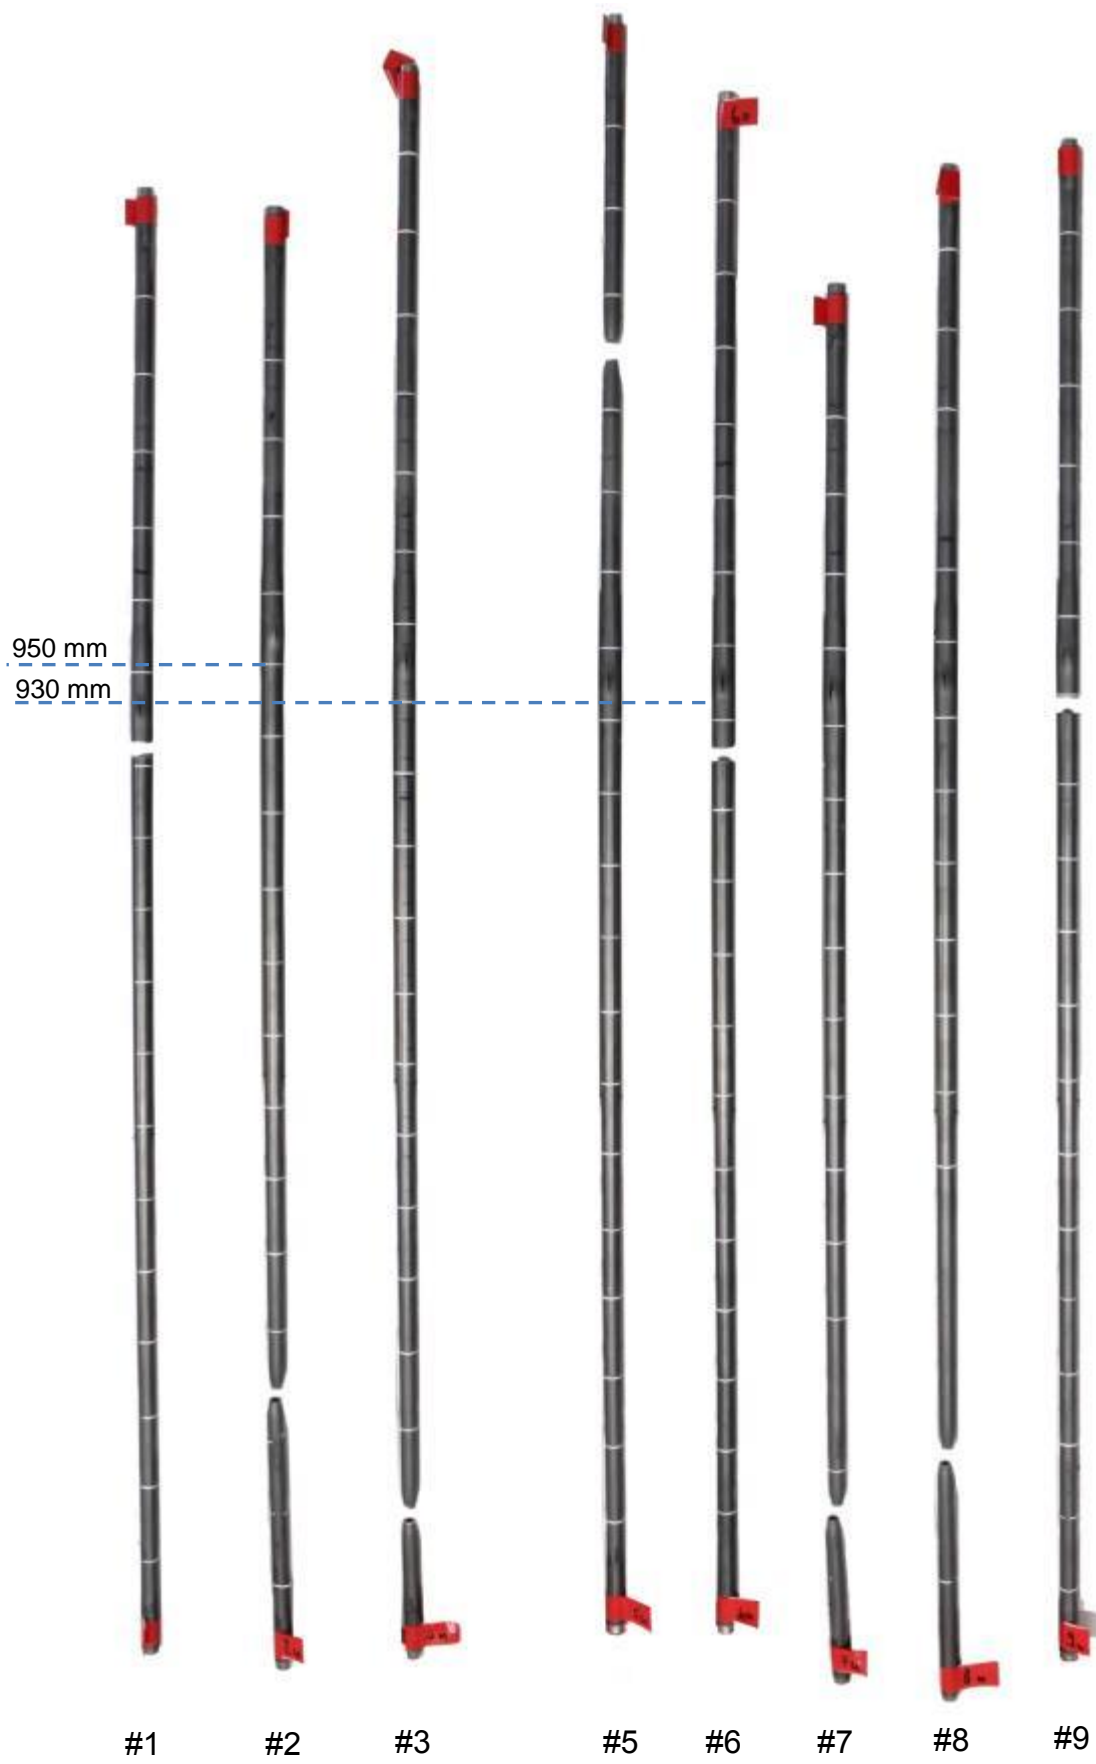
Figure 129 QUENCH-L4; Inner rods after tensile tests; ruptures due to H-embrittlement (rods 1, 6, 9) and necking (rods 2, 3, 5, 7, 8).
