QUENCH - LOCA - REPORTS Nr. 5

**Results of the LOCA bundle test QUENCH-L4
with pre-hydrogenated M5[®] claddings (SR-7712)**

J. Stuckert, M. Große, A. Pshenichnikov , C. Rössger,
M. Steinbrück, M. Walter

Karlsruher Institut für Technologie

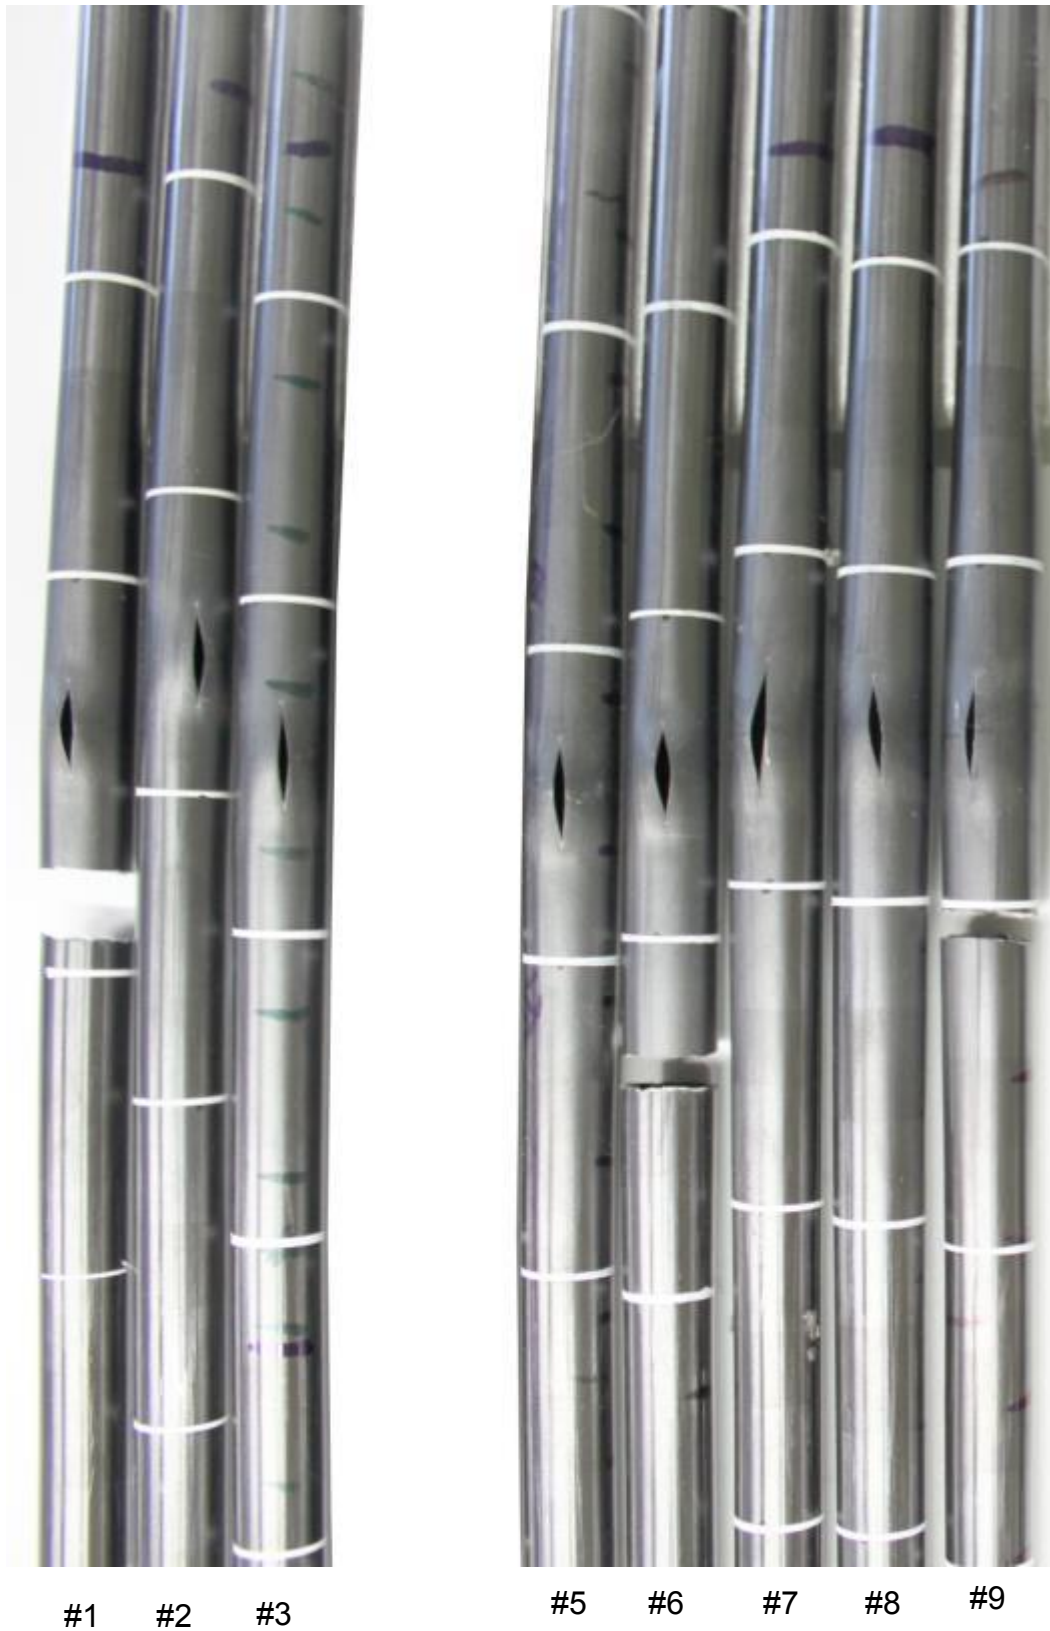
Figure 130 QUENCH-L4; Inner rods after tensile tests; ruptures due to H-embrittlement for rods 1, 6, 9; necking of the rods 2, 3, 5, 7, 8.

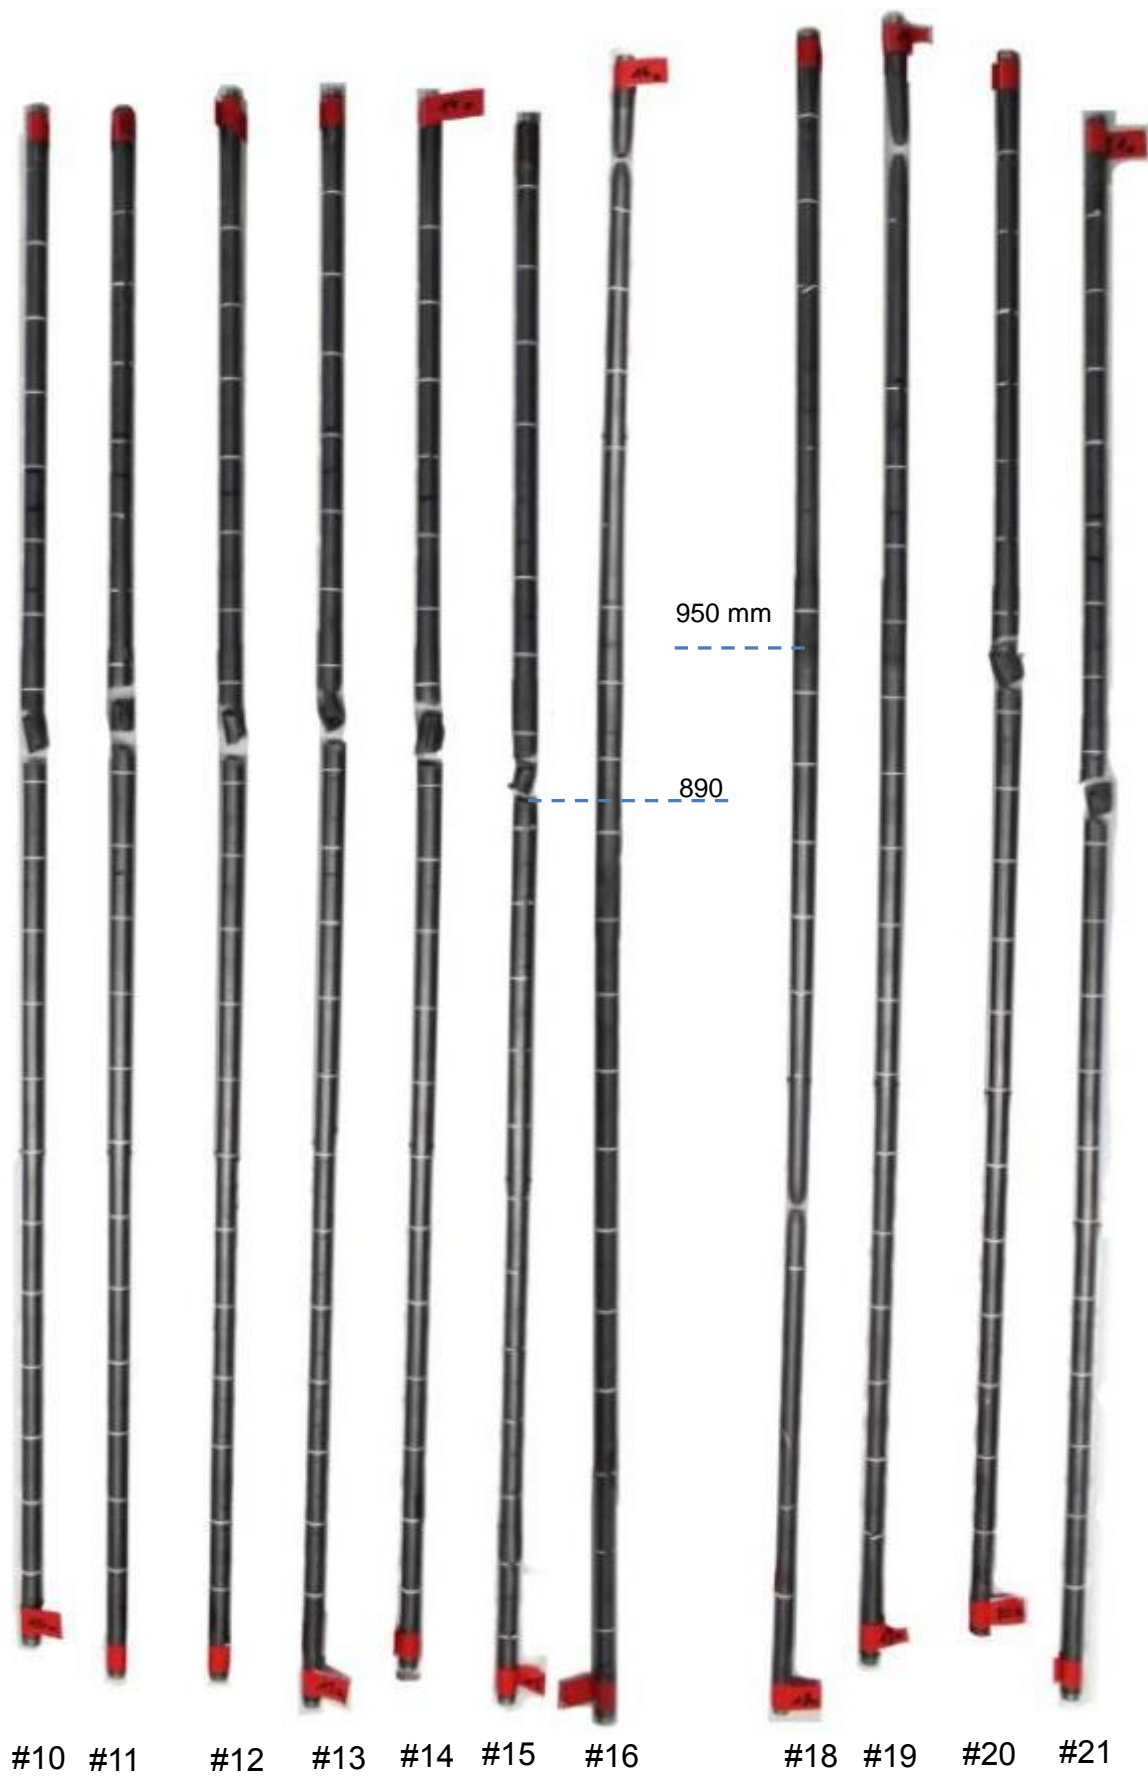
Figure 131 QUENCH-L4; Outer rods after tensile tests; ruptures due to stress concentration (rods 10-15, 20, 21) and necking (rods 16, 18, 19).

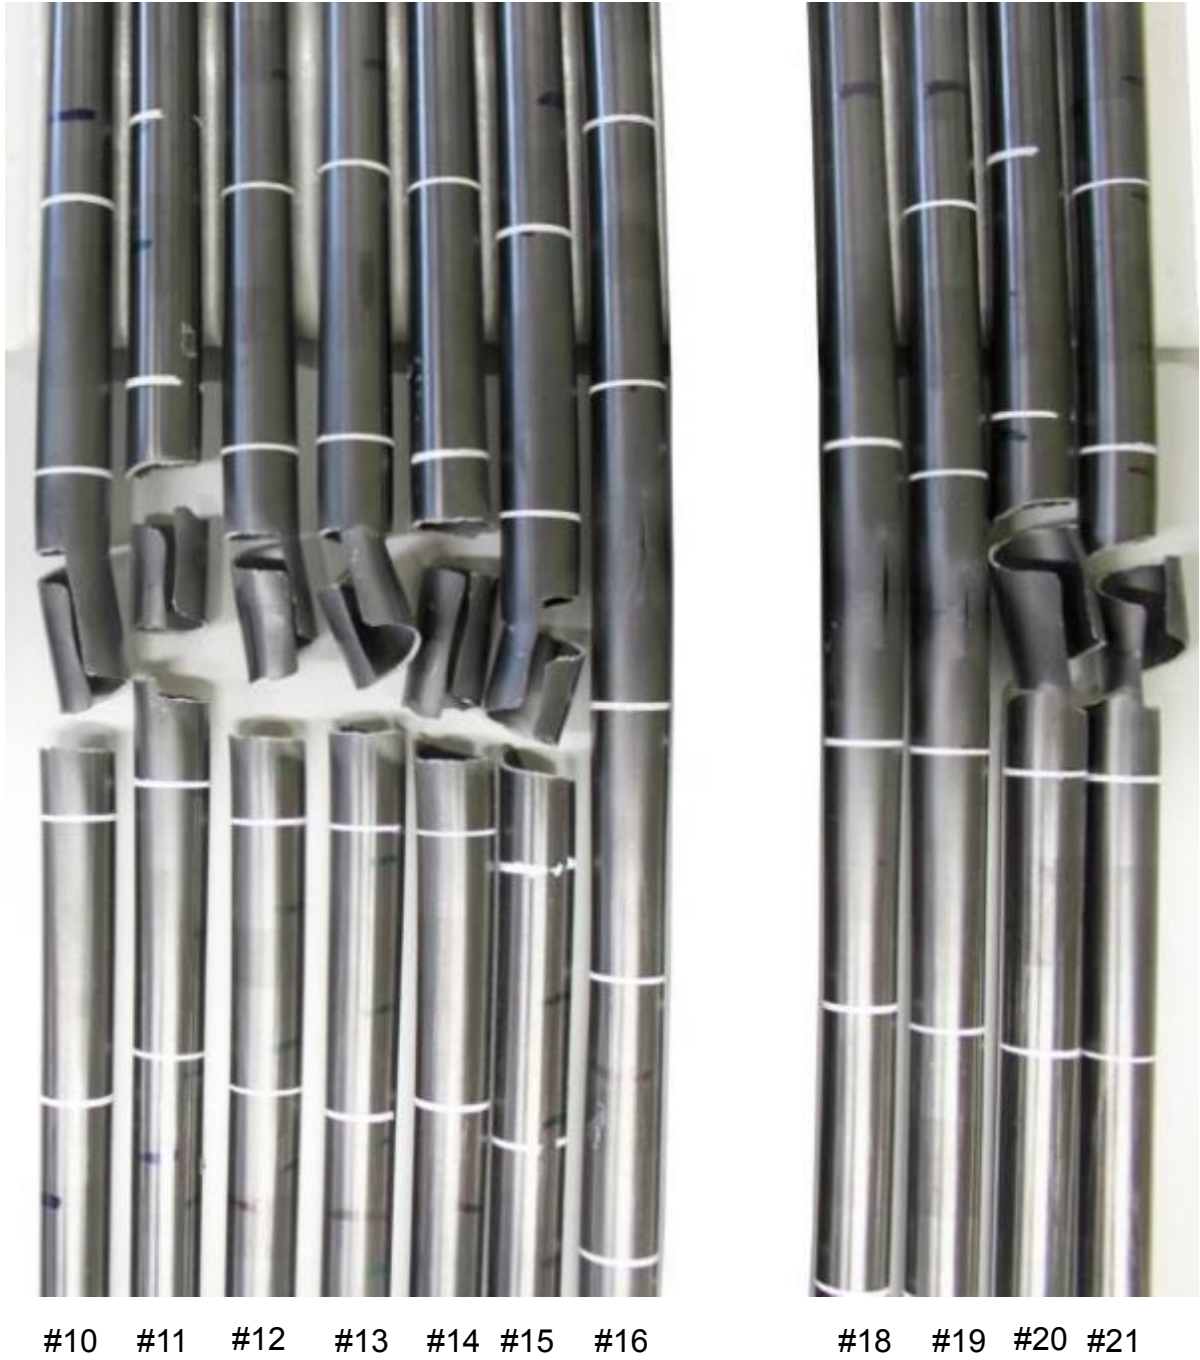
Figure 132 QUENCH-L4; Outer rods after tensile tests; ruptures due to stress concentration for the rods 10-15, 20, 21; necking of the rods 16, 18, 19.

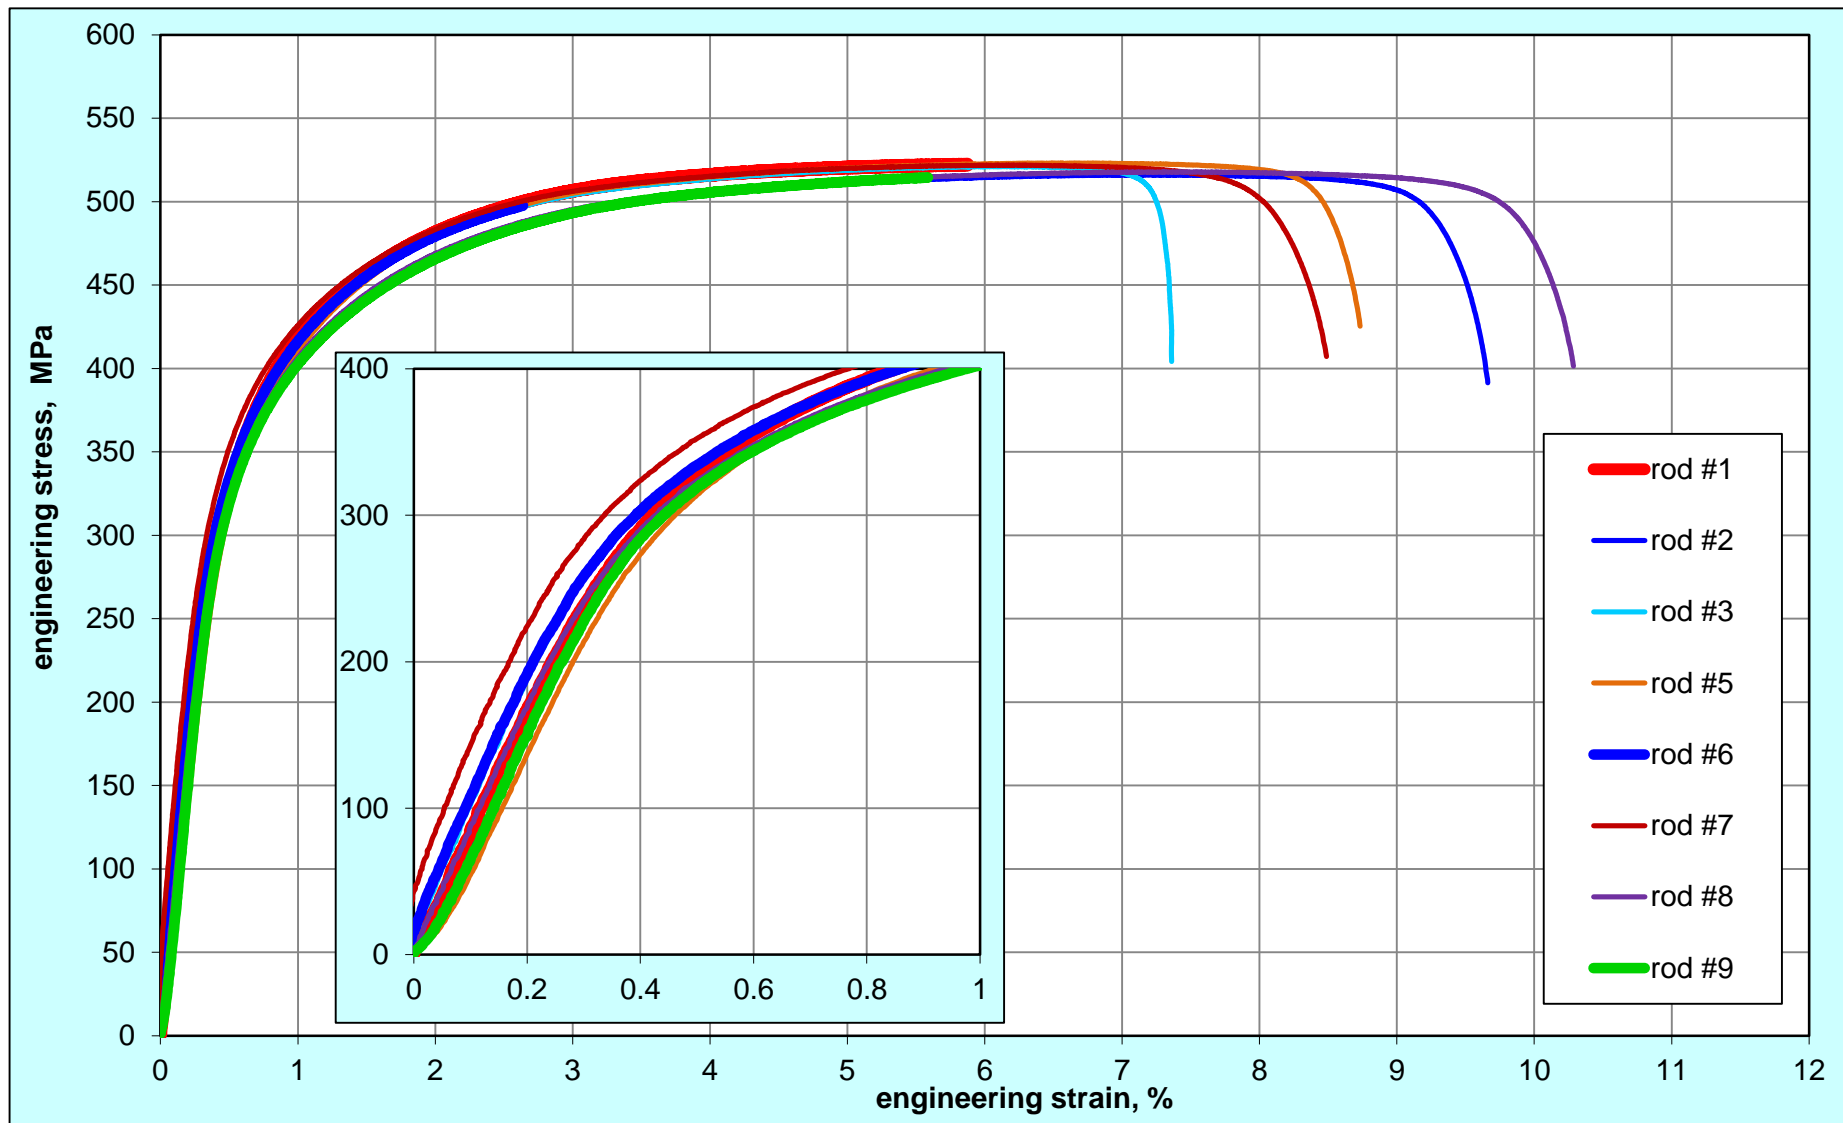
Figure 133 QUENCH-L4; Results of tensile tests with claddings of the inner rod group.

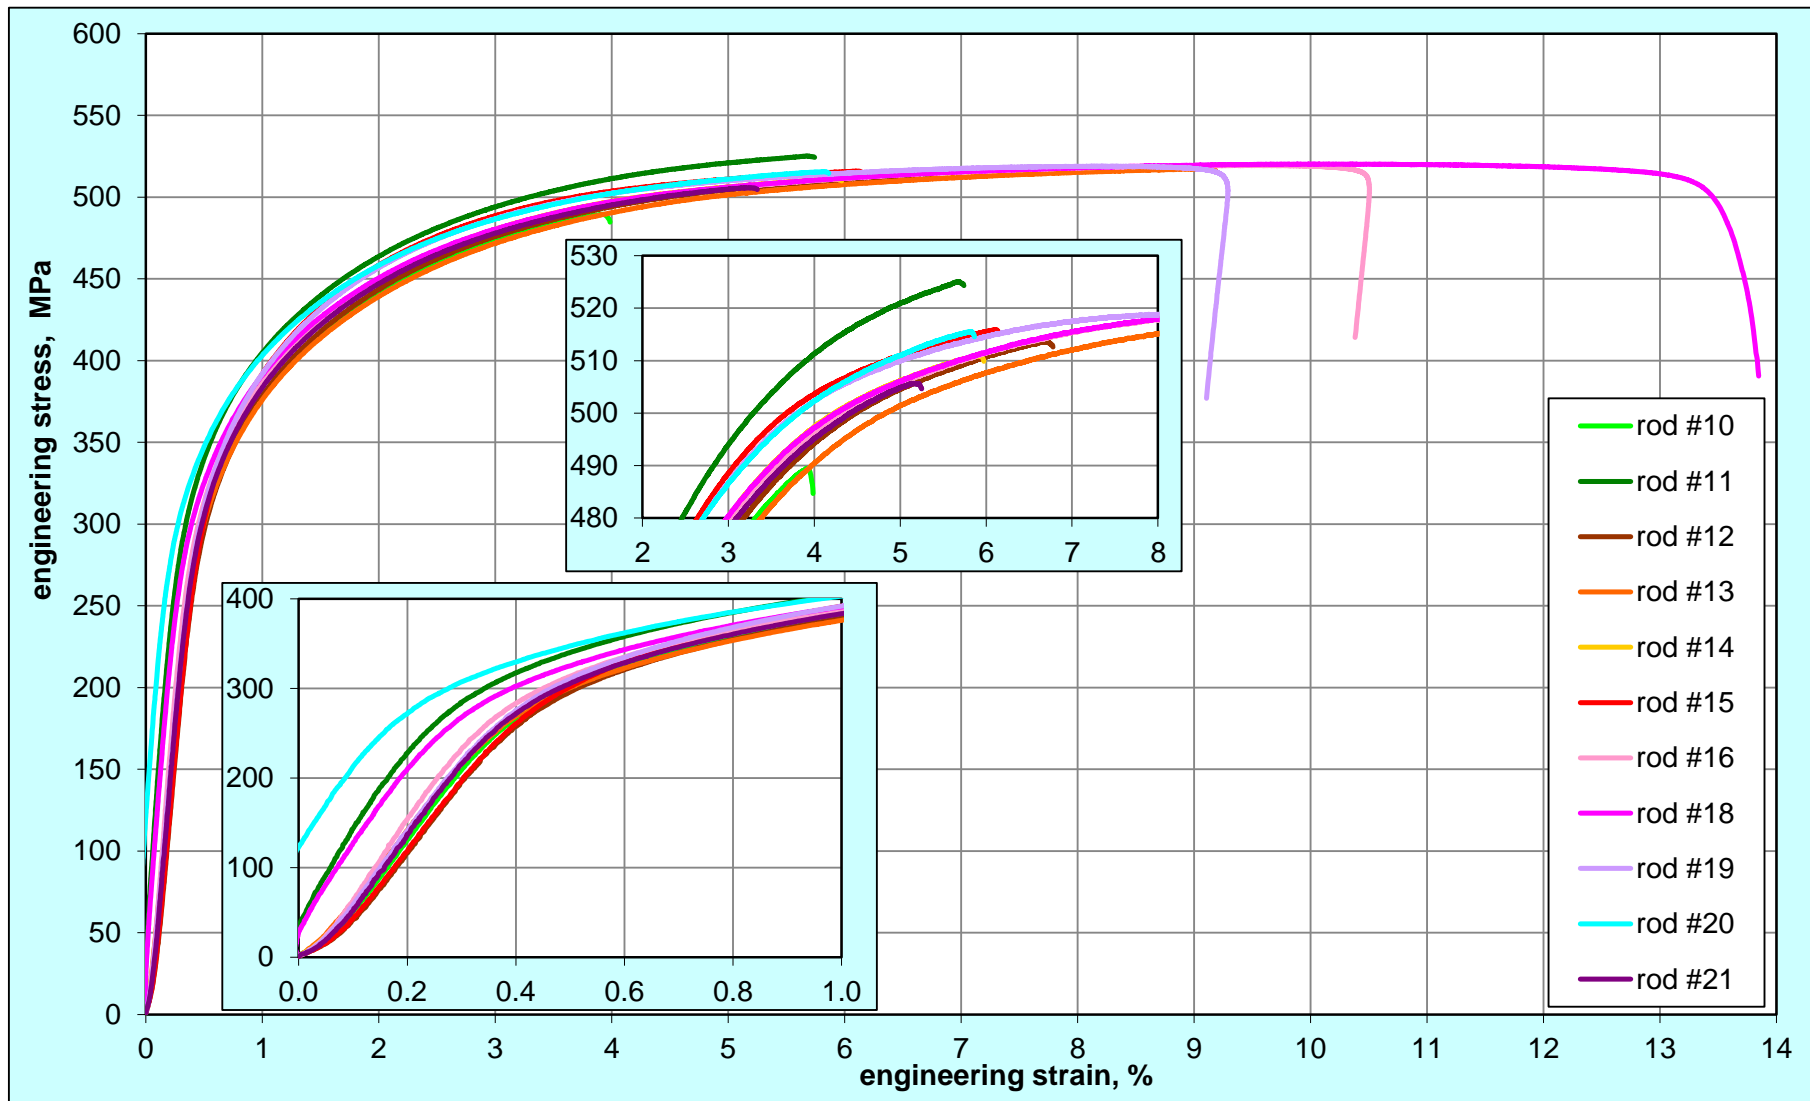
Figure 134 QUENCH-L4; Results of tensile tests with claddings of the outer rod group.

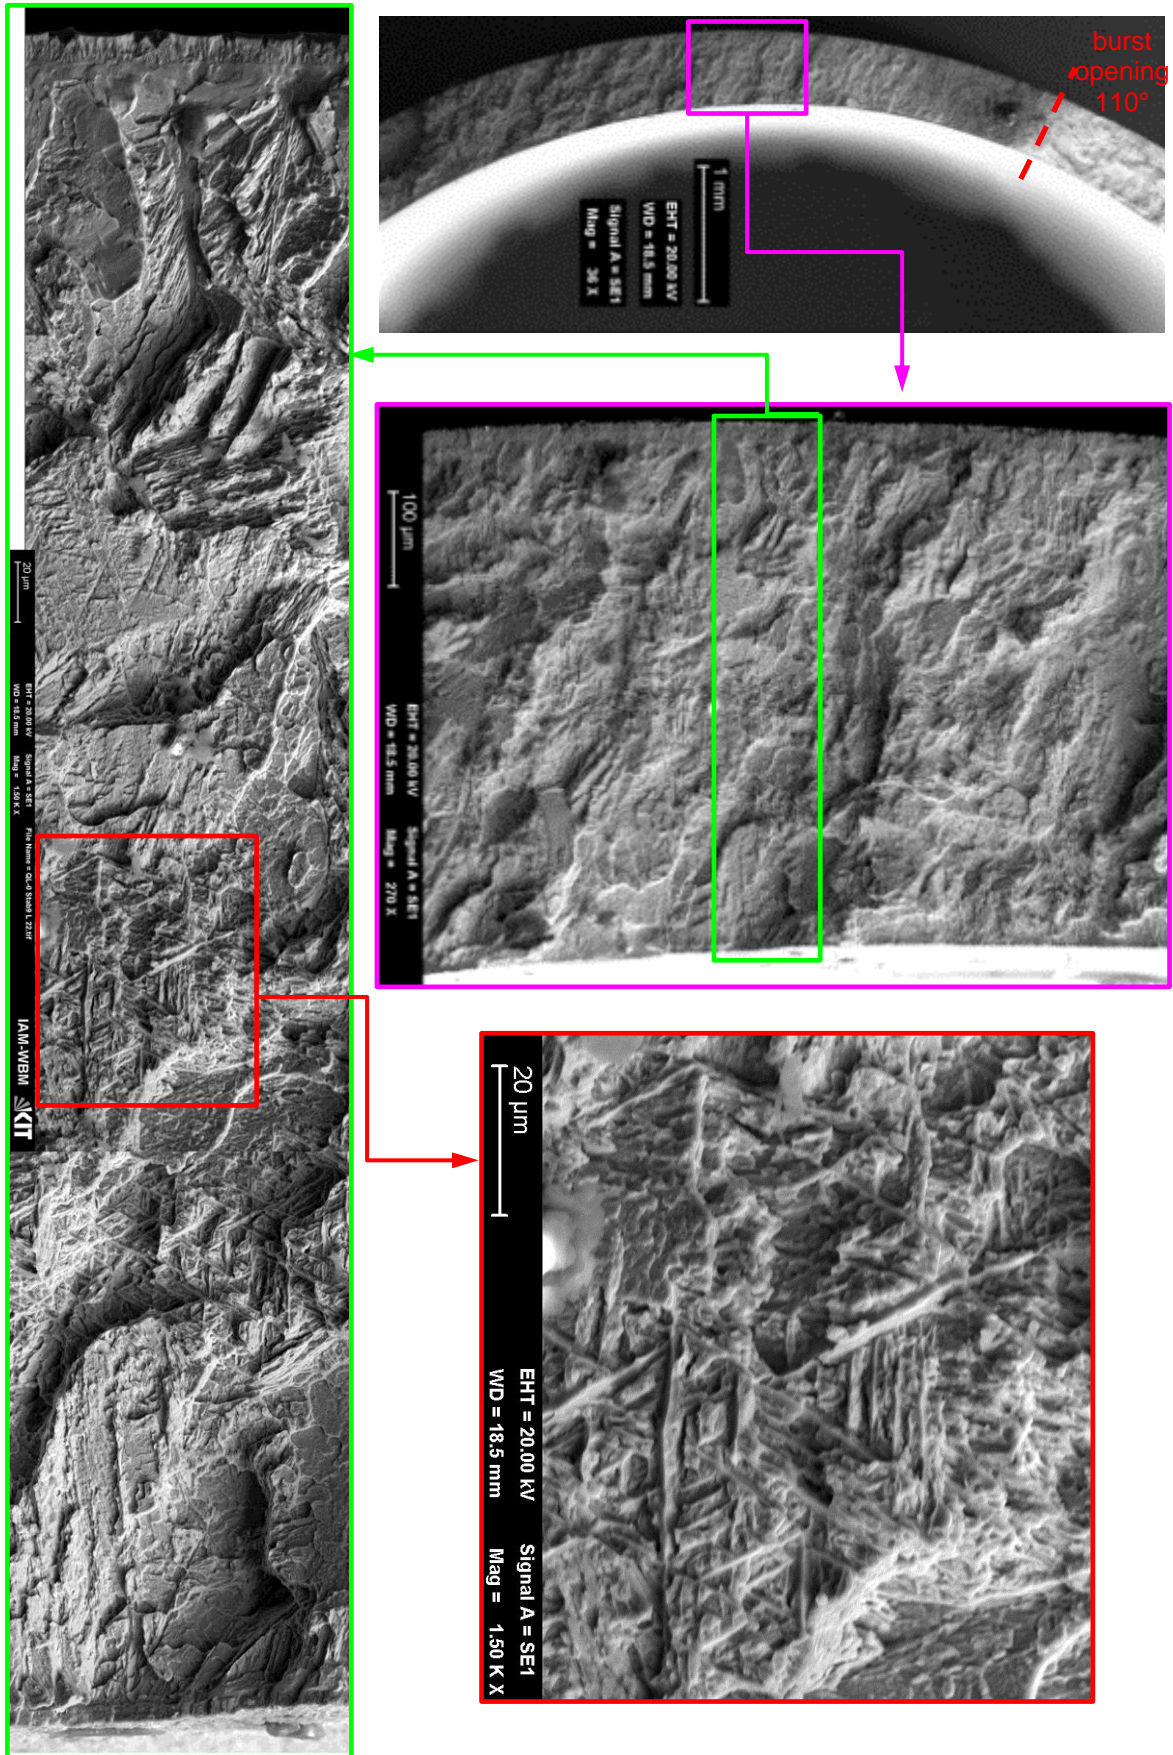
Figure 135 QUENCH-L4; SEM image of fractured surface of rod #9 at angle 90° after tensile test; top view. Brittle fracture.

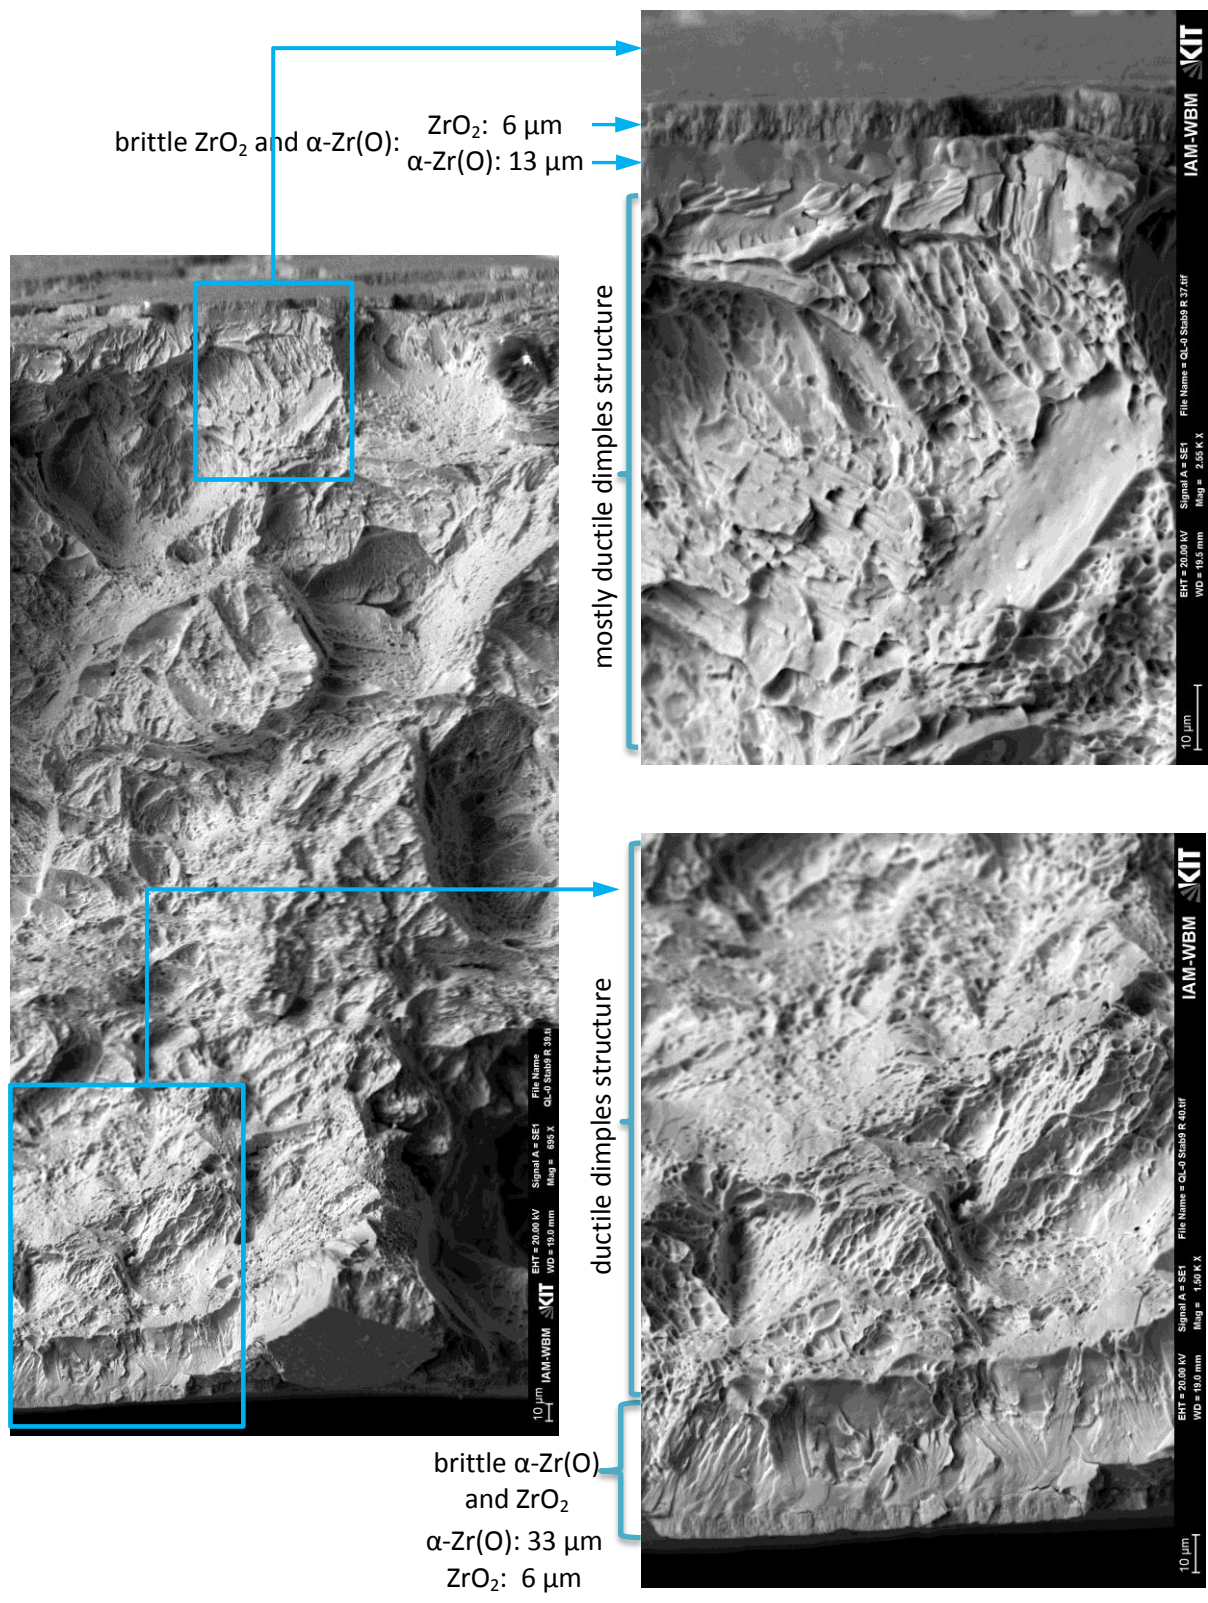
Figure 137 QUENCH-L4; SEM image of fractured surface of rod #9 at angle 290° after tensile test; top view. Ductile fracture.

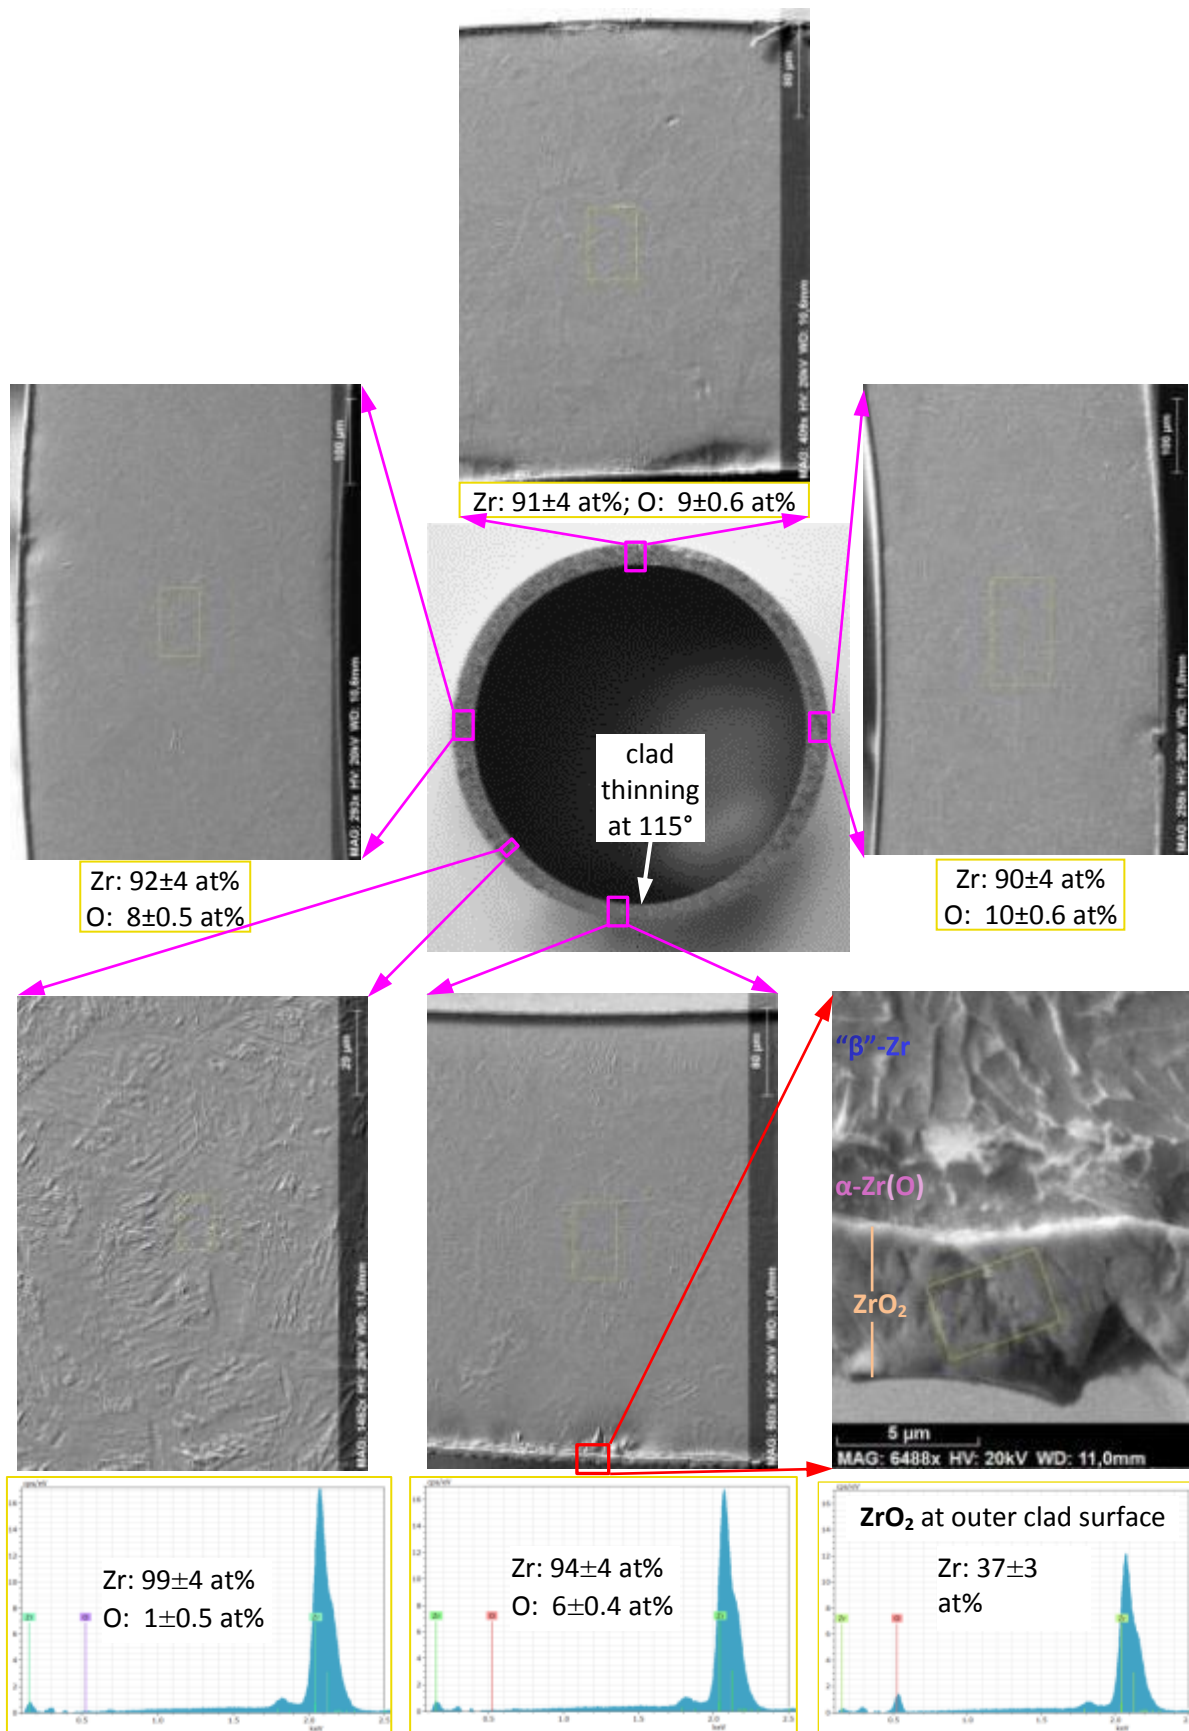
Figure 139 QUENCH-L4, Rod #9, rupture surface after tensile test (as-etched after polishing). SEM/EDX results: no oxygen in metallic part of the clad.

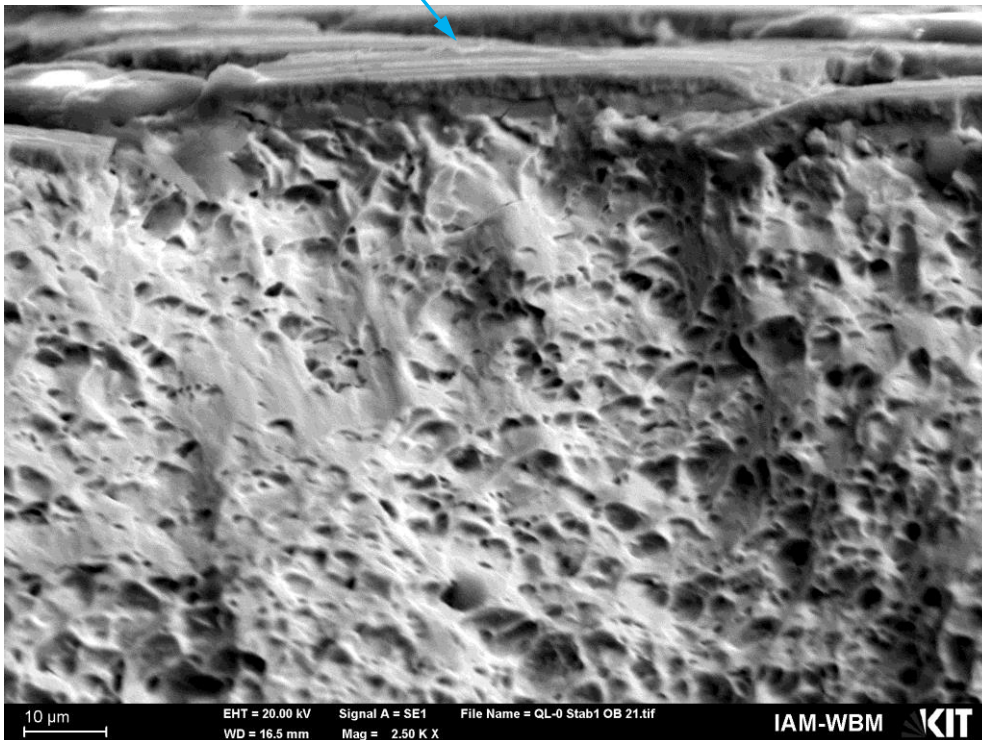
typical ductile dimples structure at *outer* cladding surface for all circumferential positions

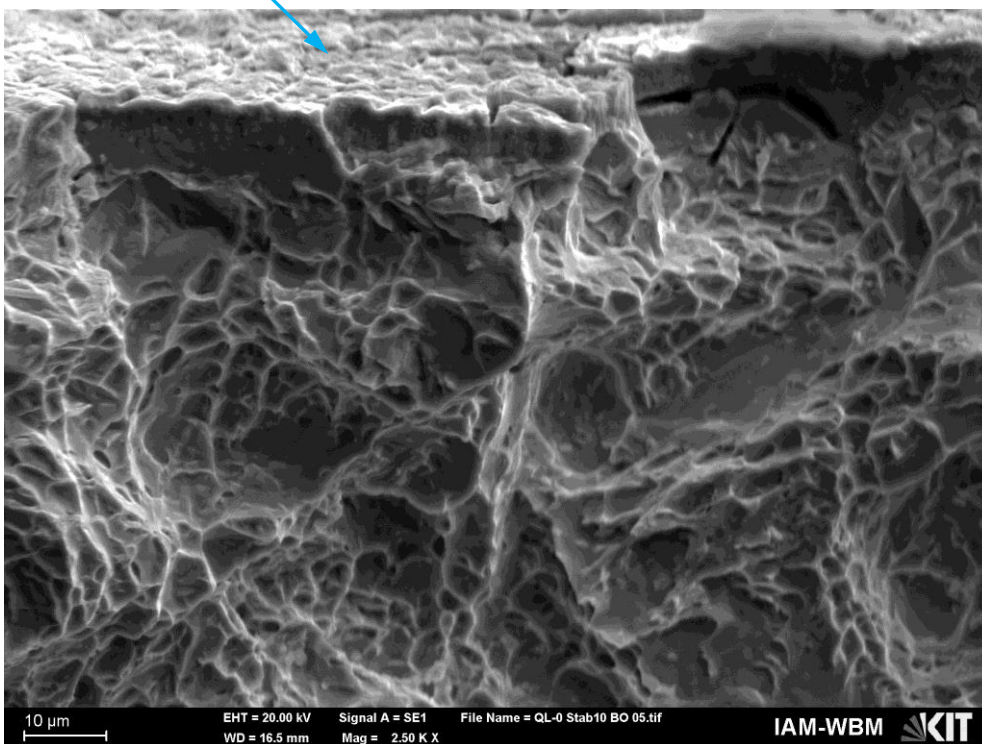
typical ductile dimples structure at *inner* cladding surface for all circumferential positions

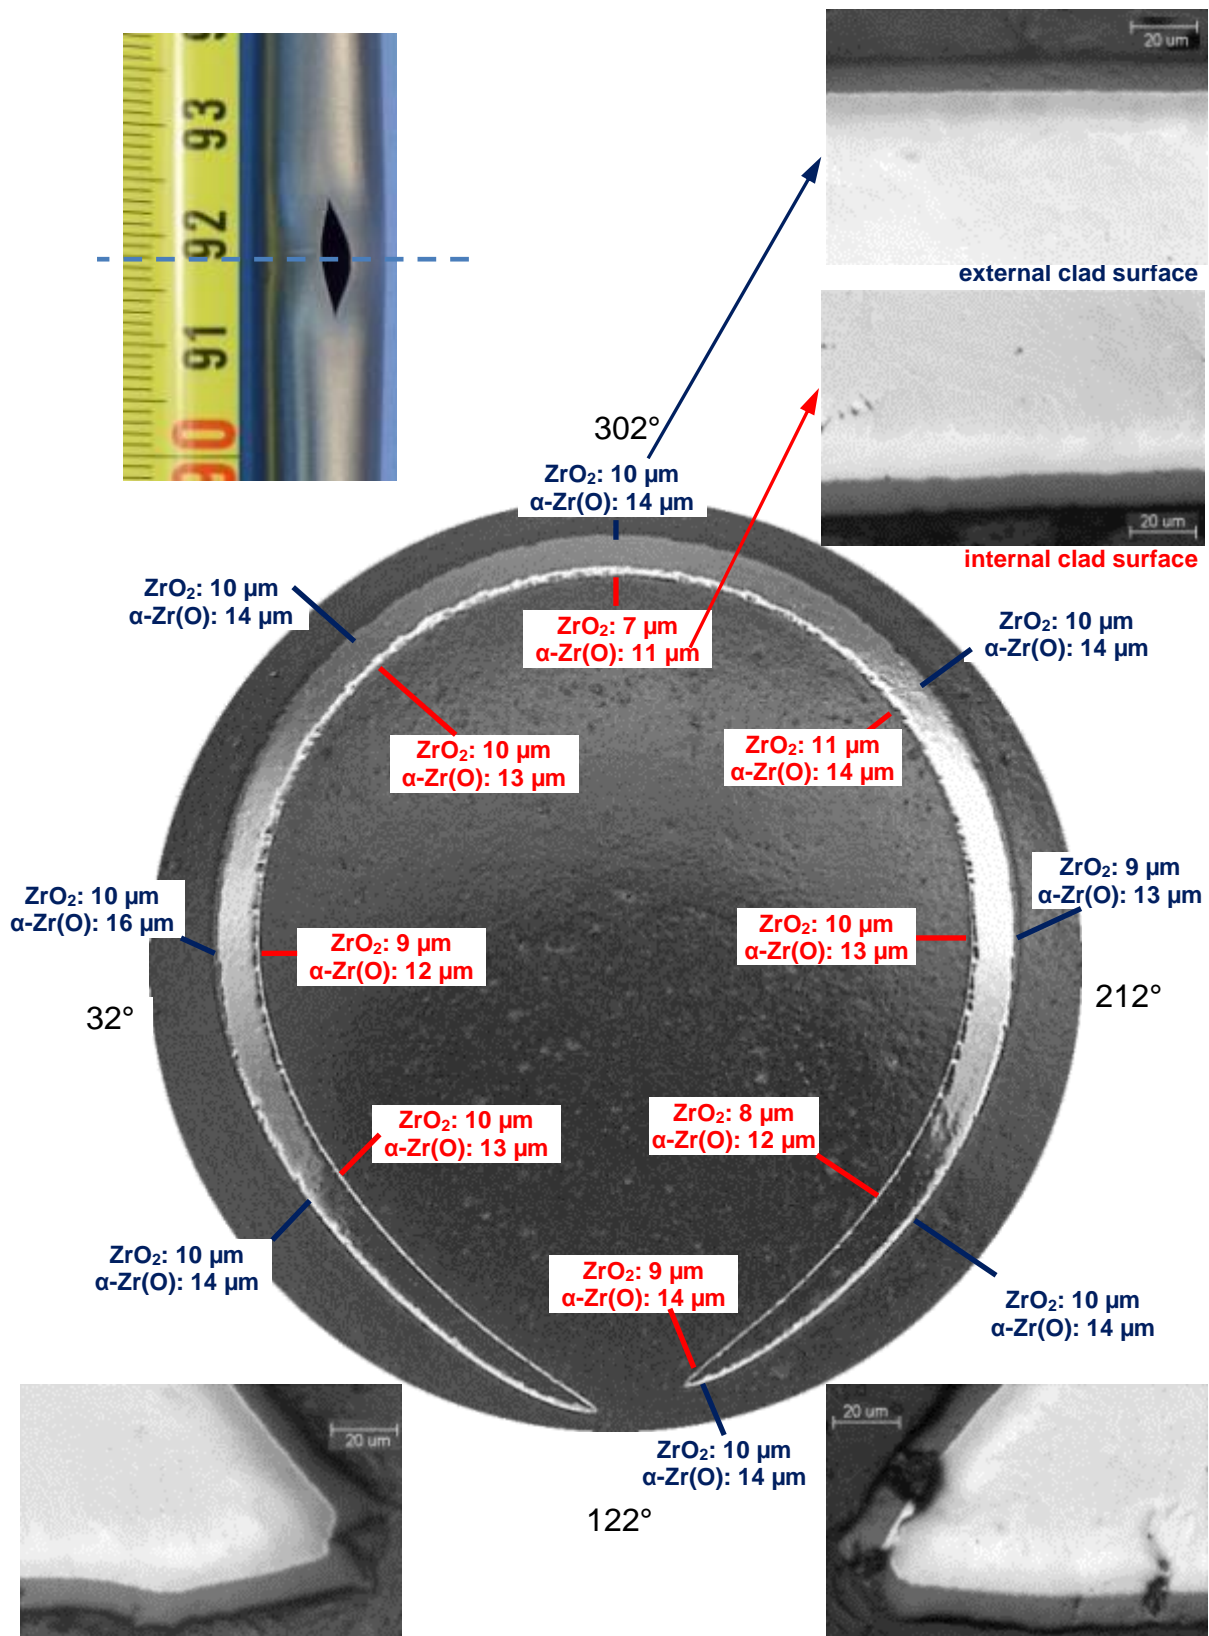
Figure 141 QUENCH-L4; Thicknesses of ZrO_2 and $\alpha-Zr(O)$ layers at outer and inner surfaces of cladding #1 at burst elevation 918 mm; top view, as polished.

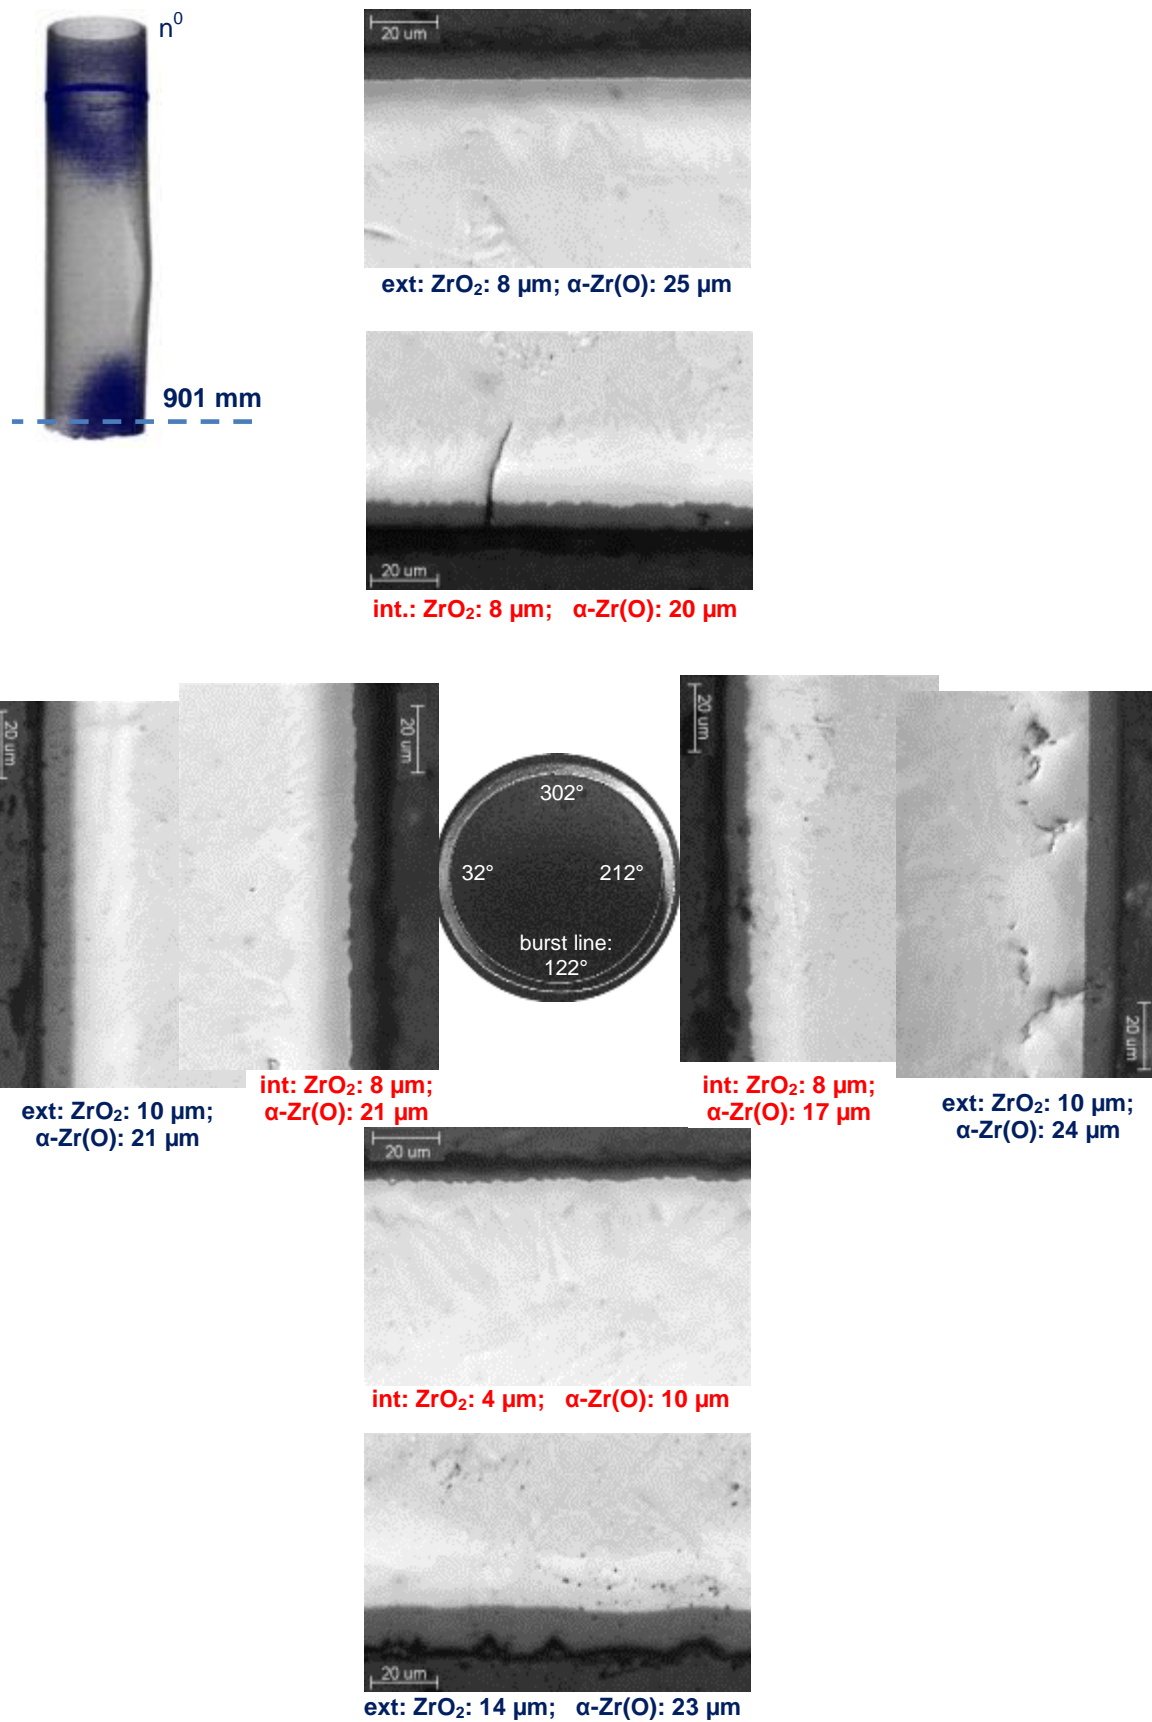
Figure 143 QUENCH-L4; Thicknesses of ZrO_2 and α -Zr(O) layers at outer and inner surfaces of cladding #1 underneath burst at bundle elevation 901 mm; top view, as polished.
