QUENCH - LOCA - REPORTS Nr. 5

**Results of the LOCA bundle test QUENCH-L4
with pre-hydrogenated M5[®] claddings (SR-7712)**

J. Stuckert, M. Große, A. Pshenichnikov , C. Rössger,
M. Steinbrück, M. Walter

Karlsruher Institut für Technologie

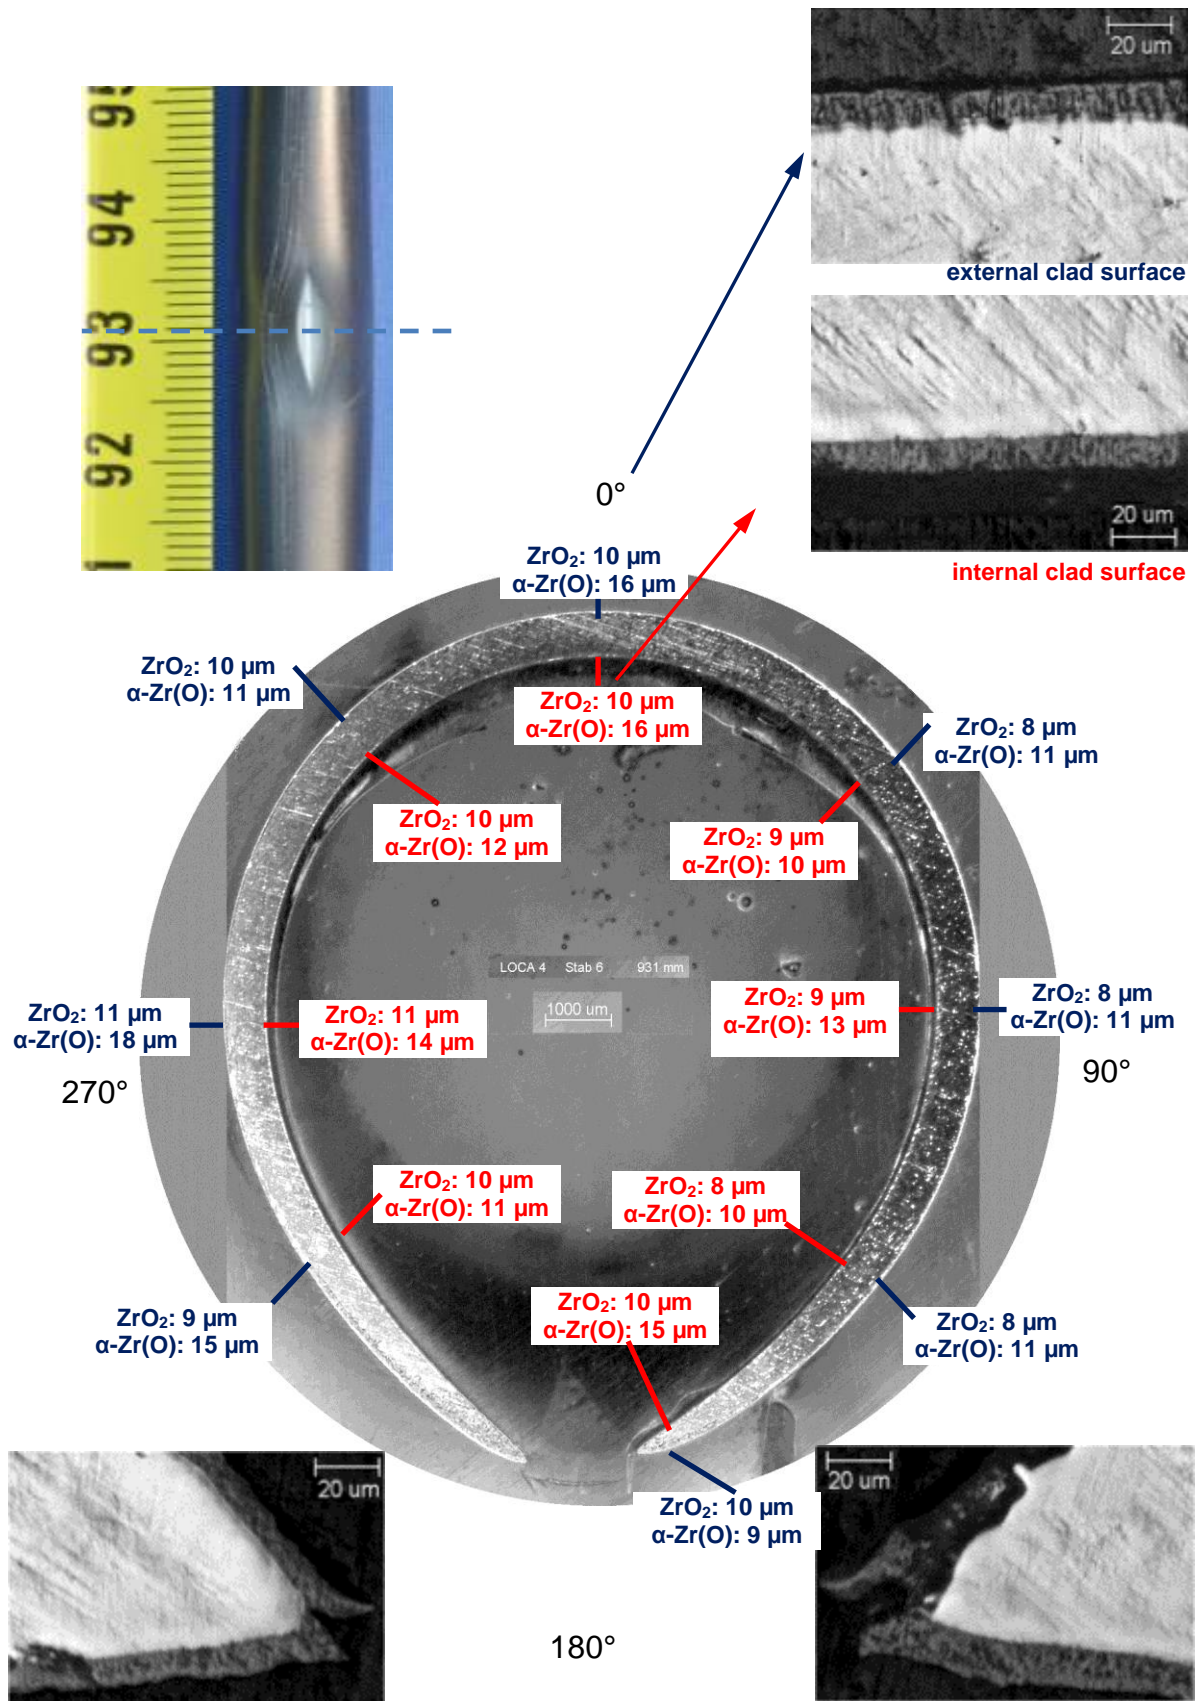
Figure 144 L4; Thicknesses of ZrO_2 and $\alpha-Zr(O)$ layers at outer and inner surfaces of cladding #6 at burst elevation 931 mm; top view, as polished.

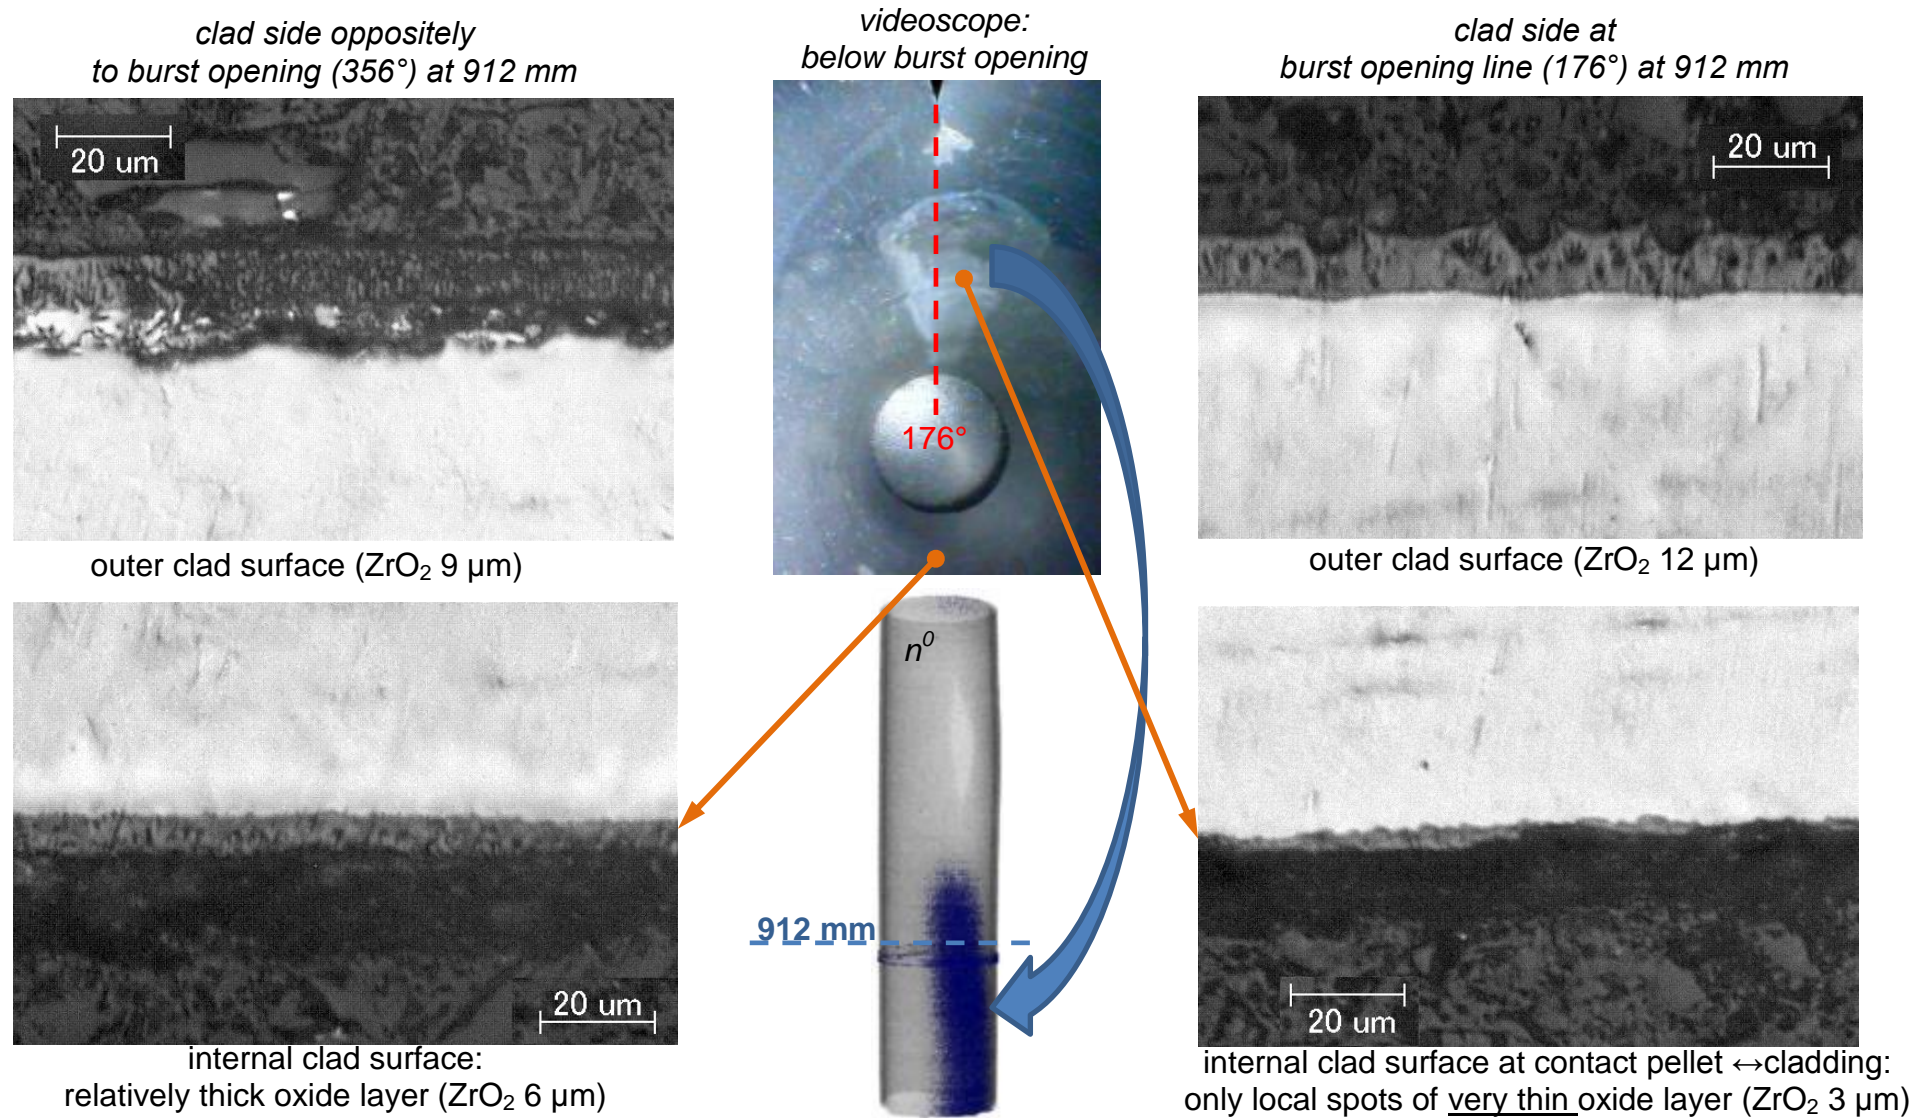
Figure 145 UENCH-L4; Correspondence between practically absence of inner oxide layer (contact clad ↔ pellet) and hydrogen spot for rod #6.

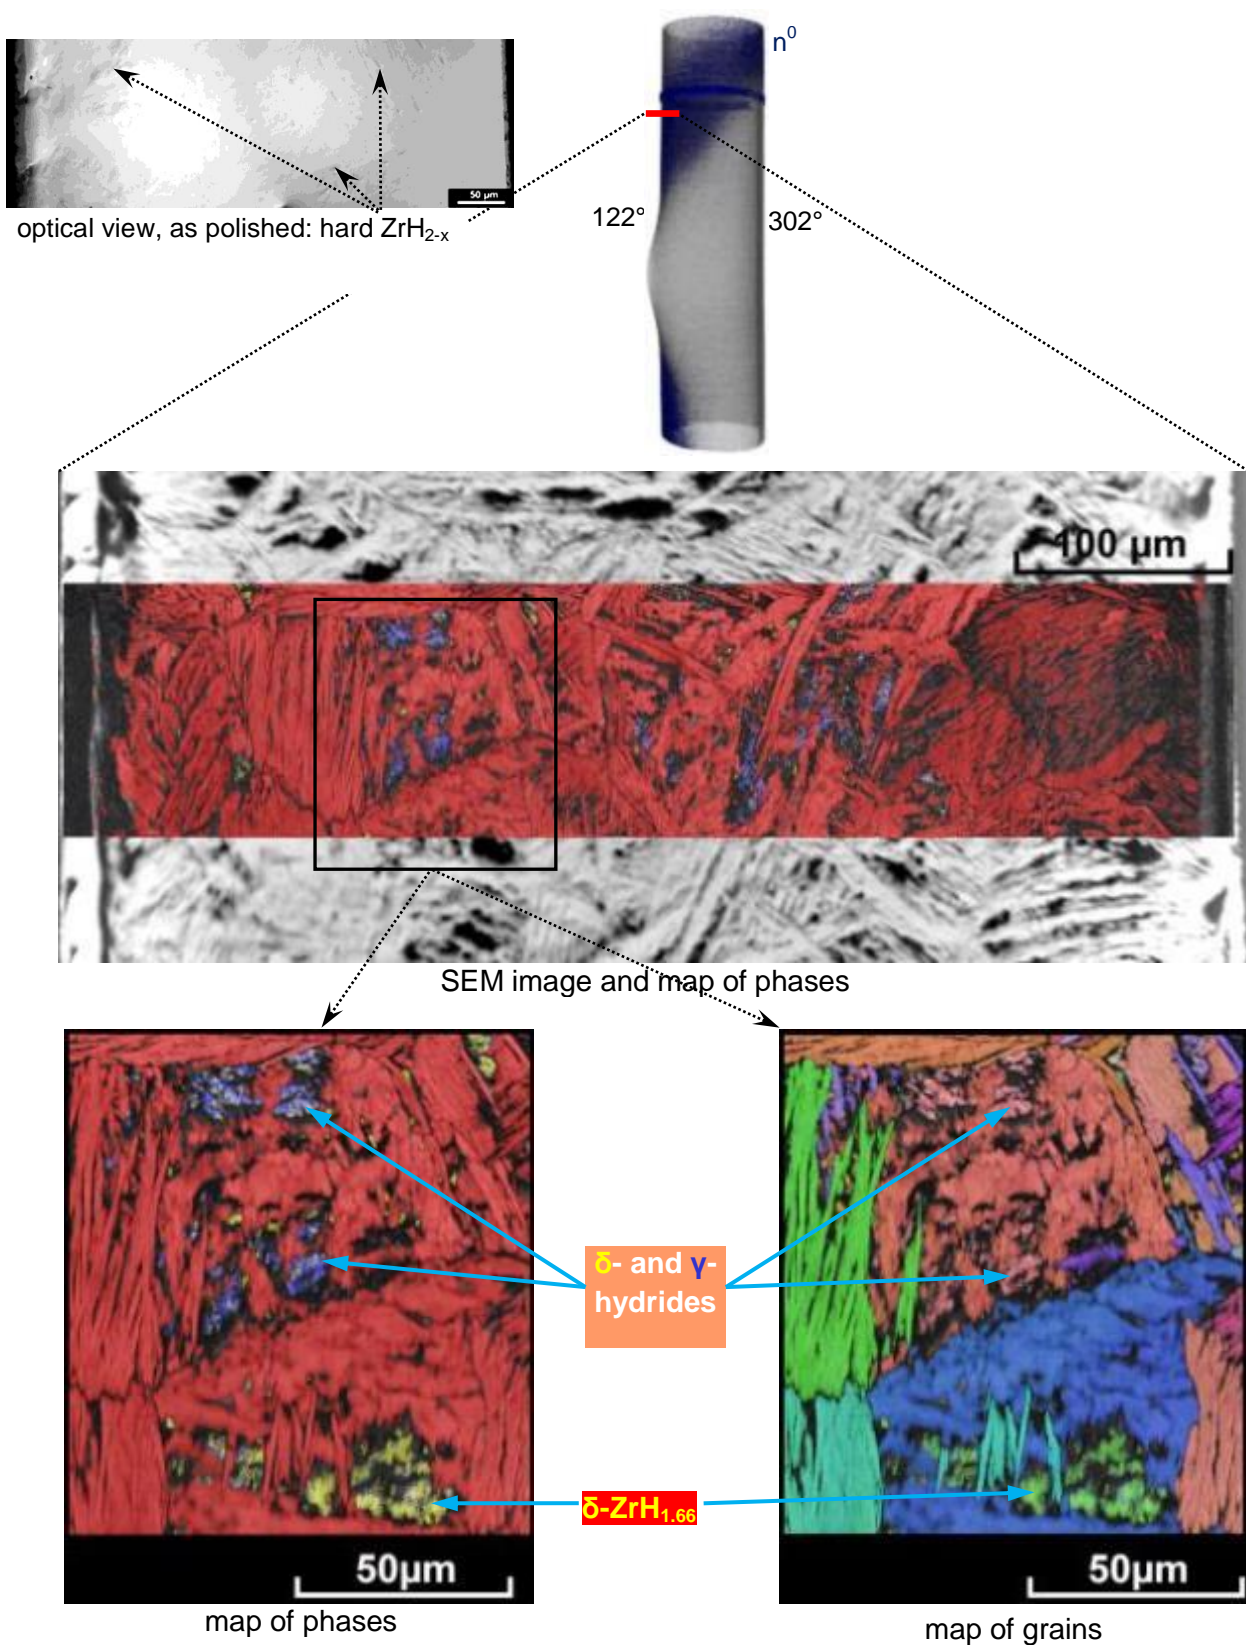
Figure 151 QUENCH-L4; EBSD analysis of δ - $ZrH_{1.66}$ and γ - ZrH hydrides (mostly intra-granular) agglomerated inside α -Zr matrix for rod #1 at elevation of 935 mm (area of hydrogen band visualized by neutron tomography) at the burst opening cladding side.

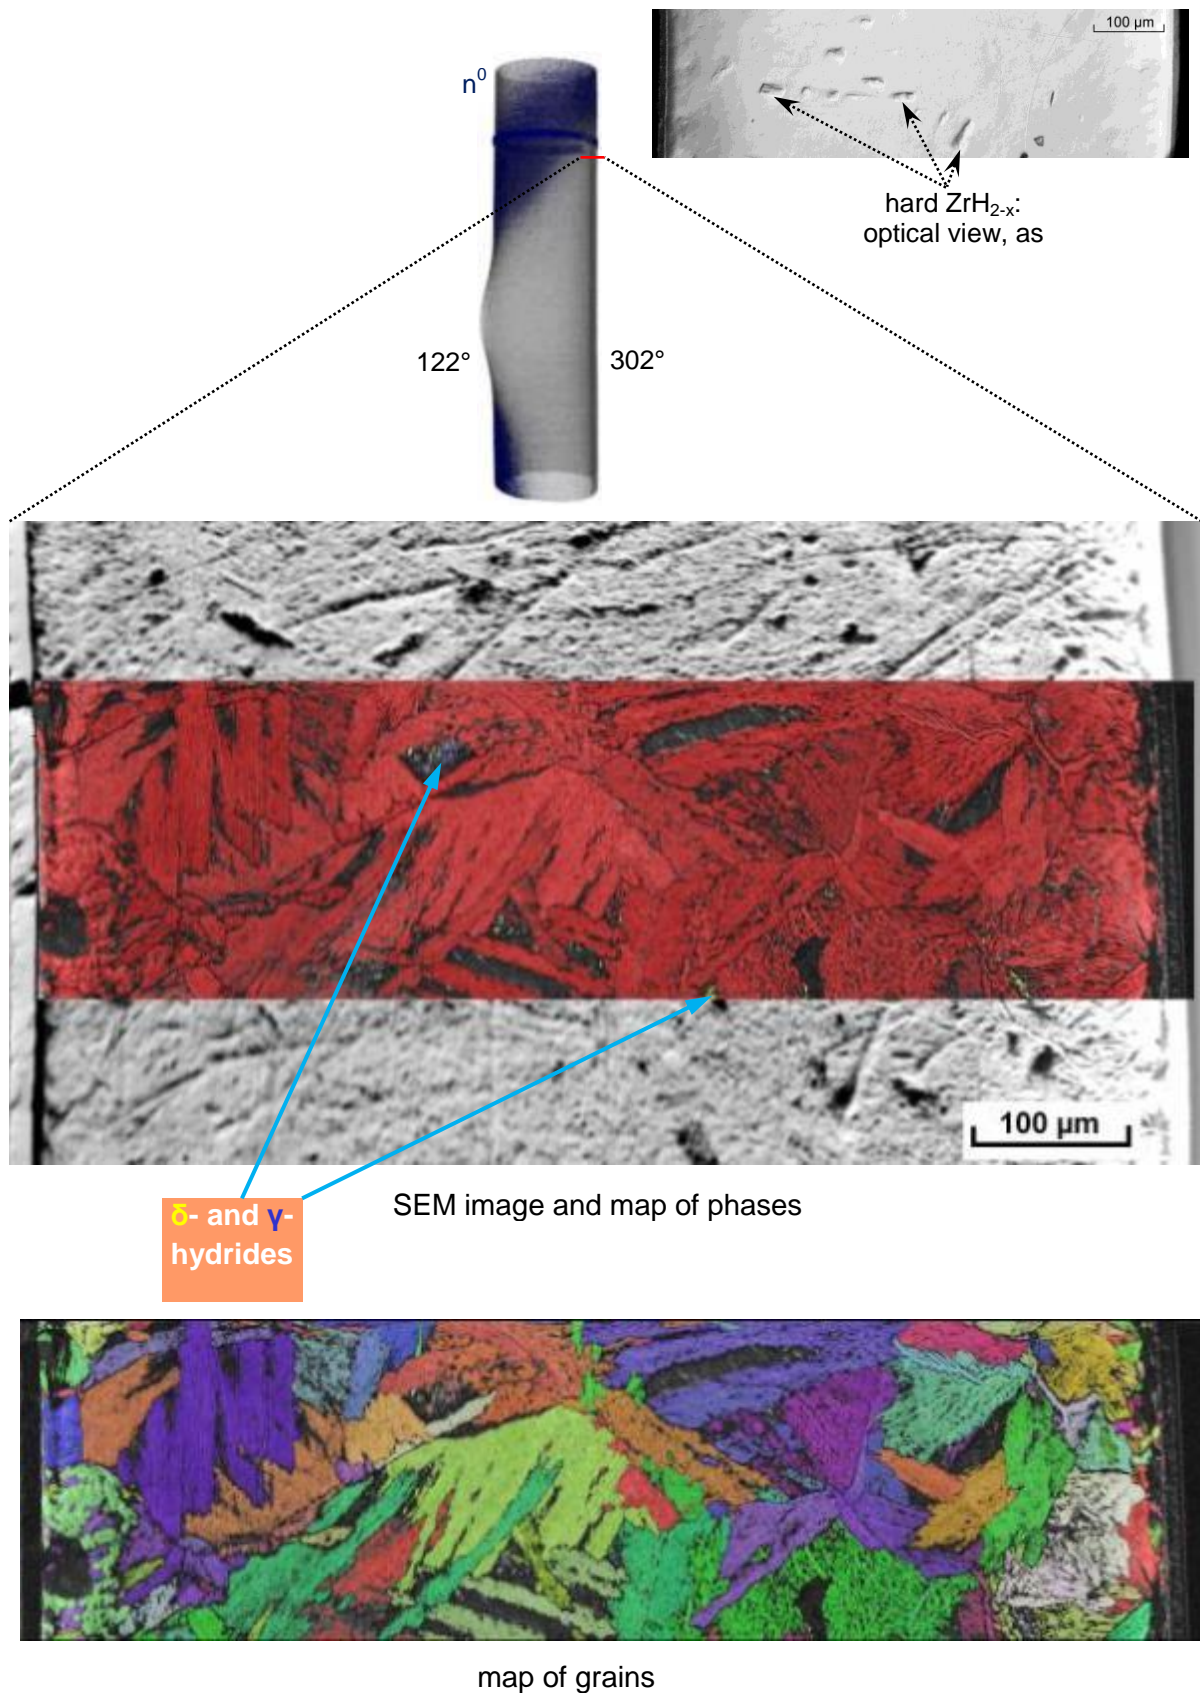
Figure 152 QUENCH-L4; EBSD analysis of δ - $ZrH_{1.66}$ and γ - ZrH hydrides (mostly intra-granular) agglomerated inside α -Zr matrix for rod #1 at elevation of 935 mm at the cladding side oppositely to the burst opening side.

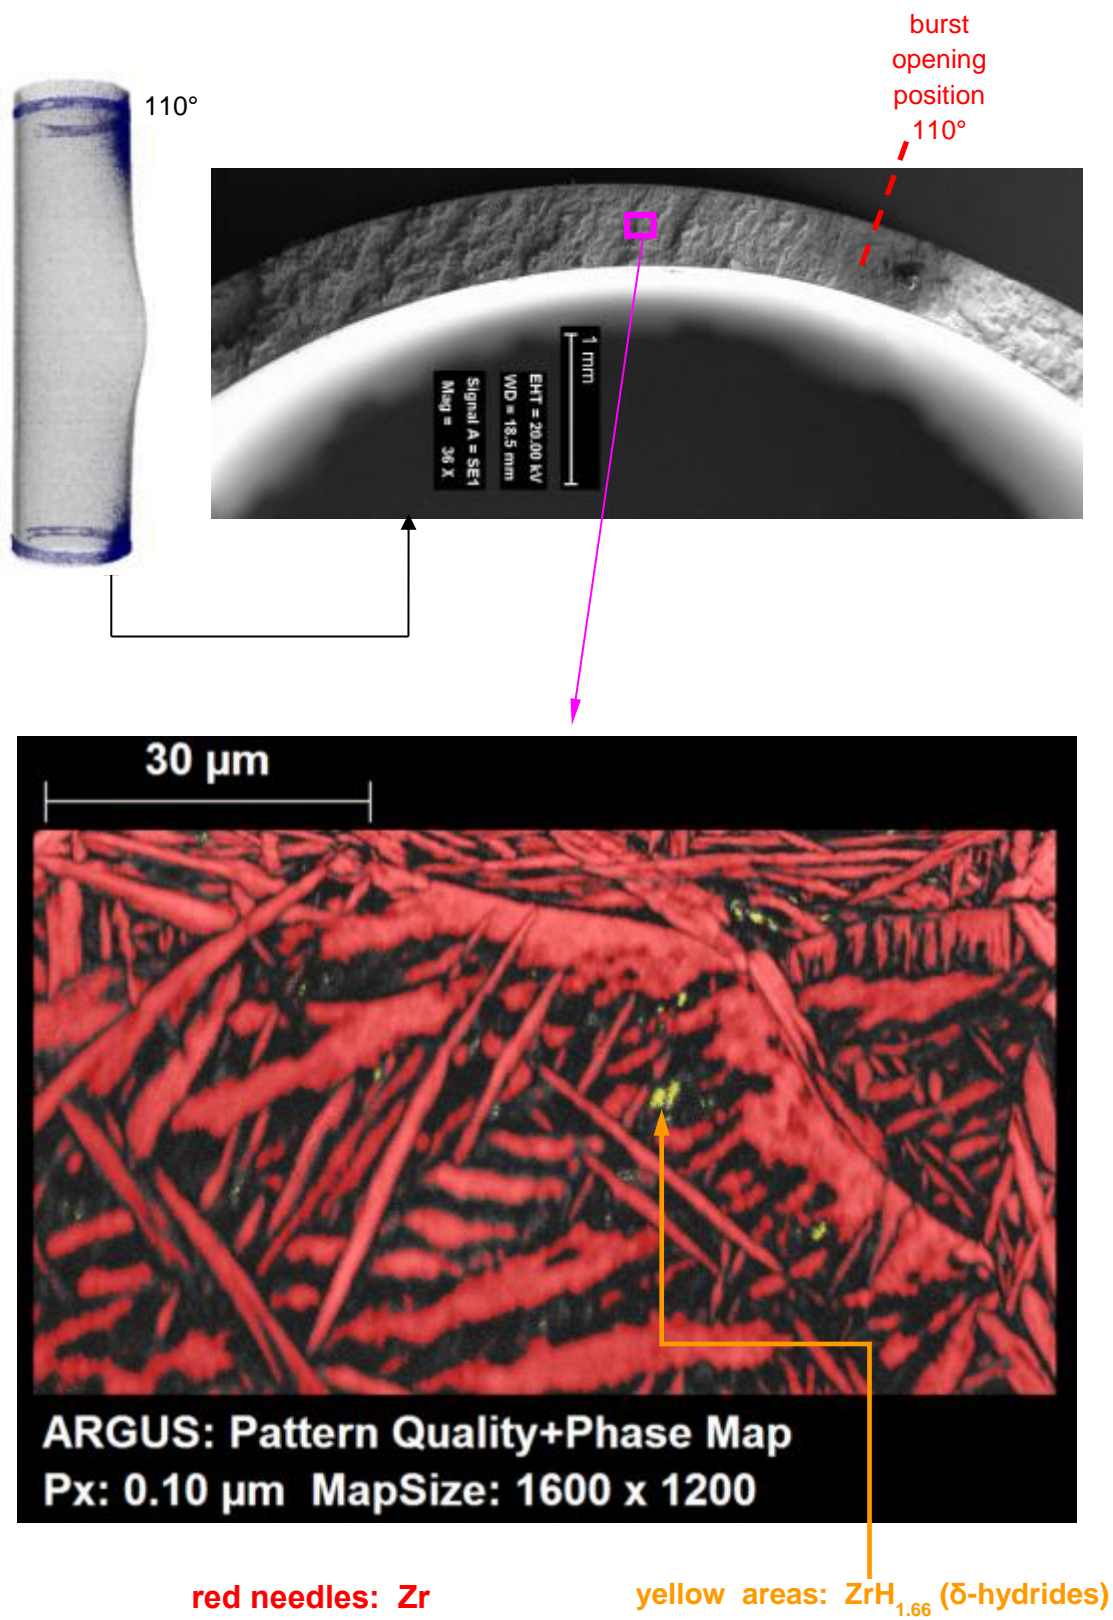
Figure 156 QUENCH-L4; EBSD analysis of fractured surface of rod #9 at hydrogen spot (on the line of burst opening 20 mm below opening; after polishing and etching).
