QUENCH - DEBRIS: Scientific Report NUSAFE 3572

**Results of the QUENCH-DEBRIS (QUENCH-17) test
with strongly oxidized Zircaloy-4 and hafnium
claddings filled with segmented pellet simulators**

NUSAFE 3572

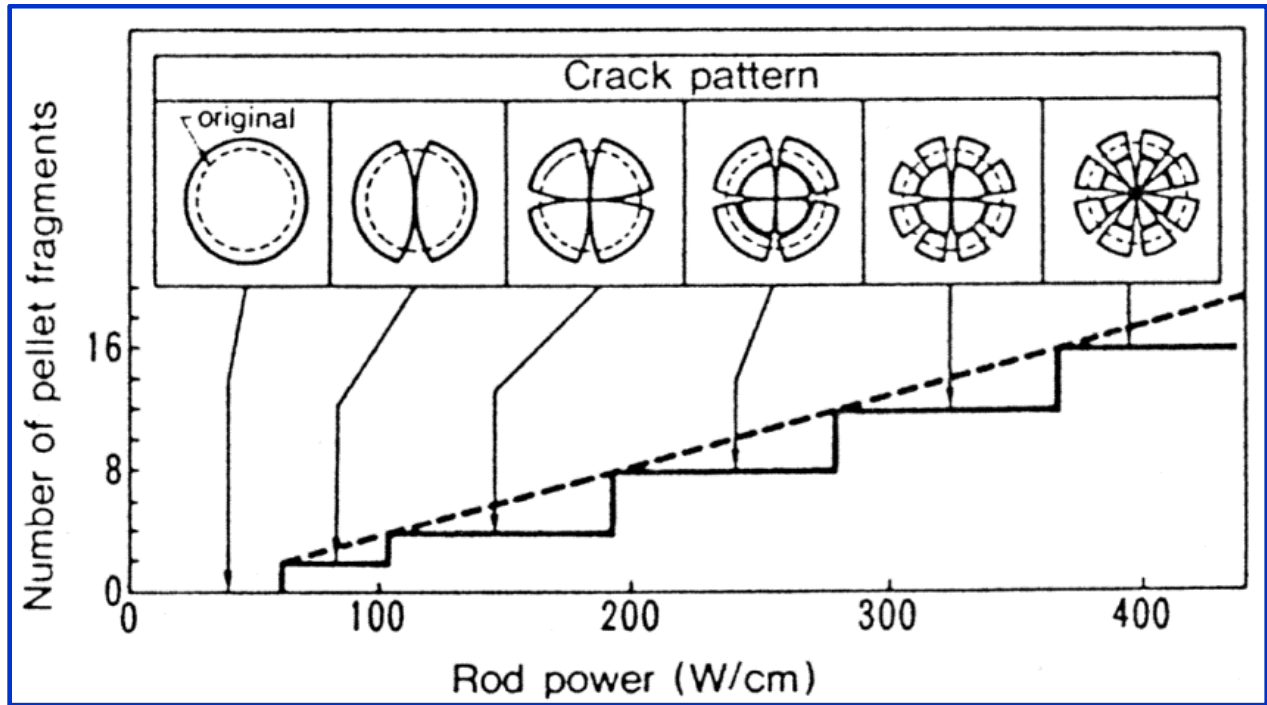
Pellet segmentation during operation [7]

Figure 16 QUENCH-17; pre-segmented pellet

unheated rods were filled with pre-fragmented zirconia pellets ([Fig. 16](#)). The number of radial segments (eight) corresponds to pellets of PWR fuel rods with average linear rod power between 200 and 300 W/cm (PWR pellets cracked due to thermal expansion) [7]. The physical properties of the pellet material are described in [Table 3](#). The gaps between segments were filled with zirconia powder to model the fine fraction of high burn-up fuel ([Fig. 18](#)). Previously, a single rod test on debris release was performed ([Fig. 17](#)).

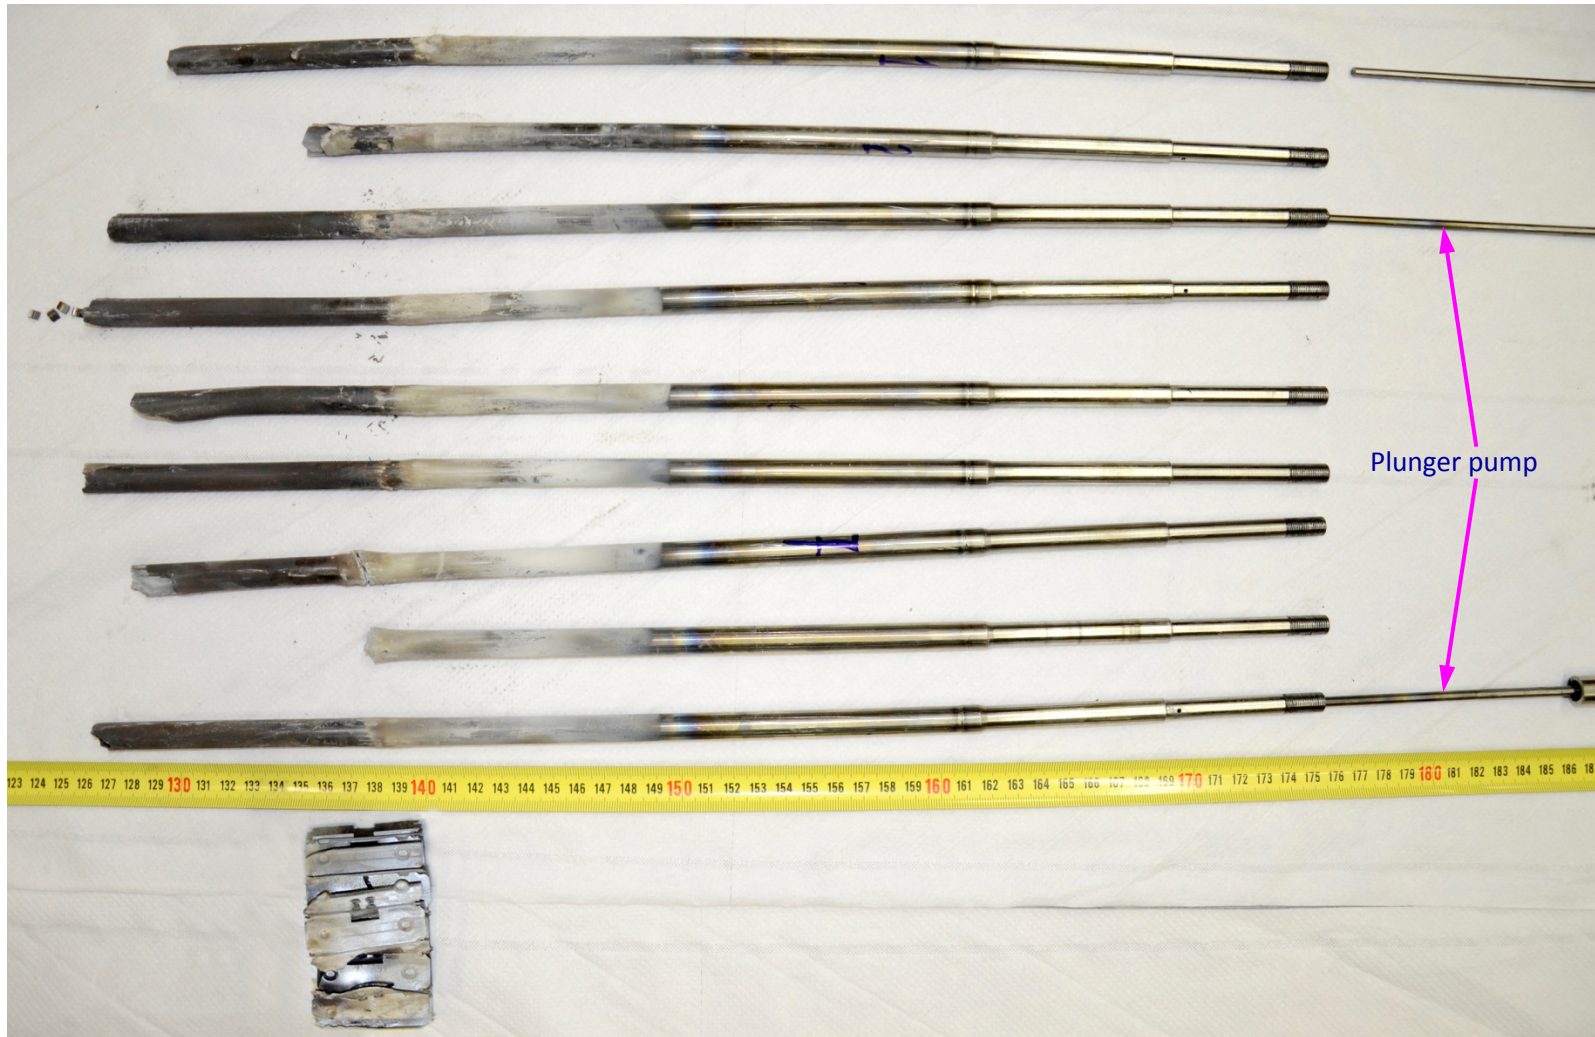
Figure 44 QUENCH-17; different parts of Hf corner rods withdrawn from the bundle after the test

The surface of the Hf corner rods withdrawn after the test showed a white oxide layer (HfO_2) between about 50 and 1100 mm (Fig. 44). The appearance of oxide layers below 1400 mm (below the upper grid spacer) is different for Zry (Fig. 45) and Hf (Fig. 46) claddings for all withdrawn upper parts of rods: whereas the oxide layer at the

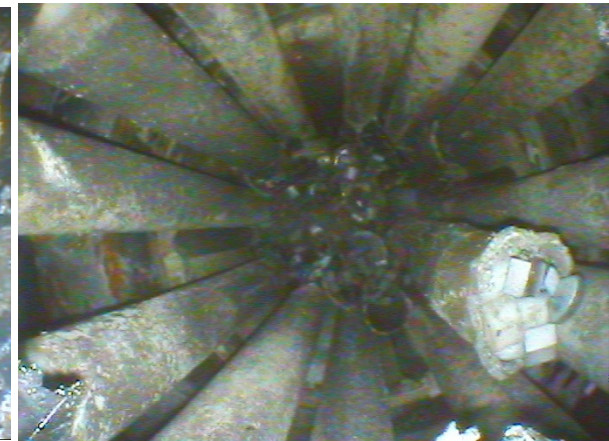
1200 mm: pellet segments inside Zry cladding of rod #8

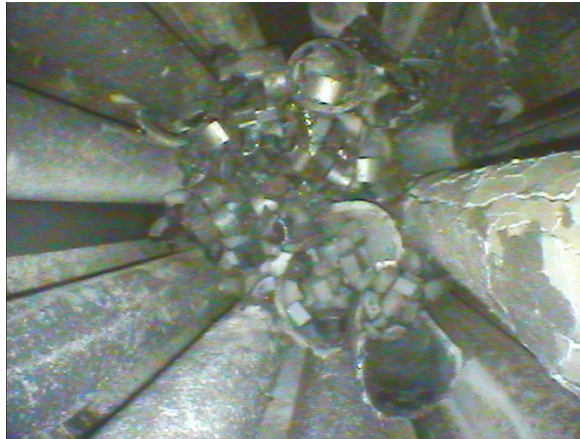
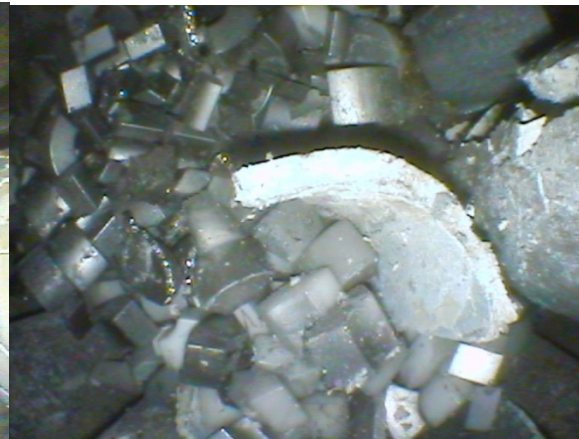
1150 mm: pellet segments inside Zry claddings and at the top of GS #3; through going cracks inside strong oxidized cladding #8; intact oxide of Hf claddings

1100 mm: pellet and Zry cladding remnants at the top of GS #3

Figure 48 QUENCH-17; videoscope observation (top view) of the bundle after removal of upper parts of 9 central unheated rods with Zry claddings and before removal of the Zry grid spacer GS #4.

surface of Hf claddings is white below and above this level, the oxide layer at the Zry surface is black below 1400 mm. The white surface of Hf claddings in this upper region was observed also by endoscope (Figs. 48, 49). The metallographic analysis showed that the oxidation of Zry claddings in this upper region was significantly stronger than the oxidation of Hf claddings. The tube segment of Zry-rod #7 was extracted from the third grid spacer and cut at elevation 1100 mm. Metallographic observation of the corresponding cross section showed complete oxidation of the cladding. The oxide thickness of the same rod at elevation 1430 mm was 30 μm , but the $\alpha\text{-Zr(O)}$ layer was very thick (270 μm). The Hf cladding of the heated rod #17 was cut at elevation 1050 mm for the determination of the hafnium oxidation. Metallographic measurements showed the formation of the hafnium oxide layer with a thickness of 110 μm ; the residual cladding metal was completely converted to the $\alpha\text{-Hf(O)}$ phase. The surface of the middle part of the Hf shroud appeared also as white oxide layer (Fig. 51).

Figs. 48 and 49 show that pellet segments from withdrawn (*after the test*) upper parts of the inner rods were collected at the upper surface of the spacer grid #3 (about 1100 mm). Inspections of the bundle top under this spacer (below 1050 mm) using an endoscope shows also the formation of a heterogeneous debris bed consisting of segmented pellets located in the sub-channels between the rods (Fig. 50). Completely oxidised Zry claddings exhibited some local shedding of spalled fragments; however the general morphology of the rods was mostly as large shards consistent with only minor damage prior to the imposed axial loading.

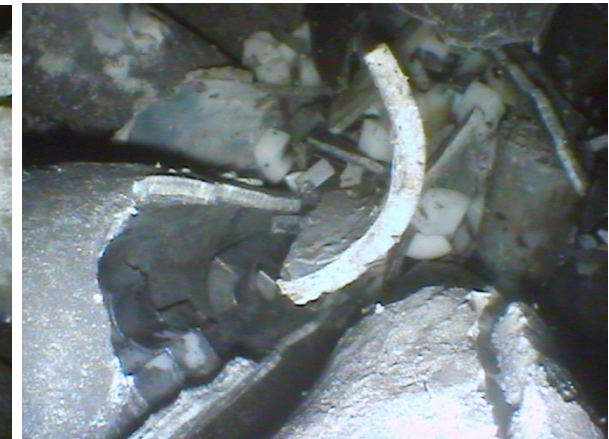
1100 mm: view of oxidized Zry claddings after partial removal of debris

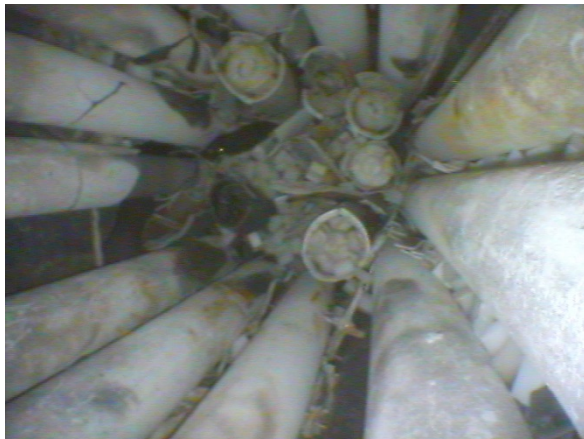
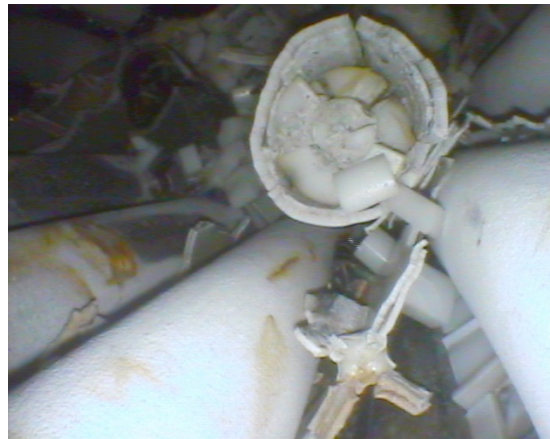
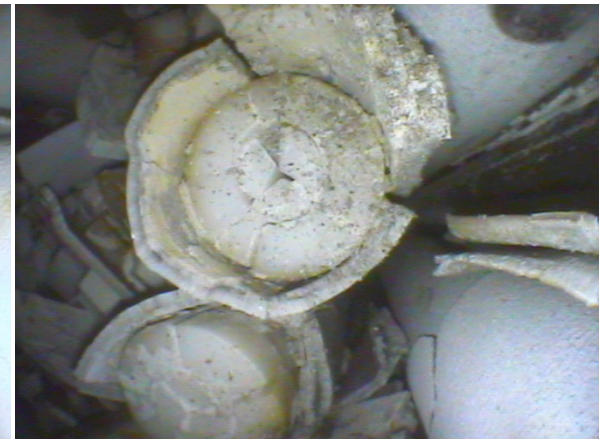
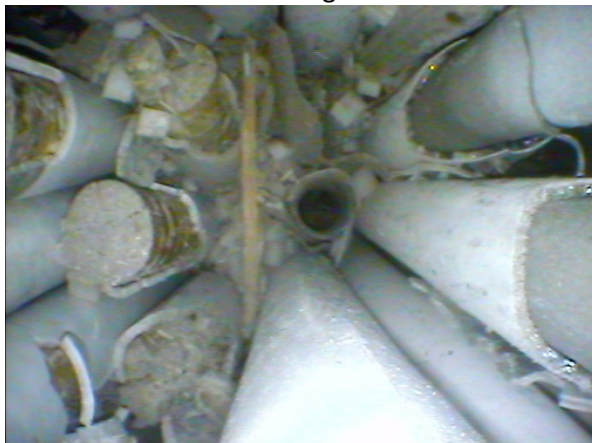
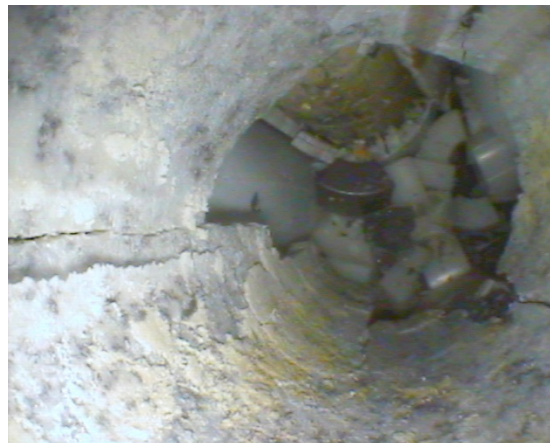
1180 mm: overview of broken central rods with Zry claddings and almost intact (partial HfO_2 spalling) peripheral heated rods with Hf claddings

1120 mm: top of broken rod #5

1100 mm: top of broken rods #3 (upper) and #4

1180 mm after strong mechanical intervention (shaking): spalling of oxide layers and emptying of rod #6

990 mm: view through the emptied rod #6

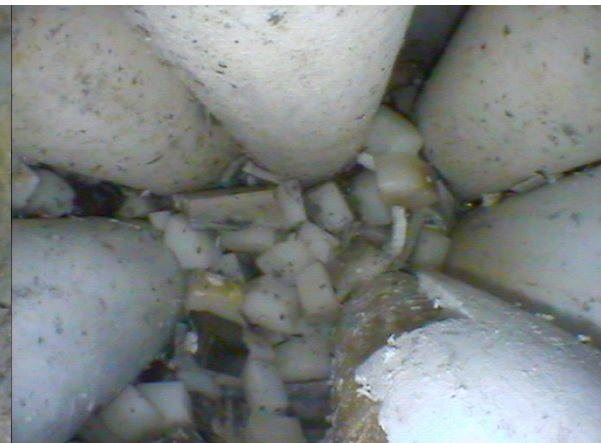
910 mm: view through rod #6, blockage of cooling channel

Figure 49 QUENCH-17; videoscope observation (top view) of the bundle after removal of upper parts of 9 central unheated rods with Zry claddings and Zry grid spacer GS #4.

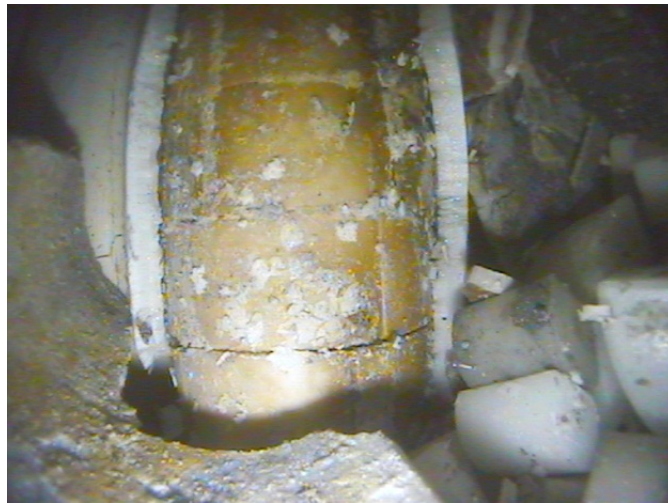
950 mm: intact pellet segment stack of rod #8

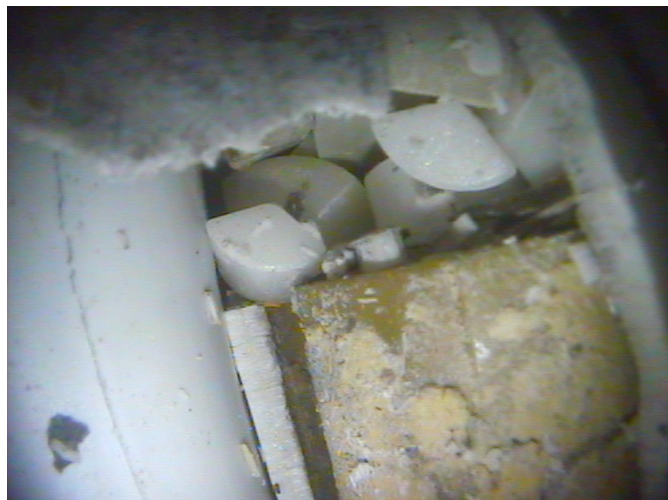
920 mm: relocated pellet segments pellet segment stack of rod #7

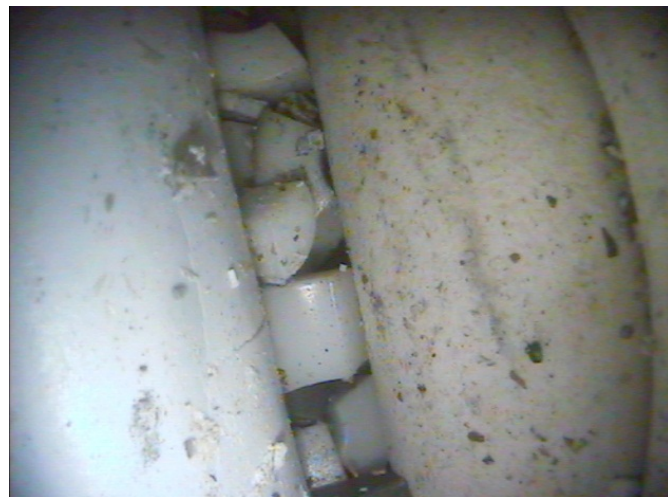
910 mm: blockage between Zry and Hf claddings

Figure 50 QUENCH-17; videoscope observation (side view objective) of bundle elements below grid spacer GS #3.

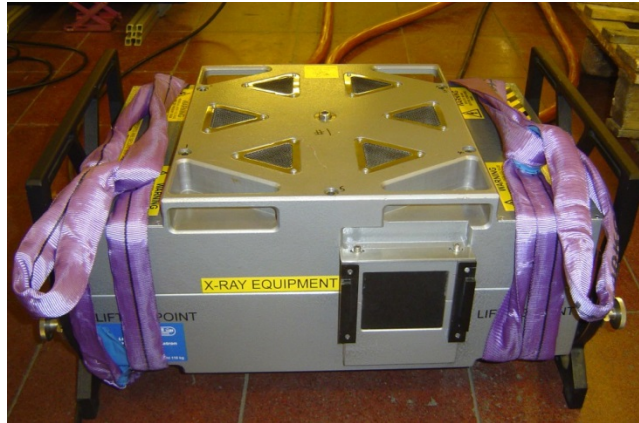
Betatron-7 with 5 MeV

The bundle was filled with epoxy resin to perform tomography and metallographic examination. High energy X-ray tomography (maximal energy 12 MeV, axial scan step 295 μm) of the bundle (Fig. 52) was performed at the Bundesanstalt für Materialforschung und -prüfung (BAM) Berlin. Fig. 53 shows the achieved results for the longitudinal bundle section between elevations 300 and 900 mm, and the cross section (top view) at elevation 400 mm. The W heaters are red, the Hf components blue, zirconia parts orange and the empty space (epoxy) grey. The image analysis results in 85% blockage of the cooling channel at 400 mm. The elevations away from the grid spacer GS2 show either complete absence of the blockage under spacer (at 350 mm) or only slight blockage above the spacer (at 518 mm) (Fig. 54).

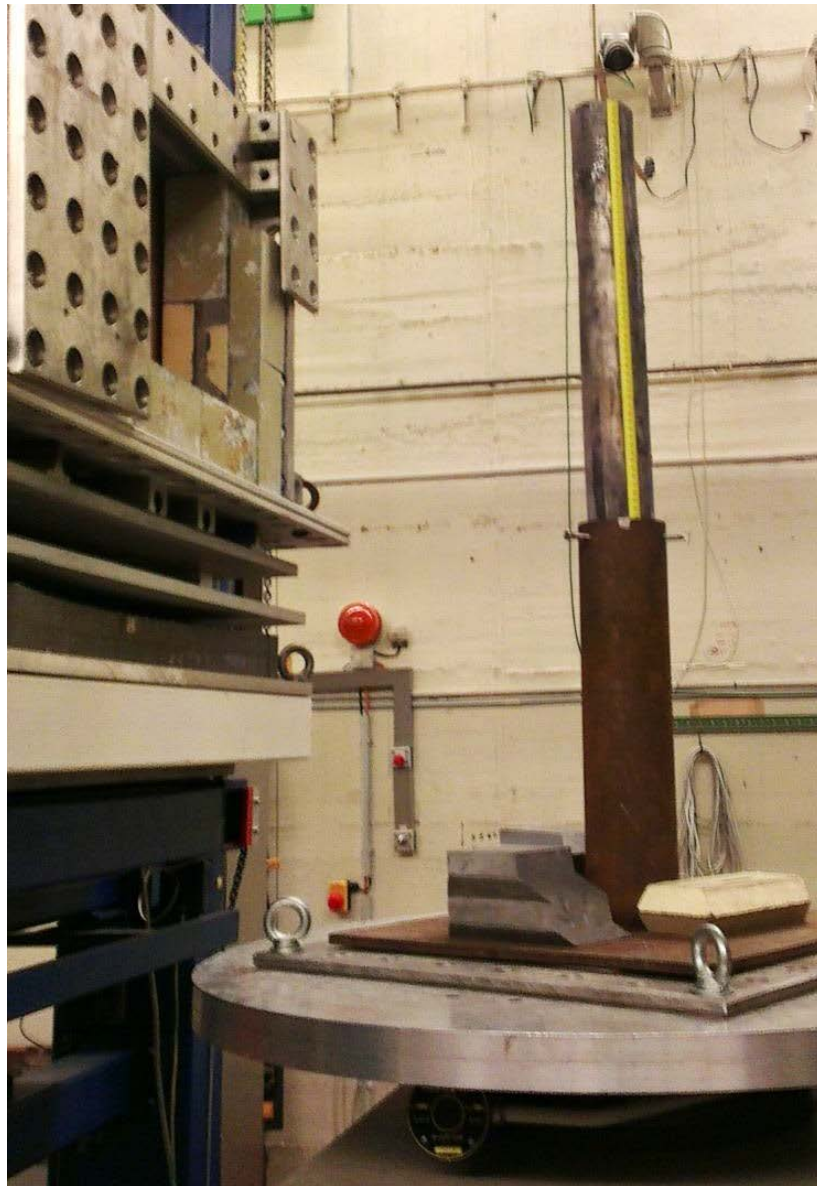
QUENCH-17 embedded bundle inserted into the steel holder

Figure 52 High energy X-ray tomography at BAM.

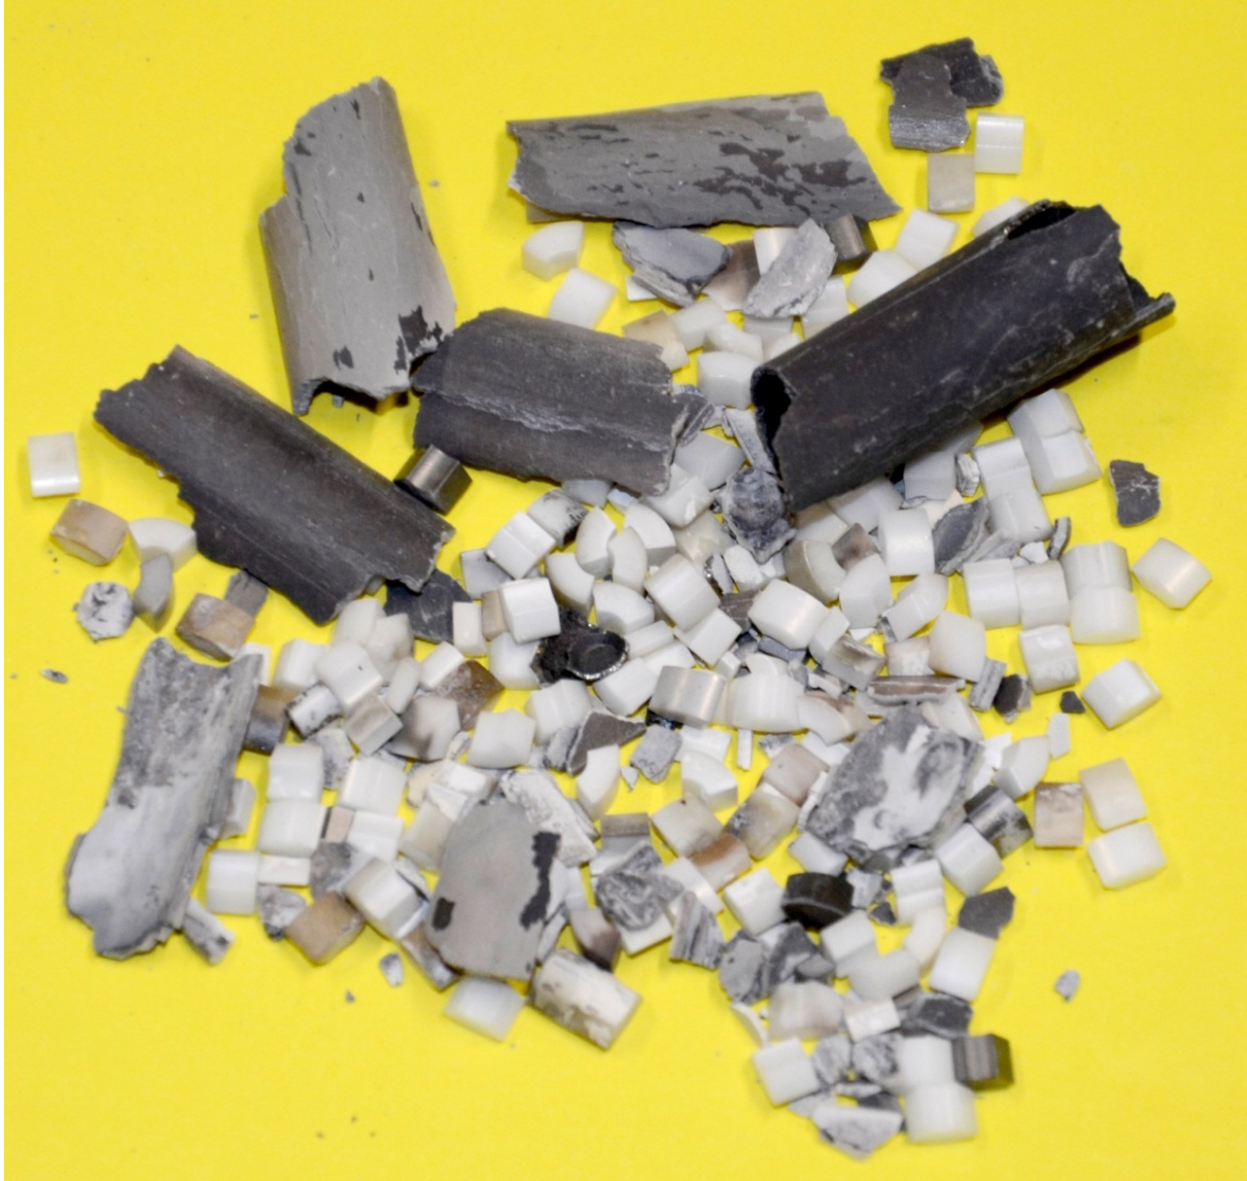
Figure 73 QUENCH-17; debris collected at the top of grid spacer #3 (1090 mm)

Both upper spacers at 1050 and 1350 mm were heavily oxidized but remained intact. The fourth spacer (at 1350 mm) was pulled out of the bundle without damaging of the spacer (Fig. 47). Large cladding fragments (as spalled oxide scales and tube segments) together with the pellet segments were collected between two upper grid spacers (Fig. 73).
