Fluorescent thermal imaging of a non-insulated pancake coil wound from high temperature superconductor tape

To cite this article: R Gyuráki *et al* 2019 *Supercond. Sci. Technol.* **32** 105006

We have wound a 157-turn, non-insulated pancake coil with an outer diameter of 85 mm and we cooled it down to 77 K with a combination of conduction and gas cooling. Using high-speed fluorescent thermal imaging in combination with electrical measurements we have investigated the coil under load, including various ramping tests and over-current experiments. We have found that the coil does not heat up measurably when being ramped to below its critical current. Two over-current experiments are presented, where in one case the coil recovered by itself and in another case a thermal runaway occurred. We have recorded heating in the bulk of the windings due to local defects, however the coil remained cryostable even during some over-critical conditions and heated only to about 82–85 K at certain positions. A thermal runaway was observed at the center, where the highest magnetic field and a resistive joint create a natural defect. The maximum temperature, ~ 100 K, was reached only in the few inner

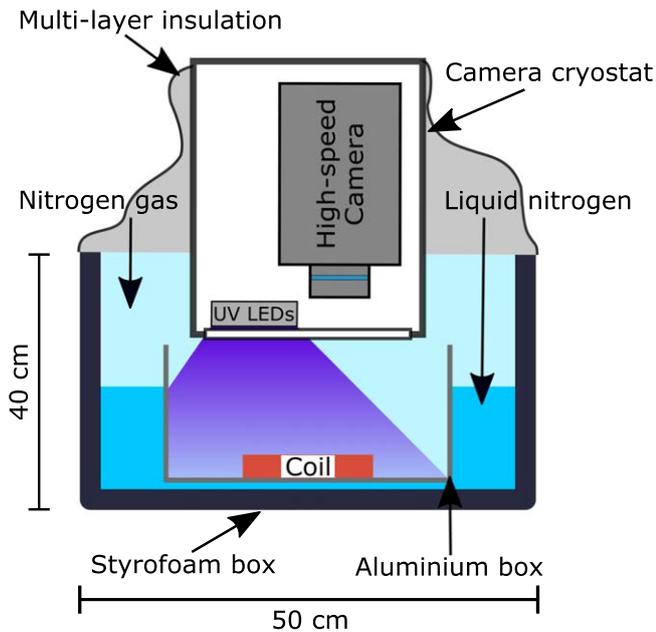
Figure 1. Cross-section view of the experimental setup.

To avoid complex and expensive vacuum and cryocooler setups with optical windows—and since the aim was to test the coil only at 77 K—a simple, two-component cryostat was constructed, as shown in figure 1. An aluminum container was placed inside a larger polystyrene container, and the space between the two was filled up with liquid nitrogen. The coil was placed into the aluminum box and a good thermal

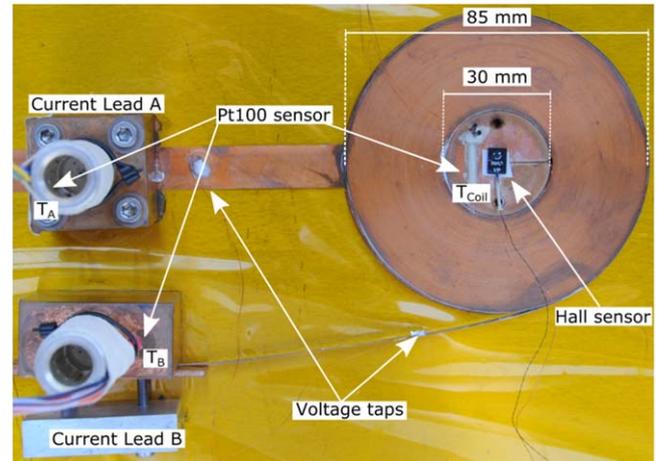
Figure 2. HTS non-insulated coil placed at the bottom of an aluminum box. A Kapton sheet served as electrical insulation in between.

A picture of the coil and the electrical instrumentation is shown in figure 2. The magnetic field was measured with a Hall sensor located at the center of the coil. The voltage was measured across two superconducting current leads. However, this path includes the resistive soldered joint between the 12 mm HTS current lead and the coil former, as well as between the coil former and the first turn. To establish the time required for reaching thermal stability inside the measurement assembly during cooling as well as to monitor any possible temperature rise during the measurements, temperatures were measured at three positions using Pt100 sensors. Each of the current contacts had an embedded sensor, labeled

T_A and T_B , respectively. In the measurements it was found, however, that these remained close to 77 K and were hence not plotted. The third sensor T_{Coil} was used for measuring the temperature inside the coil former. The coil temperature sensor allowed monitoring the temperature rise of the copper bobbin in real-time during the measurement and it is plotted in the supplementary video, available online at stacks.iop.org/SUST/32/105006/mmedia. The current was measured with a shunt resistor inserted in the circuit. This resulted in seven data acquisition channels, which were recorded using an NI-USB 6289 DAQ, at a rate of 1000 samples per second, and several Dataforth and Dewetron pre-amplifiers for acquiring low voltages. In parallel, the coil voltage was also measured with a nanovoltmeter at a slower rate of 1 sample per second for higher accuracy.

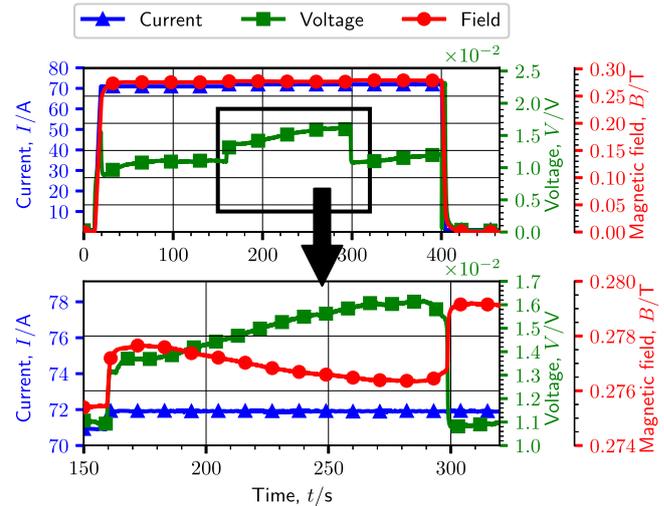
Figure 3. Electrical measurements of the coil during the 72 A over-current test. The bottom plot shows a zoomed area marked by the black rectangle. Note that the axes ranges are changed on the zoomed plot.

The coil current was first ramped up to 71 A at a rate of 10 A s^{-1} and the voltage was monitored, as shown in figure 3. It eventually stabilized and so the current was increased to 72 A, this time at a slower 1 A s^{-1} rate, as shown at time 160 s.

At this current level, a slow yet steady voltage shift was observed, and the coil was held at this level.

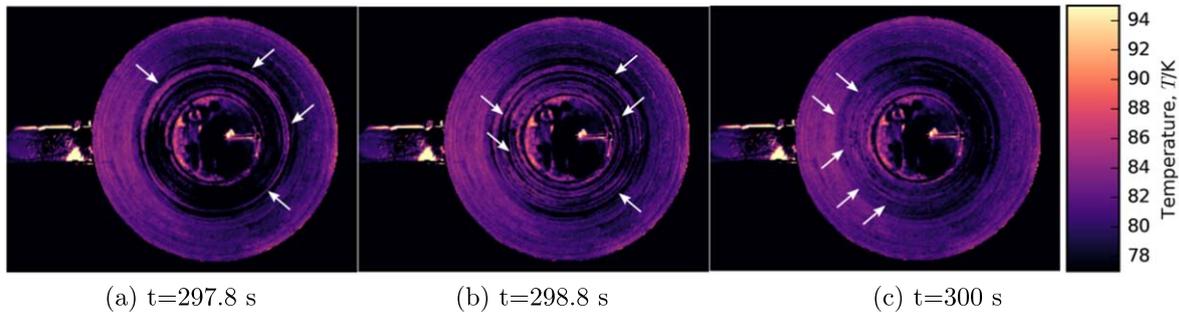
Figure 4. Thermal images of the coil during the 72 A over-current test showing different time points just before and right after the ‘self-recovery’. The white arrows indicate features, as described in the text.

Since the magnetic field also reduced with the increasing voltage, the current must have been changing from the spiral to the radial path. This is also supported by the quasi-linear voltage rise observed, as expected with increasingly more current flowing through a resistor. In figure 4(a) one can see that the outer turns of the coil are initially at a higher temperature, due to slightly worse cooling at the outer edge of the coil compared to the inner former as well as due to the over-current regime. At the same time, distinct heating is visible in the form of circles with varying width, as can be seen in figures 4(a) and (b) highlighted by the white arrows. This indicates that at particular locations in the coil, the current flows through the turn-to-turn contact resistance and generate losses. At about 298 s into the measurement, the voltage dropped and the magnetic field increased sharply, indicating that the current reverted back into the spiral path abruptly. Simultaneously, the center windings of the coil have heated up, as indicated by the white arrows in figure 4(c), where the ring-like hot areas have been replaced by an uniformly warmer zone, mostly on the left hand side of the coil. Hence the current flowing through the turn-to-turn contact resistances of the coil can be seen on the thermal image as heating over possibly several turns, which is most likely a function of the cooling performance and the distribution of local fluctuations of I_c along the length of the wound conductor.

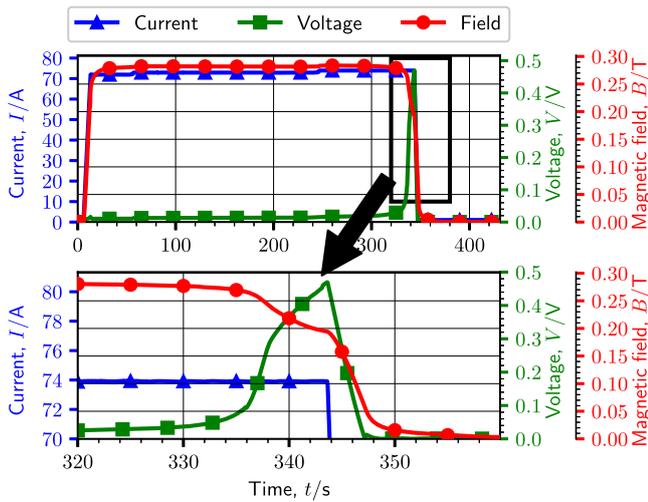
Figure 5. Electrical measurements of the coil during the 74 A over-current test. The bottom plot shows a zoomed area marked by the black rectangle.

To reproduce previous results and observe the same behavior again, the coil current was ramped up in a subsequent measurement directly to 72 A at a rate of 10 A s^{-1} , as shown in figure 5. However, in this case, no voltage drift was observed. The current was therefore ramped up to 73 A, and finally 74 A, at a slower 1 A s^{-1} rate, where the coil voltage became

unstable and started increasing once again. Over the course of two minutes at a steady current of 74 A, the coil voltage rose up continuously until its final value of 0.47 V, at which the coil current was ramped down quickly. The field started decaying with the developing voltage, indicating a slow current transfer into a radial path. Then, after 336 s, a much sharper voltage rise and accompanying field drop became visible, likely due to (some of) the HTS tapes becoming resistive. Figure 6 shows excerpts of the thermal imaging recording at three different time instants. In figure 6(a), one can see that the outside of the coil is again at a higher temperature, however still cryostable. Warmer zones are still visible around the center and middle layer of the coil (shown by the white arrows), indicating heating due to currents flowing through the turn-to-turn contact resistances. Figure 6(b) shows that the middle layers seem to have mostly cooled down, and at the same time—due to the superconducting transition—the innermost windings started heating up. At the bottom of the image, where the outer current lead arrives at the coil, a hot spot is also visible. Then in figure 6(c), just before the current was ramped down to protect the coil, the hottest temperature of around 100 K was reached at the few innermost windings of the coil. When looking at the dynamic development (see the online

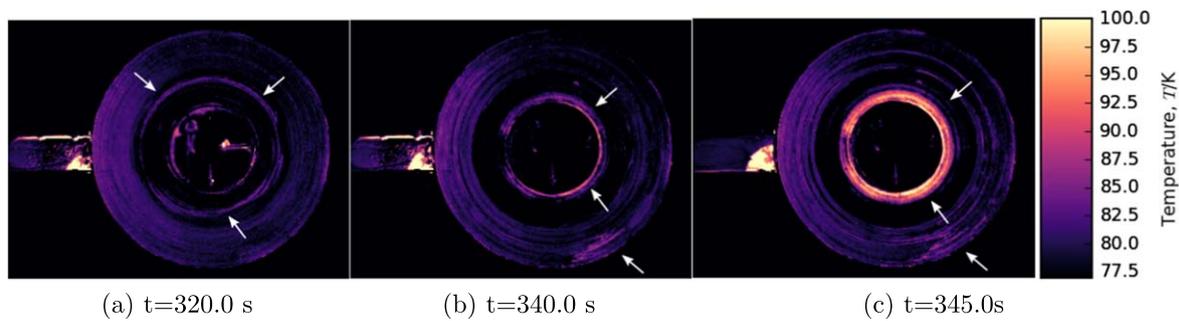
Figure 6. Thermal images of the coil during the 74 A over-current test showing different time points just before and at the moment of thermal runaway and ramping down. The white arrows indicate features, as described in the text.

supplementary video³) one can identify a stage between figures 6(a) and (b). Between these times the middle turns of the coil actually cooled down, and when the voltage continued to rise, the central windings started heating up instead. A possible explanation is that when the coil voltage is low, only the ‘major’ defects in the coil can be bypassed. However, at higher voltages, more current can be forced through the turn-to-turn contact resistances, thereby reducing the current in the superconductor as well as the local heating. Due to the fact that the energy is dissipated over a larger volume, this could then manifest in a form of a local cooling effect. Then in figure 6(c), the center windings see the combined effect of superconducting to resistive transition of the HTS due to the reduced temperature margin and high magnetic field, combined with the current bypass and joule heating due to the resistive joints. To check for damages, after each measurement, the coil resistance was measured and compared with its previous values. At the end, a second I_c measurement was also done and no degradation was observed.
