# Bypassing and tightening of an underground water retention system in permeable karst: case study of the hydropower plant (HPP) Bribin, Indonesia

## Concept of the underground hydropower plant Bribin

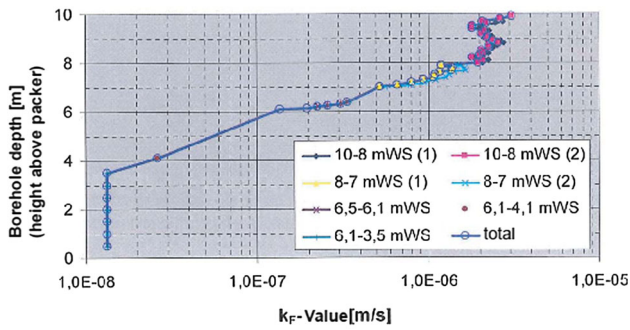
Fig. 2 Permeabilities measured above cave roof

Rock mass stability was addressed at an early planning state already. A vertical 100 m deep borehole had been drilled from the surface down to the later construction site as a preliminary investigation for the access shaft. In this borehole, falling head slug tests above the cave revealed a permeability varying over three orders of magnitude from  $2 \times 10^{-8}$  to  $5 \times 10^{-6}$  m/s, due to intense variability of the more or less porous limestone (Fig. 2).

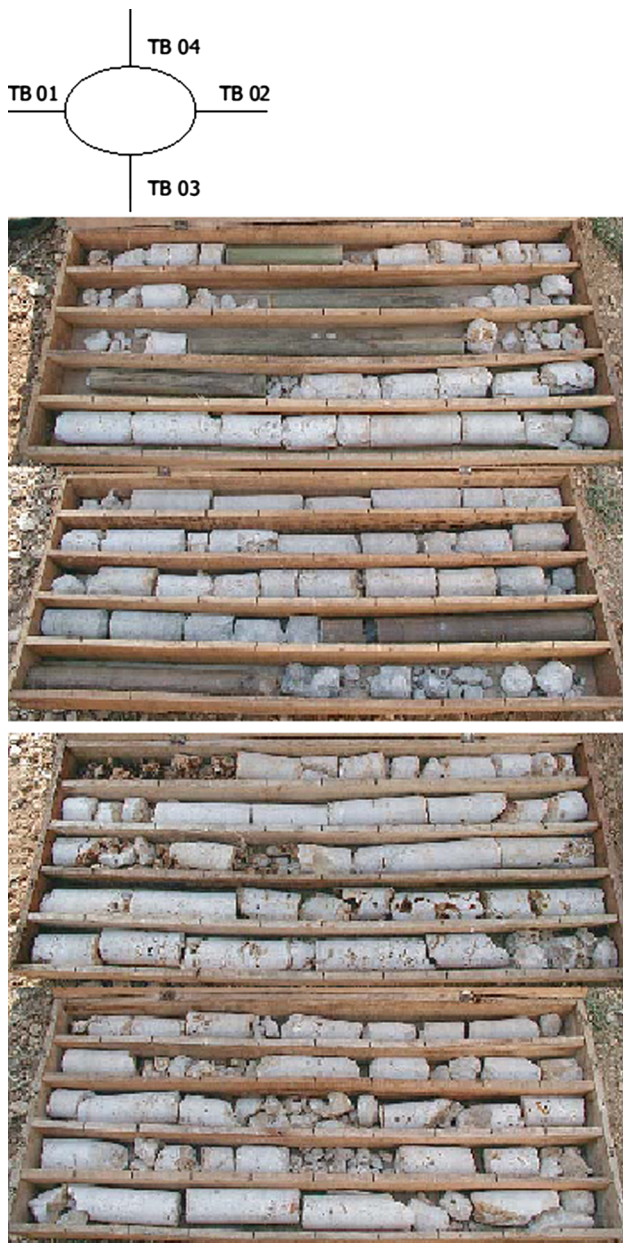
Fig. 3 Borehole orientation at the barrage site and cores from TB03 (floor) and TB04 (roof) in comparison

Investigation boreholes TB 01–TB 04 (length 10 m) were cored from the machinery platform into roof, floor and sidewalls of the cave (Fig. 3). These drillings were arranged in a vertical plane in the cross section where the barrage later was built. While the rock quality in TB 01

and TB 04 proved to be sufficient ( $RQD = 49$ ), boreholes TB 02 and TB 03 in the floor showed very poor conditions ( $RQD = 28$ ). These findings were confirmed by four supplementary vertical boreholes TB 03-1 to TB 03-4 in the floor (next to TB 03). At that time, these results gave reasons to concerns regarding the stability and permeability of the right cave wall and the floor.

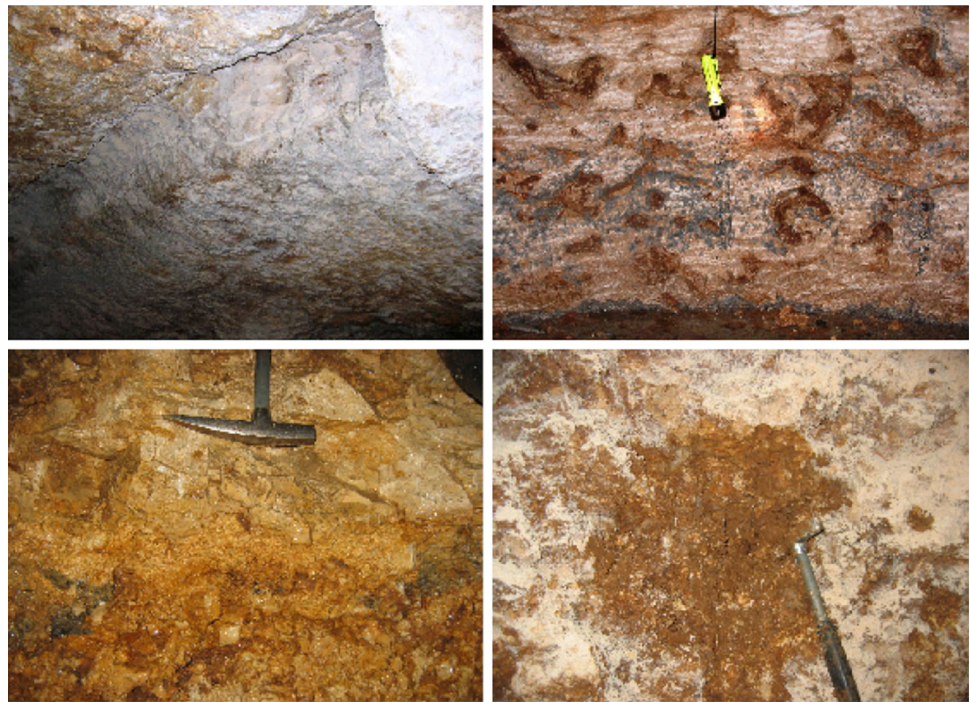
**Fig. 4** Appearance of rock mass zones: Massive (*top left*), cavernous (*top right*), broken (*bottom left*) and breccious limestone (*bottom right*)

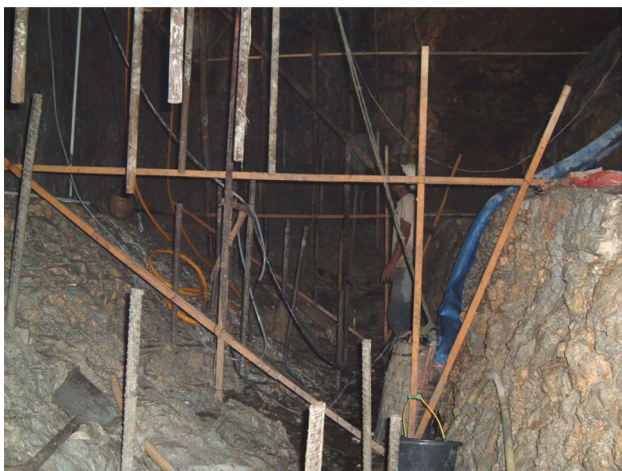
**Fig. 7** V-shaped excavation zone below the barrage with three lines of micropiles

The cave roof above the machinery platform was secured using 100 kN rock nails (0.5 nails/m<sup>2</sup>) of 4 m length. Further nails in the floor provide additional safety for the platform and the sliding valve chamber (see Figs. 1, 7) against buoyancy. Below the barrage’s base, a stiffening “shoe plate” on three rows of short micropiles was provided, improving the underlying weathered rock’s resistance against mechanic and hydraulic impact (Mutschler and Triantafyllidis 2009). An alternative concept of step-wise investigation and strengthening by soil replacement,

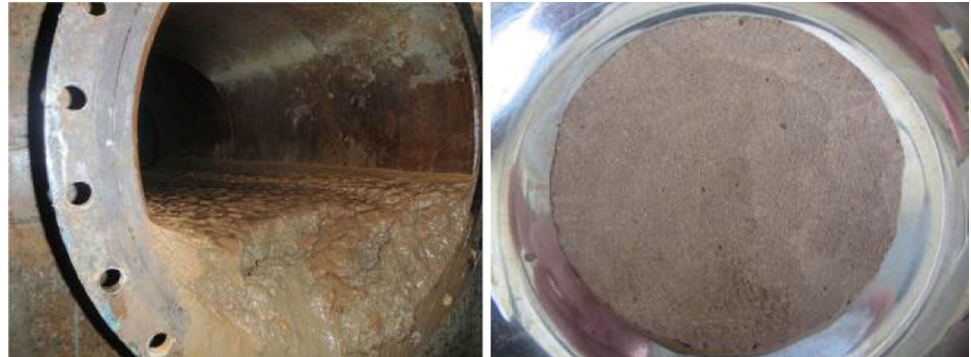
**Fig. 8** Sludge sedimentation (left) and desiccation test (right)

These tests focussed on the clayey-silty fillings, encountered as sediments at the cave floor, in karst cavities and fractures. They can be described as a fine-grained sludge containing clay and limestone nuggets of 2–5 mm side length. Their permeability is low, but also their potential resistance against dislocation and erosion (Mutschler and Triantafyllidis 2009). Grain size distribution and Atterberg limits of sludge from different locations were tested following a minor “hydraulic breakthrough” event identified by the manual seepage measurements (Table 2; Fig. 8).

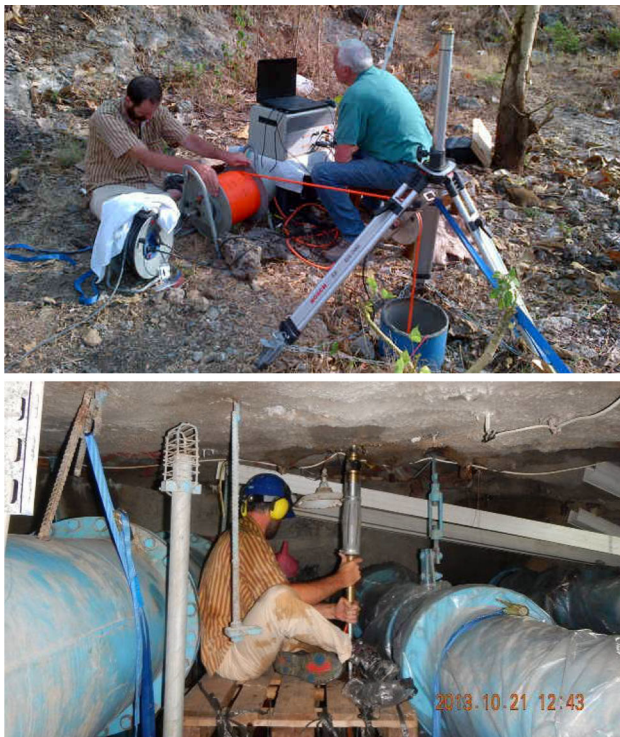
**Fig. 9** Borehole camera in use on ground surface and at the cave roof

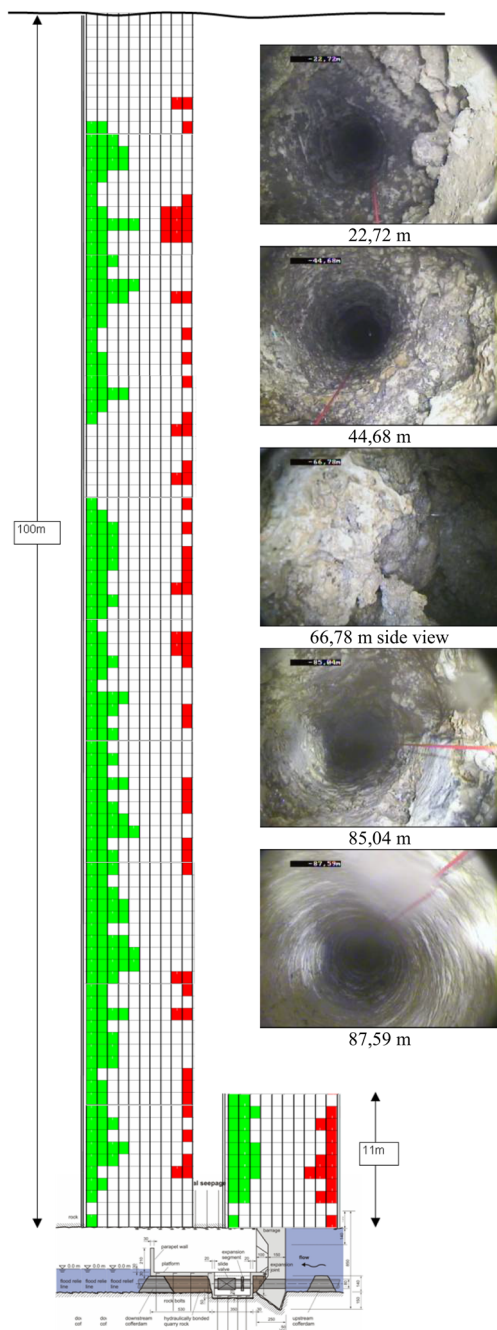
**Fig. 10** Borehole camera report above cave with snapshots

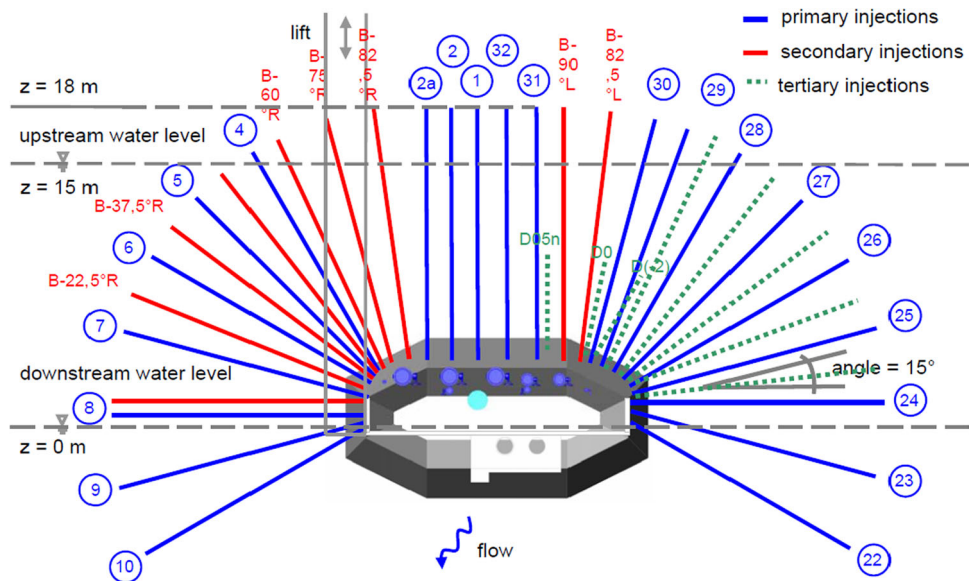
**Fig. 11** Cross section of the grout curtain (coloured: the 3 injection campaigns)

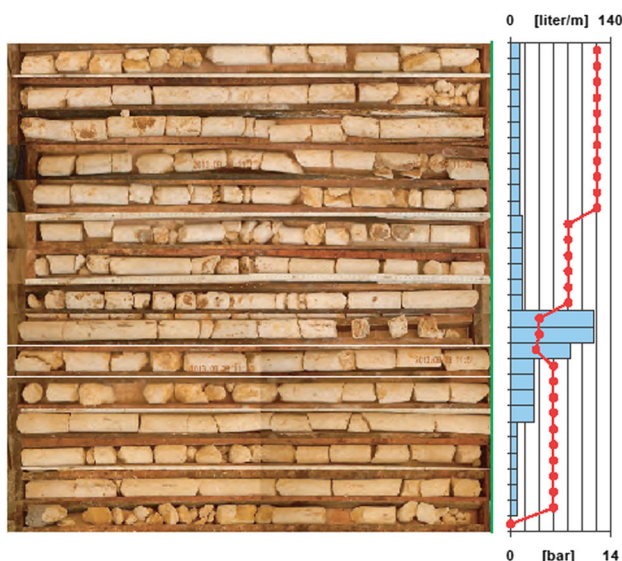
**Fig. 12** Injection borehole core 7, 5 L compared to grouting pressure and grout take (third injection campaign)

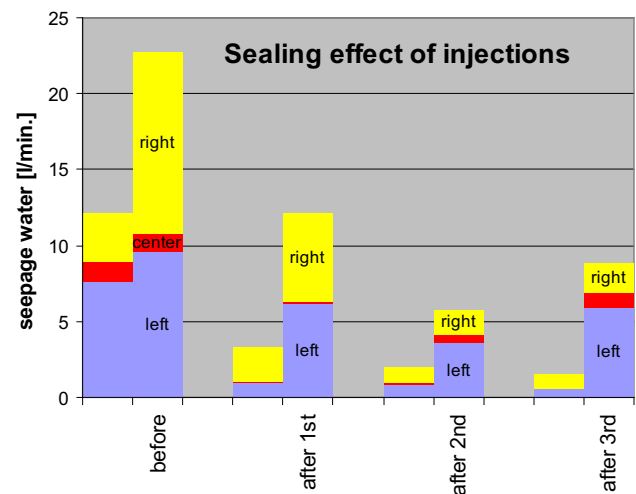
**Fig. 13** Reduction of bypassing water from right, left and center seepage area, *left column*: minimum, *right column*: mean value

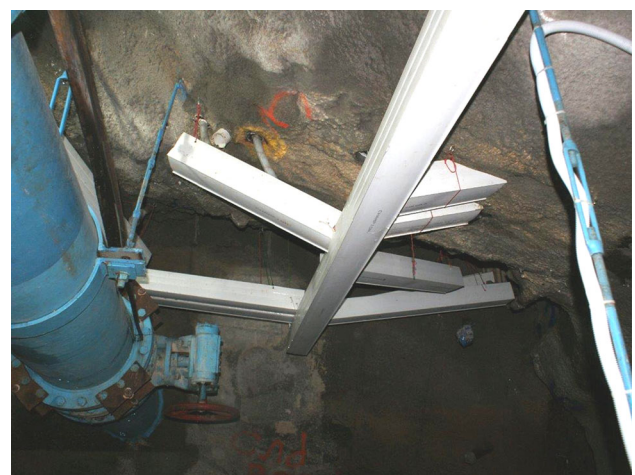
**Fig. 14** Seepage water catchment for automated seepage monitoring

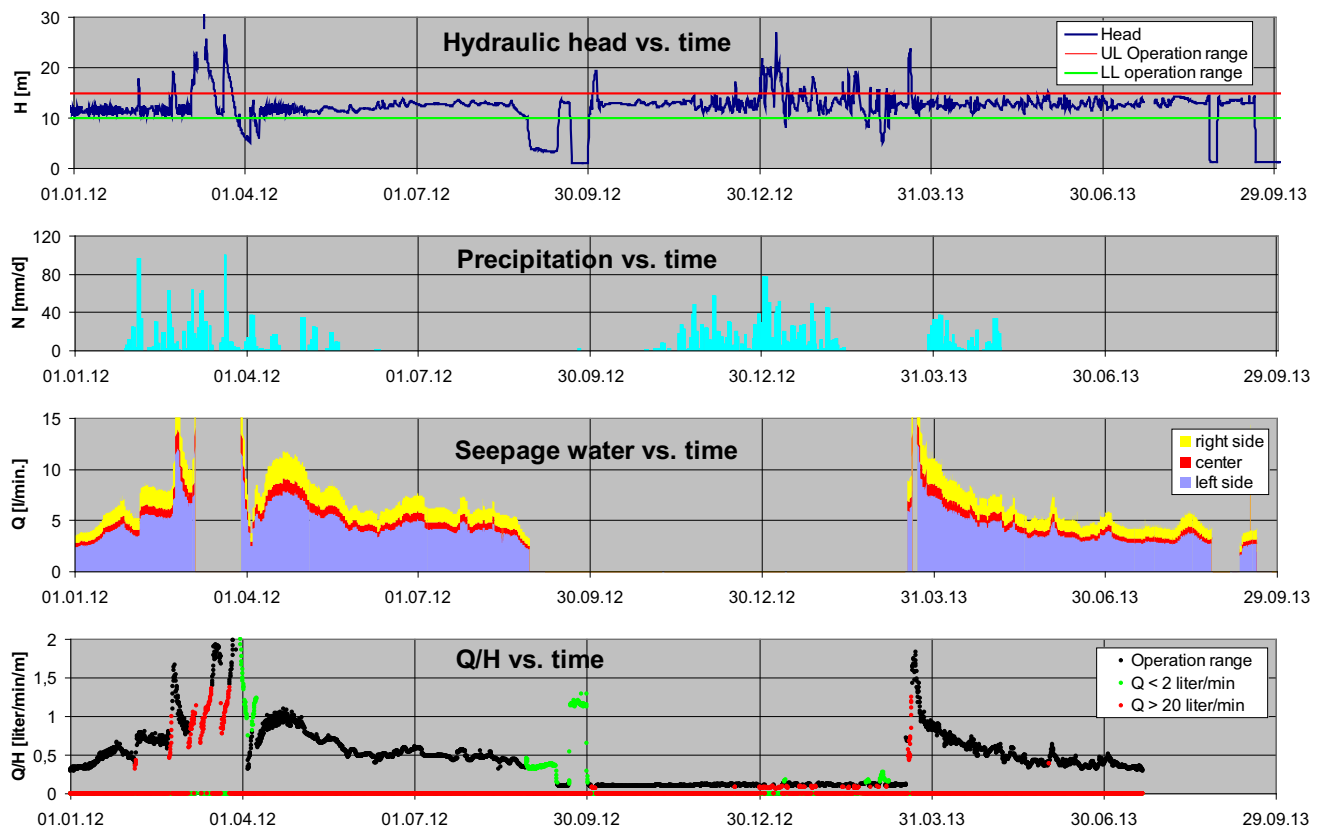
**Fig. 15** Seepage monitoring data including rainfall and  $Q/H$  evaluation over 21 consecutive months

over time. A quotient  $Q/h$  (amount of seepage water divided by hydraulic head) was introduced as a measure for the relative change of the overall rock mass permeability (Fig. 15).  $Q/h$  should remain approximately constant as long as the permeabilities and hydraulic boundaries in the system remain unchanged. This, however, is not the case and demonstrates that the flow conditions change with time.

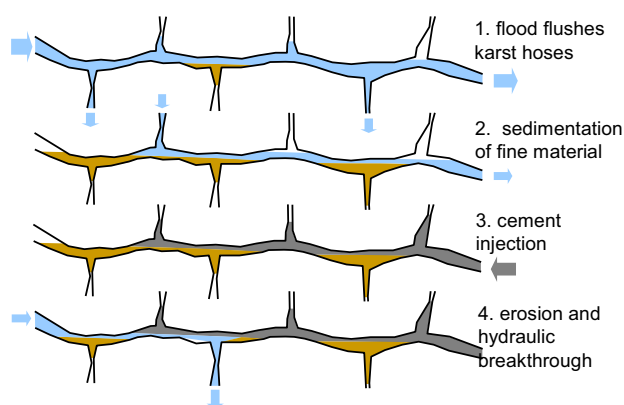
**Fig. 16** Schematic sedimentation and breakthrough model

Due to the roughness of bedding joints and the tortuosity of karst voids, the rock mass contains many depressions where fine sediments are deposited (Fig. 16). After dry seasons, the karst aquifer seems to be sealed by fine-grained sediments closing most flow paths. These fillings are dissolving resp. eroded under a new inundation and steady action of hydraulic gradients. Repeated flood events during rainy seasons erode the fillings and create cascades of local “hydraulic breakthroughs” with the consequence of increasing seepage. This effect is amplified when a sudden increase of hydraulic head exceeds the operational

range and the grout curtain is temporary overtopped. The system permeability, thus, changes distinctly between dry and wet seasons (Fig. 16).

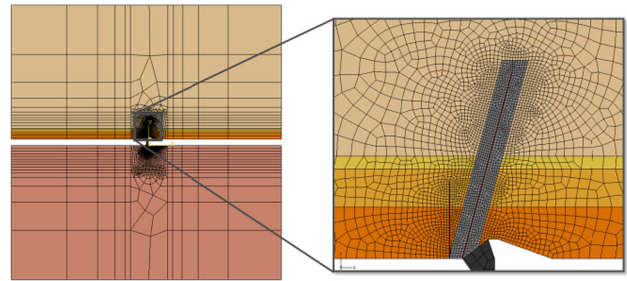
**Fig. 17** FE mesh for the 2D model, *left*: cave and barrage, *right*: detail with grout curtain

To study basic relations, a plain-strain 2D model representing the longitudinal section of Bribin cave seemed already sufficient. For simplicity, cave roof and floor were assumed to be parallel (Fig. 17). The simulation was made for a 10-week period in spring 2013 subdivided into 569 “time frames” for which pressure head as well as seepage data were complete including one flood event of  $Q > 20$  l/min. The following boundary conditions were applied:

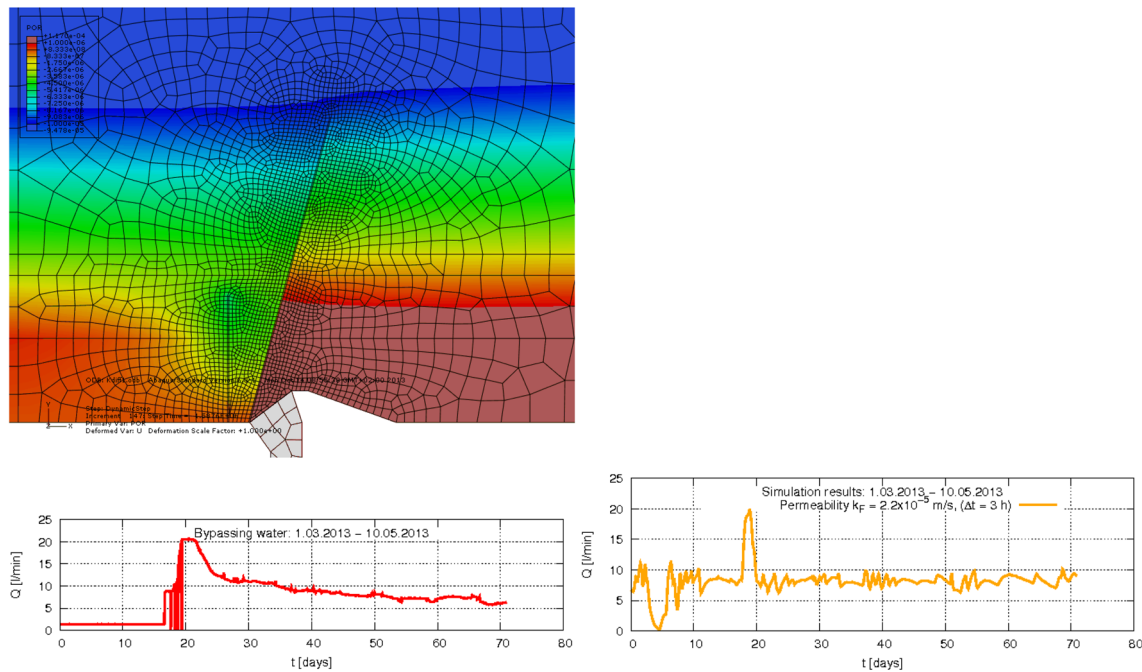
**Fig. 18** Top: calculated porewater pressure distribution for hydraulic head of 22.5 m, bottom: comparison of bypassing water over a 50-day period, top: measured, bottom: calculated for  $k = 2.2 \times 10^{-5}$  m/s

As parameter studies show that an equivalent isotropic rock mass permeability of  $k = 2.2 \times 10^{-5}$  m/s is required to explain the measured seepage volume (Fig. 18). The

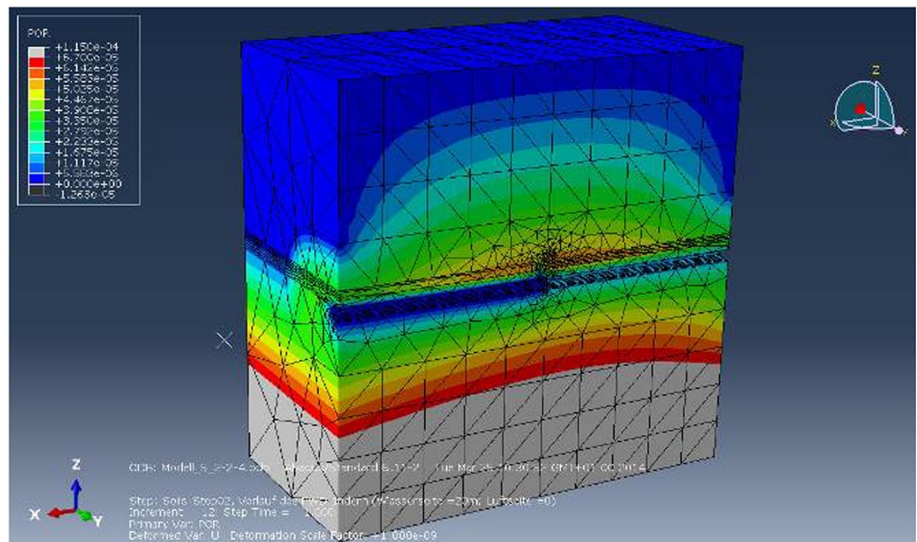
**Fig. 19** *Top*: FE mesh for the 3D model with calculated porewater pressure distribution, *bottom*: comparison of calculated bypass water with and without hydro-mechanical coupling for a 160-h period
