OXIDATION AND QUENCH BEHAVIOR OF COLD SPRAYING CR COATED ZIRCALOY FUEL CLADDING UNDER SEVERE ACCIDENT SCENARIOS

Chongchong Tang*, Mirco Grosse, Martin Steinbrueck

Institute for Applied Materials (IAM), Karlsruhe Institute of Technology (KIT), D-76021 Karlsruhe, Germany
Chongchong.tang@kit.edu

The oxidation performance and quench behavior of cold spraying Cr coated Zircaloy-4 cladding tubes were investigated from 1100°C up to 1500°C in steam. The coated samples displayed significantly improved oxidation resistance, good thermal shock resistance and high post-quench ductility during oxidation at 1100°C and 1200°C for 1 hour accompanied by subsequent quench in water. However, substantial bending of the coated tubes was observed during oxidation at 1100°C, which led to loss of protective effect of the coatings on the tensile (convex) side. The underlying mechanisms for the occurrence of bending phenomenon at such temperature seems to be related with the residual stress state and high-temperature creep behavior of the coated cladding. Once the oxidation temperature exceeds the Cr-Zr eutectic temperature (~1330°C), oxygen drives the Cr diffusing inwardly (owing to the low solubility o

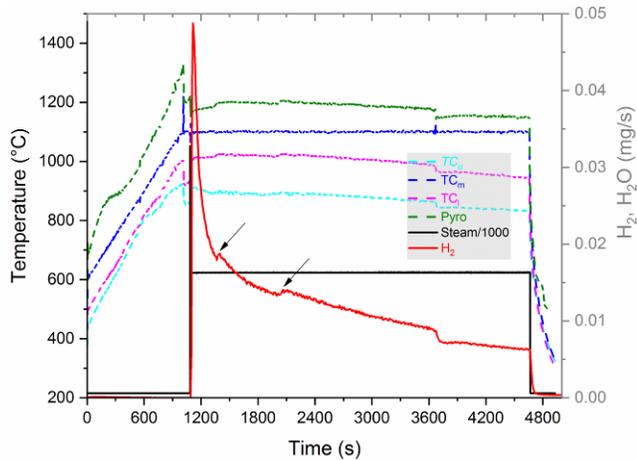
Fig. 2. Temperature profiles, hydrogen and steam flow rates during the isothermal test at 1100°C for 1 h.

The first isothermal test was performed at 1100°C ; the temperature profiles, hydrogen and steam flow rates during the test are presented in Fig. 2. Fig. 3 shows the post-test appearances of the samples. As seen in Fig. 2, the temperature recorded by the TC_m was stabilized at 1100°C during the isothermal exposure. The temperature measured by the pyrometer was around 100°C higher, accompanied by a slight gradual decrease. The temperatures at the lower and upper regions of the tubes recorded by other two thermal couples were around 1010°C and 880°C , respectively. Similar slightly decreasing temperatures were observed during the exposure, likely due to the cooling effect by the argon and steam flow. A high peak of hydrogen release was observed once the steam was introduced, indicating initially fast oxidation of the fresh surface. The hydrogen release rate then decreased continuously, except small bumps (likely owing to cracking of the coatings) on the curve marked by the arrows.

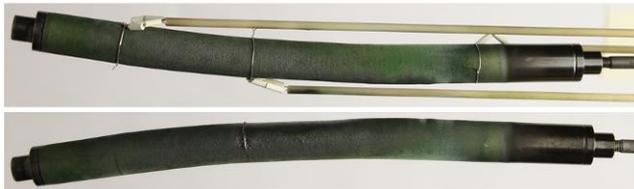
Fig. 3. Post-test appearance of the sample after the first isothermal test at 1100°C showing significant bending.

Substantial bending of the coated tube occurred during the test (Fig. 3), prohibiting final quenching of the tube because of potential damage to the facility. Thus, the sample was cooled in argon atmosphere inside the reaction tube without quenching. The surface color of the sample transformed from metallic luster to green owing to the growth of an oxide layer. A small section of the attachment wire at the middle region was incorporated into the tube surface, which could not be easily separated as seen in Fig. 3. Cracking of the coatings near and beneath the wire was shown. The maximum displacement of the tube (at the coated end) reached approximately 10.24 mm, larger than the diameter of the tube.

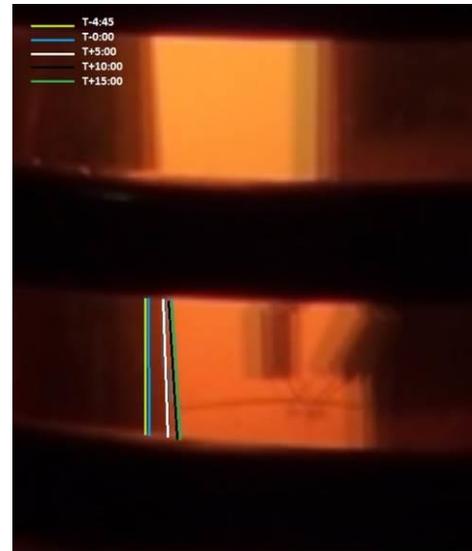
Fig. 4. Overlay images showing the degree of bending during test. T-0:00 represent the moment when steam was introduced into the furnace.

Fig. 4 displays the degree of bending as a function of time in the initial stage of oxidation. The first sign indicating the occurrence of bending was before starting the steam injection. However, the degree of the bending was very small compared to the bending occurring later with steam flow. Additionally, the majority of the bending took place within the first 5 minutes of steam oxidation.

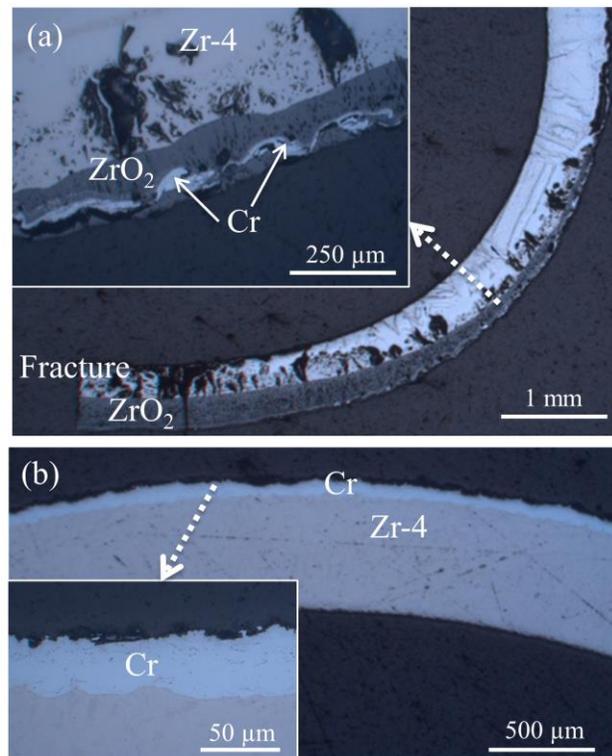
Fig. 5. Optical images of cross section of the samples at elevation ~55 mm, (a) tensile side and (b) compression side of the bending tube.

Fig. 5 are optical images of cross section of the samples at ~55 mm (distance from the coated end, similarly hereinafter). At the tensile side, nearly all coatings have peeled off from the sample surface at the location of maximum tensile strain. Significant oxidation and consumption of the metallic matrix at this region resulted in formation of a thick ZrO_2 layer with loss of strength and ductility, Fig. 5 (a), causing fracture of the tube during post-test examination. Some discontinuous fragments of the Cr coating attached at adjacent areas as shown in the inserted image. The thickness of the ZrO_2 layer decreased gradually as the position changed from the tensile side (convex) to the compression (concave) side. In the compression side, the coatings revealed good oxidation resistance and high adherence, without cracking or delamination (Fig. 5 (b)). A thin oxide layer formed on the surface and no evidence shows oxidation of the substrate. The typical high roughness of the coatings deposited by cold spray process was also clearly seen.

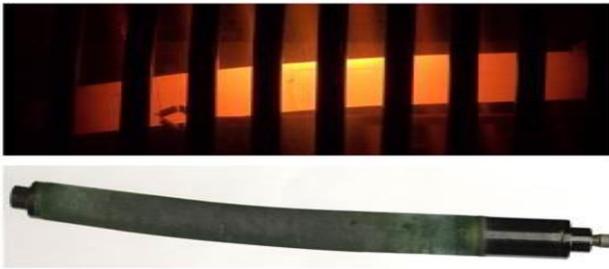
Fig. 6. Appearances of the sample during the second test at 1100°C (upper) and after the test (bottom).

However, during the second test the sample started to bend again, as seen in Fig. 6. Thus, this sample was not quenched again. During the exposure, the tensile side of the tube appeared brighter and hotter than the compression side. The final maximum displacement of the tube was similar to the first one. Note that bending of the tube probably represents a universal deformation mode at such temperature. No uncoated reference test was performed at this temperature due to the limited number of samples. However, our previous investigations on steam oxidation and quench of bare Zr alloy cladding tubes under similar conditions at 1100°C did not show bending phenomenon of the tube [11].

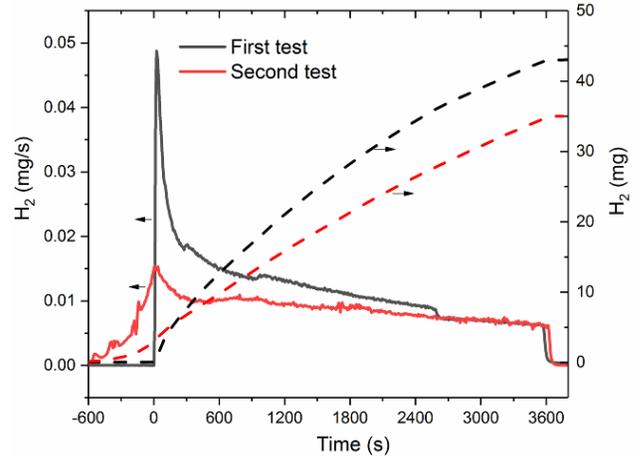
Fig. 7. Comparison of the hydrogen release rate and total hydrogen production during the two isothermal tests at 1100°C.

Fig. 7 compares the hydrogen release behaviors during the two tests. Pre-oxidation of the samples owing to early introduction of steam reduced the initial high release rate of hydrogen when the temperature was reached. The intensity of the initial peak was much lower than that of the second test. The total hydrogen productions were comparable, slightly less for the second test likely due to introduction of steam at lower temperature. The oxidation kinetics for both tests, as proved by the hydrogen production curves, roughly followed a parabolic law.

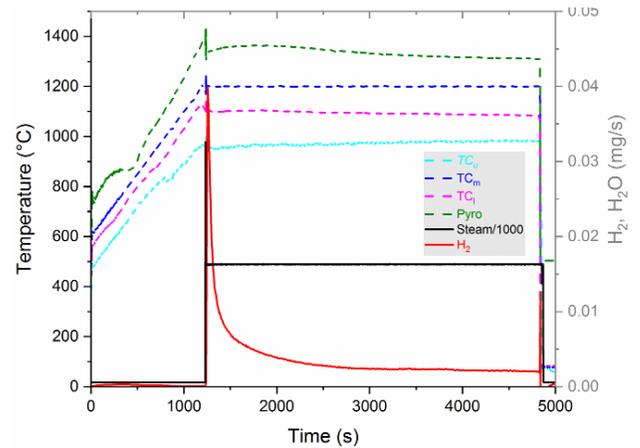
Fig. 8. Temperature profiles, hydrogen and steam flow rates during the isothermal test at 1200°C for 1 h.

The isothermal oxidation test at 1200°C was successful (no obvious bending of the tube) with final quenching of the tube in water. The temperature profiles, hydrogen and steam flow rates during the test were shown in Fig. 8. Similar to the tests at 1100°C, the temperature recorded by the pyrometer was about 210°C to 100°C higher than that of TC_m . In the quench phase, the temperature of the tube dropped from 1200°C to 60°C in ~ 5 s. The hydrogen curve also demonstrated similar evolution trend as at 1100°C, but without bumps on the curve.

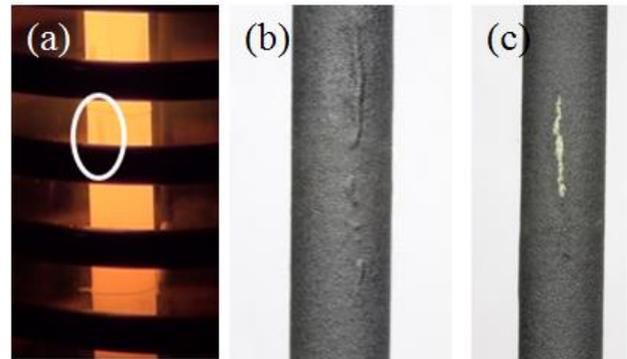
Fig. 9. Appearances of the sample (a) during the test, (b) and (c) after the test at 1200°C.

Fig. 9 displays the appearance of the sample during and after the test. Interestingly, few dark stripes were observed on the sample surface during the isothermal exposure period, one highlighted in Fig. 9 (a). Via

examining the post-test appearance it turned out that these stripes are indications of delamination within the coating layer and after quenching some oxide layer was spalled off, as seen in Fig. 9 (b) and (c). In addition, no bending of the tube appeared. The Cr coating layer revealed excellent thermal shock resistance and adherence, without cracking and spallation except at those dark stripes.

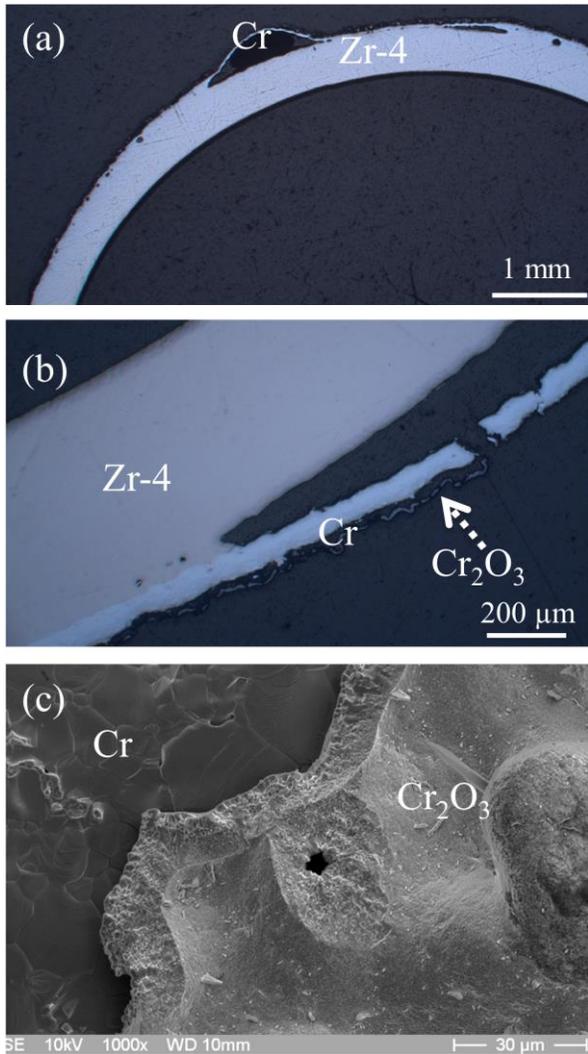
Fig. 10. (a) and (b) optical images of cross section located ~ 55 mm, (c) SEM image of surface of the samples after testing at 1200°C.

Fig. 10 shows the cross section and surface structure of the samples after testing. Delamination was observed at two interfaces, i.e. Cr_2O_3 scale/Cr coating interface and Cr coating/Zr alloy substrate interface. No sign shows oxidation of the substrate or the Cr coating inside the voids generated by delamination. Spallation of the oxide scale and cracking of the Cr coating layer at these delamination areas were seen during cooling and post-test examination.

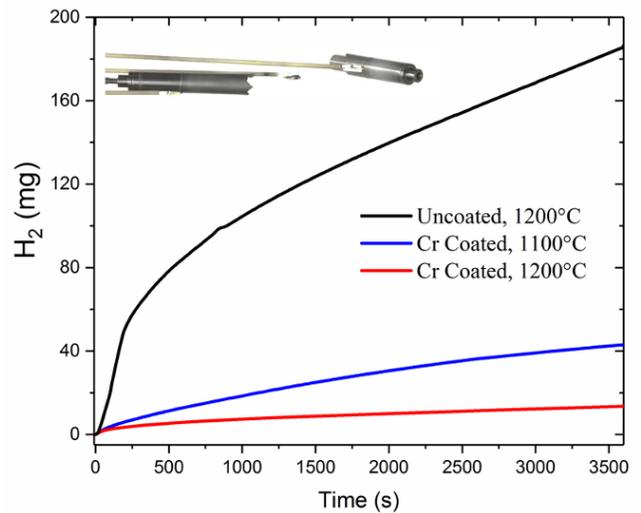
Fig. 11. Comparison of the hydrogen production of three tests. Inserted image shows fracture of uncoated Zircaloy-4 tube after 1200°C oxidation and quench.

A reference uncoated Zircaloy-4 tube was tested at 1200°C for 1 hour and Fig. 11 compares the hydrogen production of the two tests together with the first test at 1100°C. The total hydrogen production was 186.2 mg for the uncoated sample oxidized at 1200°C. In case of the coated sample, it was 13.4 mg, ~14 times less relative to uncoated one. As seen in of the inserted image of Fig. 11, the uncoated tube fractured into few pieces during quench owing to oxidation converting Zry metal to brittle oxide of the cladding tube, while the coated one still remained its physical integrity (Fig. 9). This indicates that the Cr coating layer can remarkably reduce the oxidation kinetics of the cladding with simultaneously significant less hydrogen production and higher post-quench ductility at such temperature. The hydrogen production at 1100°C was even much higher (43.3 mg) than that at 1200°C because bending of the tube led to cracking and spallation of the coating layer.

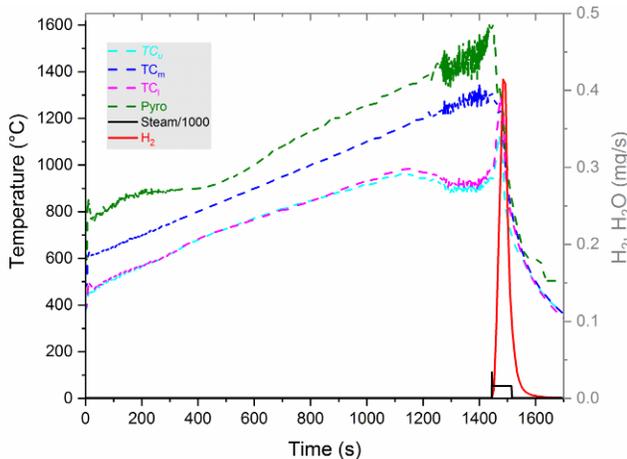
Fig. 12. Temperature profiles, hydrogen and steam flow rates during the isothermal test at 1300°C.

The original plan of the isothermal test at 1300°C, like before, was oxidizing of the sample for one hour in steam followed by quenching. Fig. 12 shows the temperature and gas flow and Fig. 13 illustrates the appearances of the sample of this test. However, during the heating period at a temperature around 1215°C the platinum-rhodium wire fixing the TC_m disappeared (Fig. 13). After this moment the temperature started to fluctuate heavily, as shown in Fig. 12. This is logical since the temperature was controlled via TC_m . A few moments later TC_m detached from the sample, and the temperature on the other thermocouples increased very fast, TC_u went from 944.5°C to 1130.7°C in 17 s. At this point, it was

noticed that the sample started to melt and the test was terminated. The steam flow, i.e. the oxidation period, lasted about 70 s. A very high peak of hydrogen was recorded as displayed in Fig. 12. The reason for the disappearing of the wire was not clear yet, probably because of a melt formation. The eutectic reaction temperature between Pt and Cr is at 1514°C, between Cr and Zr is at 1332°C, and between Pt and Zr is at 1187°C [12]. The eutectic reaction temperature of the Pt-Cr-Zr ternary system clearly is below 1187°C. Even though no direct contact of the wire with the Zircaloy-4 substrate took place, the high roughness of the Cr coating layer may have resulted in the formation of ternary liquid phases at temperatures below 1300°C owing to interdiffusion between the Cr coating layer and the substrate, especially at locations where the coating layer had lower thickness.

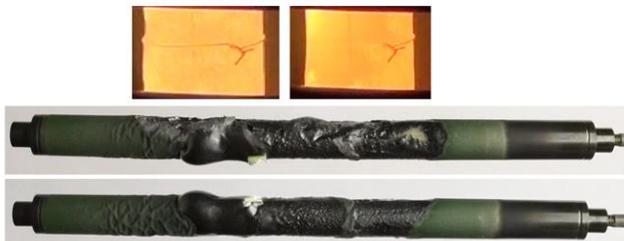
Fig. 13. Appearances of the samples during the test (upper) and after the test (bottom) at 1300°C.

Even though the test failed, it proved that the protective capability of the Cr coating was highly challenged once the temperature exceeded the Cr-Zr eutectic temperature. Formation of liquid phase accompanied by its continuous displacement and movement exposed the inside zirconia pellets at some places and resulted in rapid degradation of the whole cladding tube, Fig. 13.

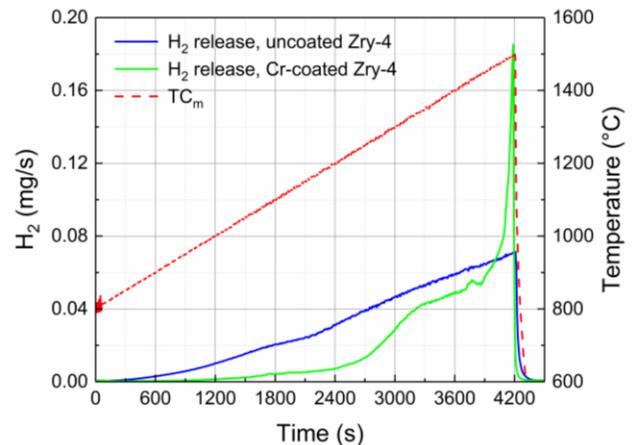
Fig. 14. Temperature profile and hydrogen flow rates of the transient tests from 800°C to 1500°C in steam.

Fig. 14 shows the temperature profile and hydrogen release rates of coated and uncoated samples during the transient test from 800°C to 1500°C in steam. The hydrogen release rate increased virtually linear with rising of oxidation temperature for the uncoated tube. In case of the Cr coated sample, the hydrogen rate first increased slowly, several times lower than that of uncoated one. The hydrogen release rate then accelerated at temperature around 1250°C, indicating fast oxidation rate of Cr at elevated temperatures and/or loss of the protective effect of the Cr scale. A steeply increased hydrogen release rate was observed at temperatures above approx. 1410°C. And immediately, the hydrogen release rate surpassed that of the uncoated reference Zircaloy-4 at temperature above ~1450°C, generating a significantly higher hydrogen peak which was not observed for the uncoated sample. This phenomenon should attribute to formation of liquid phases once the temperature exceeded the Cr-Zr eutectic temperature (~1330°C) leading to the failure of the coatings and rapid oxidation of the underneath substrate. According to the Ellingham diagram, oxygen has a higher affinity to zirconium than to chromium. When the zirconium in the eutectic melt reaches the chromia layer, the inner part of the chromia layer can be reduced. The total hydrogen productions were 125.3 mg and 81.5 mg for the uncoated and coated samples, respectively.

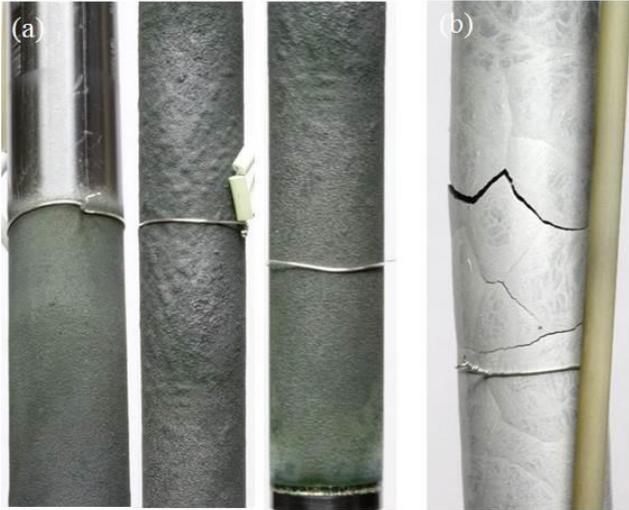
Fig. 15. Post-test appearances of the (a) coated and (b) uncoated samples after the transient test.

Fig. 15 are post-test appearances of the coated and uncoated samples after the transient test. The coated tube preserved its integrity without fracture. In comparison, the uncoated tube has cracked and fracture after the test. Examination of the coated sample surfaces clearly showed the formation of protrusions at the hottest region (middle) and the surface became rougher. No large liquid drops, as seen in Fig. 13, were observed here.

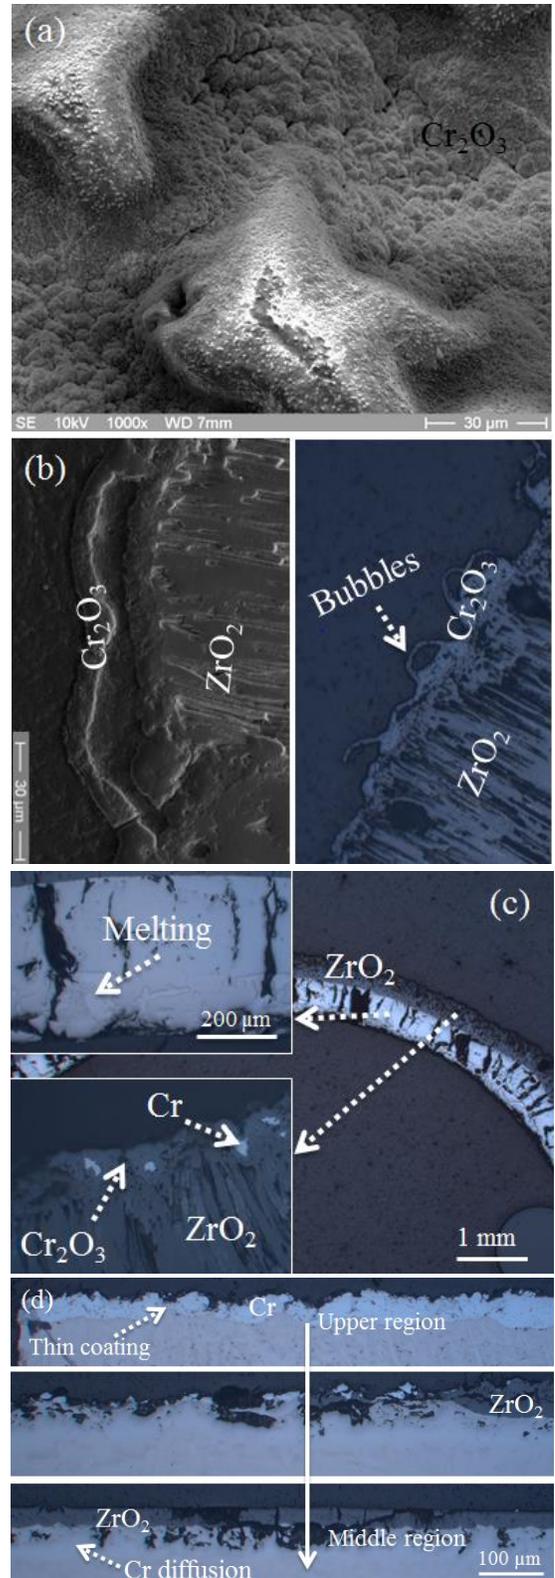
Fig. 16. Surface and cross section microstructures of the Cr coated tube after the transient test. (a) Surface structure at ~ 53 mm location, cross section of (b) and (c) at ~ 53 mm location and (d) from upper to middle region.

The surface and cross section microstructures of the Cr coated tube after the transient test are shown in Fig. 16. EDS analysis confirmed that the surface was covered by Cr_2O_3 . Micro-cracking of the oxide layer and growth of fine needle-type Cr_2O_3 grains were observed as displayed in Fig. 16 (a). The bumps or protrusions are indications of delamination or formation of bubbles within the Cr_2O_3 layer (Fig. 16 (b)). At the hottest region, a fairly uniform and thick ZrO_2 layer grew beneath the surface Cr_2O_3 layer (Fig. 16 (c)). The Cr coating has almost completely disappeared, apart from a few spots where metallic Cr particles were embedded in the Cr_2O_3 oxide layer, as revealed in the zoomed image in Fig. 16 (c). In addition, the Zircaloy-4 substrate showed some signs of melting in the inner side of the tube, which could be attributed to oxidation (oxygen) driven inward diffusion of Cr into the inner region of the cladding as reported previously [8,9]. The evolution of the cross section microstructure from the cold region (upper) to the hot region (middle) is shown in Fig. 16 (d). The maximum temperature measured by the TC_u was $\sim 1025^\circ\text{C}$. The Cr coating was protective at the upper region without obvious oxidation of the substrate. However, some discontinuity of the Cr coating layer was seen, probably owing to local spallation of the thin coating layer during metallographic treatment. As the region shift to hot areas, oxidation of the substrate accompanied by significant inward diffusion of the Cr coating into the substrate were revealed. Finally, a uniform ZrO_2 layer formed beneath the Cr_2O_3 layer on the surface.
