QUENCH - ALISA: Scientific Report NUSAFE 3570

Results of the QUENCH-18 Bundle Experiment on Air Ingress and AgInCd absorber behavior

J. Stuckert, J. Kalilainen, T. Lind, U. Stegmaier, M. Steinbrück,
Y. Zhang

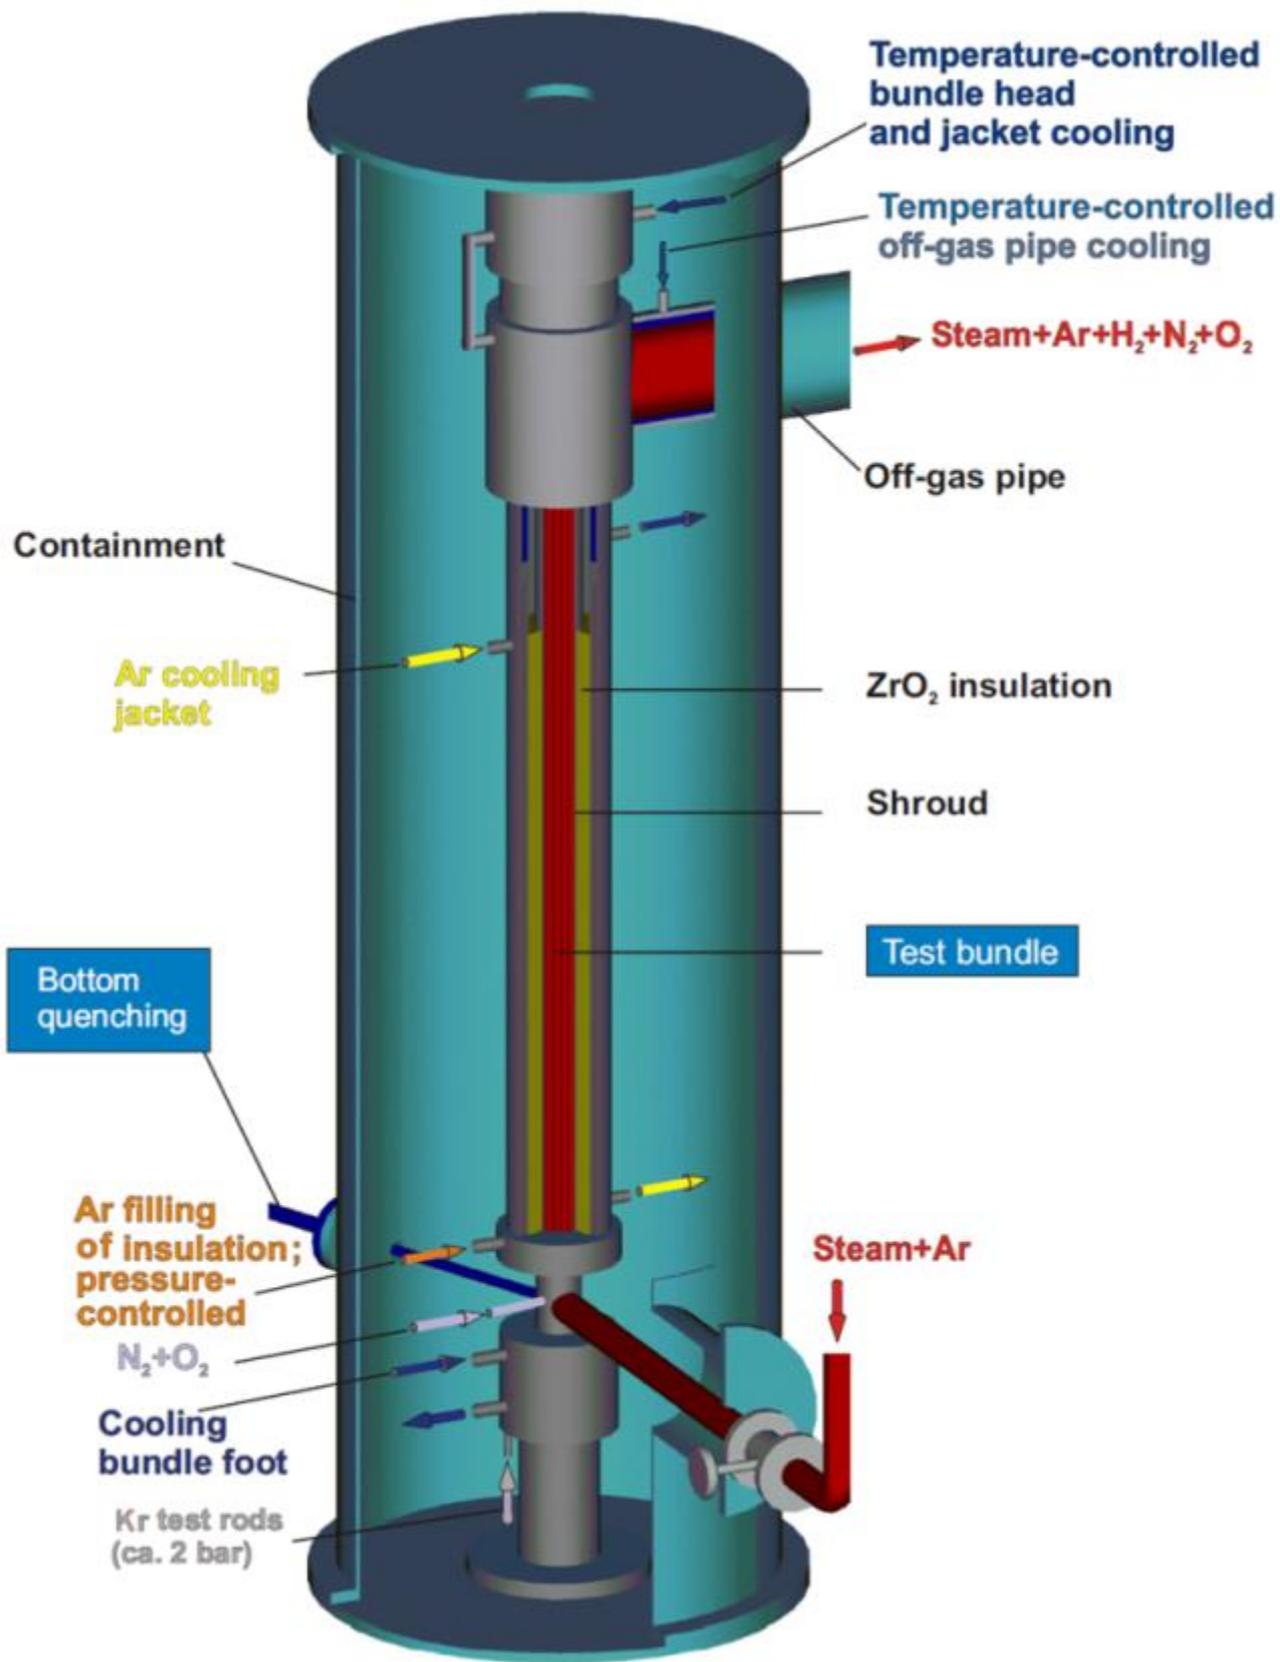
Figure 2 QUENCH-18; flow diagram of the QUENCH facility.

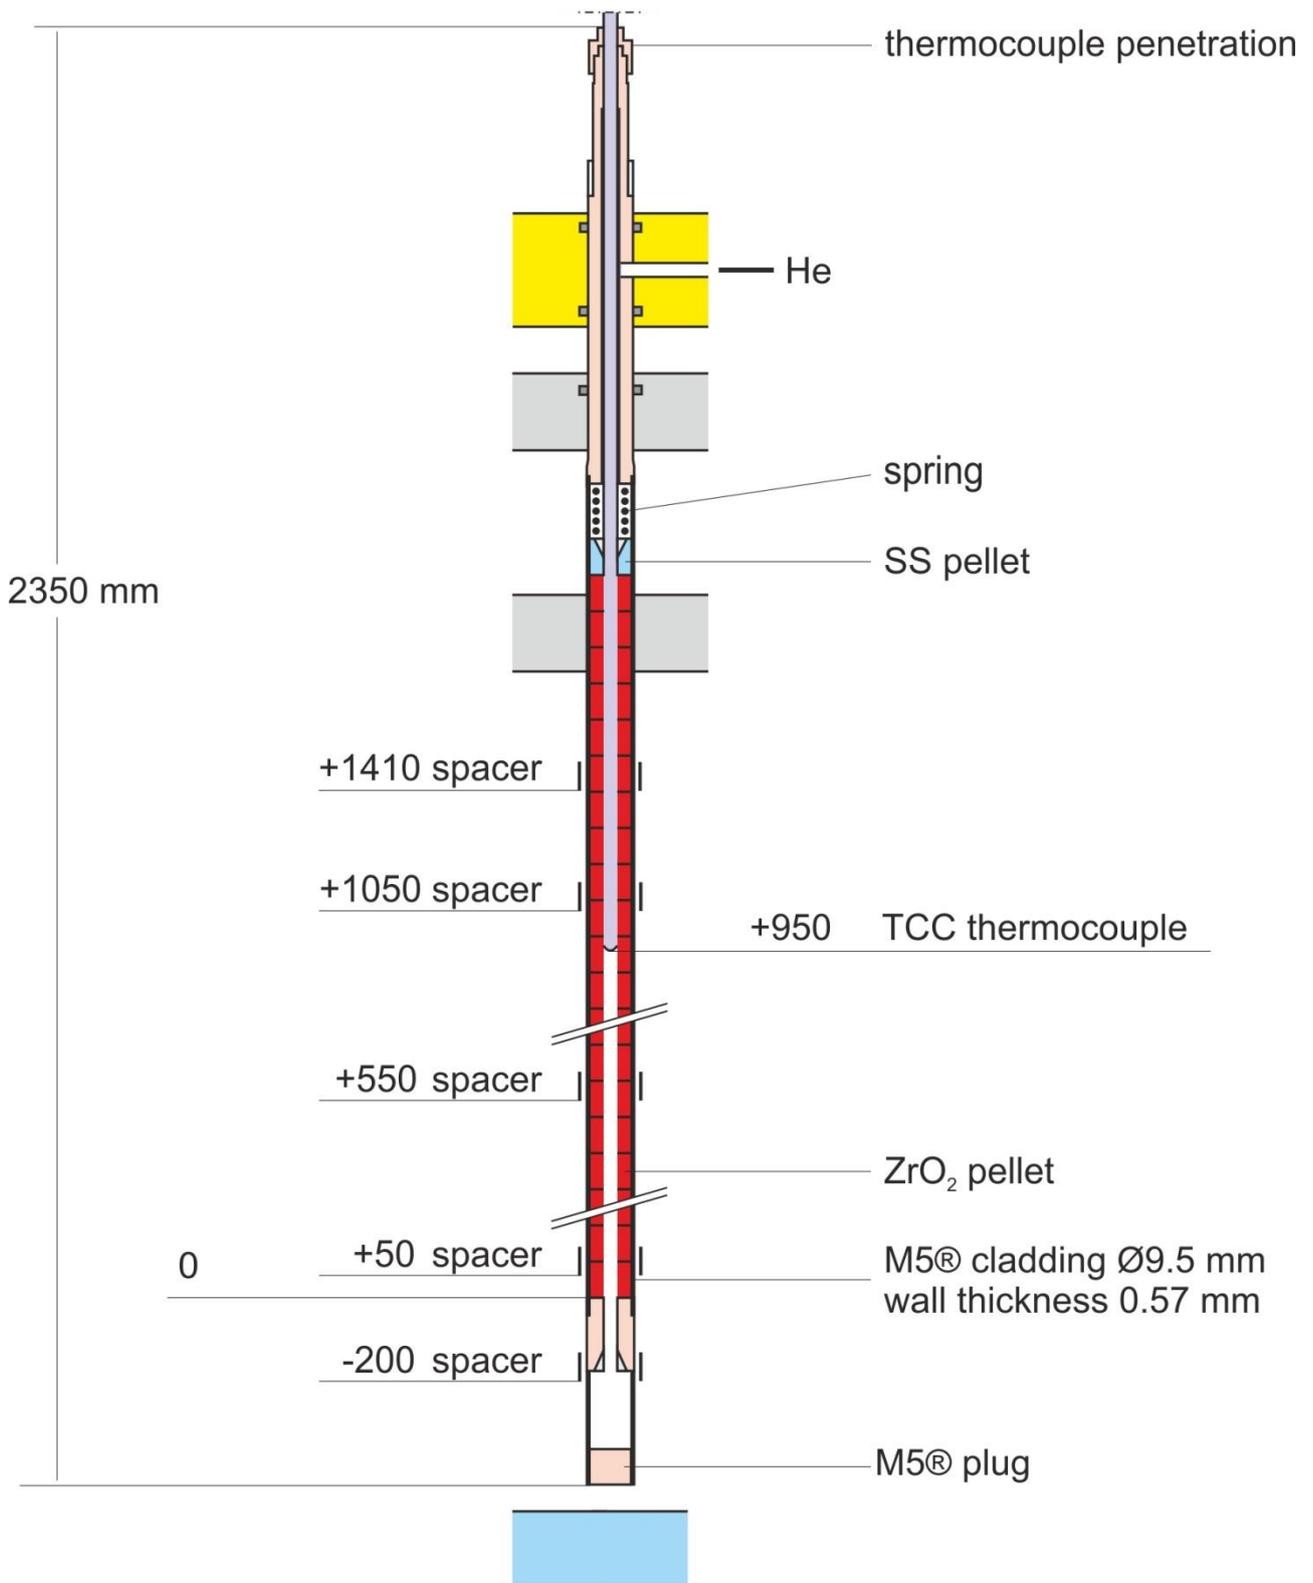
Figure 6 QUENCH-18; heated rod.

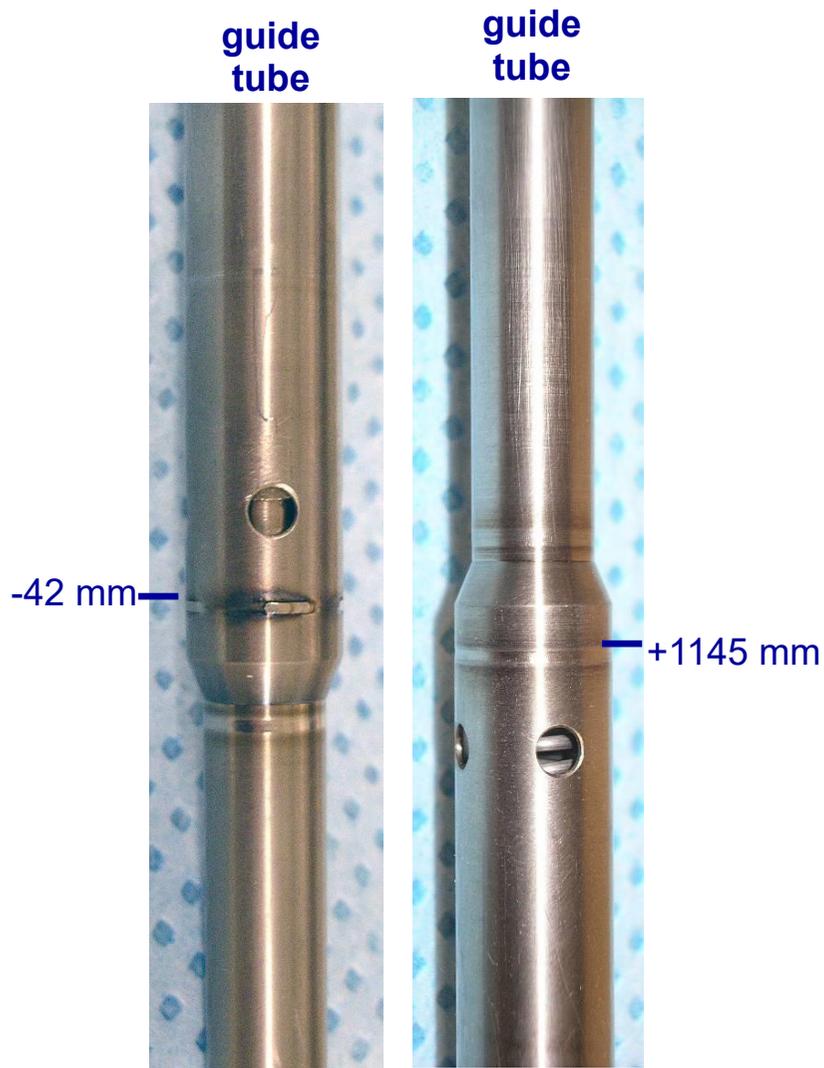
Figure 9 QUENCH-18; absorber rod features.

Absorber rod	material	80 Ag, 15 In, 5 Cd (wt-%)
	dimensions	\varnothing 8.60 mm, L=1068 mm (Elev. -15 to 1053 mm), $M \approx 633$ g
Cladding of absorber rod		SS , \varnothing 9.70 / 8.75 mm L = 1083 mm (Elev. -20 to 1063 mm)
Guide tube of absorber rod		M5® , \varnothing 12.45 / 11.25 mm L = 1187 mm (Elev. -42 to 1145 mm) Holes for coolant penetration (2x4): \varnothing 4 mm (Elev. -34 and +1137 mm)
Internal rod pressure of absorber rod		0.12 MPa abs. (He)

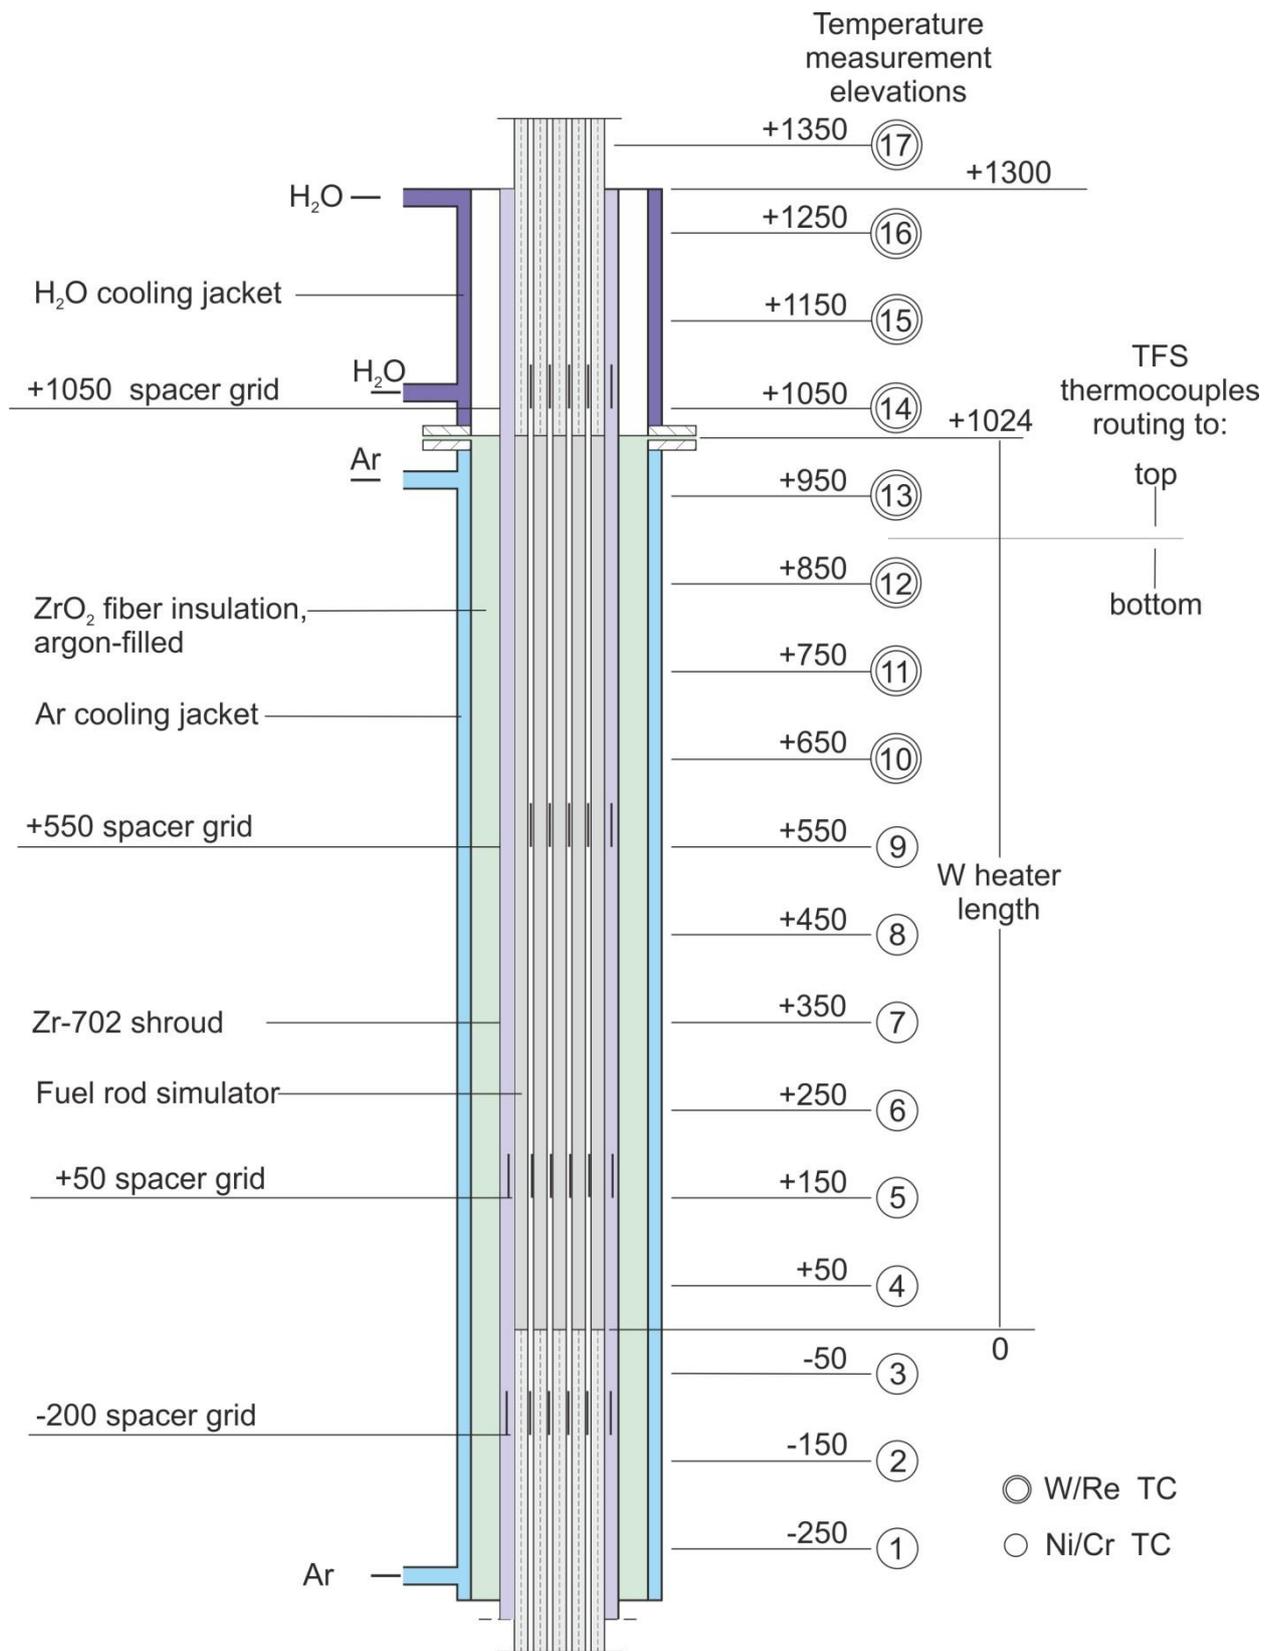
Figure 10 QUENCH-18; designation of the various thermocouples.

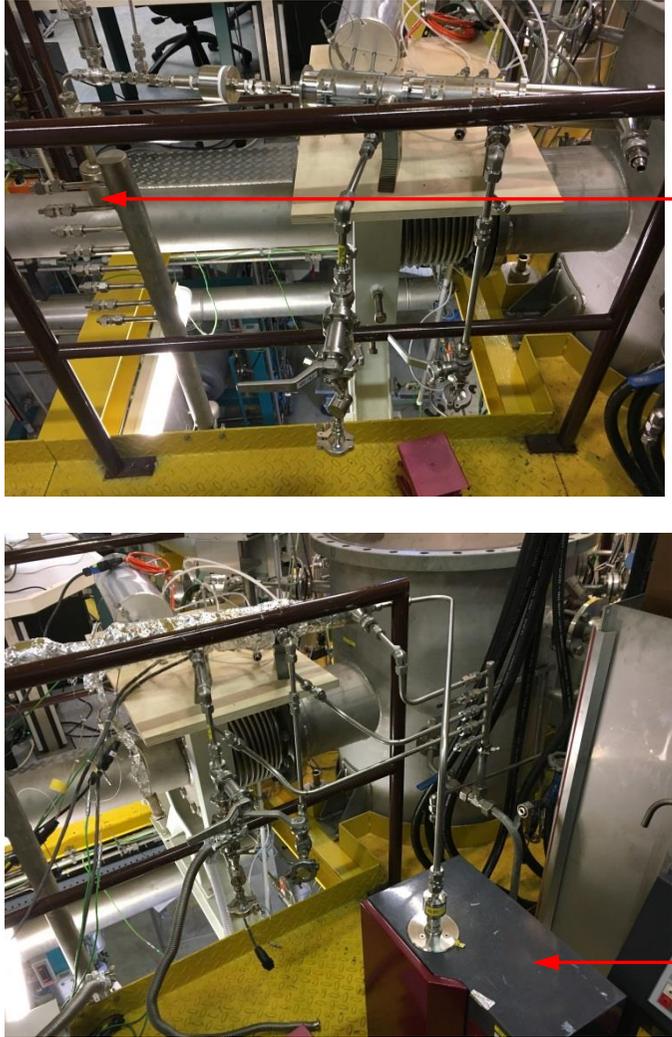
Figure 54 QUENCH-18; Aerosol measurement setup.

Aerosol measurements were performed with two systems: 1) on-line device ELPI (electrical low pressure impactor) and 2) two particle collection devices BLPI (Bernern low pressure impactor) (Figure 54). Additionally,

The scheme of aerosol measurement devices is given in Figure 54. The detailed results, description as well the corresponding analysis are given in [17], [18]. The failure of absorber rods with helium release and first Ag-In-Cd aerosol release was registered at 10530 s with a corresponding temperature of $T_{pct} = 1350$ K (at 950 mm) and $T_{550mm} = 1300$ K (Figure 55). Effective diameter of sampled particles (ELPI and BLPI) was measured to be between 0.4 and 10 μm (the main part of released particles had a diameter of about 1 μm) (Figure 56). High aerosol concentration of several g/m^3 was measured until the quench initiation (Figure 57).

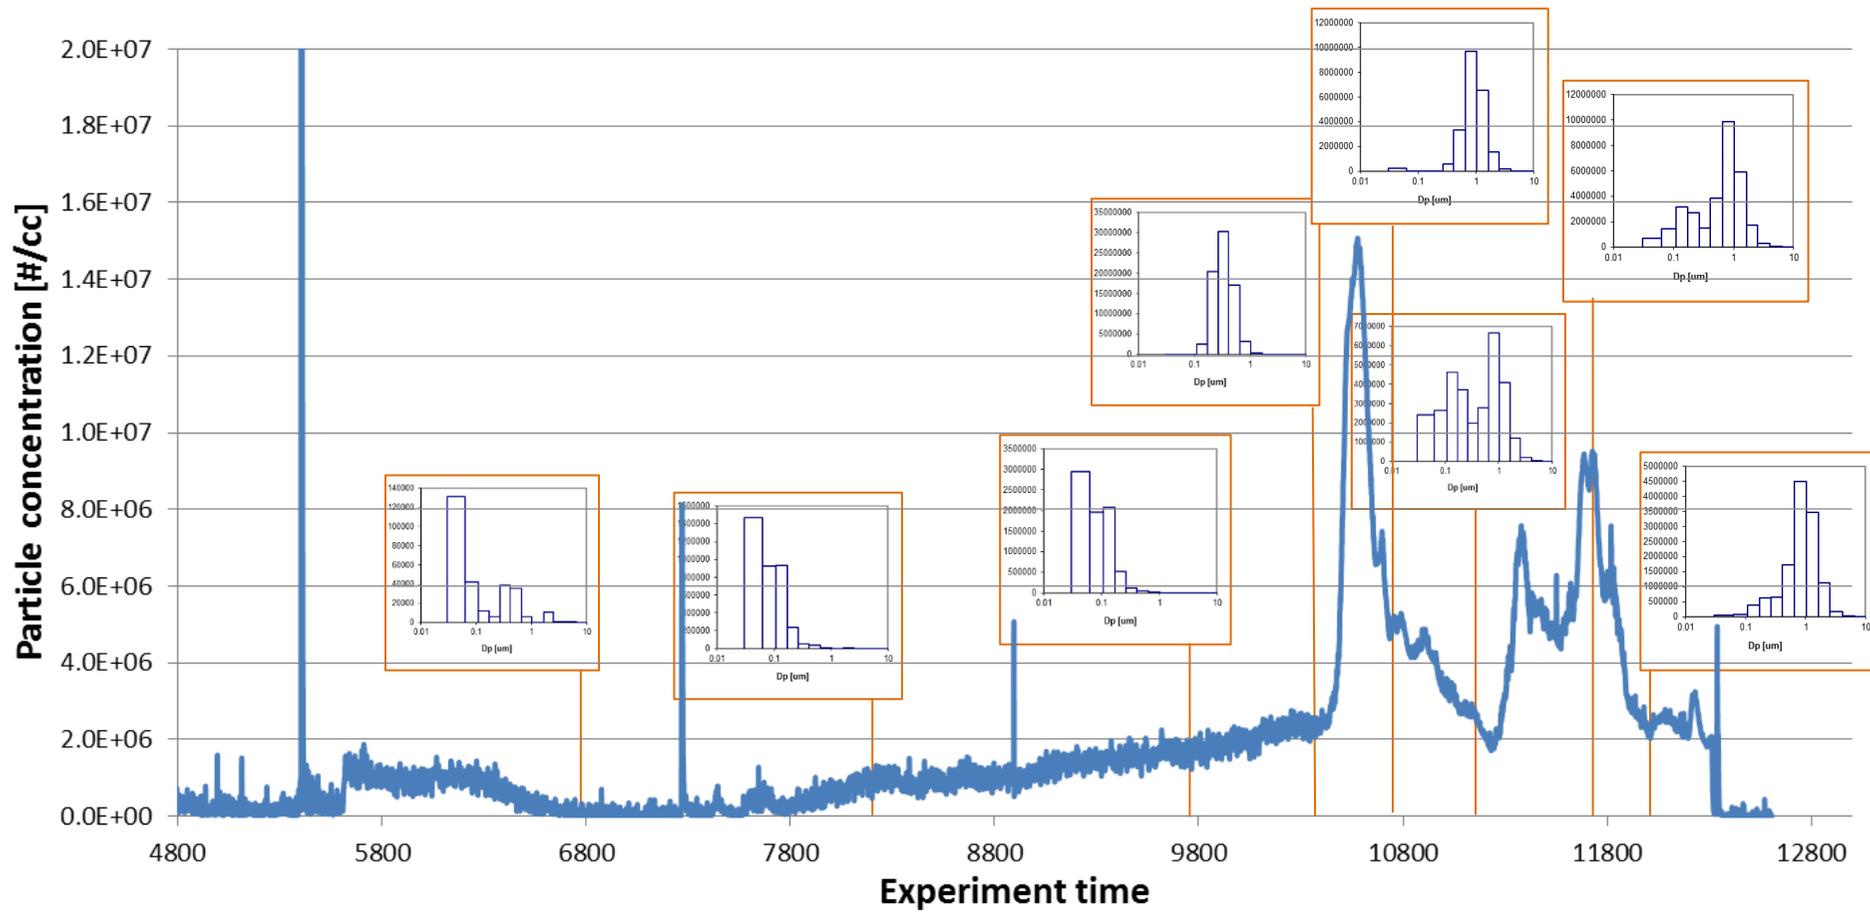
Figure 55 QUENCH-18; Failure of absorber rods indicated by He release and aerosol release measured by ELPI with indication of time periods for taking of filter and BLPI samples.

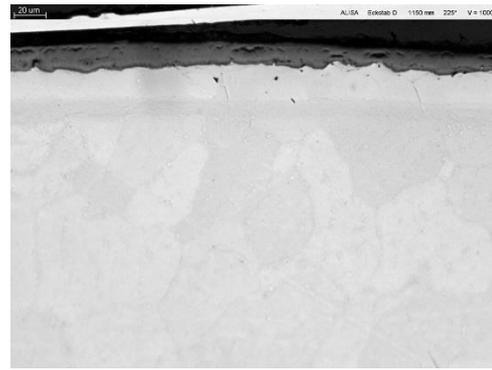
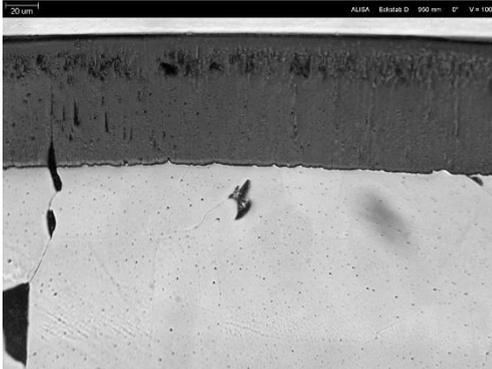
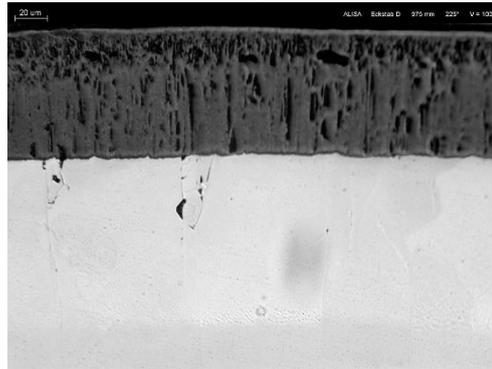
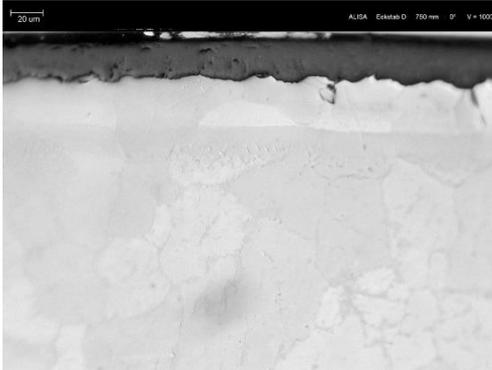
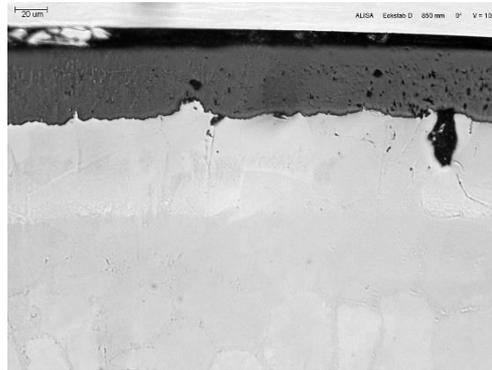
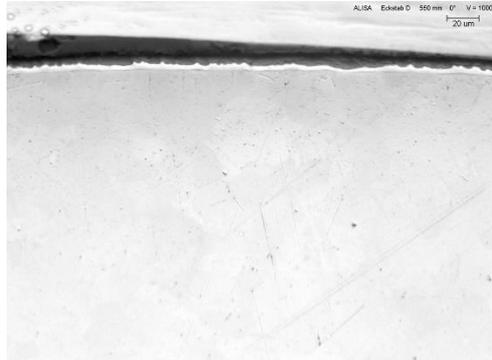
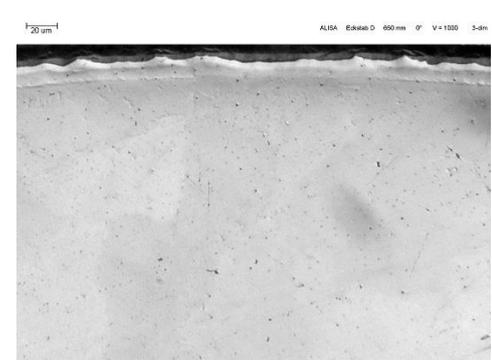
Figure 61 QUENCH-18; Metallography of corner rod D withdrawn before air ingress: layer structures and thicknesses.

1050 mm: ZrO₂ 45 µm; α-Zr(O) 56 µm

1150 mm: ZrO₂ 15 µm; α-Zr(O) 23 µm

950 mm: ZrO₂ 81 µm; α-Zr(O) 108 µm

975 mm: ZrO₂ 79 µm; α-Zr(O) 105 µm

750 mm: ZrO₂ 27 µm; α-Zr(O) 31 µm

850 mm: ZrO₂ 44 µm; α-Zr(O) 60 µm

550 mm: ZrO₂ 5 µm; α-Zr(O) 3 µm

650 mm: : ZrO₂ 6 µm; α-Zr(O) 4 µm

Towards the end of this stage, the corner rod D was extracted from the test bundle for determination of the degree of oxidation at various bundle elevations. [Figure 60](#) shows results of eddy current measurements in comparison with metallographic data. Metallographic investigations of cross sections between 550 and 1150 mm showed formation of regular oxide layers without breakaway effect ([Figure 61](#)). The highest oxidation degree was reached at the hottest (during this test stage) bundle elevation of 950 mm with an oxide layer thickness of ≈ 80 μm , and ≈ 110 μm thickness of the α -Zr(O) layer.

A maximum oxide layer thickness of $81\ \mu\text{m}$ was determined for rod D at bundle elevation of 950 mm with direct metallographic measurements (Figure 61).

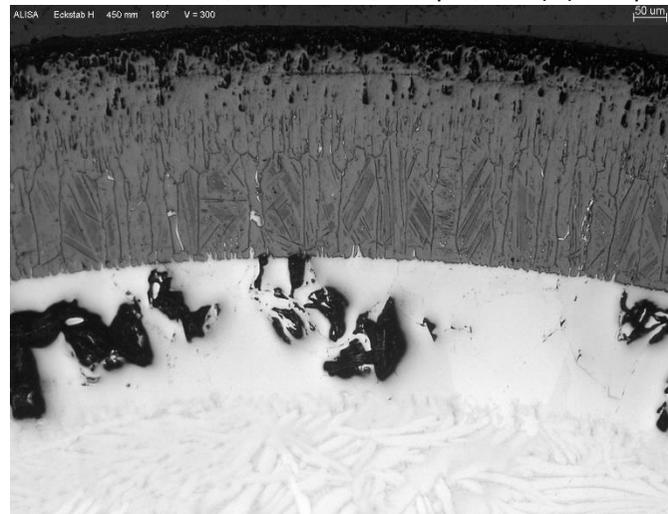
Figure 64 QUENCH-18; Metallography of lower part of corner rod H withdrawn after temperature escalation during air ingress: nitrides above 500 mm.

400 mm: no nitrides, ZrO₂ 58 μm, α-Zr(O) 80 μm

450 mm: no nitrides, ZrO₂ 340 μm, α-Zr(O) 208 μm

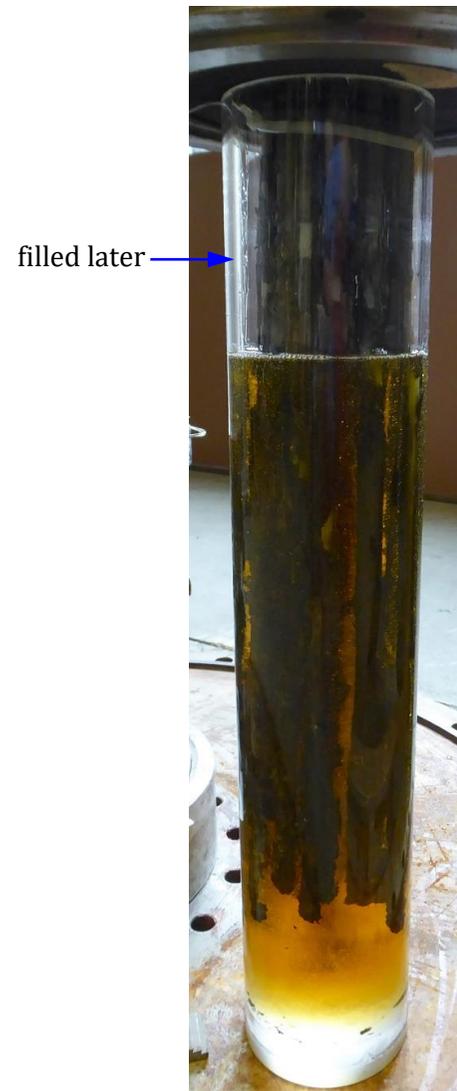
Figure 73 QUENCH-18; embedding of upper and lower parts of bundle in epoxy resin.

lower bundle part embedded in epoxy with indication of slices chosen for cutting

upper bundle part (without rods 3 and 23) embedded in epoxy

The two bundle parts were filled with epoxy resin, which was solidified after two weeks (Figure 73).

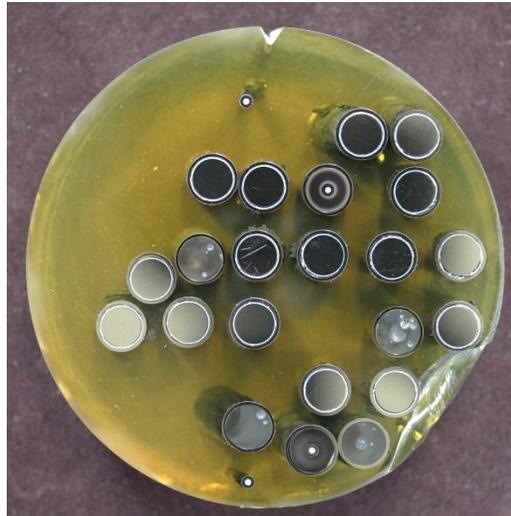
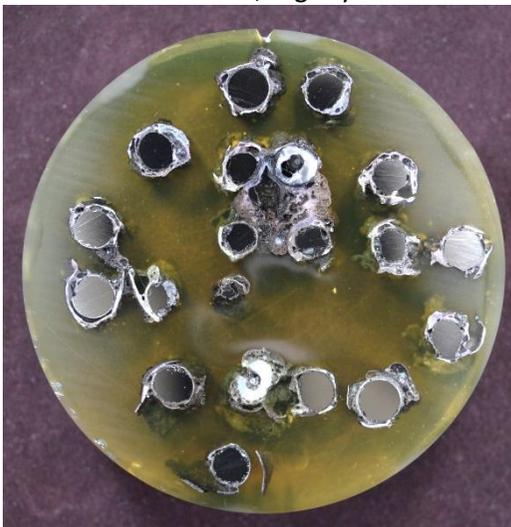
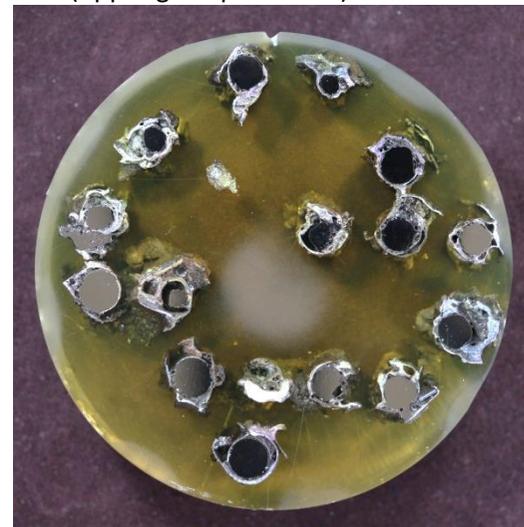
Figure 75 QUENCH-18; Post-test bundle cross-sections (without rods 3 and 23; top view) at upper elevations with coated Mo heaters, as polished.

bundle composition at upper elevations

1480 mm: intact rods, slightly oxidized clads

1350 mm: remainders of strongly oxidized clads

1250 mm: remainders of strongly oxidized clads

1150 mm: remainders of strongly oxidized clads

The separation of the bundle top (between 1090 and 1500 mm) into cross-sections (Figure 75) by diamond saw was performed according to Table 13. The metallographic investigation of claddings shows strong but not complete oxidation at elevations above 1350 mm and practically complete oxidation between 1100 and 1350 mm (Figure 76). At elevations below 1430 mm the metallic parts of the claddings were melted (Figure 77...Figure 82). During the melt relocation, the oxide layers and Mo heaters were partially dissolved. No Zr metallic melt was registered below 1350 mm - the melt was completely oxidized.

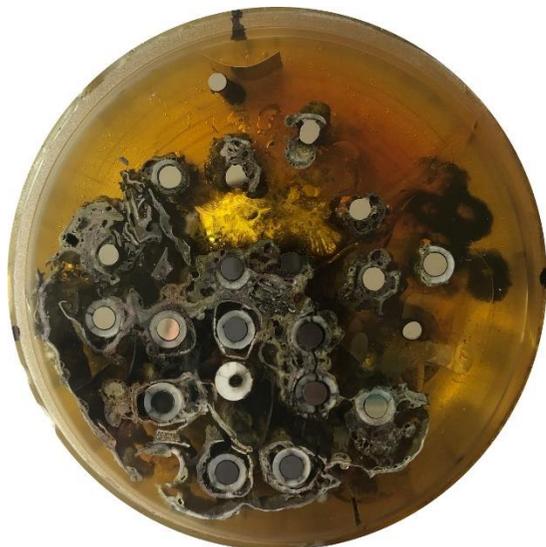
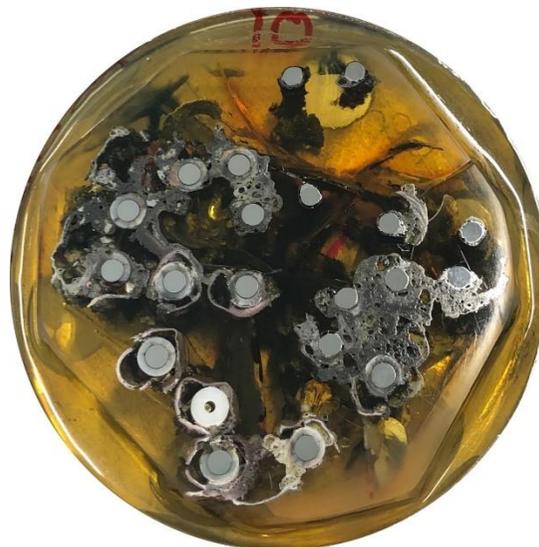
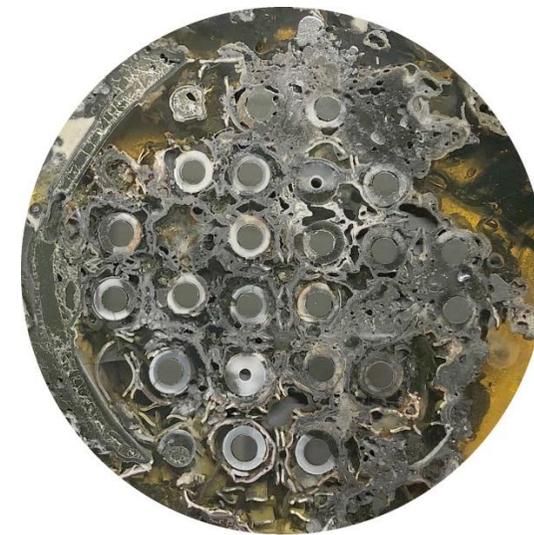
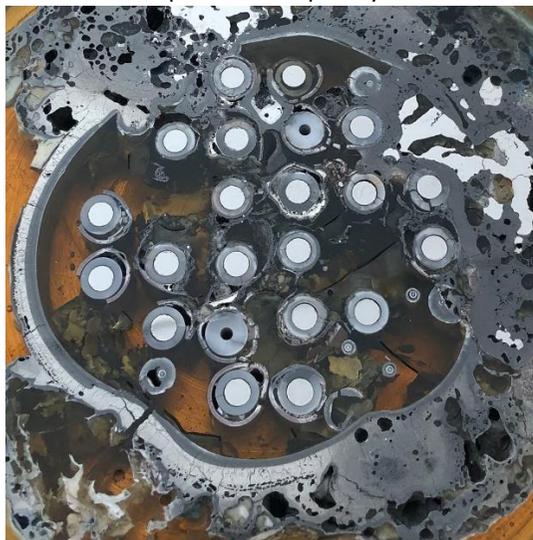
950 mm: local pools of completely oxidized melt

750 mm: local pools of oxidized melt

560 mm: melt collection inside grid spacer

350 mm: local molten pool at bundle periphery formed by relocated molten shroud

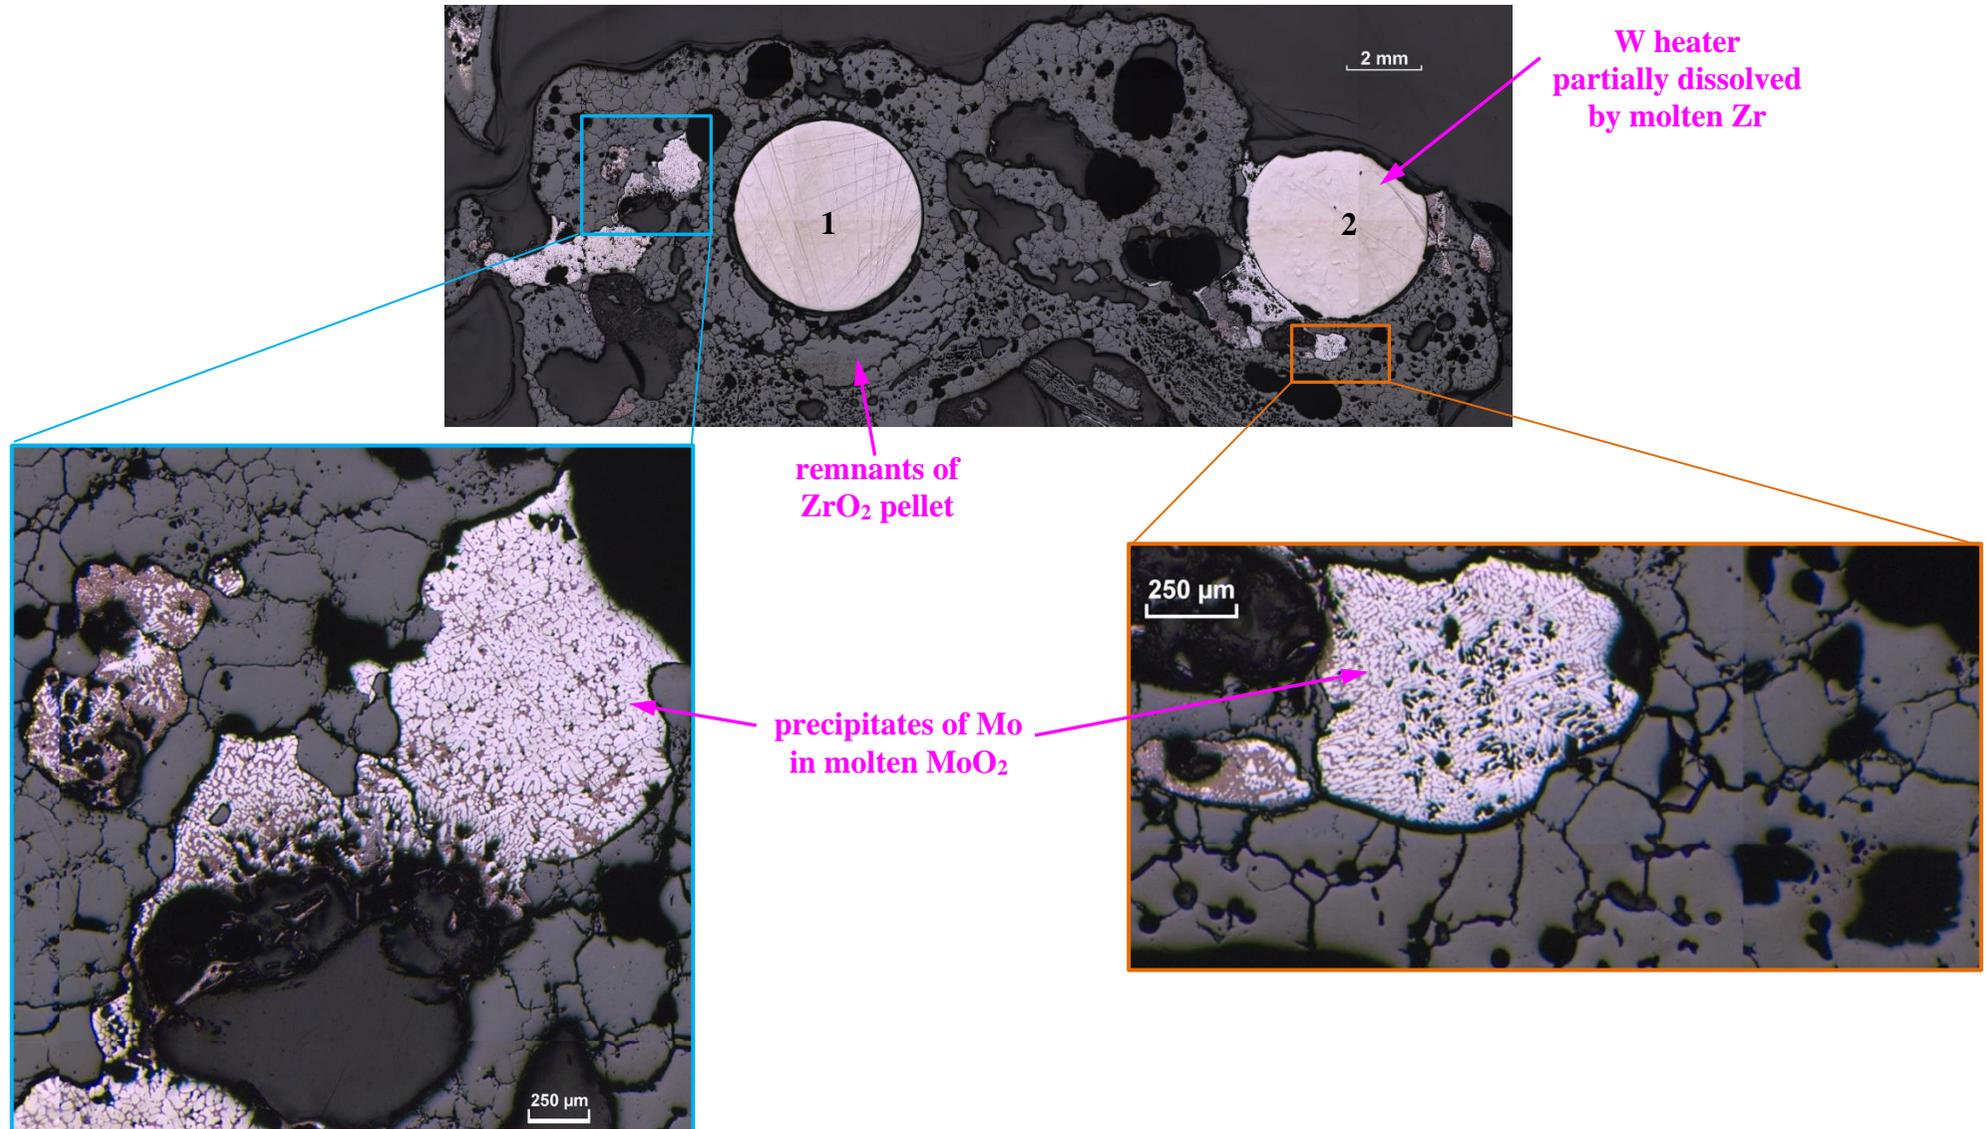
cross section, top view (perspective projection): melt and debris of unheated rod 9 and corner rods relocated downwards

Figure 84 QUENCH-18; cross section at bundle elevation 950 mm.

The bundle segment between angle positions 270°-0°-90°-135° is more damaged than other bundle parts (Figure 84). Even tungsten heaters in this segment were damaged by relocated melt. Obviously, there was a strong circumferential temperature gradient. This is also confirmed by the higher temperature peak measured by TFS 9/13 (about 2200 K at 12437 s) in comparison to the peak measured by TFS 15/23 (about 2100 K), see Figure 31. There is no metal cladding or shroud parts left here. Only completely oxidized parts of claddings and shroud as well as oxidized molten pools are observed. Several pellets were partially or completely dissolved by molten Zr (Figure 85). The bulk of frozen pools is very porous and the area of the pool cross section is strongly limited *without noticeable blockage* of the bundle cross section. Inside the oxidized zirconium melt, small inclusions of partially oxidized molybdenum are observed, transferred here in the molten state from the upper elevations.

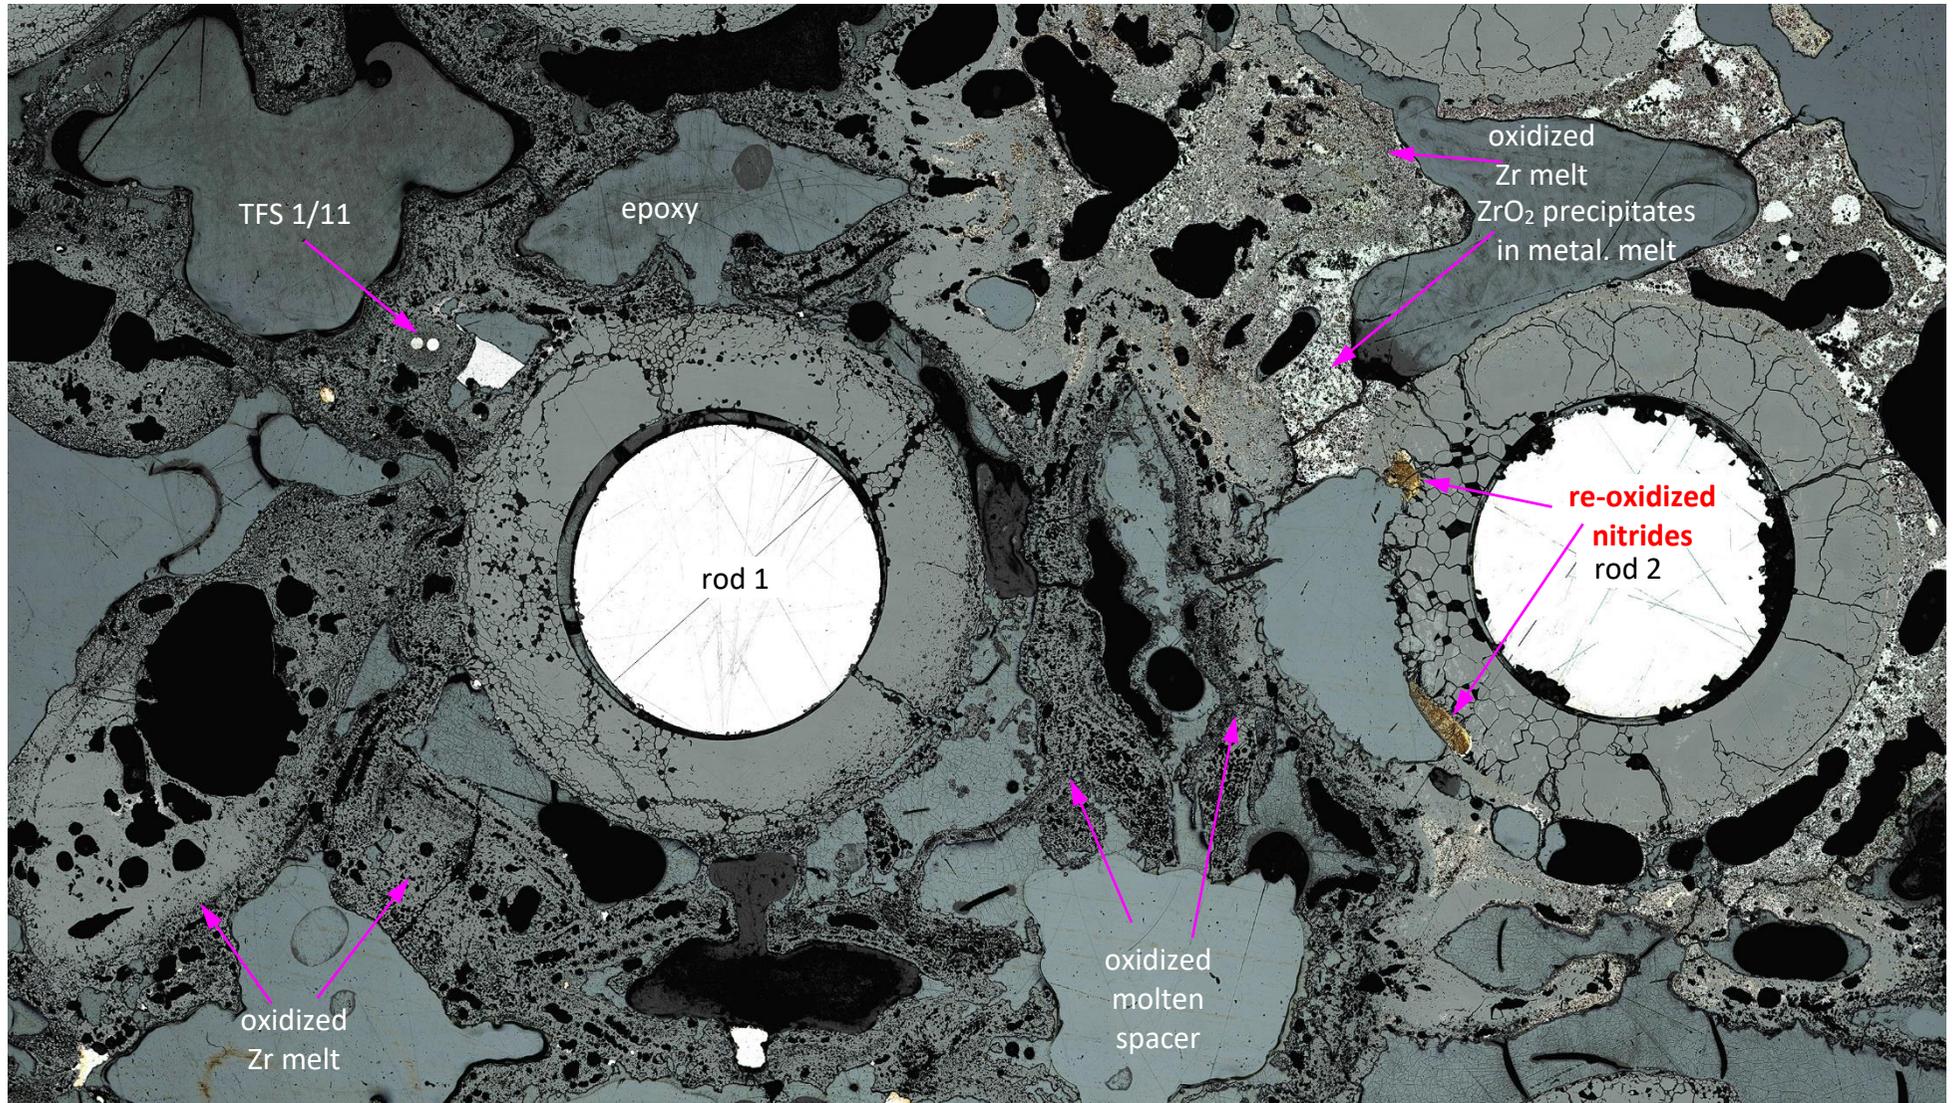
cross section top view(perspective projection), mirrored bottom of slice 560 - 580 mm

Figure 95 QUENCH-18; cross section at bundle elevation of 560 mm, oxidized melt inside grid spacer, moderate bundle blockage.

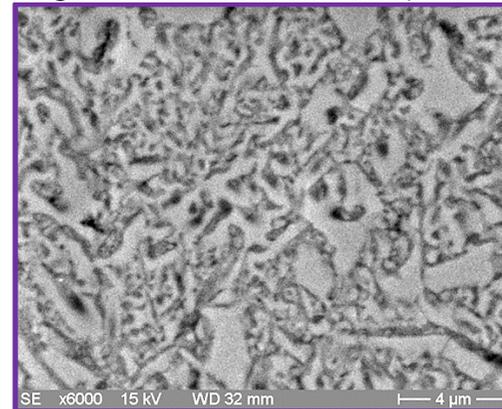
SEM/EDX of metallic melt (wt%): 1) (Fe 35%, Cr 4%, Ni 4%, Zr 35%, Mo 20%), 2) (Mo 80%, W 20%), 3) (Mo 60%, W 35%, Zr 5%)

SEM image and EDX spectrum of zirconium oxides and nitrides porous area

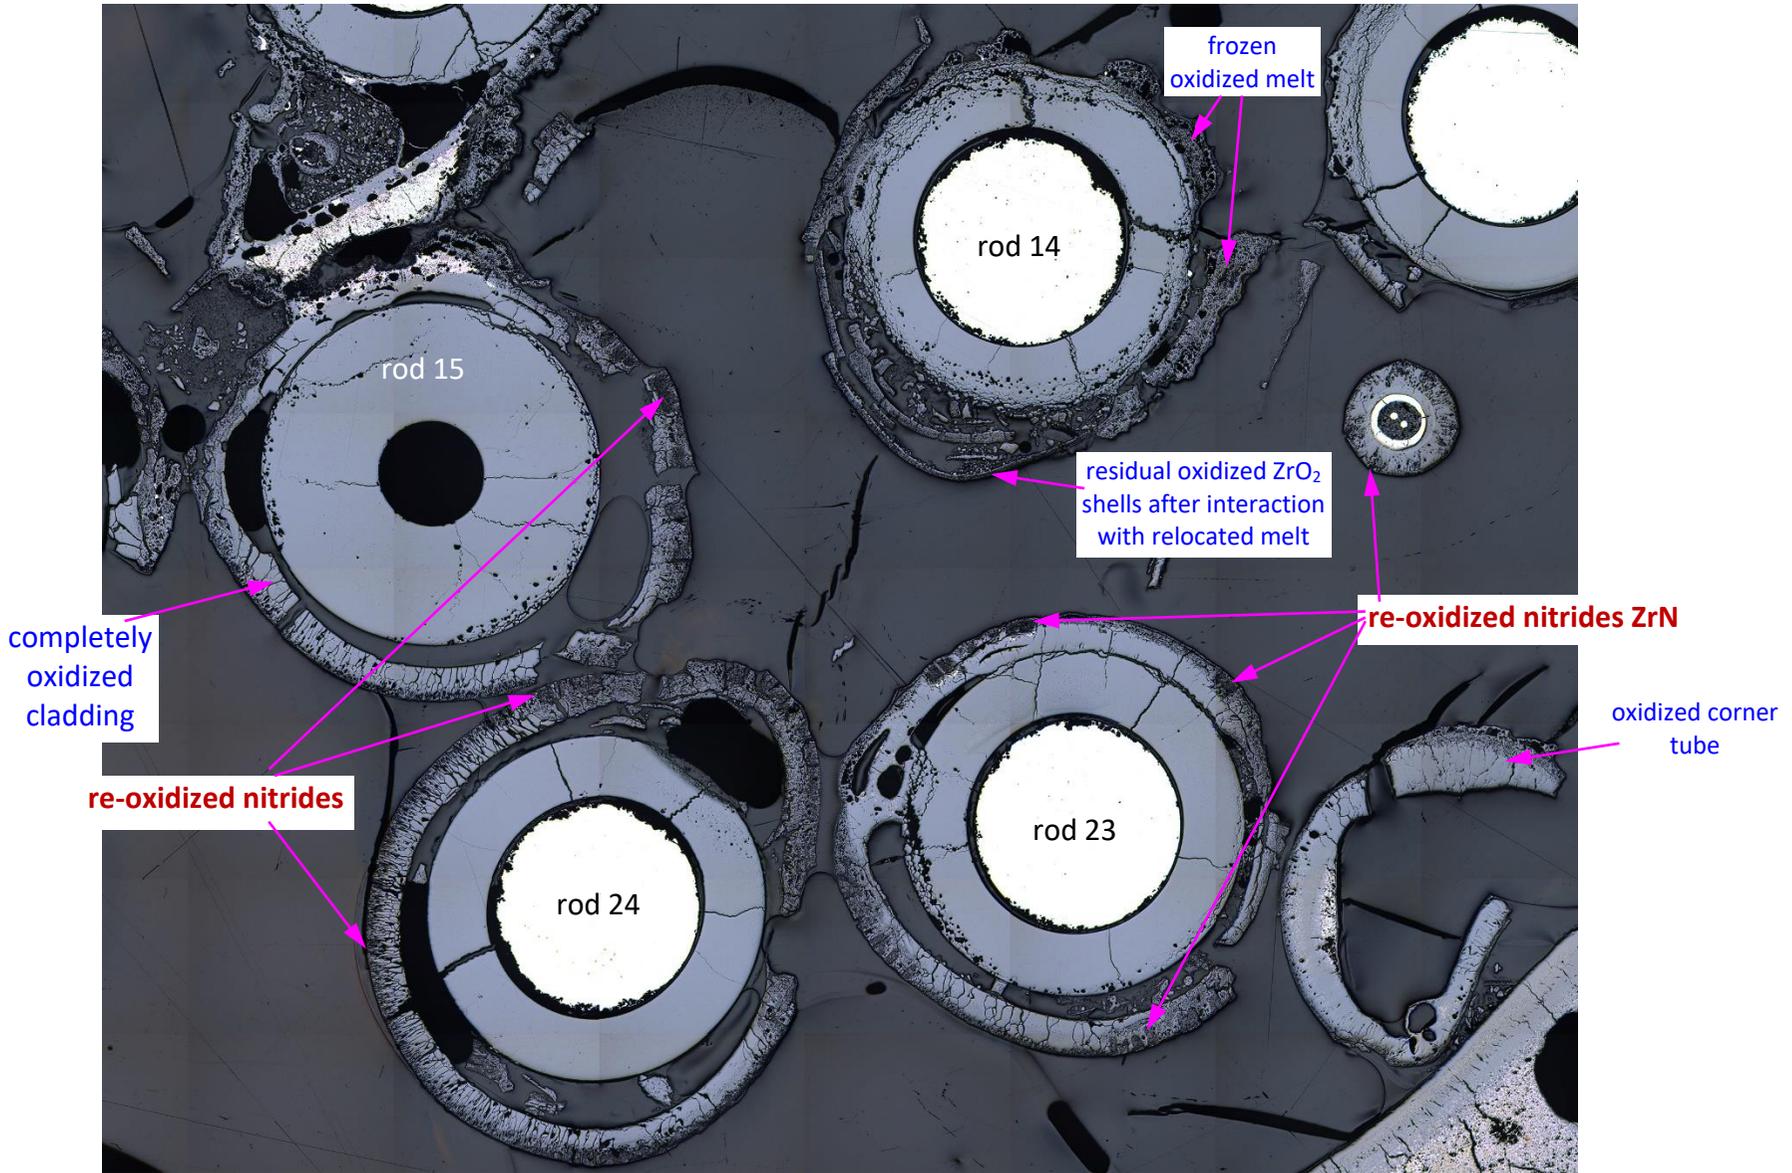
Figure 107 QUENCH-18; Zr shroud at 350 mm: thick oxide layer (between 1 and 1.5 mm) and nitride layer (about 100 μm).

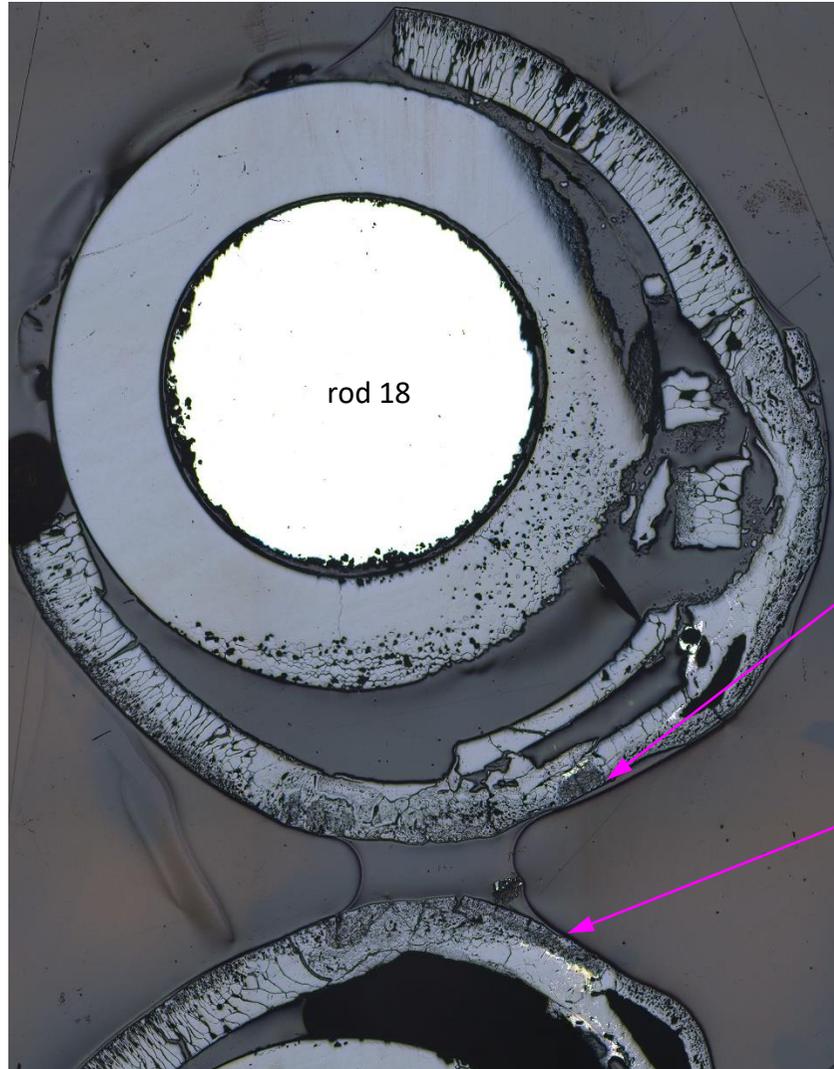
Figure 109 QUENCH-18; microstructure of rod elements for rod #23 at bundle elevation of 350 mm.
