QUENCH - ALISA: Scientific Report NUSAFE 3570

Results of the QUENCH-18 Bundle Experiment on Air Ingress and AgInCd absorber behavior

J. Stuckert, J. Kalilainen, T. Lind, U. Stegmaier, M. Steinbrück,
Y. Zhang

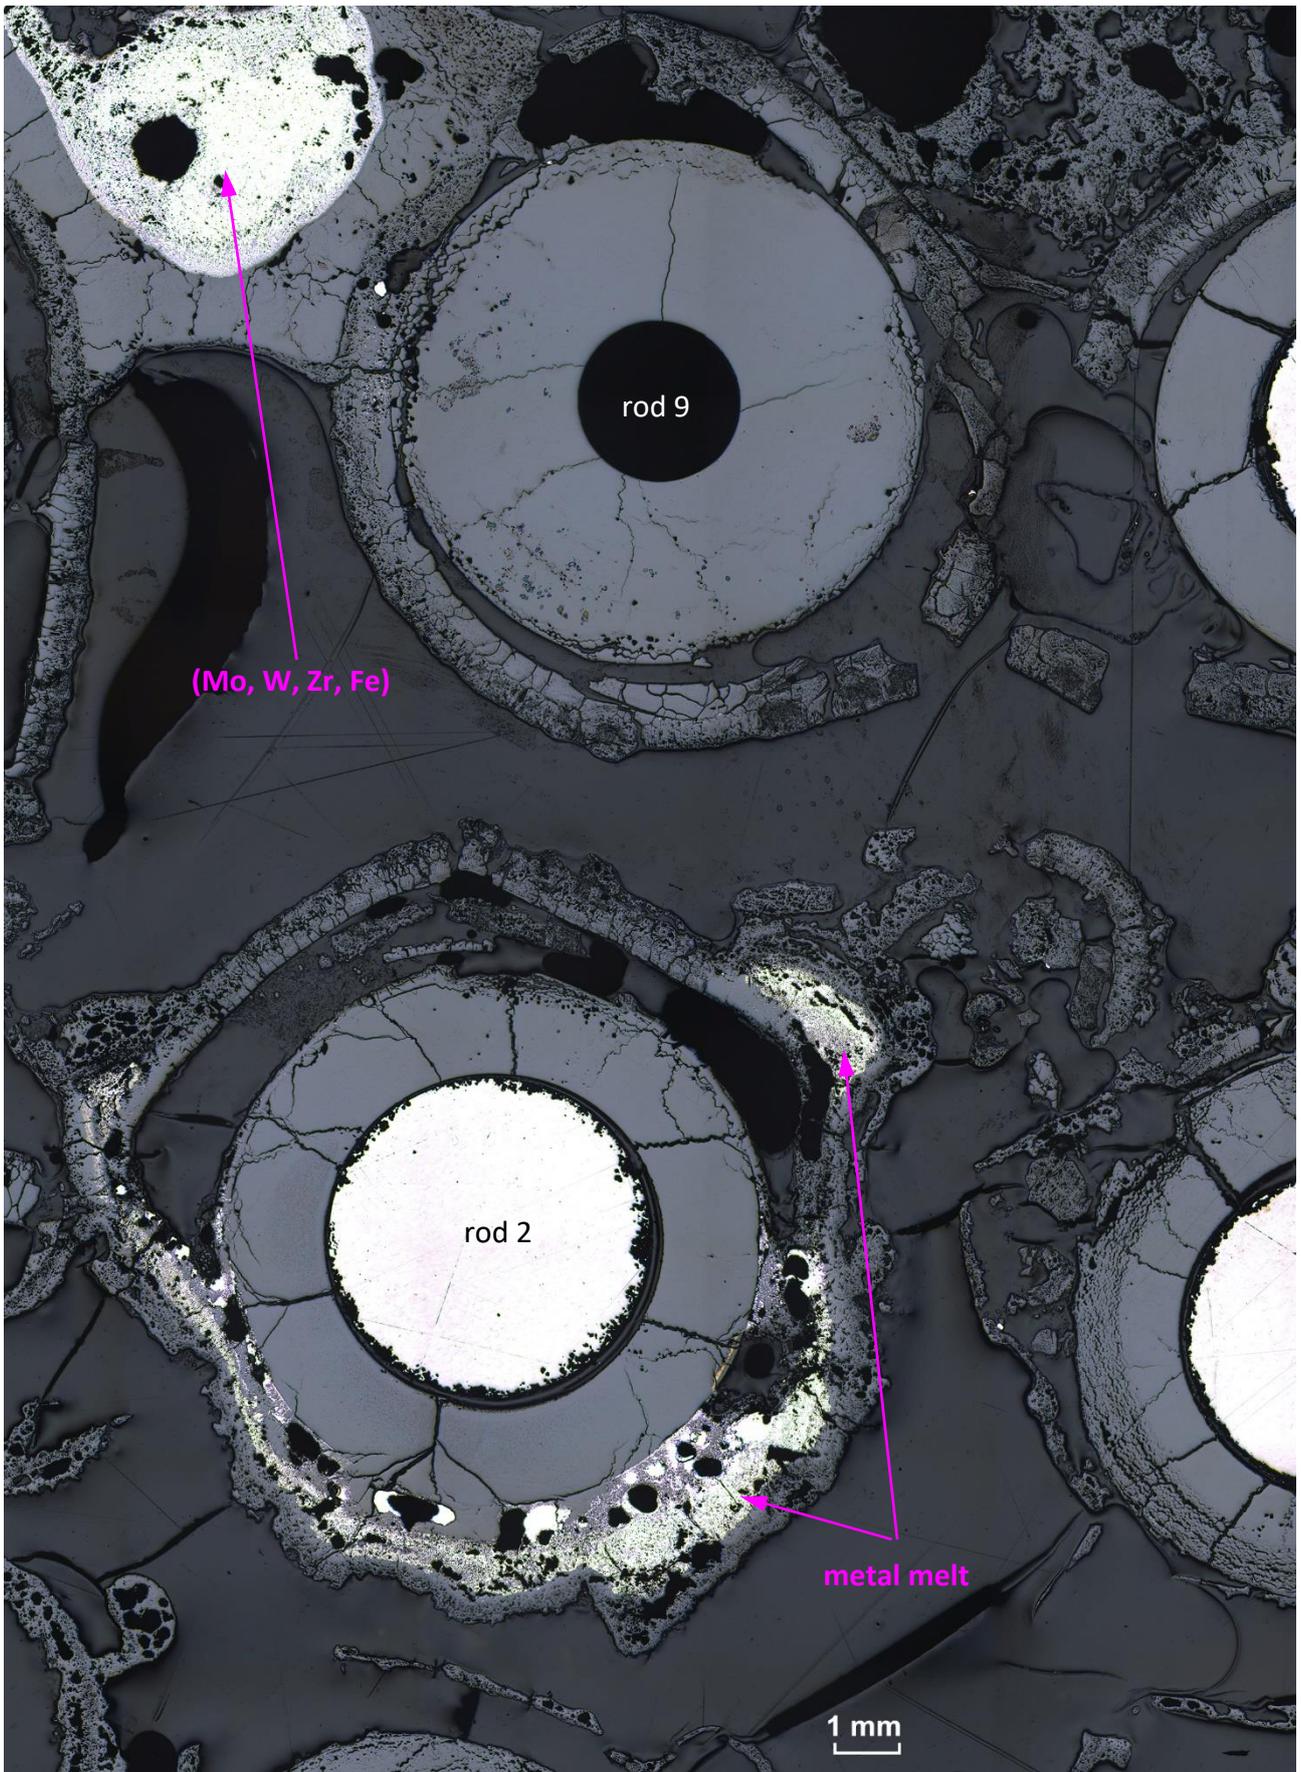
Figure 110 QUENCH-18; microstructure of rod elements for rods #17 and #18 at bundle elevation of 350 mm: porous re-oxidized nitrides at the outer cladding surface and residual nitrides at the position of prior α -Zr(O) inside the almost completely oxidized cladding.

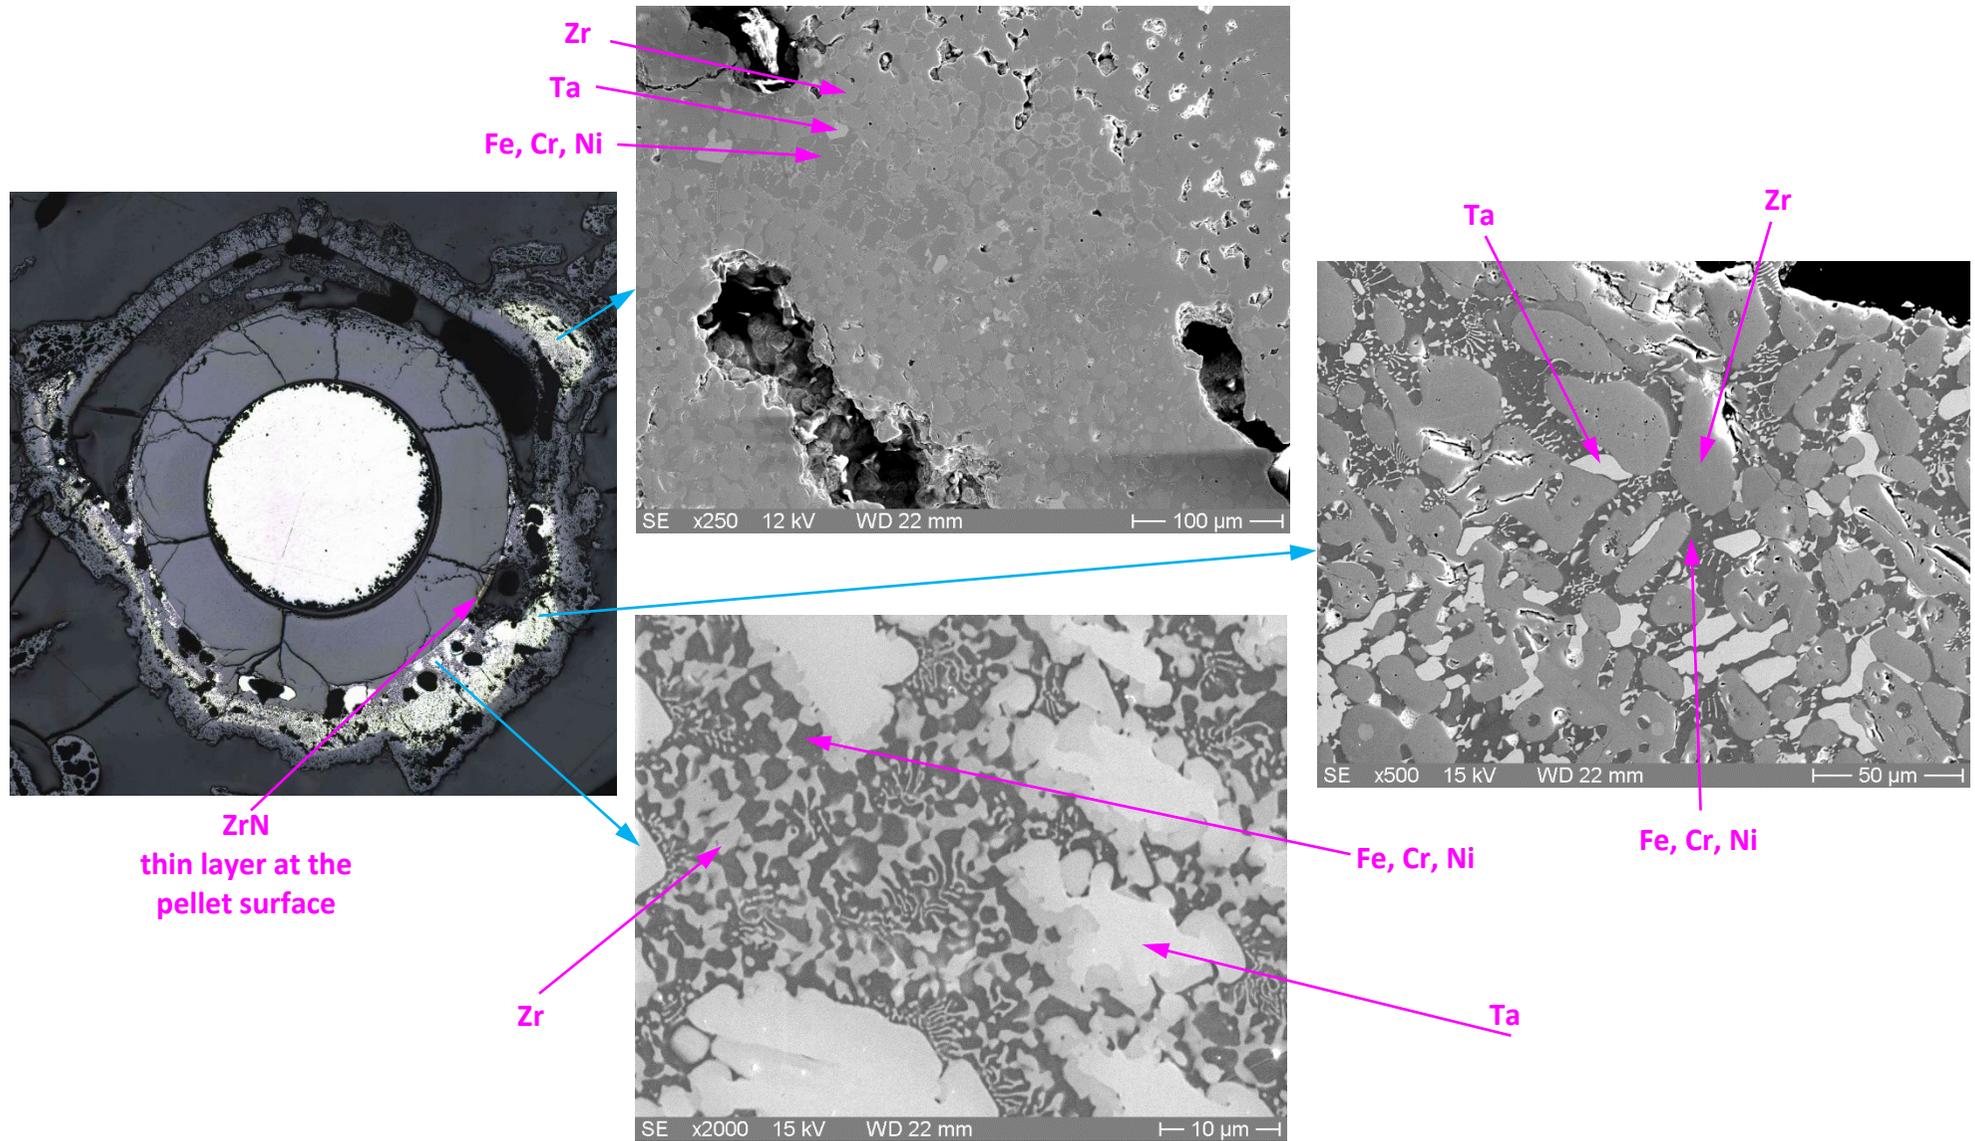
Figure 111 QUENCH-18; 350 mm: completely oxidized clad #9, oxide of clad #2 partially dissolved by melt.

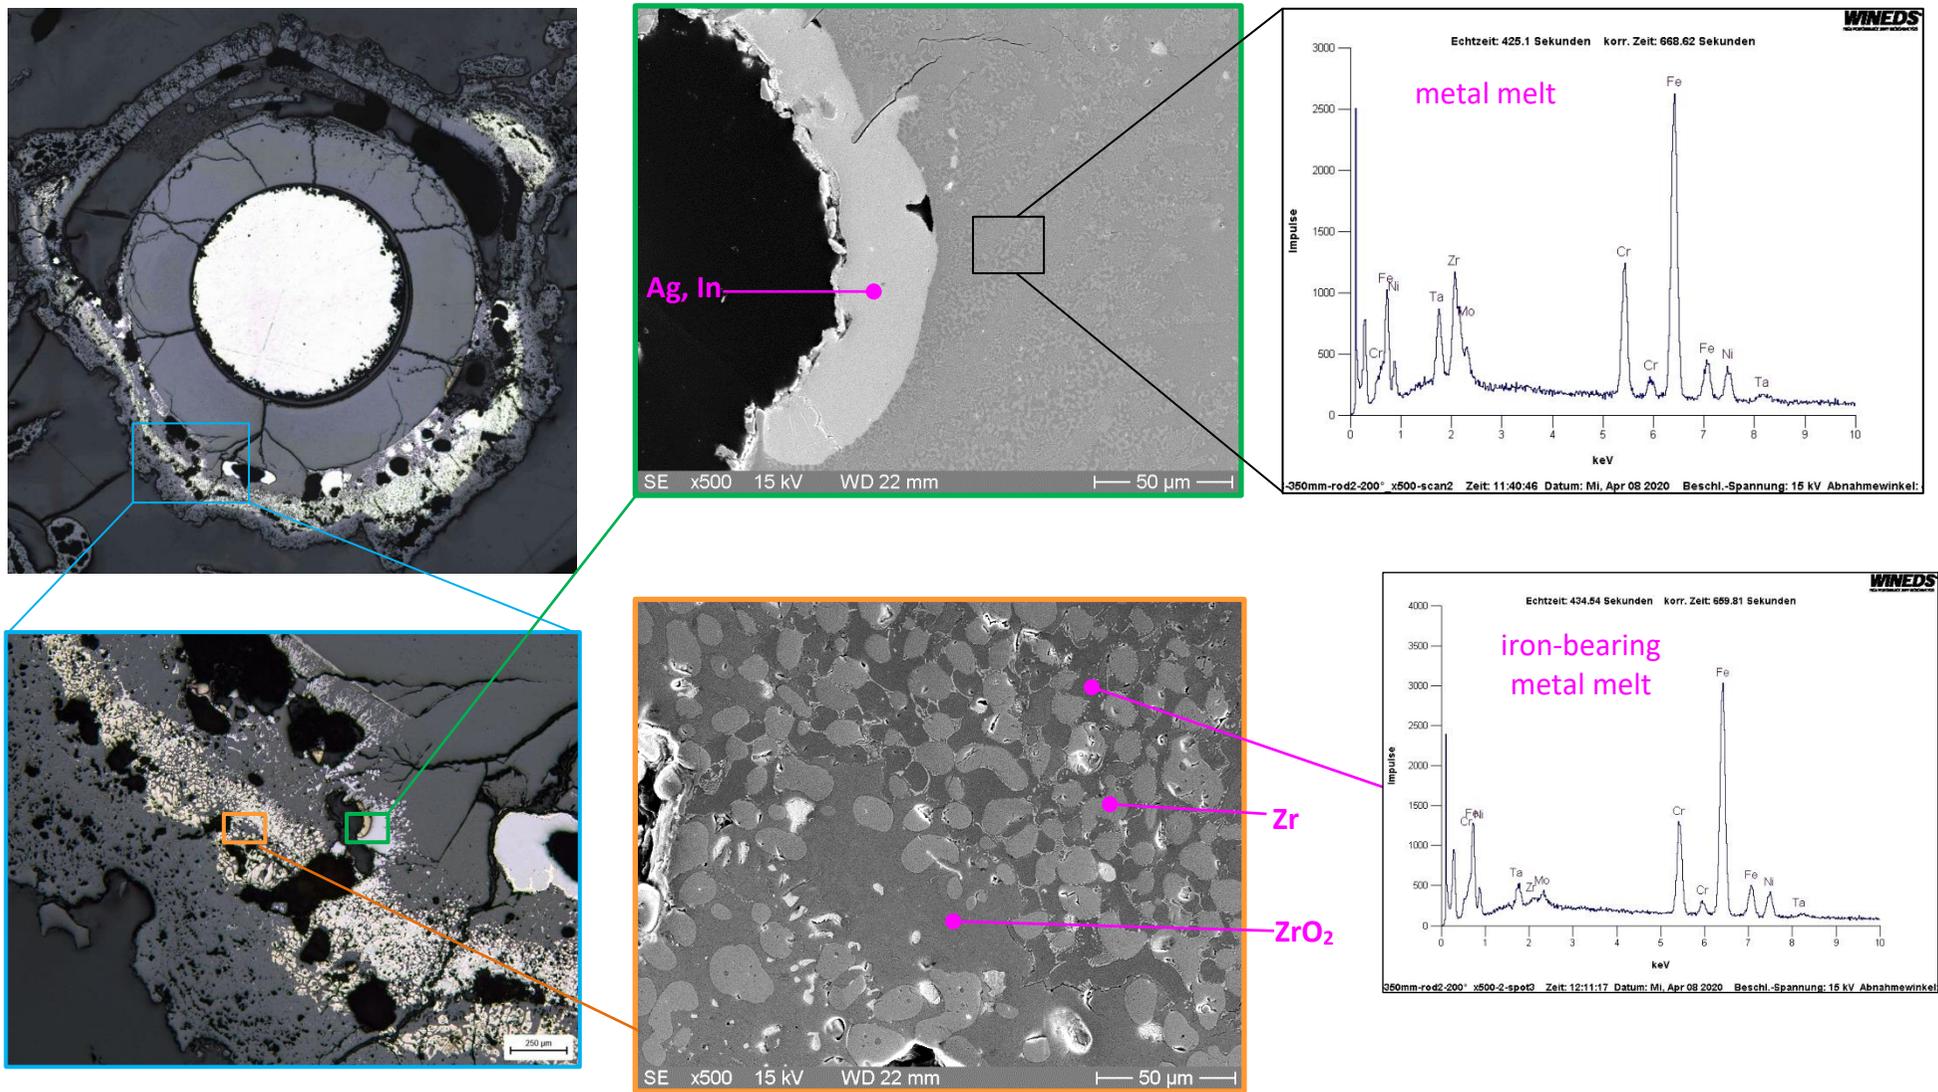
Figure 112 QUENCH-18; 350 mm: frozen metal melt around rod #2 consisting of rod cladding (Zr), absorber cladding (Fe, Cr, Ni) and TC (Ta) elements.

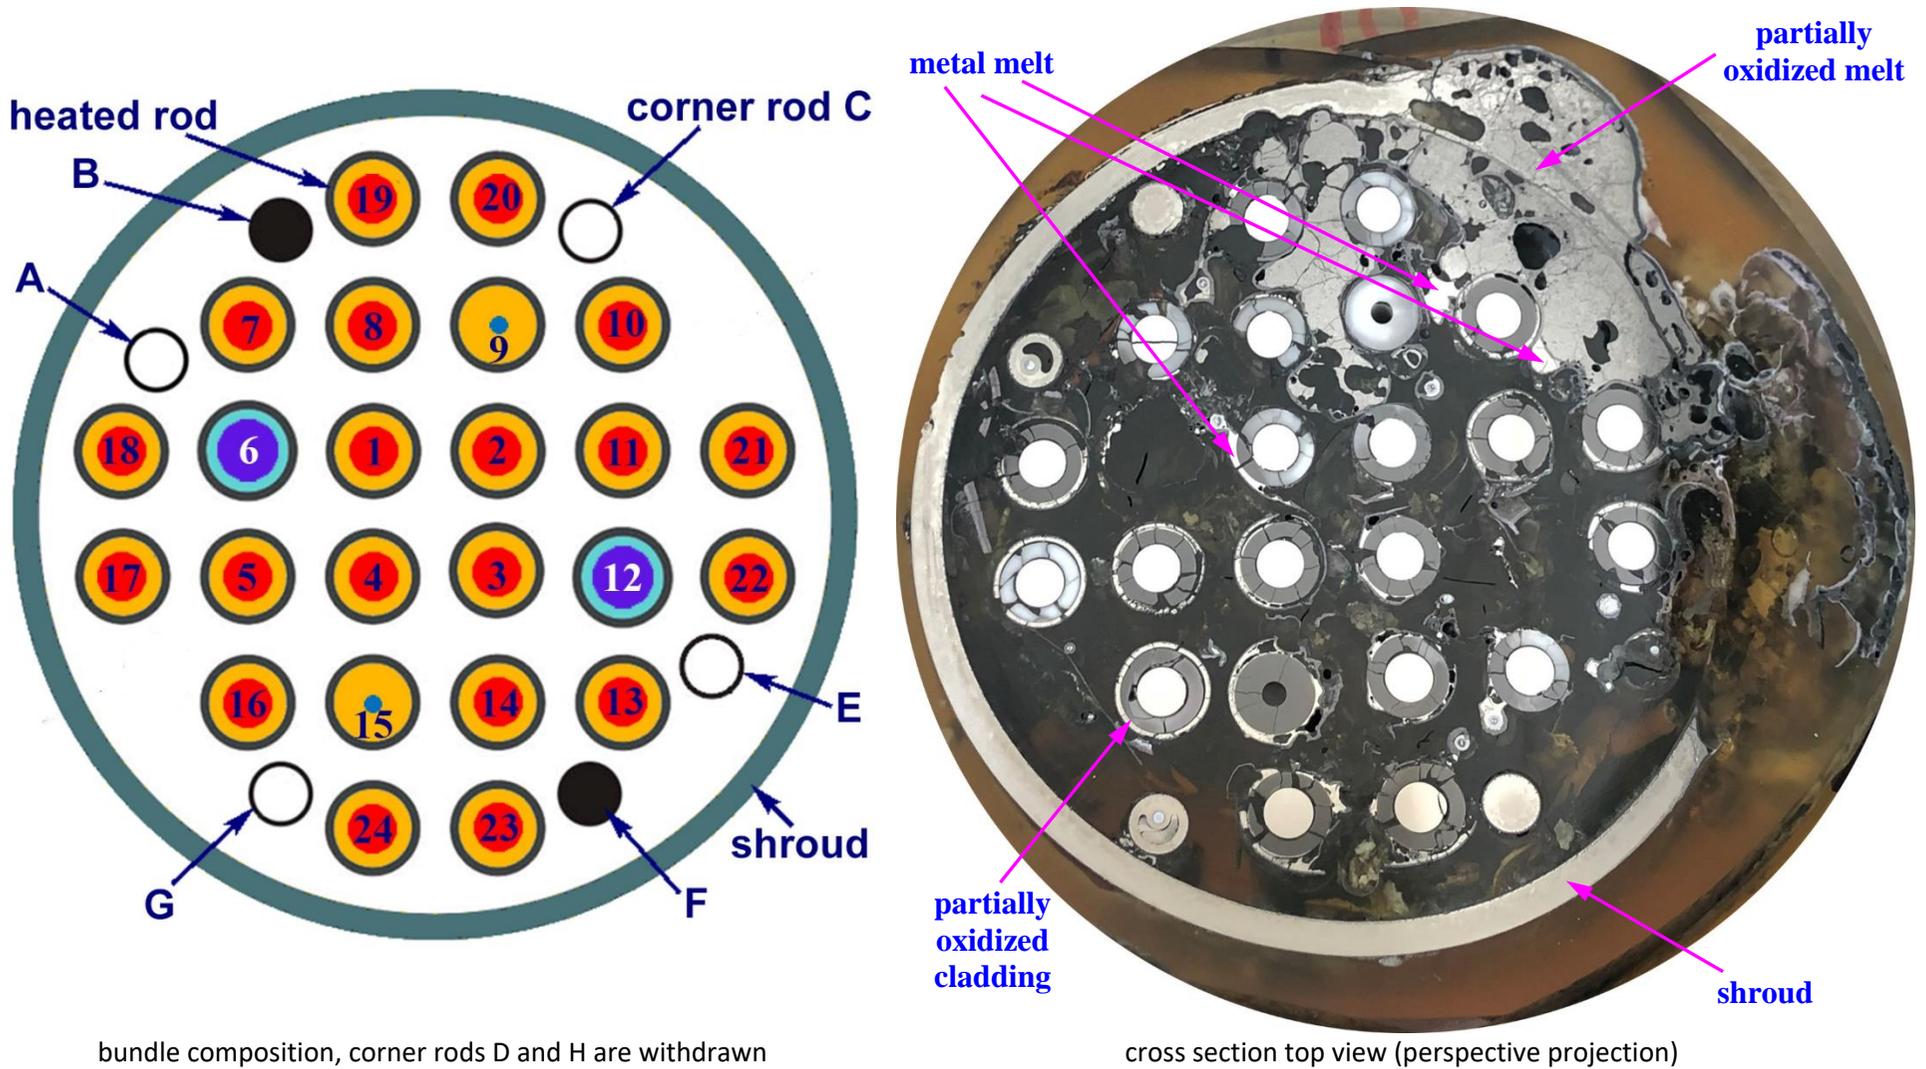
Figure 113 QUENCH-18; 350 mm, rod #2: penetration of molten absorber materials (together with absorber cladding) under oxide of fuel rod cladding.

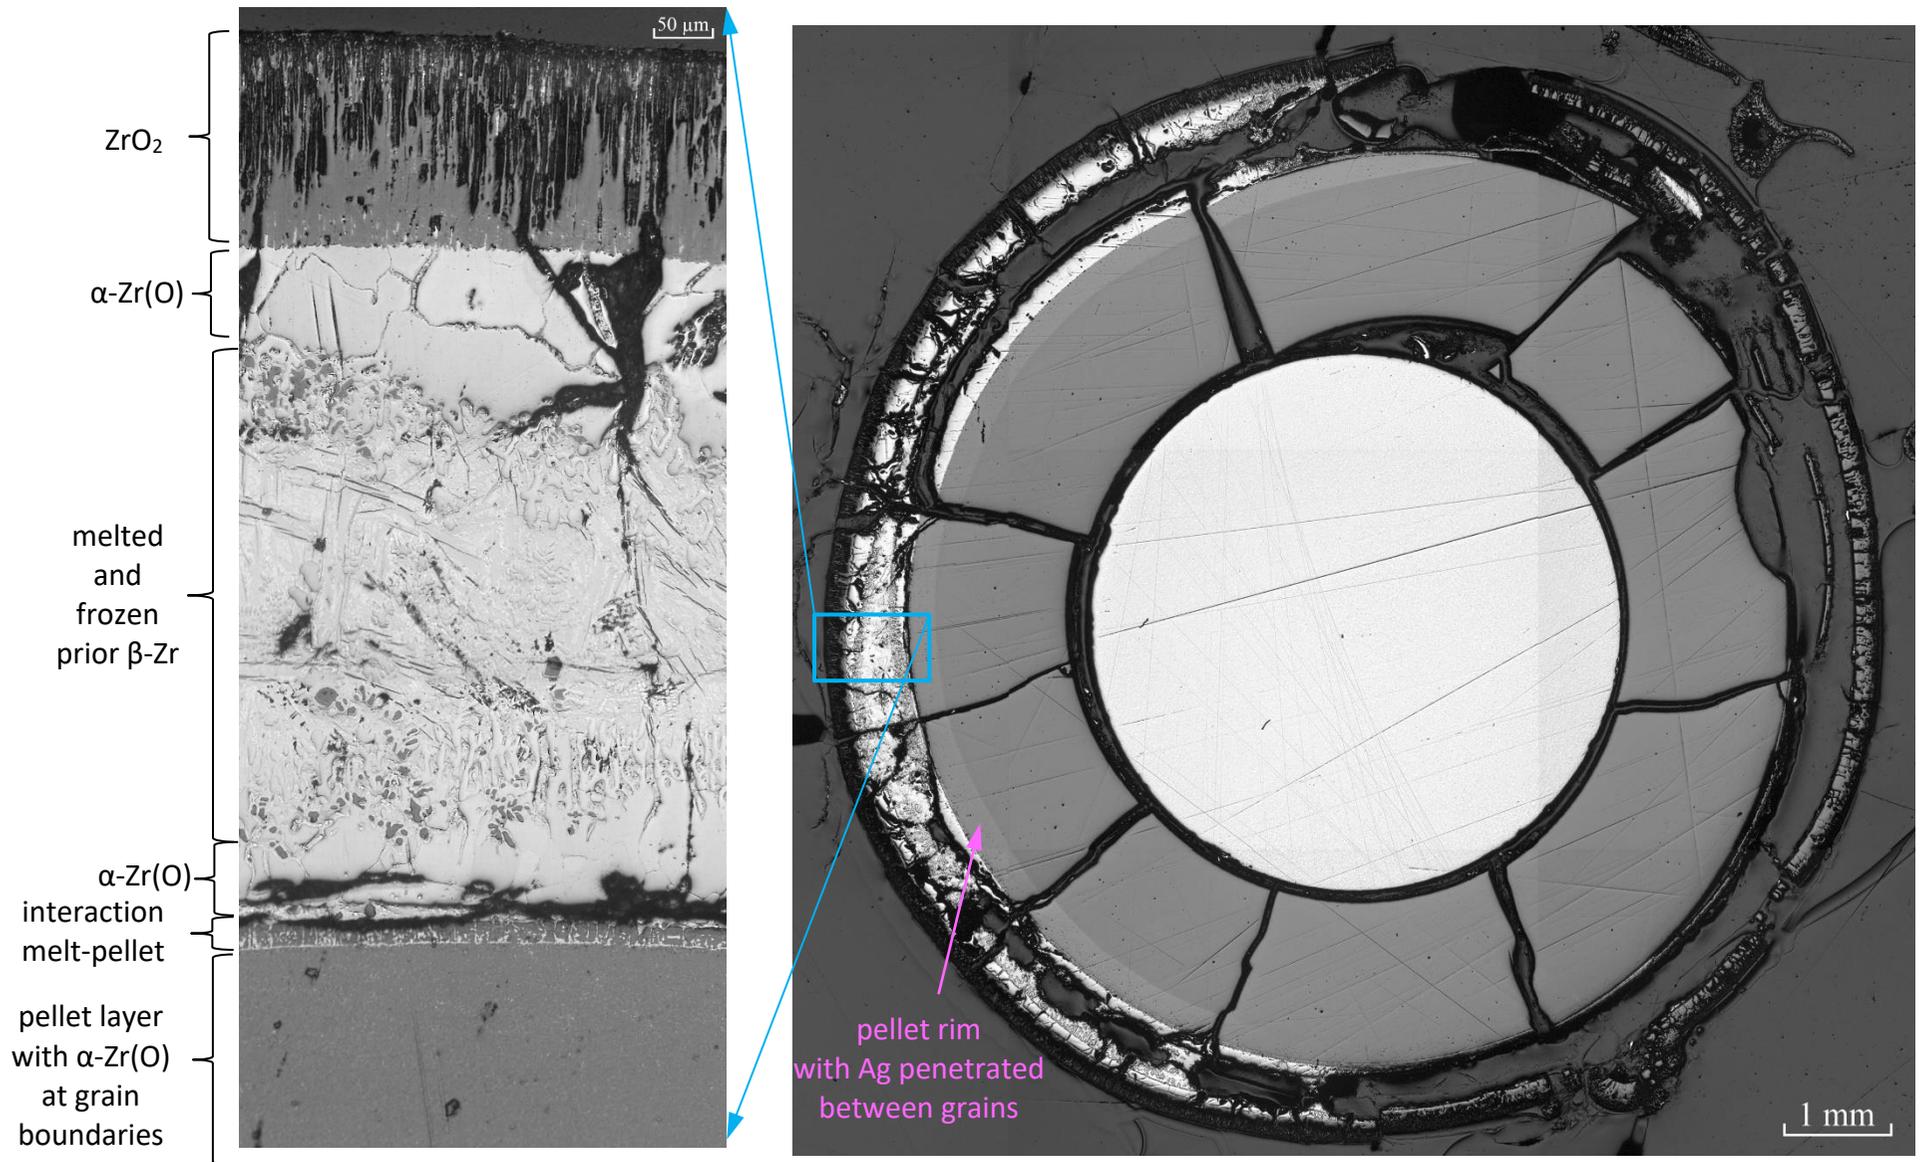
Figure 116 QUENCH-18; structure of corner rods at bundle elevation of 160 mm.

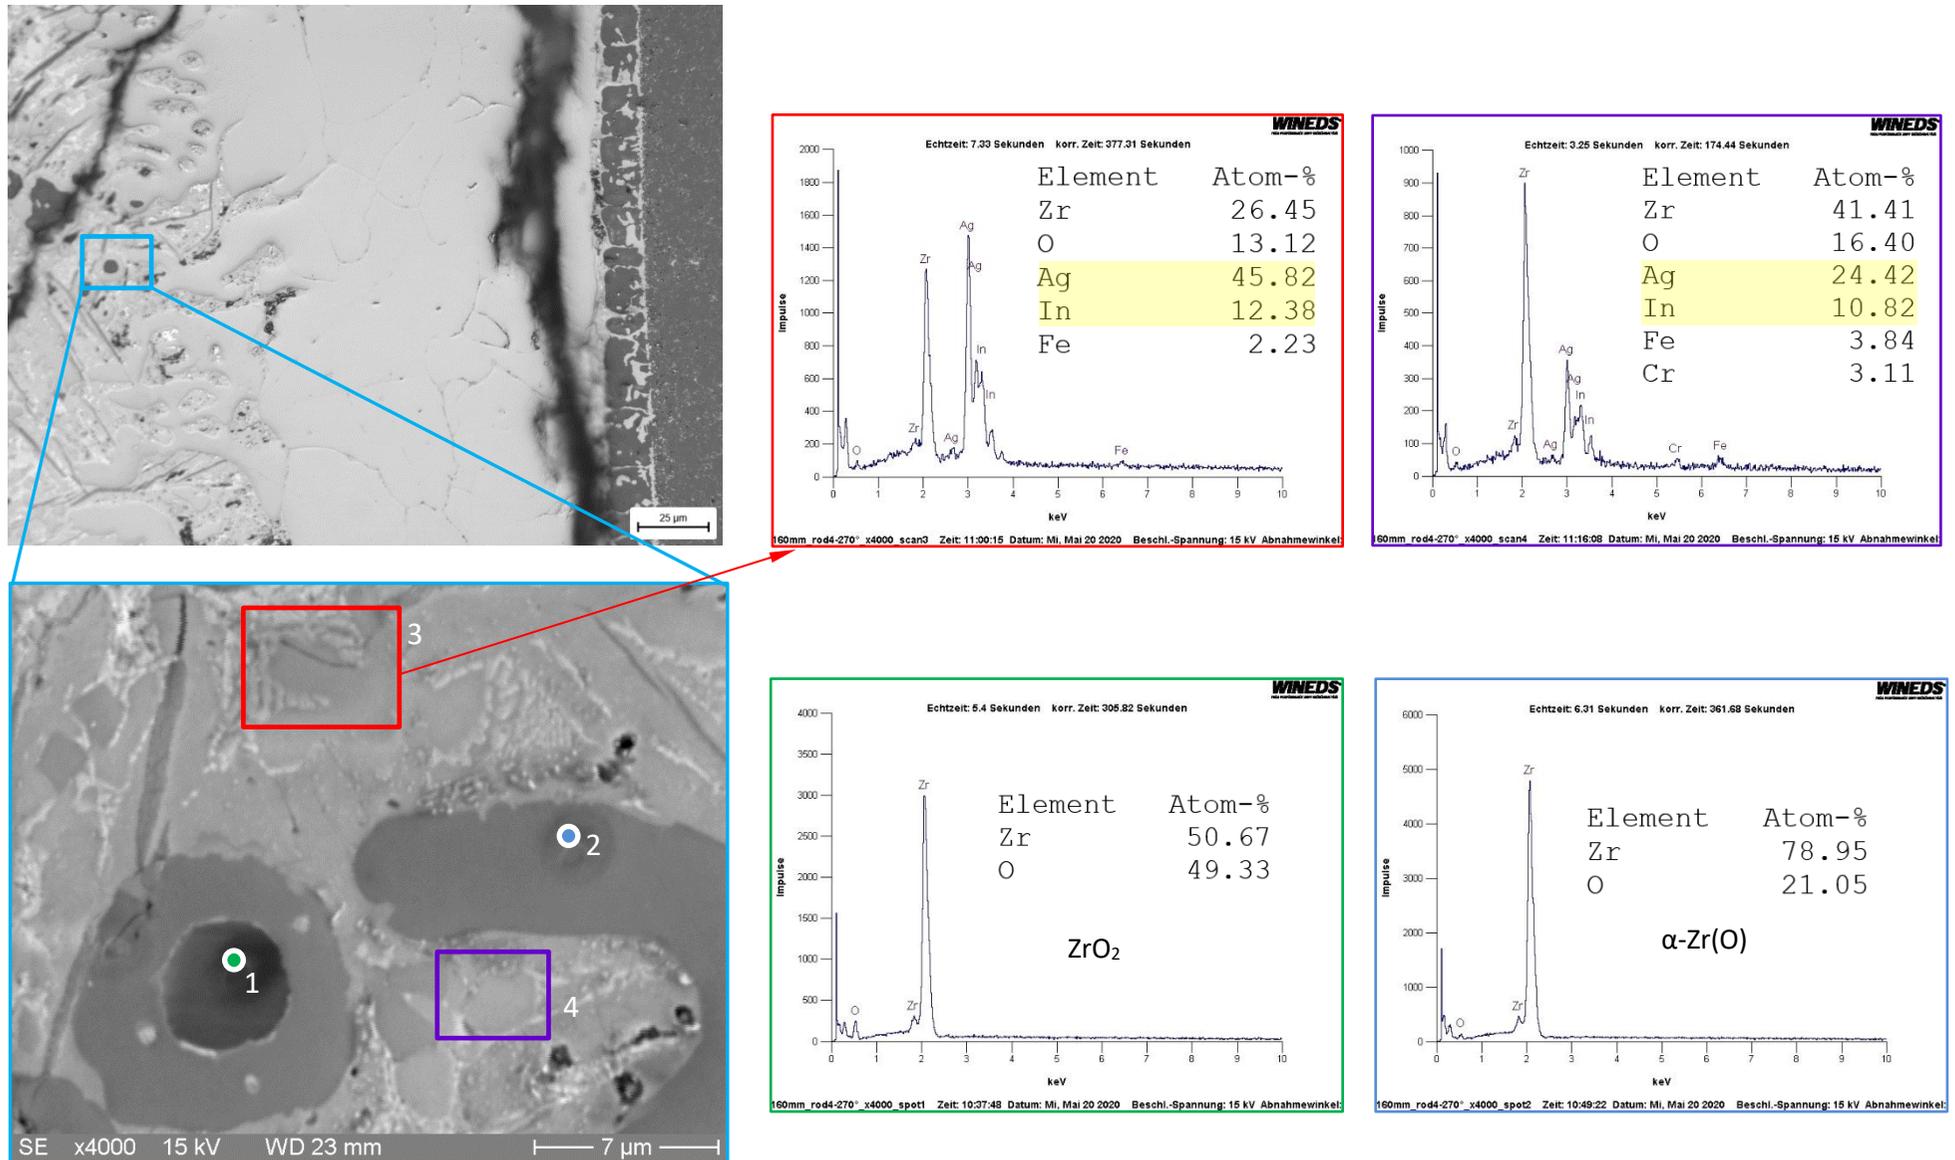
Figure 117 QUENCH-18; microstructure of rod elements for rod #4 at 160 mm.

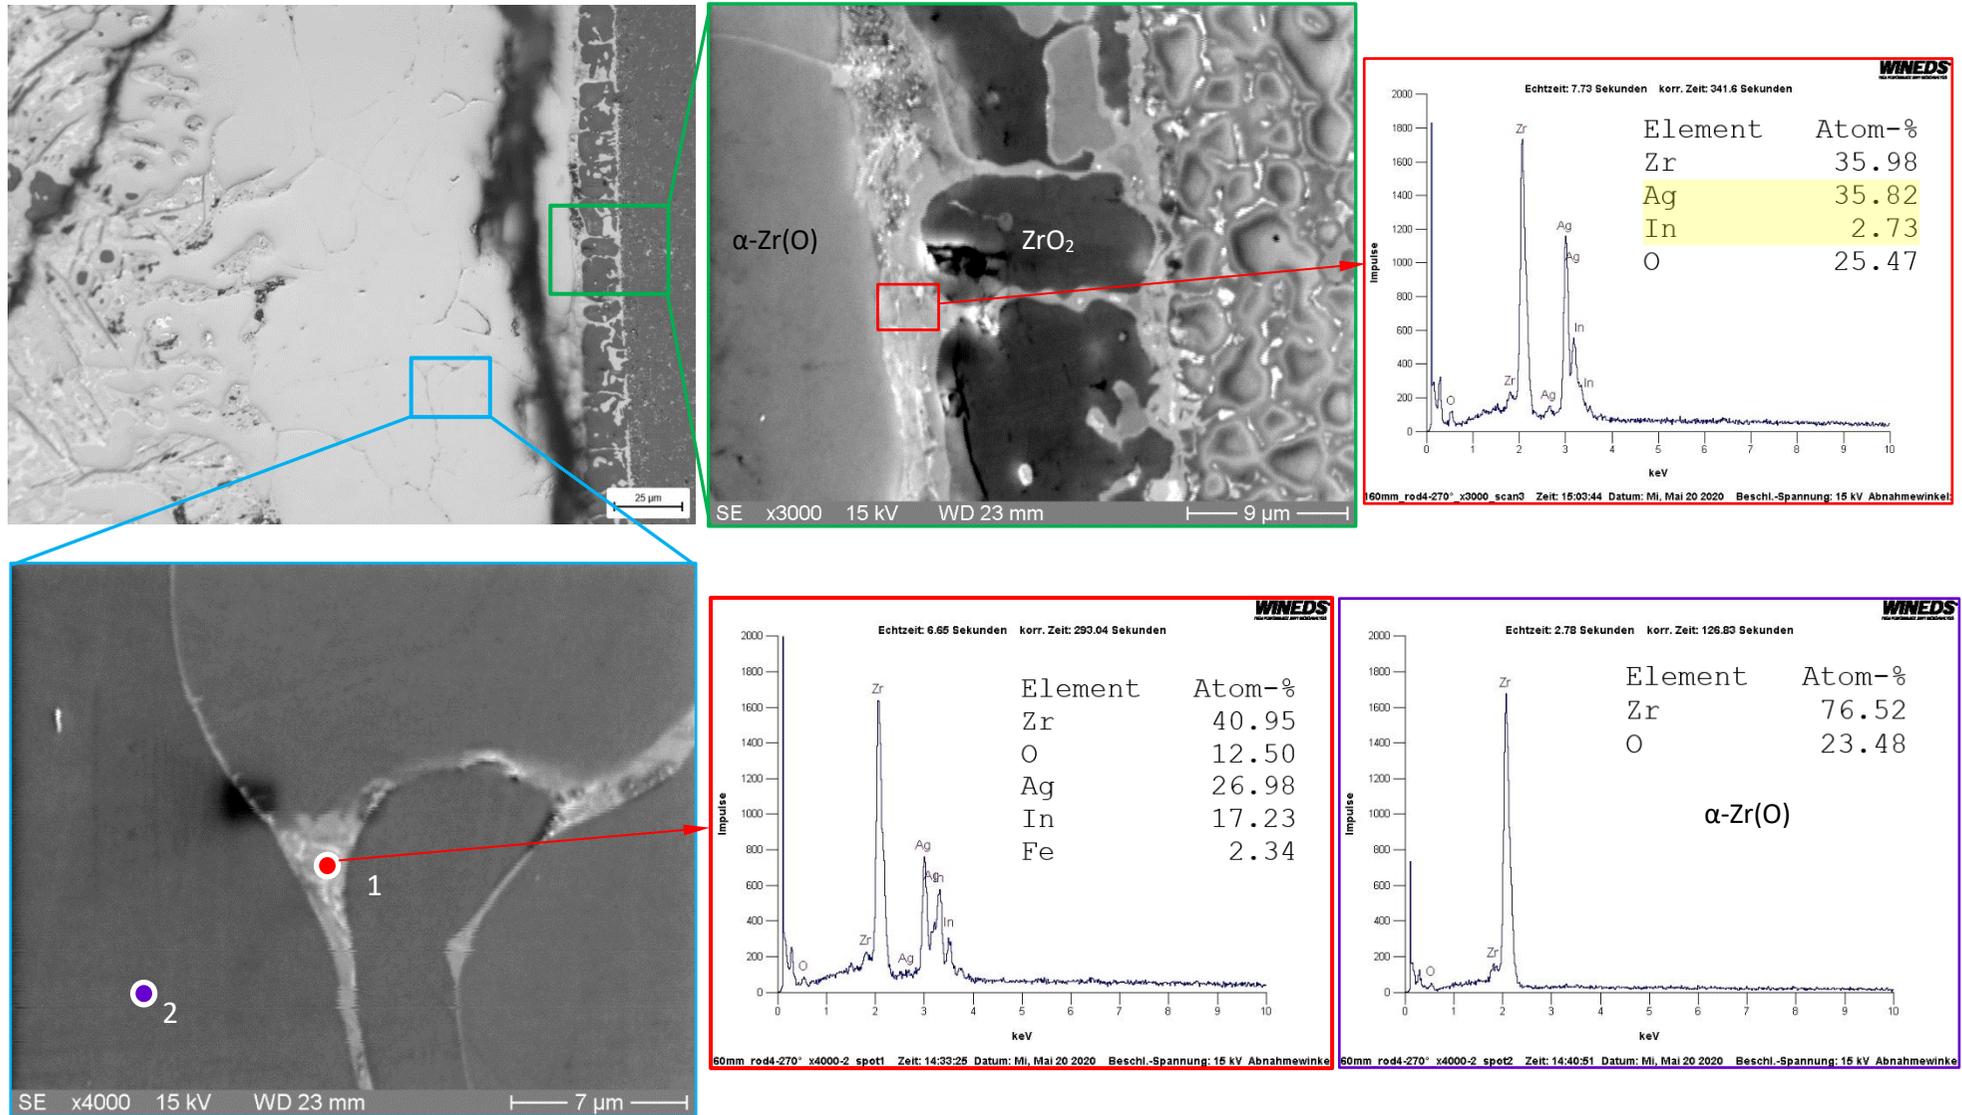
Figure 118 QUENCH-18; microstructure of prior molten cladding layer of rod #4 at 160 mm with results of EDX analysis: penetration of absorber rod and absorber cladding elements from neighbor rod #6 and mixture of these materials with molten prior β -Zr of rod #4.

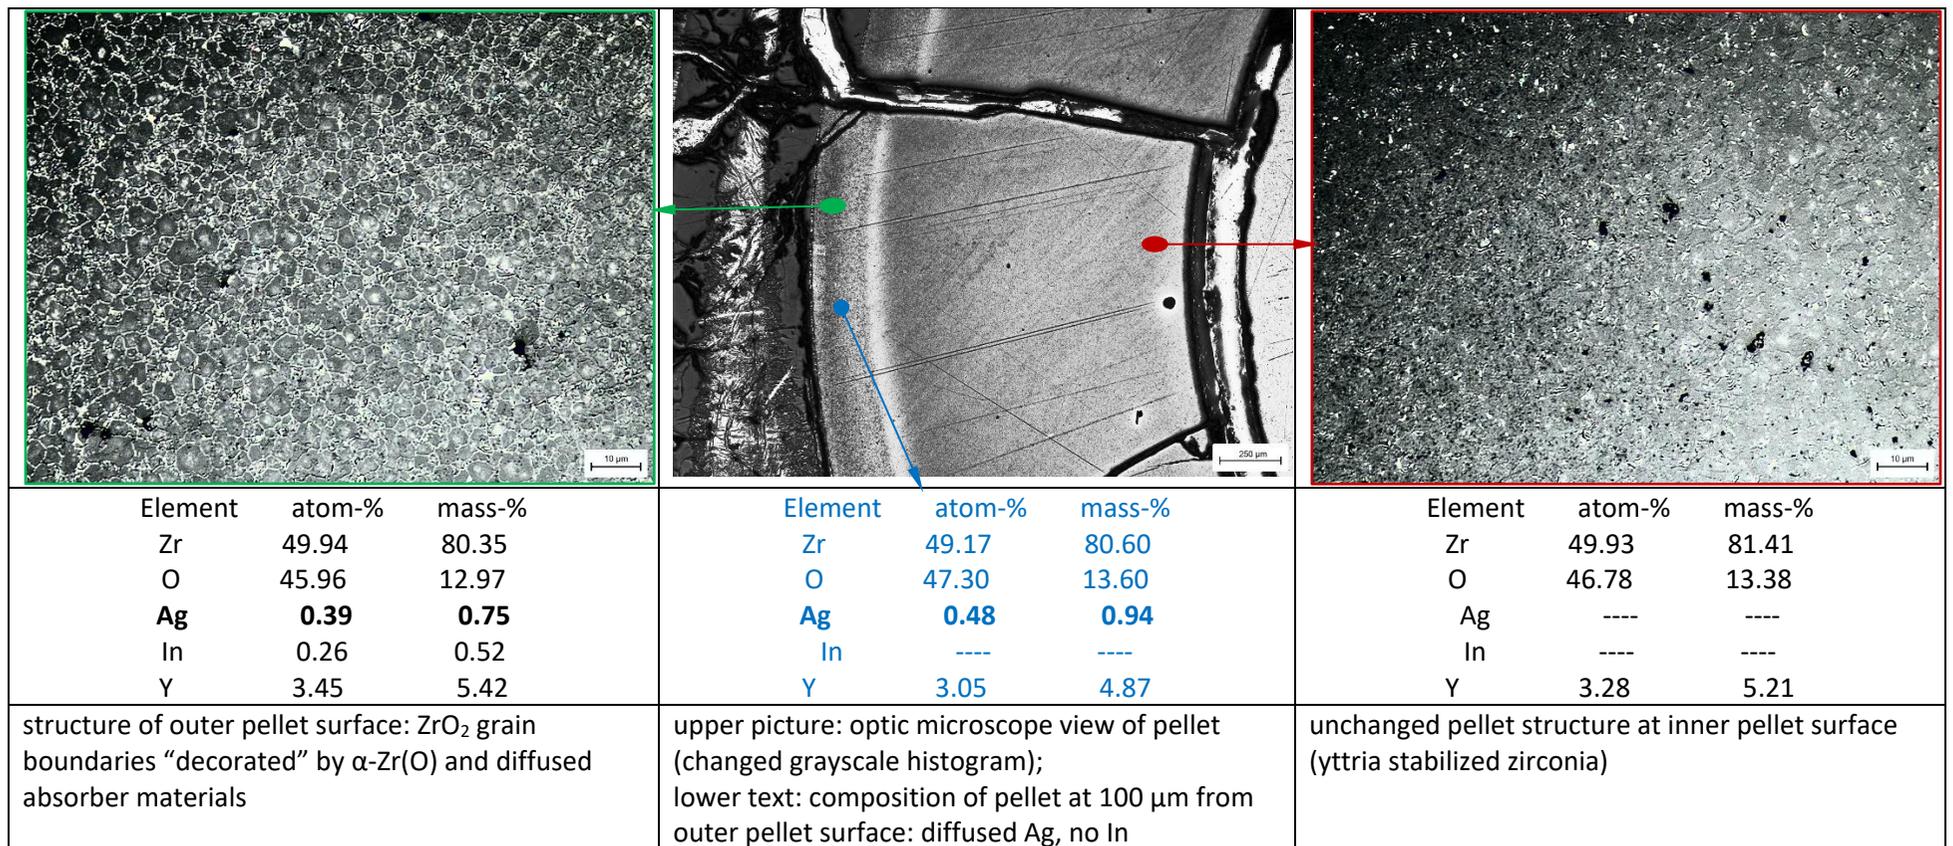
Figure 119 QUENCH-18; microstructure of prior molten cladding layer of rod #4 at 160 mm with results of EDX analysis: precipitation of absorber elements.

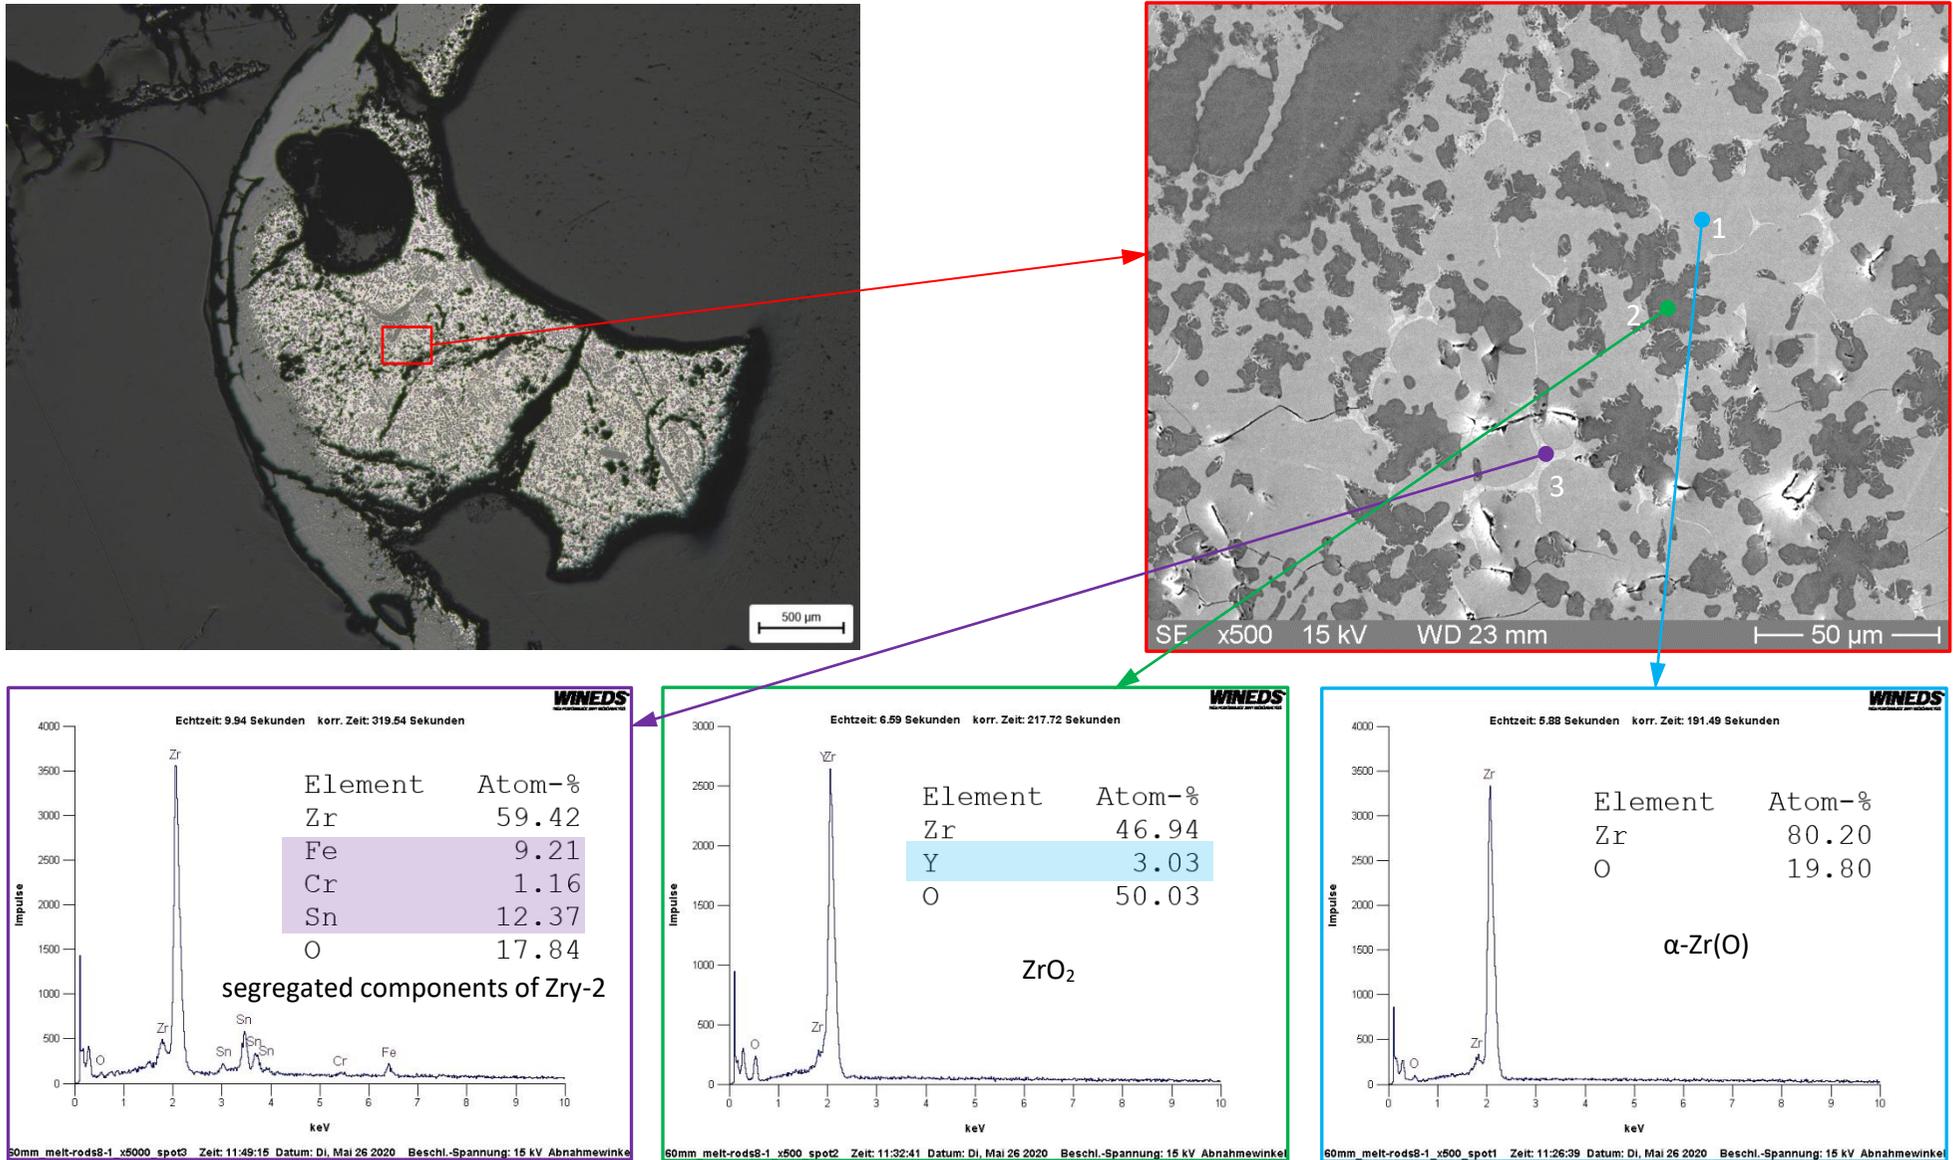
Figure 122 QUENCH-18; absorber molten pools between pellet and cladding oxide of rod #8 at 160 mm, results of EDX analysis.

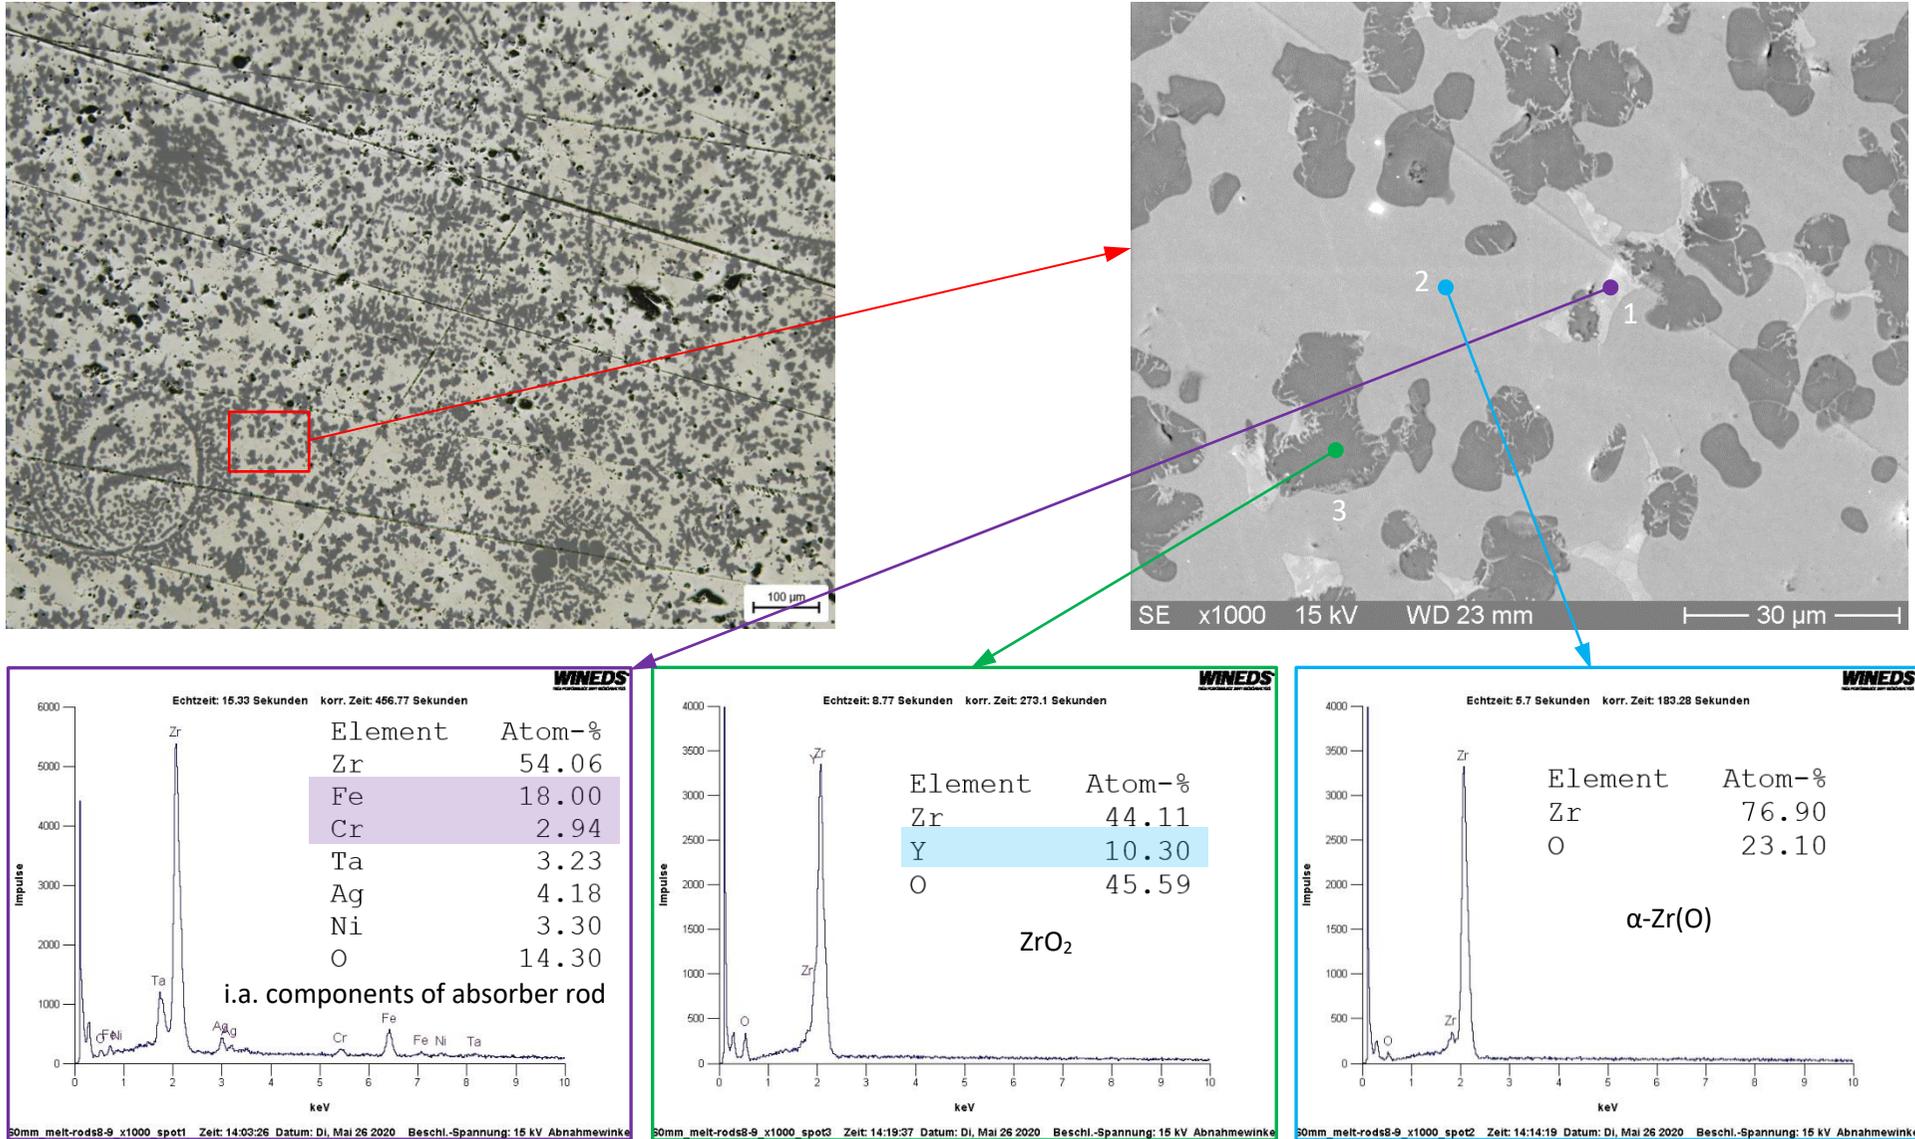
Figure 123 QUENCH-18; microstructure of frozen small molten pool near to rod #8 at 160 mm and results of EDX analysis.
