QUENCH - ALISA: Scientific Report NUSAFE 3570

Results of the QUENCH-18 Bundle Experiment on Air Ingress and AgInCd absorber behavior

J. Stuckert, J. Kalilainen, T. Lind, U. Stegmaier, M. Steinbrück,
Y. Zhang

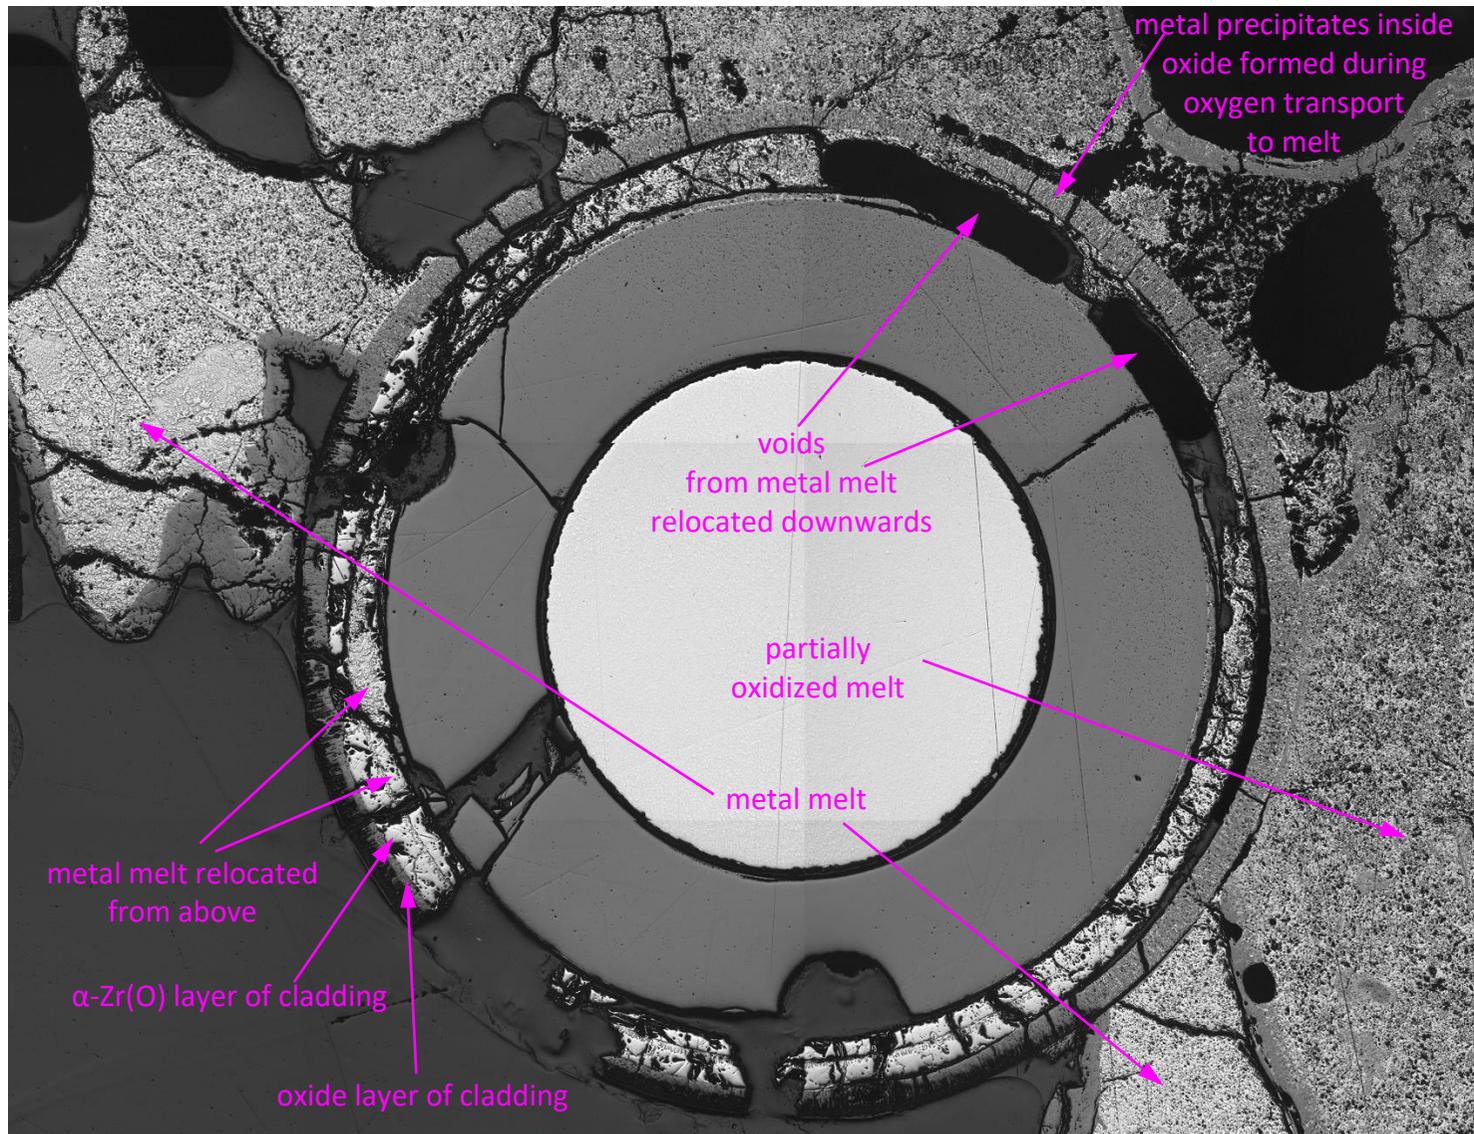
Figure 124 QUENCH-18; microstructure of frozen large molten pool between rod #8 and #9 at 160 mm and results of EDX analysis: part of ceramic precipitates are grains of disintegrated pellets (ZrO₂ stabilized with Y₂O₃).

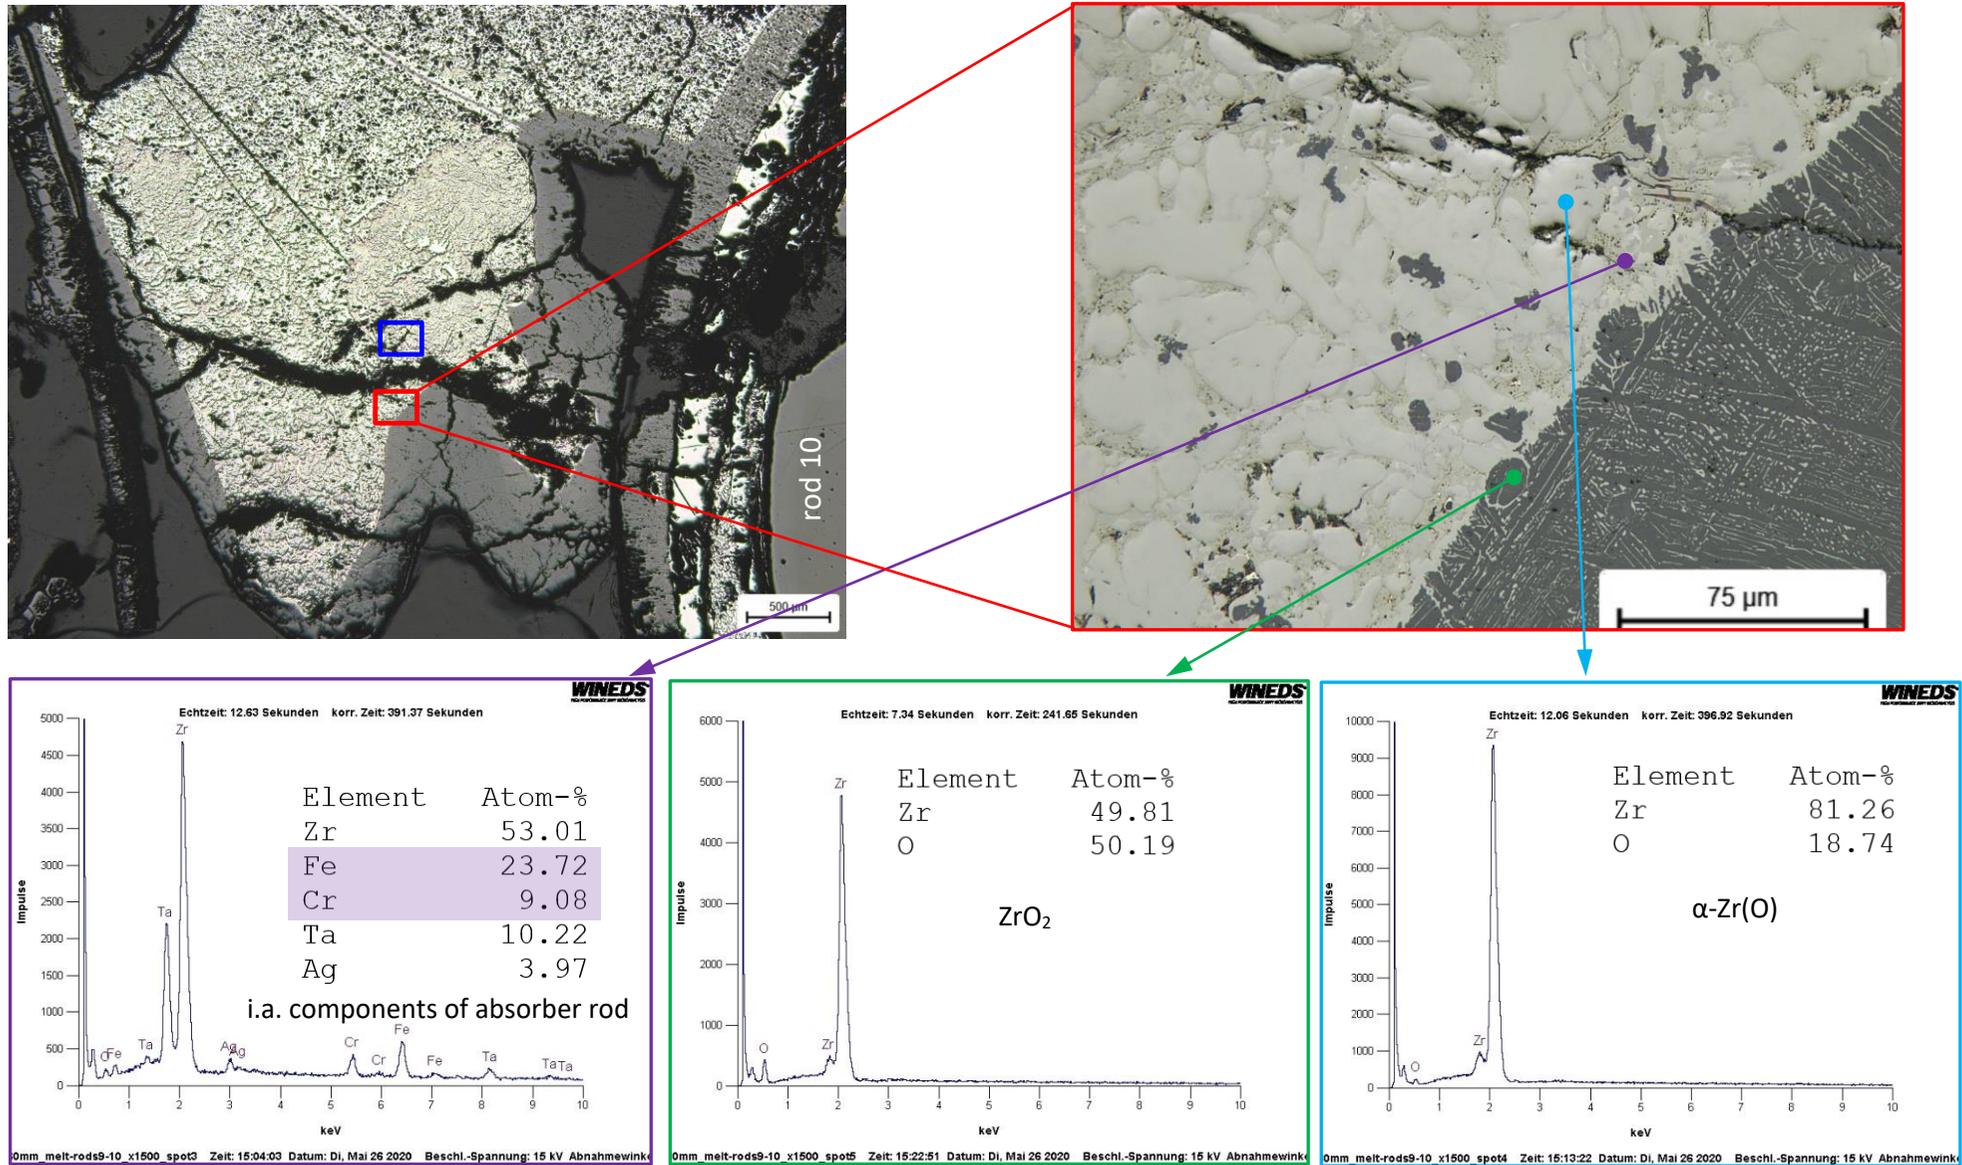
Figure 125 QUENCH-18; microstructure of rod elements for rod #10 and very porous partially oxidized melt at bundle elevation of 160 mm.

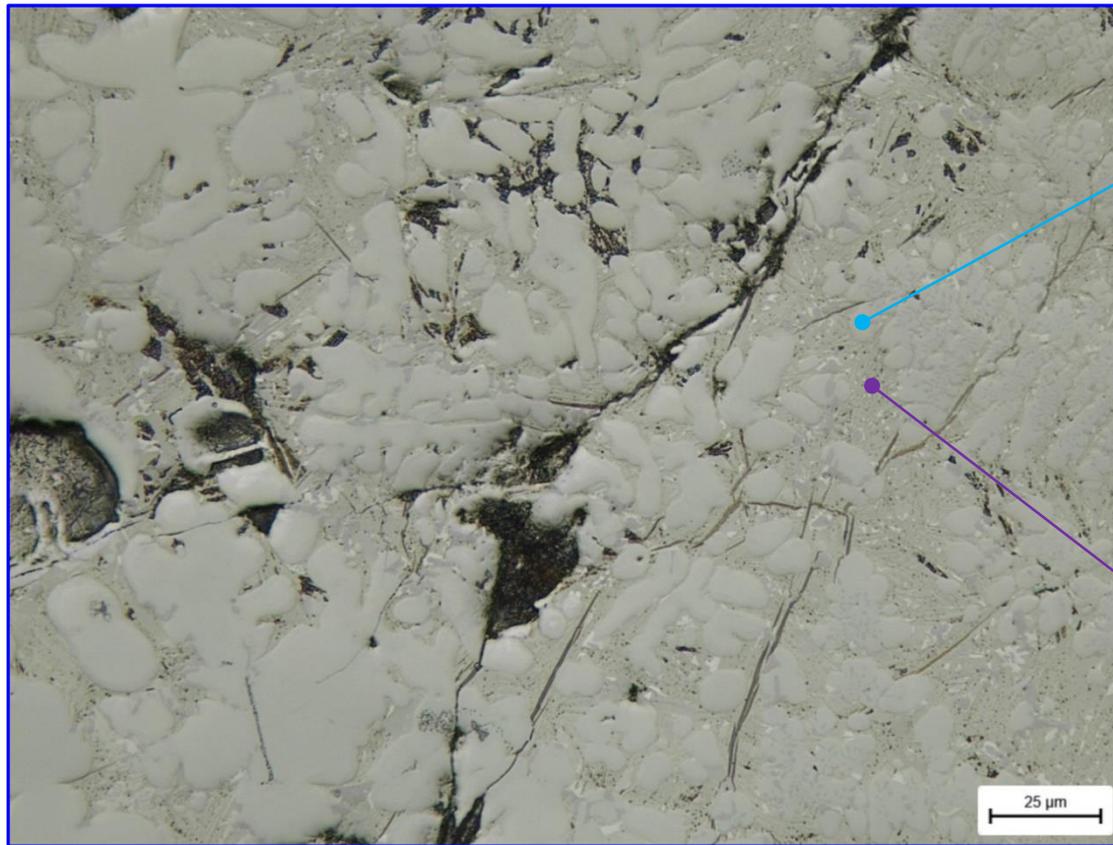
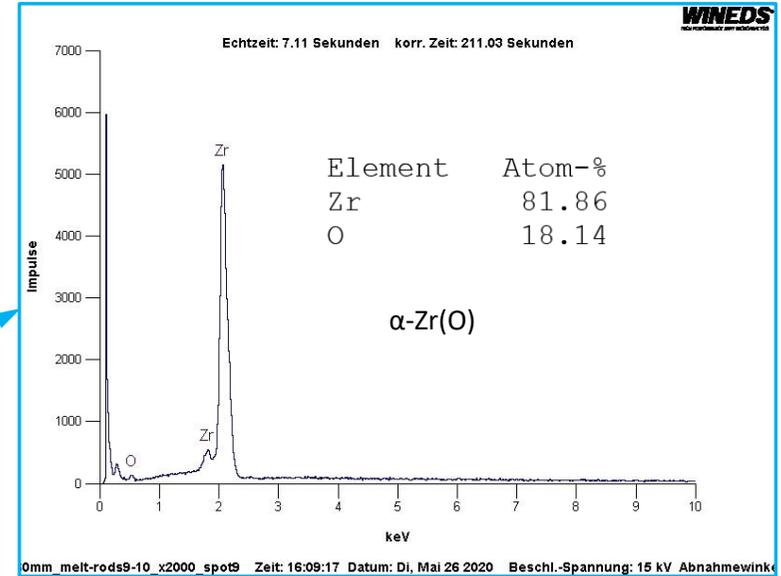
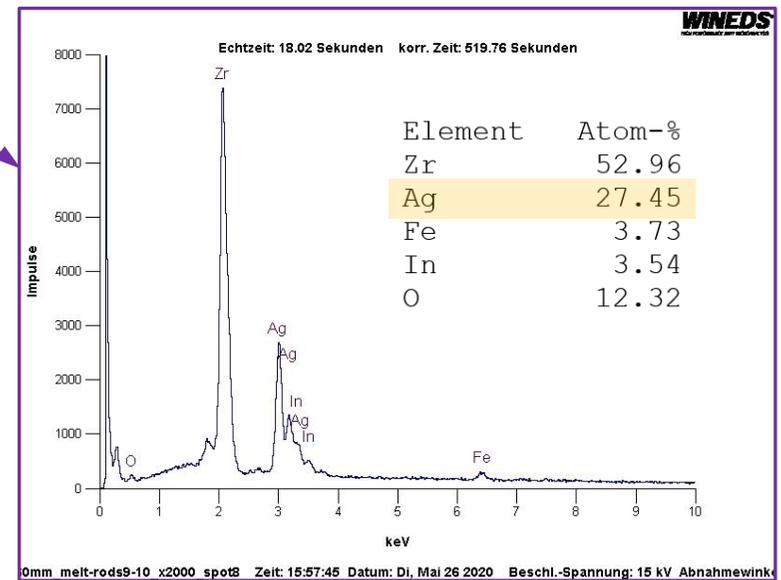
Figure 126 QUENCH-18; microstructure of molten pool near to rod #10 at 160 mm (metallic melt inside the pool and oxidized melt on its border).

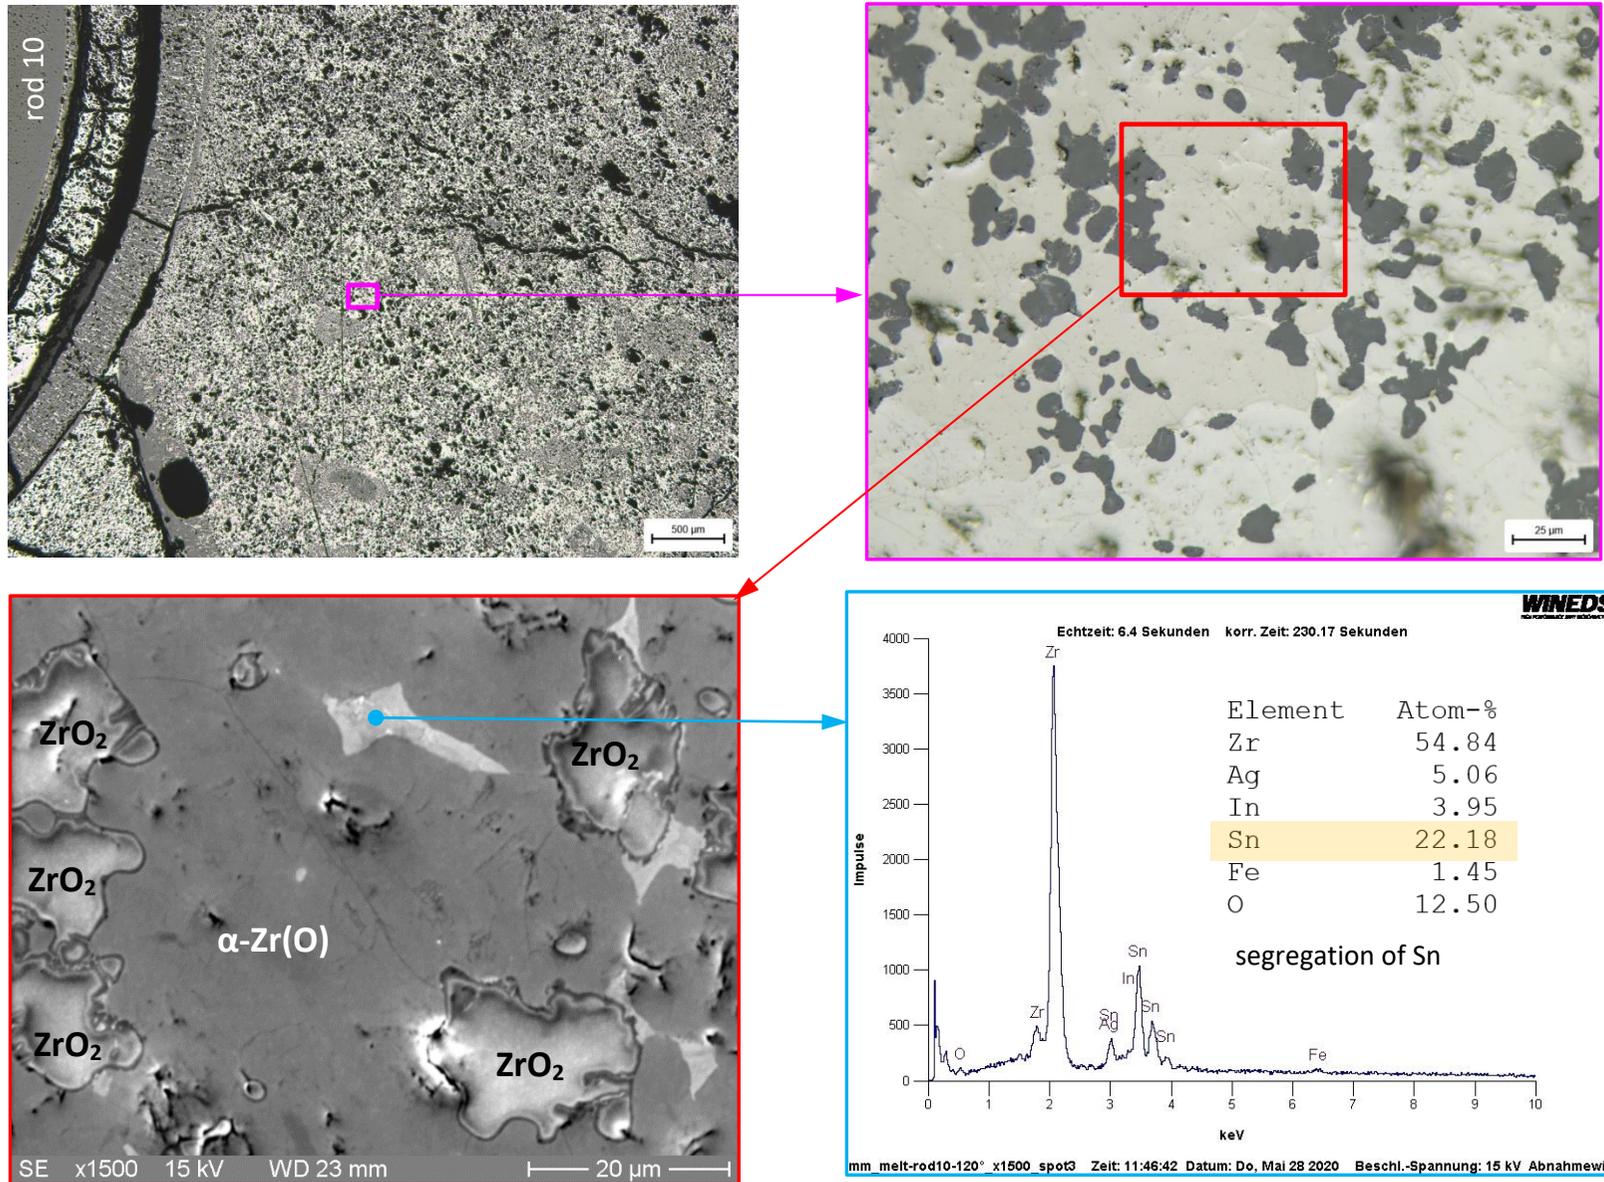
Figure 127 QUENCH-18; microstructure of molten pool between rods #9 and #10 at 160 mm (metallic melt marked with blue in previous Figure).

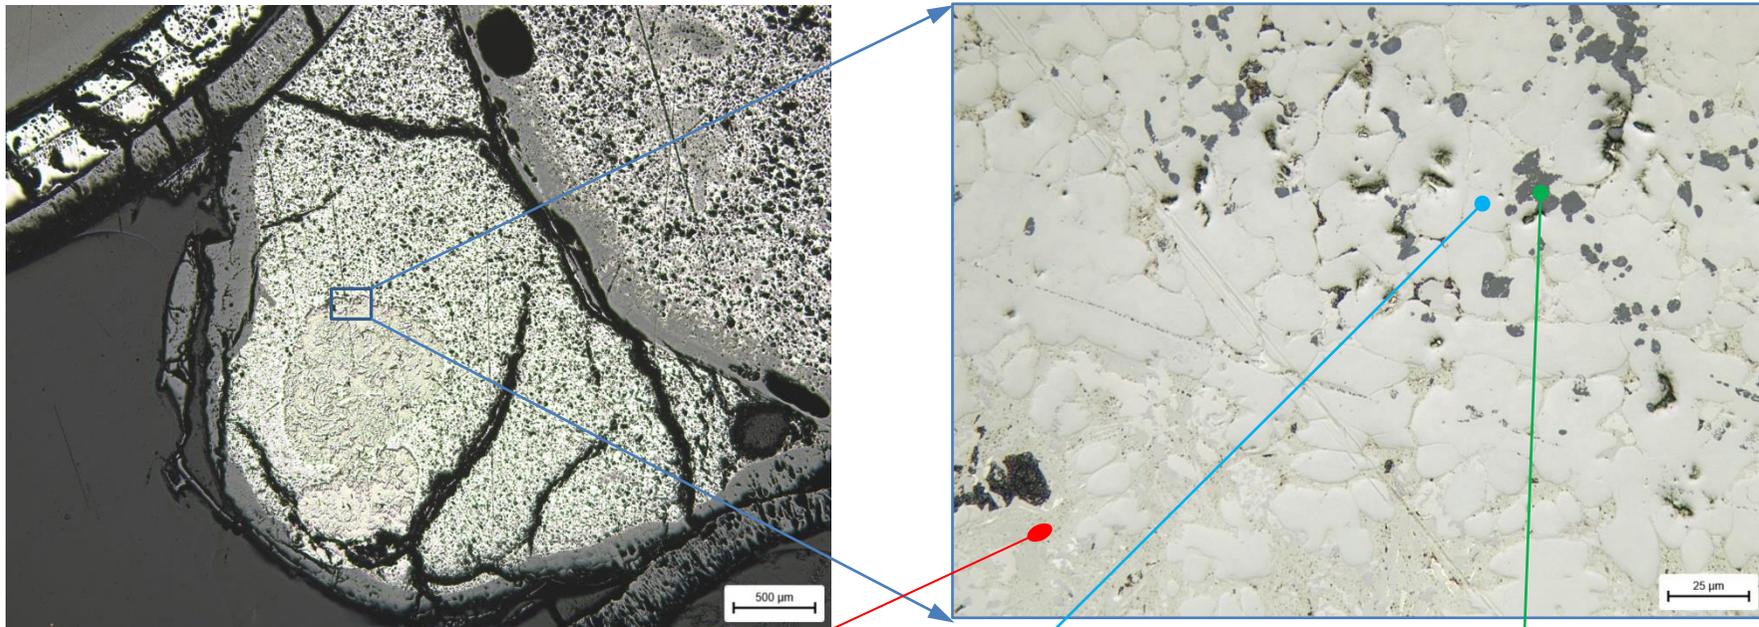
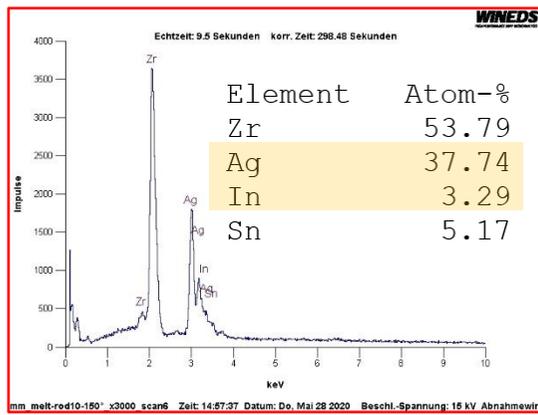
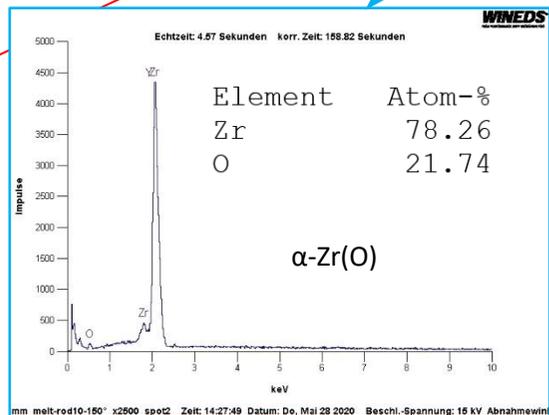
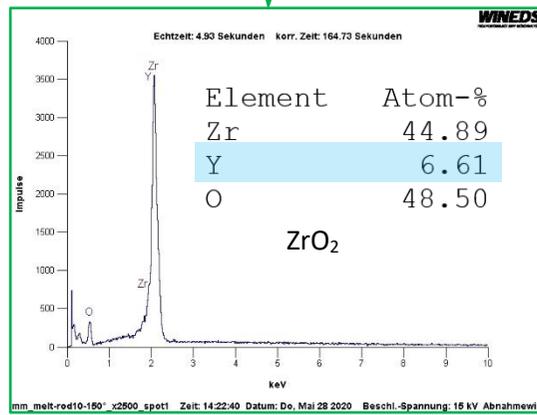
Figure 128 QUENCH-18; microstructure of molten pool between rods #10 and #11 at 160 mm partially oxidized at temperature.

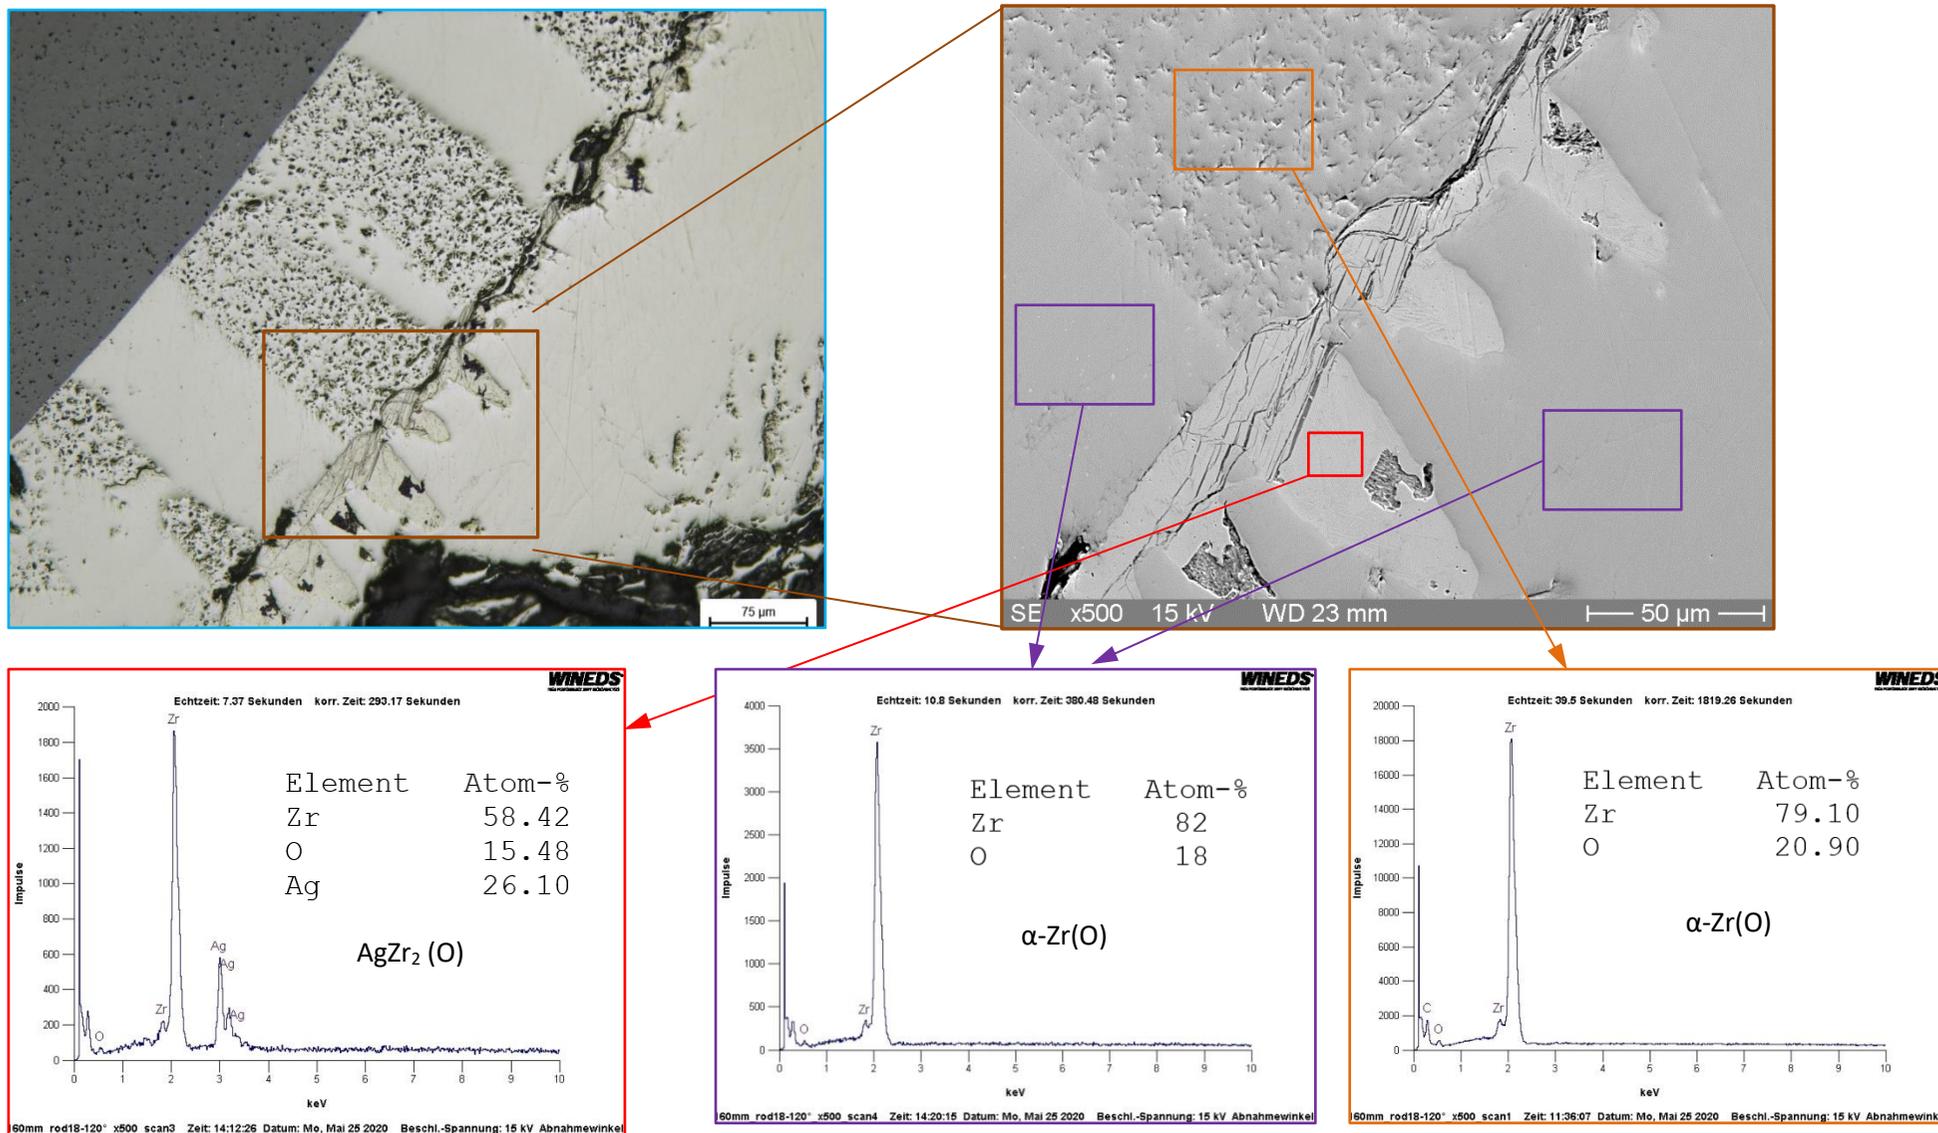
Figure 130 QUENCH-18; microstructure of rod elements for rod #18 and #6 at bundle elevation of 160 mm with regions marked for EDX analysis.

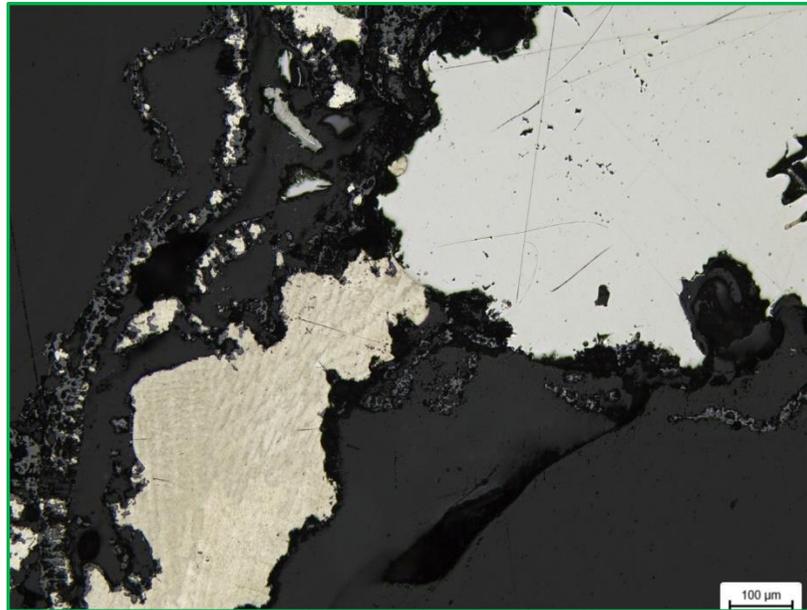
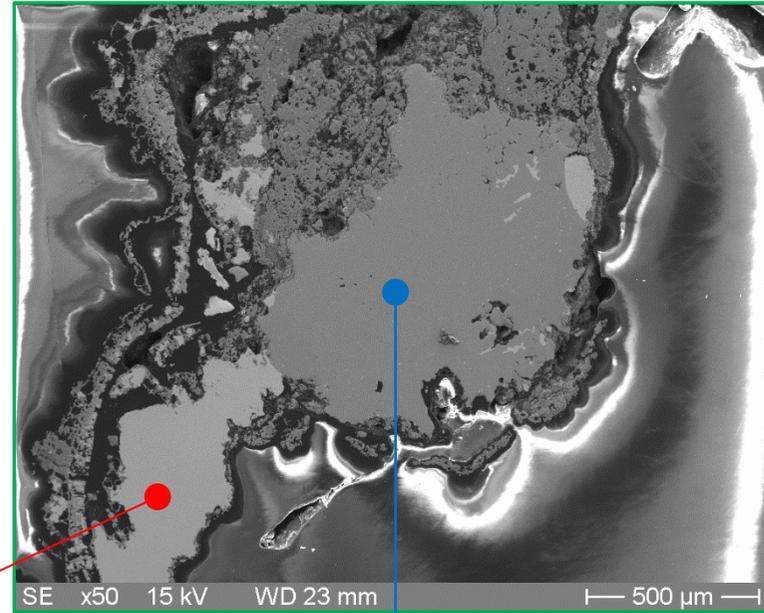
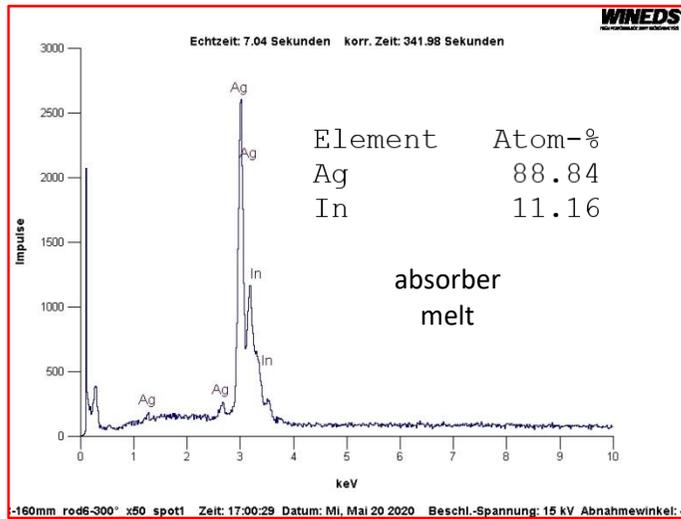
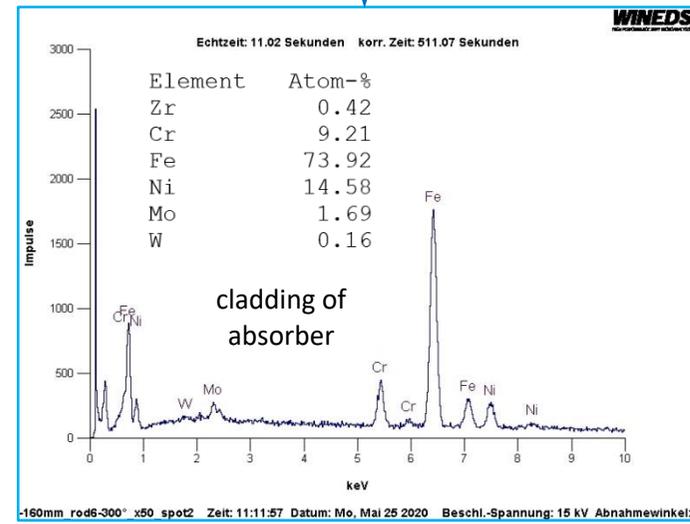
Figure 131 QUENCH-18; microstructure of cladding for rod #18 at bundle elevation of 160 mm: penetration of Ag from absorber rod #6 into the gap between cladding and cladding melt relocated from above.

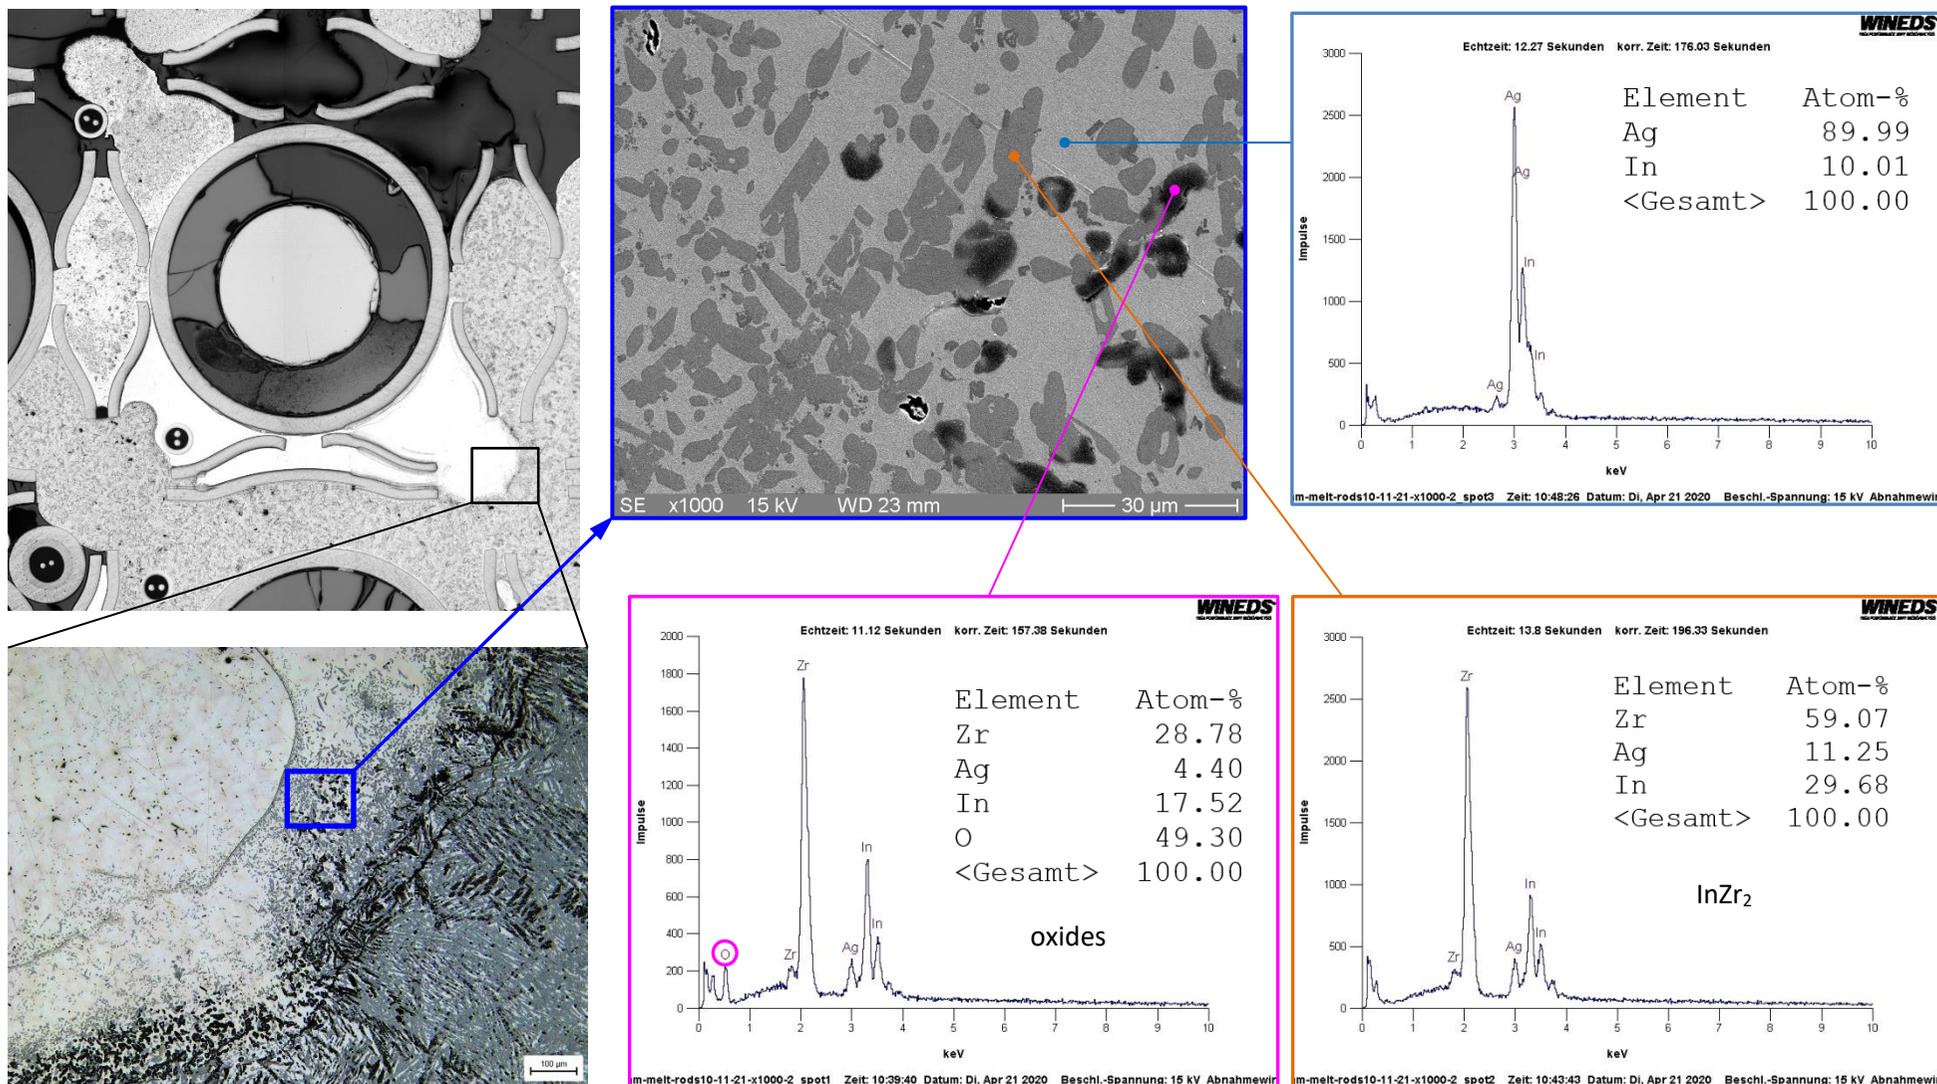
Figure 133 QUENCH-18; cross section at bundle elevation of 65 mm: metallic melts (AgInCd and Zr-bearing) downwards relocated and frozen inside grid spacer.

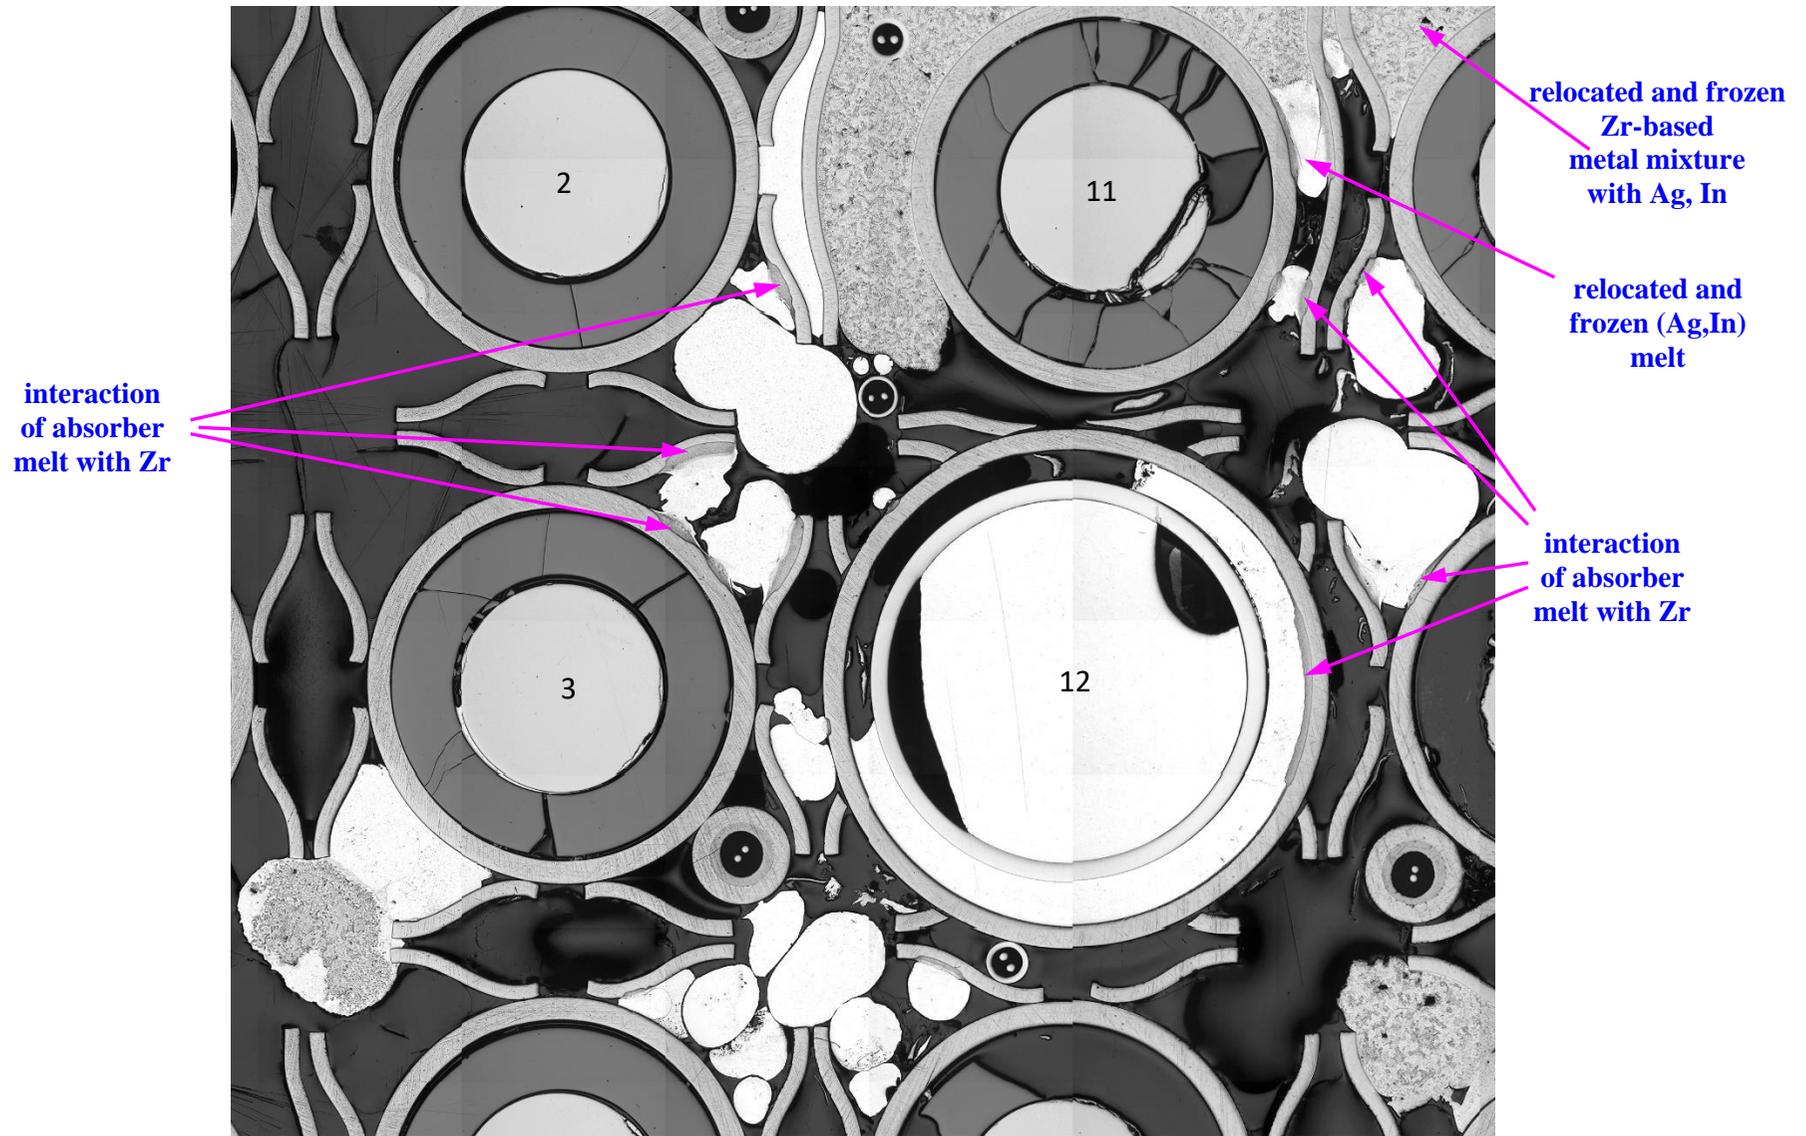
Figure 134 QUENCH-18; relocated absorber melt in the surroundings of rod #10 at bundle elevation of 65 mm, not oxidized cladding and grid spacer, roughly elemental composition: InZr₂ precipitates inside Ag melt.

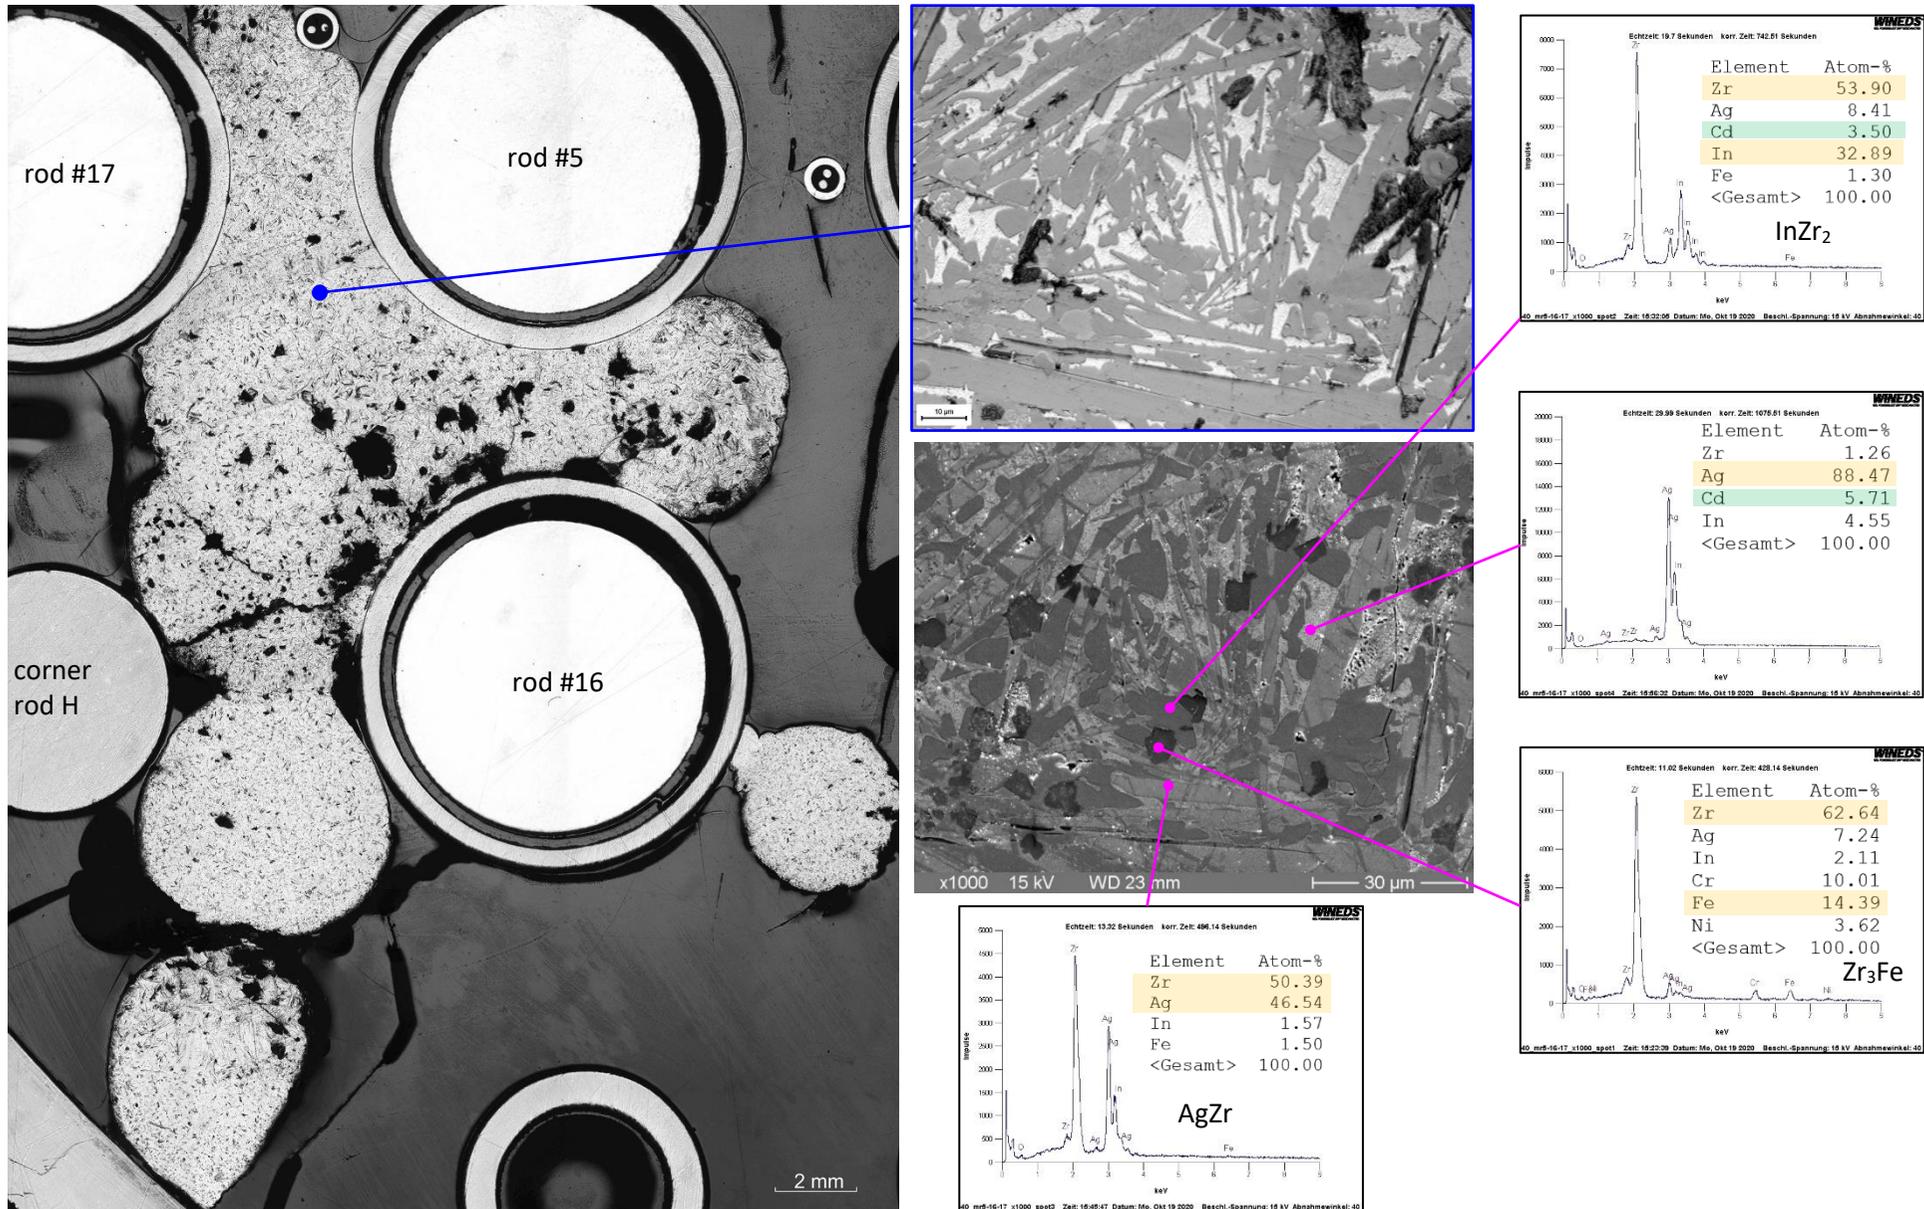
cross section mirrored bottom view of slice -40...-15 mm: frozen molten metal pools relocated from upper elevations

Figure 138 QUENCH-18; cross section at bundle elevation of -40 mm.
