Article

Aerial Thermographic Image-Based Assessment of Thermal Bridges Using Representative Classifications and Calculations

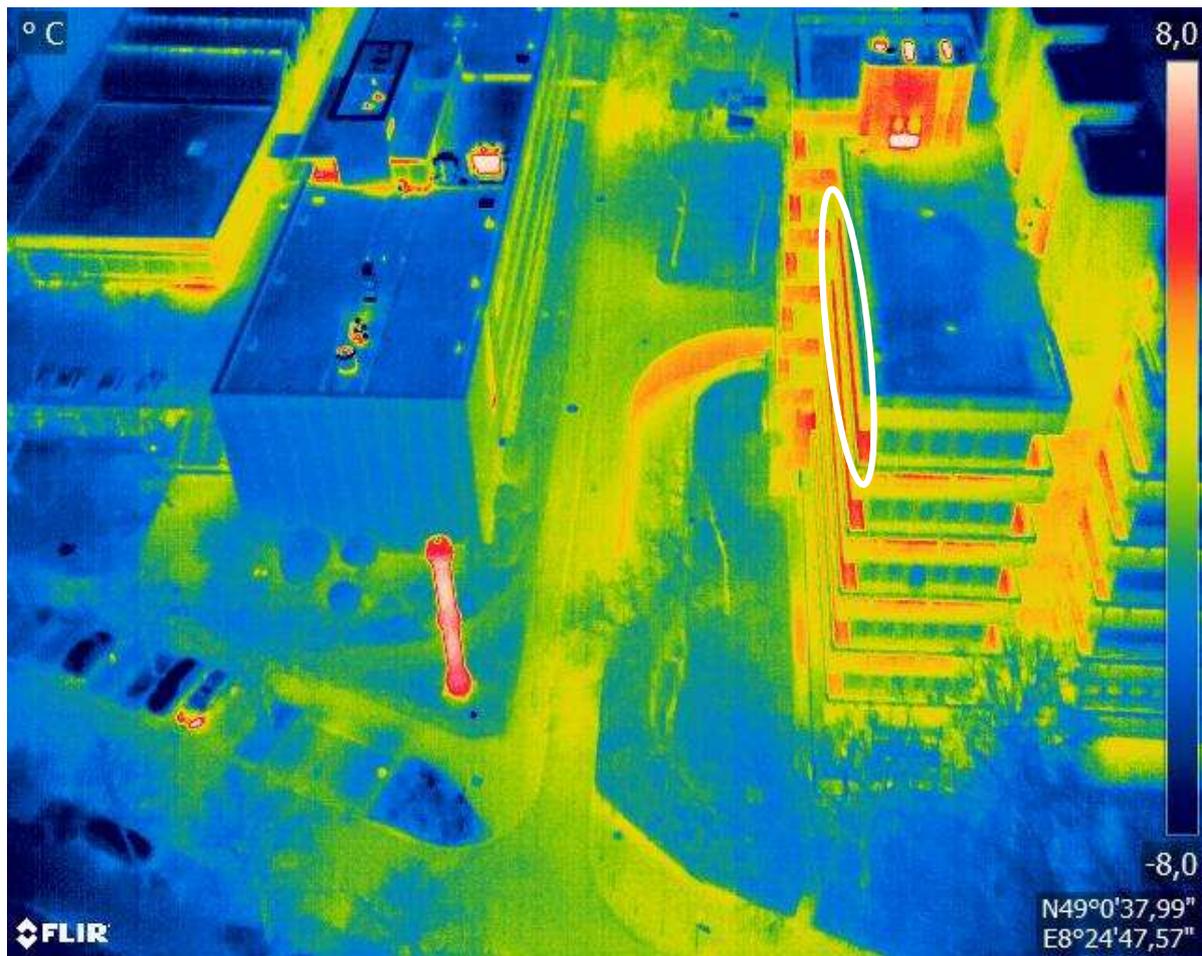
Figure A9. Example: thermal bridge of a balcony slab.

Balconies are outdoor elements and permanently exposed to changing weather conditions. A thermal bridge can occur especially in cantilevered balcony slabs of old reinforced concrete buildings, which are designed as an extension of the story ceiling without thermal decoupling. The cause of the thermal bridge is the structural design of the connection details of the balcony slab and the associated heating of the external components [8].

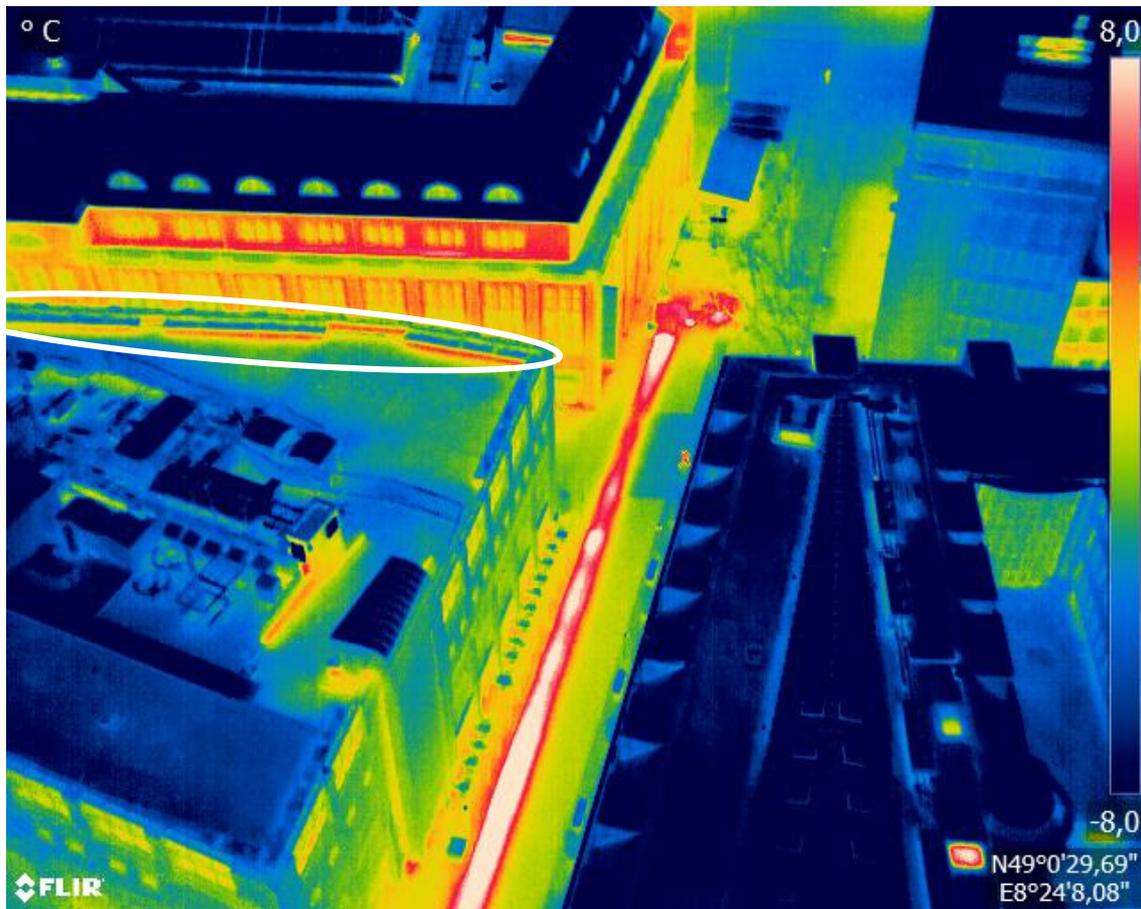
Figure A19. Example: thermal bridge of an attic.

An attic is an extension of the actual flat roof. The connection between a flat roof and an attic leads to geometric changes and can cause a thermal bridge. The connection area warms disproportionately more compared to the standard cross section, so that a significant heat loss occurs. This thermal bridge effect is reinforced by different materials used for the attic and roof surfaces [51].

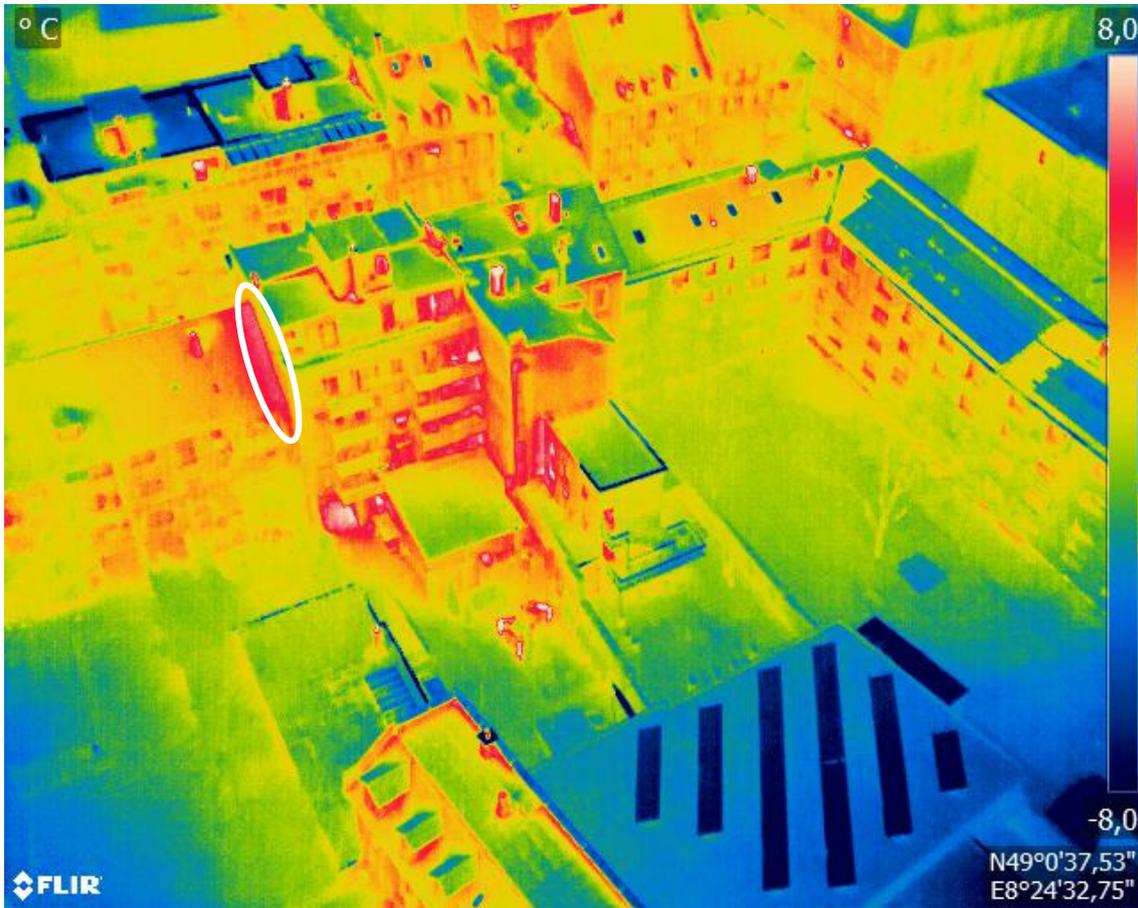
Figure A27. Example: thermal bridge of a connection between a rooftop and a wall.

Due to the different geometric conditions, the connection between a rooftop and an outer wall is associated with high demands on the quality of the insulation work. If the roof insulation is missing or incorrectly installed, this connection causes a thermal bridge. In addition, the thermal bridge potential increases considerably due to the angle of the roof and different materials of the two components [51].

An example of a thermal bridge of a connection between a rooftop and a wall is presented in Figure A27. For the retrofit of this thermal bridge type, it is necessary to demolish part of the roof structure and install additional thermal insulation material in the connection area to reduce the negative effects of the thermal bridge in the edge area. The partial removal of the existing roof structure makes the retrofit very complex and is associated with the risk of moisture problems if the vapor barrier is damaged. For the retrofit, it is important to use a sufficiently long thermal insulation layer of 30 cm, which is installed in the direct connection area to the outer wall. An illustration of this retrofit measure is shown in Figure A28, the costs of the retrofit of this thermal bridge type are

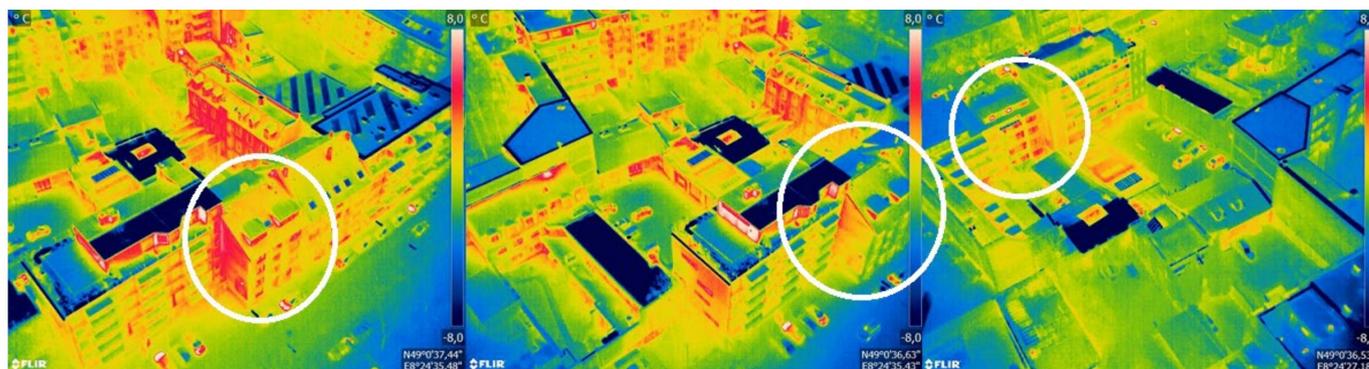
Figure A30. Thermographic aerial images of the reference building (north, east, and west orientation).
