Sensor-integrating gears: wear detection by in-situ MEMS acceleration sensors

Julian Peters¹ · Lorenz Ott¹ · Matthias Dörr¹ · Thomas Gwosch¹ · Sven Matthiesen¹

Abstract

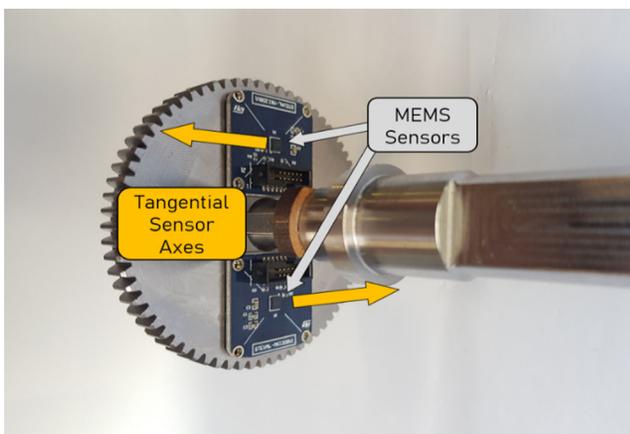
**Fig. 1** MEMS Sensors on Gear

A gear test rig with both in-situ sensors and reference sensors on the housing is used. A more detailed description of the in-situ measurement system can be found in [17]. It consists of two MEMS acceleration sensors (IIS3DWB, ST microelectronics, Geneva, Switzerland), see Table 1, which are glued on the spur gear to measure tangential accelera-

tion (Fig. 1) and a microcontroller development board for data acquisition which is mounted on the gear shaft (Fig. 2).

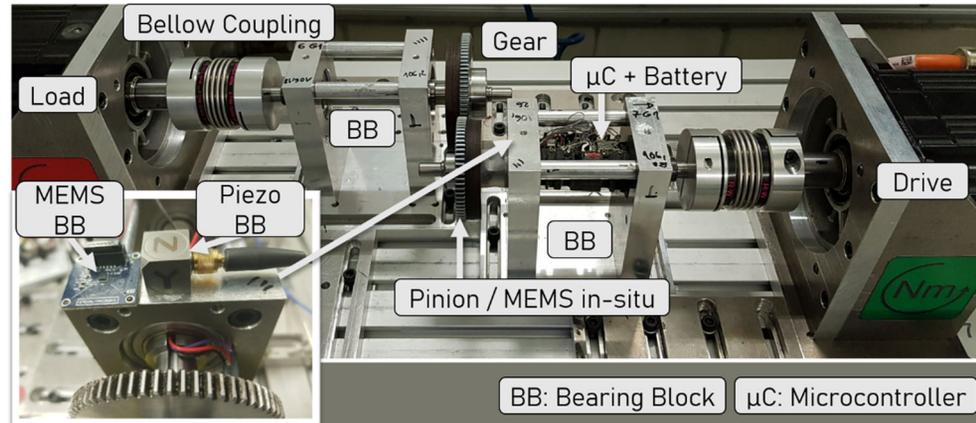
Fig. 3 Gear Test Rig with Measurement System

For reference measurements on the bearing block the sensors from Table 1 were used. First, the IIS3DWB, which is the same one as on the gear to enable a direct comparison between in-situ and bearing block positions (Fig. 3: MEMS BB). Second, the piezo accelerometer (PCB-356A02, PCB Piezotronics, Depew, NY, USA) to ensure a measurement compatible with the state of the art of CM (Fig. 3: Piezo BB).

A single gear stage was used in the test rig (Table 2). The gears are lubricated by grease. There is a demountable splash shield surrounding the gears. As drive and load electric motors (Table 3) are used. The gear test rig with measurement system is depicted in Fig. 3.

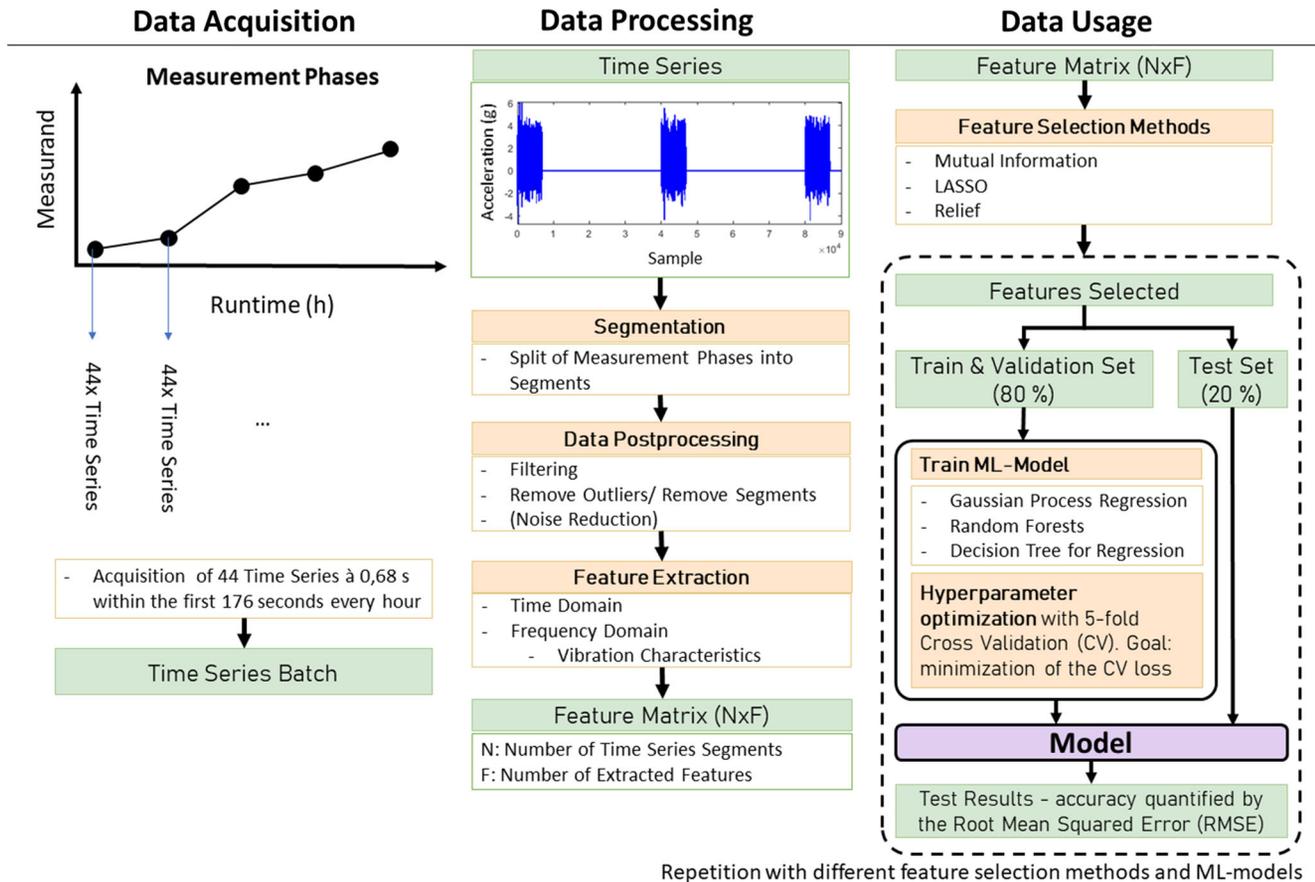
Fig. 4 Machine-Learning Framework

A machine learning model is developed (Fig. 4) that uses regression analysis to infer a relationship between features extracted from measured vibrations and the progression of wear, thus advancing formerly introduced gear metrics by another step.

Building a framework for the regression model includes the steps of data acquisition, data processing and data analysis, which is depicted in Fig. 4.

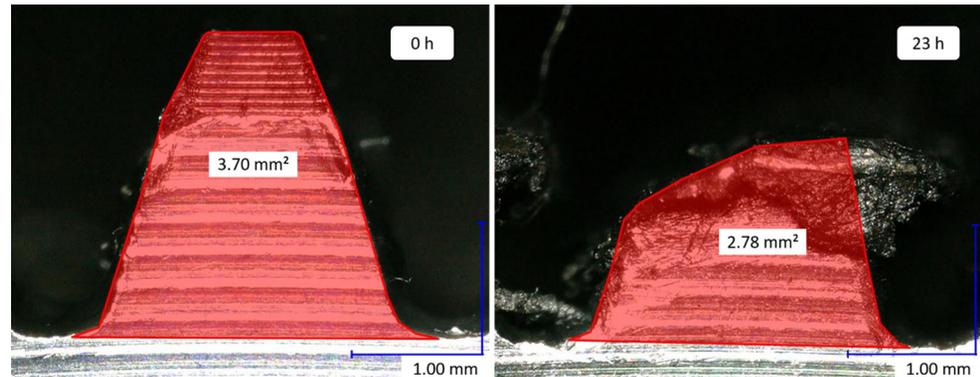
Fig. 5 Tooth profile and area at specified runtimes

The gears lasted 23h of operation until loss of function. Fig. 5 shows the degradation of a tooth profile from 3.7 to 2.78 mm².

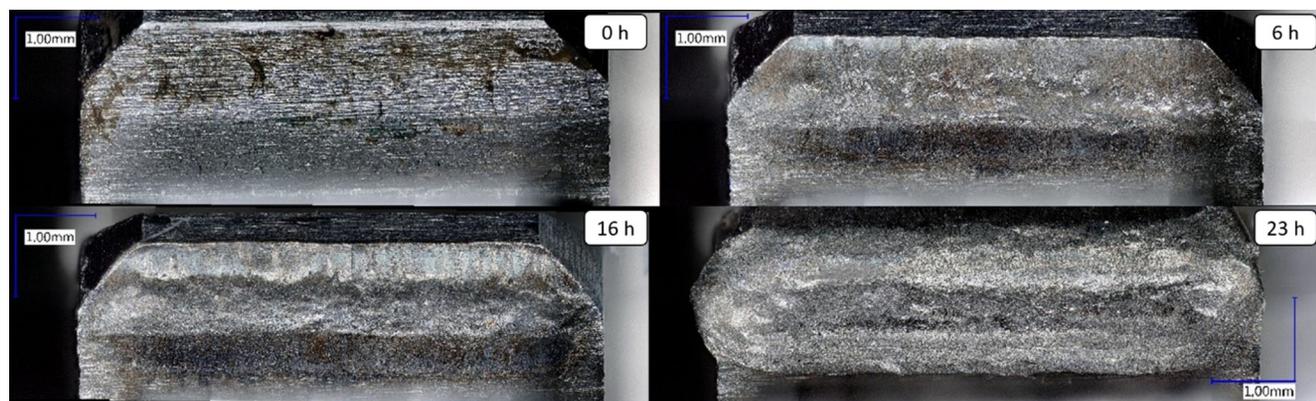
Fig. 6 Gear Tooth Flank at specified Runtimes

For assessment of actual wear in between, Fig. 6 shows the change of one tooth flank at the specified hours of runtime. The double scalloped wear pattern is visible. Using the definitions from ISO 10825 the teeth show abrasive and rolling wear [23]. Rolling wear is a sign of overloading, which was done on purpose in our tests to achieve a faster wear procedure.

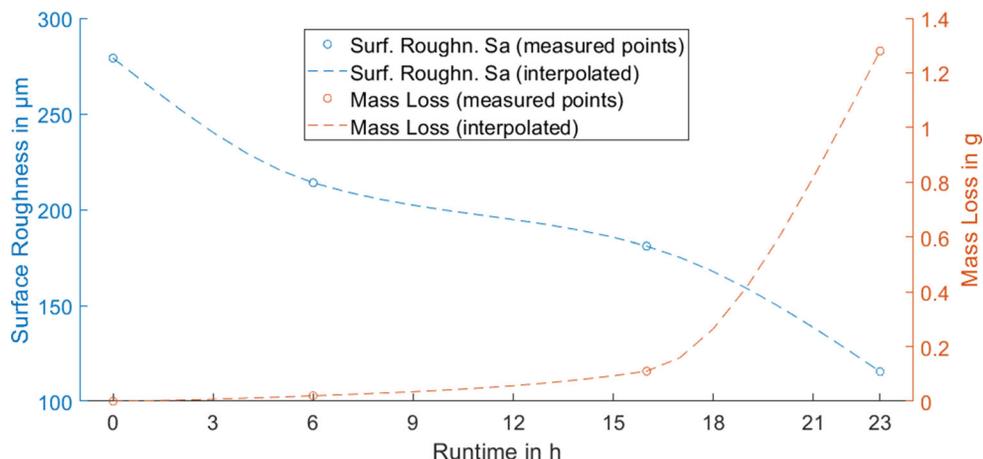
Fig. 7 Surface Roughness Sa and Mass Loss

Fig. 7 depicts the surface roughness (Sa) and the mass loss. Sa shows a decreasing trend in 3 phases, indicating a change in the tooth faces. The mass loss shows an exponential growth up to 1.28g at its top (23h). These parameters have been used successfully in other studies as well for wear assessment (Chap. 2.2). In summary, the ob-

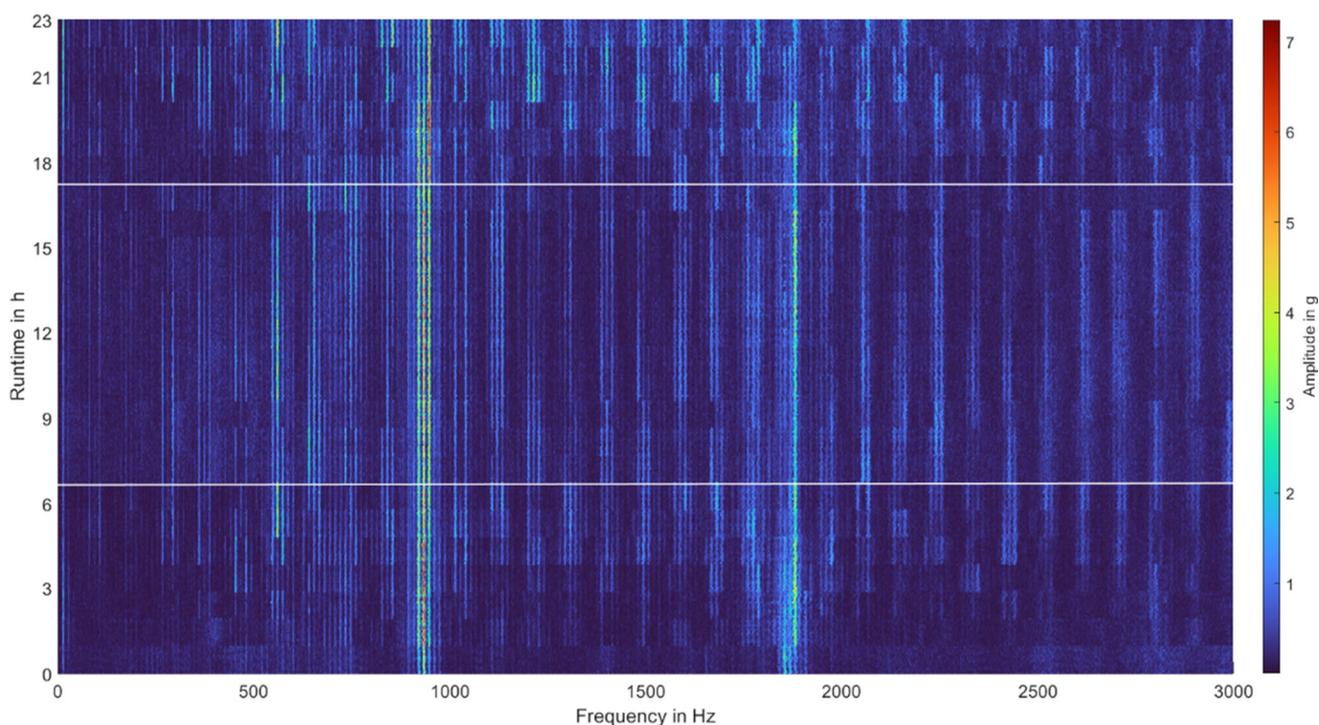
Fig. 8 Acceleration Frequency Spectrum: In-Situ MEMS Sensor, horizontal lines indicate test rig halts for wear assessments

In general: The frequency spectrums of all the sensor signal data (Figs. 8, 9 and 10) show the GMFs. MEMS in-situ, MEMS bearing block and Piezo bearing block data clearly show the first two harmonic multiples at 933.3 and 1866.7Hz as well as two sets of sidebands to each side. The 3rd harmonic at 2800Hz is also visible, however barely distinguishable from noise. An upwards trend of the peaks of the GMFs with proceeding runtime is observable in all sensor data, which is a good indication for the wear detectability carried out afterwards.

MEMS in-situ (Fig. 8) vs. MEMS bearing block (Fig. 9): The peaks of the GMFs of the in-situ data are higher than those of the bearing block. The upwards trend at the end representing the wear progression is steeper in the bearing block sensor data. In-situ from runtimes 18h and later the 1st

GMF reduces whereby the 1st sidebands at 933.3 ± 13.3 Hz increase rapidly, especially the higher one. This is also earlier visible at the 2nd GMF and can be regarded as an indicator of wear. The bearing block sensor does not show the 1st sidebands but the 2nd ones at $933.3 \pm 2 * 13.3$ Hz which also increase in amplitude.

The in-situ shows the gear rotation frequency (13.3Hz) and lots of peaks at integer multiples of it with the GMF-sideband structure. The same is observable in the bearing block sensor data with lower amplitudes, however not at the first order.

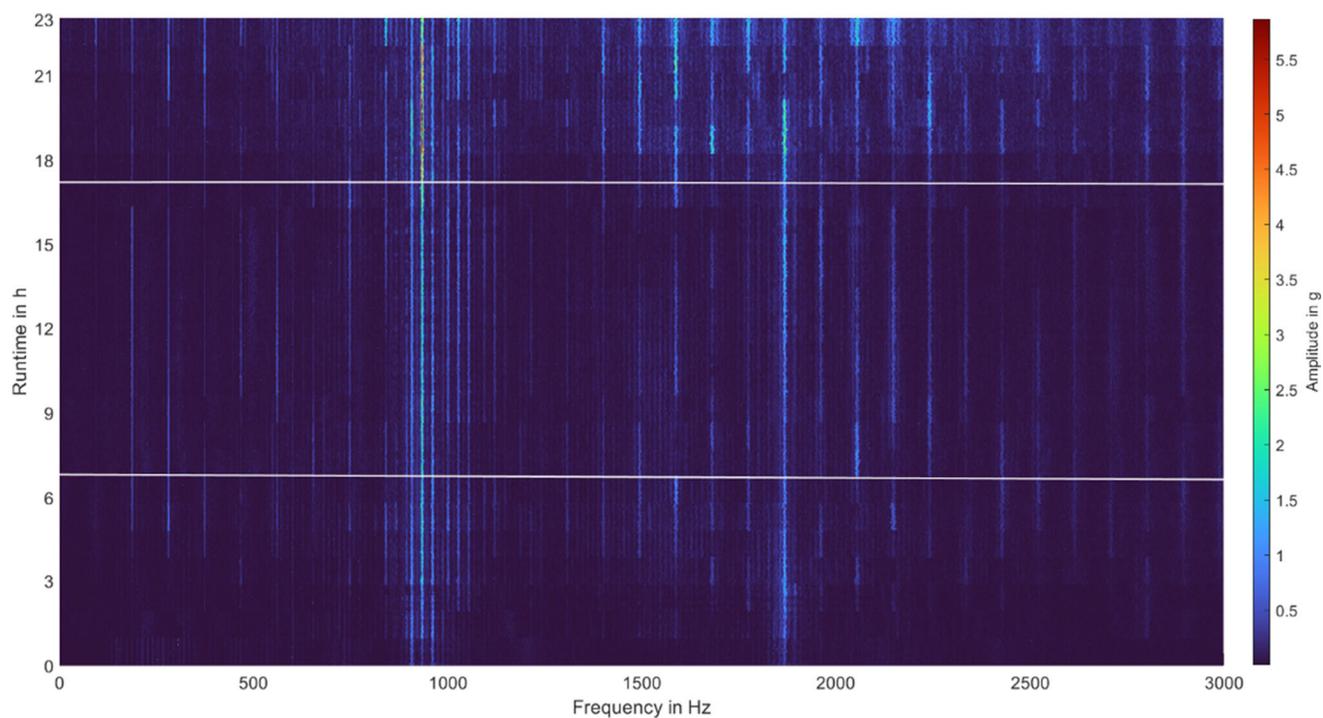
Fig. 9 Acceleration Frequency Spectrum: Bearing Block MEMS Sensor Z, horizontal lines indicate test rig halts for wear assessments

Bearing block MEMS (Fig. 9) vs. piezo (Fig. 10): Both bearing block sensors show similar frequencies. The piezo sensor

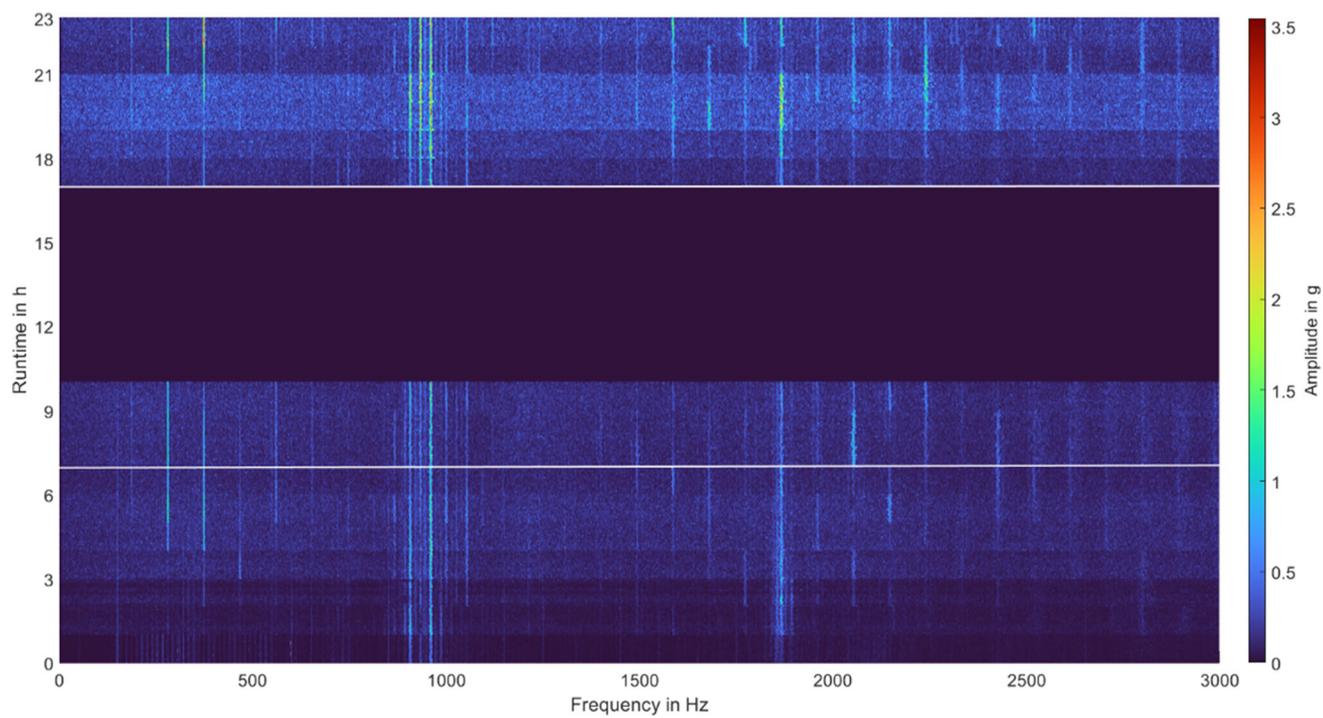
Fig. 10 Acceleration Frequency Spectrum: Bearing Block Piezo Sensor Z, horizontal lines indicate test rig halts for wear assessments

data has lower amplitudes and more noise than the MEMS. The upwards trend in the 1st GMF is similar, in the 2nd GMF is steeper in the piezo sensor data.

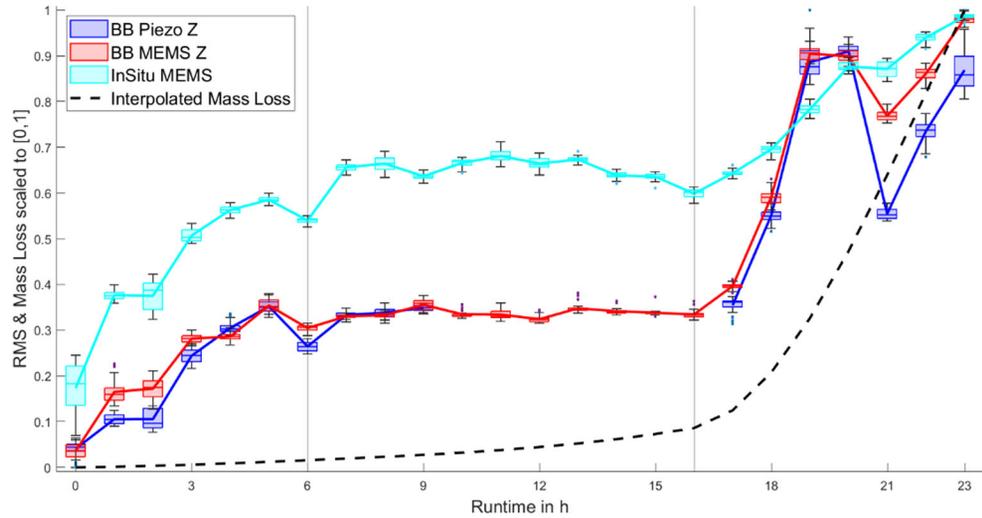
Fig. 11 RMS of Sensor Data with Vertical Lines at Run-In and Accelerated Wear Phase

In the first phase the **RMS** (Fig. 11) shows the run-in period (6h) of the gear pair by an increase in all sensors. The in-situ sensor yields higher values in stationary phase. All sensors indicate the start point of accelerated wear at about the same time (16h). In the last phase the gradient of the in-situ sensor is lower compared to the mass loss,

whereas the bearing block sensors gradient is higher with a break at 21 h. The MEMS in-situ does not have this break, but its range was exceeded sometimes in the last phase. Bearing block MEMS and piezo match well apart from a slight deviation at the end. The change of RMS absolute value in bearing block MEMS from before to after the remountings (6h, 16h) is <5% whereas the overall change due to wear is >400%.

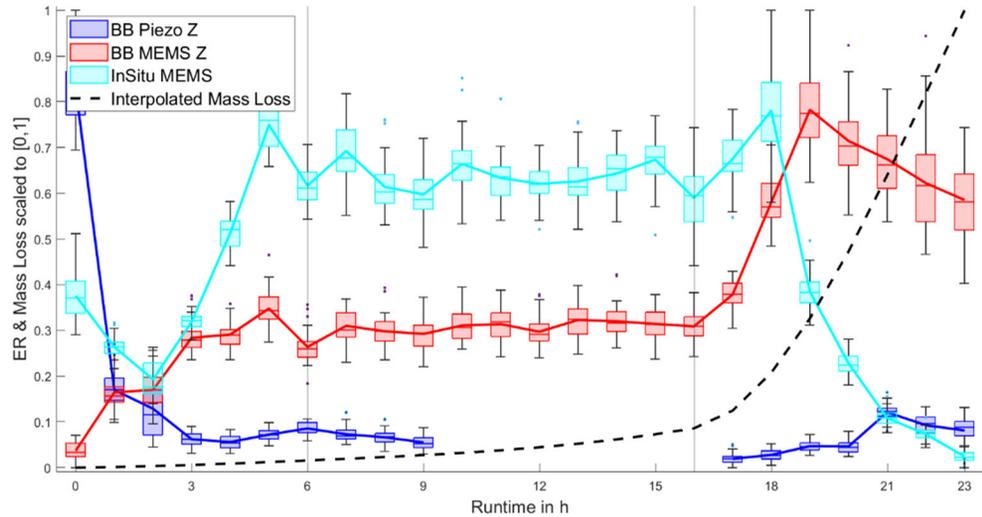
Fig. 12 Energy Ratio of Sensors with Vertical Lines at Run-In and Accelerated Wear Phase

The **ER** (Fig. 12) shows a very fluctuating process for all sensor data. In the run-in period the MEMS in-situ and bearing block sensors show overall increasing values, followed by a stationary phase until the accelerated wear phase at 16h. The gradient of the wear in the last phase is best covered by the bearing block MEMS sensor, followed by the in-situ MEMS sensor. Contrary to the wear, the in-situ MEMS decreases again after 18h and continues falling until the end. The MEMS bearing block sensor covers the increase longer until 19h, but also starts falling before the end. The bearing block piezo sensor shows a bathtub curve,

which is a common characteristic of the gear life, with a decrease in the run-in phase, followed by a stationary phase and a slight increase in the accelerated wear phase. It also starts to decrease a little before the end.

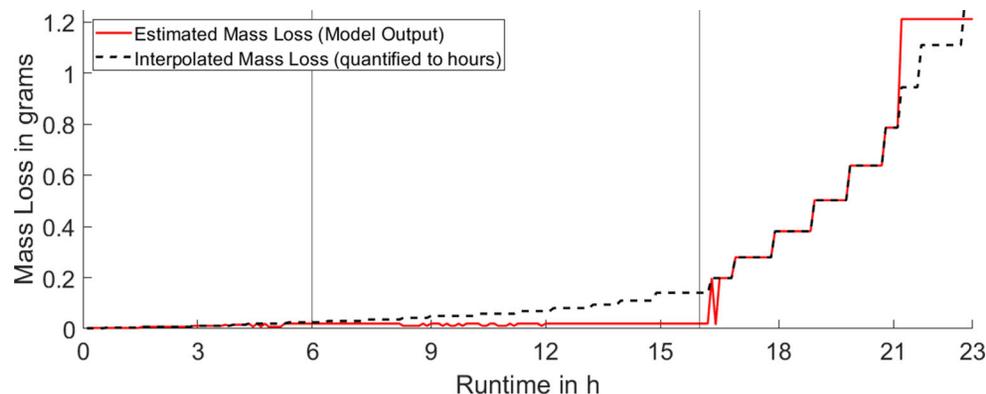
Fig. 13 Estimation of Wear (Mass Loss)—Regression Model Output

The model provides the best results with decision tree as model and mutual information as feature selector with a RMSE of 0.028 g (RRMSE=2.2%, $R^2=99.48\%$). The output of the model, the estimated mass loss, is shown in Fig. 13 together with the interpolated mass loss which is quantified hourly to fit the measurement periods every hour (Chap. 2.3). From the beginning up to the point of accelerated wear (16 h) the estimation does not fit the slight increase of the wear. But afterwards the estimation matches the wear very well apart from the last two hours, where it deviates again in a conservative way.
