EMOS: Development of a mobile, automated, optical inspection system for radioactive drums

Tania Barretto, Eric Rentschler, Melanie Müßle

Institute of Technology and Management in Construction (TMB) - Deconstruction and Decommissioning of Conventional and Nuclear Buildings

SafeND – Interdisziplinäres Forschungssymposium für die Sicherheit der nuklearen Entsorgung

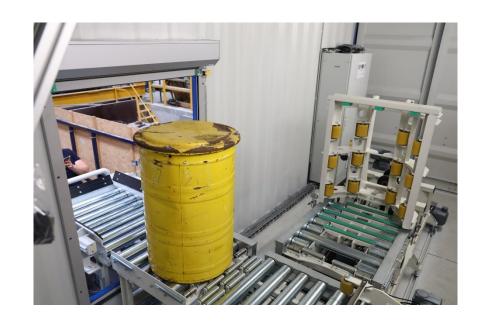
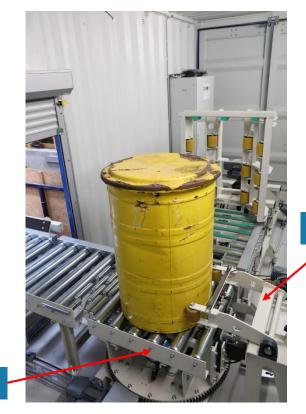
■ Step 1 – Drum is carried to the turntable and gets centered

Drum centering

Turntable

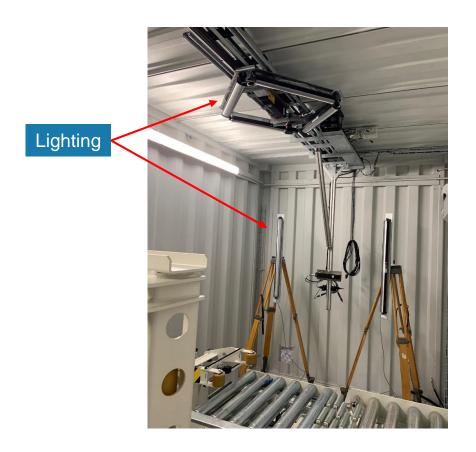
camera

Laser line profile sensor

2 cameras

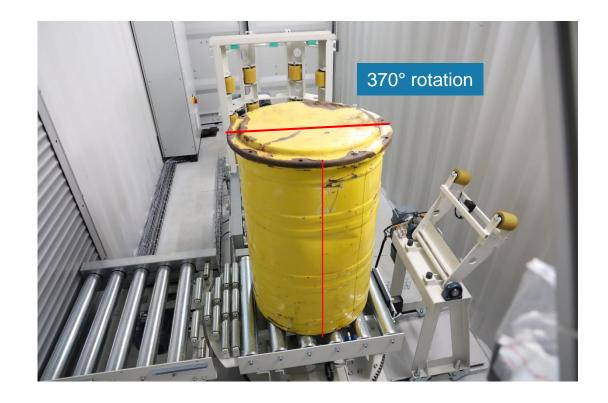
■ **Step 1.1** — Drum coat und drum top scan

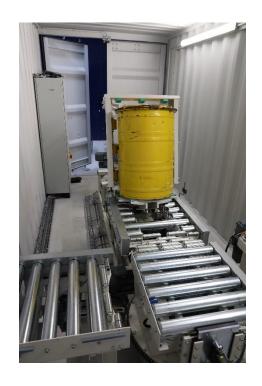
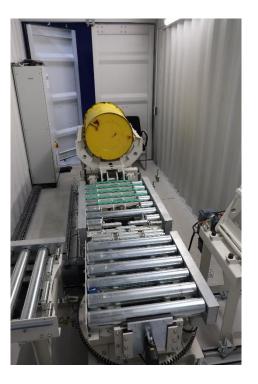
Step 2: Drum is carried to the tipping system and gets tipped
