Cryogenic testing of a 25 kV RIS bushing

Stefan Fink, Uwe Fuhrmann and Volker Zwecker

Abstract. High voltage bushings for cryogenic current or voltage leads must master safely the special thermal stress in addition to the high voltage requirements. Resin impregnated synthetic (RIS) bushings have proven their usability for room temperature high voltage application since few years. Such paper free bushings are less hygroscopic than paper based bushings, which can be an advantage for components exposed to cryogenic temperatures on one side and to air conditions on the other. A conventional 25 kV, 2 kA room temperature RIS bushing was assembled to an open bath cryostat and subjected to five thermal cycles. High voltage tests were successfully performed under cryogenic conditions. No degradation of the bushing was found after the thermo-mechanical stress of the fast cool downs and one fast warm up. This paper focuses on the thermal tests.

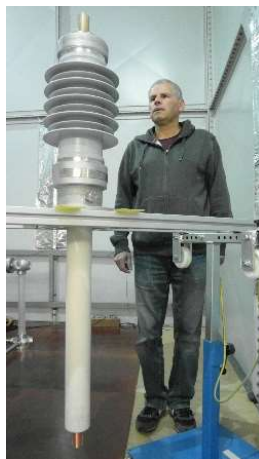
Figure 1. RIS bushing.

The RIS sample was the transformer bushing STARIS Sia 25-2000 E5,34 (figure 1). The total length is 1401 mm. Other dimensions are specified in [10]. Its highest phase to phase voltage for equipment is 25 kV. The rated current is 2 kA. The specified ambient temperature is -30 °C up to 50 °C.

After delivery the high voltage tests of KIT were performed initially at room temperature conditions outside the cryostat (figure 1). For further tests, the bushing was clamped on a steel lid with a diameter of 650 mm (figure 2). Pt100 temperature sensors were installed at heights corresponding to the maximum (LN2_max_level) and minimum (LN2_min_level) liquid nitrogen level foreseen for high voltage operation. Another Pt100 sensor was installed at the height of the bottom insulator end of the bushing (bushing_bottom). The lid was mounted on top of a cryostat with a diameter of 400 mm (figure 3). This setup was an open cryostat version because the used lid does not allow tight fixation for evacuation. The used RIS bushing is not specified for overpressure operation.

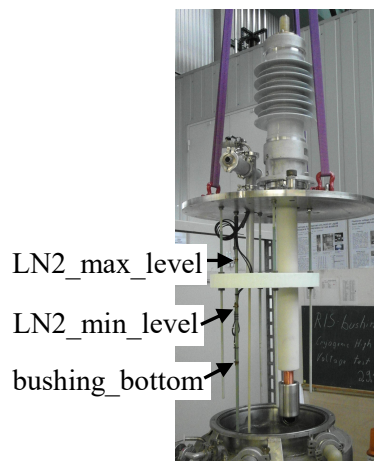
Figure 2. Temperature sensor positions for RIS bushing assembled on lid.

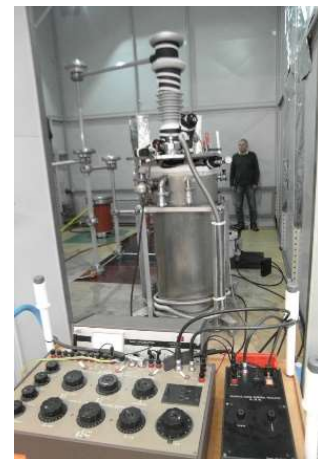
Figure 3. Schering bridge test with bushing and lid assembled on the cryostat.

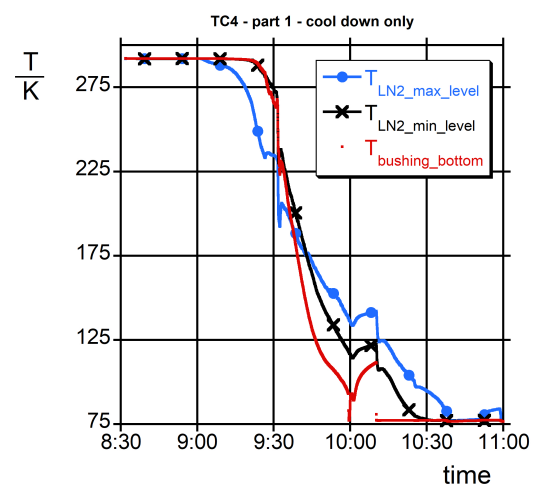
Figure 5. Temperature measurement vs. daytime for initial cool down process of thermal cycle 4.

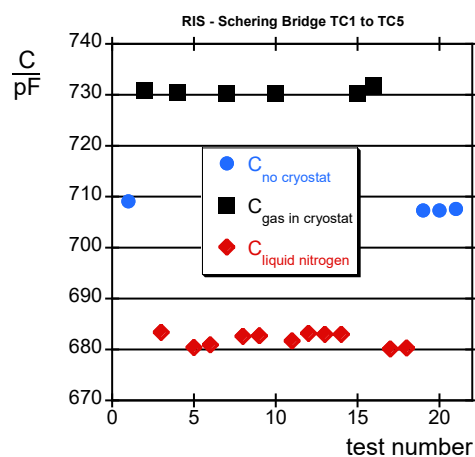
Schering bridge measurements were usually performed after the routine partial discharge tests for status monitoring of capacitance and dissipation factor. Figure 6 shows the measured capacitance and figure 7 the dissipation factor for the tests during thermal cycle 1 to 5. There is a clear relationship depending on the test condition for the measured capacitance as well as for the dissipation factor. The bushing had a capacitance around 710 pF under room temperature conditions outside the cryostat. Assembly in the cryostat increased the capacitance to values around 730 pF, which can be explained by the increase of stray capacitance to the cryostat wall. After cool down the capacitance decreased to values around 680 pF although liquid nitrogen has a permittivity of 1.41 and not 1.0 like air or nitrogen gas. This behavior can be explained by decrease of the permittivity of the insulator material of the bushing. The dissipation factor for room temperature was measured between 0.250% and 0.289% whereas the dissipation factor was between 0.466% and 0.519% for cryogenic conditions.

Schering bridge measurement on RIS material have shown a capacitance decreasing with temperature and at least one local maximum of dissipation factor between room temperature and 77 K which is a frequently reported behavior of polar materials [14] [15]. The higher dissipation factor for the bushing under cryogenic conditions than at room temperature conditions does not necessarily mean that the insulator material itself has a higher dissipation factor for liquid nitrogen temperature. The insulator was only partially immersed in liquid nitrogen. Also insulator spaces below the liquid nitrogen level were warmed by the copper rod. In addition, the air side insulator material was cooled by the copper rod. Hence the temperatures of relevant portions of the insulator volume were shifted towards the region where higher dissipation factors than at room temperature can be expected leading to an overlaying effect in relation to the dissipation factor reduction by the regions which were around liquid nitrogen temperature.

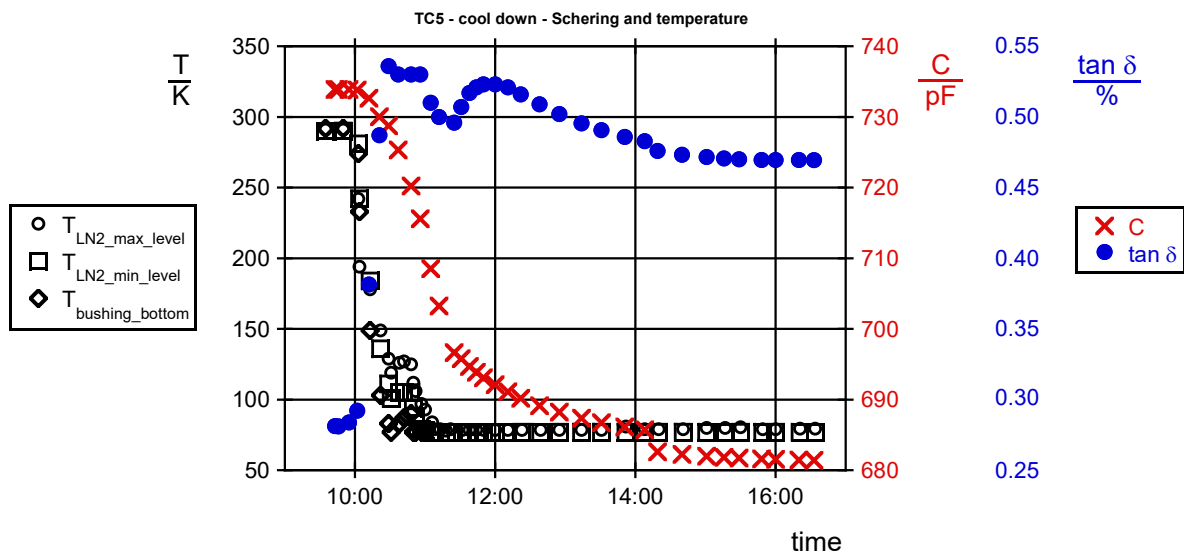
Figure 8. Temperatures (T), capacitance (C) and dissipation factor ($\tan \delta$) measurement vs. time during a single 8 h shift starting with warm nitrogen gas flow at nine o'clock. Liquid nitrogen filling was stopped at 11:22.

The capacitance was strictly monotonically decreasing after starting the cool down process. The dissipation factor had two local maxima at 10:29 and around 12:00. Then the dissipation factor was strictly monotonically decreasing. Between 16:00 and 16:33 the capacitance decreased for 0.16‰ and the dissipation factor for 0.32‰ only. It can therefore be concluded that concerning cool down a quasi-static temperature distribution of this RIS bushing can be achieved within a single 8 h shift.

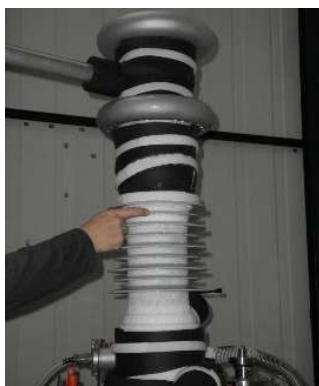
Figure 9. Optical imaging of the air side of the bushing.

Surface temperature on the air side of the bushing (figure 9) was investigated with a thermal imaging camera (figure 10) under air temperature of 20.5 °C. Simple thermal insulation based on synthetic rubber was sufficient to avoid icing or low temperatures on the high voltage connection above the bushing.

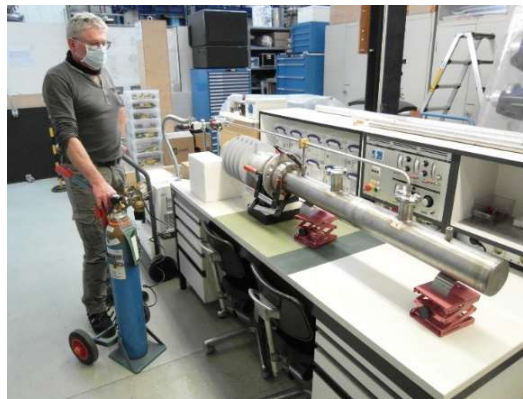
Figure 11. Leak test after fifth thermal cycle with evacuated tube around the insulator side which had been cooled with liquid nitrogen.

No mechanical degradation was found by visual inspection. Leak testing was performed at KIT before first and after last voltage test (figure 11). For the incoming inspection, leaks were found at the clamping piece of the top flange and on the air release screw of the mounting flange. A break of 17 days was taken between lifting the bushing out of the cryostat and the second leak test. Leak rate was above $3 * 10^{-4}$ hPa l / s on the air release screw. A leak rate of $\leq 2.8 * 10^{-9}$ hPa l / s was found for the clamping piece, which means that it can be considered as tight.

The disappearing of the leak on the clamping piece may be explained by a blocking of the leakage by water due to condensation which means the waiting time for the leak test after warm up was too short. Nevertheless axial leakage may be an issue for further improvement. The insufficient leak tightness of the air release seal could be fixed by closing the drilling on the steel flange if necessary. For
