# EMOS: Development of a mobile, automated, optical inspection system for radioactive drums

ICOND 11<sup>th</sup> INTERNATIONAL CONFERENCE ON NUCLEAR DECOMMISSIONING, NOVEMBER 15<sup>th</sup> – 17<sup>th</sup>, 2022 in Aachen

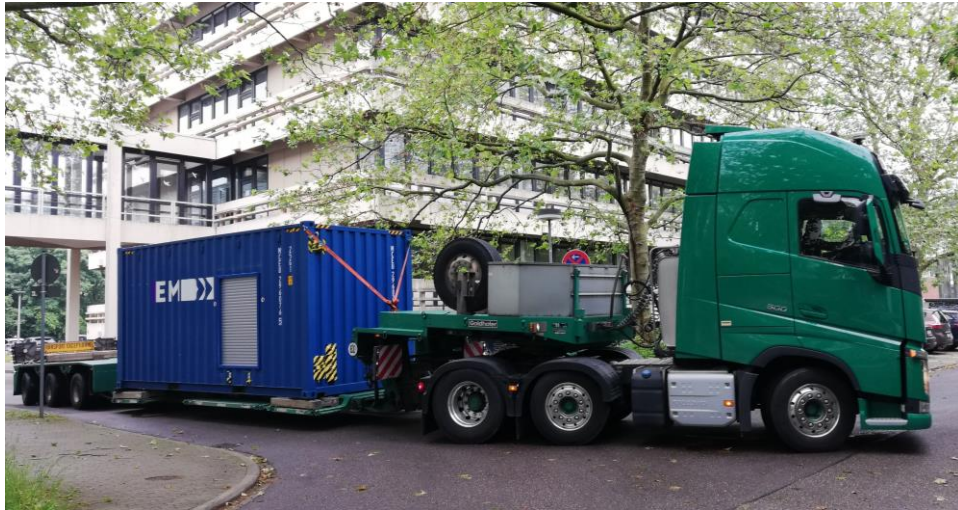
Mobile inspection system

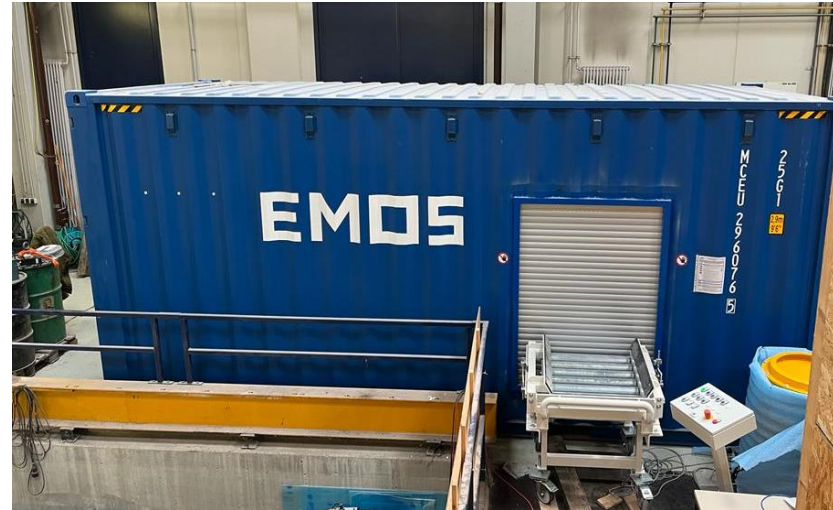
20ft high cube container with a rolling gate at the long side

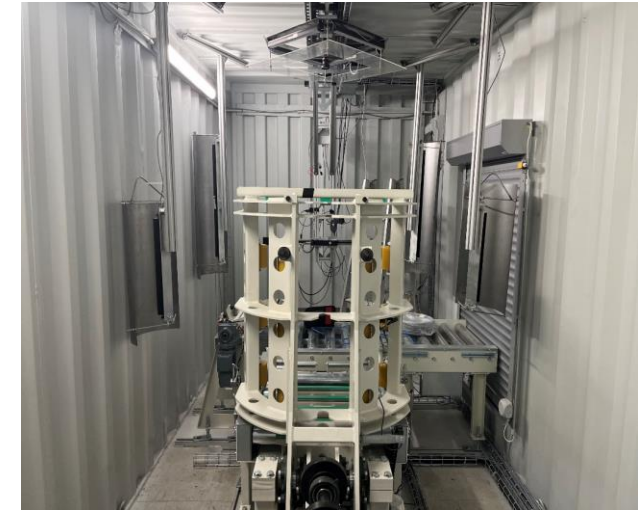
component installation

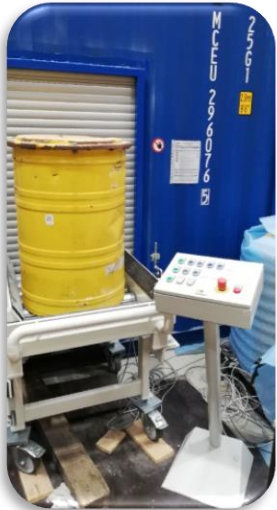
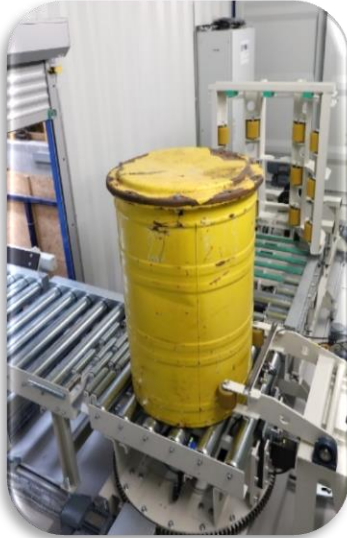
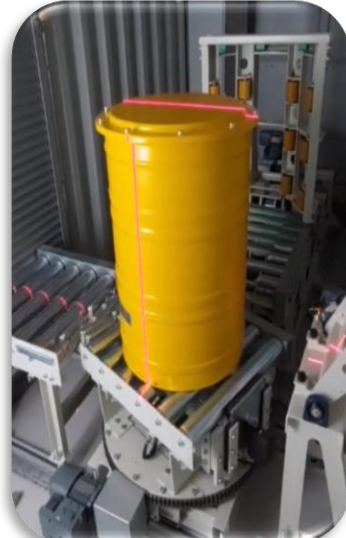
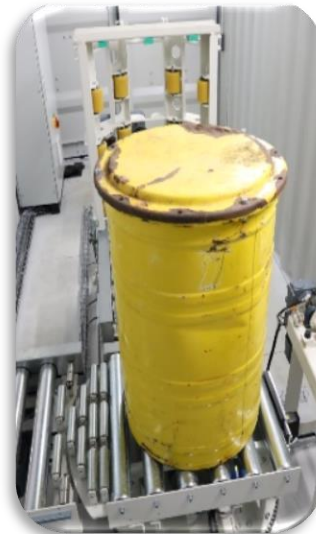
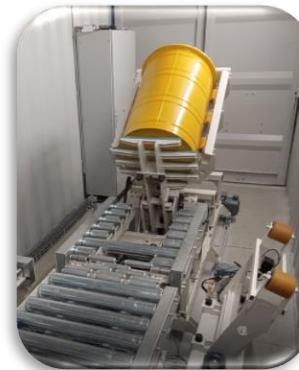
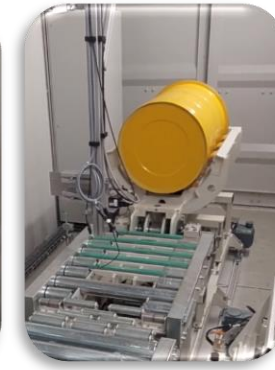
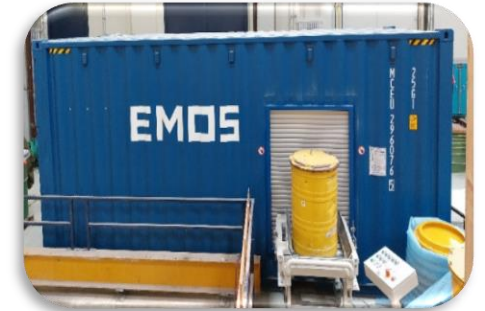
# Inspection process

control panel  
remote  
controlled

Drum on turntable

Drum shell  
and drum lid  
scan

Drum shell  
and drum lid  
photograph

Drum on  
tipping  
system

Drum  
bottom scan  
photograph

Drum return

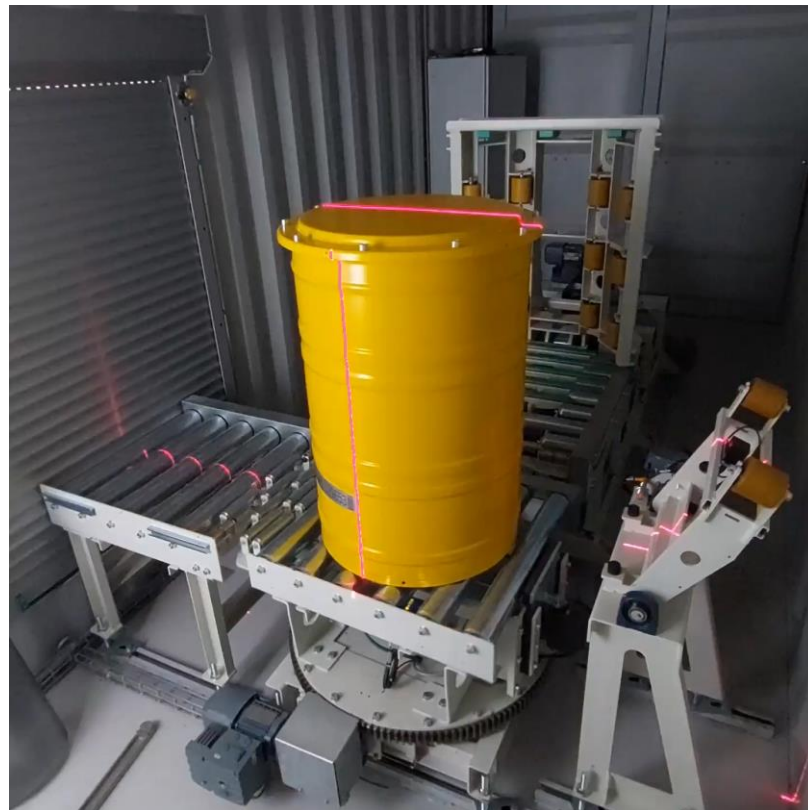
# Inspection process: Laser line profile sensor

## ■ Drum shell and drum lid scan

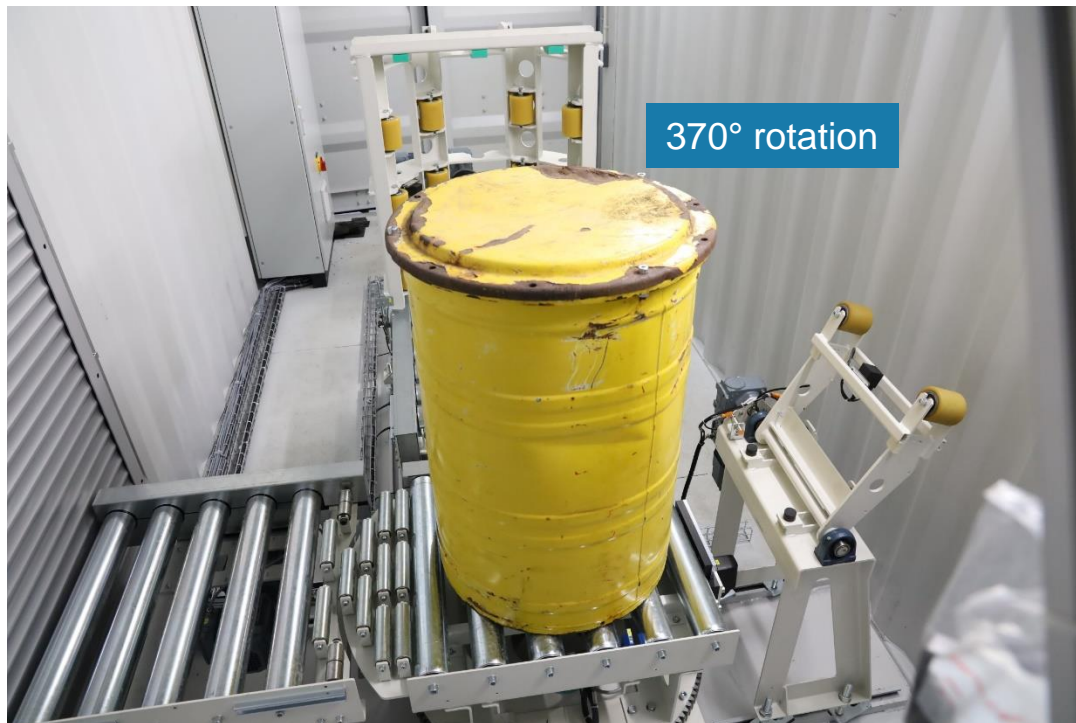
# Inspection process: Camera

## ■ Drum shell and drum lid photograph

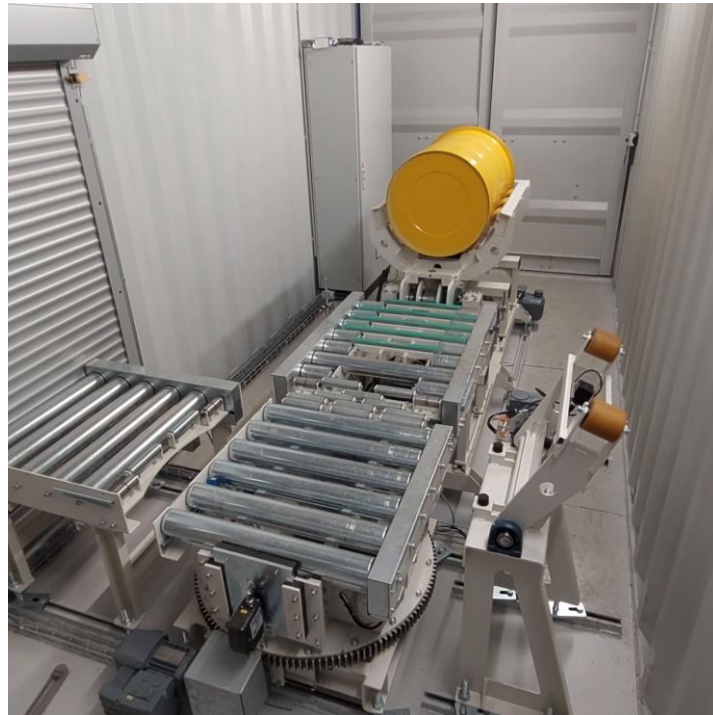
## ■ Scan and photograph the bottom of the drum

➤ In order to ensure an optimal measurement, a distance of approx. 900 mm from the bottom of the drum to the sensors is required

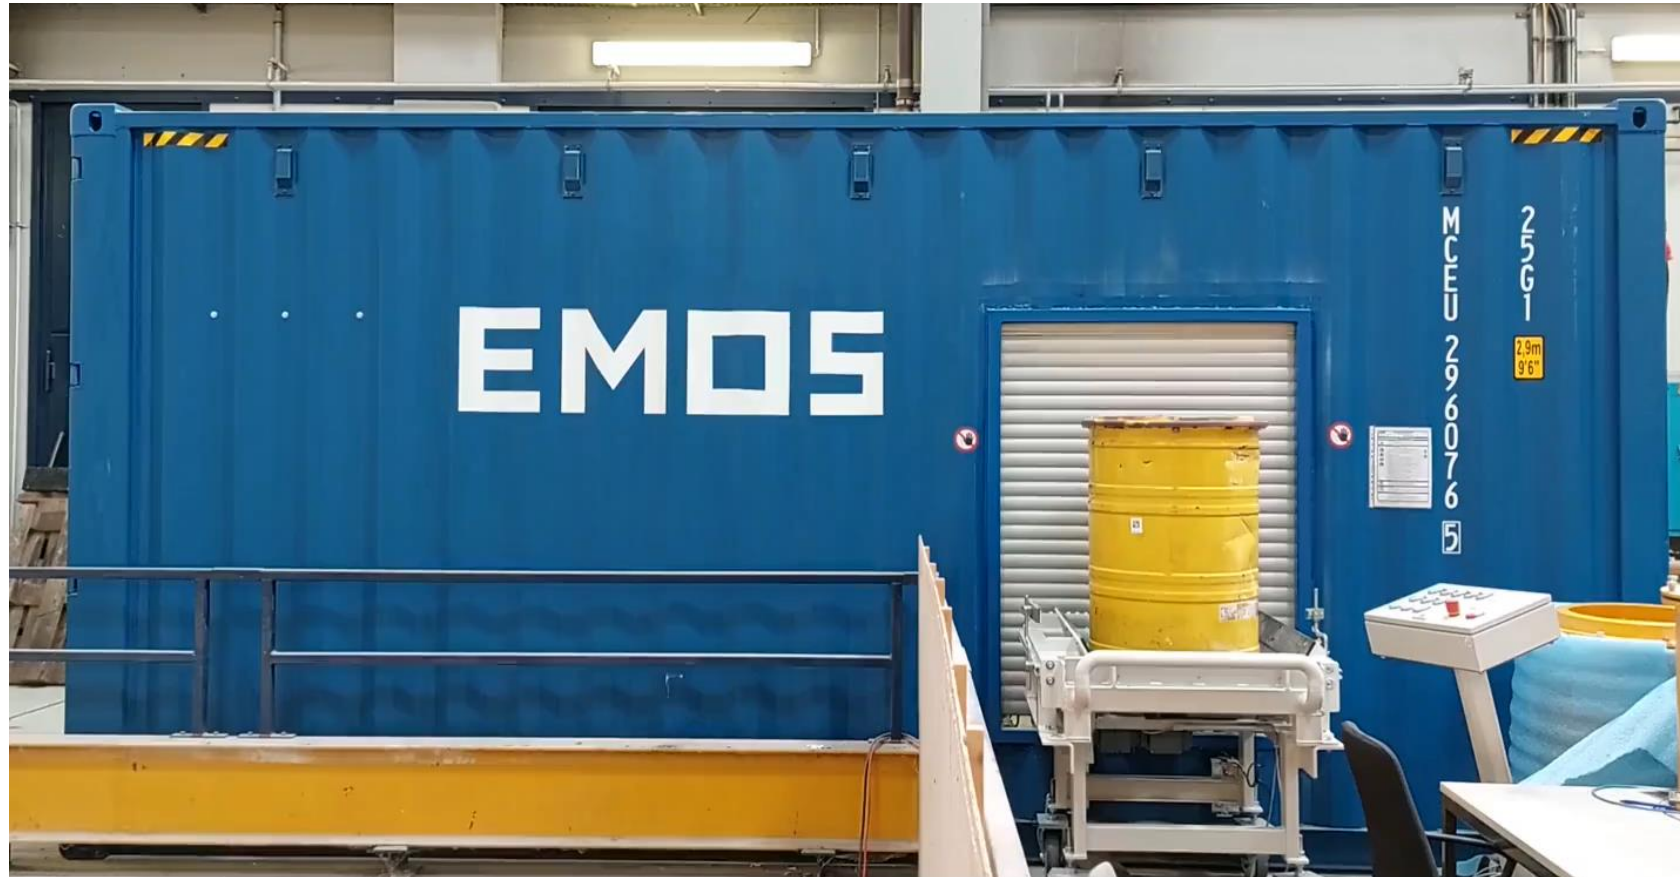
- Duration of complete inspection process: about 9 minutes

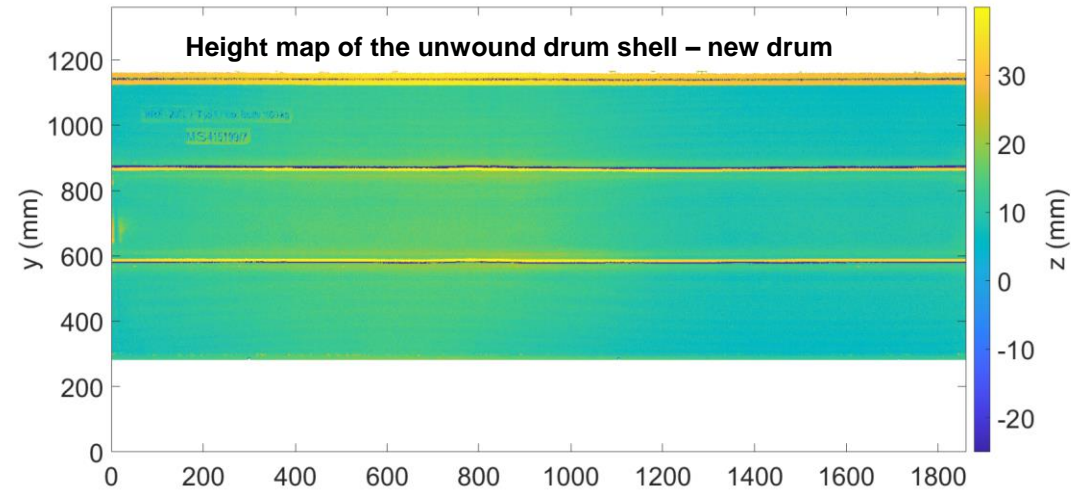
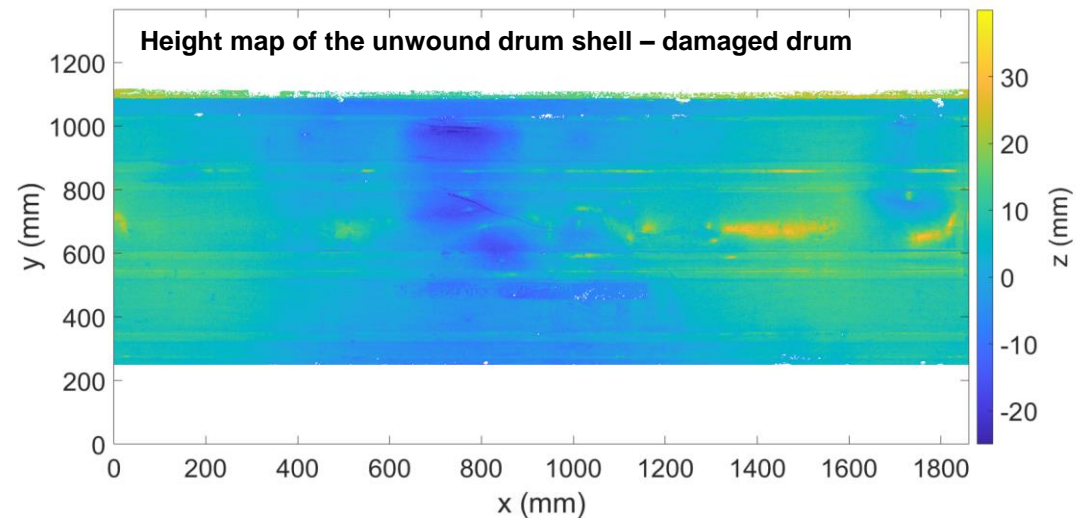
# Results: Laser line profile sensor

➤ Detection of geometric damage, such as bumps and dents

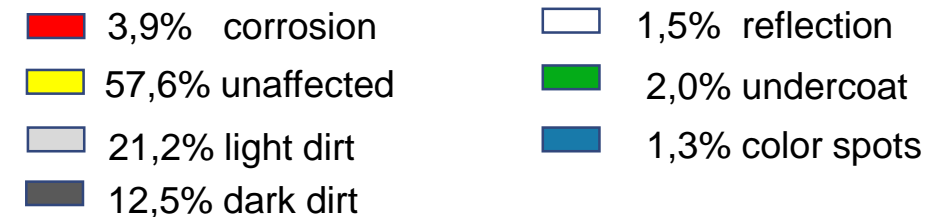
Detection and classification of visual damage
