Four Years of Tritium Operation of the KATRIN Experiment at TLK

Abstract — The Karlsruhe Tritium Neutrino (KATRIN) experiment measures the tritium β -spectrum close to the maximum decay energy to achieve the value of the electron-antineutrino mass with a sensitivity of 0.2 eV/c² (90% confidence level). Since only a small fraction of the decay electrons carries nearly all the energy, a high luminous tritium source, with its supporting infrastructure facilities, is necessary.

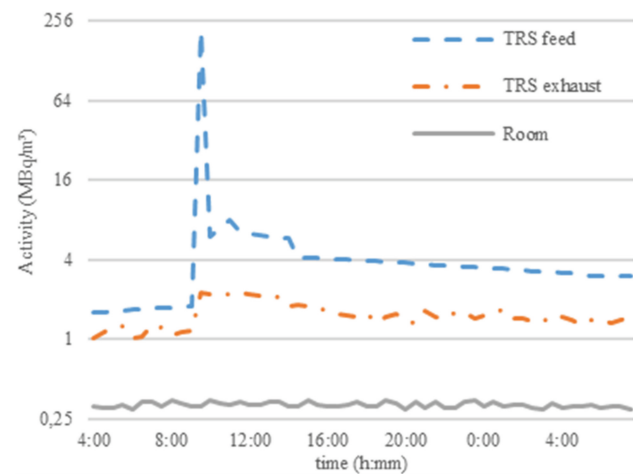
Fig. 2. Activity measurement from a tritium retention system during an increased tritium release into the glove box from a defective sampling container.

The TLK technical and administrative standards and processing procedures were successfully validated during the safe and reliable operation of the KATRIN tritium loops. This holds true even during events causing an elevated activity concentration of a glove-box atmosphere ($>100 \text{ MBq/m}^3$), as shown in Fig. 2. This proves the effectiveness of the TLK multibarrier concept.

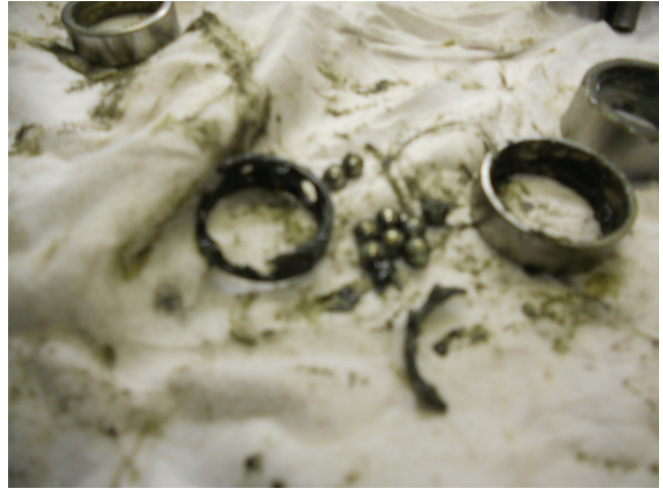
The Normetex Model 15 scroll pump has three shafts with four bearings each. The disassembly of the shaft mountings showed a broken gear cage at one of the bearings, as shown in Fig. 4. It is unlikely that the broken bearing cage was the cause of the initial crash, but like the temper colors,

Fig. 4. Broken ball bearing cage Normetex model 15.

one of the consequences. A new cage was manufactured and reassembled. No other shaft mount showed any damage.

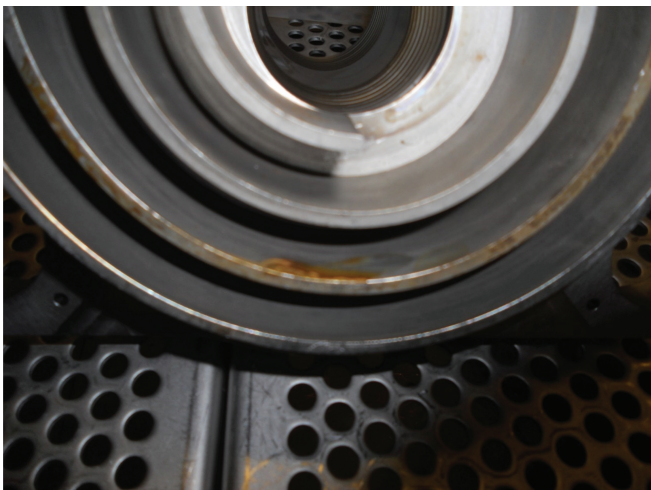
As shown in Fig. 3, corrosion marks are found at the fixed and orbiting scroll as well as the other parts connected with the pumping volume. Furthermore, both scrolls showed temper colors and damages with the form of the opposite spiral indicating contact between them. Before reassembly, rust and temper colors were removed. To protect the glove box from dust, a foil tent was constructed. All machining operations were performed inside the tent.

Fig. 3. Corrosion marks and temper colors at the orbiting scroll.

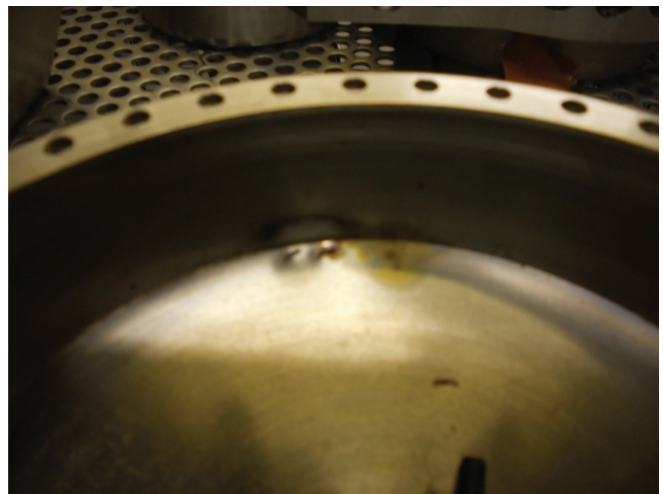
To enclose the pumping volume between the spirals, a cover is mounted on the orbiting scroll, as shown in Fig. 5. This cover shows a dent with surrounding temper colors that match the position of similar damage found at the static scroll. Most likely, the initial crash derailed the orbit of the movement to an extent such that these two components collided. After reassembly, the pump rotated freely. The reassembled pump achieved a pressure difference of 100 mbar with a total pressure of 200 mbar at the outlet. This performance was not sufficient. It is currently unknown whether the performance loss was because of an internal leak or the spacing of the spirals. It is also not known whether the spirals were set to one another in a force-fitting or in a form-fitting manner. The latter would mean that the examined

Fig. 5. Dent with surrounding temper colors at the cover of the scrolls.

pump cannot be restored since parts were probably plastically deformed.

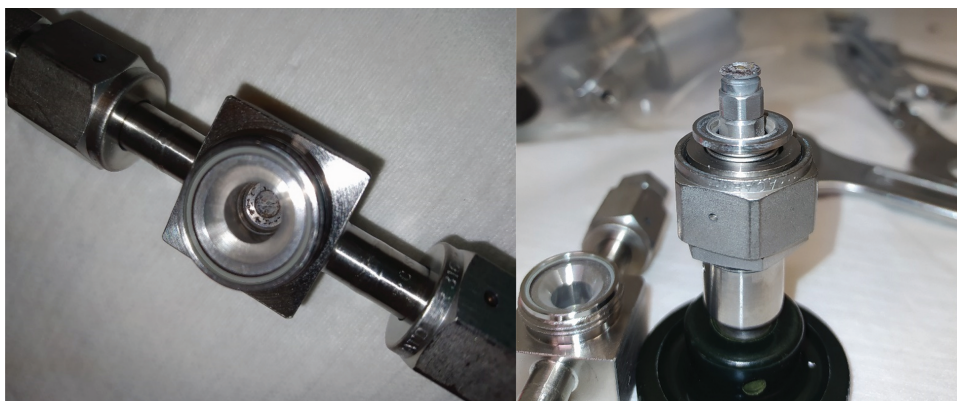
An intervention valve in the ISS primary system showed a severe internal leakage. The following inspection revealed a nontritium compatible stem tip,

Fig. 6. Inspection hand valve with a tritium incompatible tip. Radiochemical processes dissolved the tip, rendering the valve unusable.

as shown in Fig. 6. Because the difference in the article number regarding the material of the tip is only one (different) letter, failures like this happen if the inspection procedure prior to installation is not thoroughly followed. Therefore, an extra step in our commissioning and change management system has been added to double check the component suitability.

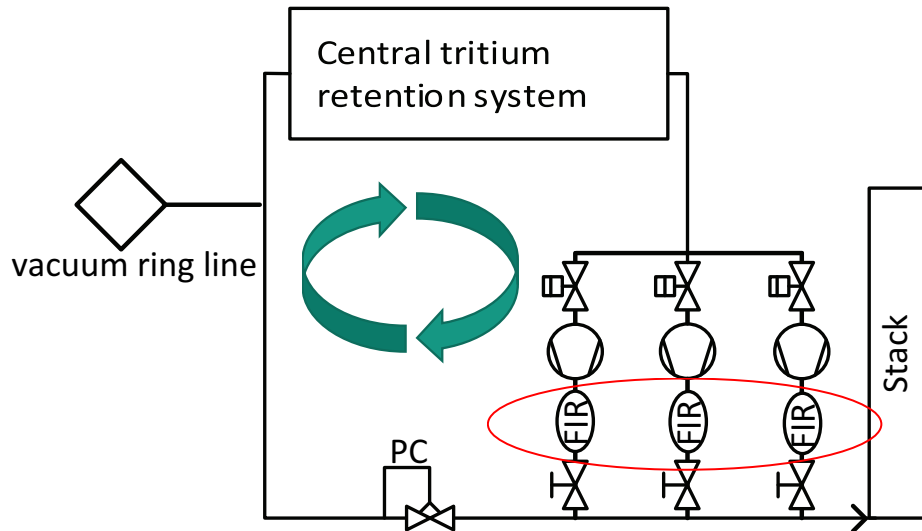
In Fig. 7, a simplified scheme of the central tritium retention system (ZTS) is shown. Originally, mechanical flow monitors were used to monitor the gas flow of the blowers responsible for maintaining the below-atmospheric pressure for the glove boxes. Although these are designed for continuous operation, in practice they fail over time. The turbines and their bearing points are not designed to withstand the fast flow reversal that occurs when the active line is changed, resulting in the failure of the bearing-turbine connection and in a loose turbine (Fig. 8).

Fig. 7. Simplified scheme of the ZTS.

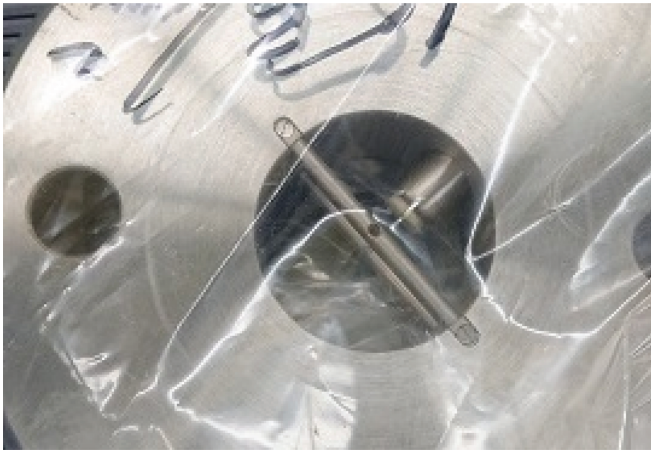
Fig. 8. Defective flowmeter from the ZTS without its turbine.

Due to the importance of the ZTS, all flow monitors have been replaced with thermal flowmeters. These operate with no moving parts, and a practically infinite service life can be expected from them.
