Influence of DC corona discharge on CFRP behavior in hot air and molten salt

A. Bologna, H-J. Gehrman, K. Woletz, D. Stapf

Karlsruhe Institute of Technology, D-76344, Eggenstein-Leopoldshafen, Germany

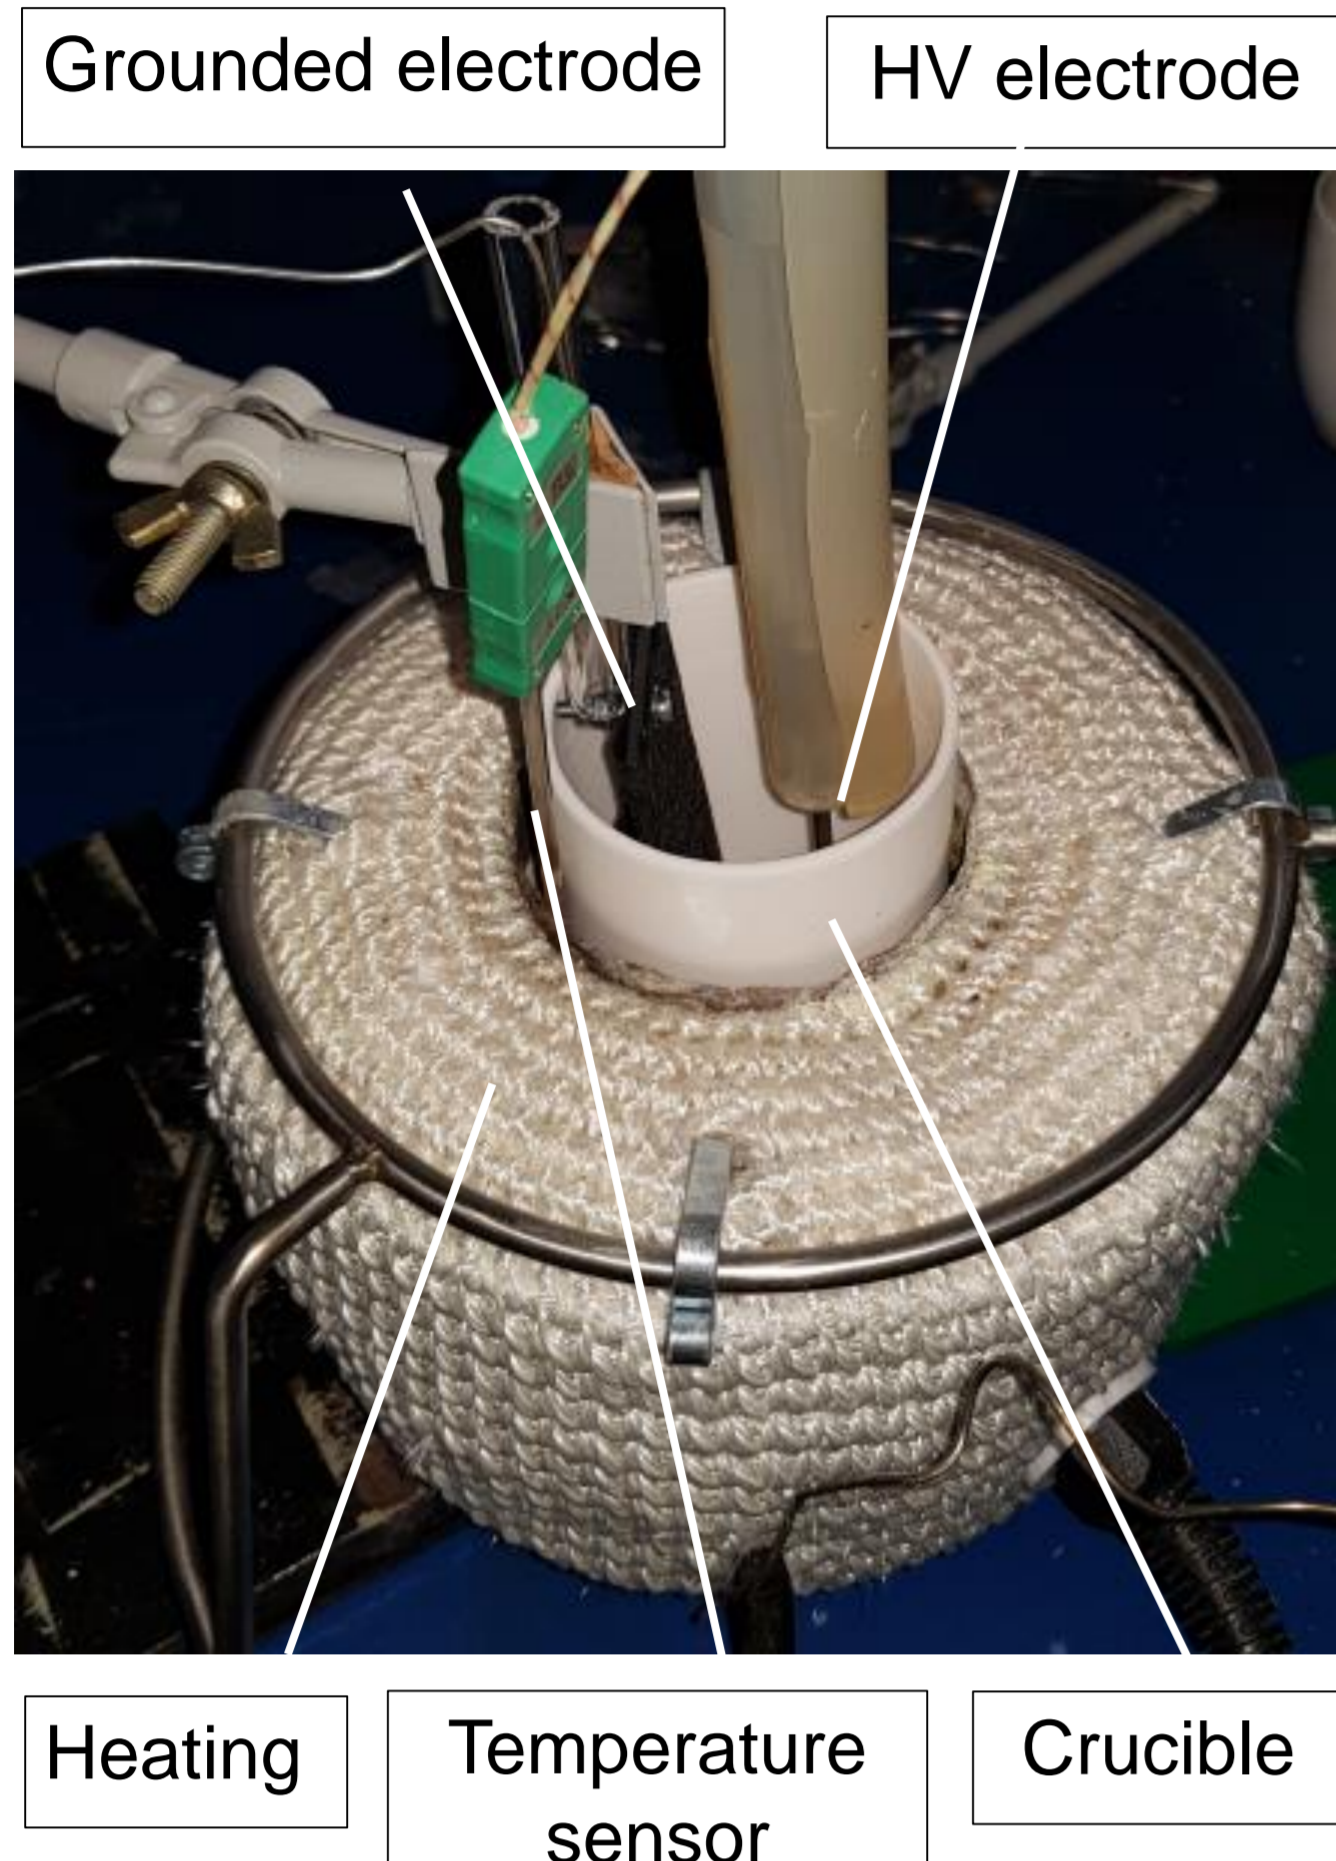
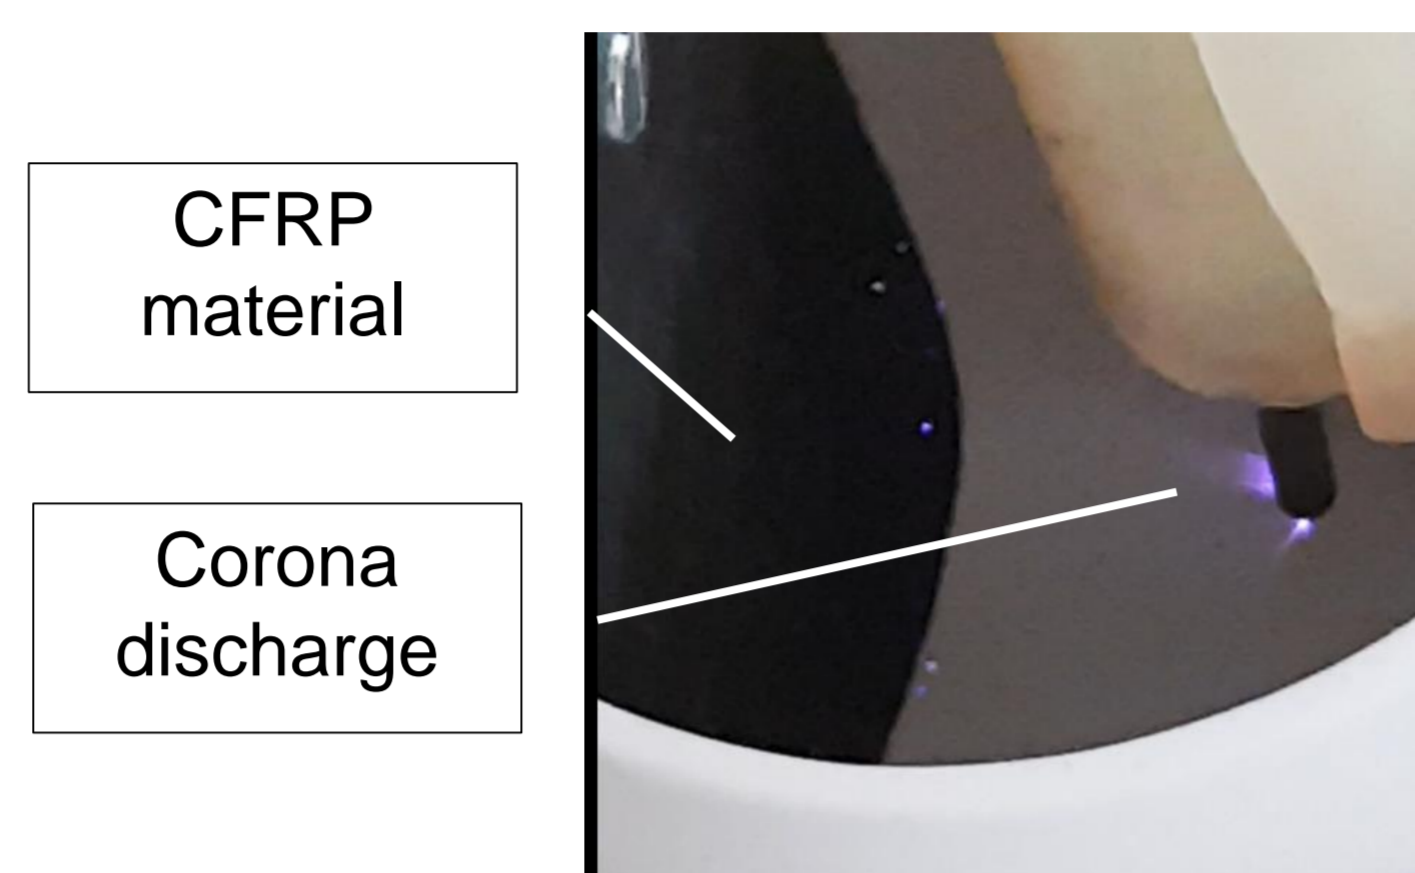
Laboratory test facility

Test facility includes heating unit (operating temperature up to 800°C). DC corona discharge is generated between needle high voltage (HV) electrode and CFRP material, which is fixed on a grounded electrode. Electrodes are installed inside a ceramic crucible.

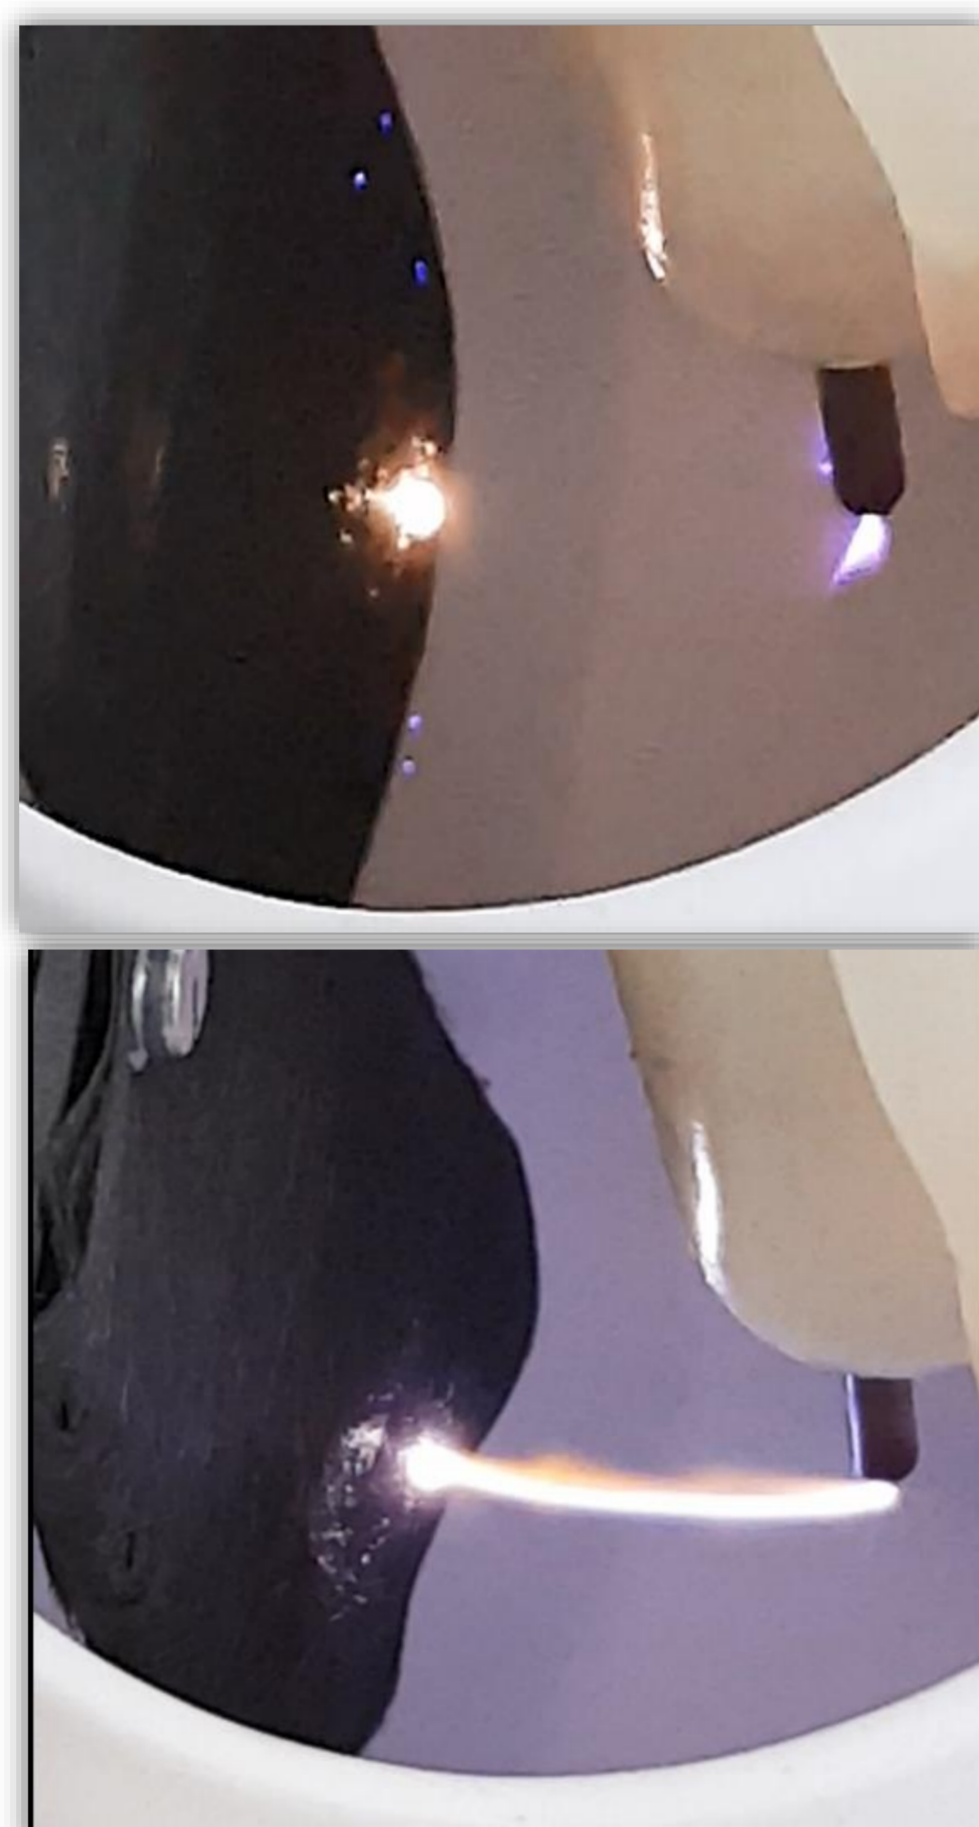
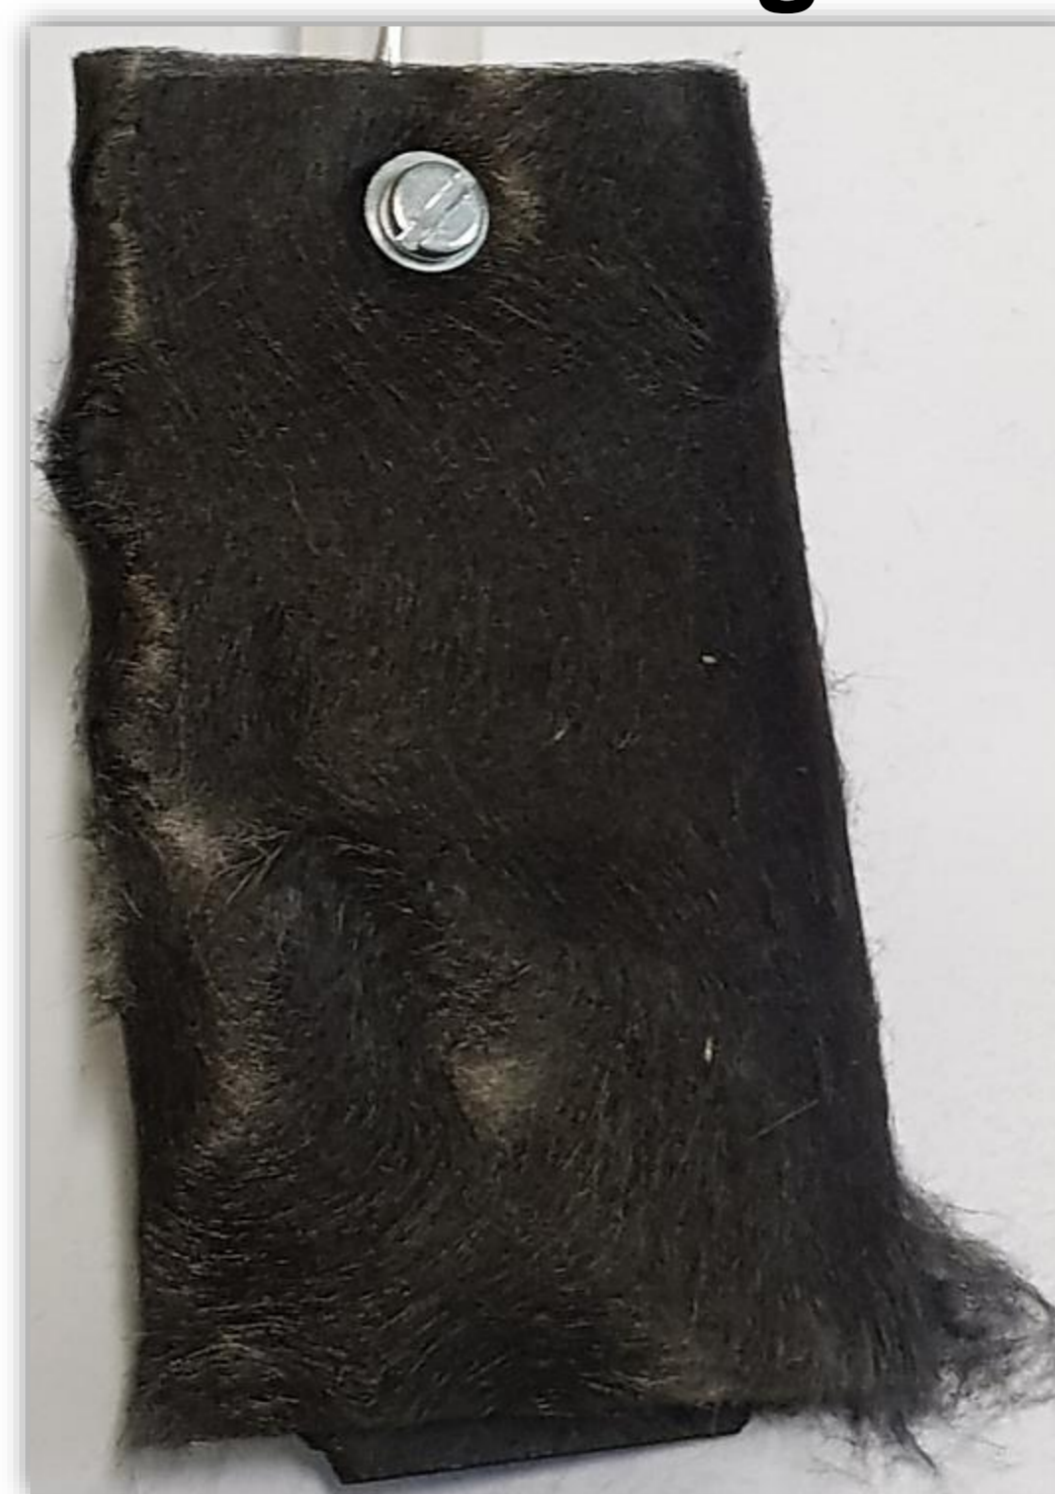
CFRP material before treatment

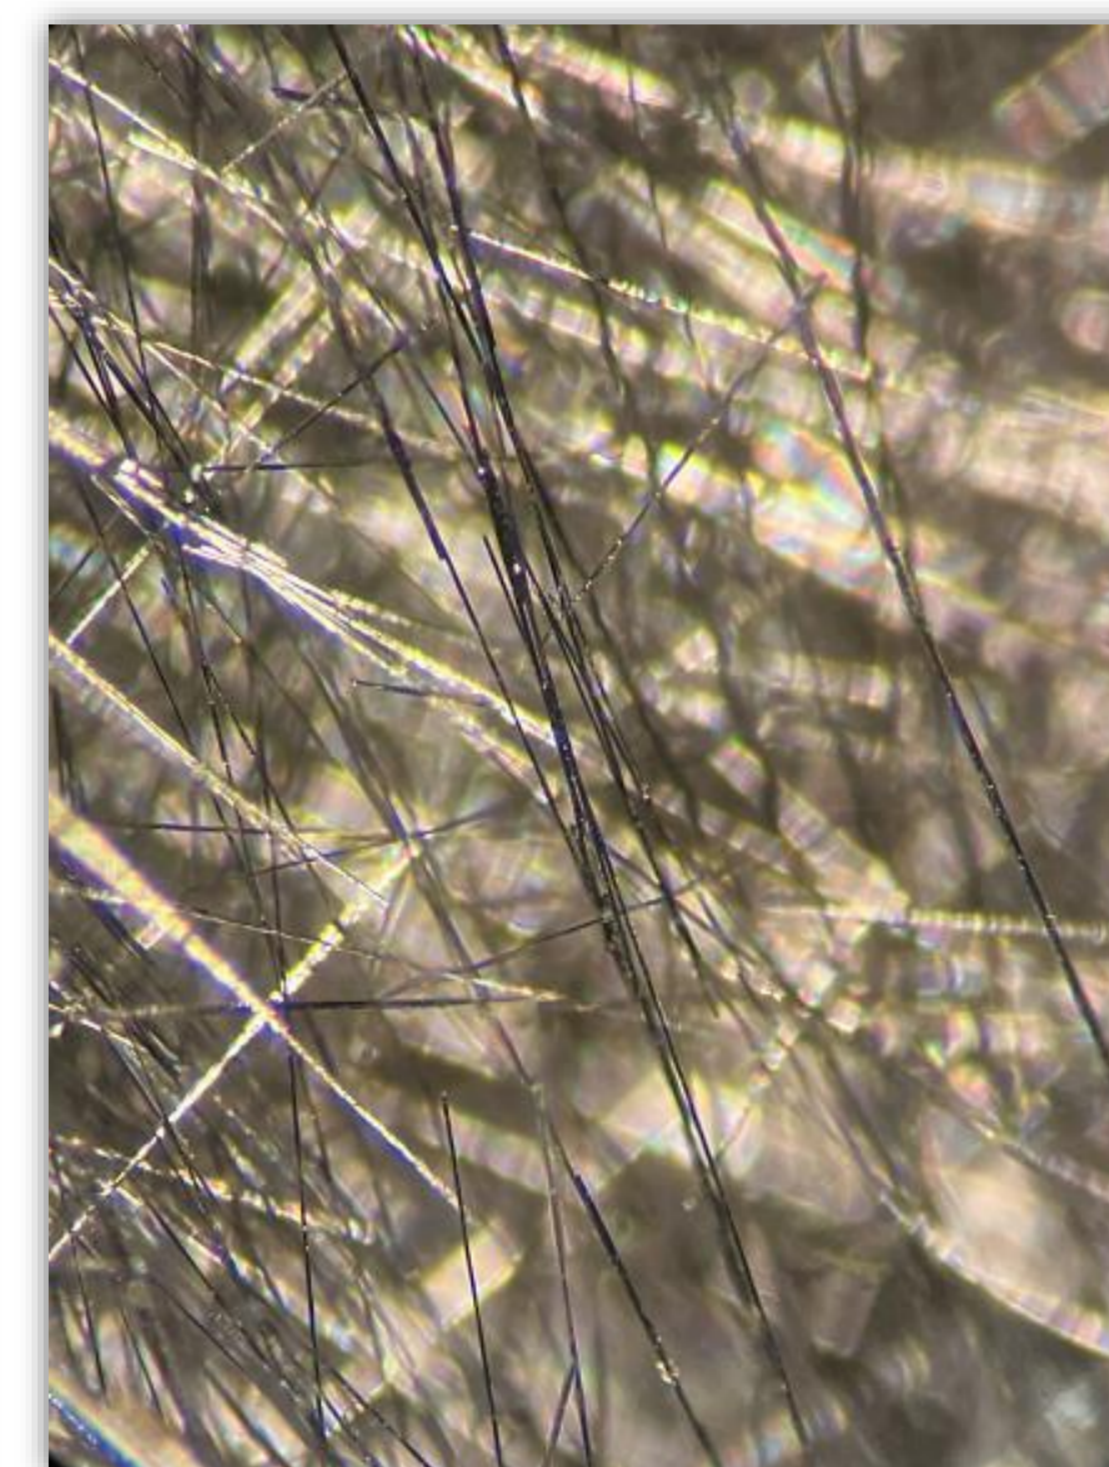
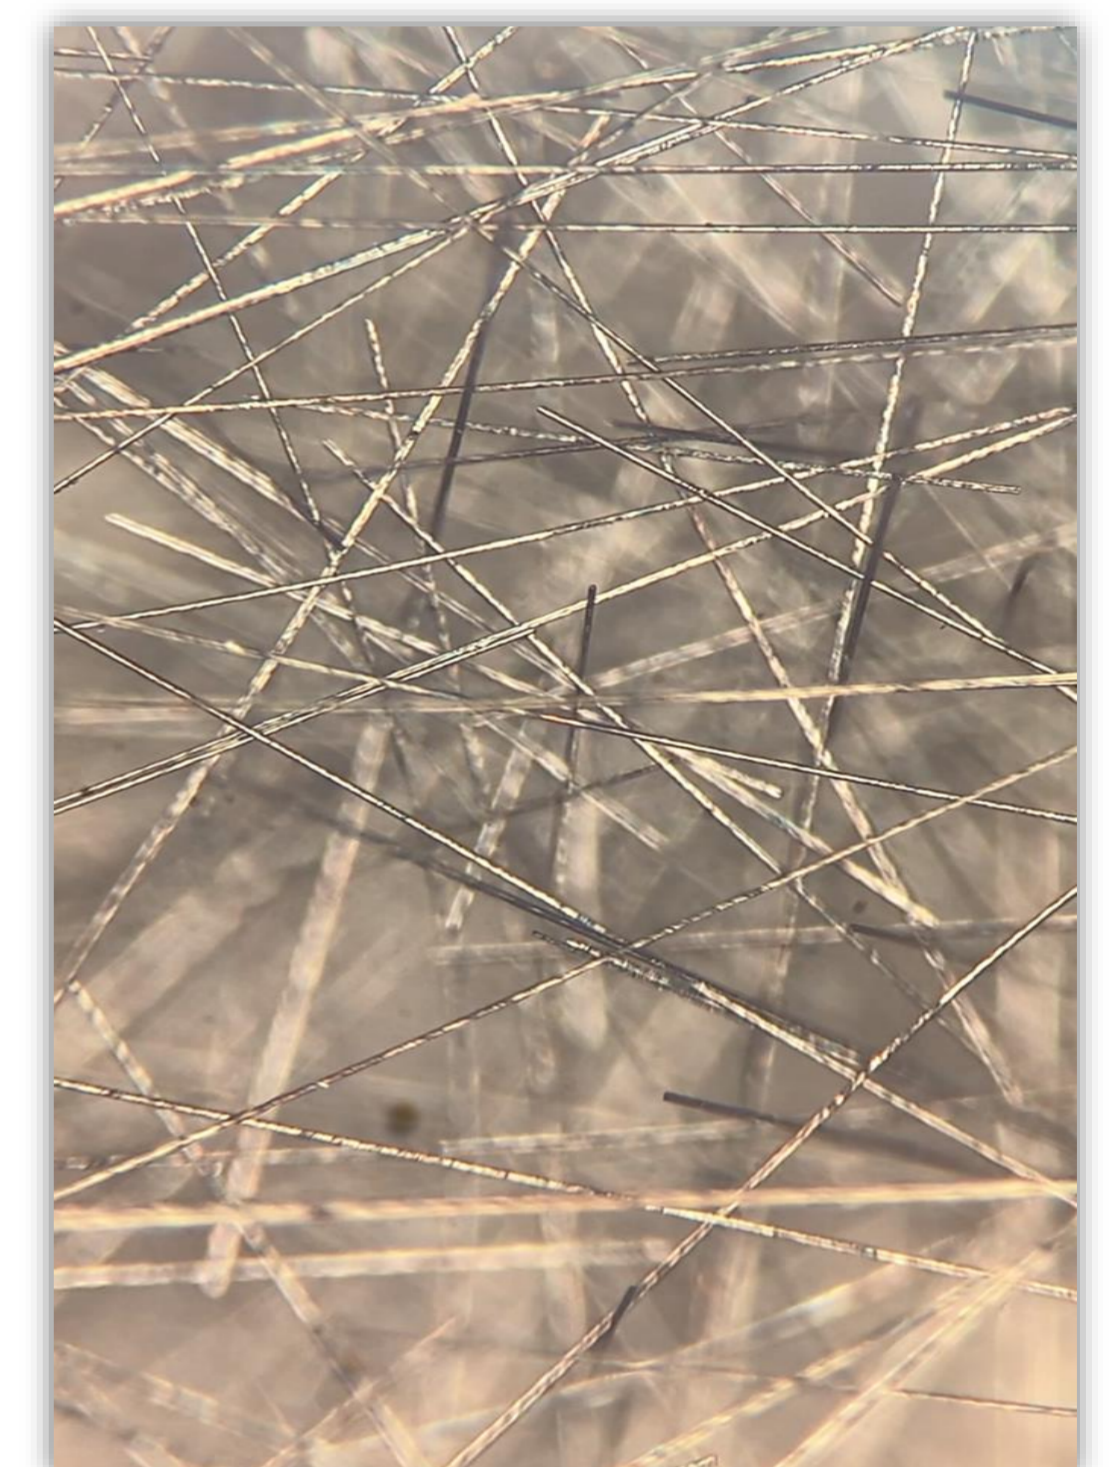
CFRP material after treatment

Degradation of carbon fibers!

- Back corona from CFRP, loss of structural stability and degradation of carbon fibres after treatment in a DC corona in air.
- In molten salt, CFRP matrix loses its' structural stability. Carbon fibres are homogeneously distributed inside the crucible.
- EHD phenomena during treatment in a DC corona discharge: carbon fibres free zone under HV electrode.
- No back corona is observed during the treatment of carbon fibers in molten salt.

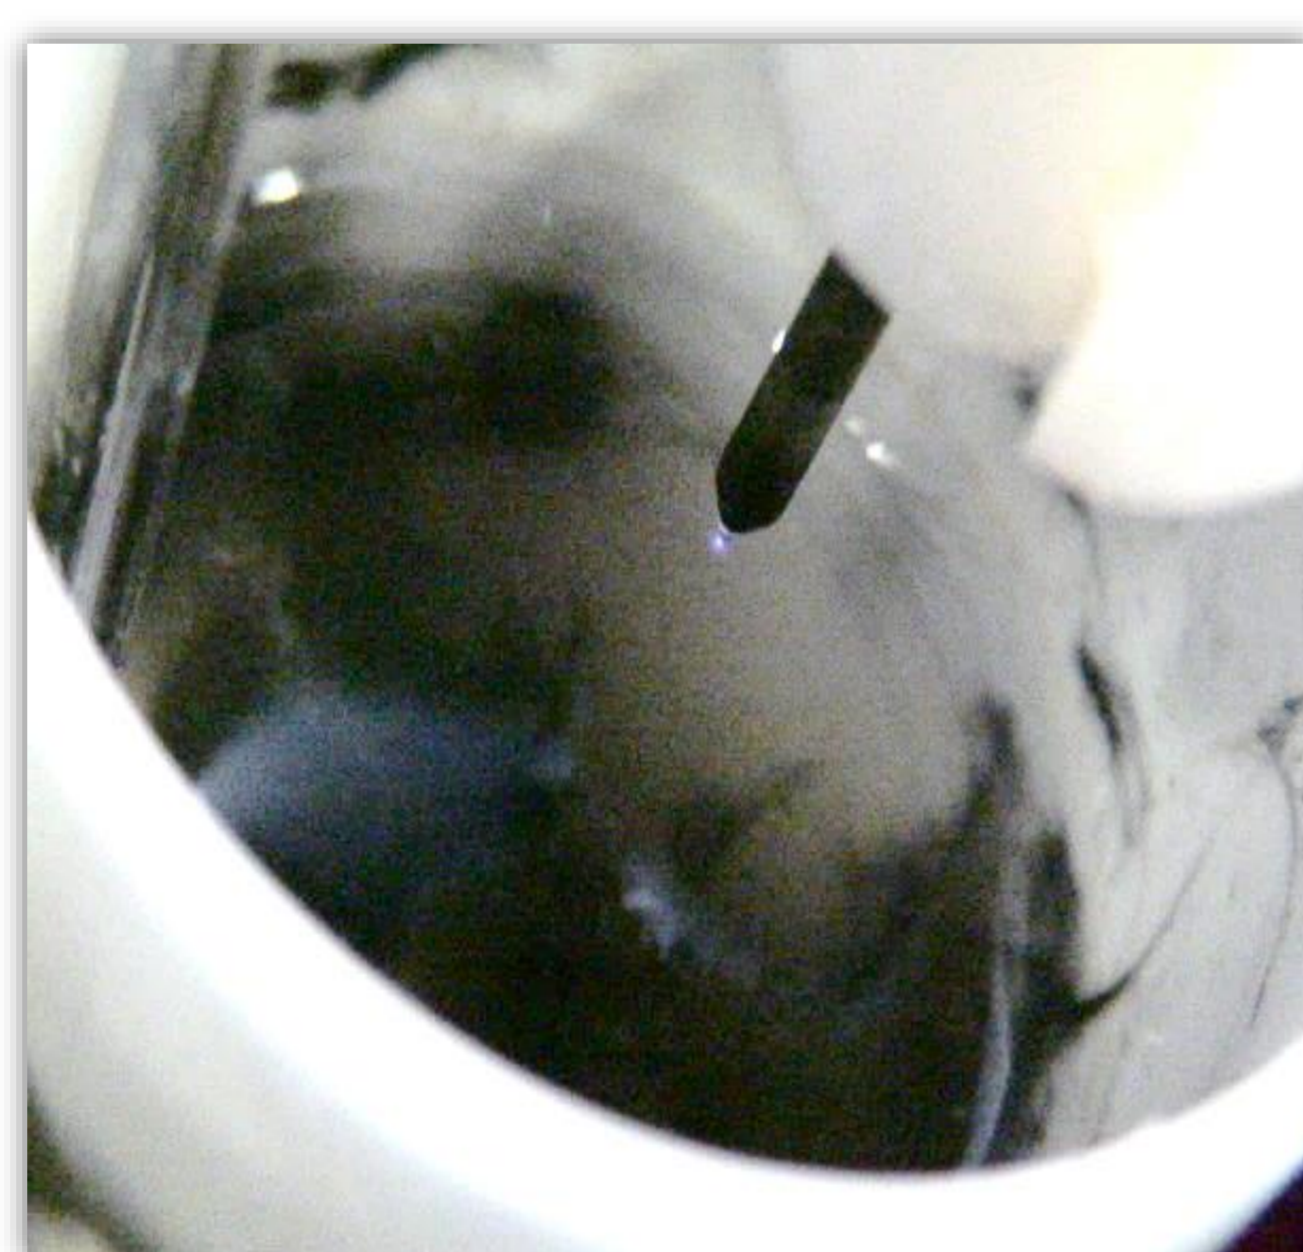
CFRP material before treatment

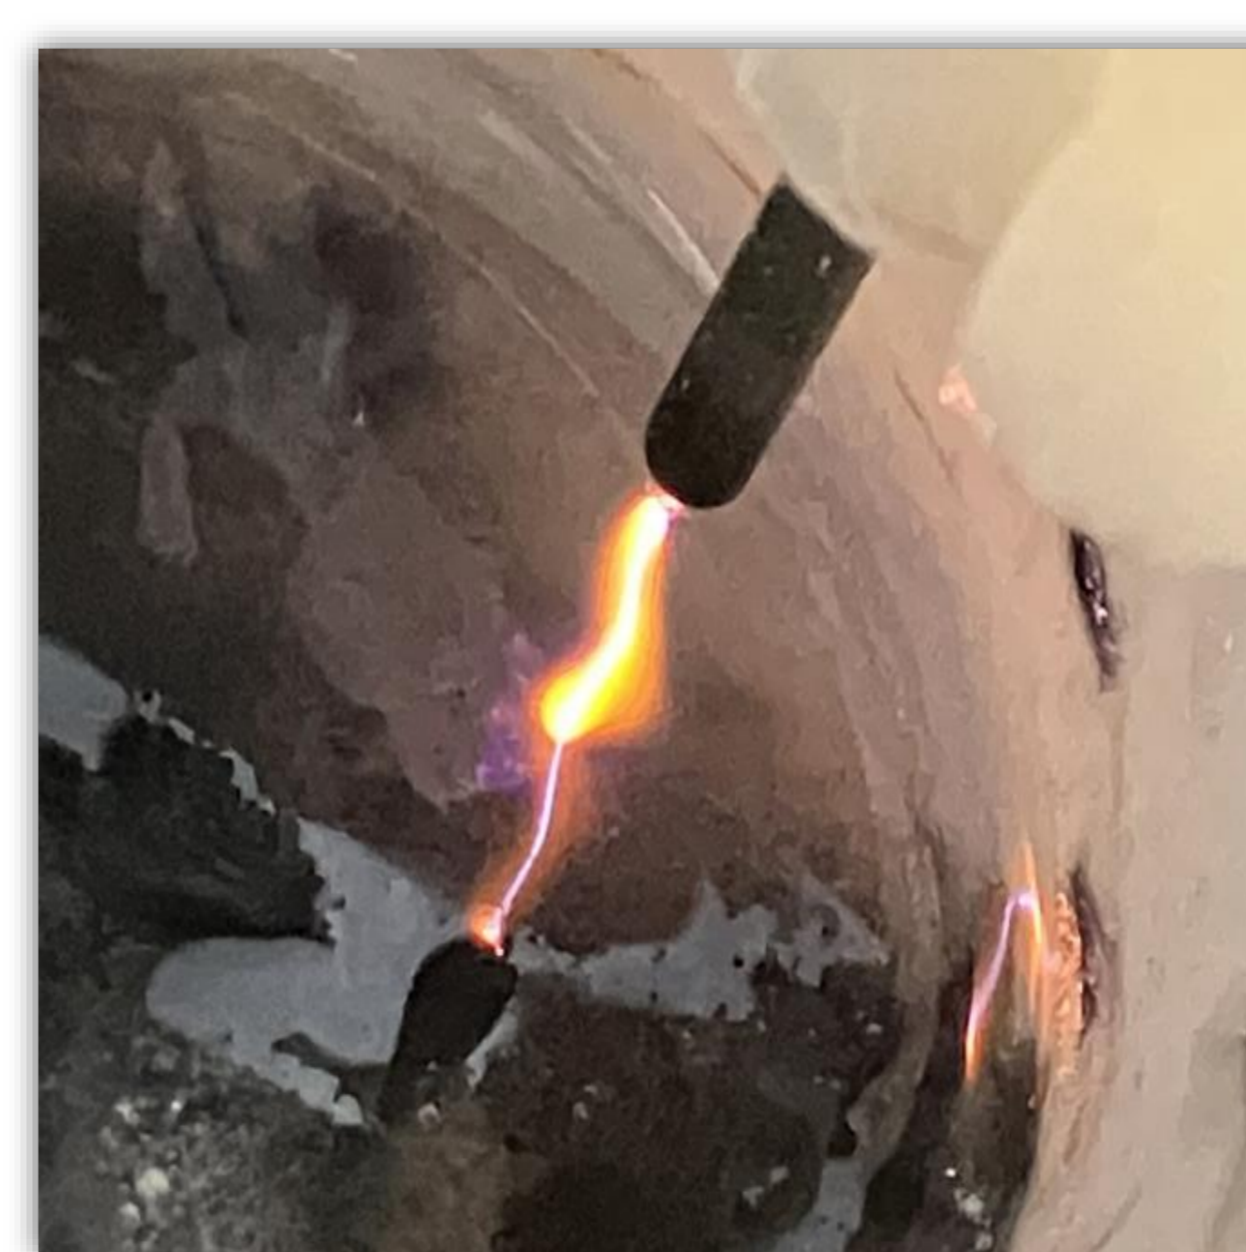
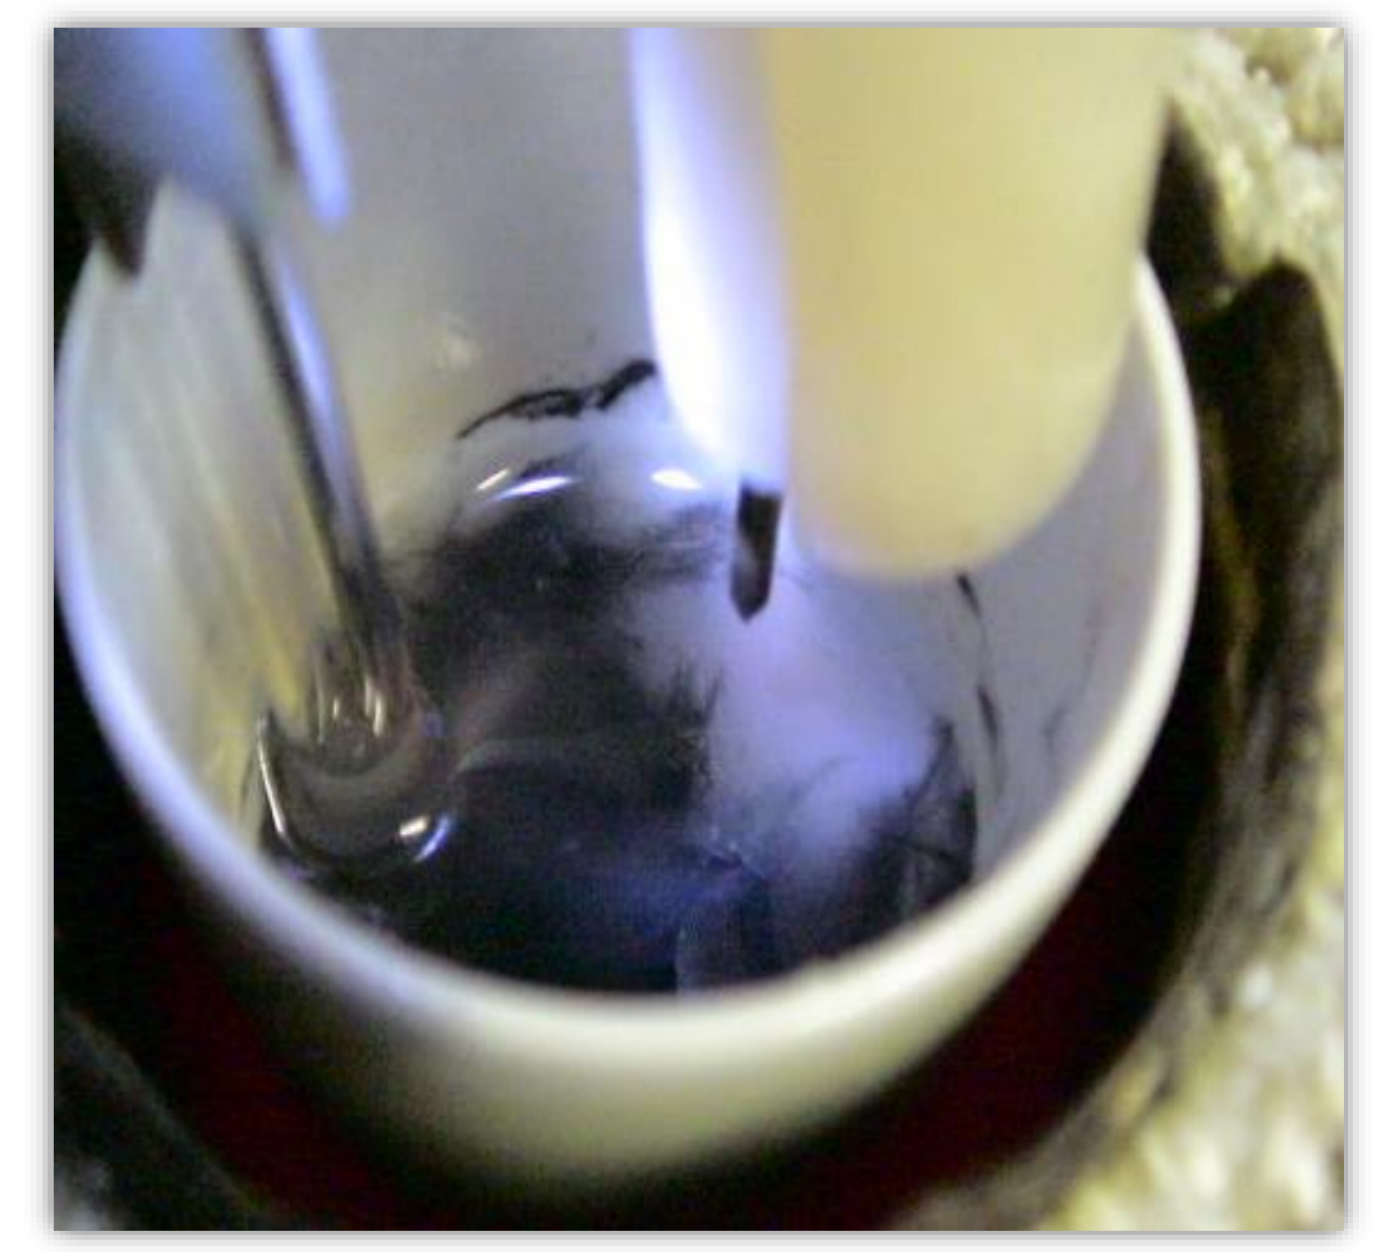
Corona discharge, spark-overs and EHD phenomena

No degradation of carbon fibers!
