Effect of ceramic breeder environment on low-cycle fatigue of EUROFER97

DISSERTATION

Dipl.-Ing. Elvina Gaisina

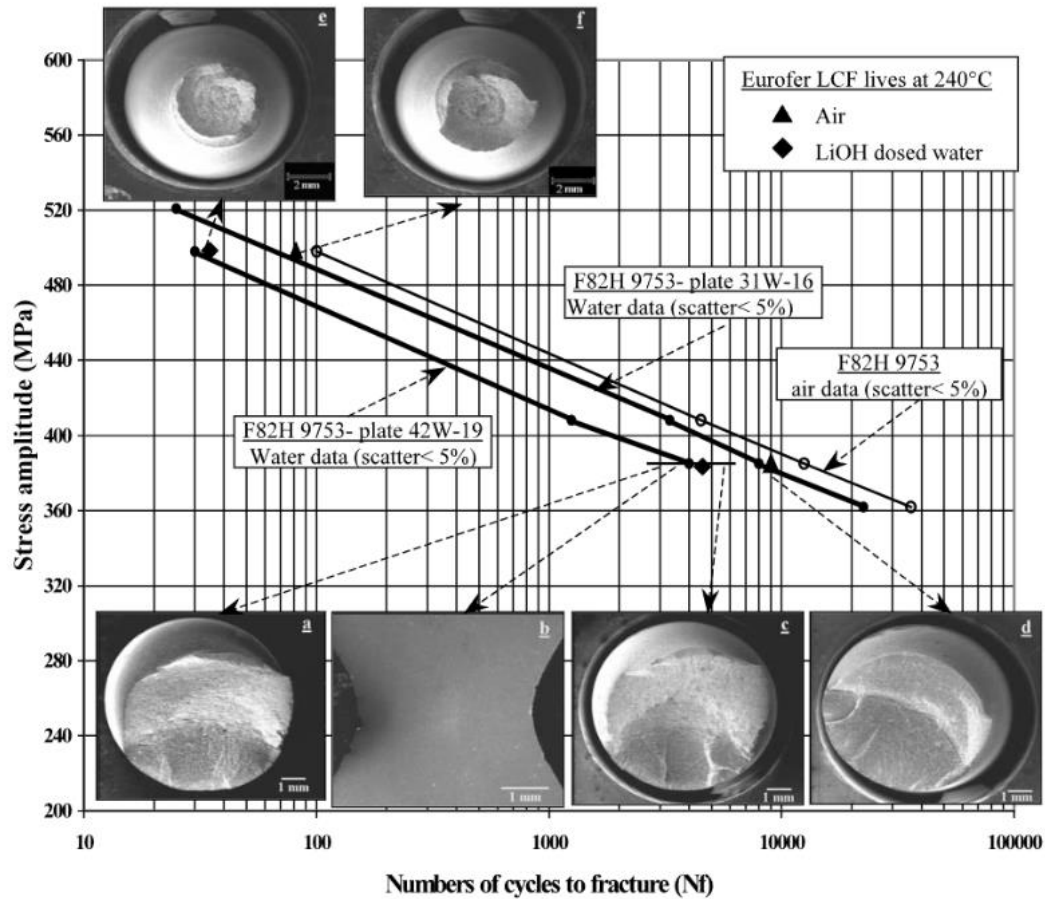
Fig. 2.10. Effect of testing environment at 240°C on number of cycles to failure of EUROFER97 and F82H steels with the corresponding fracture surfaces [31]

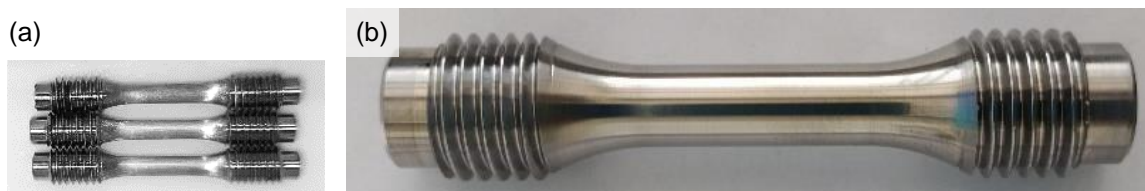
In order to gain insight into the mechanical behavior under cyclic loading of EUROFER97 exposed to the ceramic breeder environment, low-cycle fatigue testing was conducted on both sub-sized (Fig. 3.7a) and full-size standard (Fig. 3.7b) specimens. These specimens were manufactured from a heat-treated EUROFER97 steel plate and prepared according to their specific dimensions. The sub-sized specimens had a nominal diameter of 2 mm and a gauge length of 7.6 mm, with an overall length of 27 mm (A.1). The design of the sub-sized specimens was developed at the Karlsruhe Institute of Technology (KIT), Germany, within the framework of an irradiation program. The miniature geometry was chosen to enable the maximum number of samples to be exposed and tested during the first stage of the experiment. This facilitated the identification of trends in properties based on exposure time in the ceramic breeder environment. The standard specimens had a nominal diameter of 8.8 mm and a gauge length of 23 mm, with an overall length of 77 mm (A.1). The specimens were fabricated using a turning process and were polished to remove turning marks, thereby minimizing the impact of surface quality on the test results. The only difference in the final polishing of the specimens was that the sub-sized specimens were polished axially to eliminate any possible influence of radial scratches, while the standard specimens were polished conventionally in the radial direction.

Fig. 3.7 Low-cycle fatigue specimens: (a) sub-sized, (b) standard. Photographs are presented with the preservation of the original size ratio

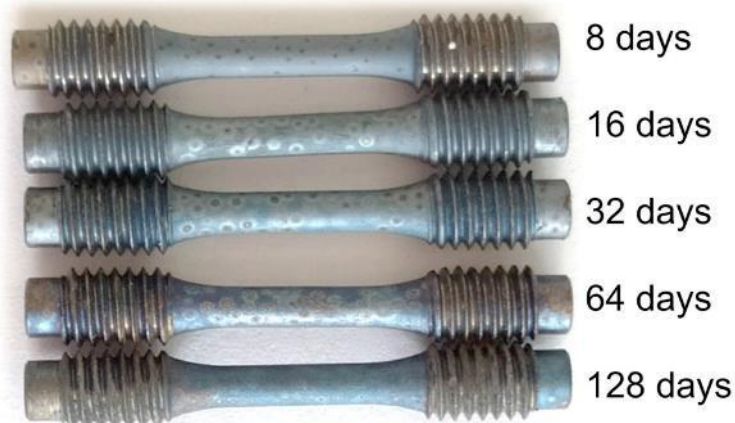
Fig. 4.1 illustrates the visual appearance of sub-sized LCF specimens of EUROFER97 after exposure to 550°C in contact with Li-ceramics pebbles in a purge gas flow atmosphere (ceramic breeder environment) [42,43]. The surface color of the specimens has been altered as a result of exposure. After 8 days of interaction, black dots corresponding to the contact zones (imprints) of ceramic pebbles can be observed. With prolonged exposure for 16–64 days, imprints become more evident as black dots encircled by a brighter region. After exposure for 128 days, imprints are barely visible.

Fig. 4.1. Sub-sized low cycle fatigue specimens of EUROFER97 after exposure to the ceramic breeder environment for different durations [43]

Fig. 4.54 illustrates the appearance of EUROFER97 specimens after additional exposure experiments. In the first experiment, the specimens were exposed to lithium-ceramics pebbles in vacuum for 64 days at 550°C [43]. Unlike the main experiment, the imprints of the lithium ceramics are barely visible and the sample has a brownish color (Fig. 4.54a). In the second experiment, the specimens were exposed to a purge gas atmosphere without the presence of ceramic pebbles at 550°C for 64 days. The specimen has a bluish color (Fig. 4.54b) that is similar to the specimens from the main experiment (Fig. 4.1).

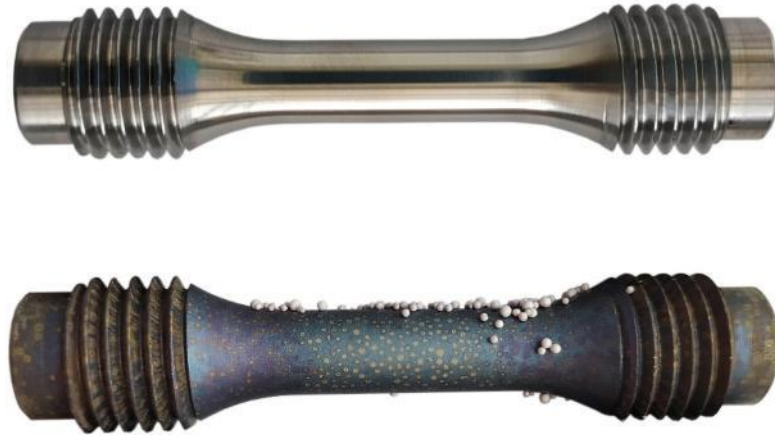
Fig. 4.40 depicts the appearance of standard specimens used in LCF tests in their as-received state and after exposure to the ceramic breeder environment for 64 days [46]. It should be noted that the surface of the standard specimens at the final stage of polishing was carried out radially, while the sub-sized specimens were polished axially (Fig. 4.2d), since the quality of surface preparation in the case of small specimens is obviously more important from the point of view of fatigue properties. After the exposure, the specimens displayed a bluish surface color resembling that of the sub-sized specimens shown in Fig. 4.1. The contact zones with the lithium-ceramics pebbles are clearly visible to the naked eye, revealing a portion of the pebbles that adhered to the surface during exposure (Fig. 4.40). These pebbles are easily dislodged from

the surface and were manually removed before conducting the fatigue test without affecting the corrosion layer. Additionally, the distance between the contact zones again represents the average diameter of the pebbles. As the standard specimens are much larger in size, the number of imprints of lithium ceramics is proportionally higher than that of sub-sized specimens.

Fig. 4.40. Standard ($\varnothing 8.8$ mm) LCF samples made of EUROFER97 in the as-received state (top) and after exposure to the ceramic breeder environment for 64 days (bottom) [46]

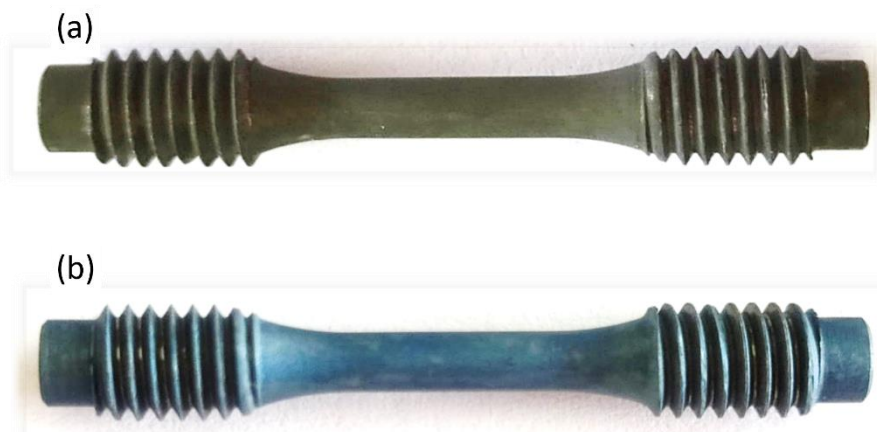
Fig. 4.54. LCF specimens of EUROFER97 for additional experiments: (a) after exposure to Li-ceramics pebbles in vacuum for 64 days, (b) after exposure to a purge gas atmosphere for 64 days [43]

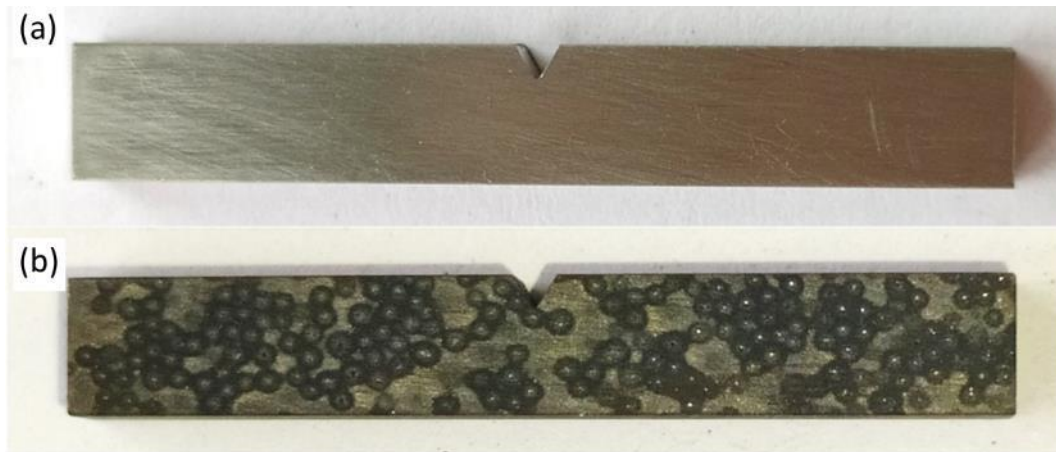
The Charpy impact test is considered one of the most sensitive methods for detecting various types of material embrittlement. To this end, sub-sized Charpy specimens of EUROFER97 were exposed to lithium-ceramics pebbles in a purge gas atmosphere for 64 days (Fig. 4.66). For comparison, specimens in their original state were also tested, alongside specimens exposed to vacuum (without ceramic pebbles) for the same duration of 64 days. The experiments were performed at temperatures ranging from -120 to -50°C .

Fig. 4.66. Charpy impact test specimens (a) before and (b) after exposure to the ceramic breeder environment for 64 days
