# 2021 Inspection of Enguri Pressure Tunnel Reveals Unexpected Insights for the Seismicity after Reservoir Impoundment in 1978

Thomas Niederhuber<sup>1</sup>, Nino Tsereteli<sup>2</sup>, Mirian Kalabegishvili<sup>3</sup>, Thomas Röckel<sup>4</sup>, Bernd Aberle<sup>5</sup>, Birgit I.R. Müller<sup>1</sup>, Frank R. Schilling<sup>1</sup>

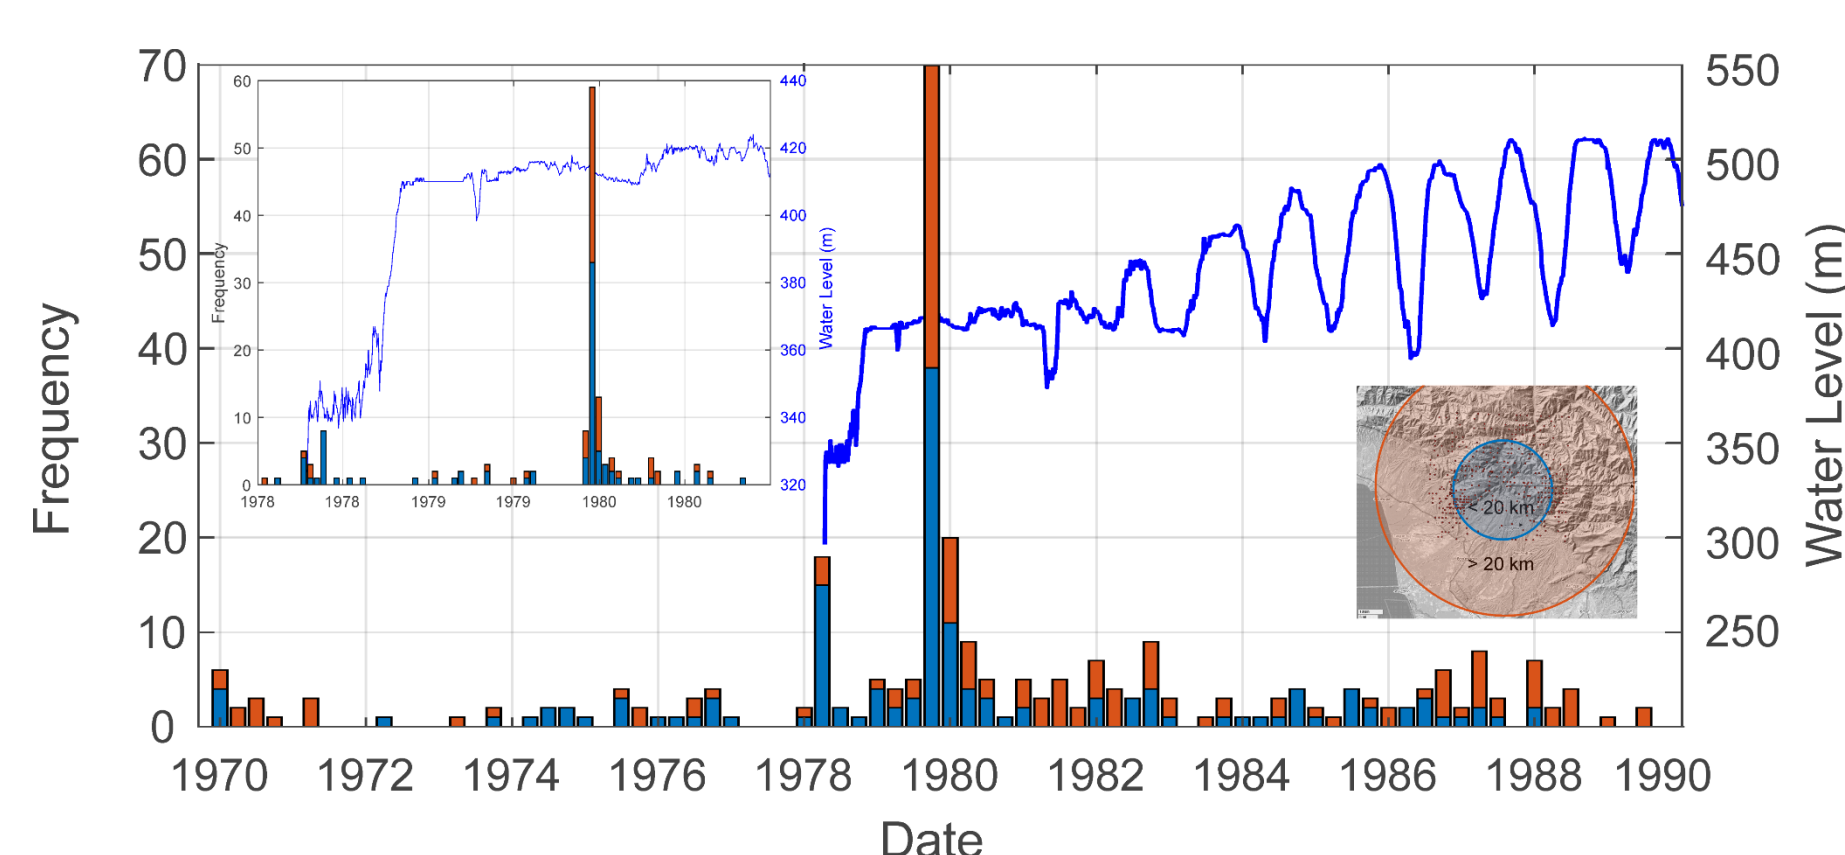
Histogram of seismicity and water level around reservoir impoundment (with respect to m.s.l.) in the Jvari reservoir. Blue circle and histogram color denote 20 km radius, orange circle and histogram color 50 km radius around dam.

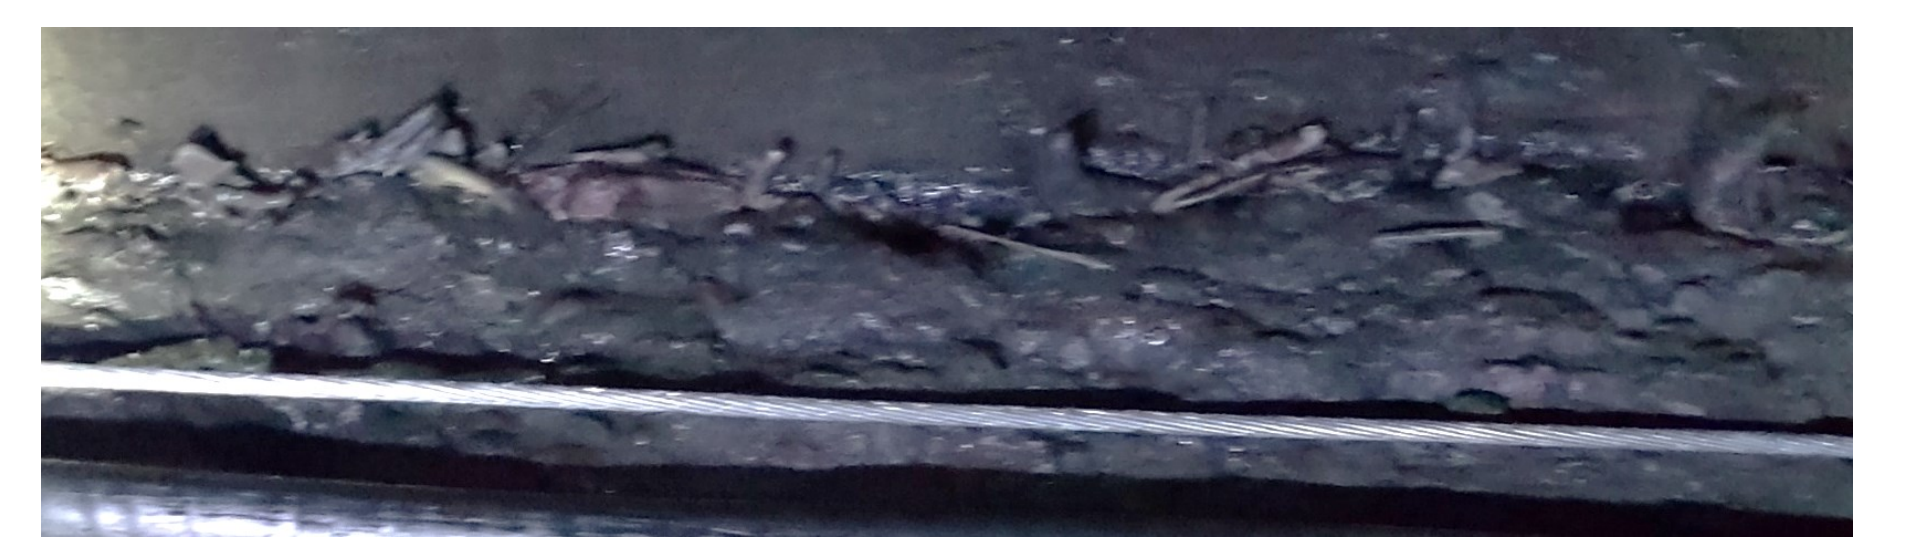
Part of a 40 m long open construction joint found at km 13.7 in the pressure tunnel. In this tunnel section, mud, larger fish and pieces of wood and plastic got stuck (Photo B. Aberle).

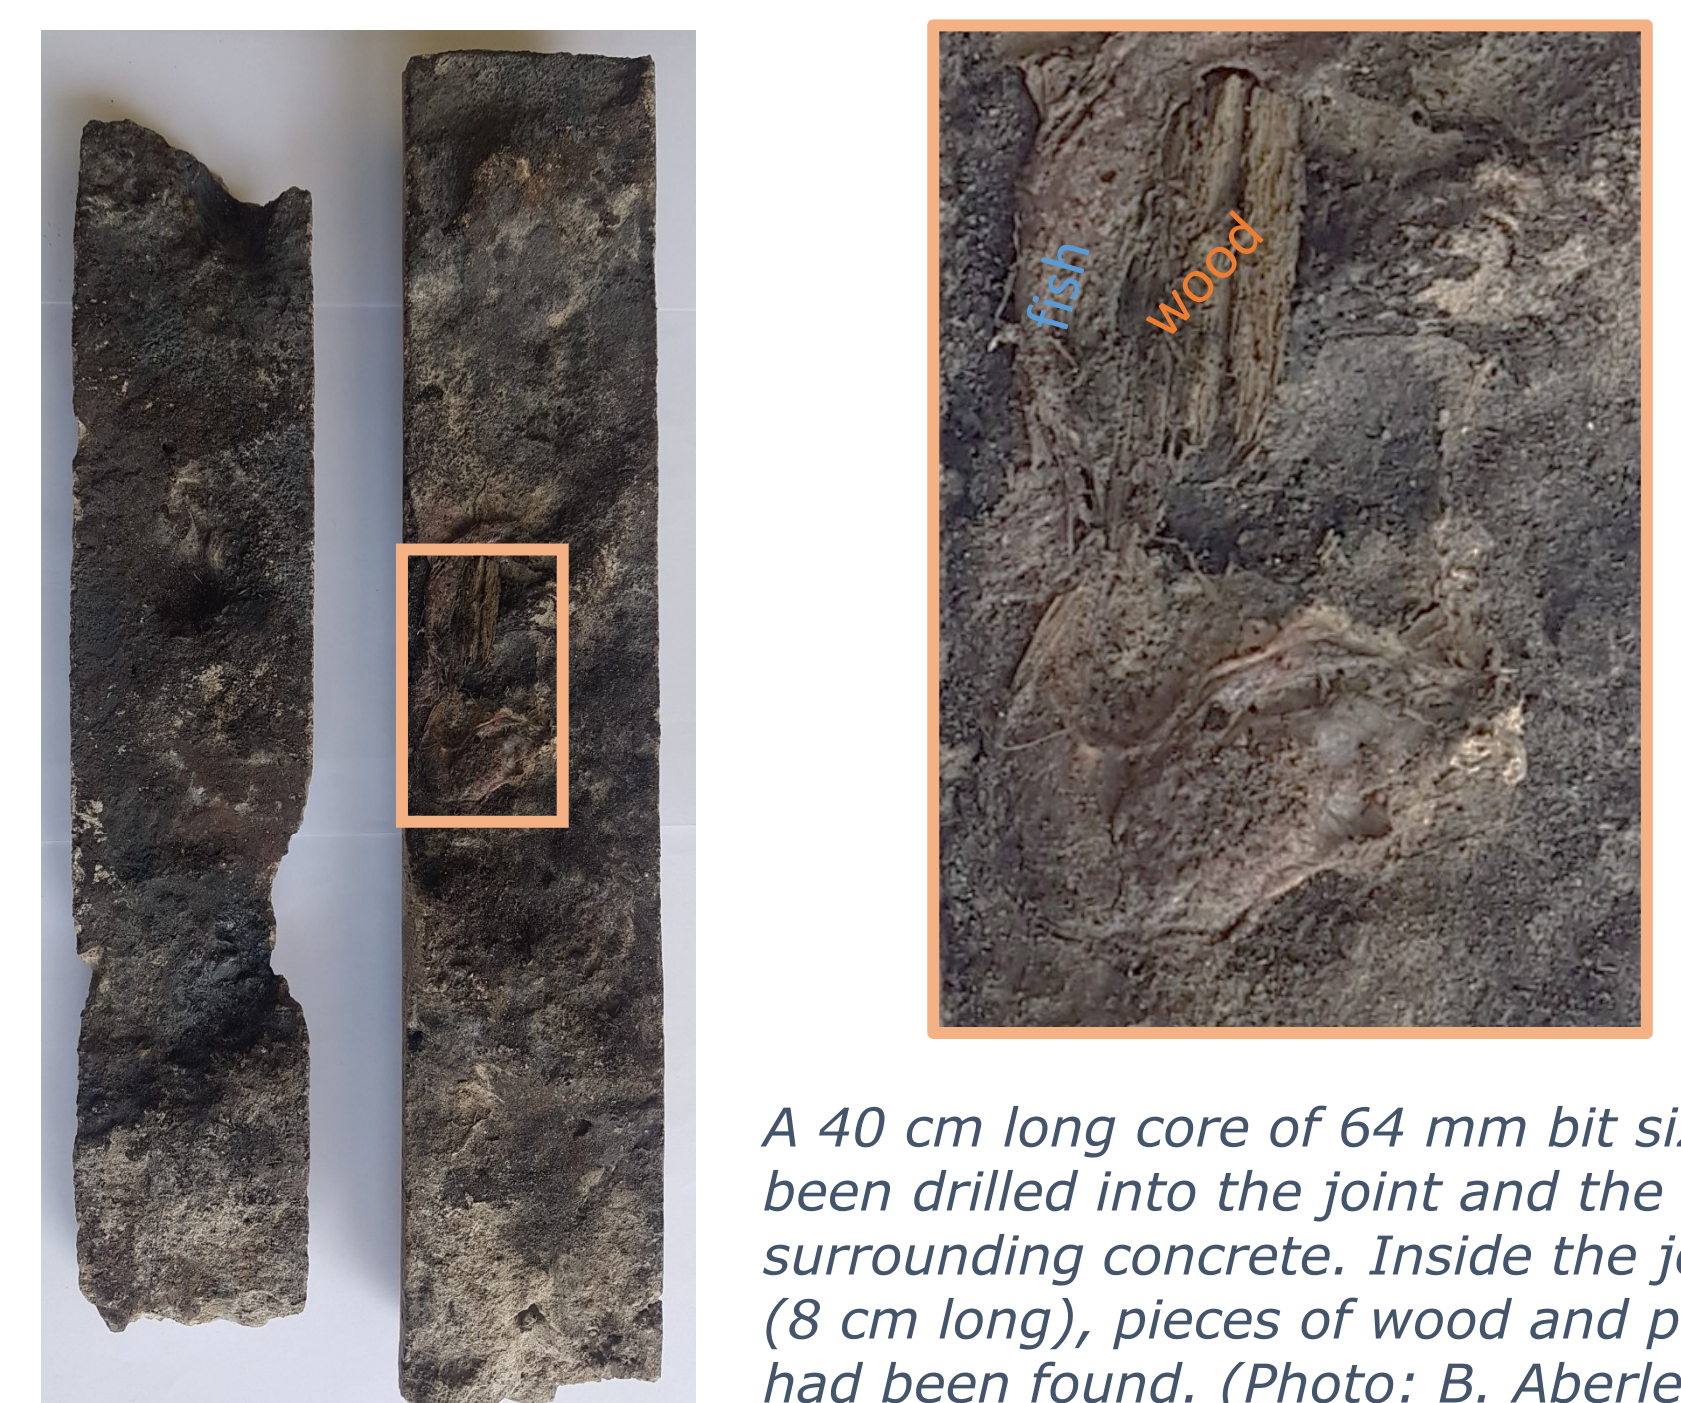
A 40 cm long core of 64 mm bit size had been drilled into the joint and the surrounding concrete. Inside the joint fish (8 cm long), pieces of wood and plastic had been found. (Photo: B. Aberle).
