Secondary Hydrogenation of Zircaloy-4 Cladding Tubes During LOCA Bundle Tests Performed at KIT.

C. Roessger J. Stuckert, M. Grosse, M. Steinbrueck

Institute for Applied Materials, IAM-WPT, IAM-AWP; Program NUKLEAR

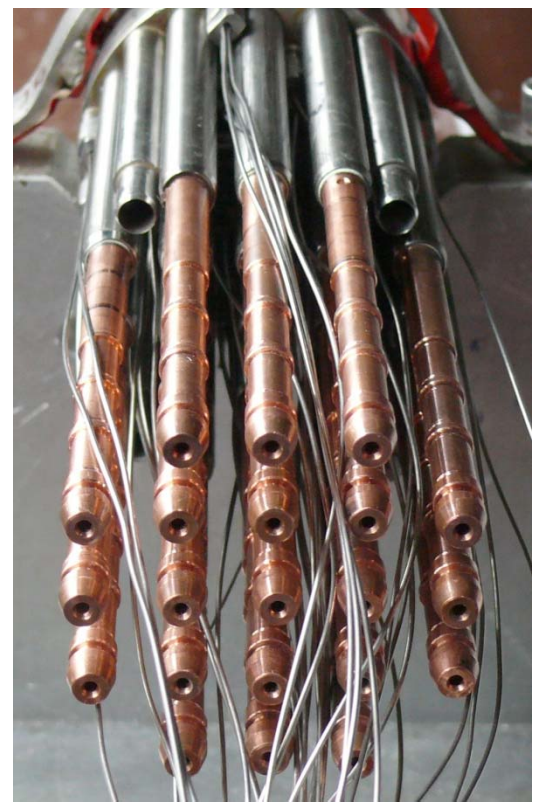
Copper electrodes

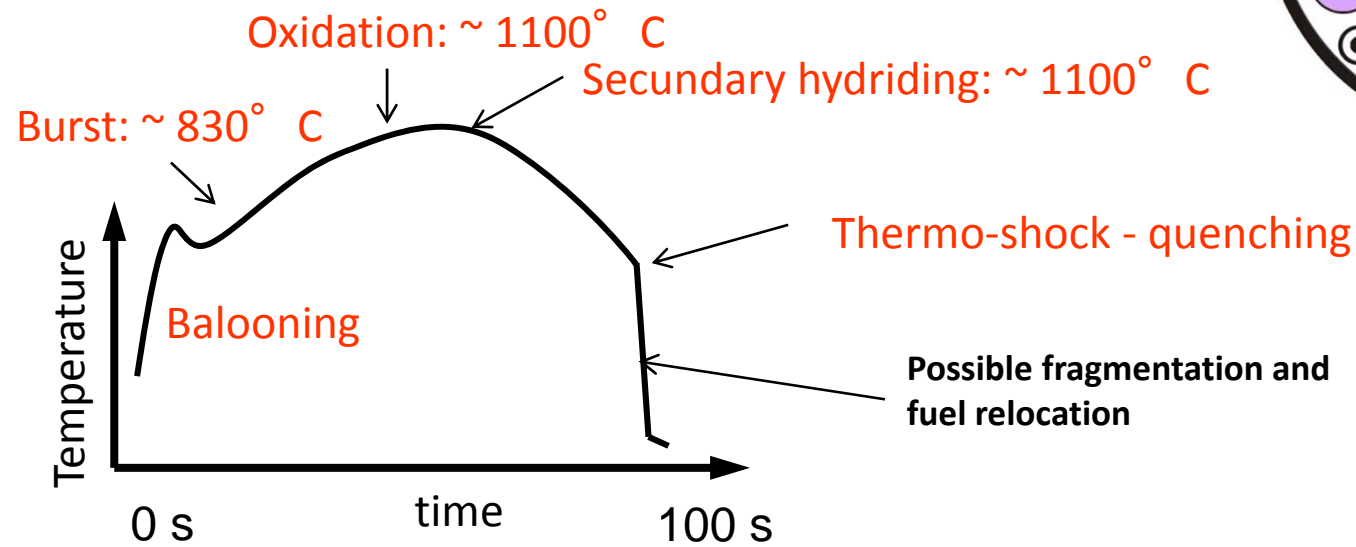
Cladding temperature evolution during a loss of coolant accident (LOCA)

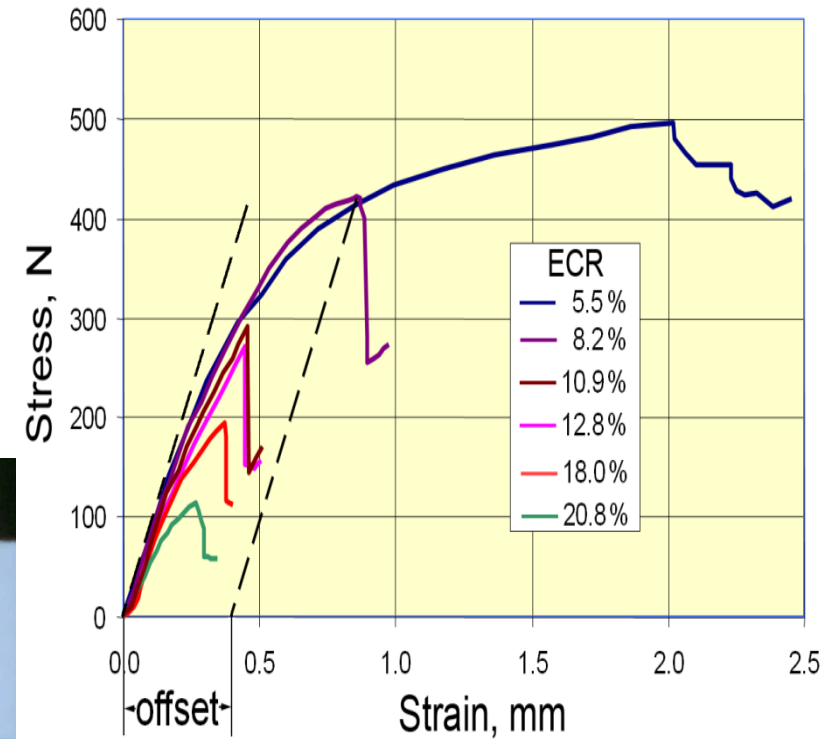
ANL ring compression tests: Embrittlement occurs when permanent plastic deformation (offset strain) $d/D < 2\%$

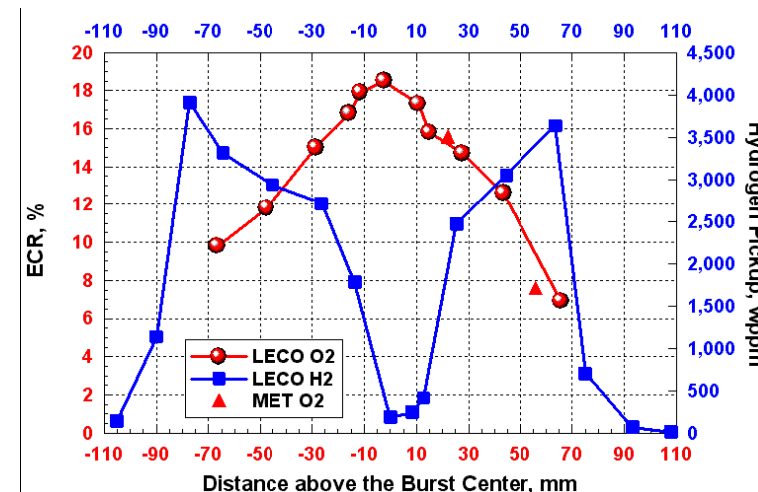
ECR criteria is not conservative
if the local hydrogen concentration is
above 500 wt.ppm

M. Billone et al.
NUREG/CR-6967/ANL-07/04
