Update of the QUENCH Program

M. Steinbrück, M. Große, L. Sepold, J. Stuckert
Forschungszentrum Karlsruhe

*Cooperative Severe Accident Research Program Meeting (CSARP)
Bethesda, ML, 15-17 September, 2009*

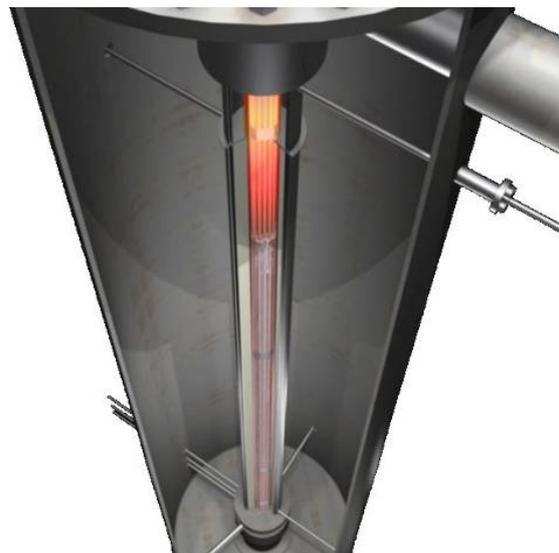
QUENCH-14 and QUENCH-15

- Bundle tests with M5[®] and ZIRLO[™] claddings in the frame of QUENCH-ACM
- Test protocol identical to reference test QUENCH-06 with Zry-4 cladding (OECD ISP-45)
- Conducted at 2 July 2008 and 27 May 2009
- ➔ First analyses of results indicate a similar global bundle behaviour of QUENCH-14/-15 and QUENCH-06

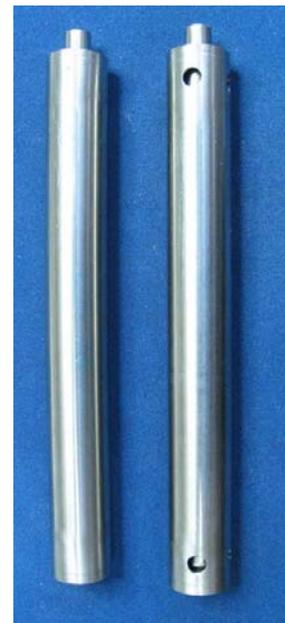
AgInCd control rod tests in the QUENCH-SR rig

- Four tests retracing temperature history of 950 mm elevation in QUENCH-13
 - with and w/o inner oxidation of Zry-4 guide tube
 - with and w/o initial contact between Zry-4 and SS tubes
- One test retracing temperature history of 750 mm elevation in QUENCH-13
 - asymmetric, with holes
- One test without Zry-4 guide tube
