# Results of the reference bundle test QUENCH-L1 with Zircaloy-4 claddings and future planning of the QUENCH-LOCA program

J. Stuckert, C. Rössger, M. Walter, M. Große, M. Steinbrück

*QWS18, Karlsruhe 2012*

Institute for Applied Materials; Program NUKLEAR

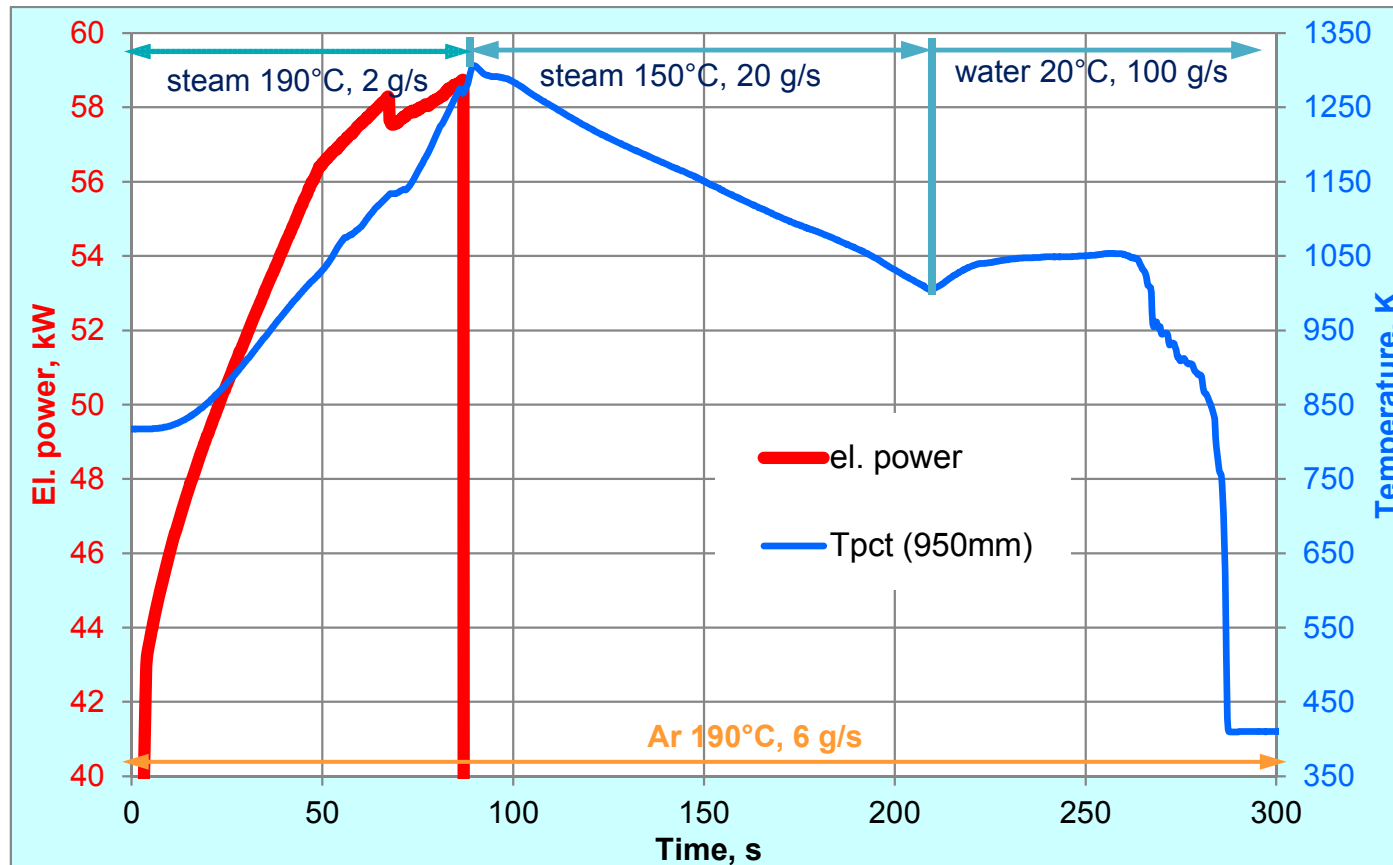
## Scenario of the QUENCH-L1 test

maximal reached power:  
 QUENCH-L1 (Ta-heaters, Ø 6 mm): 58.5 kW,  
 QUENCH-L0 (W-heaters; Ø 6 mm): 43 kW

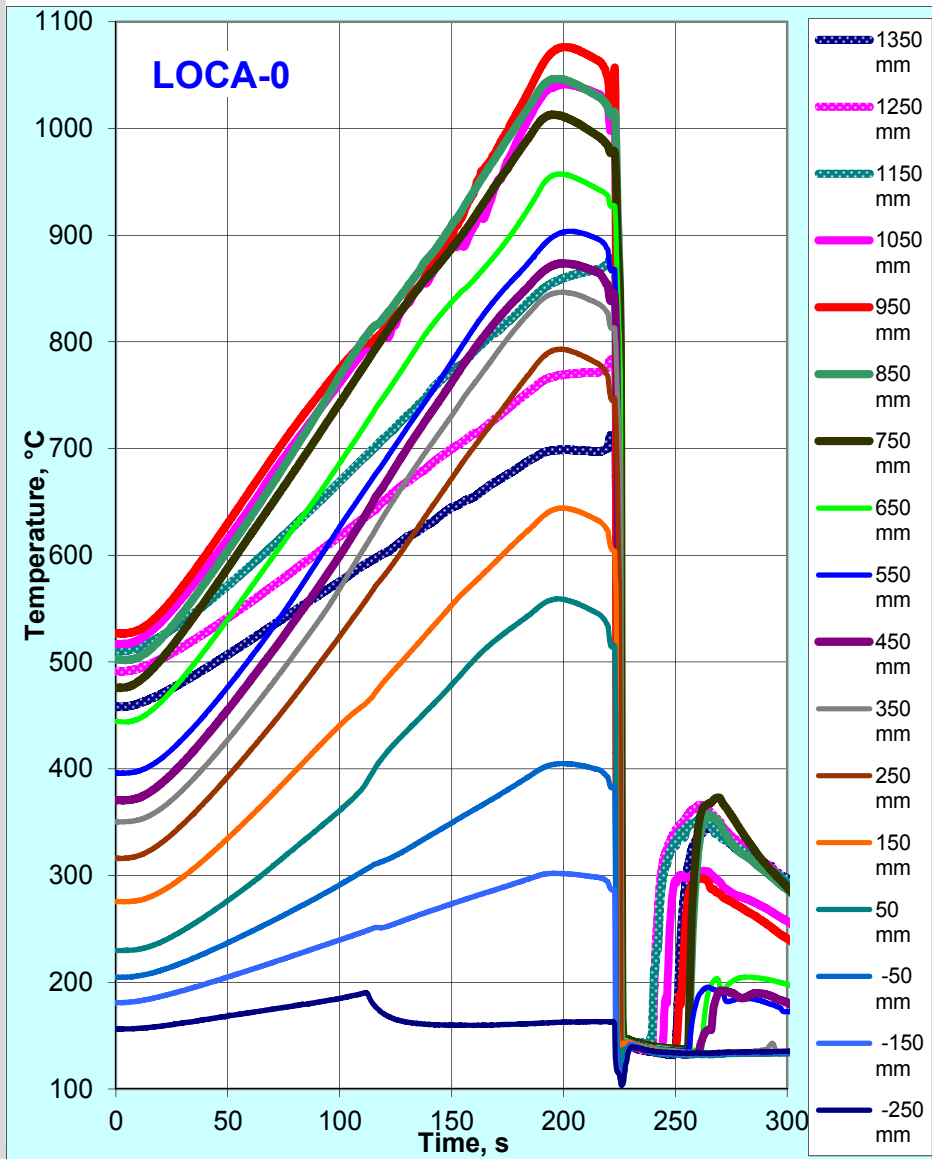
# Comparison of maximal cladding temperatures at different elevations for QUENCH-L0 and -L1

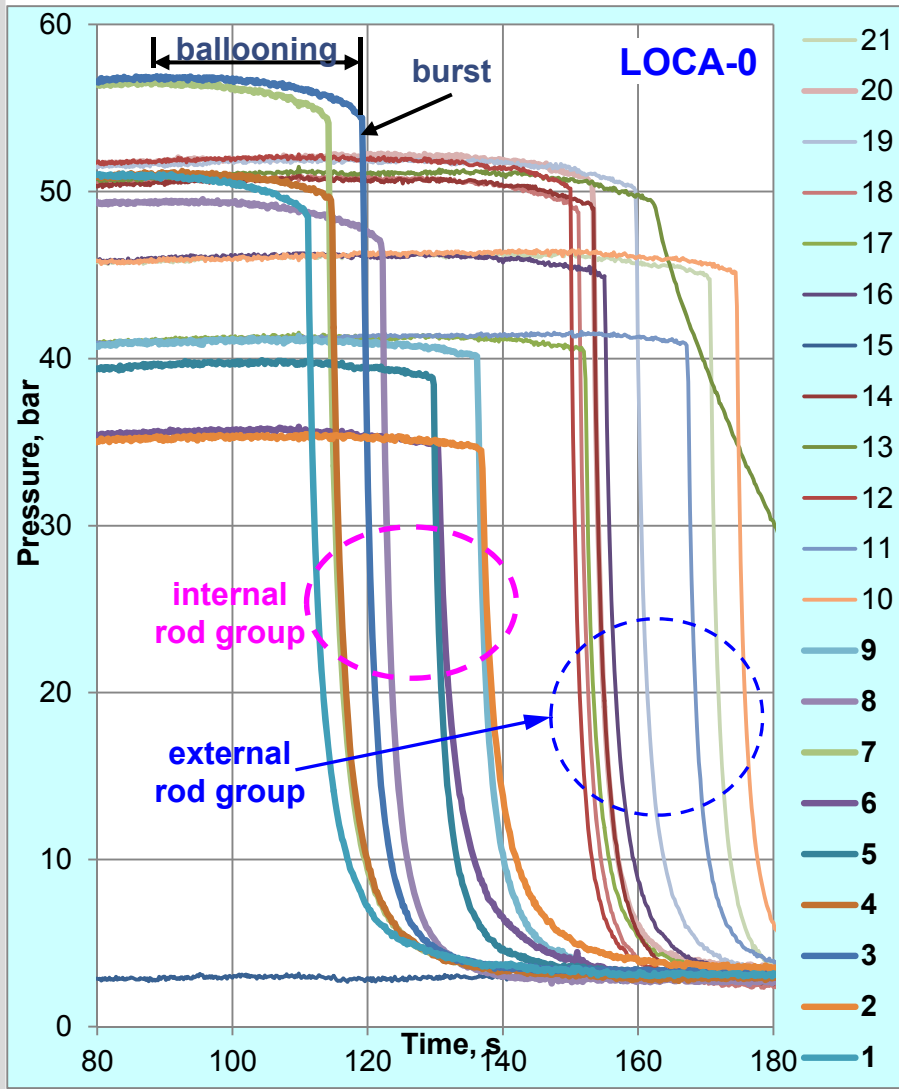
# Rod pressure evolution during heating phase for QUENCH-L0 and -L1: burst time indication (coincided with MS results on Kr release)

duration of decrease of the inner pressure to the system pressure:  $\tau_0 \approx 38$  s

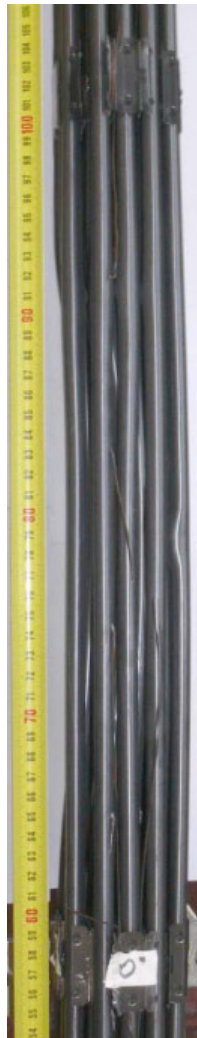
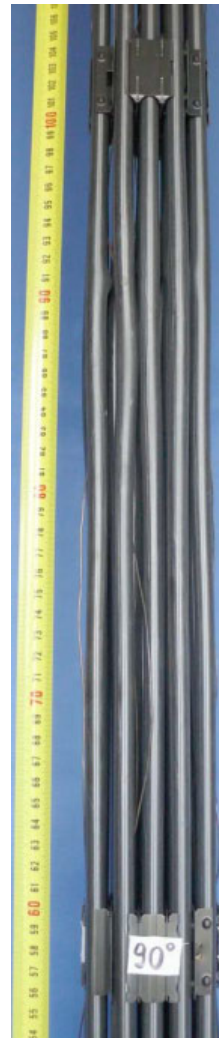
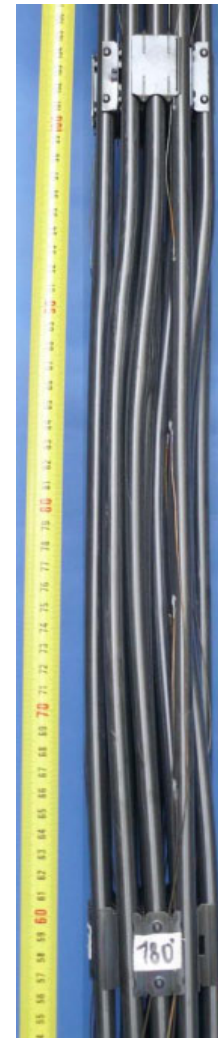
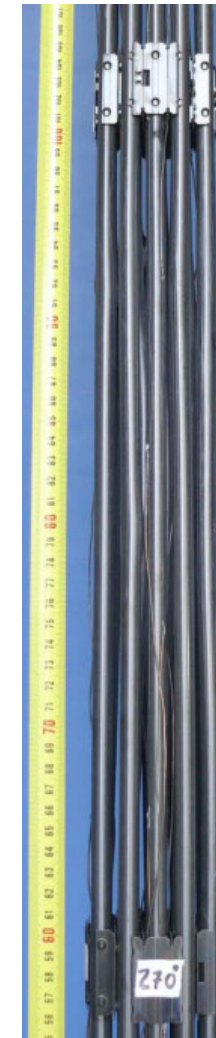
# Post-test QL1 bundle view between GS3 and GS4

180°: rod bending

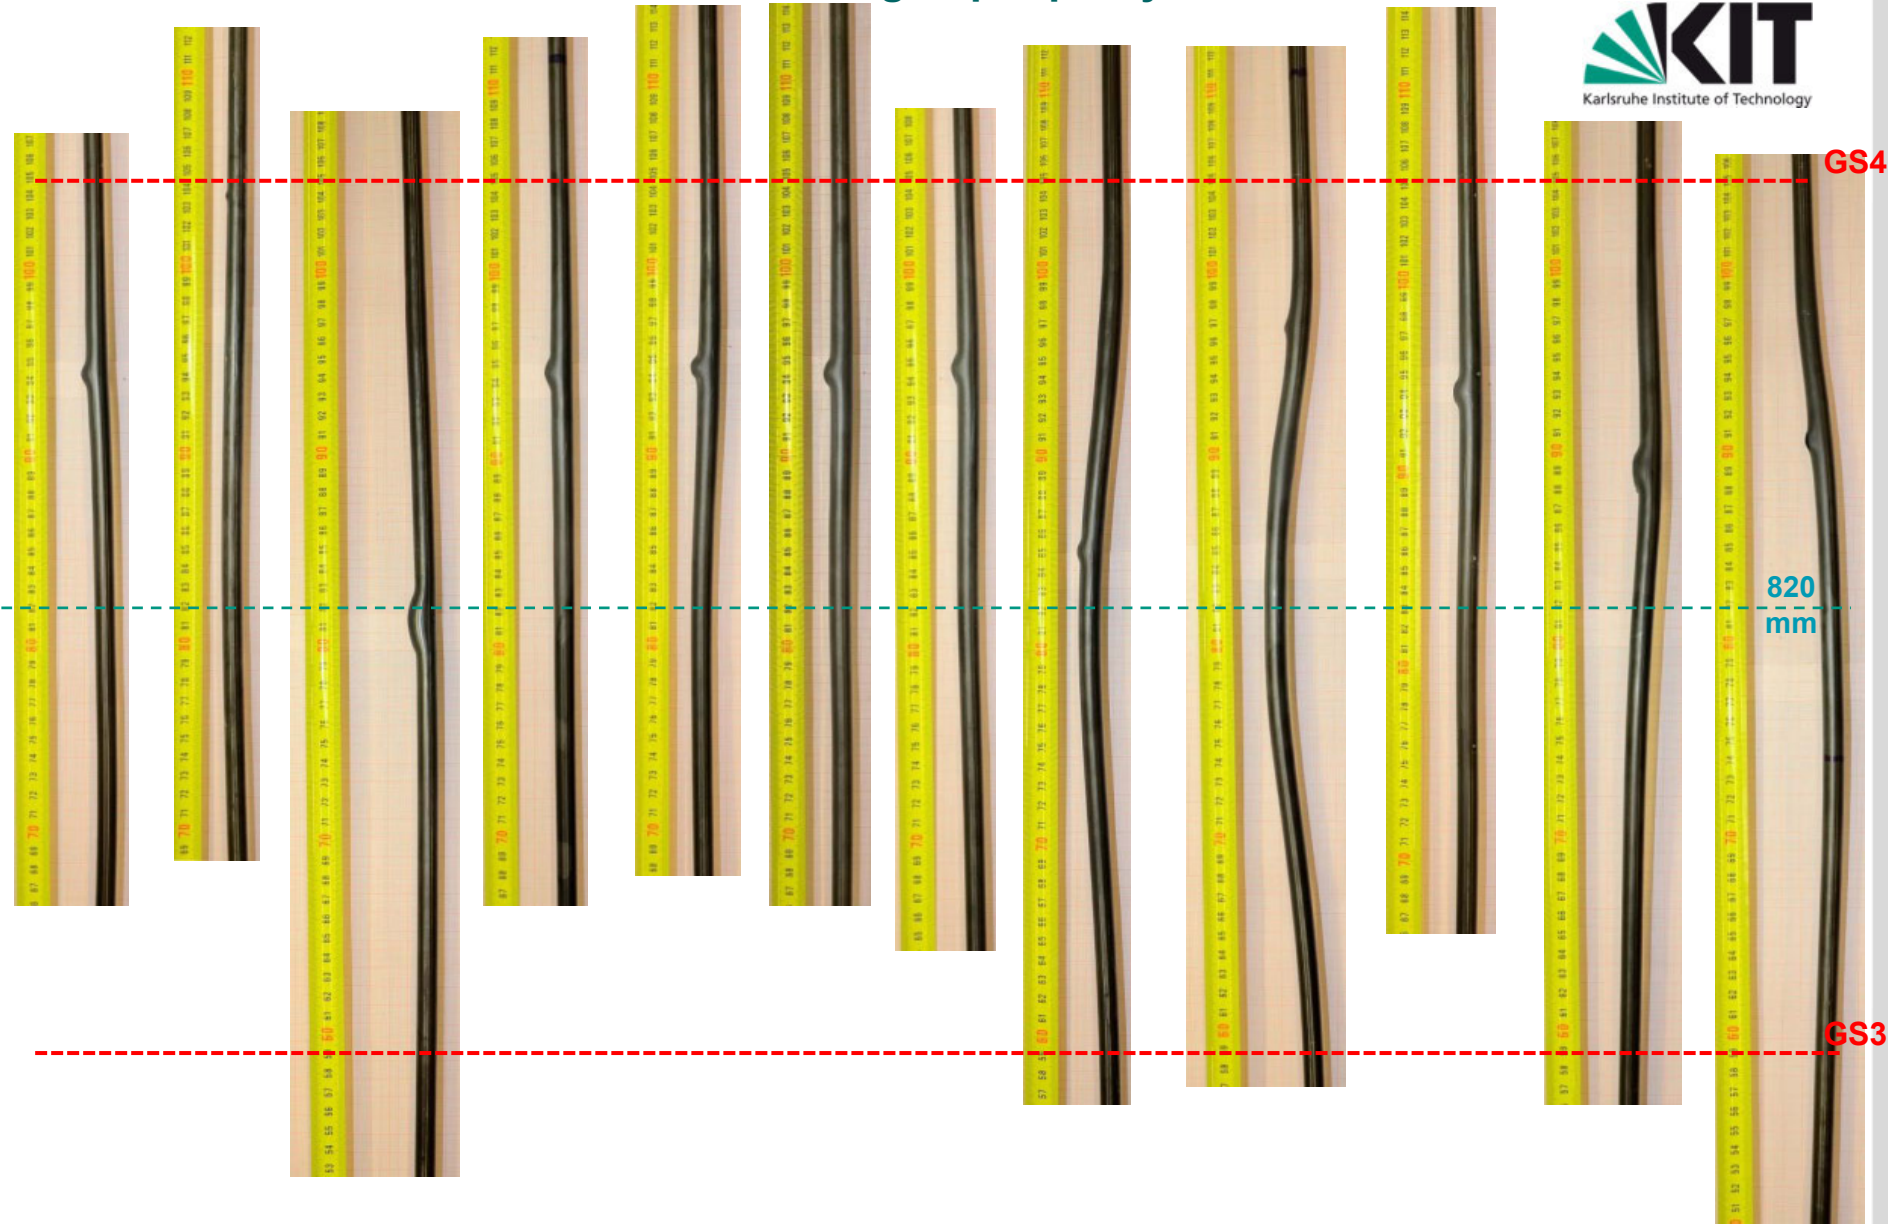
# QL1: Bending of periphery rods

#10 #11 #12: 5 mm #13 #14 #15 #16 #17: 17 mm #18: 22 mm #19 #20: 16 mm #21: 15 mm

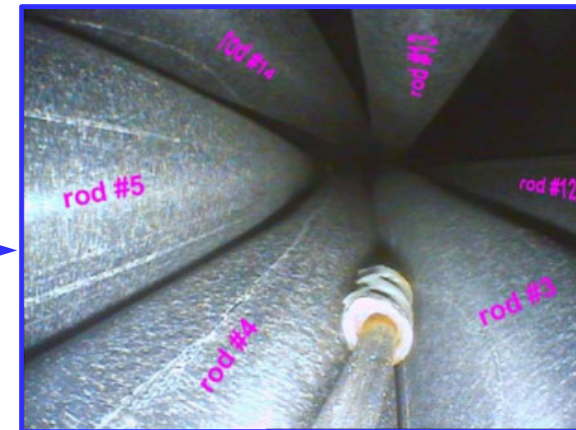
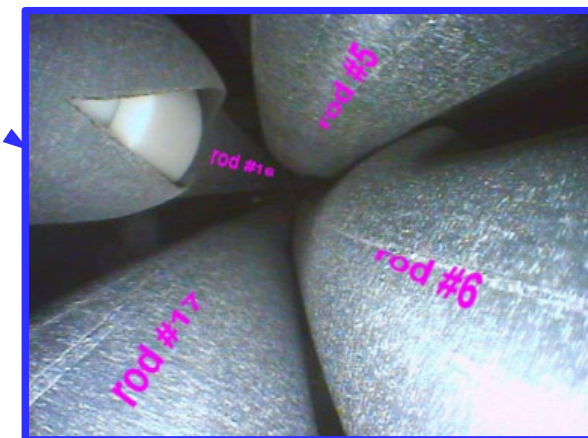
# QL1: estimation of rod position near to middle position between two spacer grids according to measured rod bending and videoscope observations

850 mm: touched rods # 3, 4, 5

950 mm: touched rods # 5, 6, 17

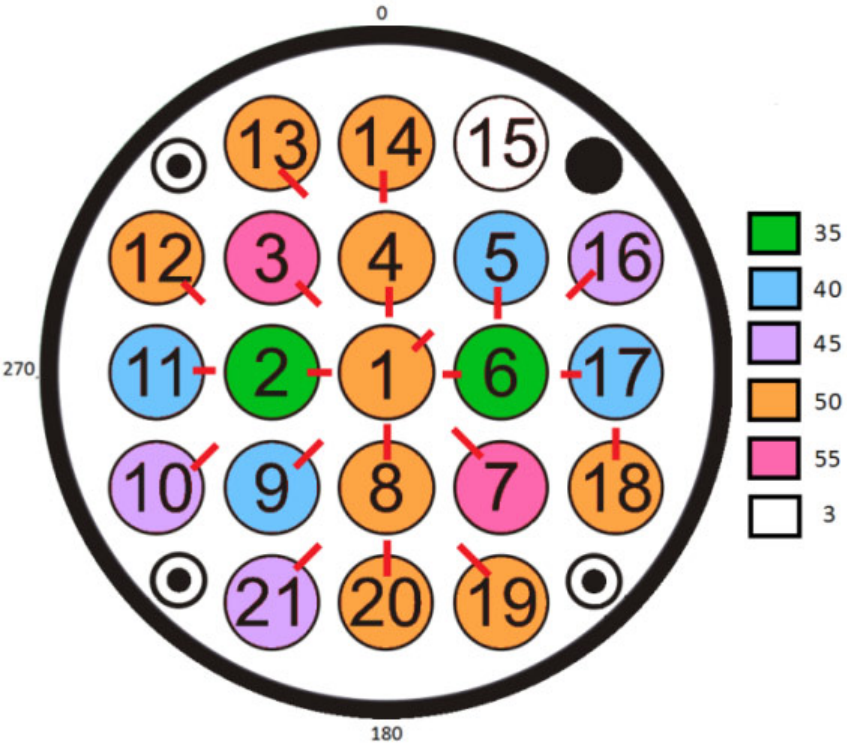
# Circumferential position of burst openings

**LOCA-0:**  
 openings oriented  
 to bundle center  
 due to strong radial T gradient

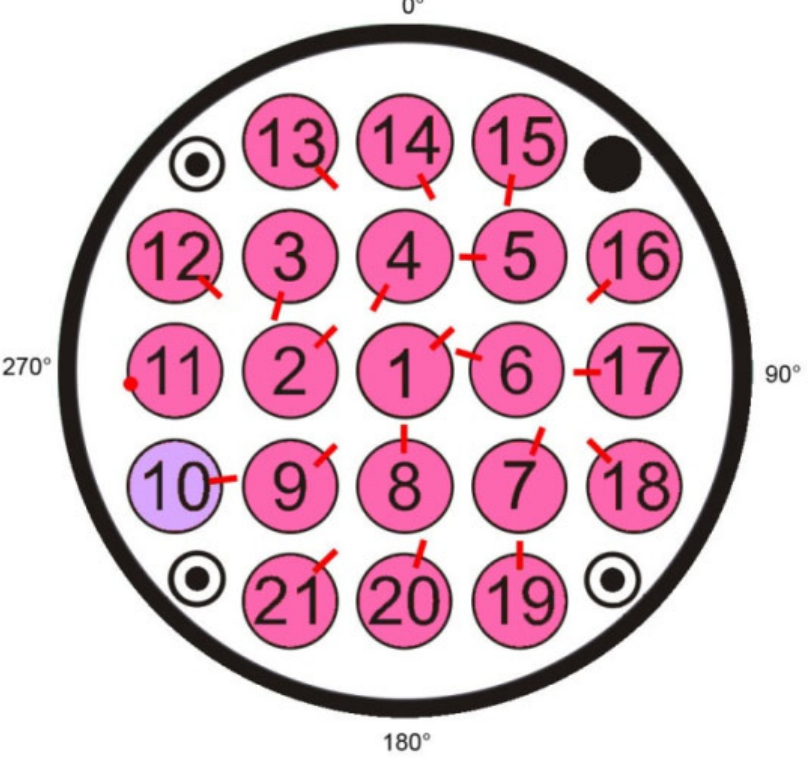
**LOCA-1:**  
 not strong orientation  
 to bundle center

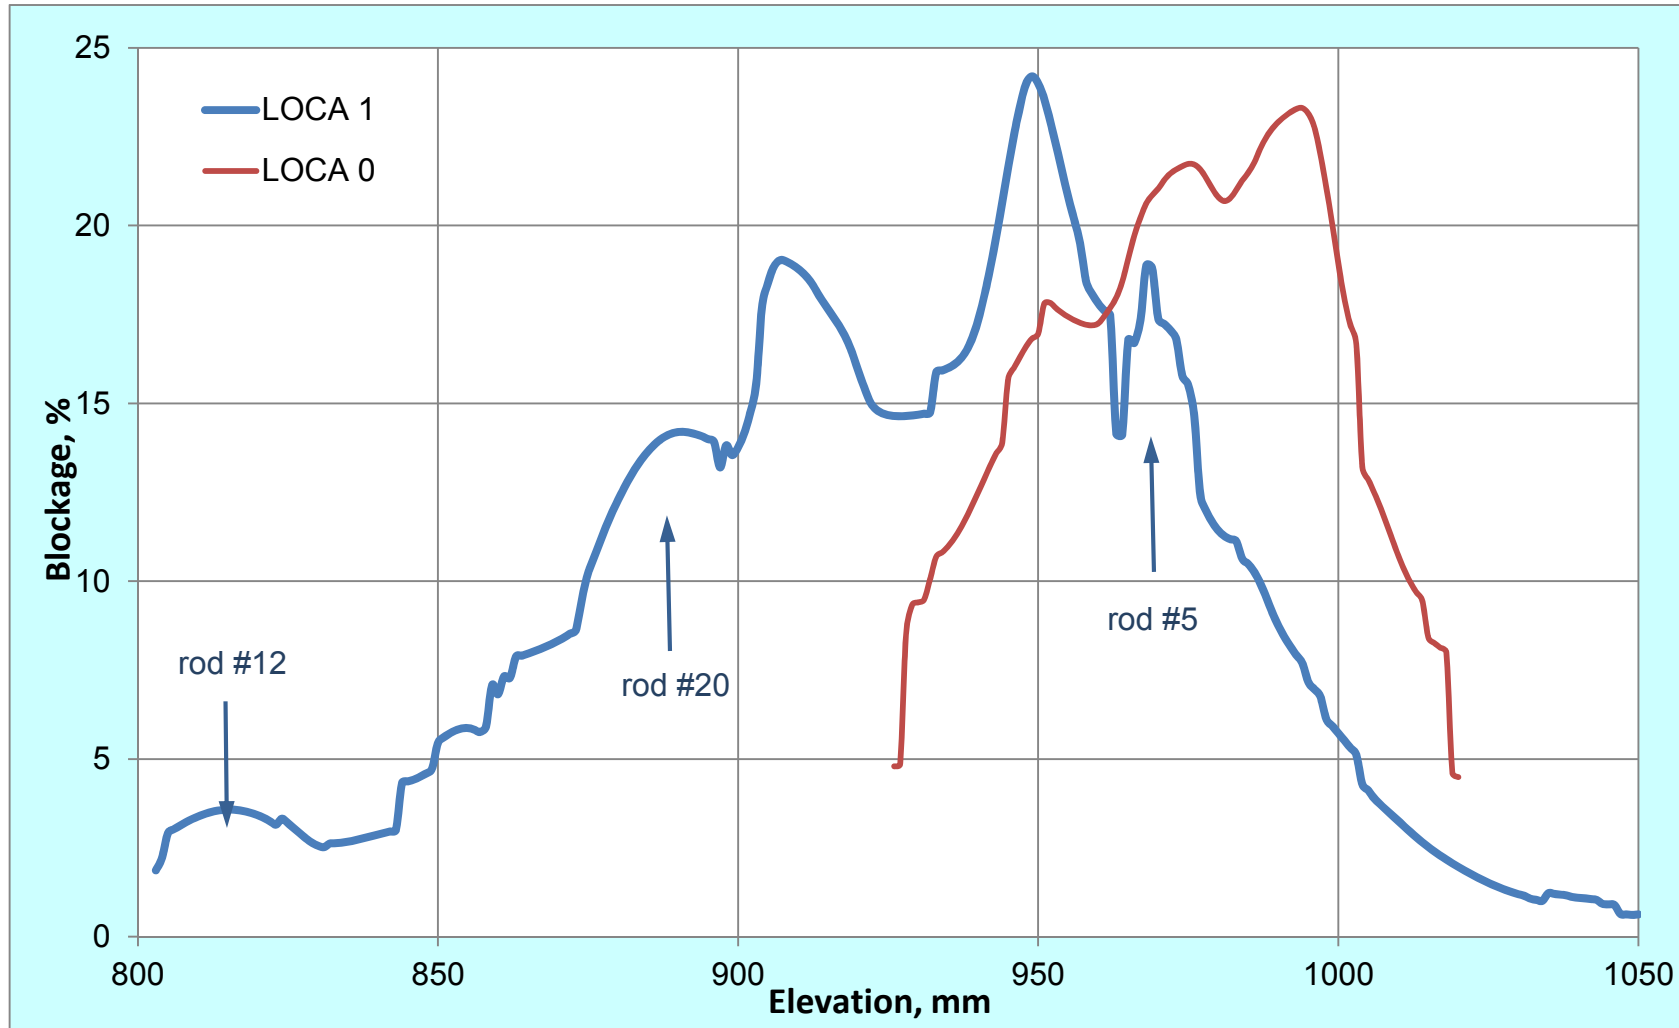
# Cooling channel blockage for LOCA-0 and LOCA-1

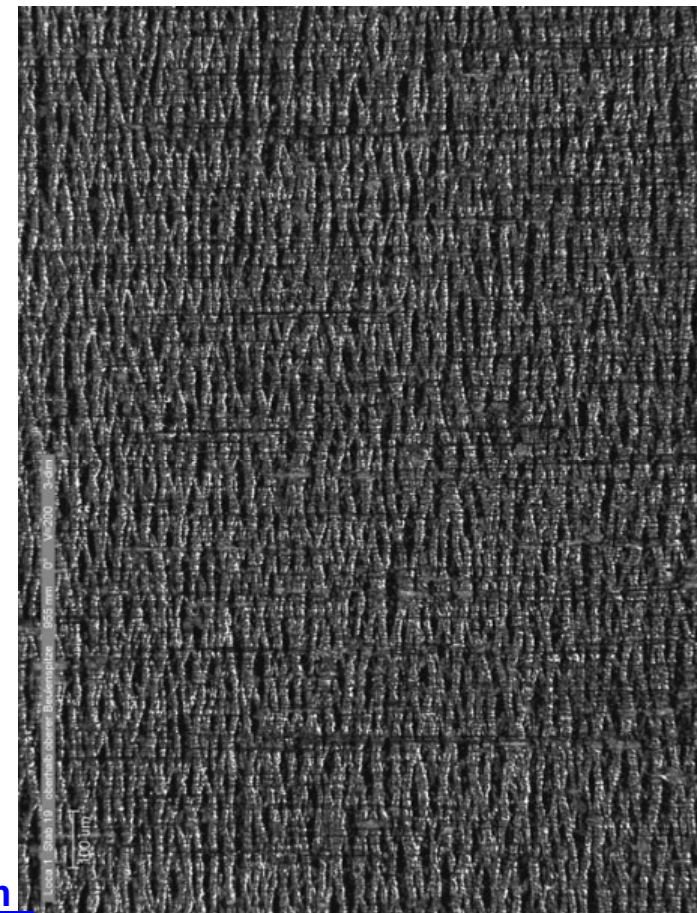
# LOCA-1, oxidised outer surface of ballooning region (rod #19): typical tree bark structure with micro cracks formed due to strain during ballooning

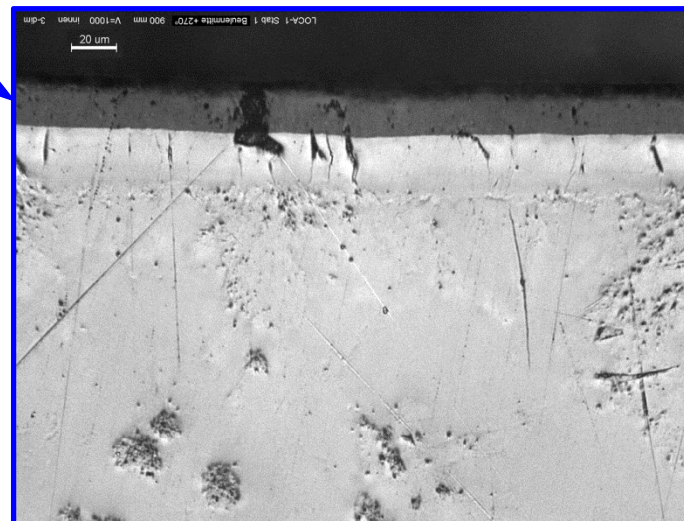
# Outer and inner cladding oxidation at 900 mm for LOCA-1, rod #1

inner and outer oxide:  
**20 μm**

inner oxide:  
**20 μm**

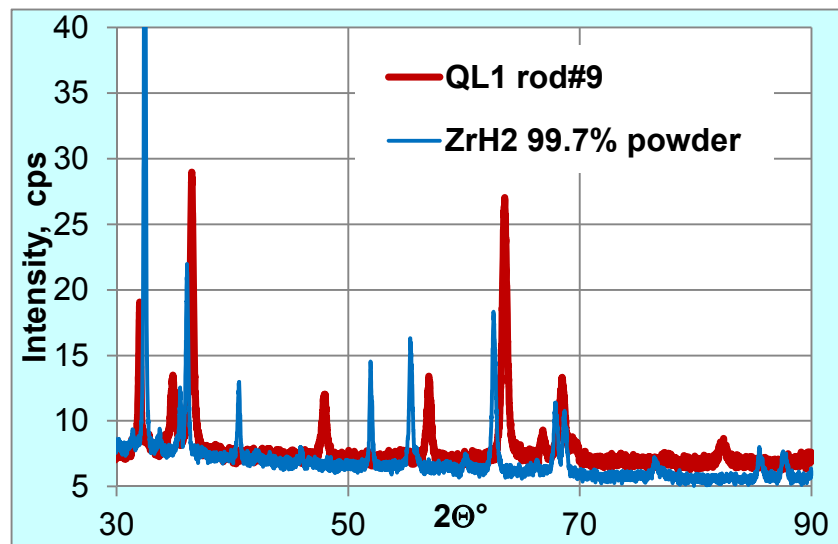
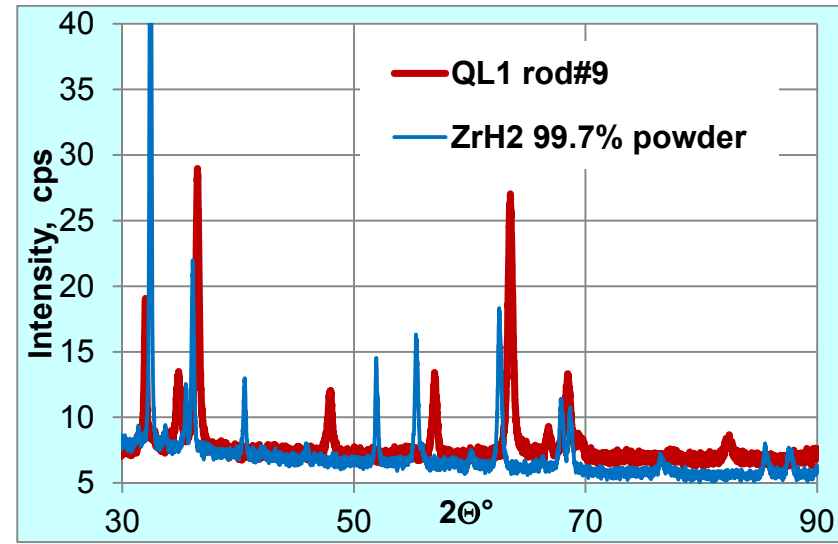
# QL1, results of X-ray ( $\lambda=154$ pm) diffractometry: no evidence of hydrides with sizes more 10 nm

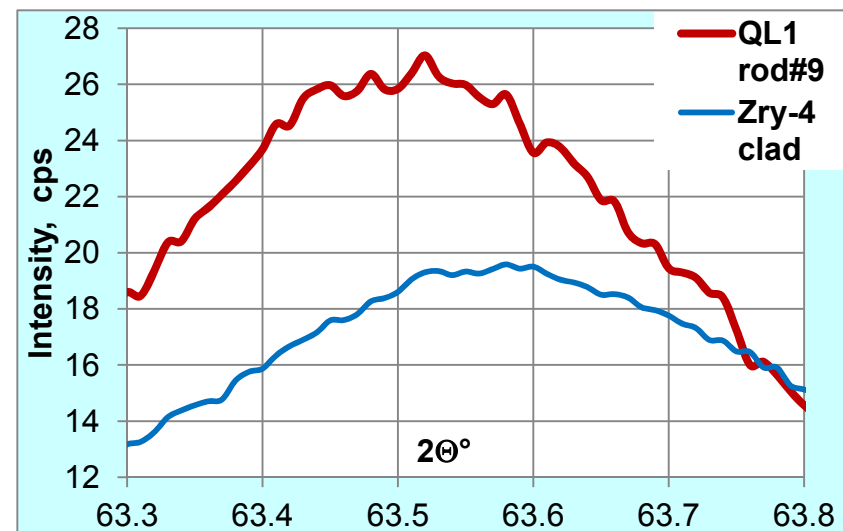
# QL1, shift of XRD peaks:

increase of lattice parameters due to dissolved hydrogen

$$\Delta\Theta = -0.07^\circ \rightarrow C_H \approx 260 \text{ wppm}$$

$$\Delta\Theta = -0.02^\circ \rightarrow C_H \approx 75 \text{ wppm}$$

$$\Delta\Theta = -0.04^\circ \rightarrow C_H \approx 150 \text{ wppm}$$

$$\Delta\Theta = -0.05^\circ \rightarrow C_H \approx 190 \text{ wppm}$$

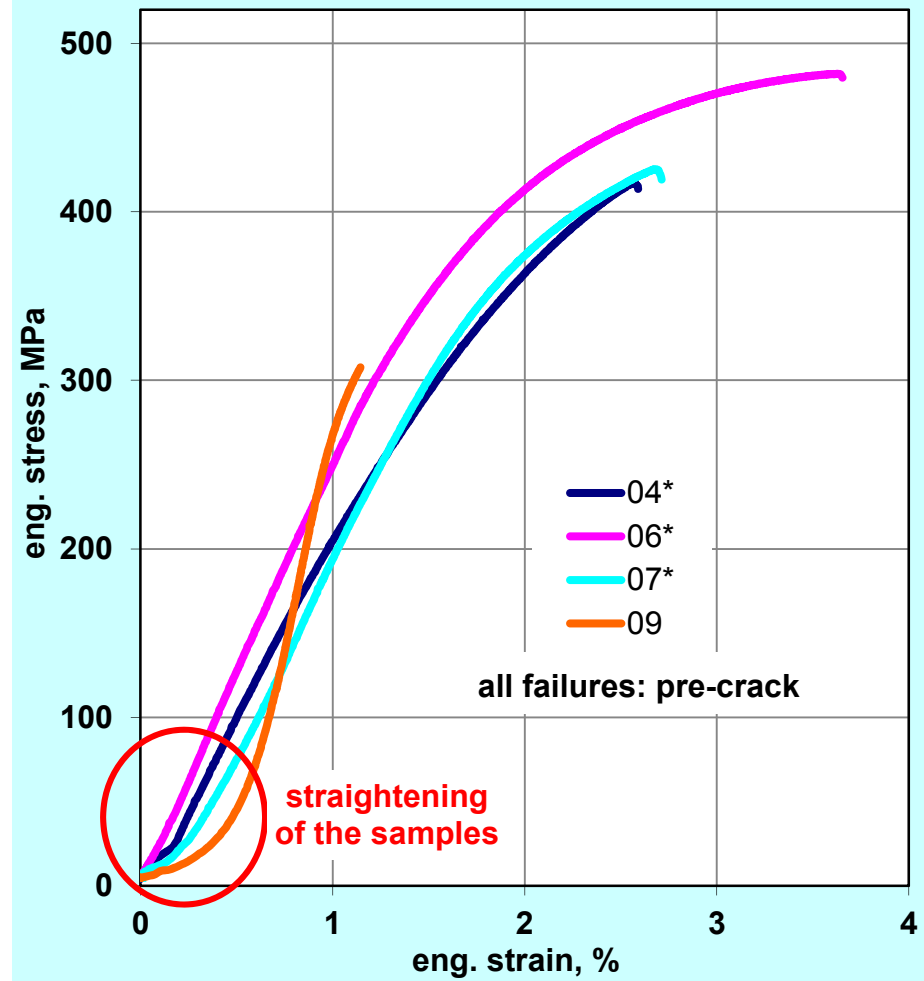
# Tensile tests for inner rods

QL0 sample length 500 mm or 250 mm\*

QL1 sample length 1000 mm or 250 mm\*

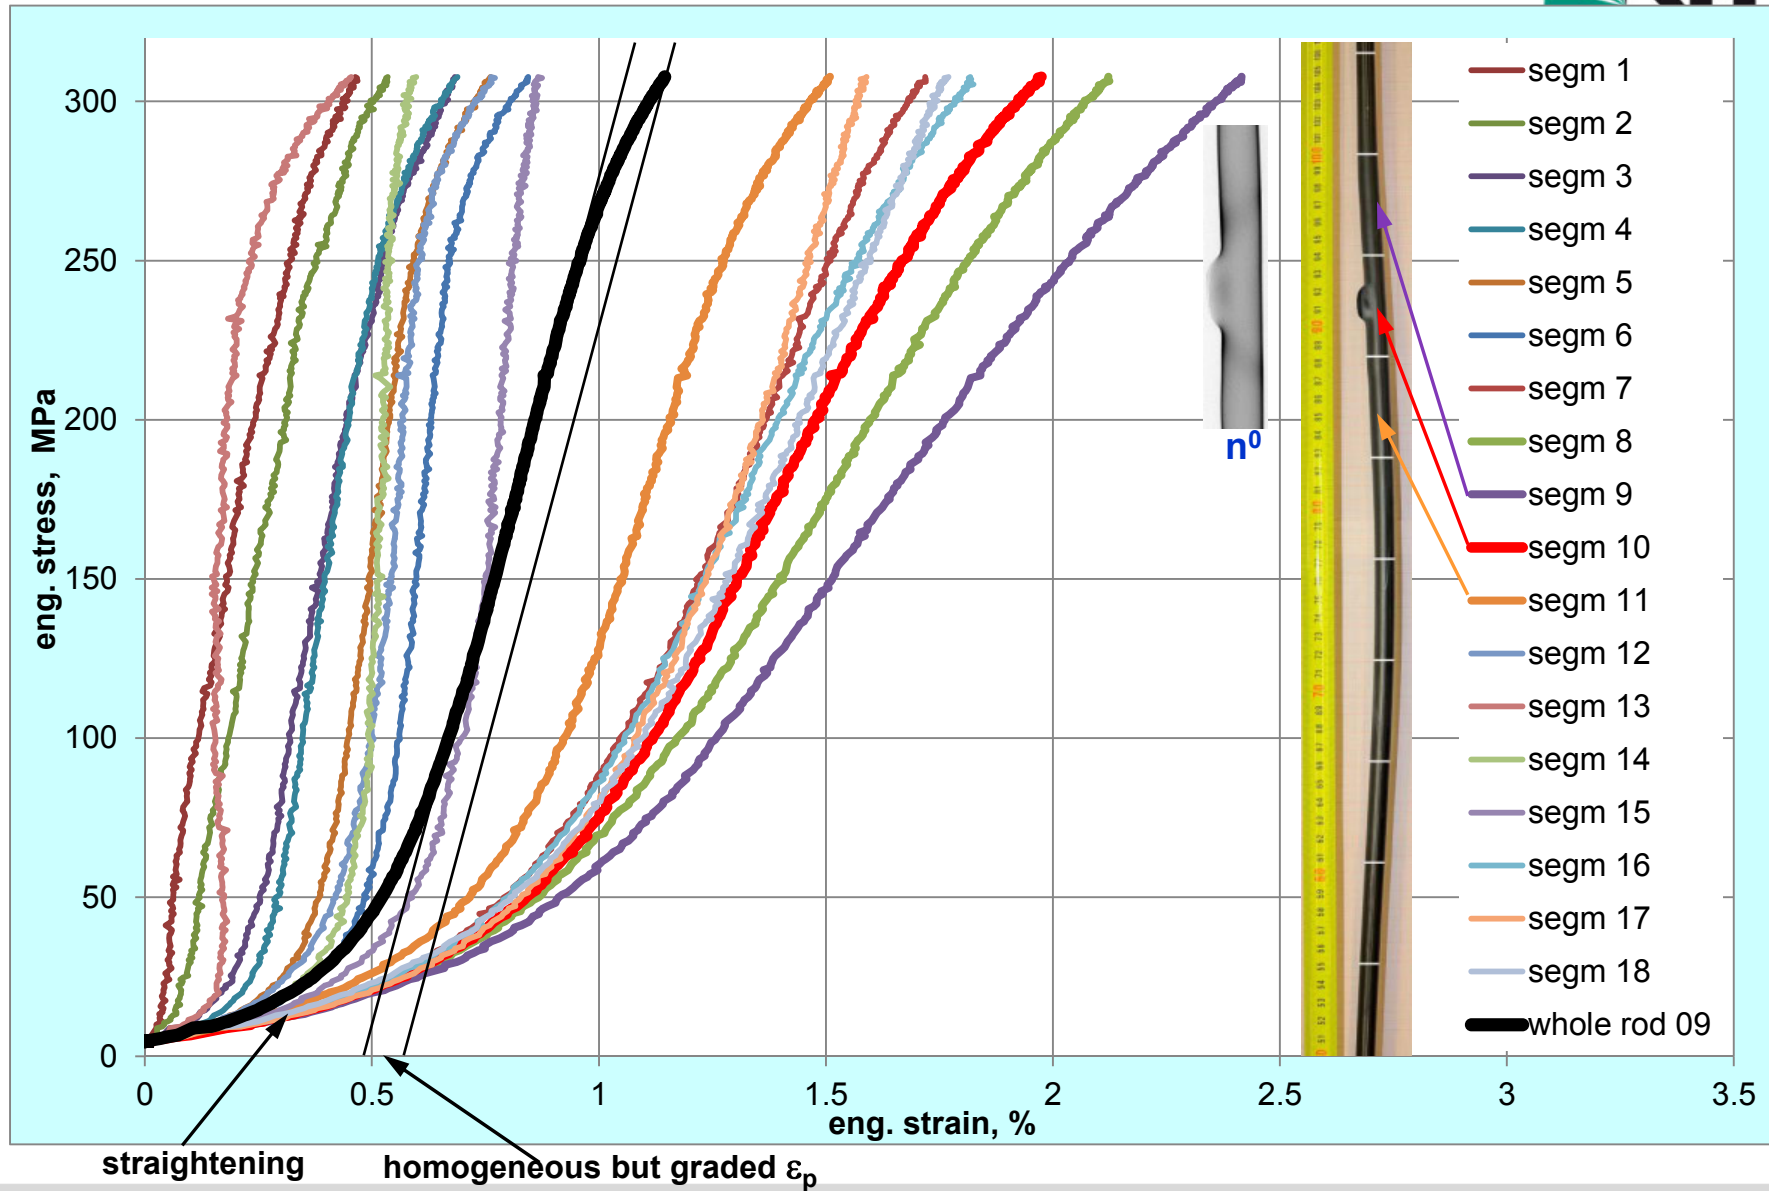
# QL1: tensile test with bended rod #09 with detected secondary hydrogenation

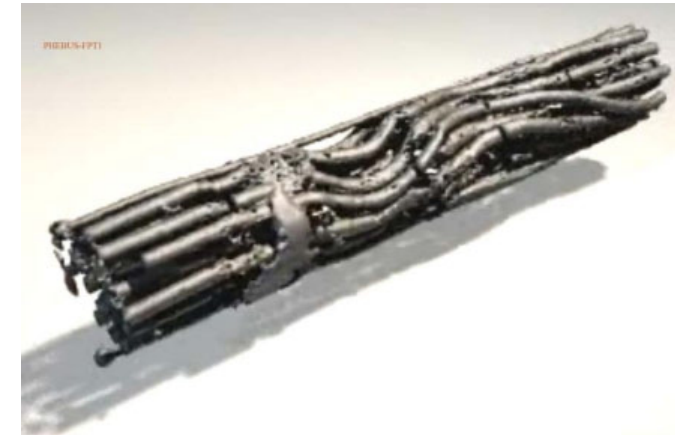
# What is prototypical rod bending rate?

High temperature PHEBUS-FPT1 in-pile test

Results of the **FR2** in-pile single rod tests: out-of-pile results [Chung], showing significant bending below 840°C ( $\alpha$ -Zr(O)) and negligible values above 840°C, **were not confirmed** by the in-pile tests. However, the orientation of the rod bend was consistent with out-of-pile results, i.e., the rupture was on the inside of the bend.

NRU MT-4 (1982) in-pile bundle test: no noticeable bending

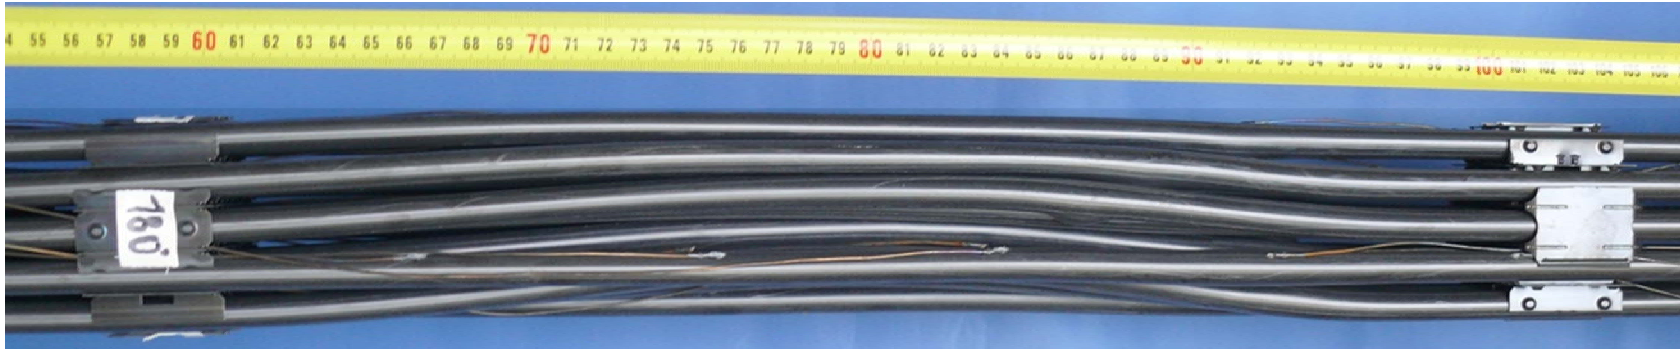
**Two locations of friction during the thermal expansion:**

**1. (prototypical) friction between oxidised grid spacers and ballooned claddings**

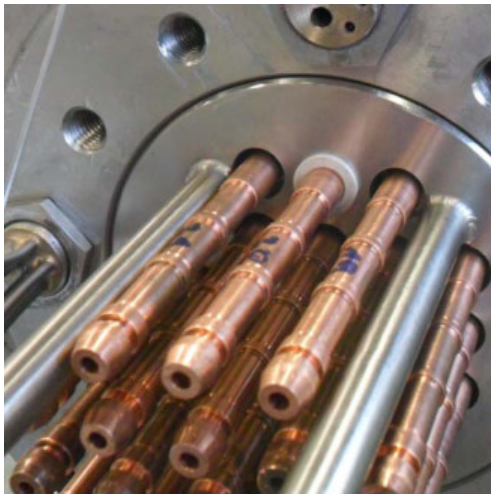
**2. (not prototypical) friction inside the electrode group**

**Cu electrodes**

**Cu electrodes with Au slide contacts**

**Cu block putted on electrodes**
