Analysis of the Secondary Hydrogenation during the QUENCH-LOCA Bundle Tests with Zry-4 Claddings and its Influence on the Cladding Embrittlement

**M. Grosse, J. Stuckert, C. Roessger, M. Steinbrueck, M. Walter (KIT)
A. Kaestner (PSI)**

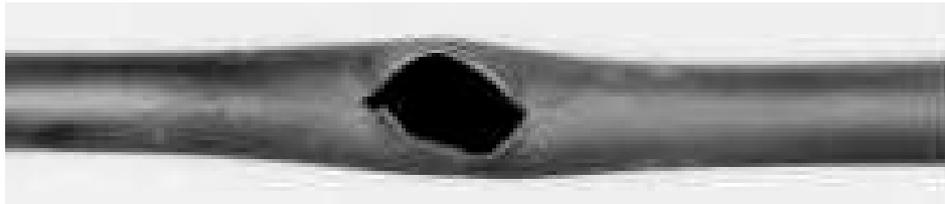
Secondary hydrogenation during LOCA

- No hydrogen in the burst region
- Two broad peaks in the hydrogen concentration at both sides of the burst opening
- High H-concentrations up to 4000 wppm
- H embrittlement
- Is the ECR < 17 % criteria in the presence of a high amount of hydrogen still conservative?
