Results of the QUENCH-DEBRIS bundle test

QWS19, Karlsruhe 2013

Institute for Applied Materials; Program NUKLEAR

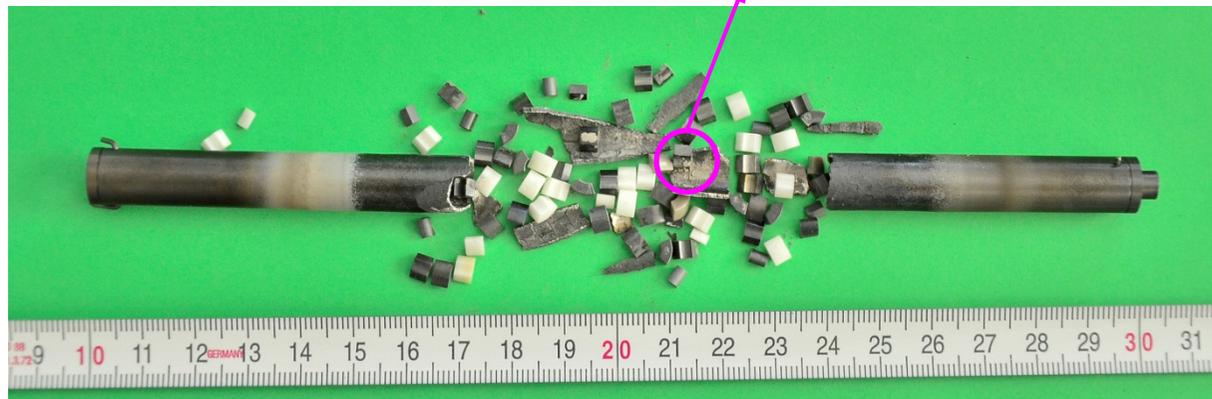
sample was destroyed during handling

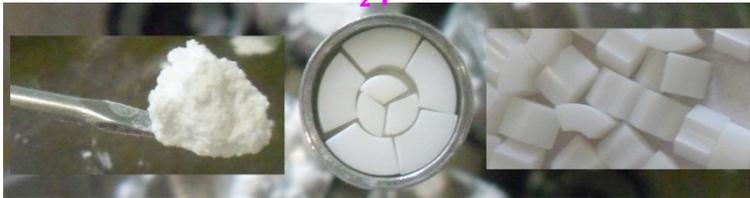
Zry cladding filled with ZrO_2 pellet segments and ZrO_2 powder

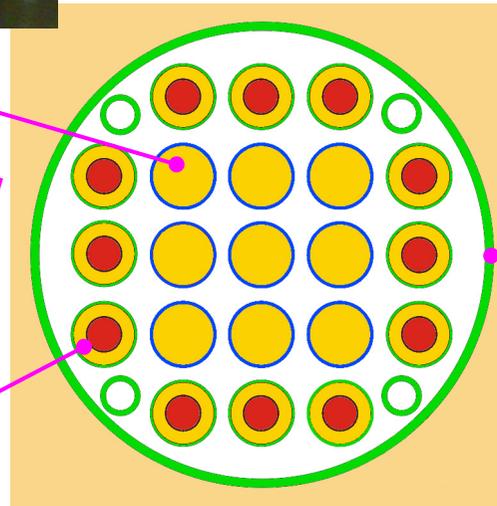
9 unheated rods with Zry-4 cladding

12 heated rods with Hf cladding

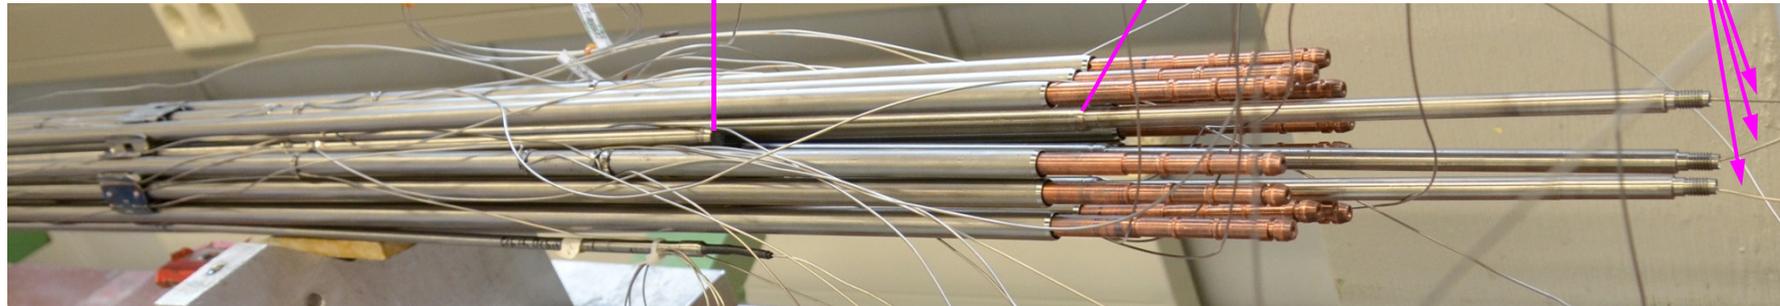
Bundle elements at bundle bottom

bottom of six Zry-4 rods
-420 mm

bottom of
Zry-4 rods #4, 6, 8
-590 mm

Zr-wires
of indicator rods
4, 6, 8

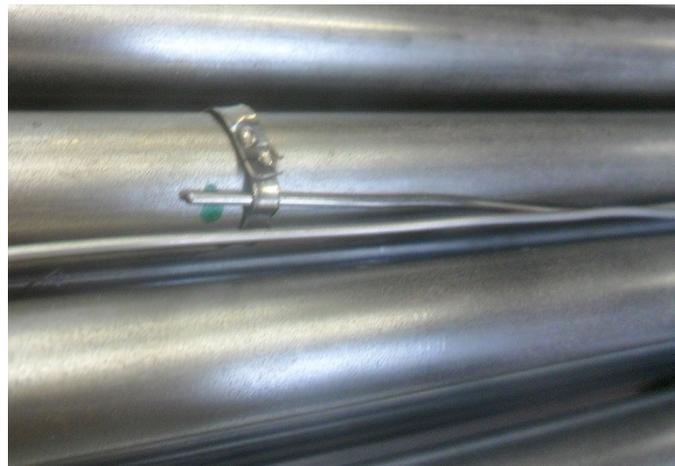
bundle bottom

fastening of NiCrNi thermocouple

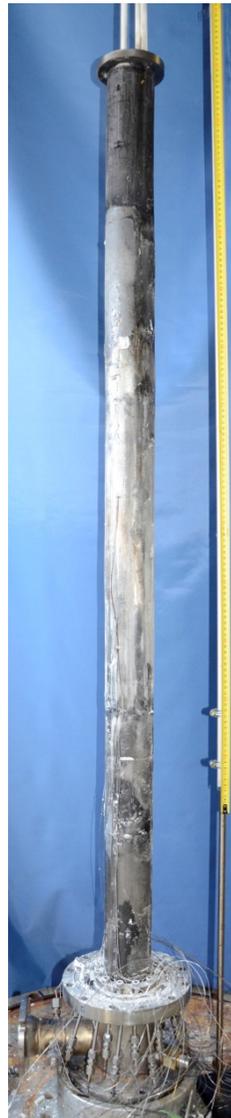
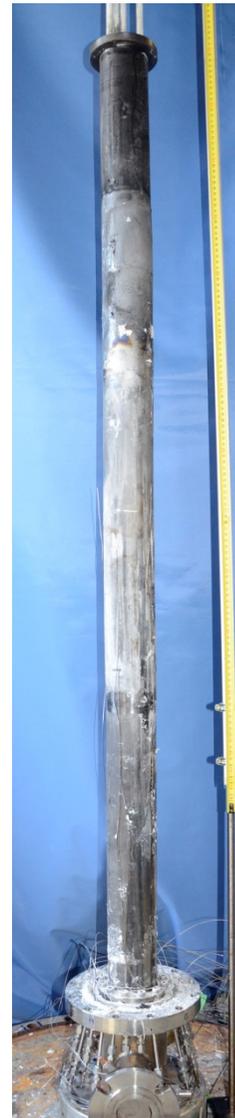
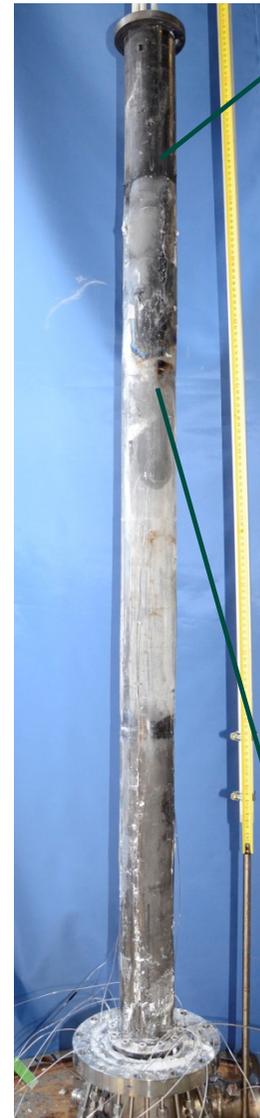
Post-test: overview of mostly intact Hf-shroud (only several cracks) after dismantling of heat insulation

0°

90°

180°

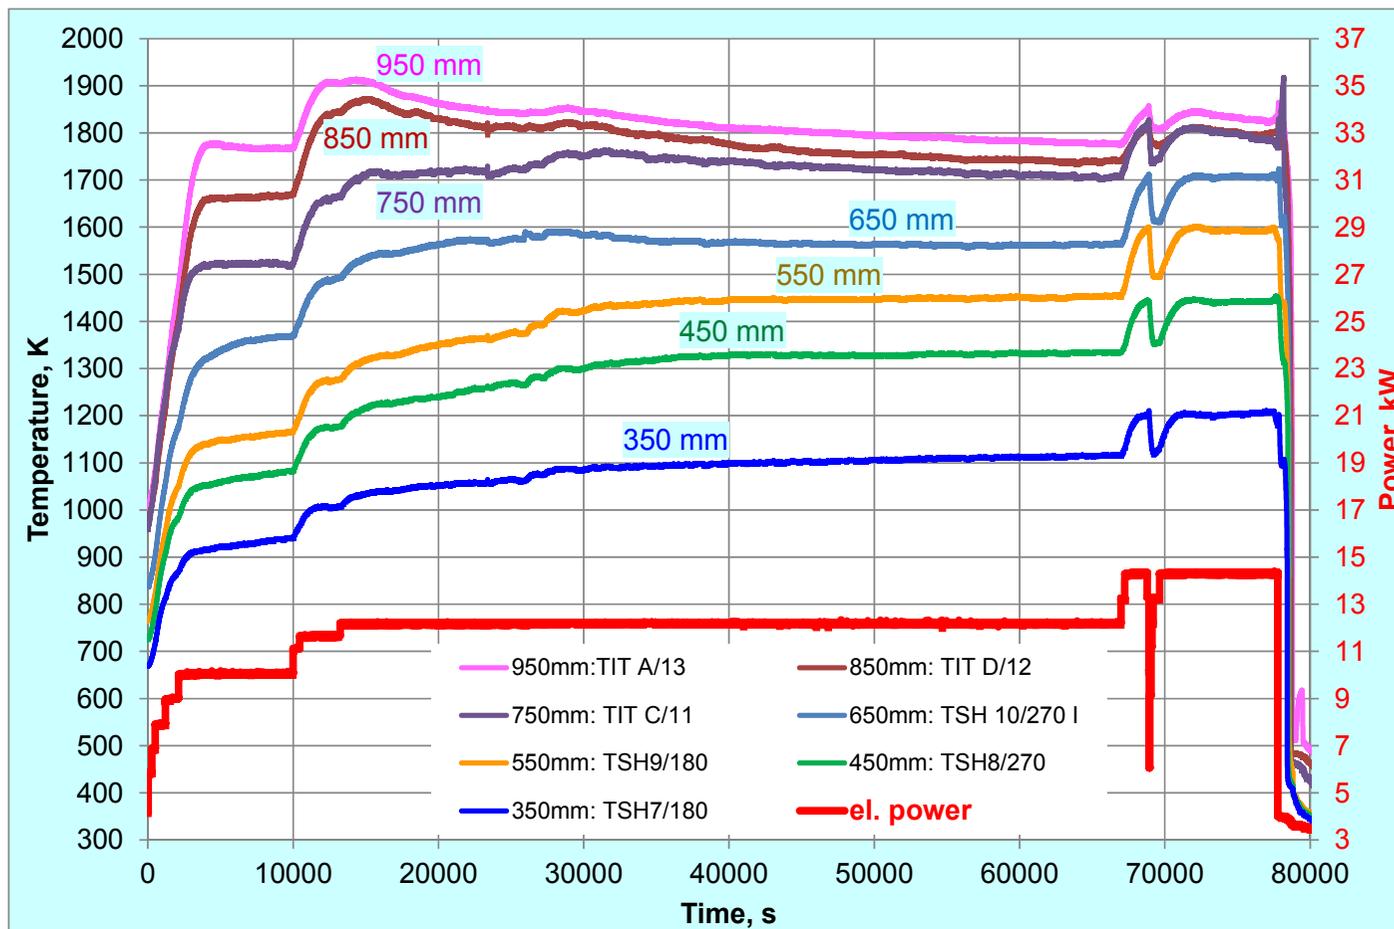
Test scenario: el. power and TC readings at different elevations

- 1) pre-oxidation stage with 2 g/s steam and 2 g/s Ar. Complete oxidation of Zry-4 clads between 650 and 1150 mm
- 2) Test termination: reflood from bottom with water flow rate 10 g/s.

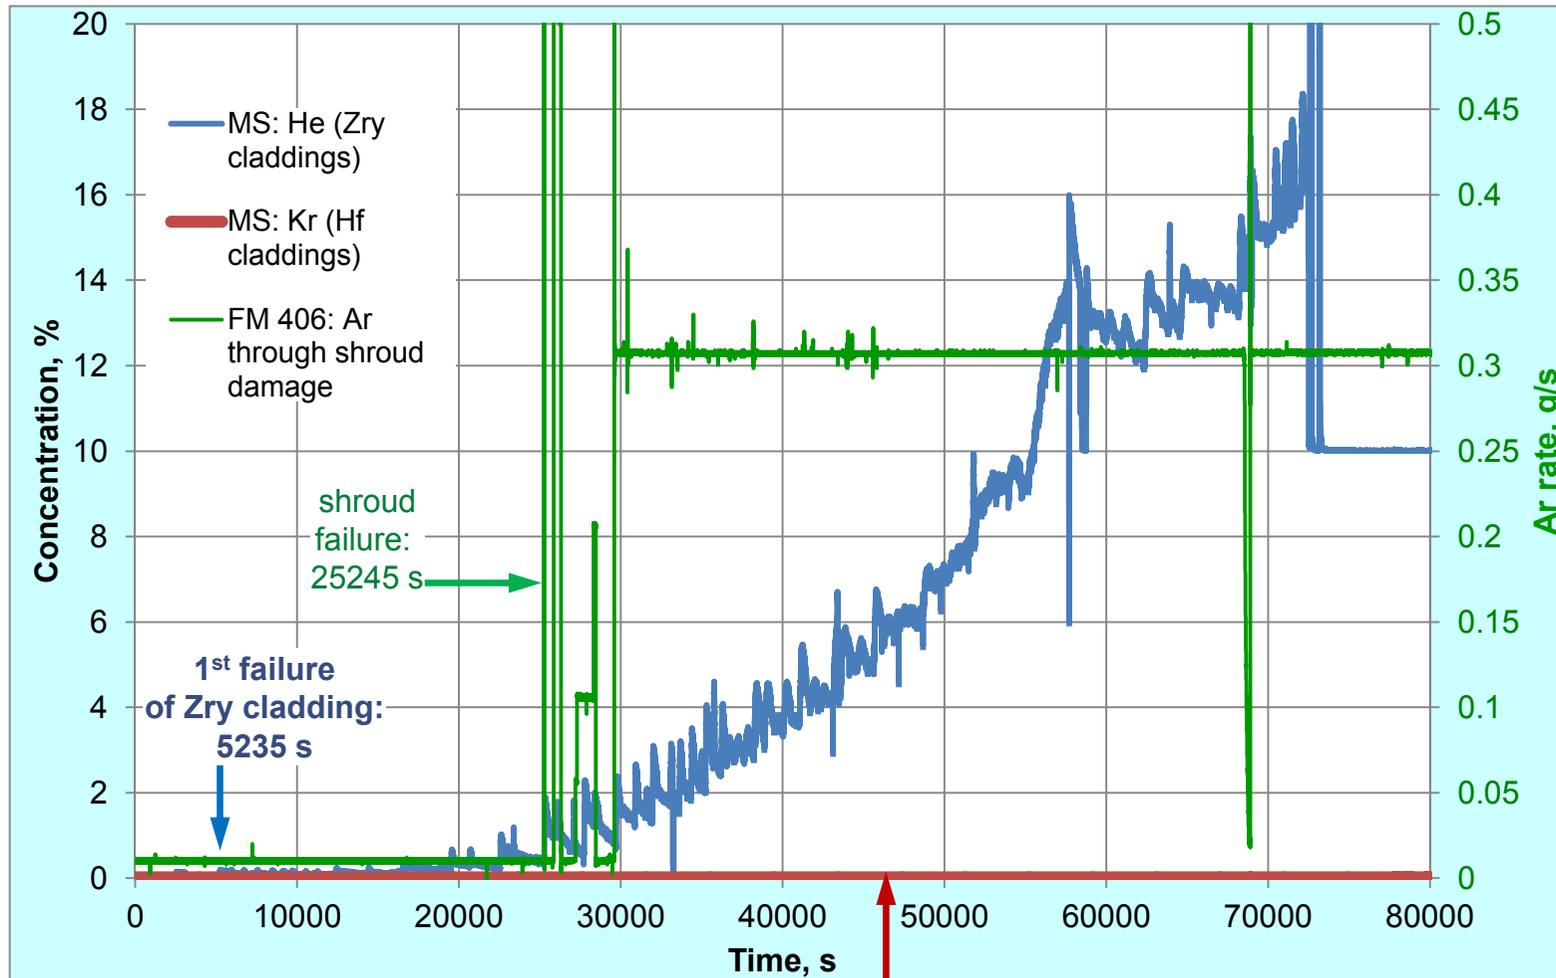
Failures of Zry claddings and Hf shroud

no failure of Hf claddings was registered

- Hf claddings of heated rods were intact during whole test, Hf shroud was failed at 850 mm after 25000 s. First failure of Zry-4 cladding was registered at 5500 s. Noticeable internal oxidation was observed at upper bundle elevations.

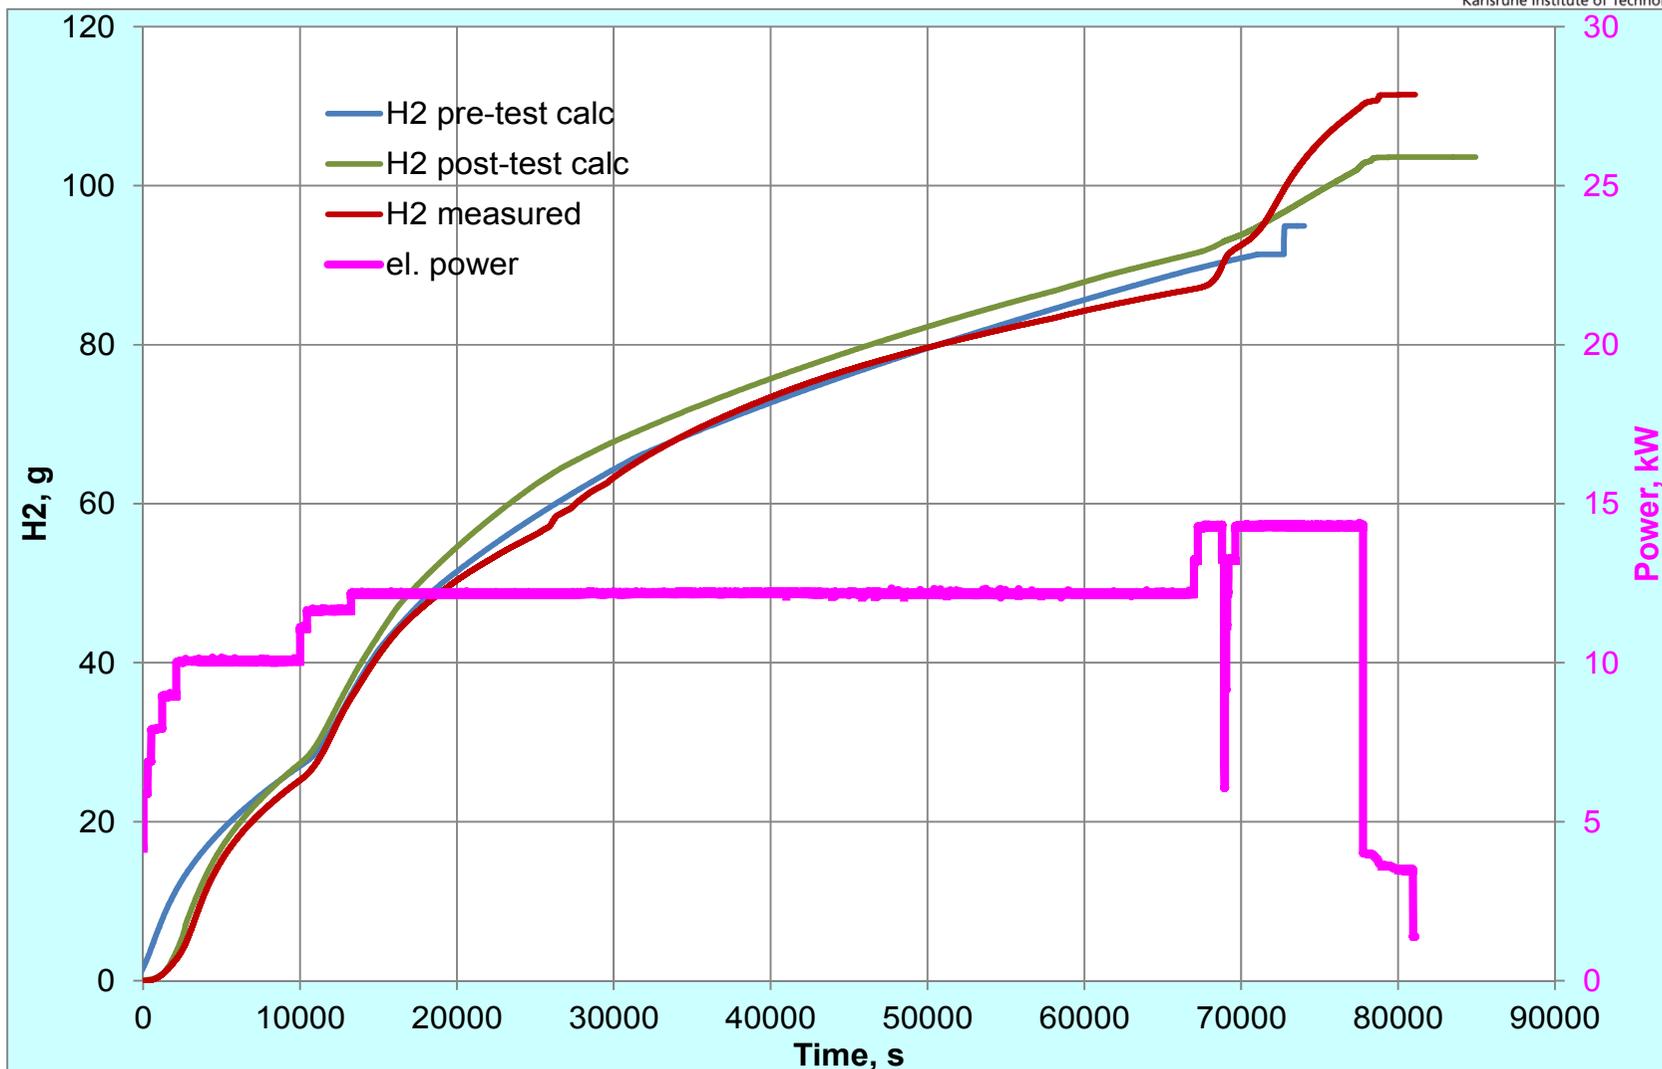
Integral criterion of bundle oxidation progression: hydrogen release during oxidation of Zry and Hf parts

the course of the experiment closely followed the pre-test prediction

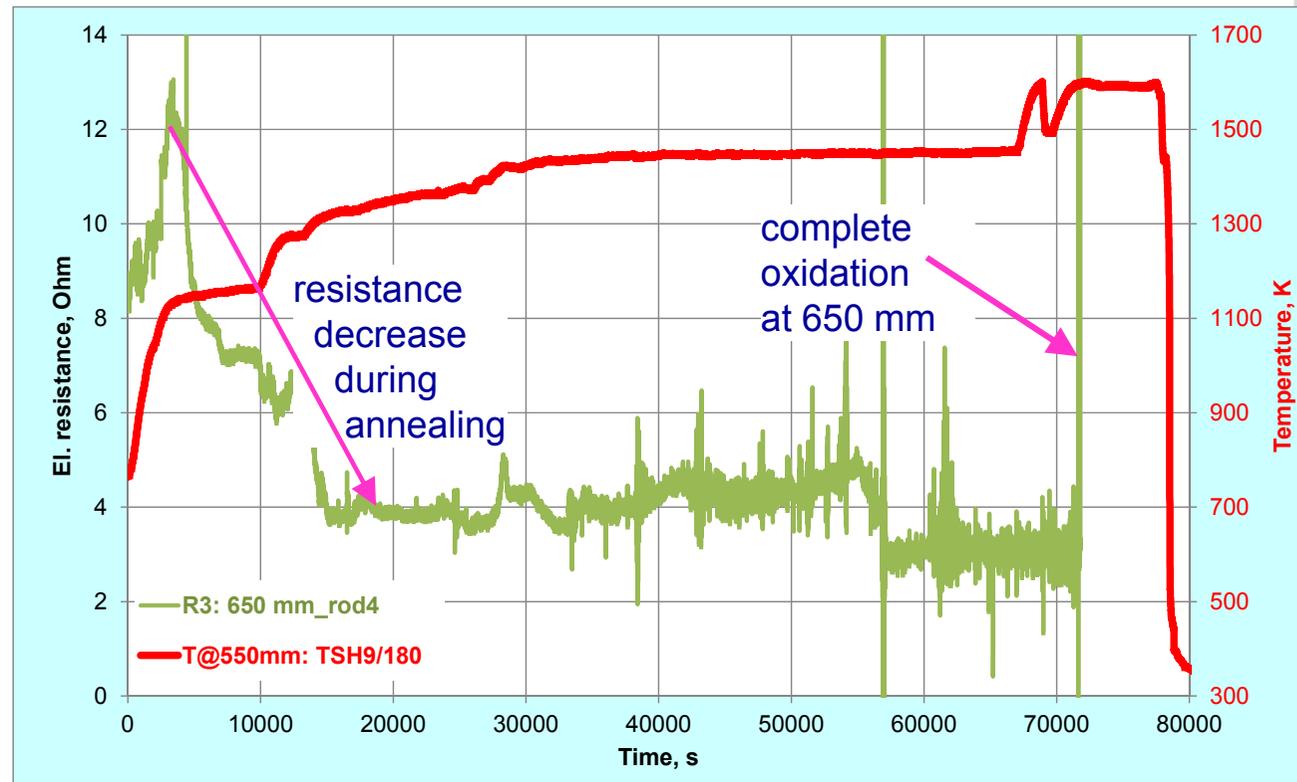
Indication of complete oxidation at 650 mm by el. resistance measurement

3 welded joints:

R1 at 550 mm for rod #8,

R2 at 650 mm for rod #2,

R3 at 650 mm for rod #4

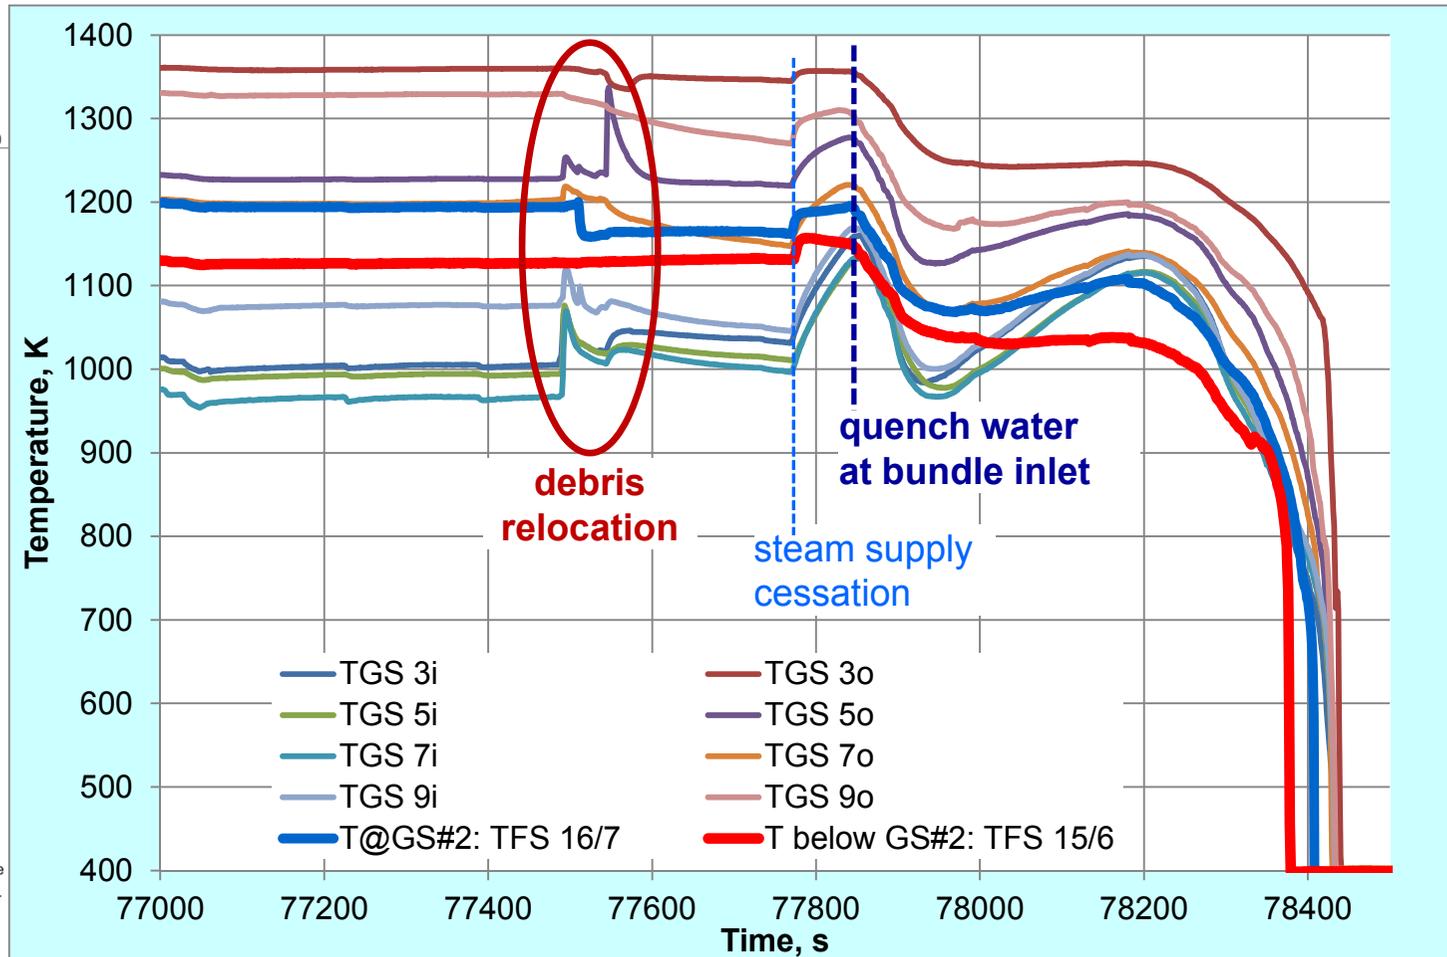
Indication of debris relocation to GS#2 (reaction of thermocouples TGS installed at the top of GS#2)

TC (TGS)

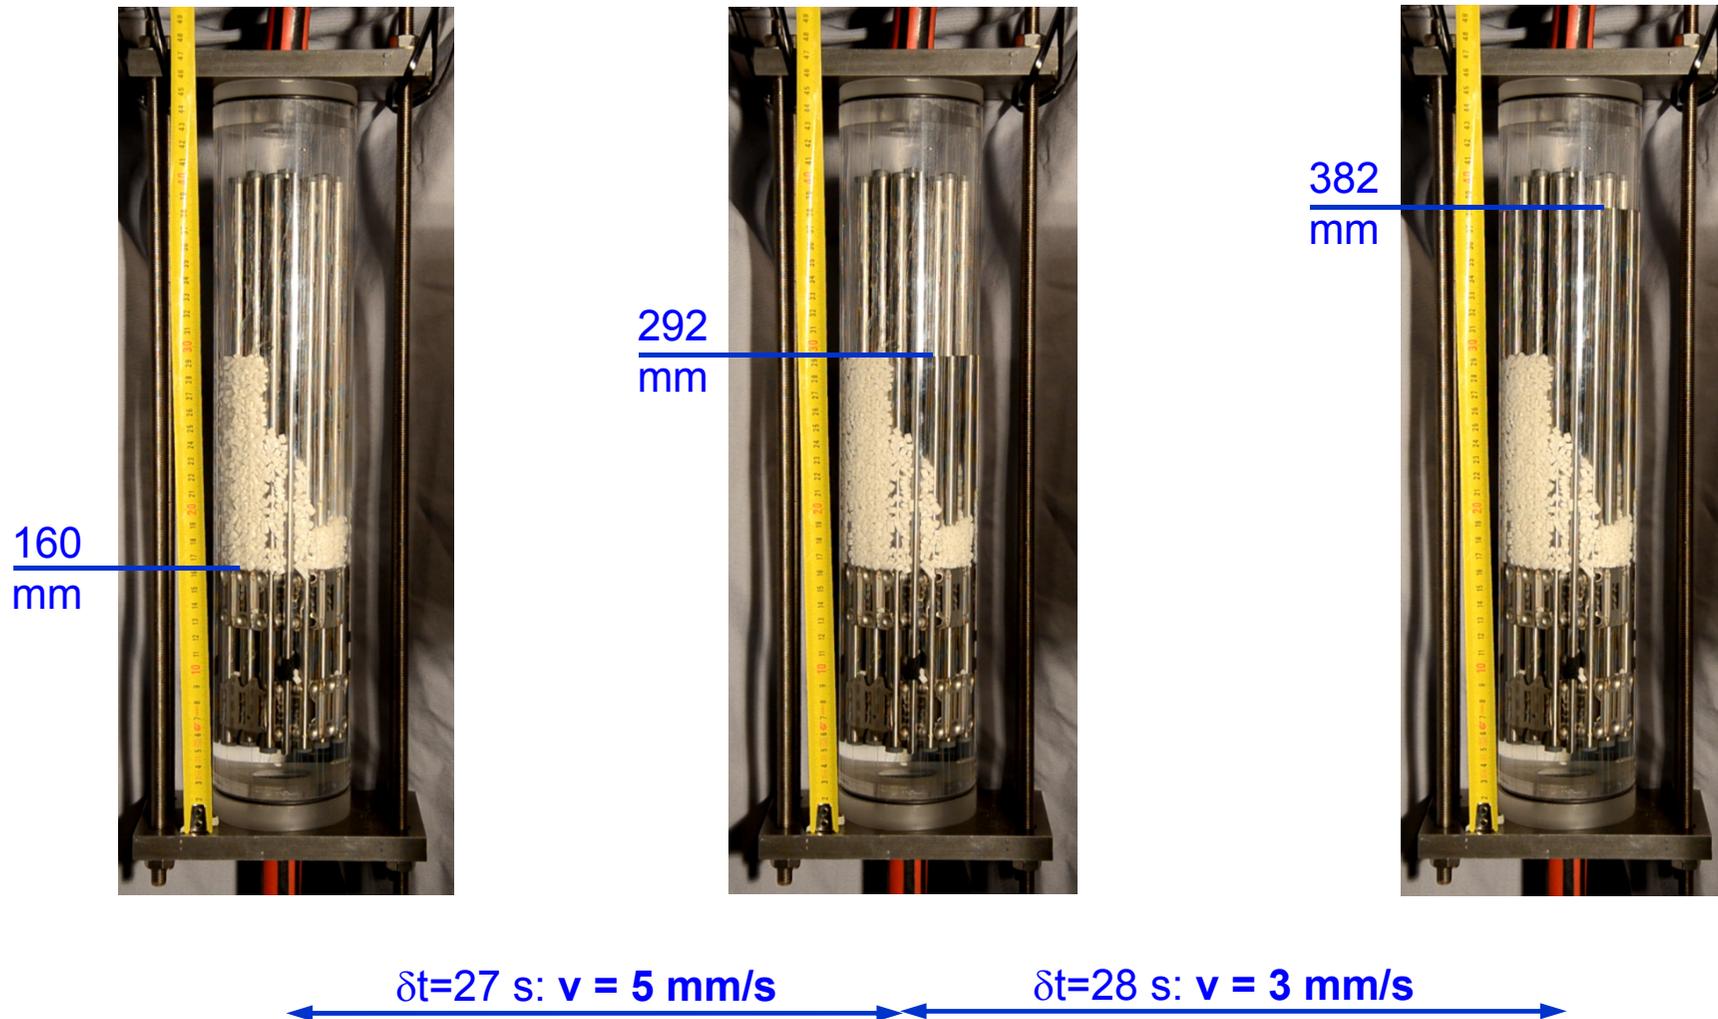
Reflood simulation with pellet debris inside 21-rod-bundle. Cold water flow rate 10 g/s

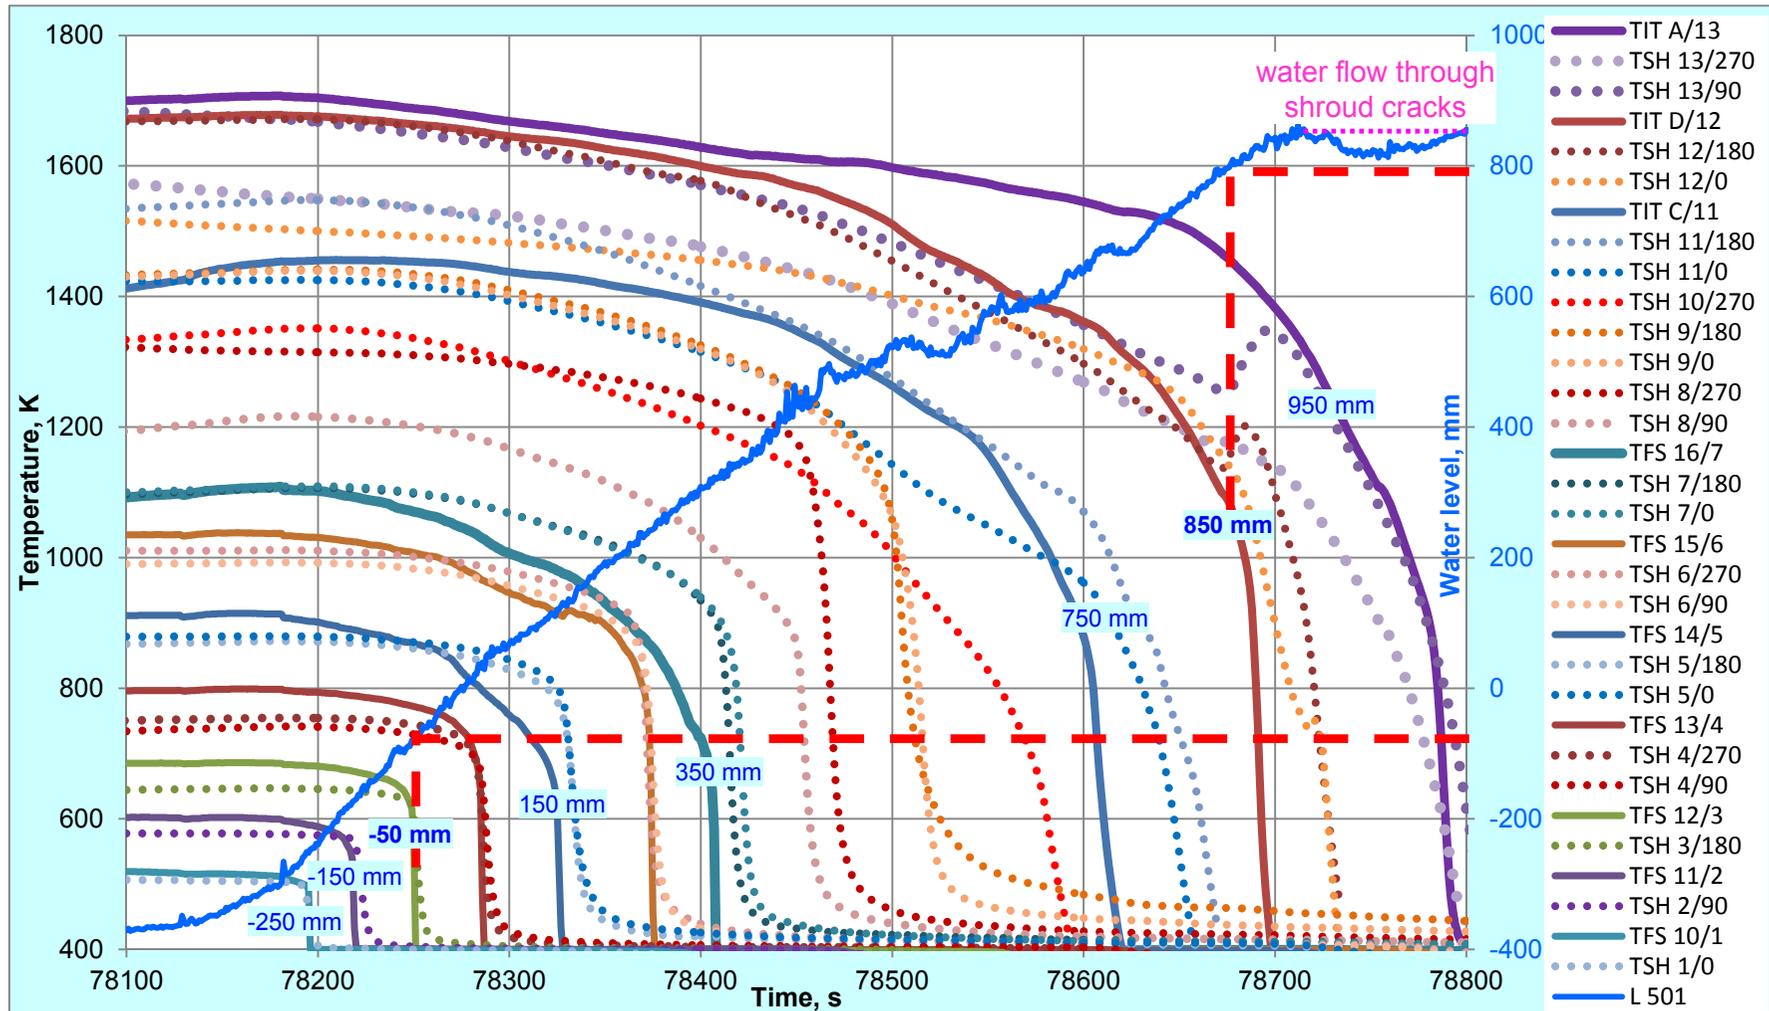
Quench phase: collapse water level and TC wetting

TC wetting at high elevation by 2-phase fluid

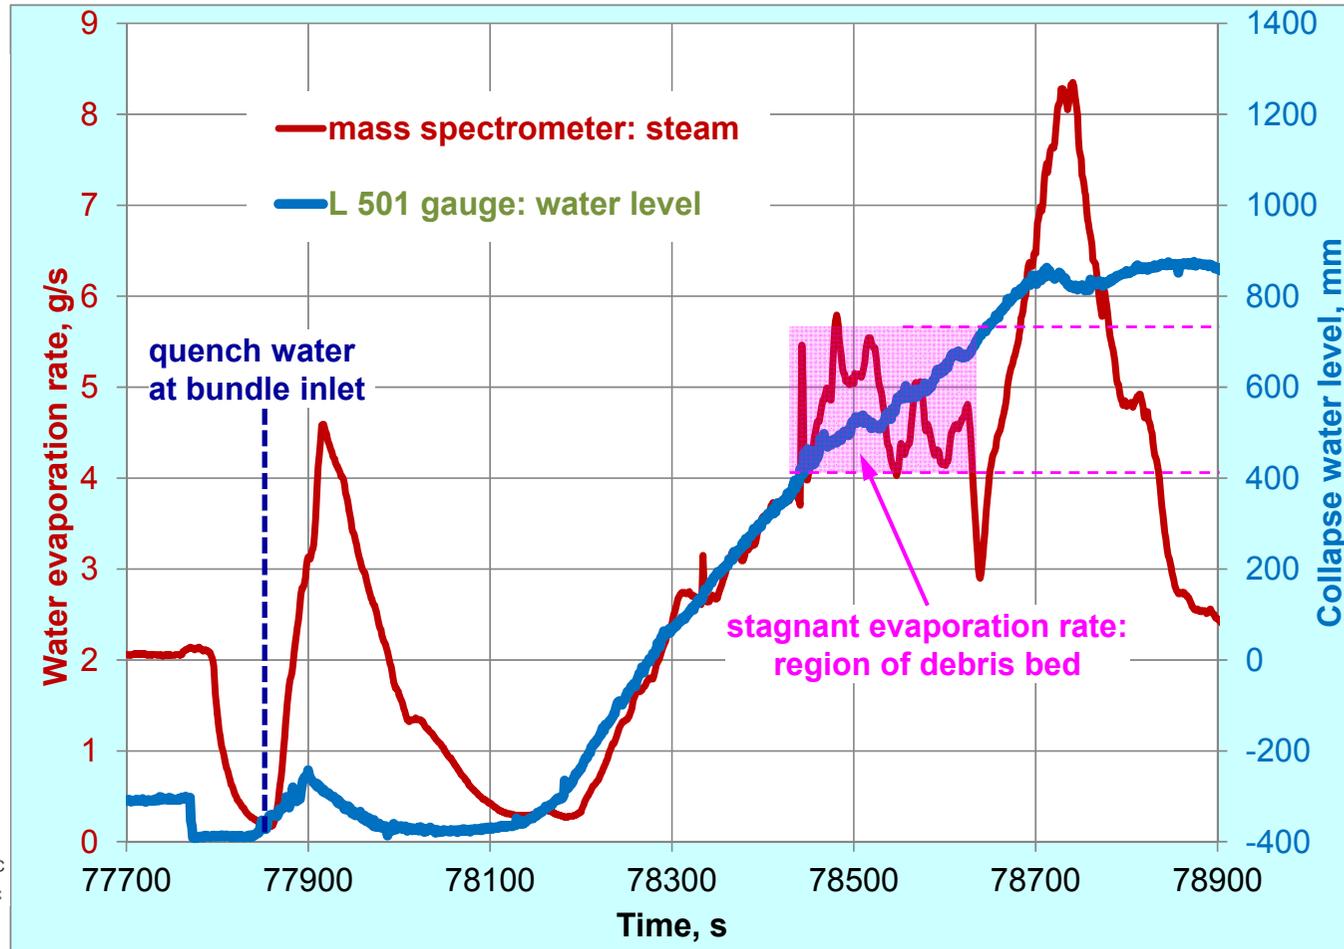
Quench phase: water level oscillations and evaporation rate

- Steam production rate was **stagnated** during propagation of flooding water through the debris collected above grid spacers at 350 mm.
- Despite additional gas flow from breaches in the shroud and unheated rods, the course of the experiment closely followed the pre-test prediction, indicating that those events did not impact the test conduct.

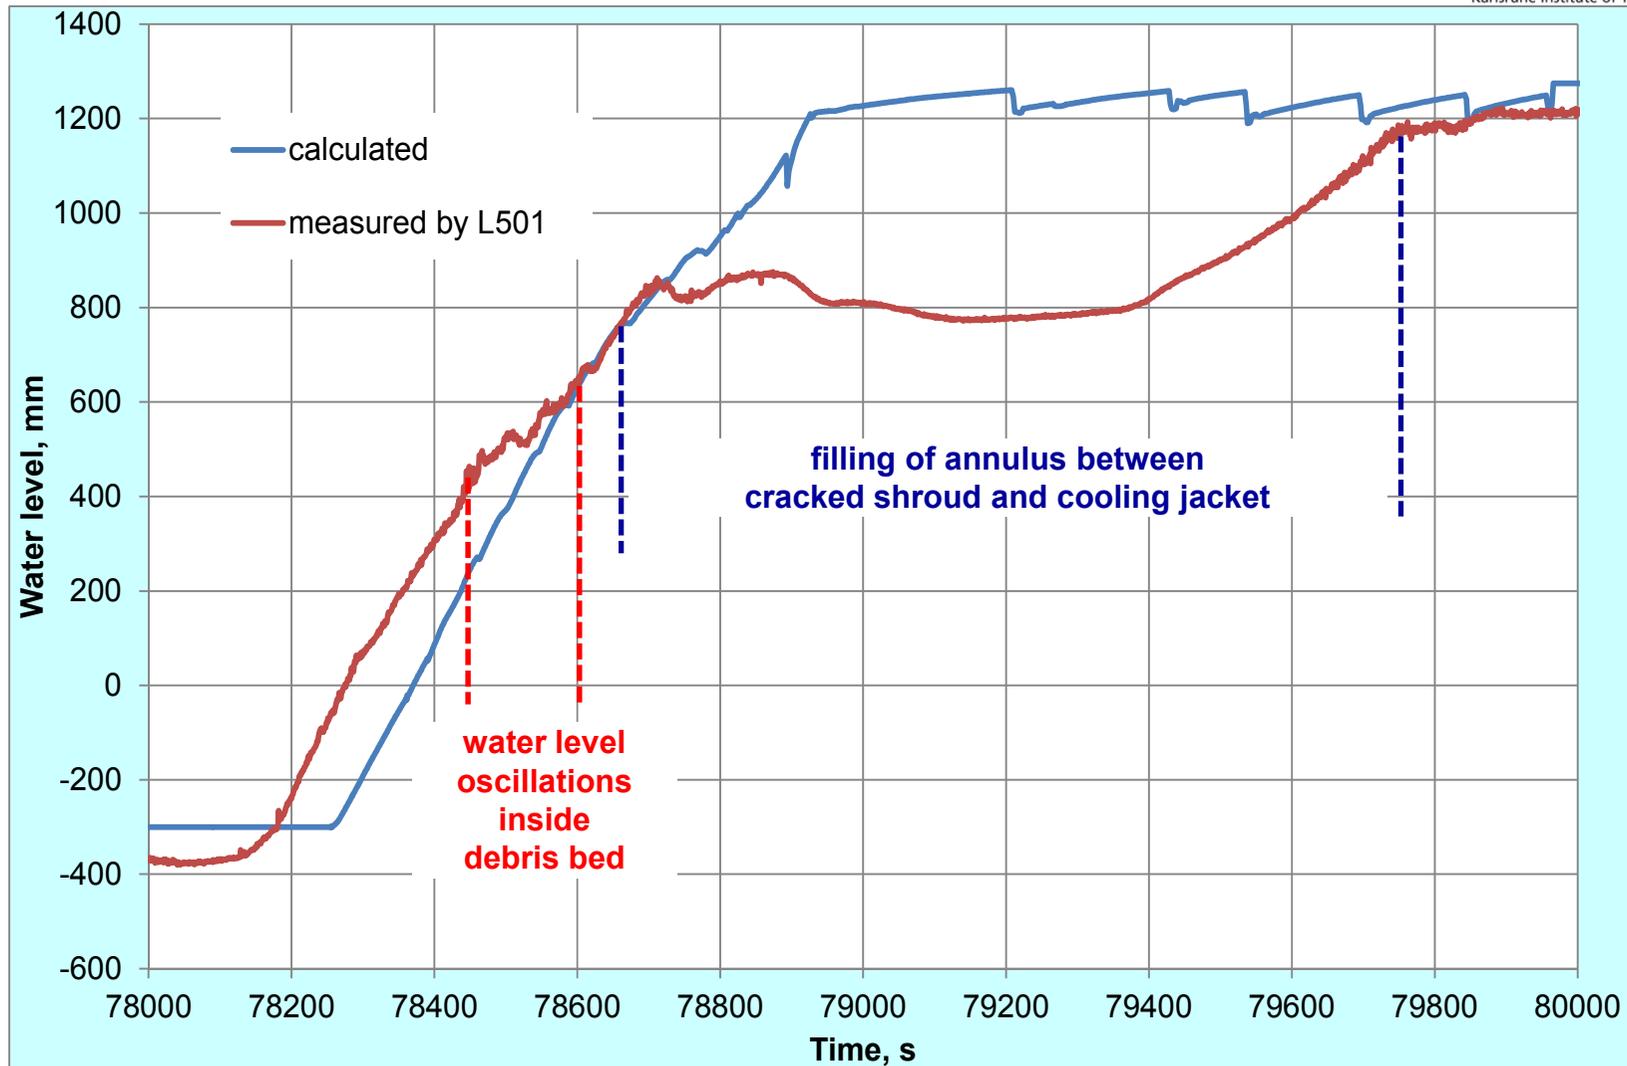
Quench phase: measured and calculated water level

averaged good agreement between pre-calculated and measured results,
but no prediction for water level oscillations

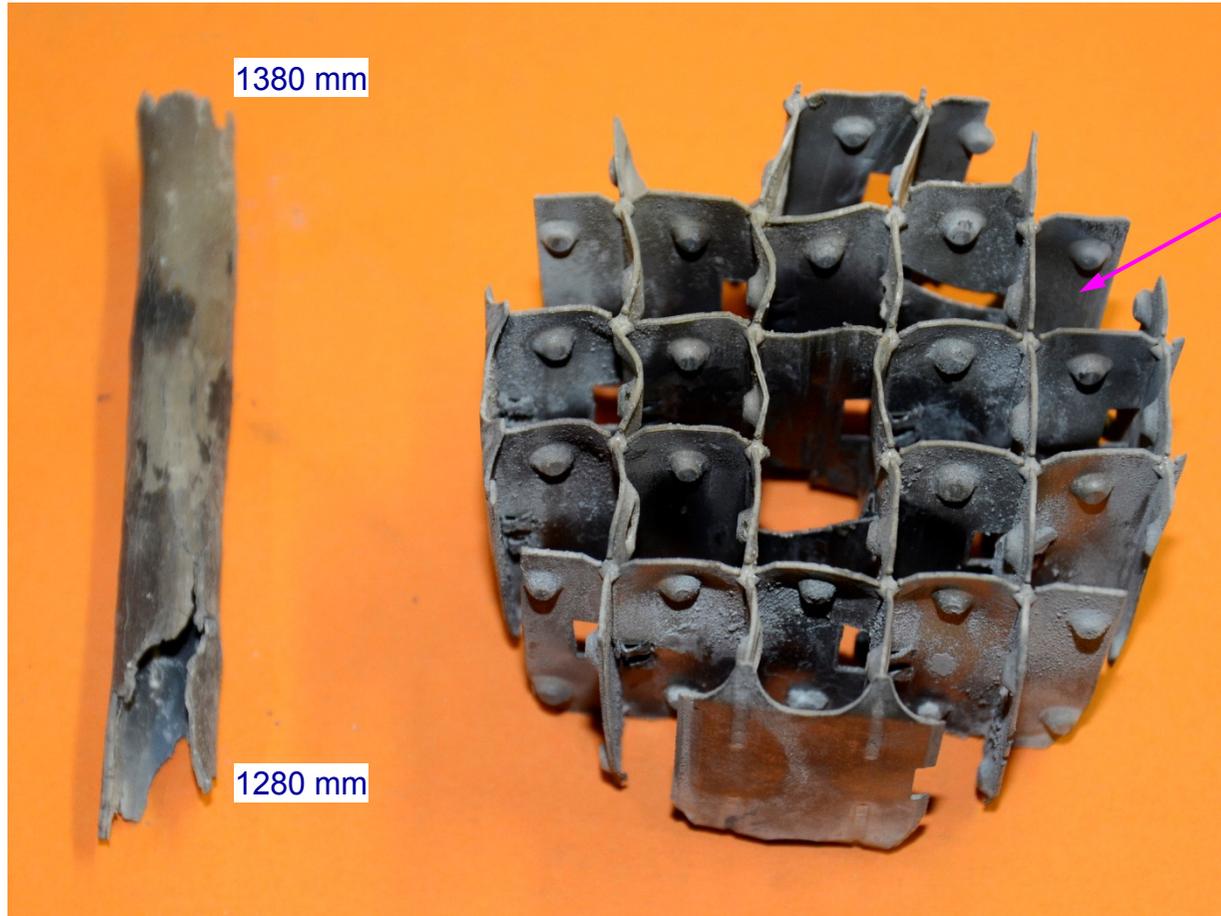
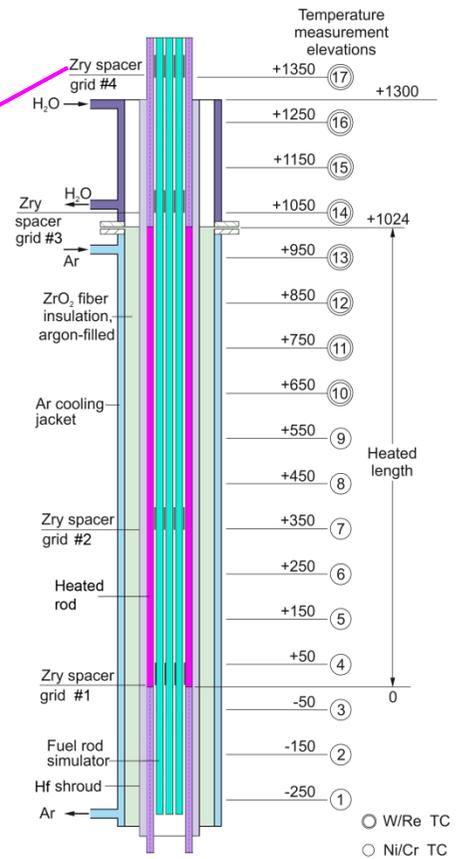
Withdrawn grid spacer #4 (1350 -1390 mm) and remnant of cladding

remnant of rod #8:
significantly oxidised

GS #4:
completely oxidised

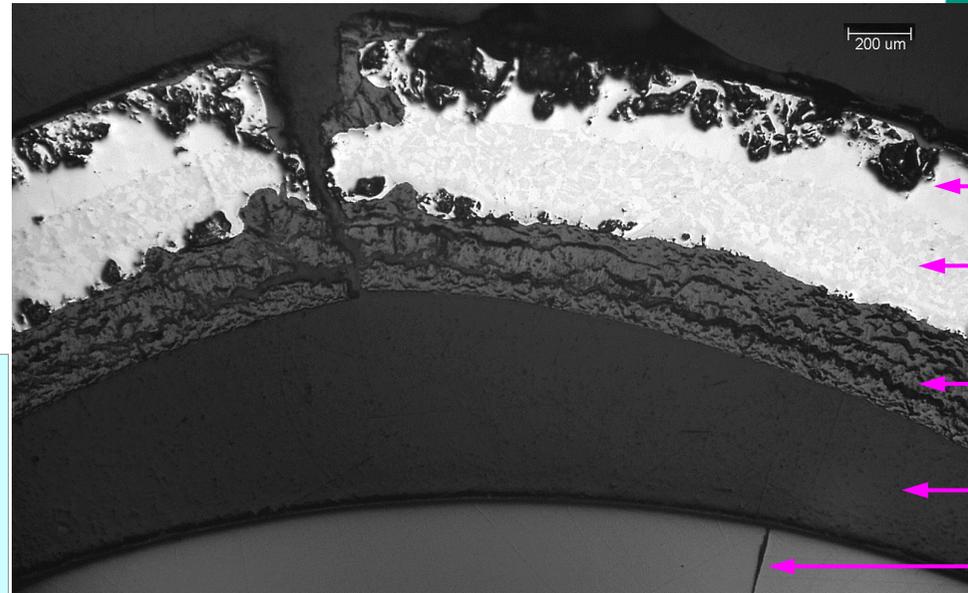
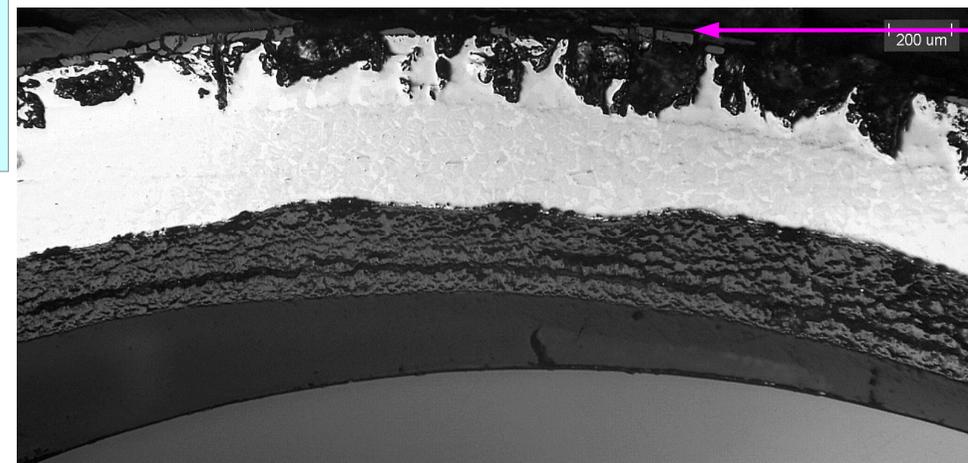
Structure of oxidized Zry cladding remnant at 1328 mm, $T \approx 1000$ K

- ← α -Zr(O)
- ← prior β -Zr
- ← **thick inner oxide layer (breakaway)**
- ← gap
- ← upper not segmented pellet

- ← **thin outer ZrO_2 (starvation, spalling?)**

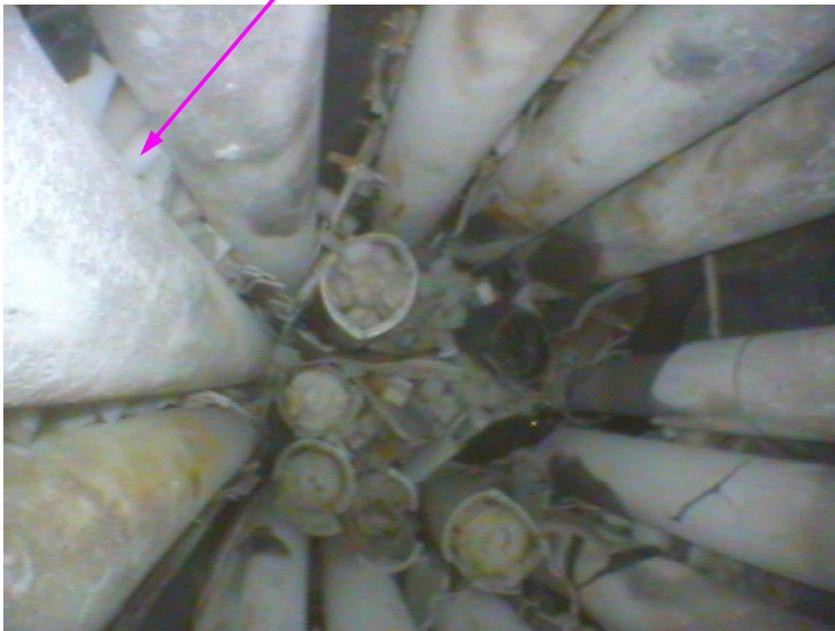
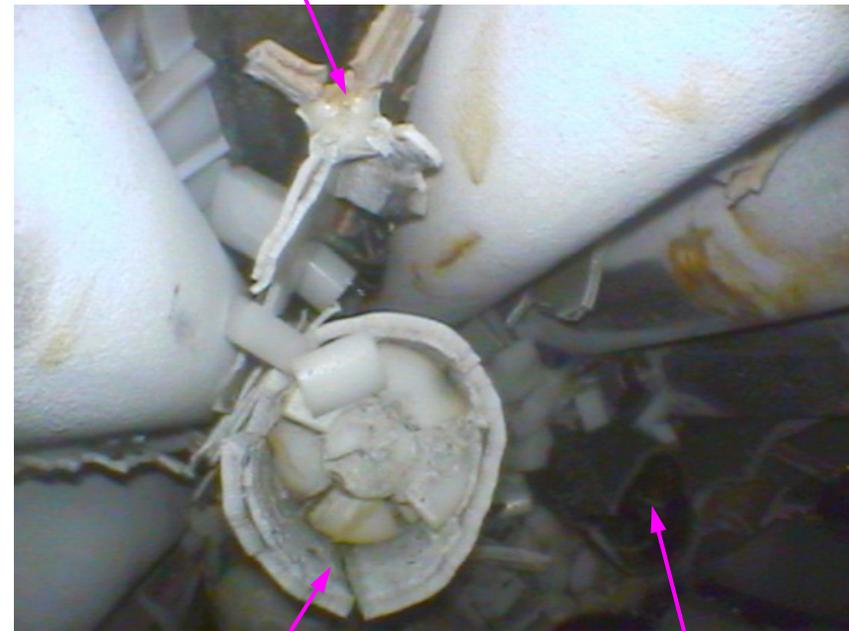
Top view of grid spacer #3 (1090 mm)

pellet segments
between heated rods

completely oxidised GS #3

cladding filled
with pellet segments

empty
cladding

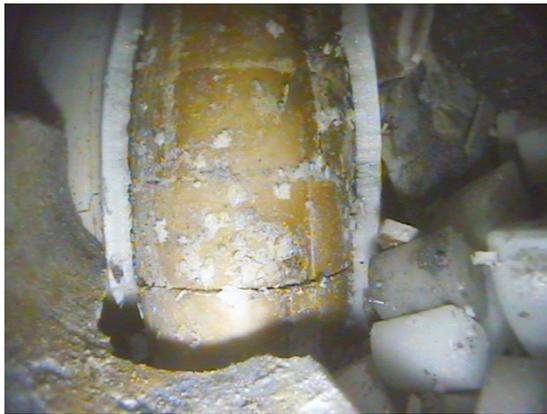
sintered pellets at 950 mm

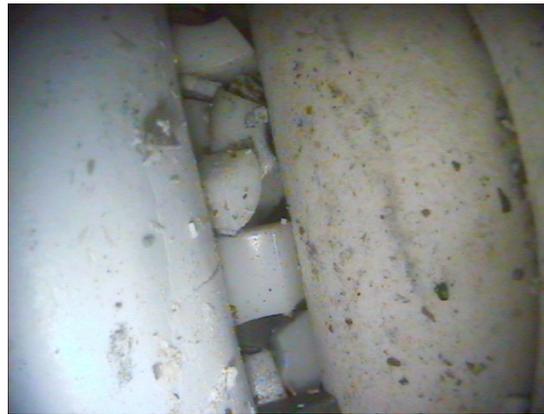
pellet segments at 920 mm
between Zry and Hf claddings

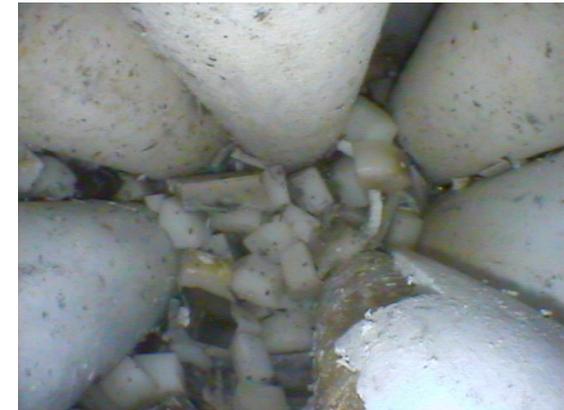
blockage at elevation 910 mm

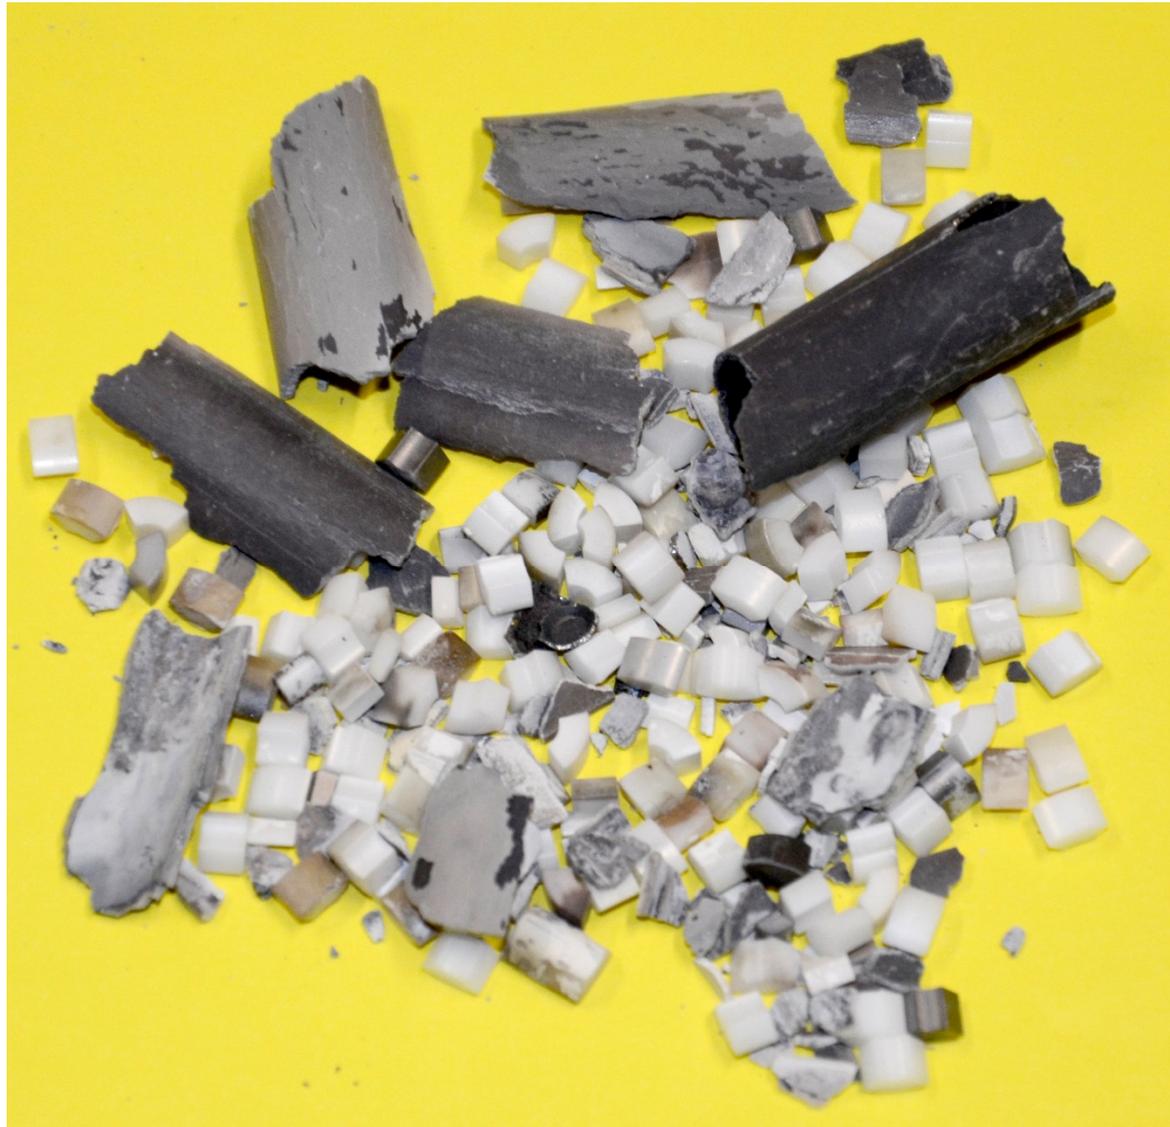
Debris collected at the top of grid spacer #3 (1090 mm)

- Mechanical impact on the end of pre-oxidation caused debris relocation to grid spacers at 1050 mm and 350 mm. Some Zry-4 claddings were not significantly damaged; the pellet segments relocated from the failed rods were captured between corresponding neighbour rods. Ceramics debris collected at the top of grid spacers consist of separate pellet segments and **relatively large cladding segments**.

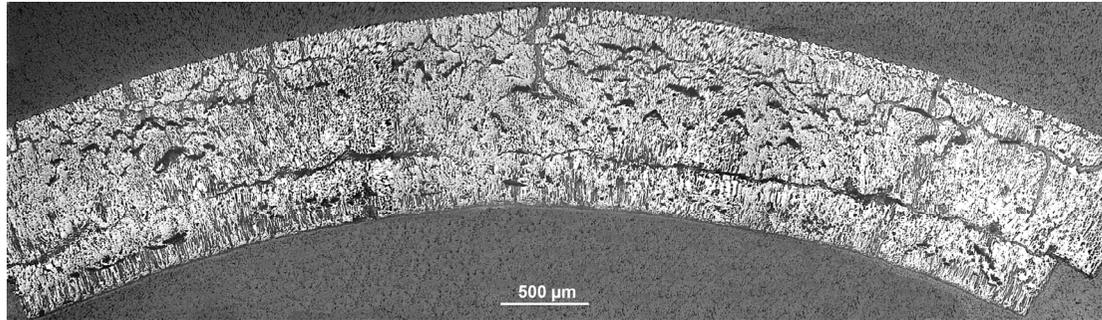
Structure of claddings at elevations 1050 mm

completely oxidized Zry cladding (segment of tube debris)
