Results of the QUENCH-DEBRIS bundle test

QWS19, Karlsruhe 2013

Institute for Applied Materials; Program NUKLEAR

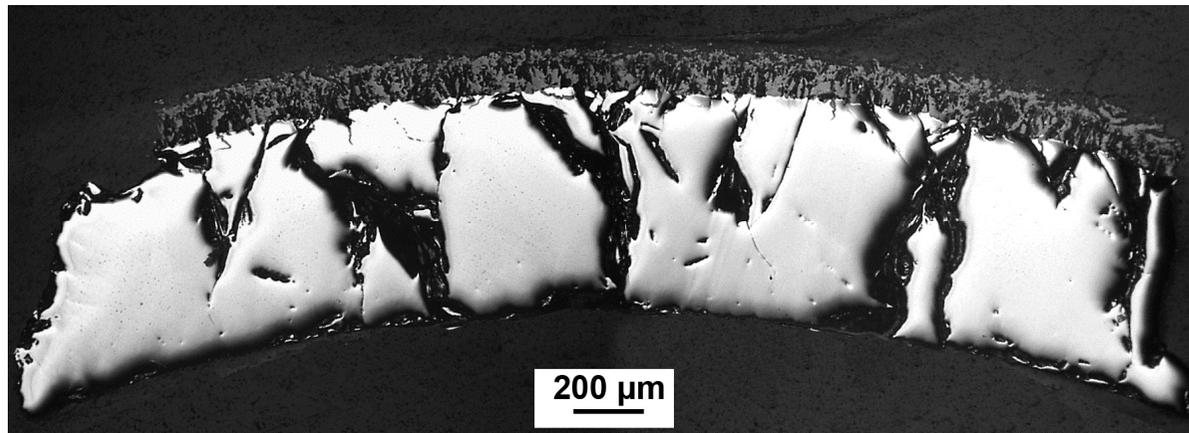
partially oxidized Hf cladding (deleted segment of cladding)

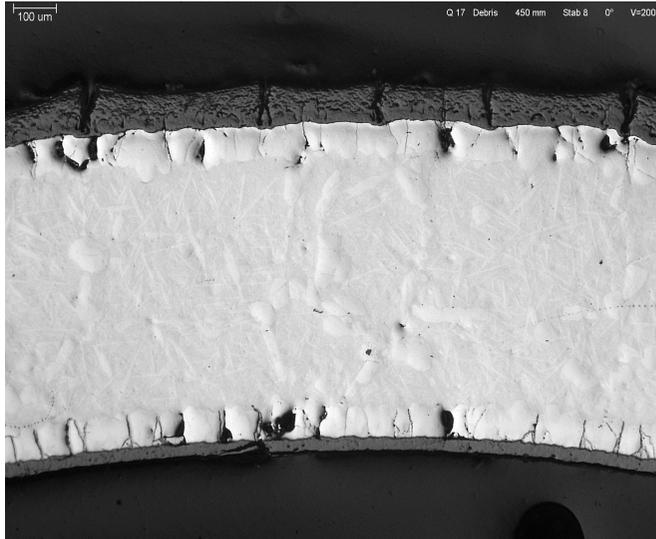
450 mm: outer ZrO₂ 75 µm, inner ZrO₂ 25 µm, α-Zr(O) 70 µm (outer and inner), prior β-Zr rest

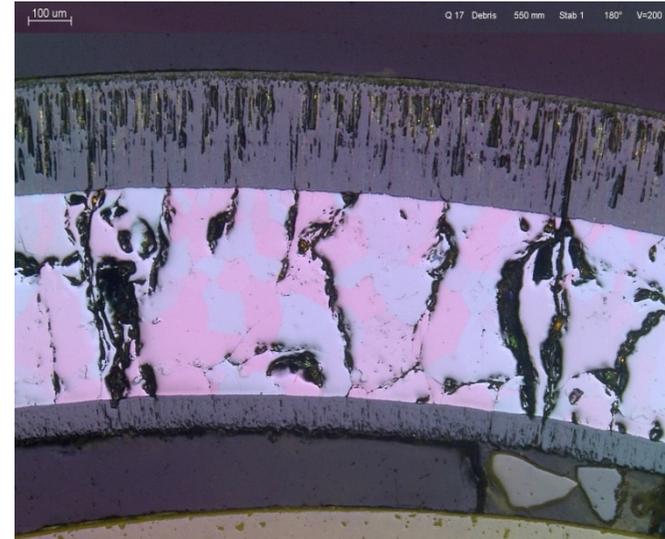
550 mm: outer ZrO₂ 250 µm, inner ZrO₂ 75 µm, α-Zr(O) rest

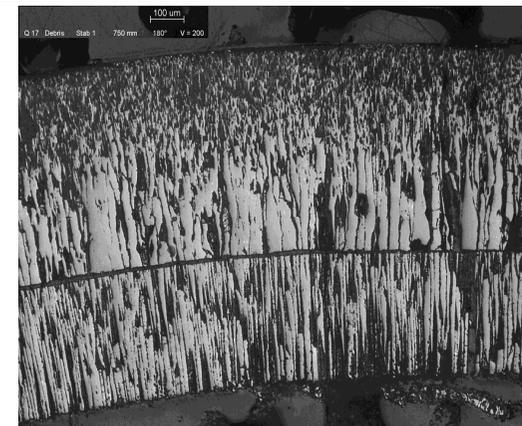
750 mm: completely oxidised

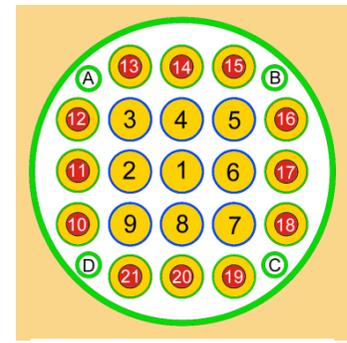
bundle composition

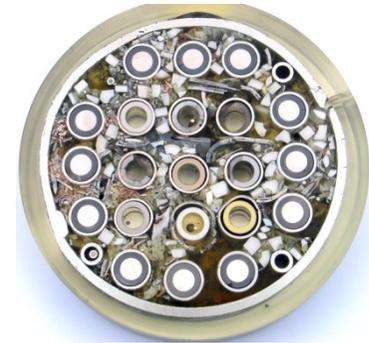
cross-section at 400 mm: metallography

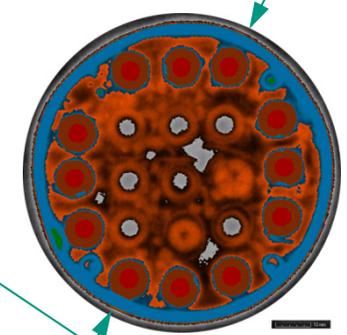
cross-section at 400 mm: tomography; blockage 85%

- The **porosity** of debris bed is **significant**, no dense packing of debris particles was observed. **Large empty volumes** formed due to bending of rods. The maximum bundle blockage was about 85%.
