Results of the QUENCH-DEBRIS Test

J. Stuckert, M. Große, Y. Onel, C. Rössger, M. Steinbrück

ICAPP 2014, Paper 14150

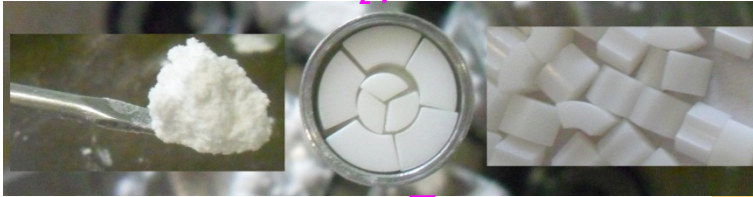
Zry cladding filled with ZrO_2 pellet segments and ZrO_2 powder

9 unheated rods with Zry-4 cladding

12 heated rods with Hf cladding

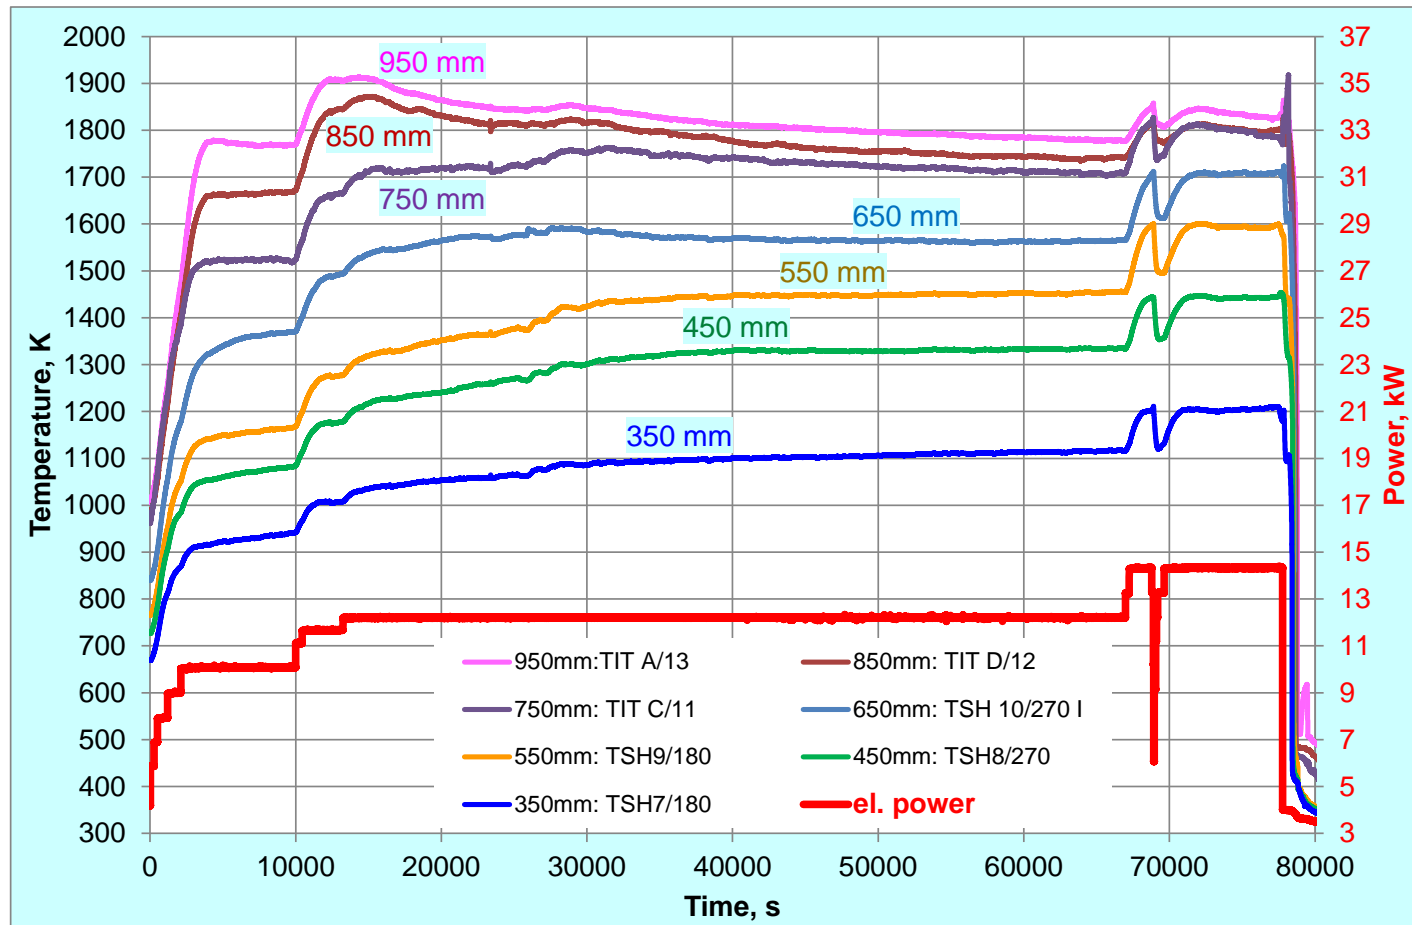
Test scenario: el. power and TC readings at different elevations

- 1) pre-oxidation stage with 2 g/s steam and 2 g/s Ar. Complete oxidation of Zry-4 clads between 650 and 1150 mm
- 2) Test termination: reflood from bottom with water flow rate 10 g/s.

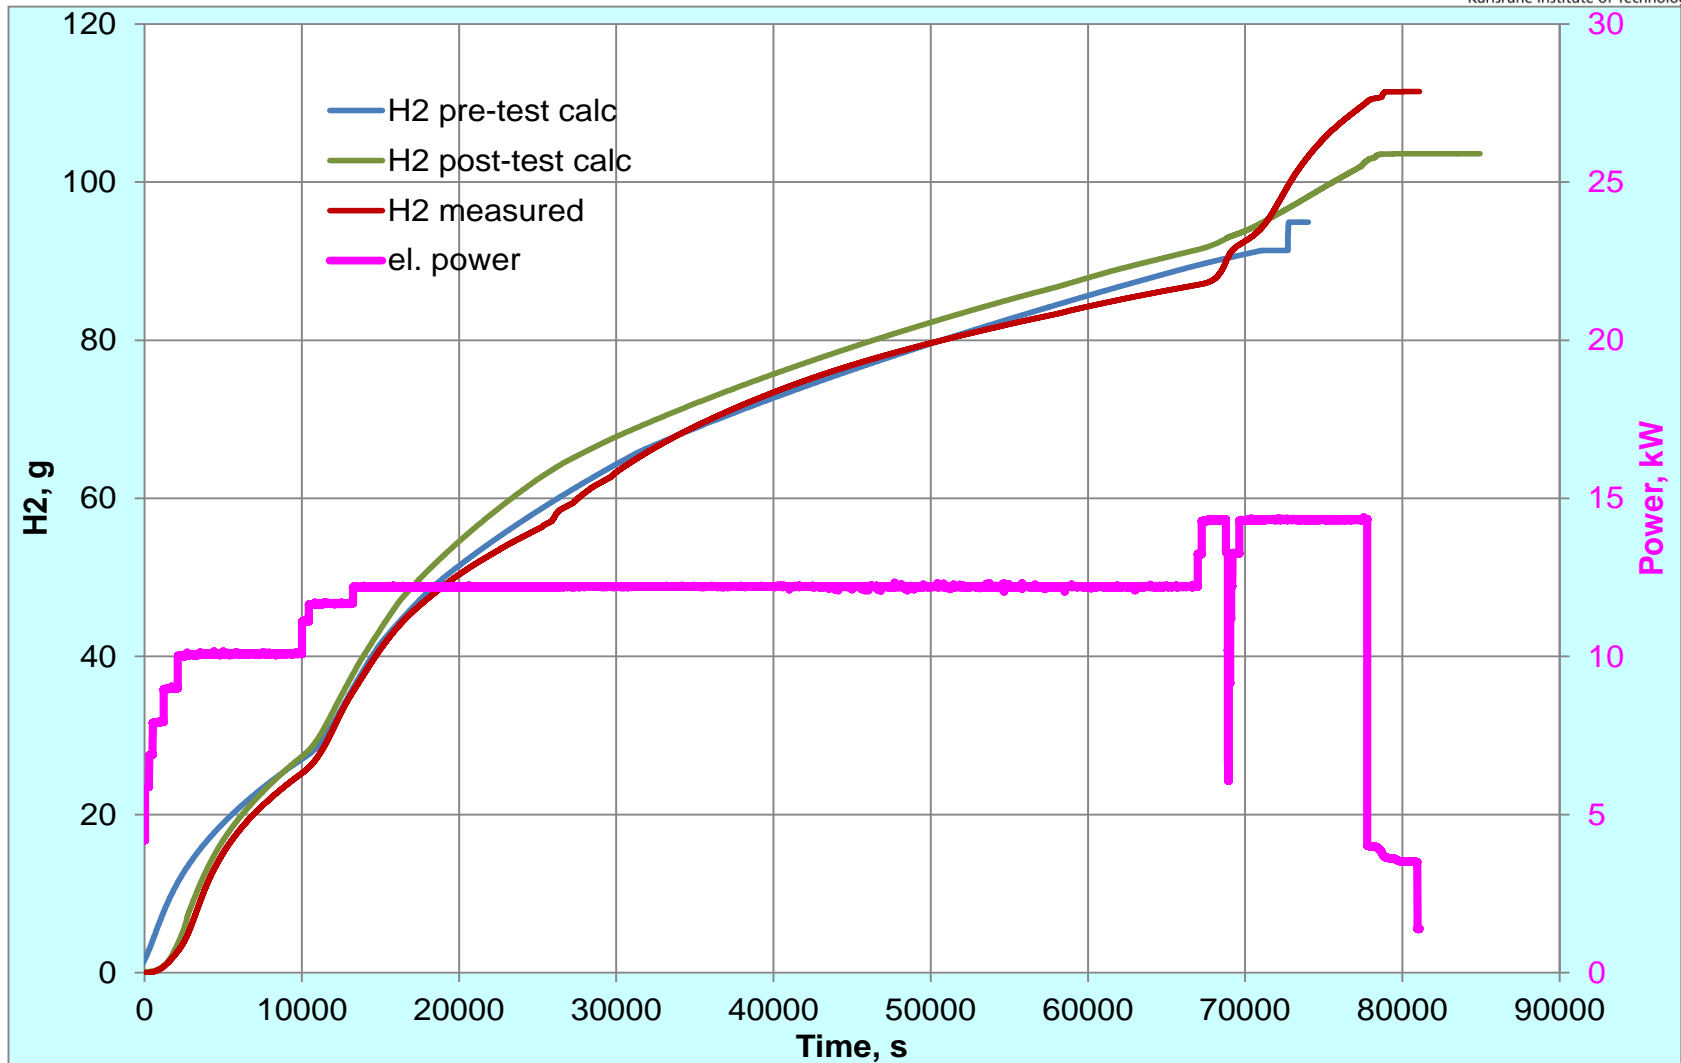
Integral criterion of bundle oxidation progression: hydrogen release during oxidation of Zry and Hf parts

the course of the experiment closely followed the pre-test prediction

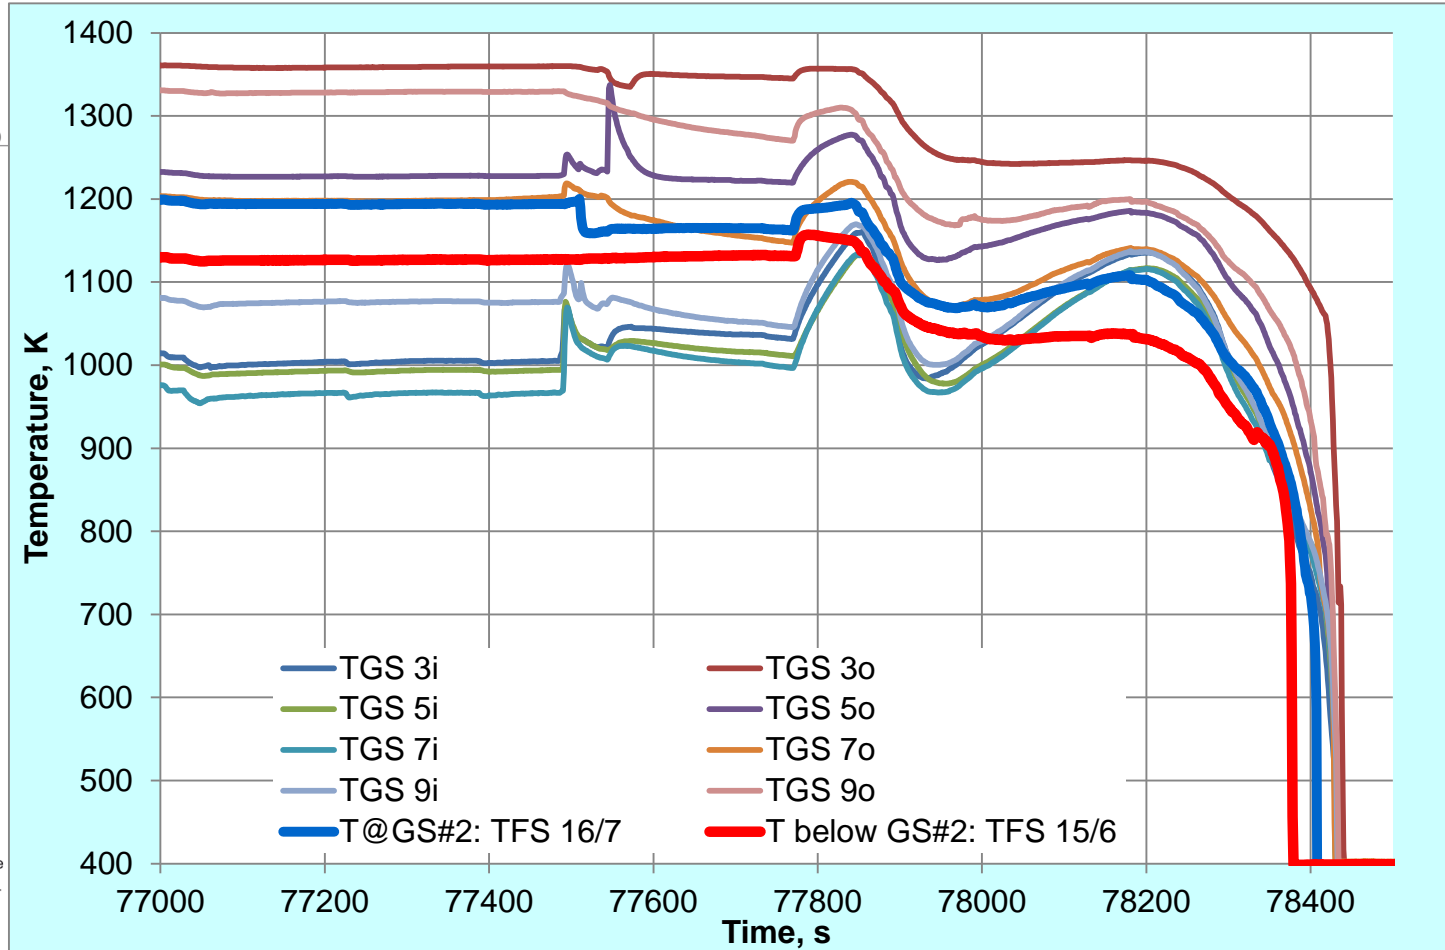
Indication of debris relocation to GS#2 (reaction of thermocouples at the top of GS#2) after mechanical impact on the bundle top

TC (TGS)

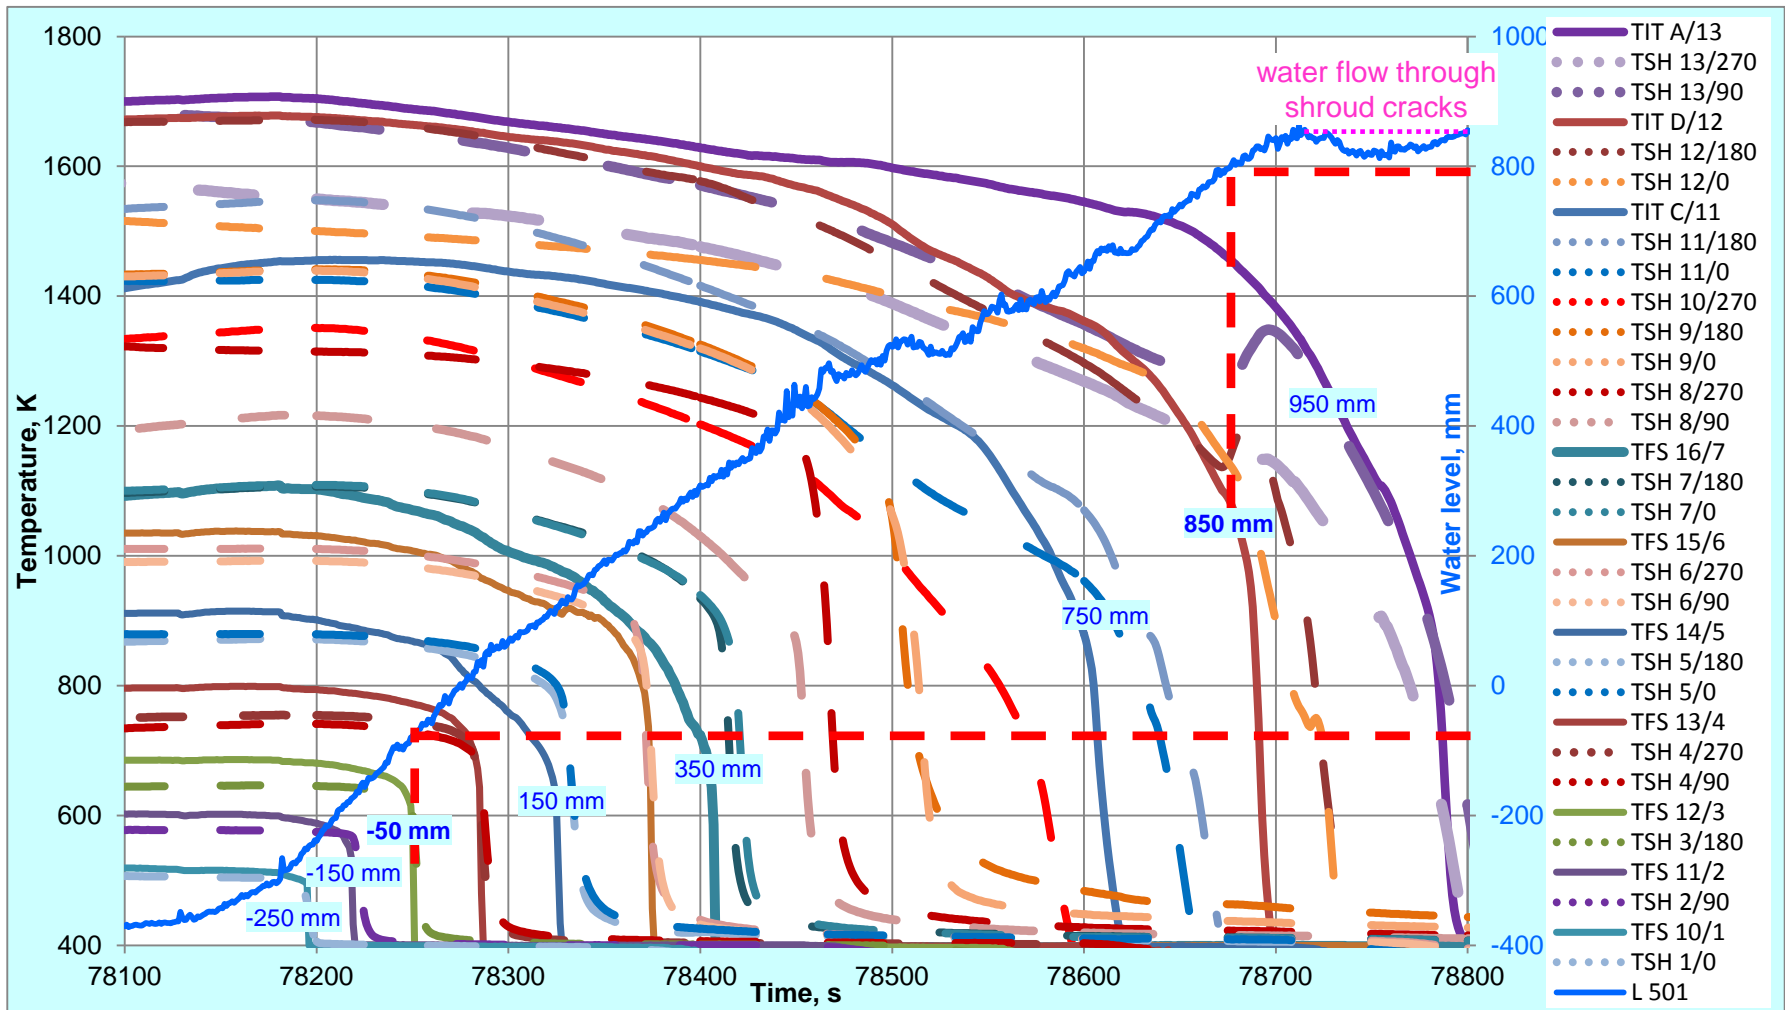
Quench phase: collapse water level and TC wetting

TC wetting at high elevation by 2-phase fluid

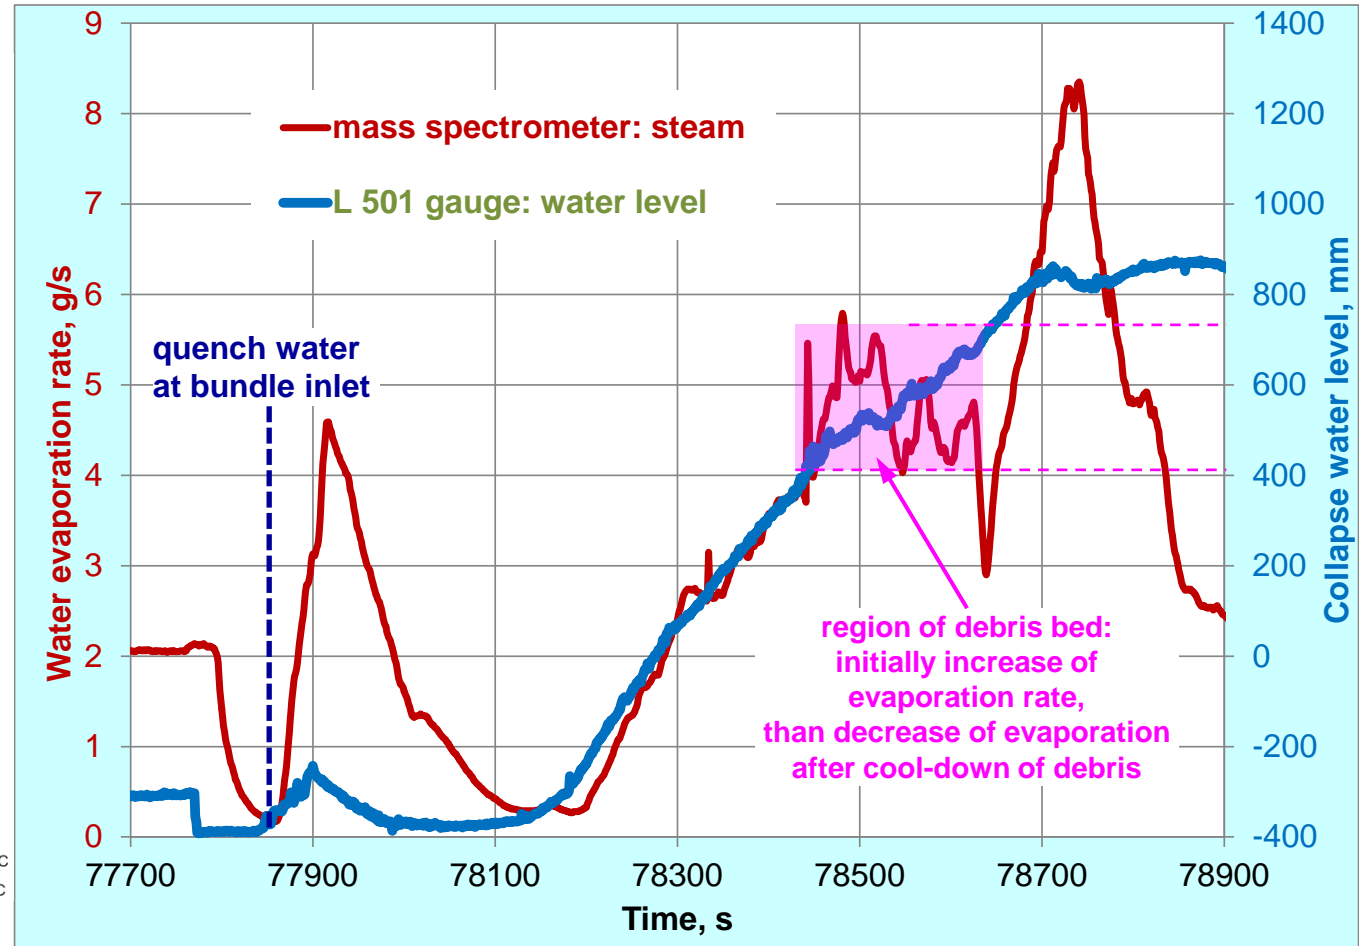
Quench phase: water level oscillations and evaporation rate

- Steam production rate was strongly **oscillated** during propagation of flooding water through the debris collected above grid spacers at 350 mm.
- The **porosity** of debris bed is **significant**, no dense packing of debris particles was observed. **Large empty volumes** formed due to bending of rods. The maximum cooling channel **blockage** was about **85%**.

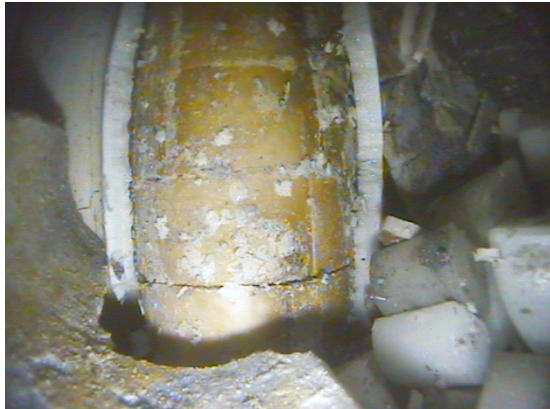
sintered pellets at 950 mm

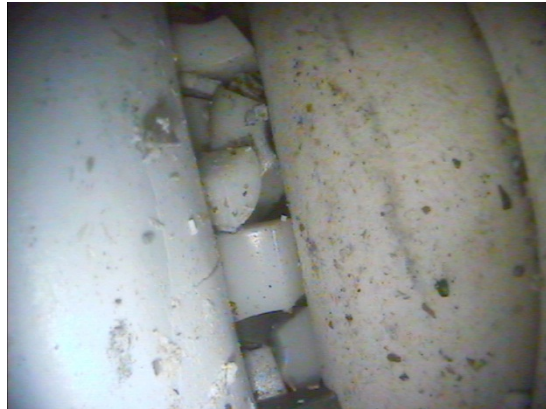
pellet segments at 920 mm
between Zry and Hf claddings

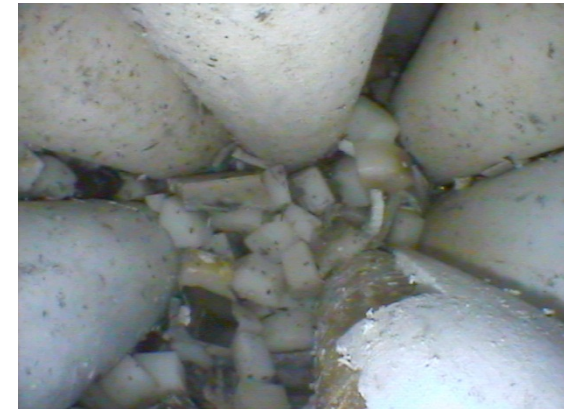
blockage at elevation 910 mm

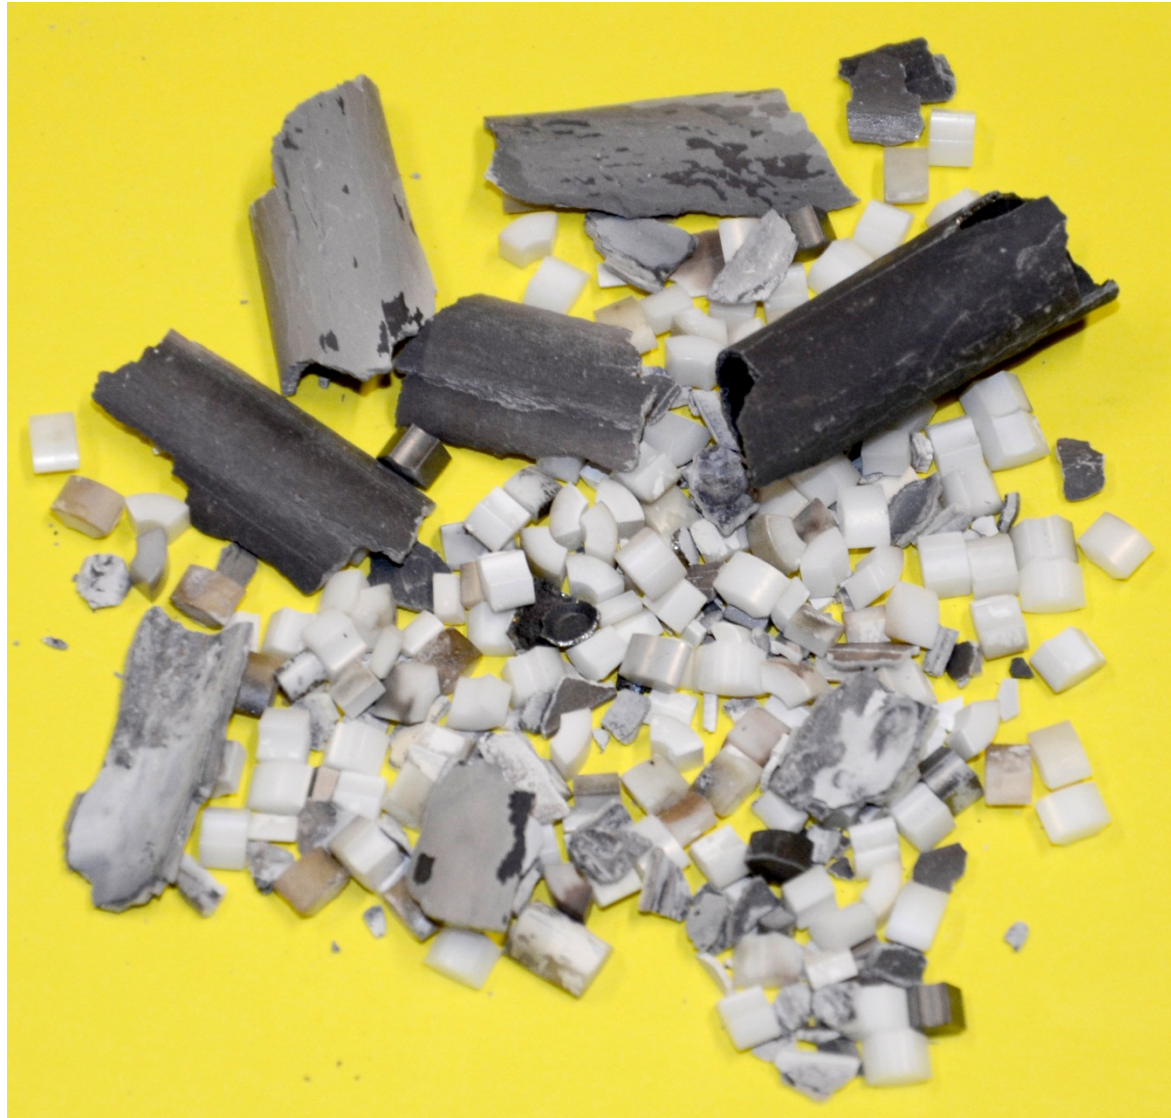
Debris collected at the top of grid spacer #3 (1090 mm)

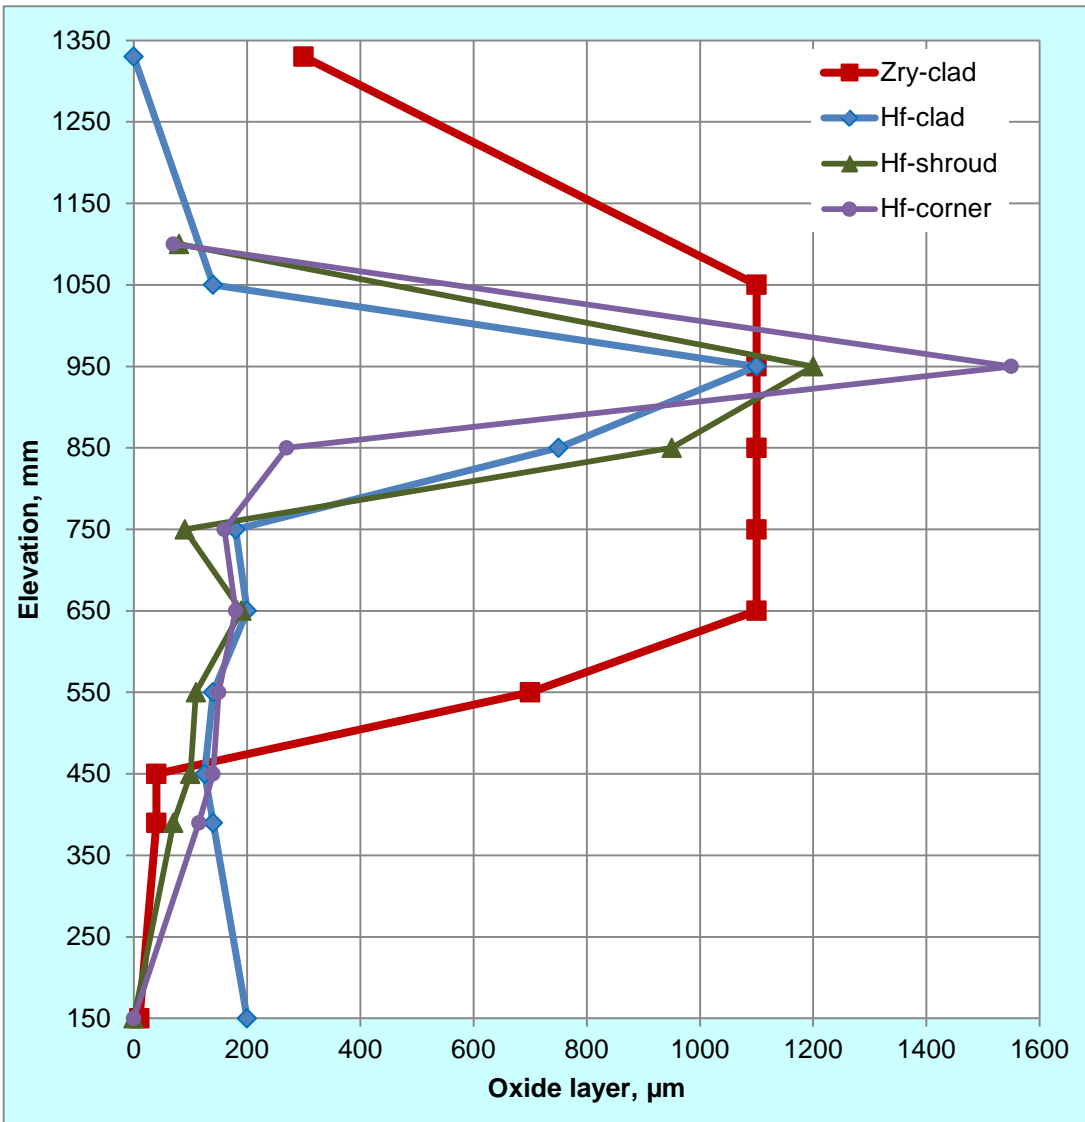
Axial distribution of oxide layers

Elevation, mm	ZrO ₂ , μm	HfO ₂ -clad, μm
150	10	200
390	40	140
450	40	125
550	700	140
650	1100	200
750	1100	180
850	1100	750
950	1100	1100
1050	1100	140
1330	300	0

Elevation, mm	HfO ₂ -shroud, μm	HfO ₂ -corner, μm
150	0	0
390	70	115
450	100	140
550	110	150
650	190	180
750	90	160
850	950	270
950	1200	1550
1100	80	70

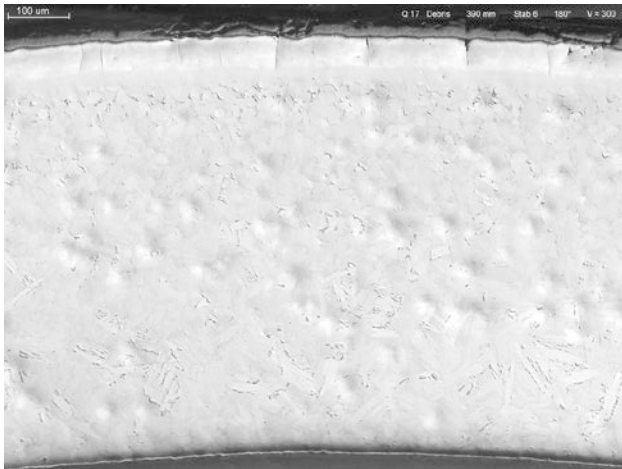
rod #6: outer ZrO_2 25 μm ; $\alpha\text{-Zr(O)}$ 50 μm ;
no debris \rightarrow *good heat removal*

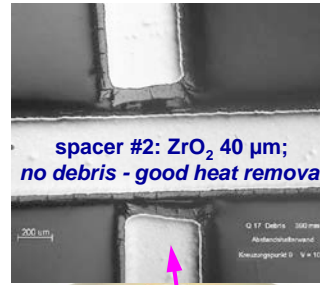
spacer #2: ZrO_2 40 μm ;
no debris - good heat removal

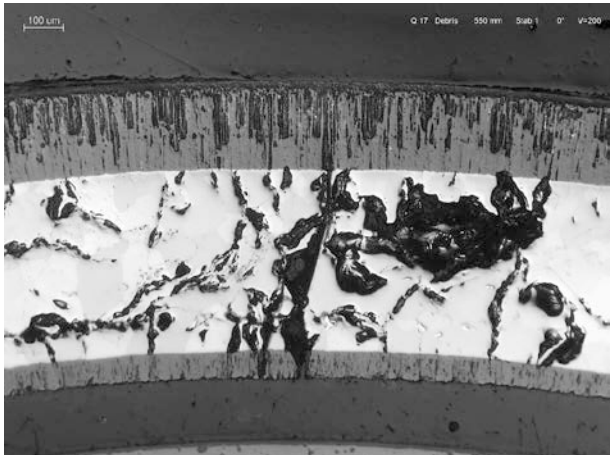
rod #1 (similar to #2 - #6):
 outer ZrO_2 220 μm ; inner ZrO_2 70 μm ;
 through-going crack

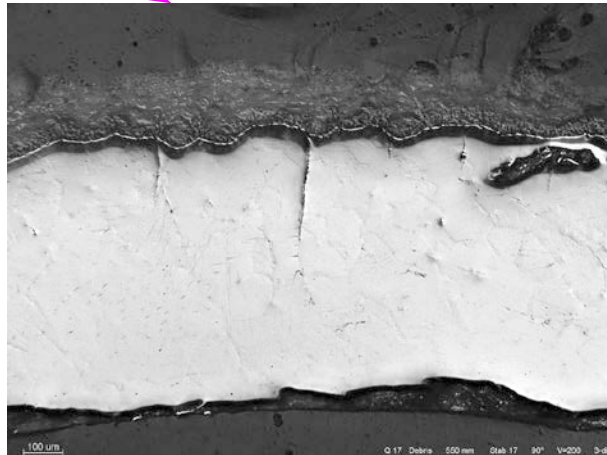
rod #17: outer HfO_2 160 μm , breakaway
 $\alpha\text{-Hf(O)}$ remnant

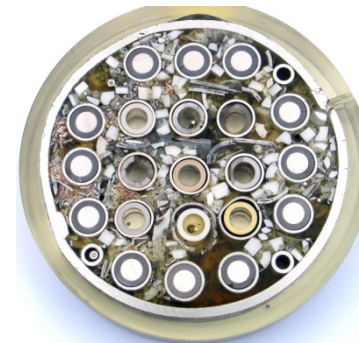
cross-section at 400 mm:
metallography 25°

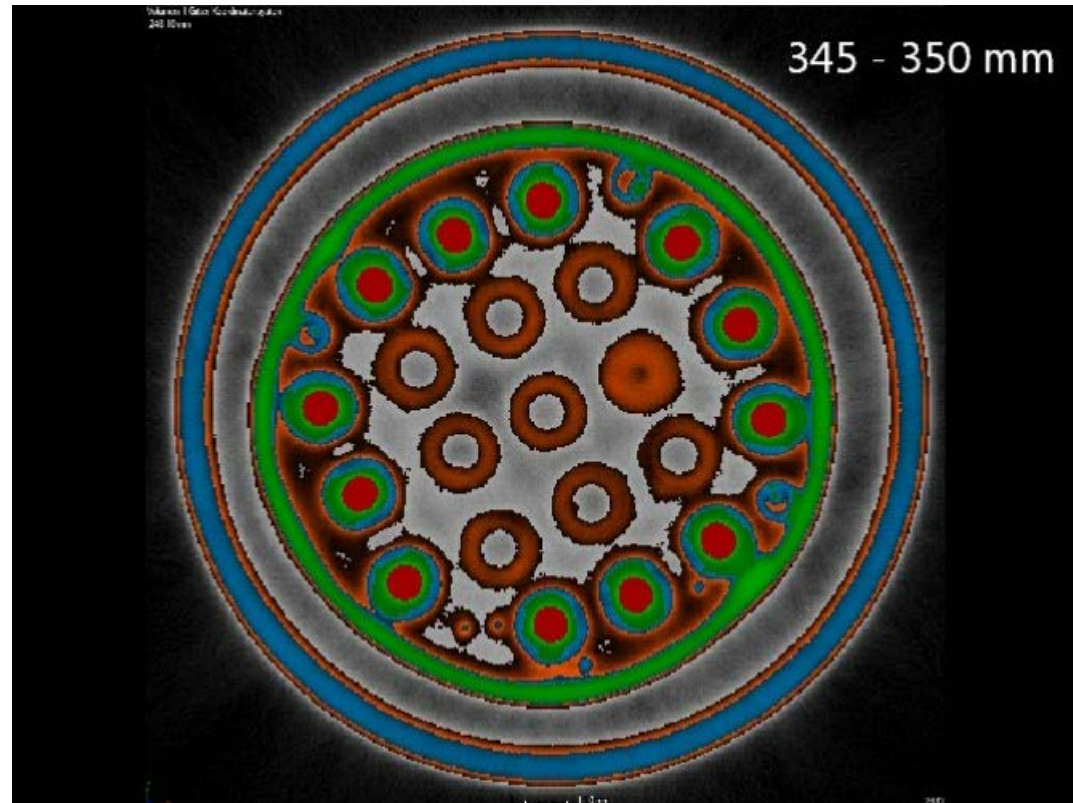
X-ray tomography: debris formed before flooding above grid spacer GS2

Movie: debris between 392 mm (GS top) and 765 mm
