Influence of the Temperature History on Secondary Hydriding and Mechanical Properties of Zircaloy-4 Claddings - an Analysis of the QUENCH-LOCA Bundle Tests

Paper ICONE22-30792

Institute for Applied Materials; Program NUKLEAR

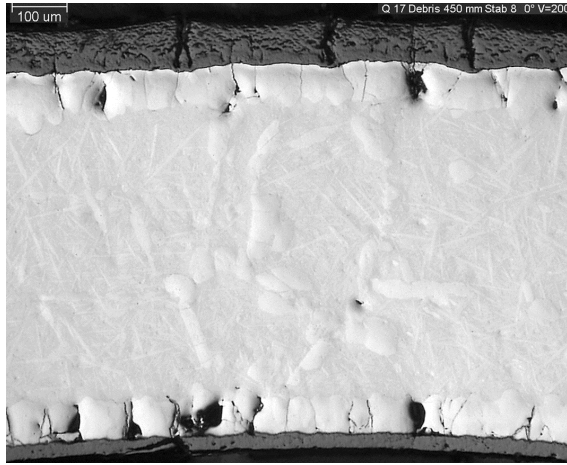
Embrittlement due to oxidation

1250 K
 outer ZrO₂ 100 μm; α-Zr(O) 70 μm;
 inner ZrO₂ 30 μm; α-Zr(O) 80 μm

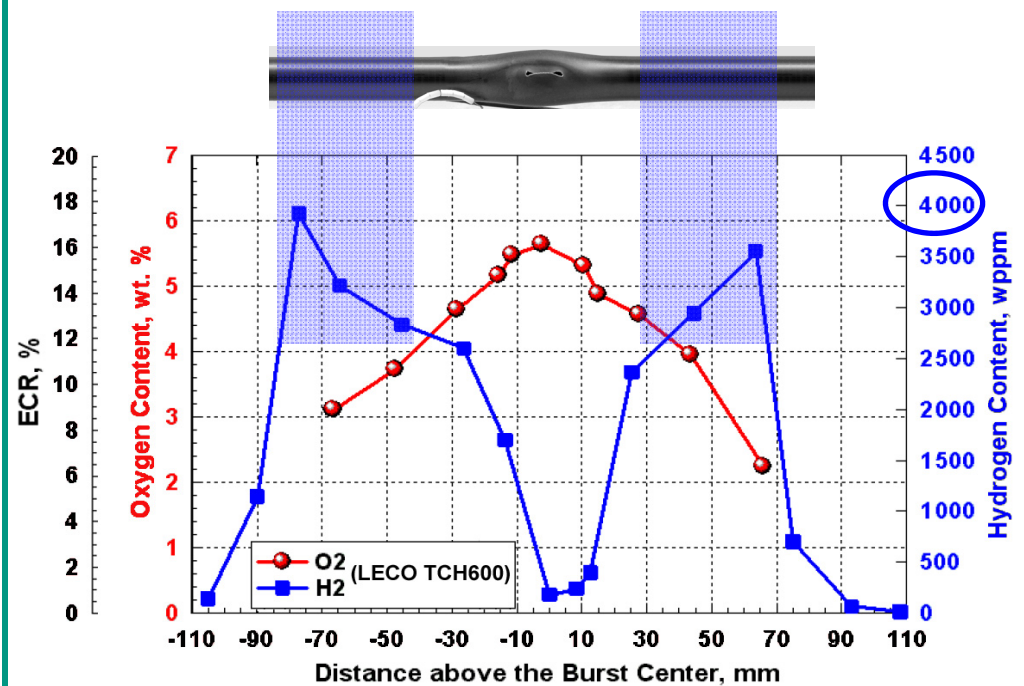
2008, ANL: strong hydriding at 1200°C up to 4000 wppm

NUREG-6967 (Billone et al.): unirradiated pressurised sample OCL11 (Zry-2) ramped in steam from 300°C to 1204°C at 5 K/s, held at 1204°C for 300 s, cooled at 3 K/s to 800°C, and cooled from 800°C to RT

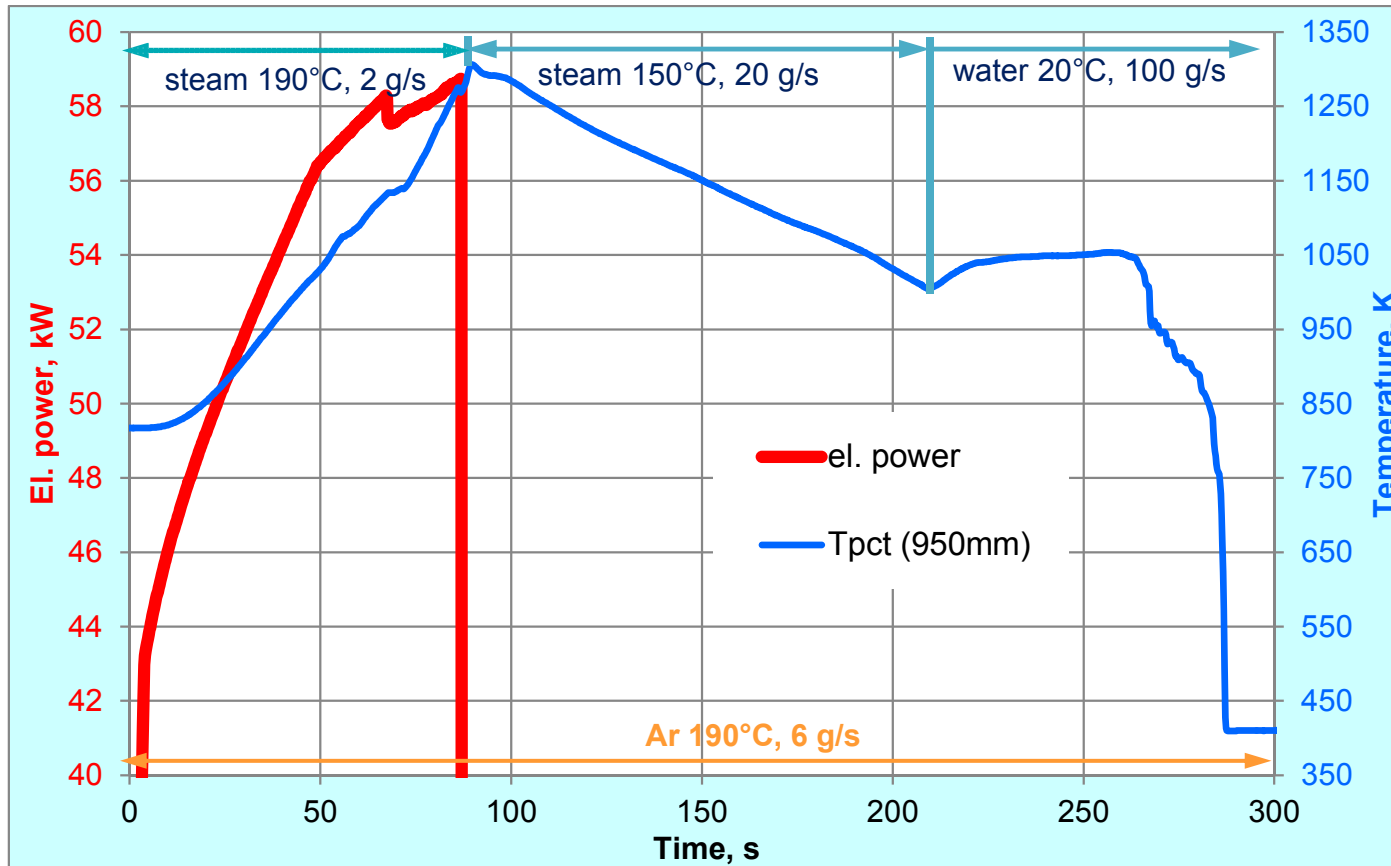
Progress and boundary conditions of the QUENCH-L1 test

maximal reached power:
QUENCH-L1 (Ta-heaters, Ø 6 mm): 58.5 kW,
QUENCH-L0 (W-heaters; Ø 6 mm): 43 kW

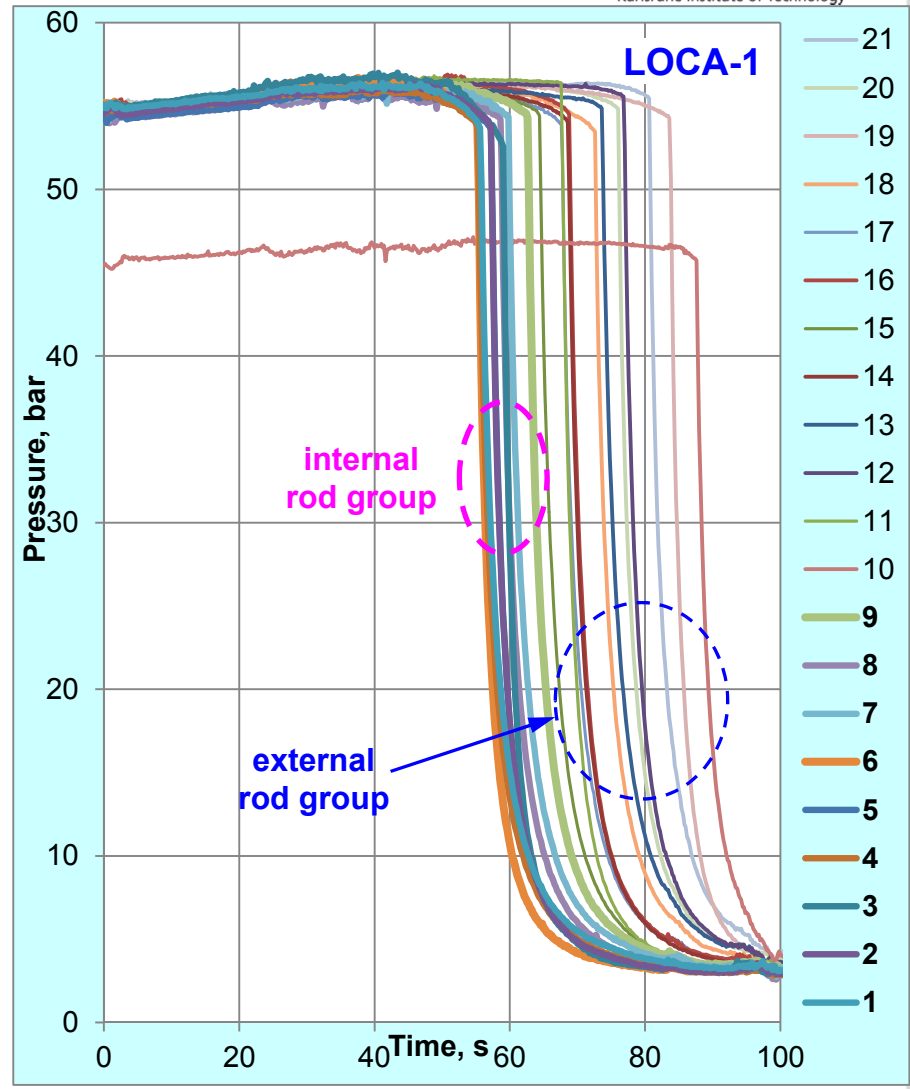
Rod pressure evolution during heating phase for QUENCH-L0 and -L1: burst time indication (coincided with MS results on Kr release)

duration of decrease of the inner pressure to the system pressure: $\tau_0 \approx 38$ s

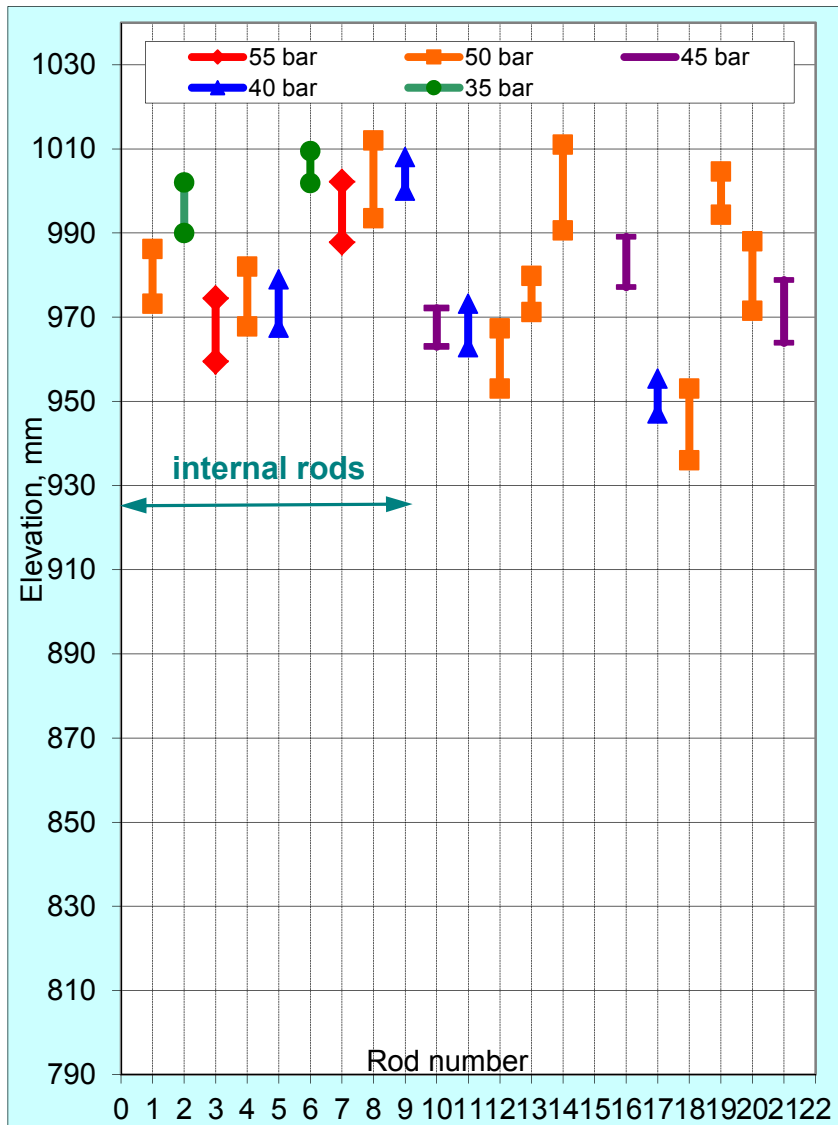
LOCA-0

Length and axial position of burst openings

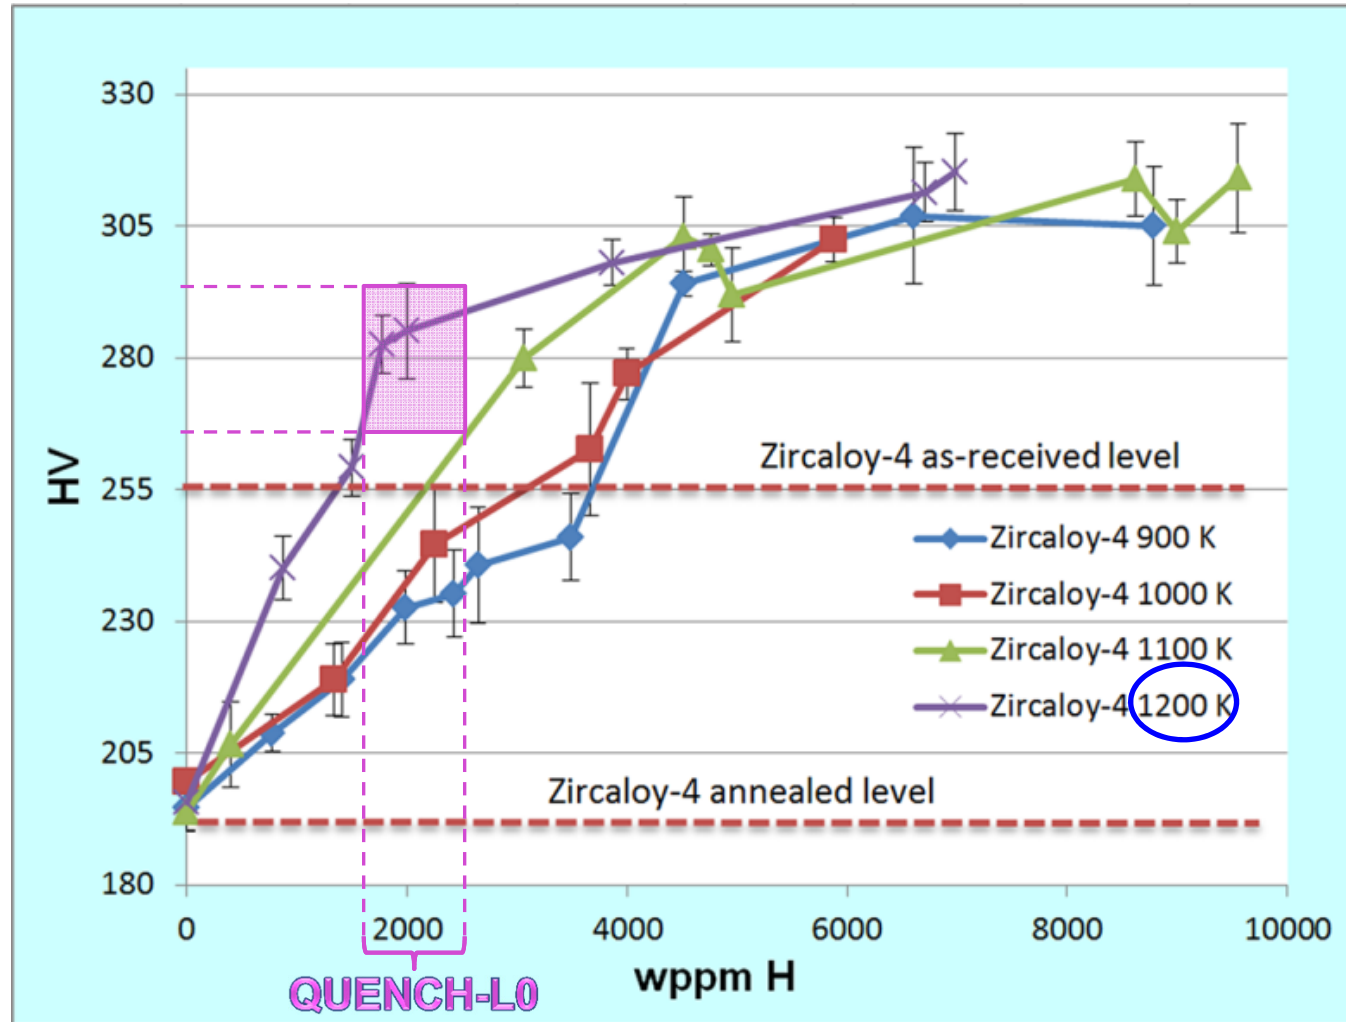
Micro hardness (Vickers) of hydrated single samples: dependence on hydrogen content and temperature

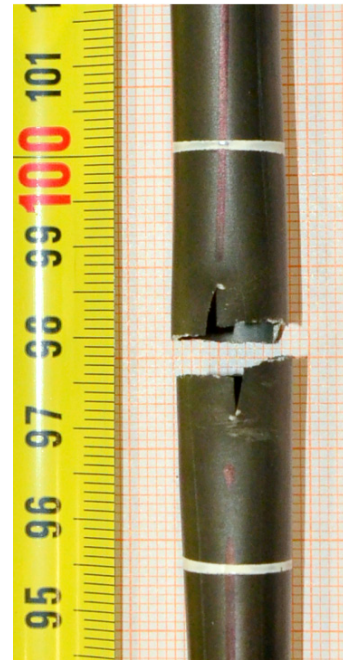
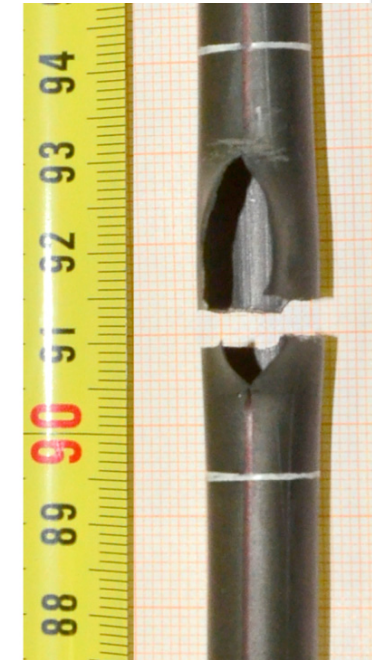
QL1: only stress concentration
(excepted rod #1 brittle ruptured during handling)

rod #4
 $C_H = 730$ wppm

rod #6
 $C_H = 795$ wppm

rod #9
 $C_H = 1270$ wppm

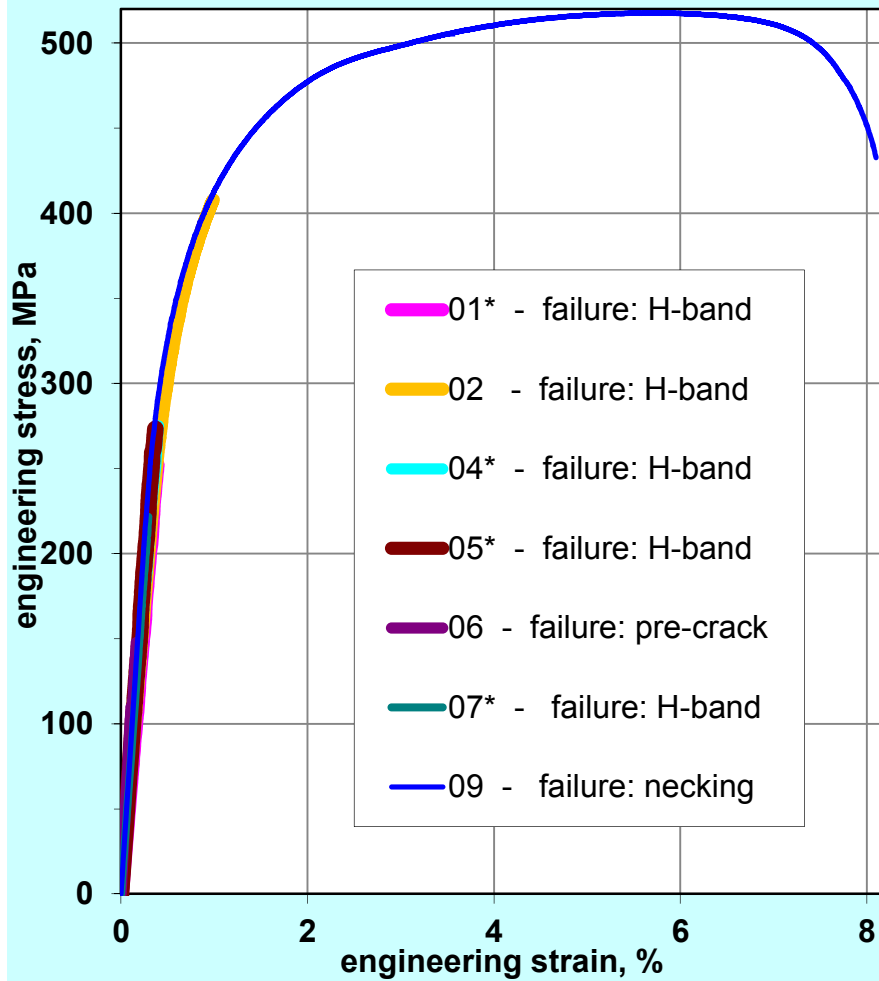
Tensile tests for inner rods

QL0 sample length 500 mm or 250 mm*

rod l ₀ =500 mm *l ₀ =250 mm	ultimate tensile strength [MPa]	fracture stress [MPa]	elongation at fracture [%]	rupture based on:
01*	254	254	0.38	hydrogen embrittlement
02	408	408	0.99	hydrogen embrittlement
04*	276	276	0.40	hydrogen embrittlement
05*	274	274	0.37	hydrogen embrittlement
06	148	148	0.16	stress concentration
07*	222	222	0.29	hydrogen embrittlement
09	518	433	8.10	necking
10	512	507	10.12	necking
11	509	391	11.67	necking
12	502	499	6.44	stress concentration
13	504	504	9.18	stress concentration
14	430	430	1.97	stress concentration
15	505	450	11.70	necking
16	512	389	10.95	necking
17	501	497	3.83	failure at stuck pellet
18	513	458	10.19	necking
19	489	368	11.80	necking
20	452	447	2.20	stress concentration
21	506	498	8.11	stress concentration
