## First results of the high temperature bundle test QUENCH-L3HT with optimized ZIRLO™ claddings

*QWS-20, Karlsruhe 2014*

Institute for Applied Materials; Program NUKLEAR

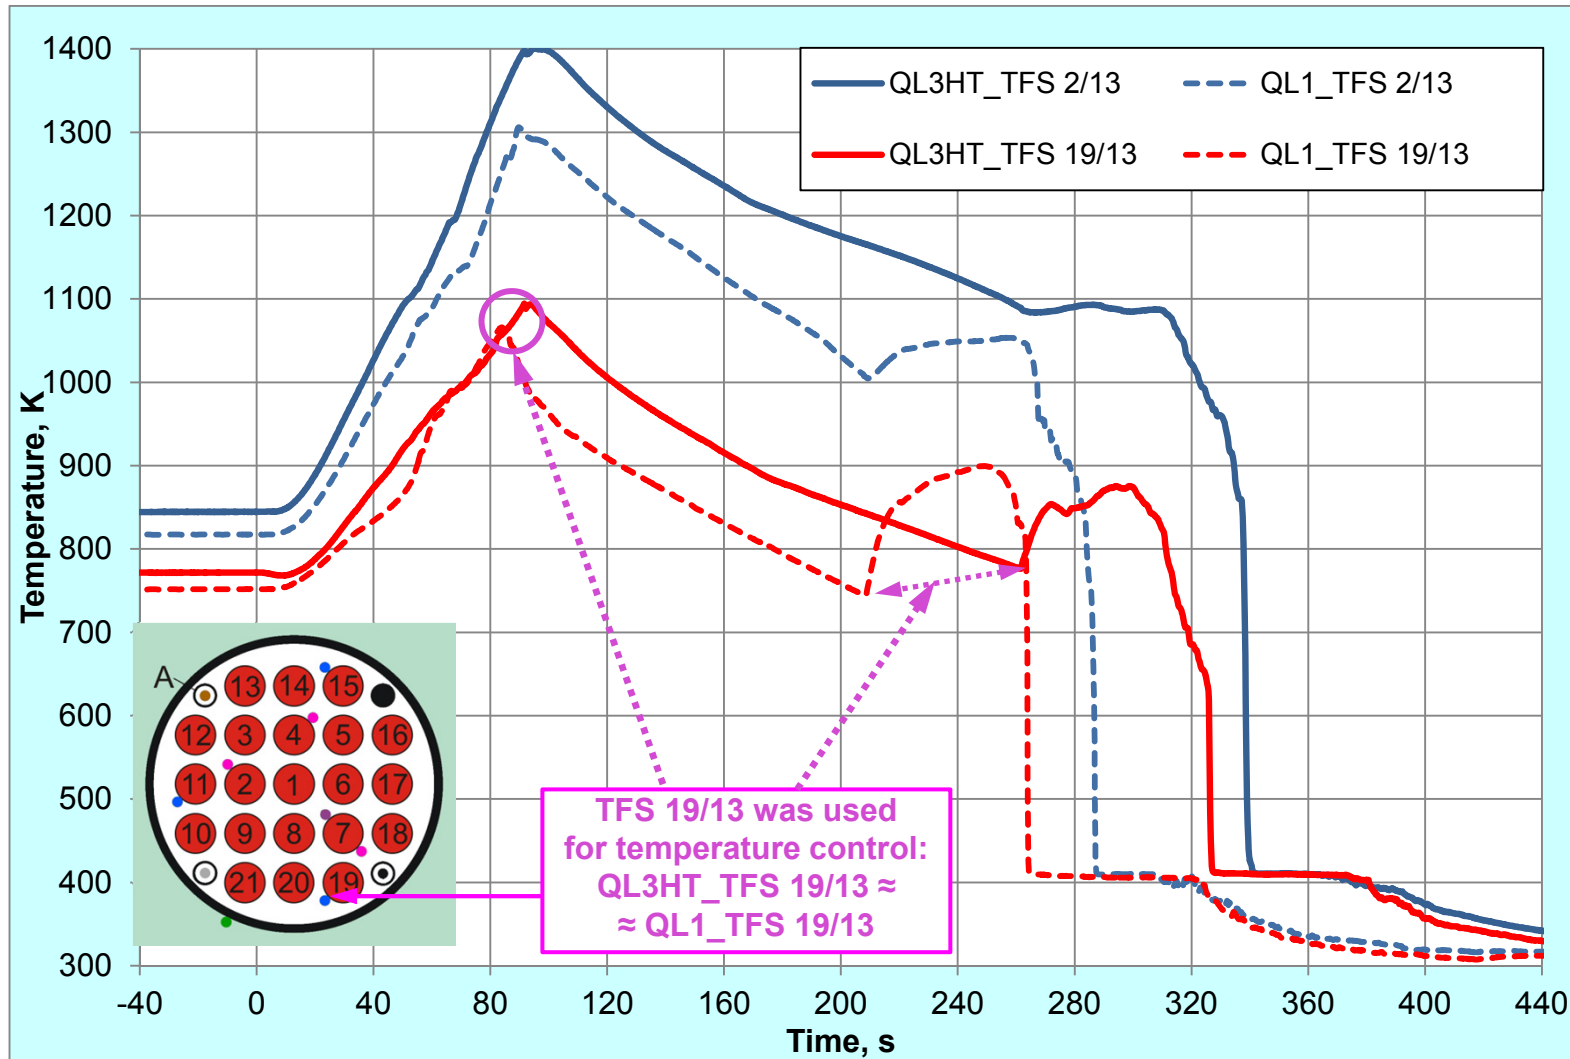
# Conduct of QUENCH-L3HT test on the basis of QUENCH-L1 temperature history: similar temperatures for outer rods on the end of transition and cool-down phases

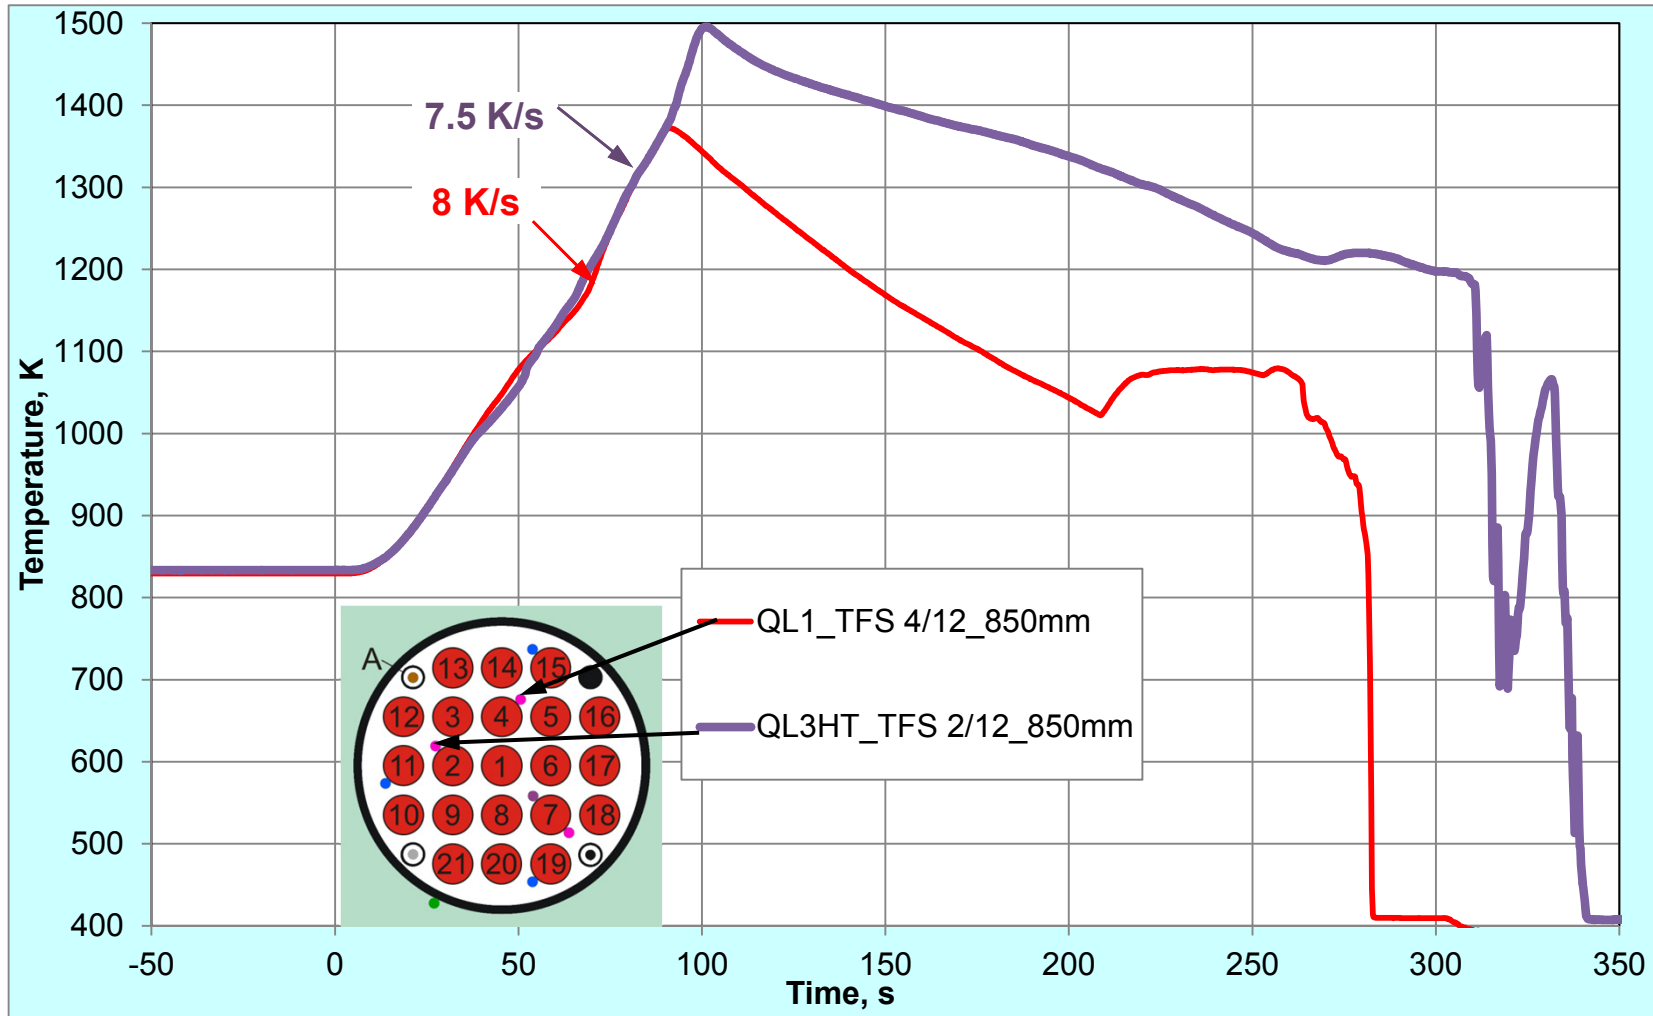
# Maximal cladding temperatures of internal rods in hottest region of QUENCH-L1 (Zry-4, reference test) and -L3HT bundles

**QL3HT vs. QL1: similar transient, higher  $T_{pct}$ , delayed cool-down**

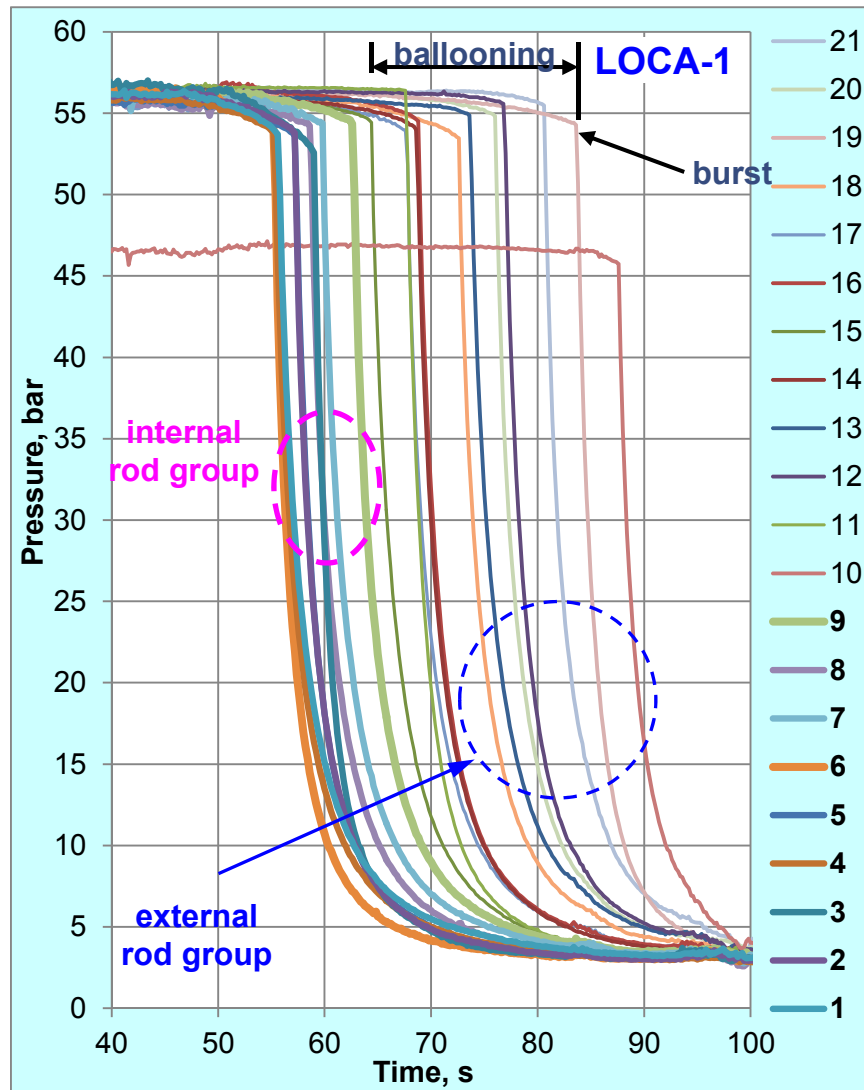
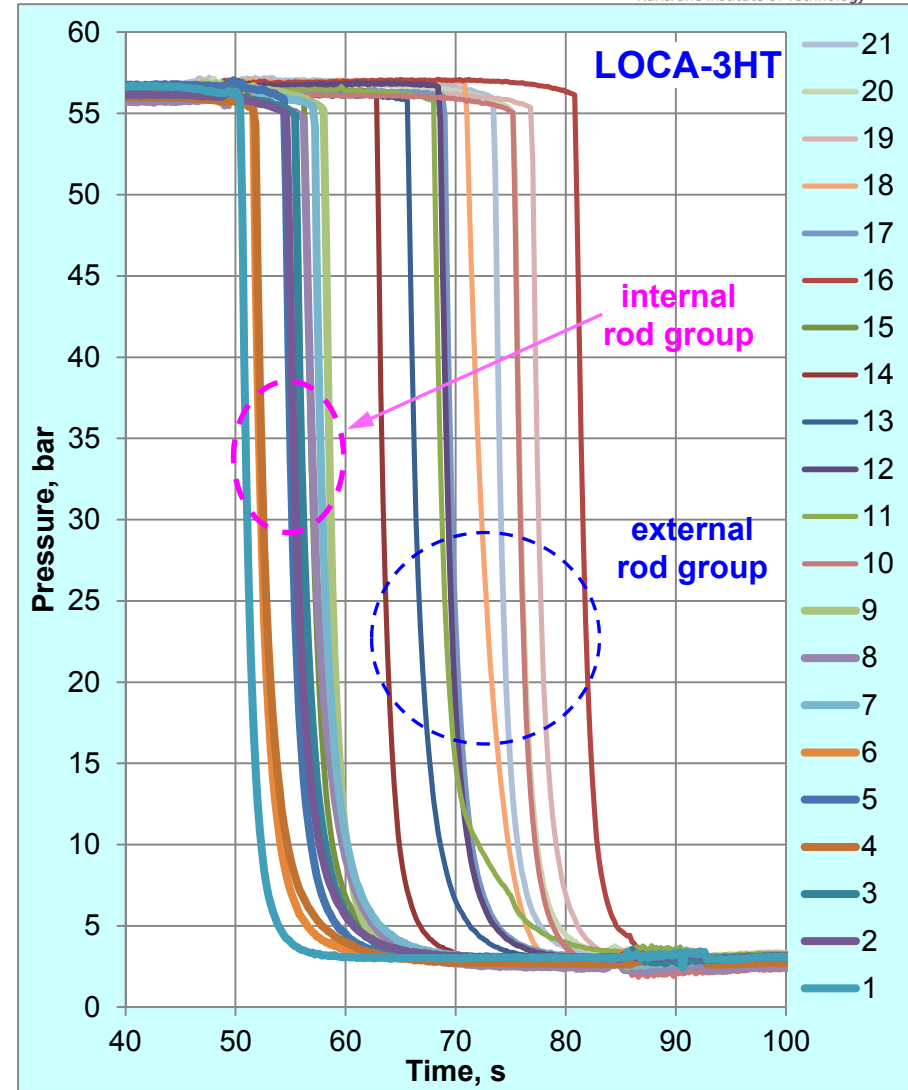
# Rod pressure evolution during heating phase for QUENCH-L1 and -L3HT: burst time indication

duration of decrease of the inner pressure to the system pressure:  $\tau_0 \approx 30$  s

- The cladding burst occurred at temperatures between 1030 and 1200 K; the average burst temperature was  $1127 \pm 48$  K (QUENCH-L1:  $1126 \pm 33$  K). The inner rod pressure relief to the system pressure during about 30 s.

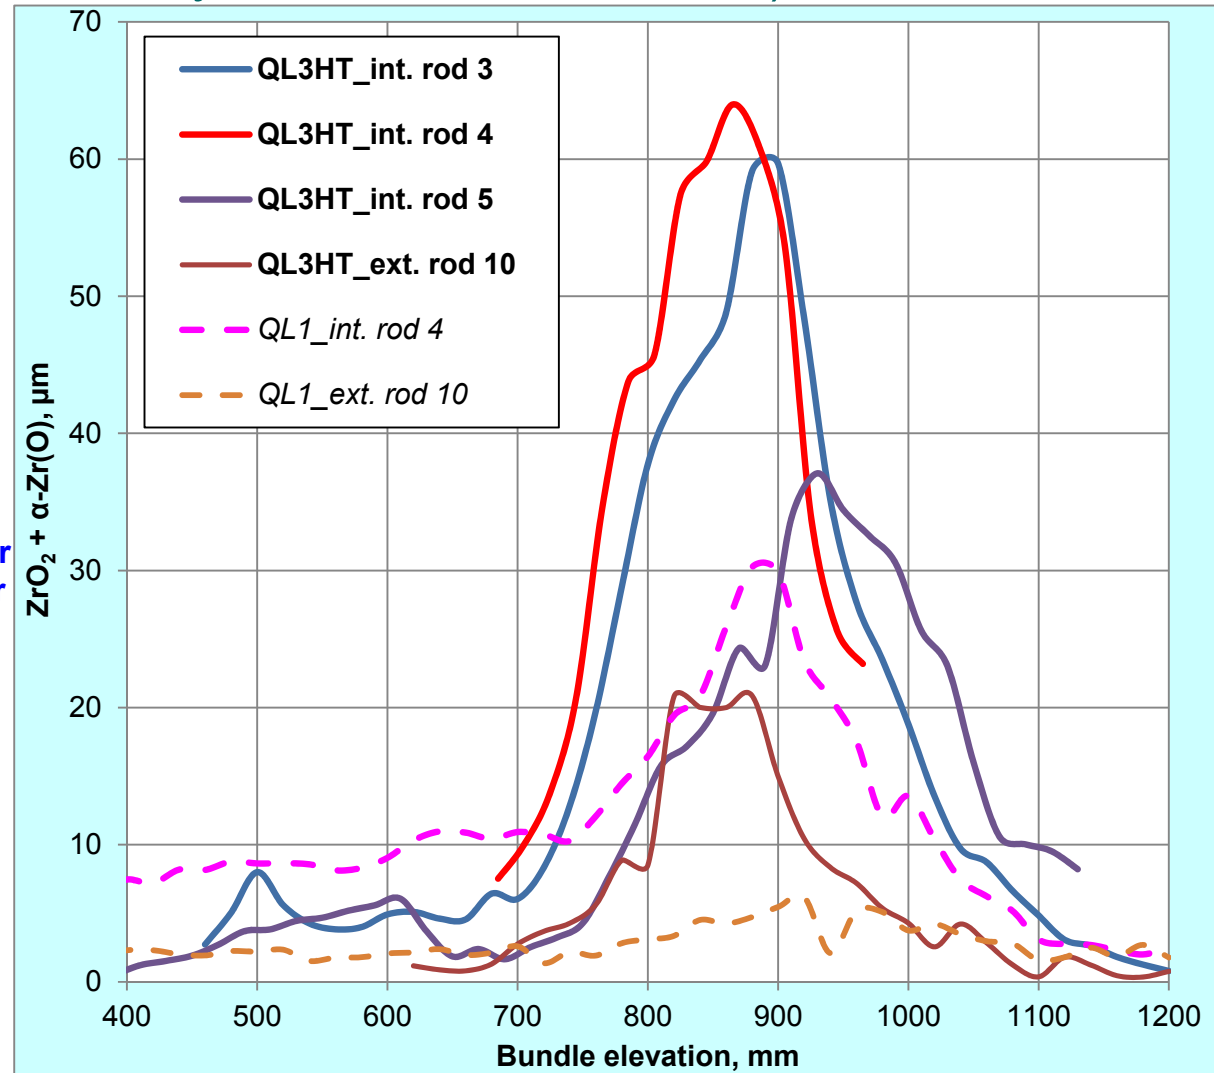
# Cladding oxidation degree for QL3HT and QL1: total thickness of outer $ZrO_2$ and $\alpha$ -Zr(O) layers (tangential average of eddy-current measurements)

Consistence with higher temperatures and increased radial T gradient for QL3HT

- The first stage (transient) of the QUENCH-LOCA-3HT test was performed according to a typical LBLOCA transient with maximal heat-up rate 7.5 K/s. However, due to technical problems the transient was terminated at *not prototypical* peak cladding temperature of more than 1500 K (at bundle elevation 850 mm). As result, increased cladding oxidation was occur.

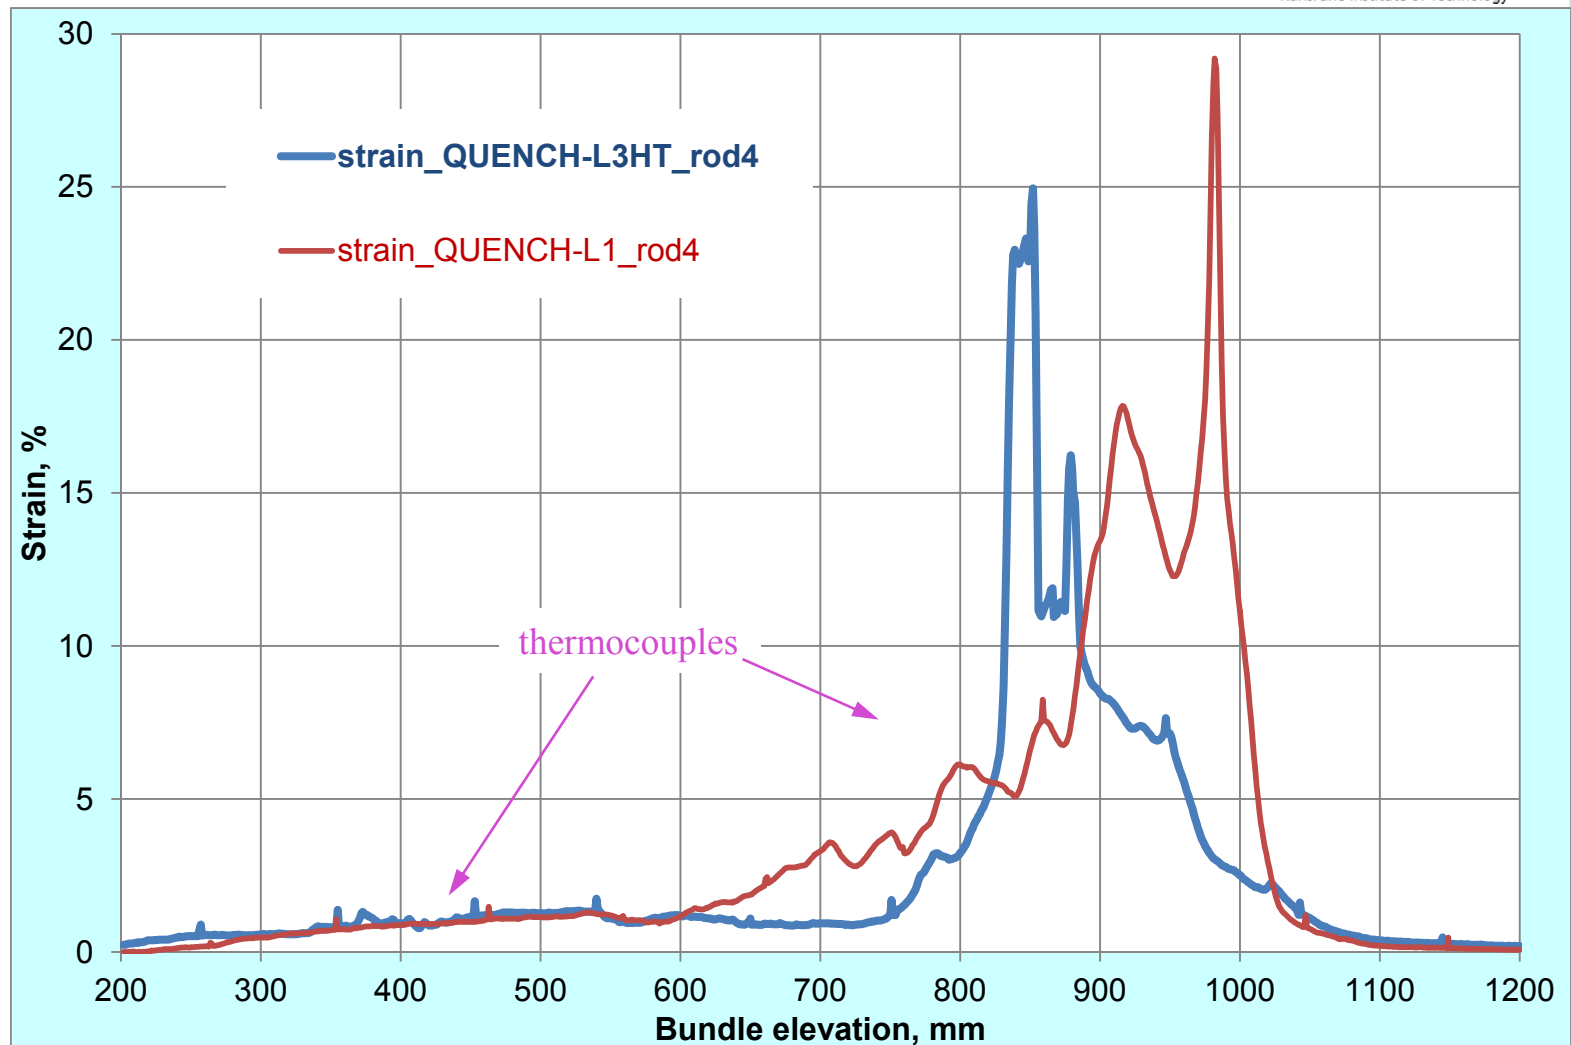
**Laser profilometer: axial strain distribution for rod #4.  
Estimation of maximal blockage of coolant channels.**

**Calculation: for coplanar positions of all burst openings (max blockage B):  $B_{QL1} = 46\%$ ;  $B_{QL3HT} = 35\%$**

- Not prototypical increased rod bending occurred due to axial limitation of thermal expansion.
- Due to low ballooning degree the maximum of *virtual coplanar* blockage ratio of cooling channel (35%) was lower in comparison to QUENCH-L1 (46%). Due to moderate blockage a good bundle coolability was kept for both bundles.

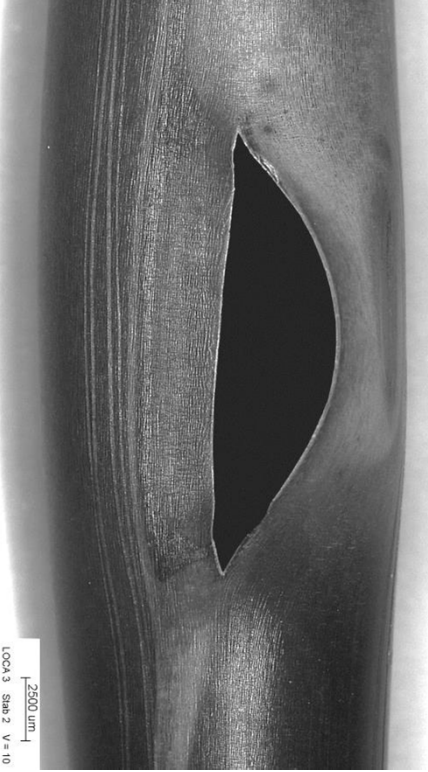
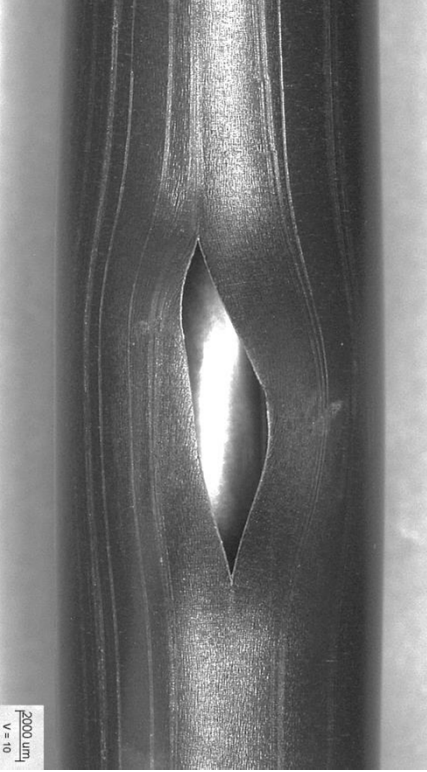
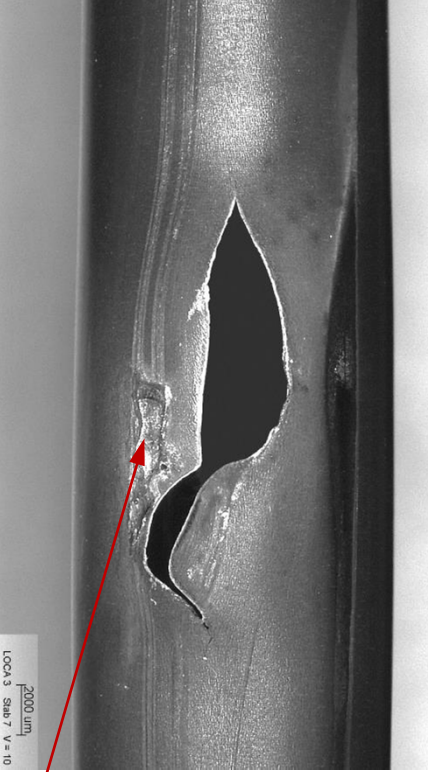
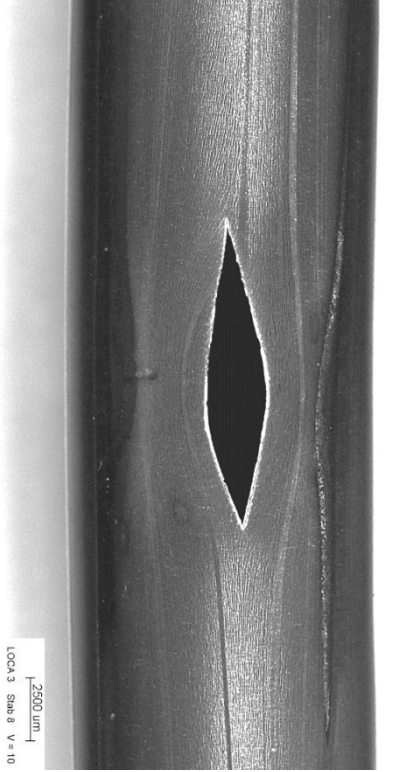
# QUENCH-L3HT: burst openings of several claddings

<p>welding traces of TC TFS 7/12 i</p>

<p>rod #2: elevation 900 mm  <math>H_{op} = 17.2</math> mm  <math>max W_{op} = 4.7</math> mm  <math>A_{op} = 50.7</math> mm<sup>2</sup></p>	<p>rod #5: elevation 908 mm  <math>H_{op} = 13.5</math> mm  <math>max W_{op} = 3.0</math> mm  <math>A_{op} = 24.0</math> mm<sup>2</sup></p>	<p>rod #7: elevation 850 mm  <math>H_{op} = 16.6</math> (10.6) mm  <math>max W_{op} = 3.4</math> mm  <math>A_{op} = 29.7</math> (25.2) mm<sup>2</sup></p>	<p>rod #8: elevation 837 mm  <math>H_{op} = 11.6</math> mm  <math>max W_{op} = 2.3</math> mm  <math>A_{op} = 15.9</math> mm<sup>2</sup></p>

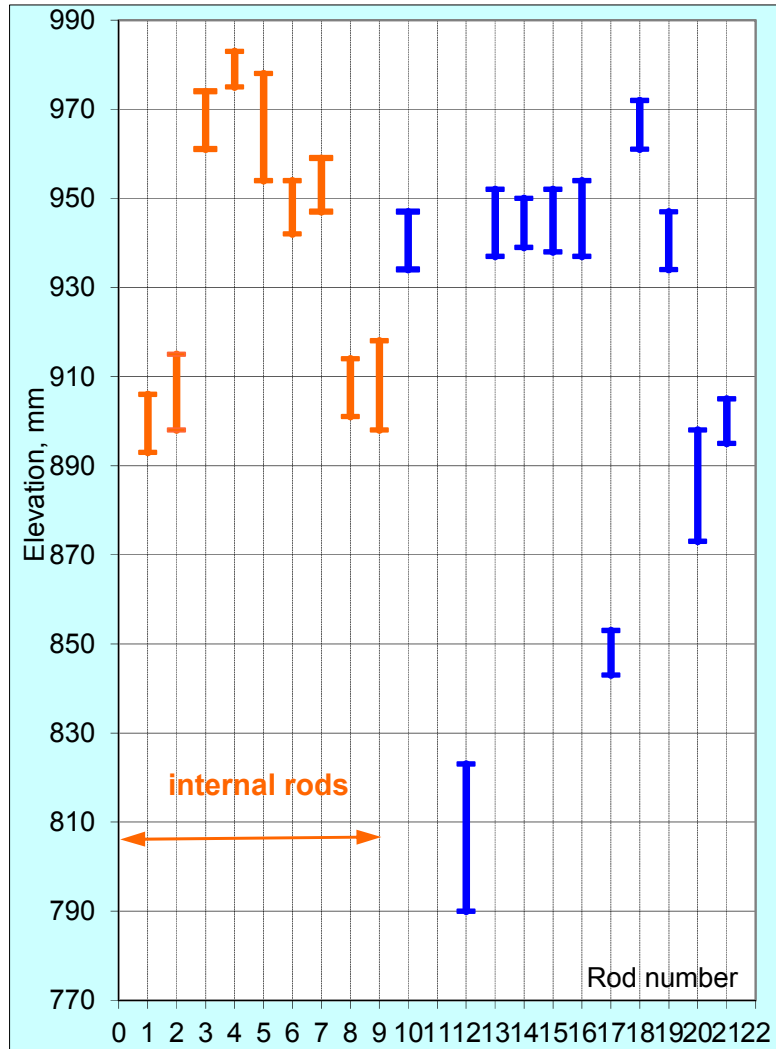
LOCA-1

# Length and axial position of burst openings
