Hydrides and fracture of pure zirconium and Zircaloy-4 hydrogenated at temperatures typical for loss-of-coolant accident conditions

Anton Pshenichnikov, Juri Stuckert, Mario Walter, Dimitri Litvinov

ICONE23, Chiba, Japan, 2015

Institute for Applied Materials (IAM), Program NUSAFE

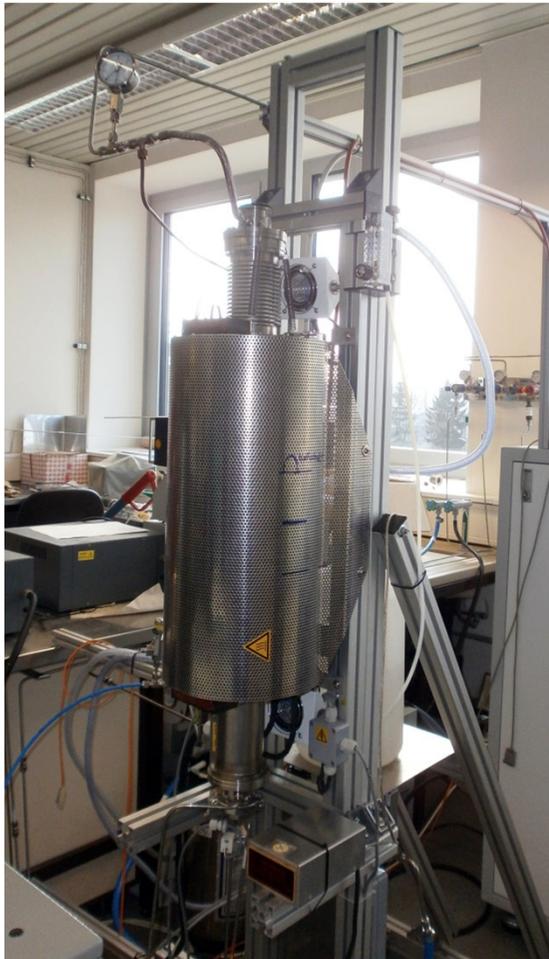
**Hydrogenation facility
LORA furnace**

**Hydrogen gas partial
pressure 0.1 bar**

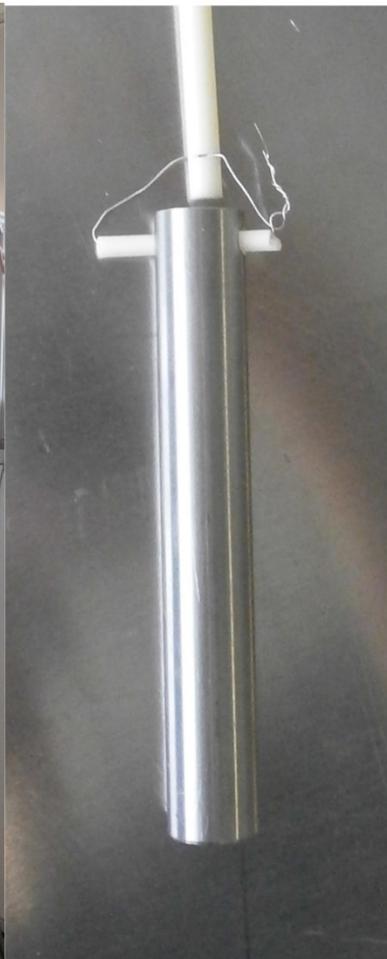
**Specimen before
hydrogenation**

**H₂ duration
2 to 12 minutes**

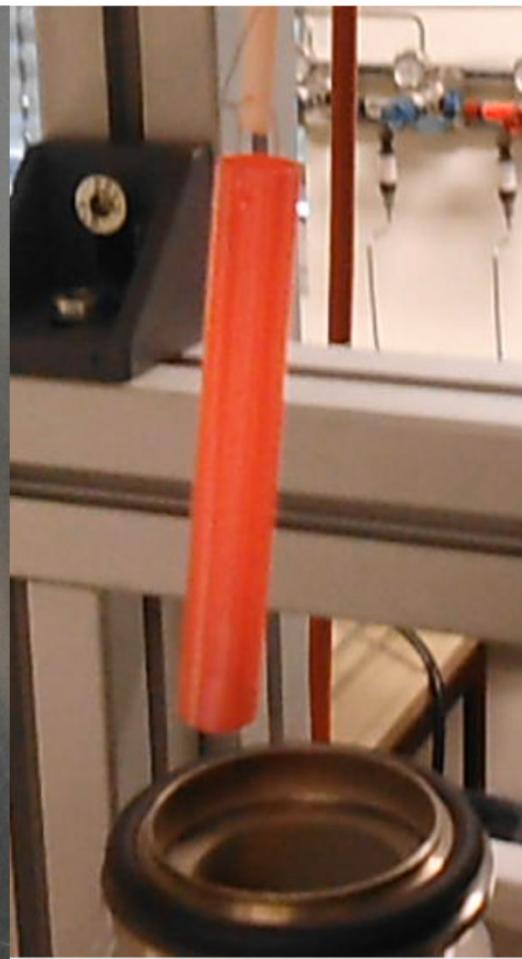
**Specimen withdrawal in air
after hydrogenation**

**Estimated cooling rate
5 K/s**

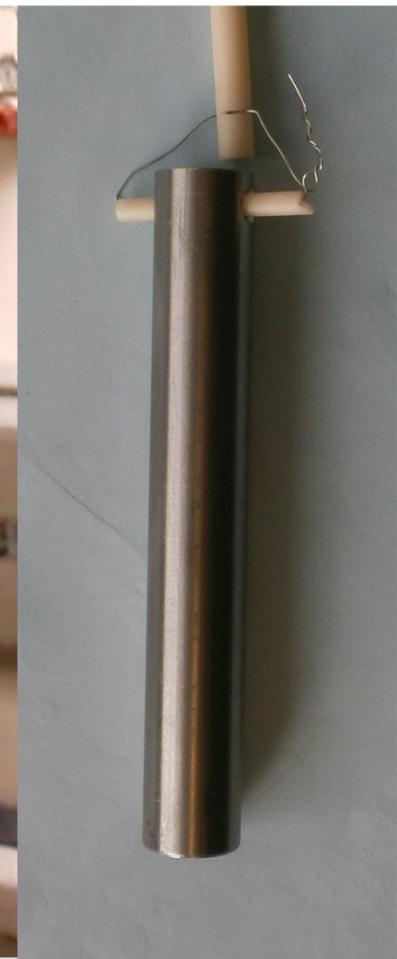
**Cooled specimen
after hydrogenation**

**Mass gain technique to
calculate hydrogen
content**

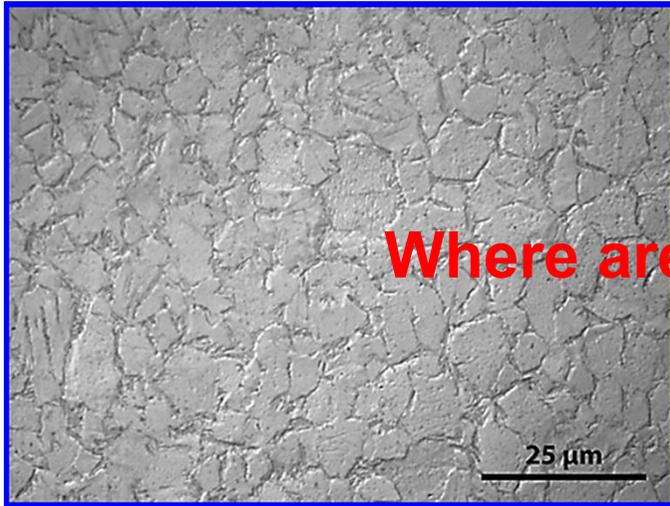
1330 wppm H

Hydrogenation of Zircaloy-4 cladding at 700 °C in Ar+H₂ mixture and fast cooling in air

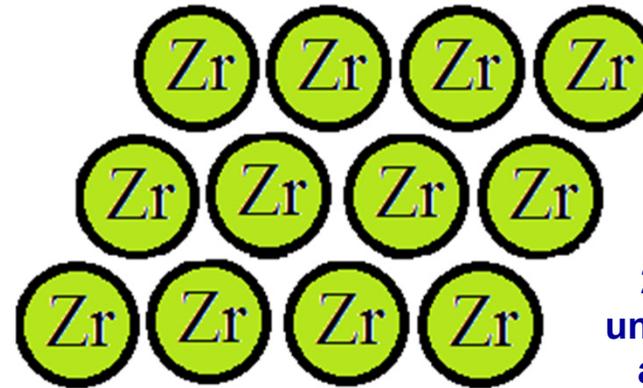
Decoherence mechanism*

Cohesion

2D simplified understanding of atomic layers

Decoherence

- The decohesion mechanism helps to understand the embrittlement of zirconium and Zircaloy-4 and other hydride forming alloys with hexagonal close-packed crystal lattice. The fact of the increase of the lattice parameter “c” allows to suggest that the decohesion mechanism accompanied by increasing internal stress due to hydrogen atoms inside the lattice could be responsible for cladding material destruction.
