KfK 3656  
August 1983

# **Temperature Escalation of Zircaloy-Clad Fuel Rods and Bundles under Severe Fuel Damage Conditions**

Paper prepared for the International Meeting on  
Light Water Reactor Severe Accident Evaluation,  
Cambridge, Massachusetts, USA, August 28 - September 1, 1983

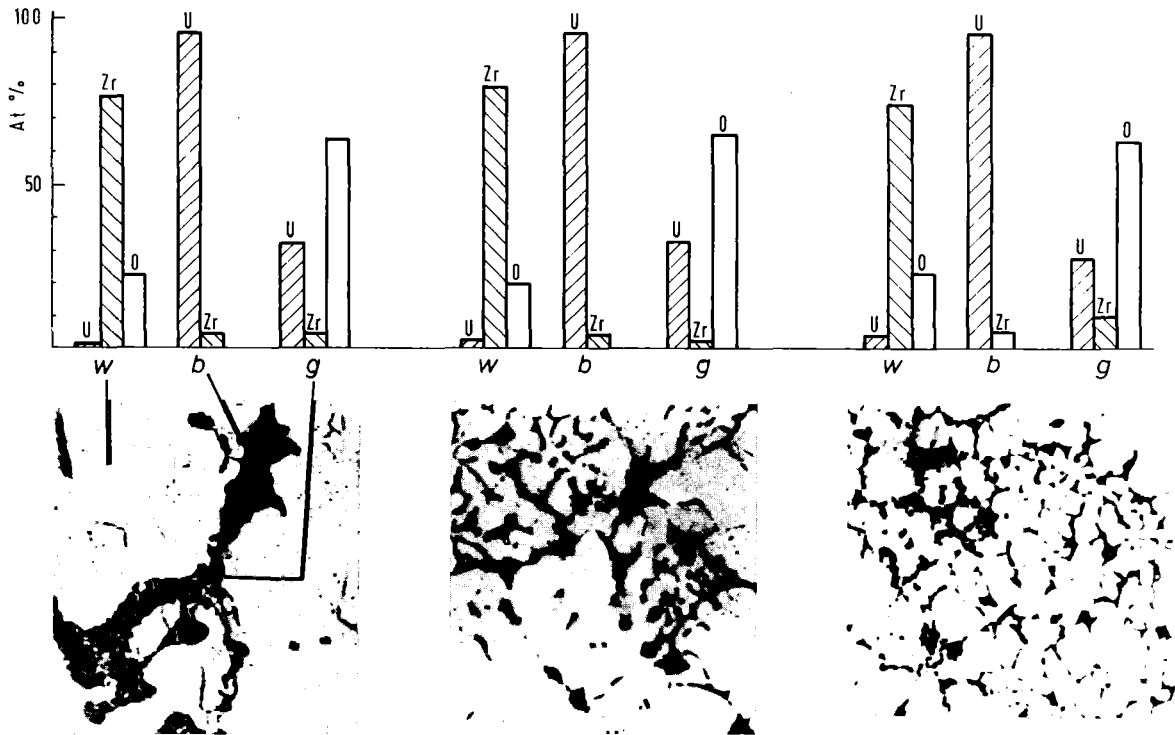
Figure 13. Microprobe analysis of the 3 phases in the refrozen melt of ESBU 1 (116, 51, and 7-mm above the bottom of the bundle).

Three distinct phases were found in the refrozen melt, two metallic and one ceramic: (a) oxygen-stabilized  $\alpha$ -Zr(O) containing some uranium, (b) a uranium-rich (U,Zr) alloy, and (c) ceramic  $(U,Zr)O_2$  with a low Zr content. Figure 13 shows the results of microprobe analyses of the melt at the same relative location in three cross sections of ESBU 1 at different axial elevations (116, 51, and 7 mm above the bottom of the bundle). The melt had not been in direct contact with either a fuel rod simulator or steam at these locations. The composition of each phase is shown in atom percent, and it is clear that the number of phases and phase compositions do not vary with axial elevation. However, the relative amounts of the phases vary with axial elevation, with more ceramic phase higher in the blockage. The grain sizes also vary, increasing with elevation. Presumably, the melt remained hot longer at the higher elevations due to its greater mass, and the larger grains formed during the slower cooldown.

Visual comparison of Figure 13 with  $UO_2/Zr$  melt standards of varying  $UO_2/Zr$  ratios indicates that the melt contained roughly 40 wt.%  $UO_2$  ///. Assuming all of the zircaloy cladding in a given axial section melted and dissolved fuel, 40 wt.%  $UO_2$  in the melt corresponds to a reduction of the original  $UO_2$  pellet radius from 4.6 to about 4.2 mm. At the higher elevations (Figure 11) the  $UO_2$  ring pellets are smaller by approximately this amount. At the lower elevations substantial thinning of the ring pellets is not evident.
