KfK 3508
Dezember 1983

**Temperature Escalation in PWR
Fuel Rod Simulator Bundles due
to the Zircaloy/Steam Reaction
Test ESBU-1
Test Results Report**

S. Hagen, H. Malauschek, S. O. Peck, K. P. Wallenfels
Hauptabteilung Ingenieurtechnik

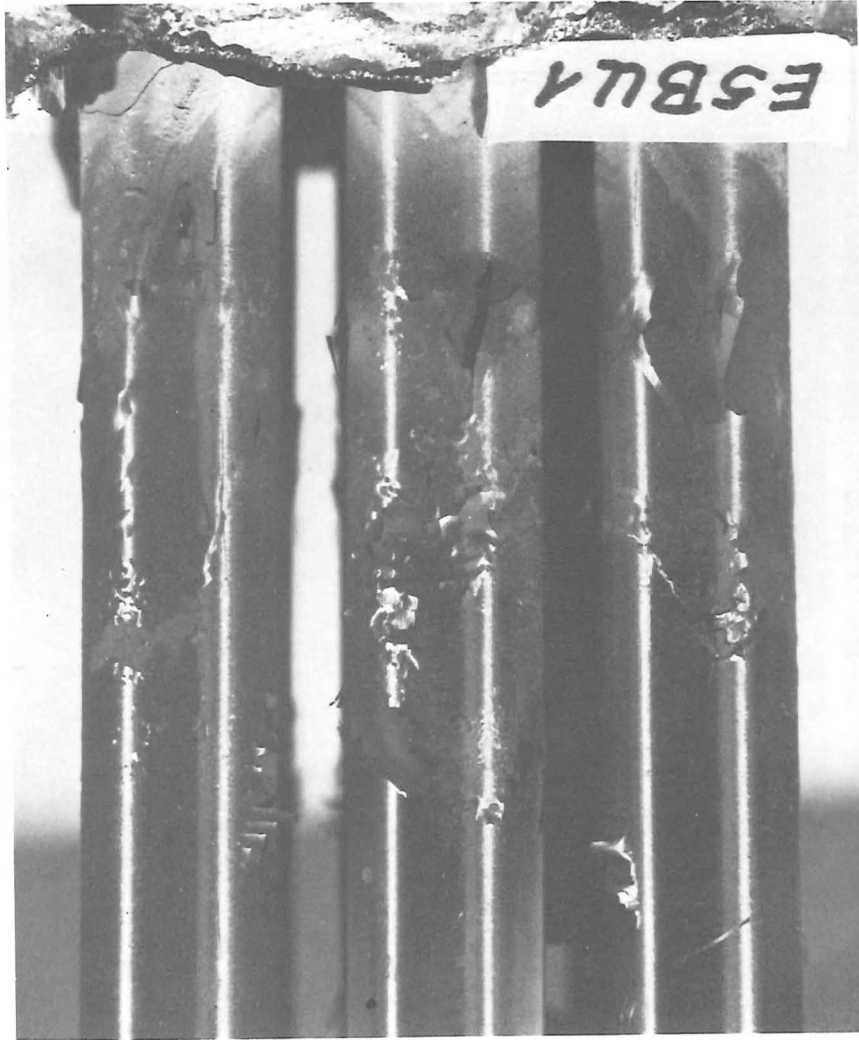
FIGURE 8: DETAILS OF OXIDE SPALLING AND REFROZEN MELT OF ESBU-1 BELOW BLOCKED REGION

Figures 7 and 8 detail the appearance of the lower bundle region. Oxide spalling is evident as is refrozen drops of the liquefied material. The refrozen melt shows poor wetting of the solid surface as indicated by the large wetting angles and small contact areas. Melt viscosity, oxygen content, and relatively cold fuel rod simulators probably influenced the refreezing behavior in this region.

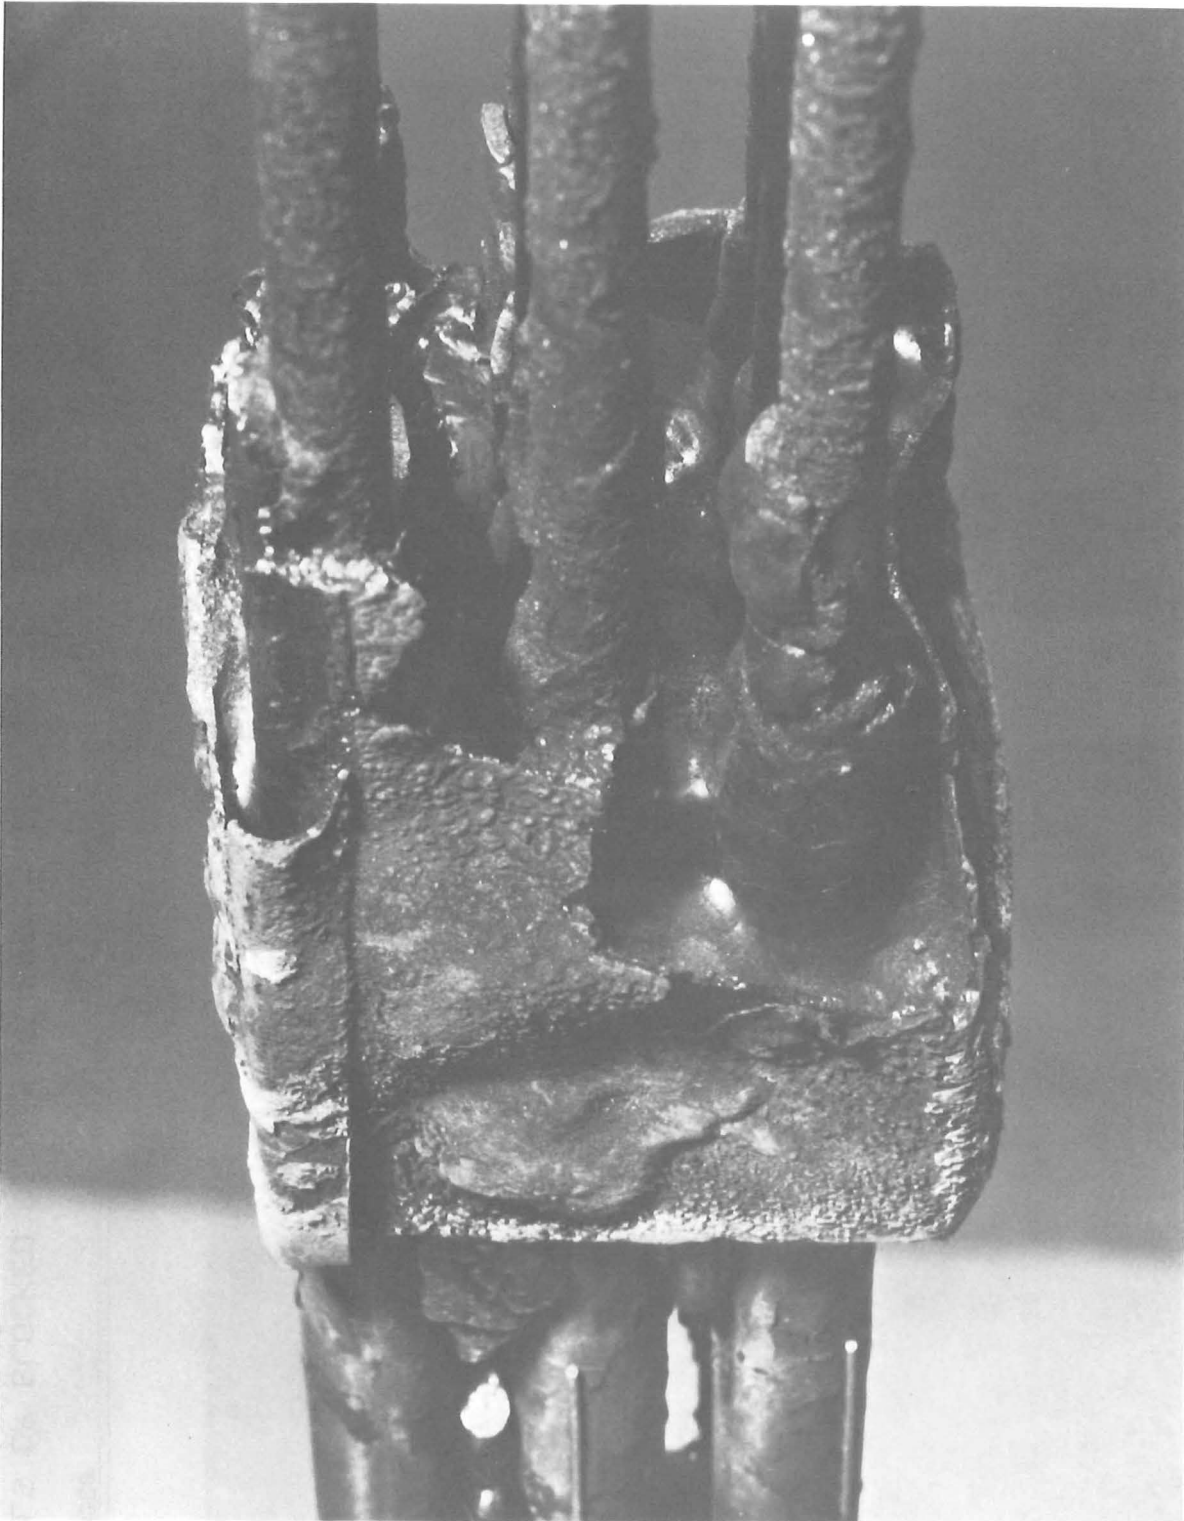
FIGURE 11: ENLARGEMENT OF THE BLOCKED REGION OF ESBU-1
ILLUSTRATING THE WETTING BEHAVIOR OF THE MELT

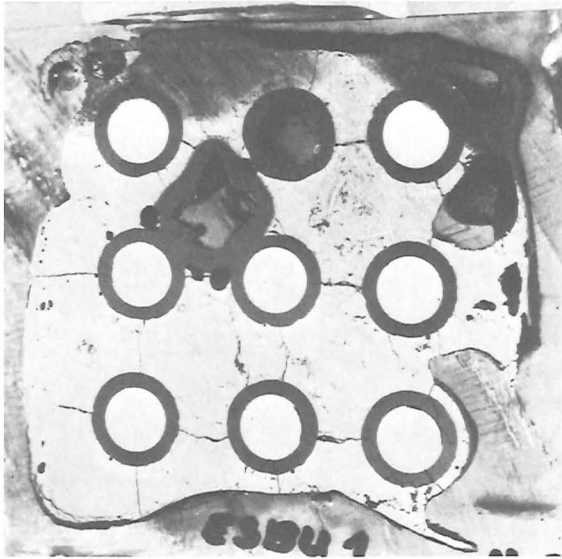
FIGURE 14: BUNDLE CROSS SECTION SUMMARY. THE FOLLOWING FIGURES GIVE DETAIL

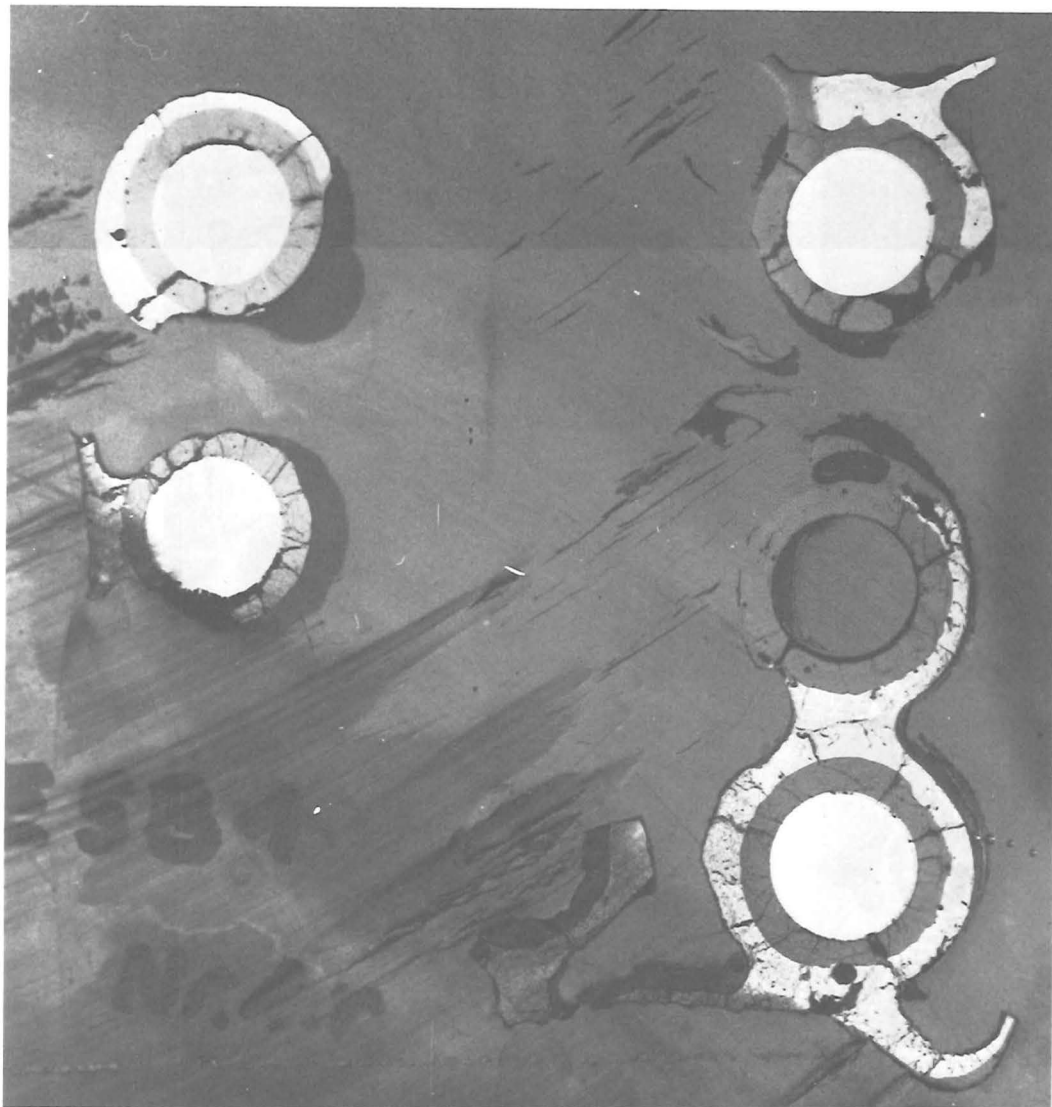
FIGURE 15: CROSS SECTIONS OF ESBU-1 AT 129 AND 119 MM ABOVE THE BOTTOM OF THE BUNDLE

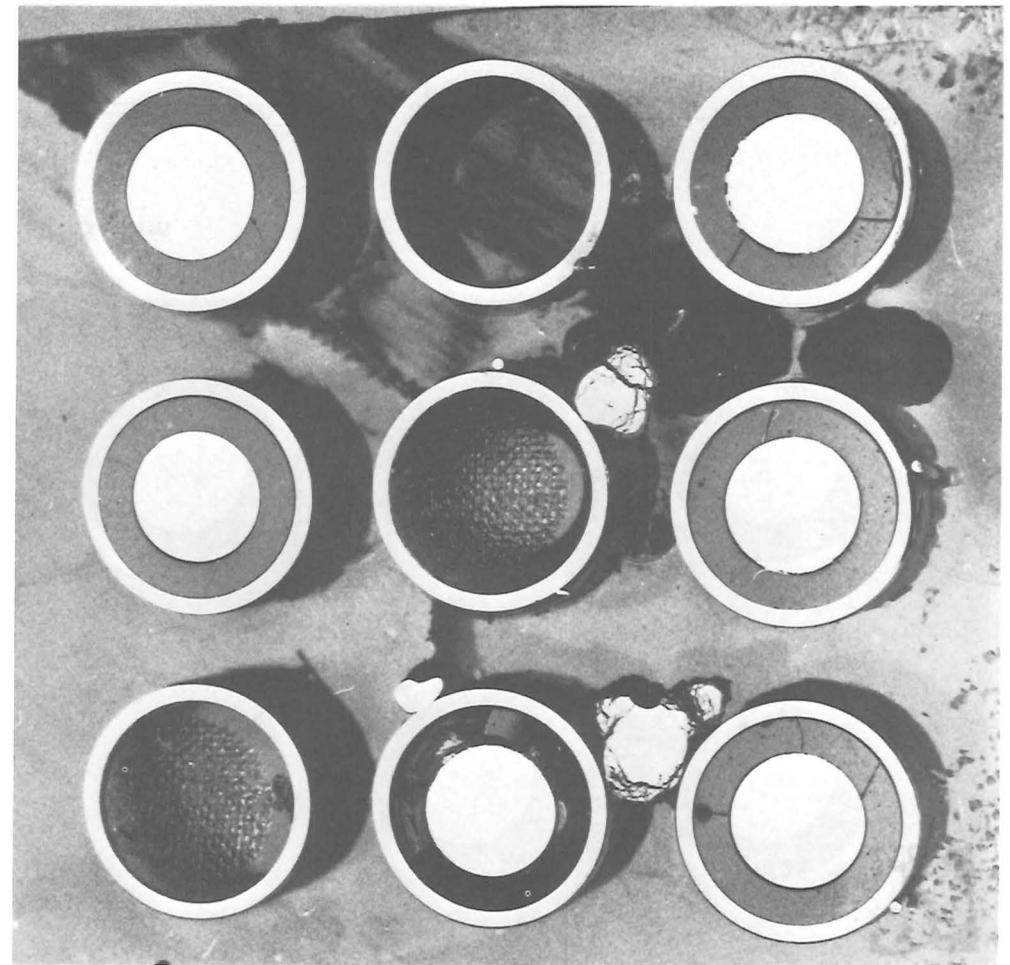
FIGURE 19: CROSS SECTIONS OF ESBUs AT 51 AND 15 MM ABOVE THE BOTTOM OF THE BUNDLE ↴

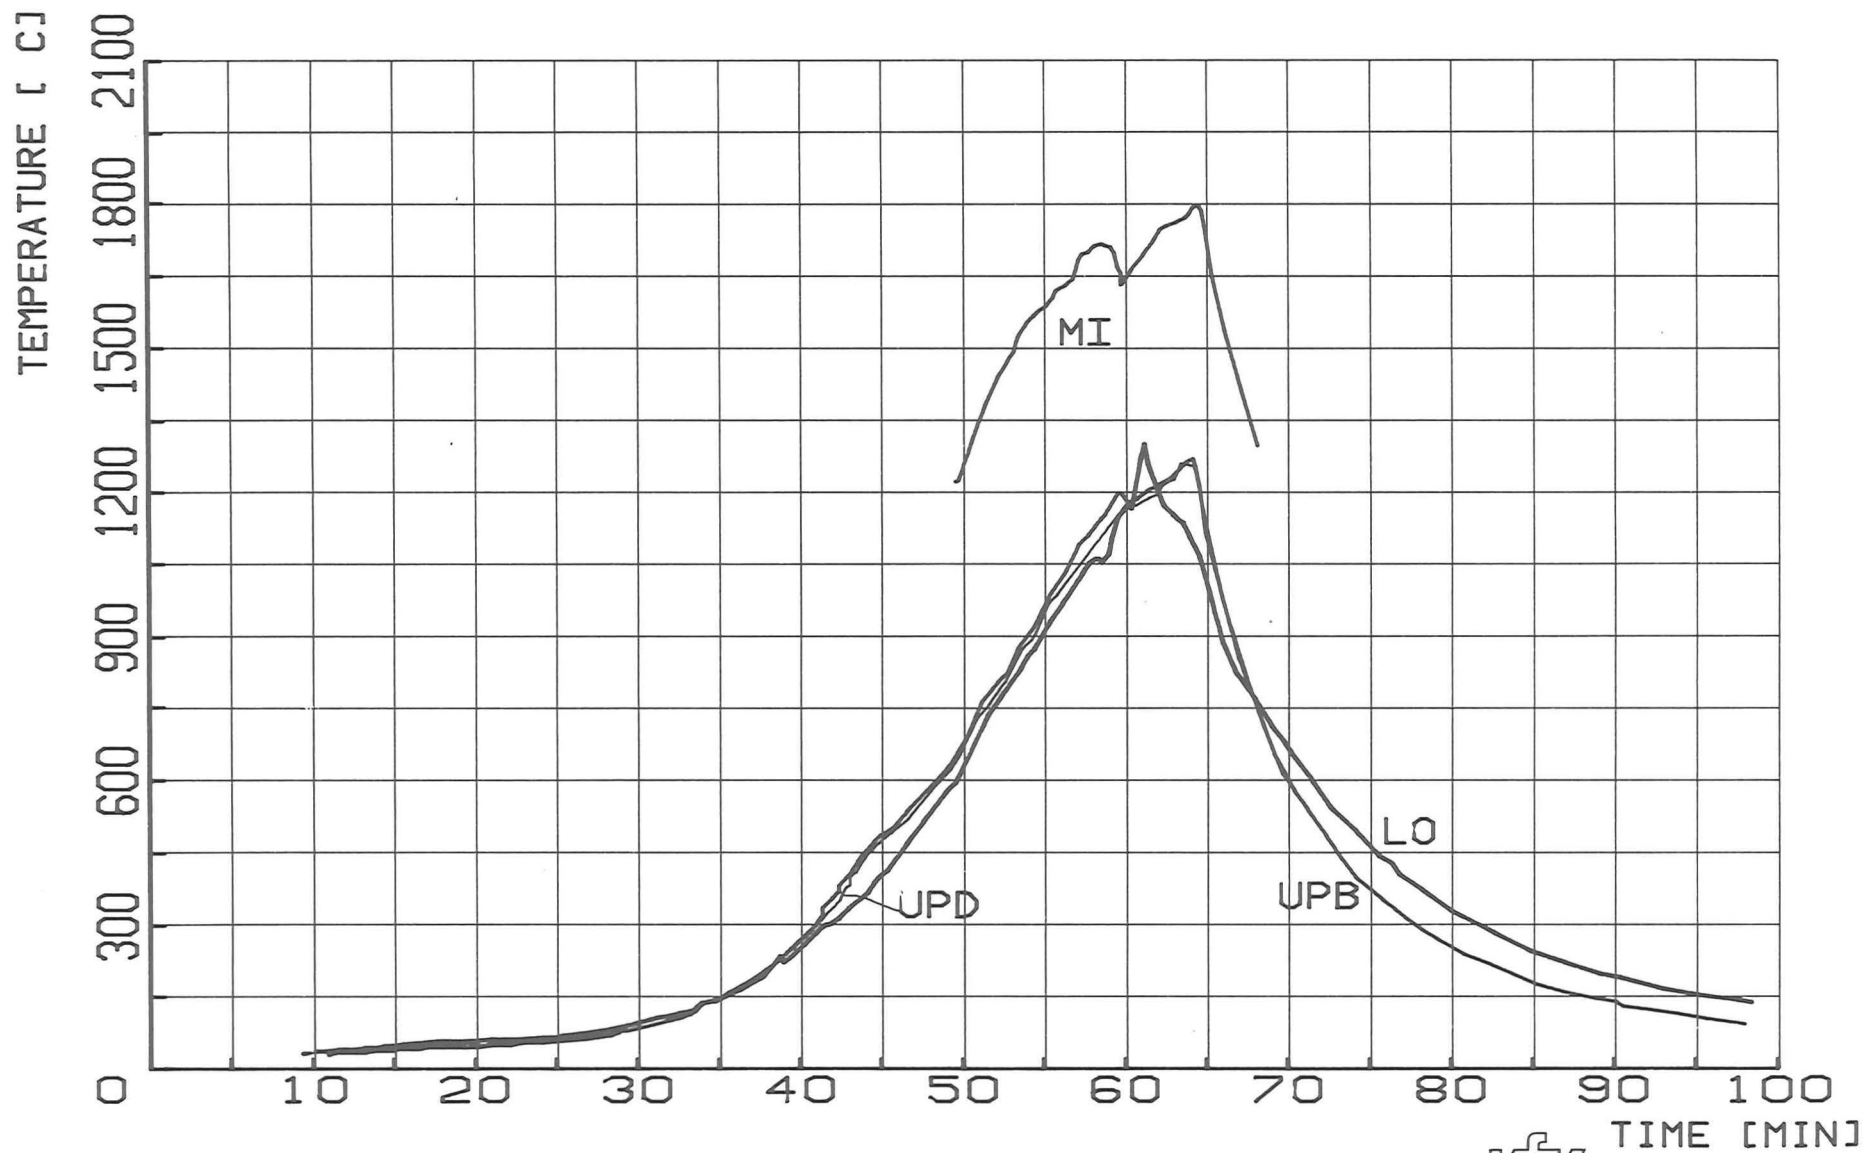
FIG.23: TEMPERATURES ON THE SIDE ROD AT 50 MM FROM THE LOWER END (LO), AND 25 MM (UPB AND UPD) AND 145 MM (MI) FROM THE UPPER END : ESBU-1

Time dependent temperatures at different axial positions on the central rod, side rod, and shroud are shown in Figures 22 through 24 and 28 through 31. Figures 22 and 23 show the thermocouple measurements made at the top and bottom of the rods compared to the pyrometer reading at 145 mm from the top. Figure 24 shows the thermocouple measurements on the shroud at the top, middle and bottom on an expanded scale. Top and bottom thermocouple measurements alone on an expanded scale are shown in Figures 29 through 30 for the central, side, and corner rods, respectively. Figure 31 shows all measurements made on the shroud. The middle region of the bundle was clearly the hottest area and the location where a temperature escalation occurred. On the other hand, the temperatures at 50 mm from the lower end and 25 mm from the upper end were of the same order. The measurement positions were chosen so that the thermocouples would survive the maximum temperatures if possible. The deviation from axial temperature symmetry was due to the influence of differing heat losses. The lower thermocouples were located outside the insulated region and the upper thermocouples were placed inside the insulation. At the lower positions the steam had nearly the inlet temperature, while at the upper positions the steam was superheated after flowing through the heated bundle. Figure 22 demonstrates the influence of the steam flow on the center rod. Before steam was introduced (41 minutes) the difference between the temperature 50 mm from the lower end and the temperature 25 mm from the upper end was about 75°C. After steam was inlet the temperatures were nearly the same, indicating that the axial temperature distribution had been shifted up the rod. In both cases water cooling of the copper electrodes affected the rod end temperatures.
