**KfK 3509  
Juli 1984**

**Temperature Escalation in PWR  
Fuel Rod Simulator Bundles due  
to the Zircaloy/Steam Reaction:  
Test ESBU-2A  
Test Results Report**

**S. Hagen, H. Kapulla, H. Malauschek  
S. O. Peck, K. P. Wallenfels  
Hauptabteilung Ingenieurtechnik  
Projekt Nukleare Sicherheit**

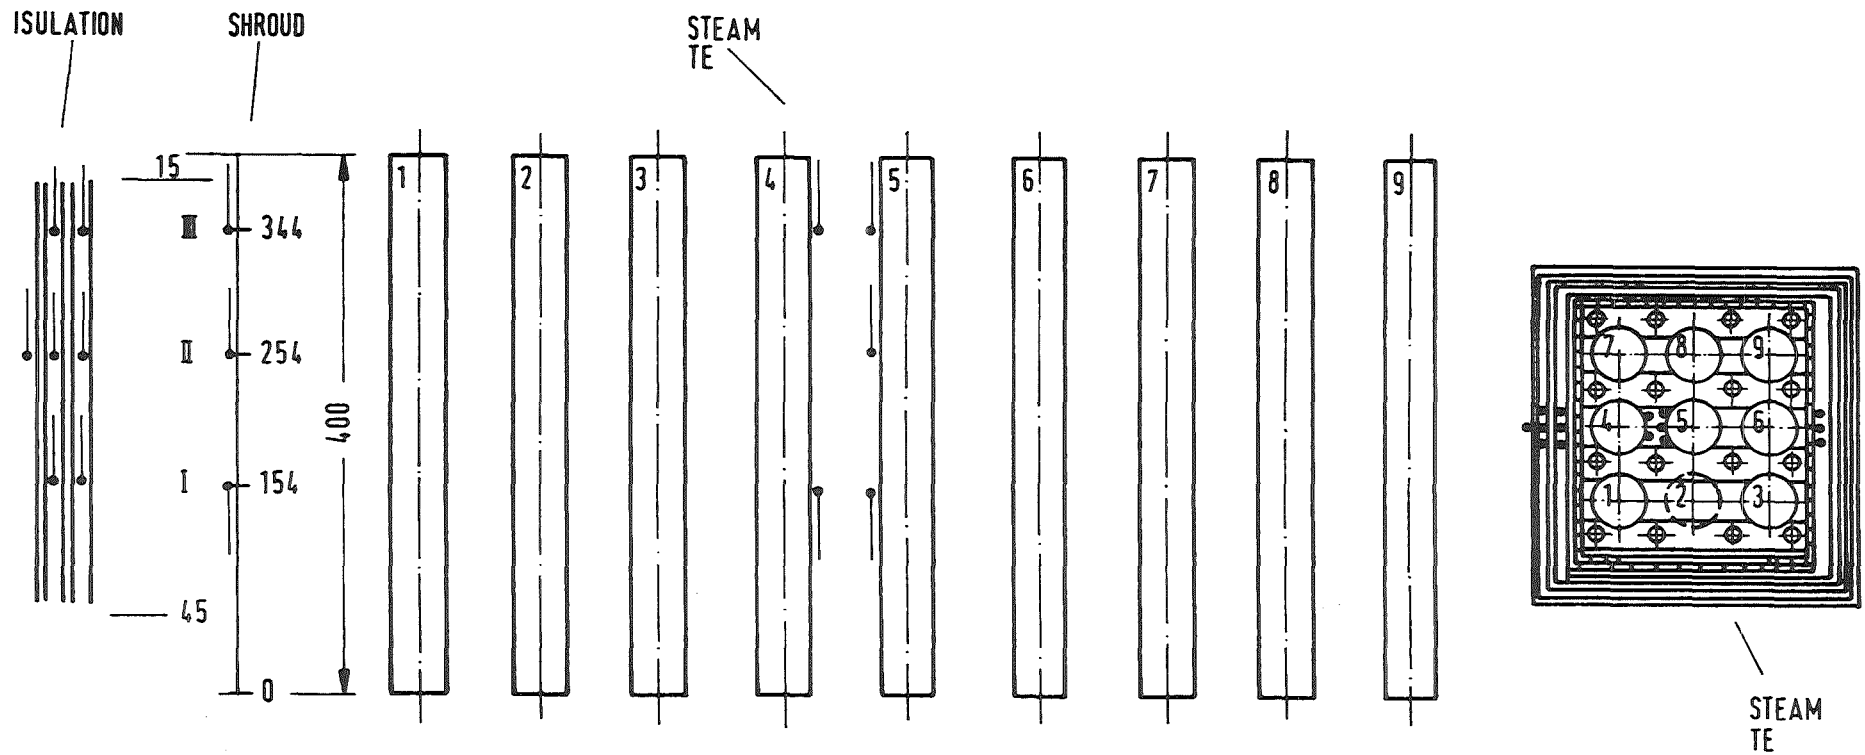
FIGURE 2: AXIAL AND RADIAL POSITIONS OF THE THERMOCOUPLES OF TEST ESBU-2A

Temperatures were measured by two color pyrometers and NiCr/Ni thermocouples with Inconel sheaths. Four pyrometers were located 255 mm from the bundle bottom, on the sides of the bundle. By removing the middle portion of one of the side rods and making holes in the shroud and insulation, the pyrometers measured temperatures on the central rod surface, two side rod surfaces, and the shroud surface. An additional pyrometer was located 345 mm from the bottom and focused on the center rod (Figure 1). The thermocouple locations are shown in Figure 2. The central rod (5) was instrumented with thermocouples at elevations of 155, 255, and 345 mm. The side rod (4) had thermocouples at elevations of 155 and 345 mm. The shroud was fitted with three thermocouples at the same elevations as the central rod. The insulation was fitted with seven thermocouples as shown in Figure 2, placed at the same elevations as the rods on the outside of the first, third and fifth layers of 1.2 mm thick insulating. Finally, four thermocouples were installed in the steam flow channels, one on the inlet itself, one above the inlet at 50 mm elevation, and two at the steam exit (380 mm elevation), 4 and 15 mm respectively from the shroud wall.

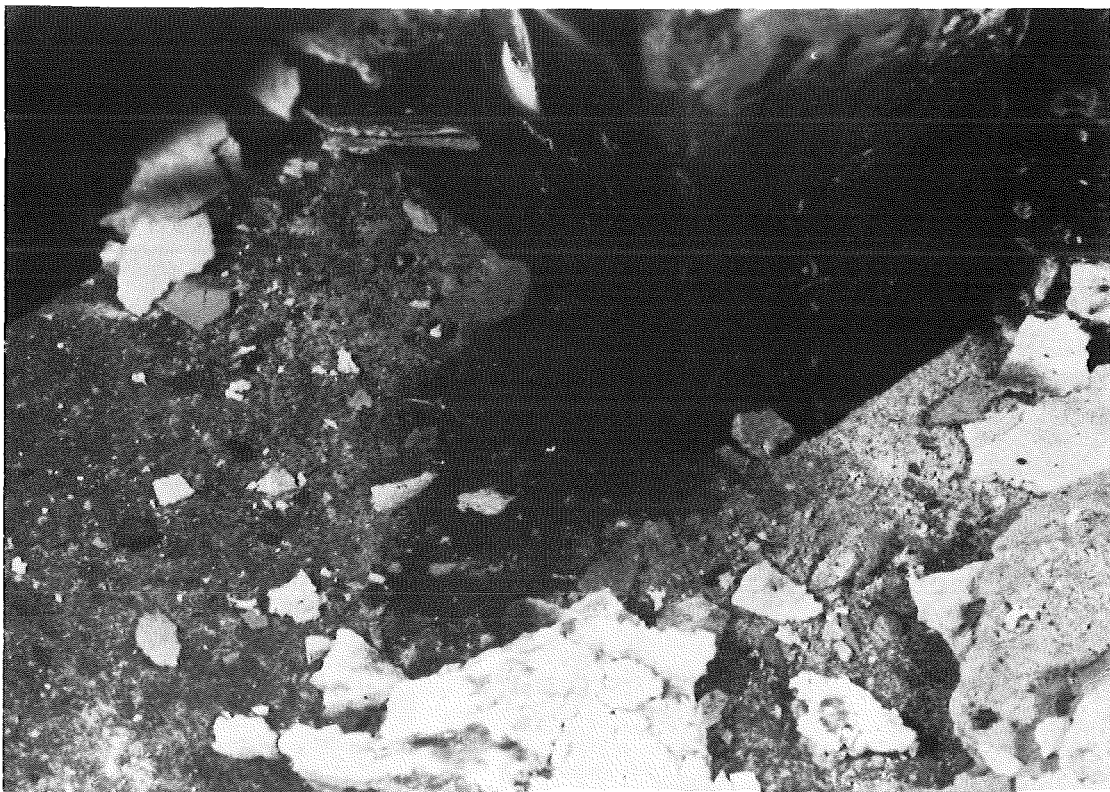
FIGURE 8: POWDERY RUBBLE FOUND DURING DISASSEMBLY OF ESBU-2A

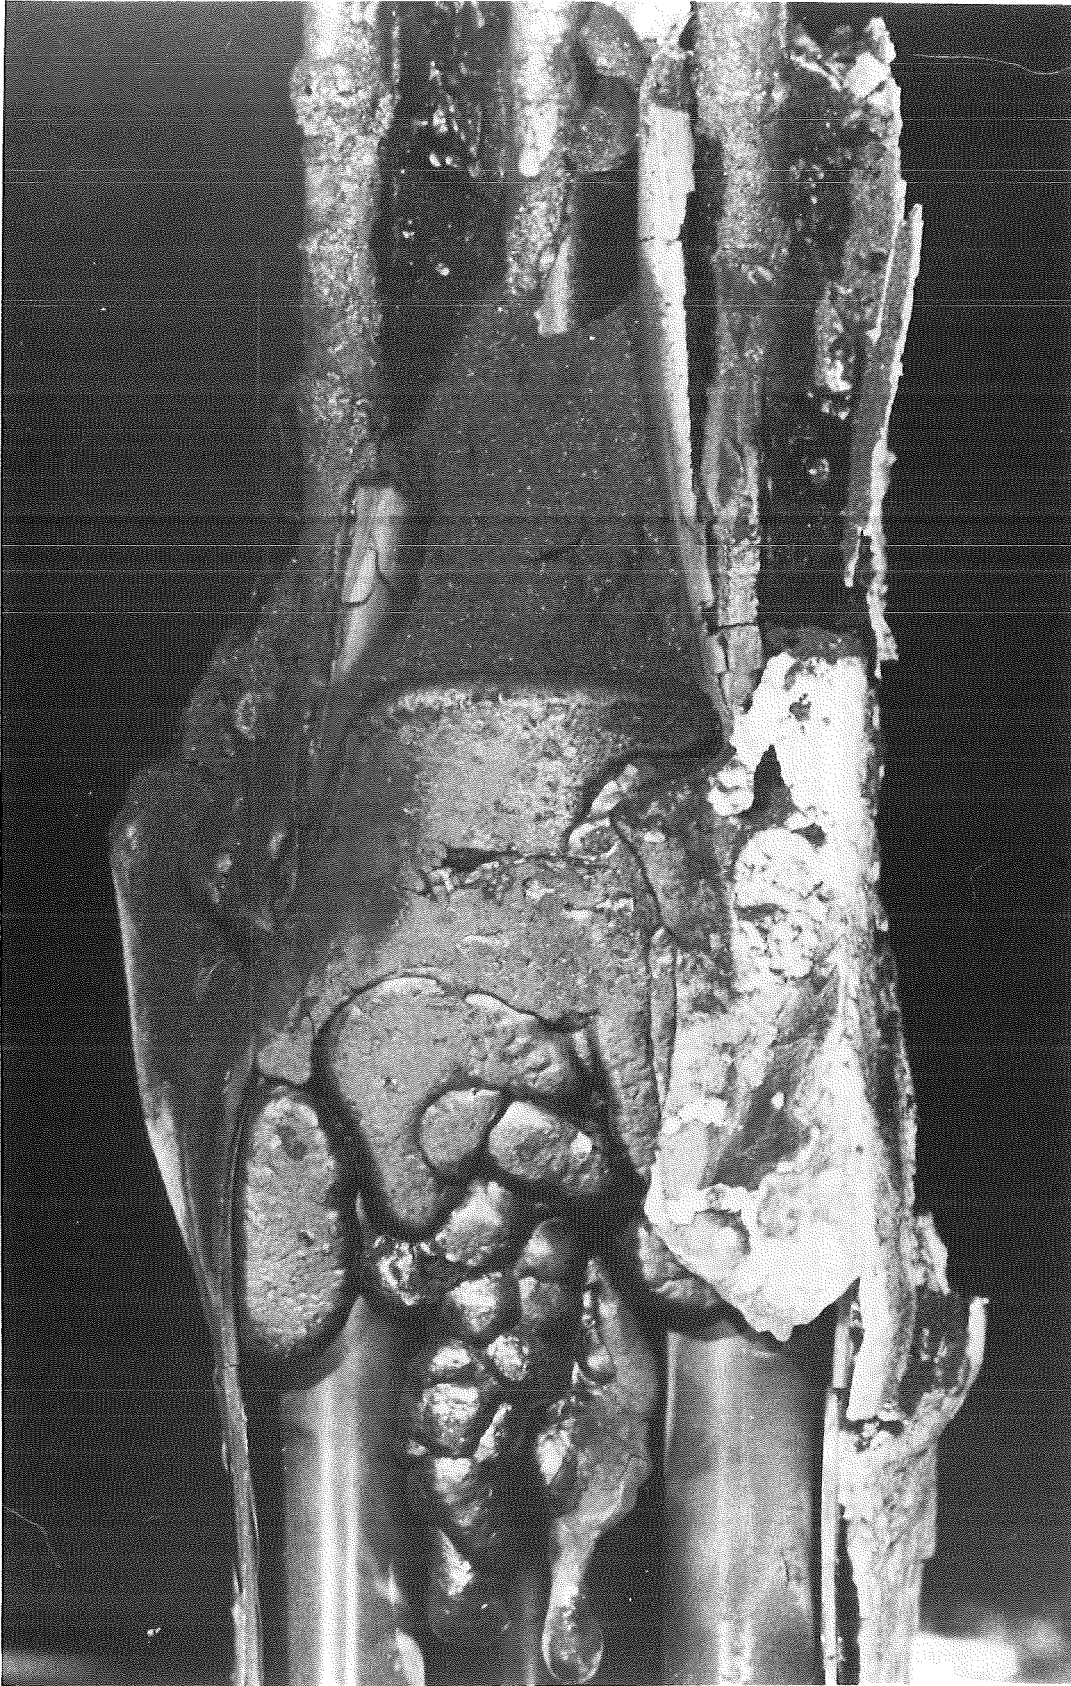
FIGURE 14: ENLARGEMENT OF THE REFROZEN MELT AND POWDERY RUBBLE FROM ESBU-2A

Figure 12 shows the fuel rod simulators after removal of the shroud. The cladding from all nine rods melted in the center region of the bundle, liquefied some fuel, flowed down the rods, and froze in a solid mass near the bottom of the bundle. The frozen material substantially blocked the coolant flow channels. The shroud adhered to the refrozen mass. A large amount of powdery rubble, probably fuel fractured during cooldown, was found on top of the blockage (Figures 13-15).

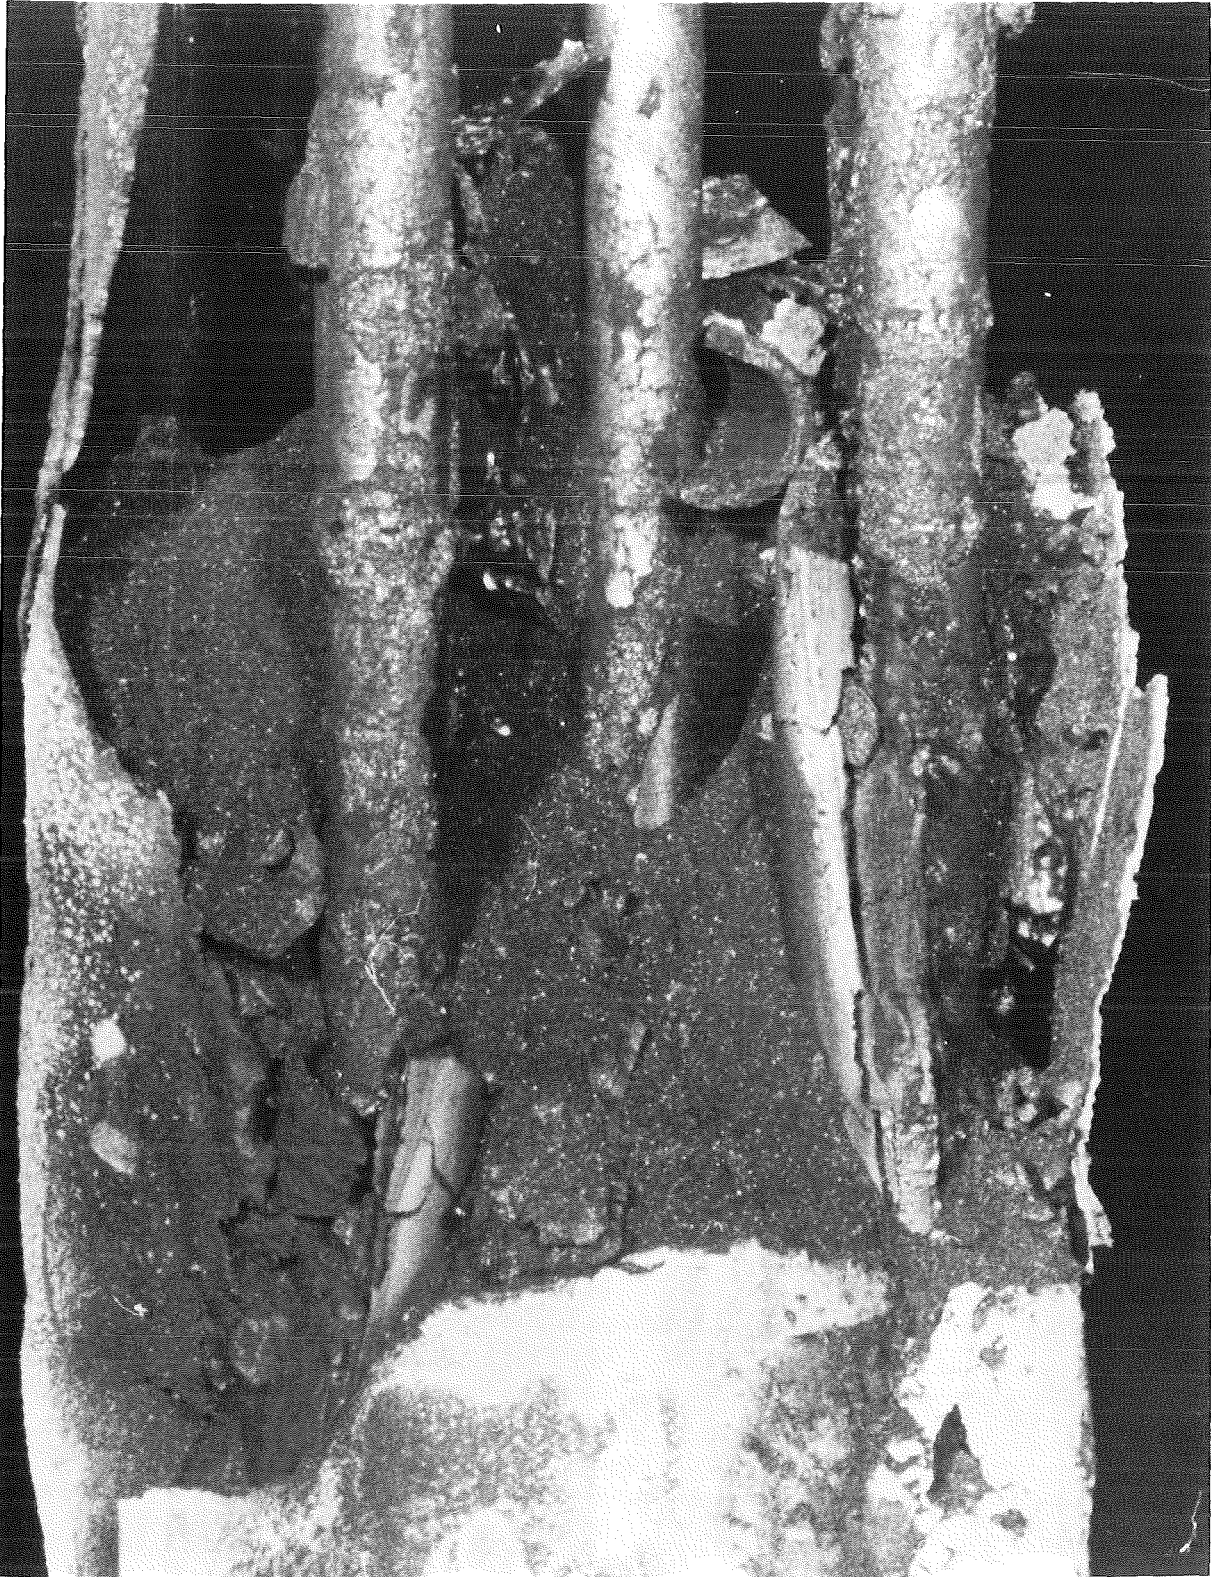
FIGURE 15: ENLARGEMENT OF THE RUBBLE FOUND ABOVE THE REFOZEN MELT IN ESBU-2A

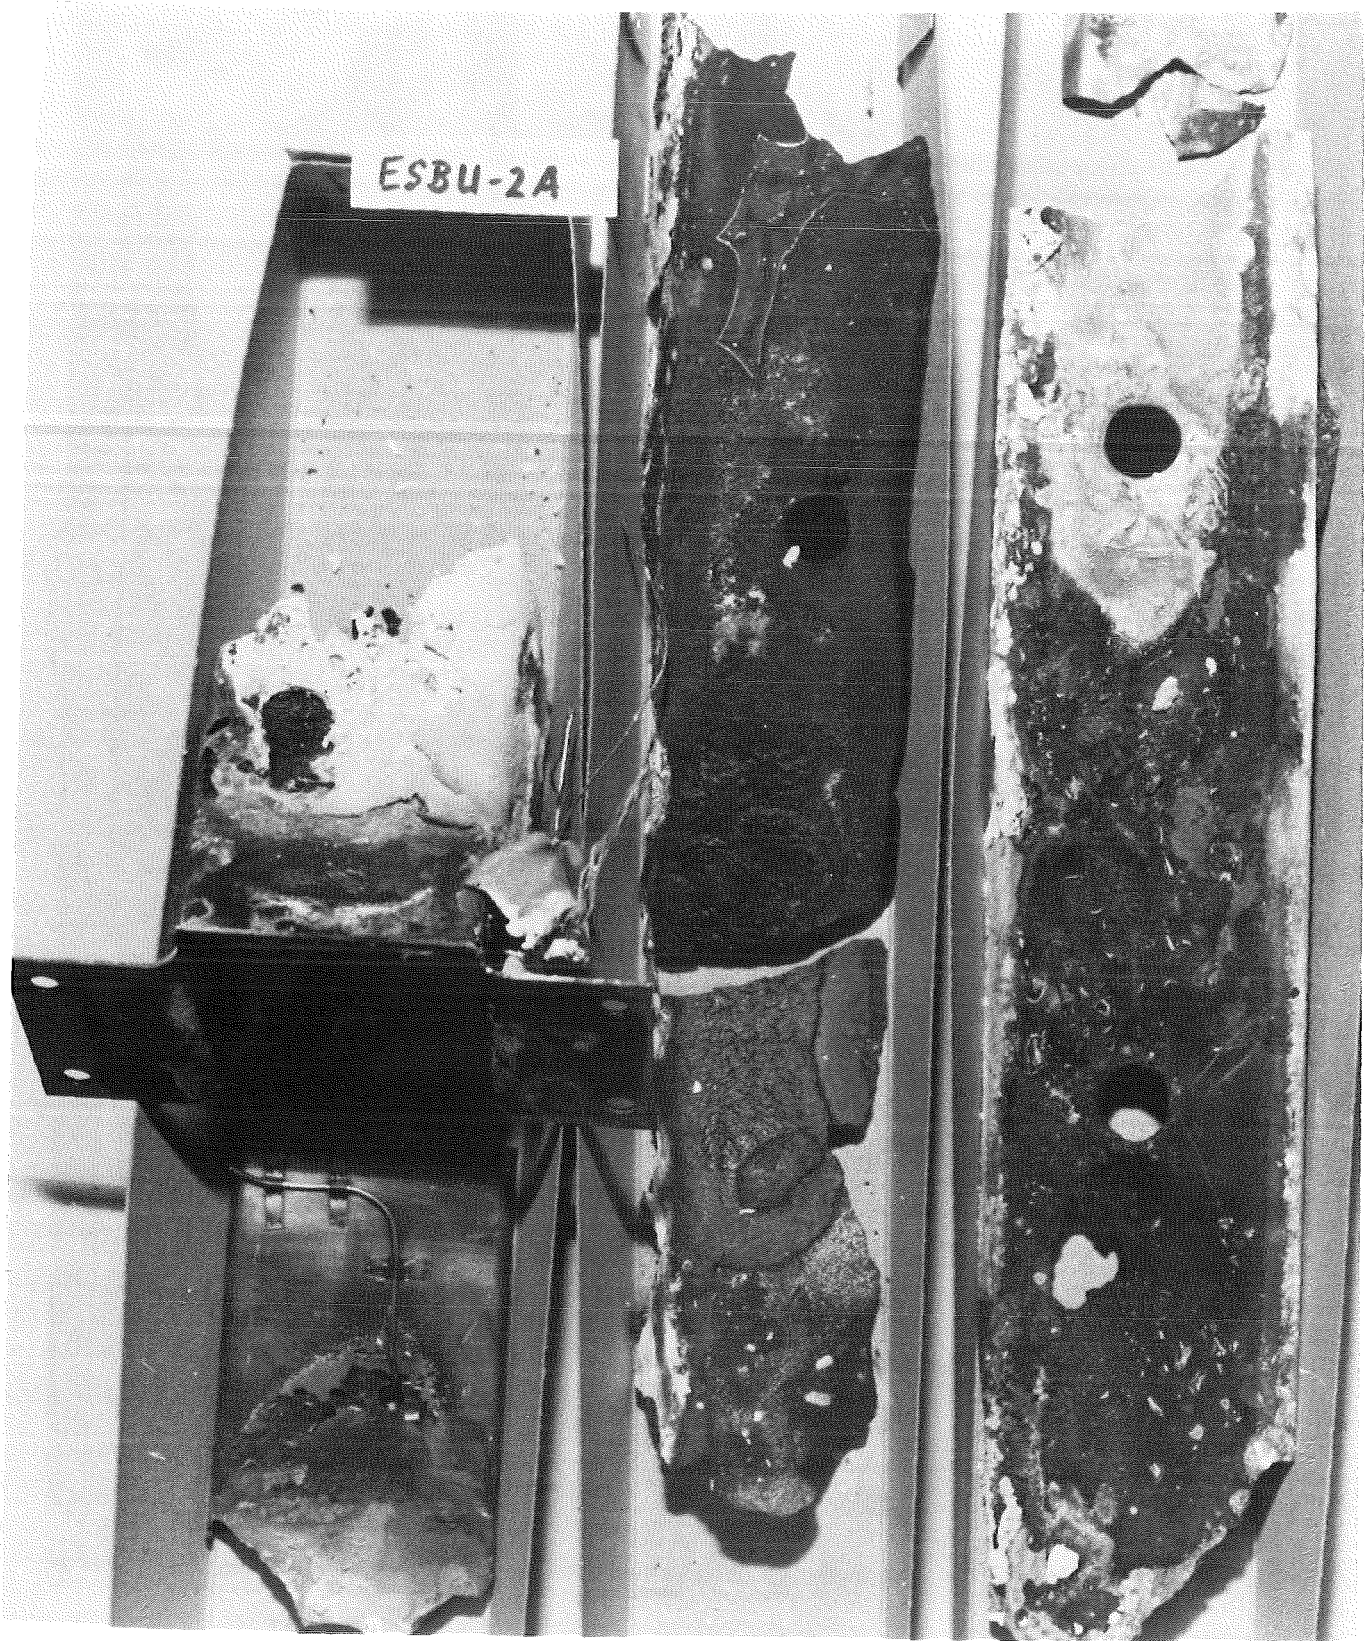
FIGURE 22: POSTTEST APPEARANCE OF THE ESBU-2A SHROUD AFTER REMOVAL

- Fig. 21: Posttest appearance of the ESBU-2A insulation after removal.
- Fig. 22: Posttest appearance of the ESBU-2A shroud after removal.
- Fig. 23: Close-up of the ESBU-2A shroud showing the outer surfaces.

The posttest appearance of the bundle before removing the insulation is shown in Figure 6. The insulation and shroud were still intact following the test. However, both were severely embrittled, as the removal of the insulation from the shroud showed (Figure 7). The insulation, originally a flexible mat, broke into many pieces (Figure 7 + 21). Even though the insulation was carefully removed, pieces of the shroud broke off (Figures 7). Powdery rubble was found below the test rig during disassembly of the bundle (Figure 8). The shroud was severely oxidized over the center region of the bundle and broke away in several places, revealing the fuel rod simulators (Figure 9). Figures 10 and 11 show closeups of the remaining upper and lower shroud, respectively.
