KfK 5309
März 1994

Corrosion Studies on Selected Metallic Materials for Application in Nuclear Waste Disposal Containers

Annual report 1993 prepared within the framework of the 1991-1994 programme of the European Atomic Energy Community: "Management and storage of radioactive waste". Task 3: Characterization and qualification of waste forms, packages and their environment. EC-Research Contract No. FI2W-CT90-0030.

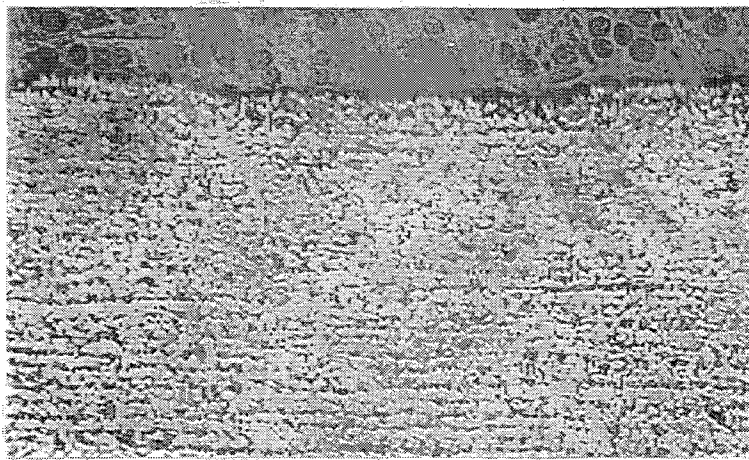
Brine 1 (MgCl₂-rich)

Brine 2 (MgCl₂-rich)

Brine 3 (NaCl-rich)

Fig.2: Optical micrographs of the steel TSt E 355 after 166 days exposure to brines at 150°C and 10 Gy/h

Surface profiles and metallographic examinations of corroded specimens have shown that the steel is resistant to pitting corrosion in both irradiated and unirradiated brines. In all brines, a non-uniform general corrosion was observed. However, the measured maximum penetration depth of this uneven corrosion corresponds to the values of the average thickness reduction. Figure 2 shows optical micrographs of steel specimens after 166 days of exposure to the test brines at 150°C and 10 Gy/h.

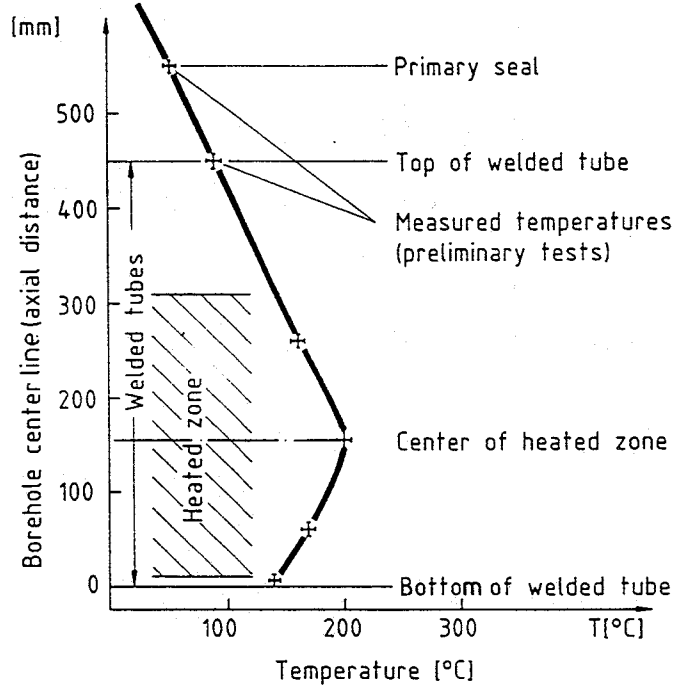
Fig. 7: Vertical temperature distribution on the welded tube wall

perature of 200°C occurred in the centre of the heated zone, the minimum temperature of 90°C was measured in the upper tube zone. The temperature in the centre between two boreholes nearly corresponded to the rock salt temperature of about 32°C at the 775 m level. The temperature was measured using NiCr-Ni thermocouples. In order to avoid invalidation of the corrosion results due to the corrosion induced by the contact of the thermocouples and tube surface, the temperature measurements were performed in reference boreholes of identical experimental set-up. In the experiments with the presence of brine and $T = 200^{\circ}\text{C}$, the pressure in the annular gap of the real test boreholes was measured continuously with a manometer, which was introduced into the brine inlet tube. The maximum pressure measured was 0.28 MPa which corresponds to a salt brine boiling point of 140°C. This means that the water contained in the brine evaporates at points of elevated temperature and recondenses at the upper cooler end of the tube (90°C).

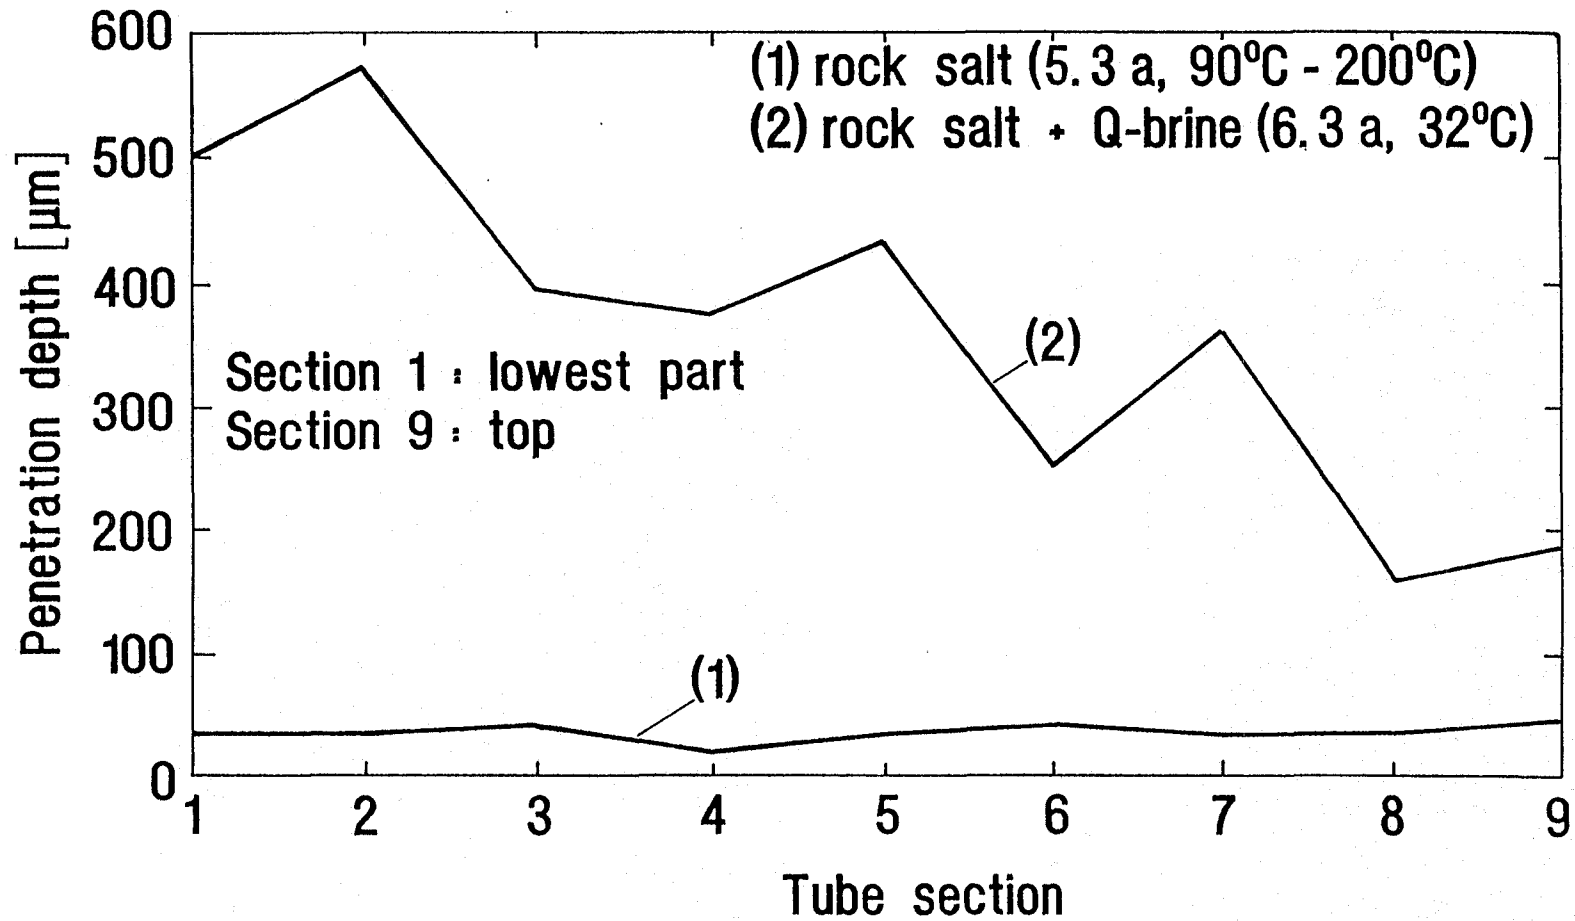
Fig. 10: Surface profilometry results of in-situ tested cast steel tubes. Maximum depth of non-uniform corrosion in rock salt and rock salt+ brine

Figure 10 shows the maximum penetration depth of corrosion in various sections of the cast steel tubes exposed to rock salt (very small corrosion) and to rock salt plus brine (extensive corrosion). It is evident that in rock salt plus brine the greatest corrosion attack of $570\ \mu\text{m}$ occurred at the lower part of the tube, while the smallest of $180\ \mu\text{m}$ existed at the top of the tube. These values determined after 6.3 years of test duration at 32°C correspond to average corrosion rates of about $30\ \mu\text{m/a}$ (top of the tube) and $90\ \mu\text{m/a}$ (bottom), respectively, and are smaller than those obtained in previous studies [10] at 90°C - 200°C . A possible explanation for the smaller corrosion of the upper tube part is the lowering of the brine level in the borehole during the test period due to water consumption

by the corrosion reaction with Fe. This means that the upper tube part was not exposed to brine during the entire test period.

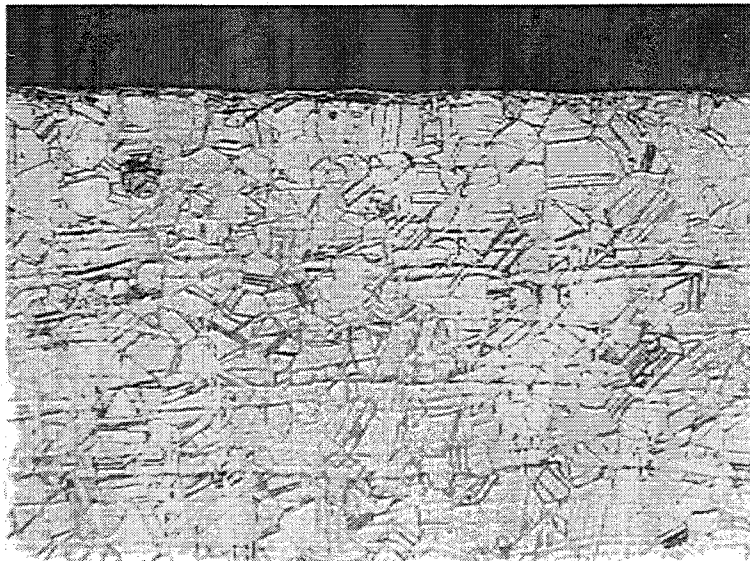
Fig. 14: Optical micrograph of the steel tube plating material Hastelloy C4 after 6.3 years in-situ testing in rock salt plus NaCl-brine at 32°C (x 200)

The examination of the cast steel tubes provided with a corrosion protection of Ti 99.8-Pd and Hastelloy C4, respectively, has not shown any changes on the surface of the plating materials by corrosion attacks in rock salt or rock salt plus brine. Neither on the mechanically finished surface nor on the hot-rolled and electron beam welded sheet metal surface were any signs of corrosion observed. Even the crack produced by a steel needle in order to simulate severe conditions due to handling of the containers did not stimulate a corrosion attack. Figures 13 and 14 show optical micrographs of the plating materials Ti 99.8-Pd and Hastelloy C4 after testing in rock salt and rock salt plus brine.

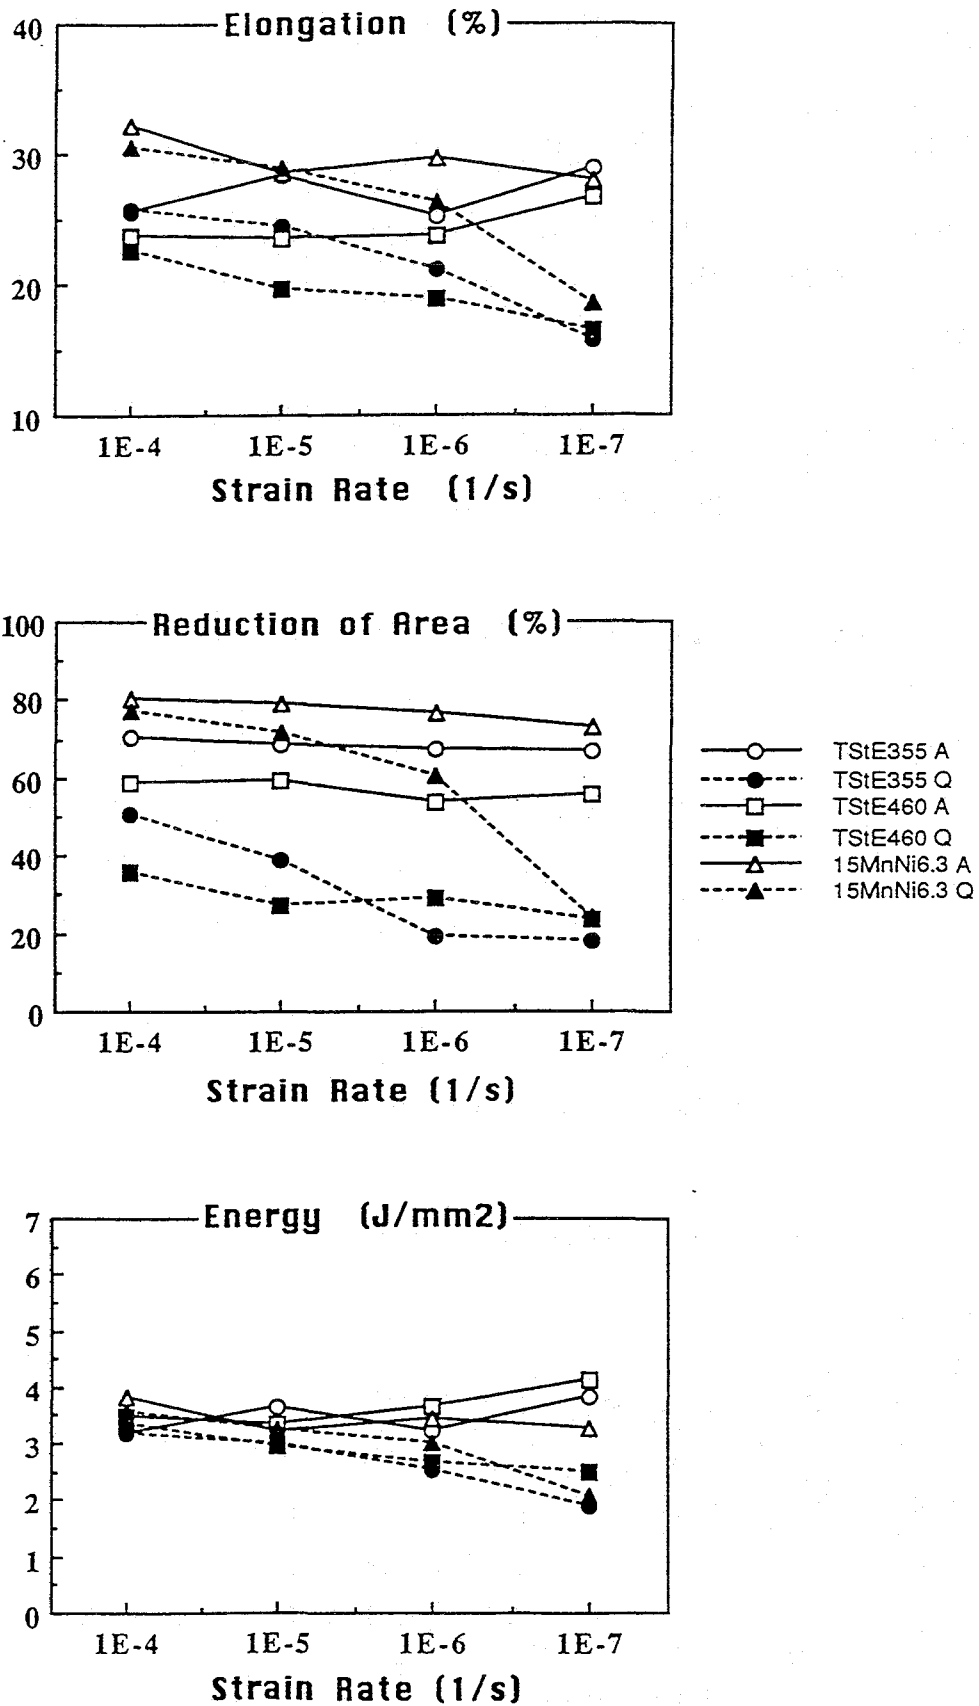
Fig. 15: Elongation, reduction of area and energy versus strain rate for the steels TStE 355, TStE 460 and 15MnNi6.3 tested at 90°C and 13 MPa in argon and Q-brine

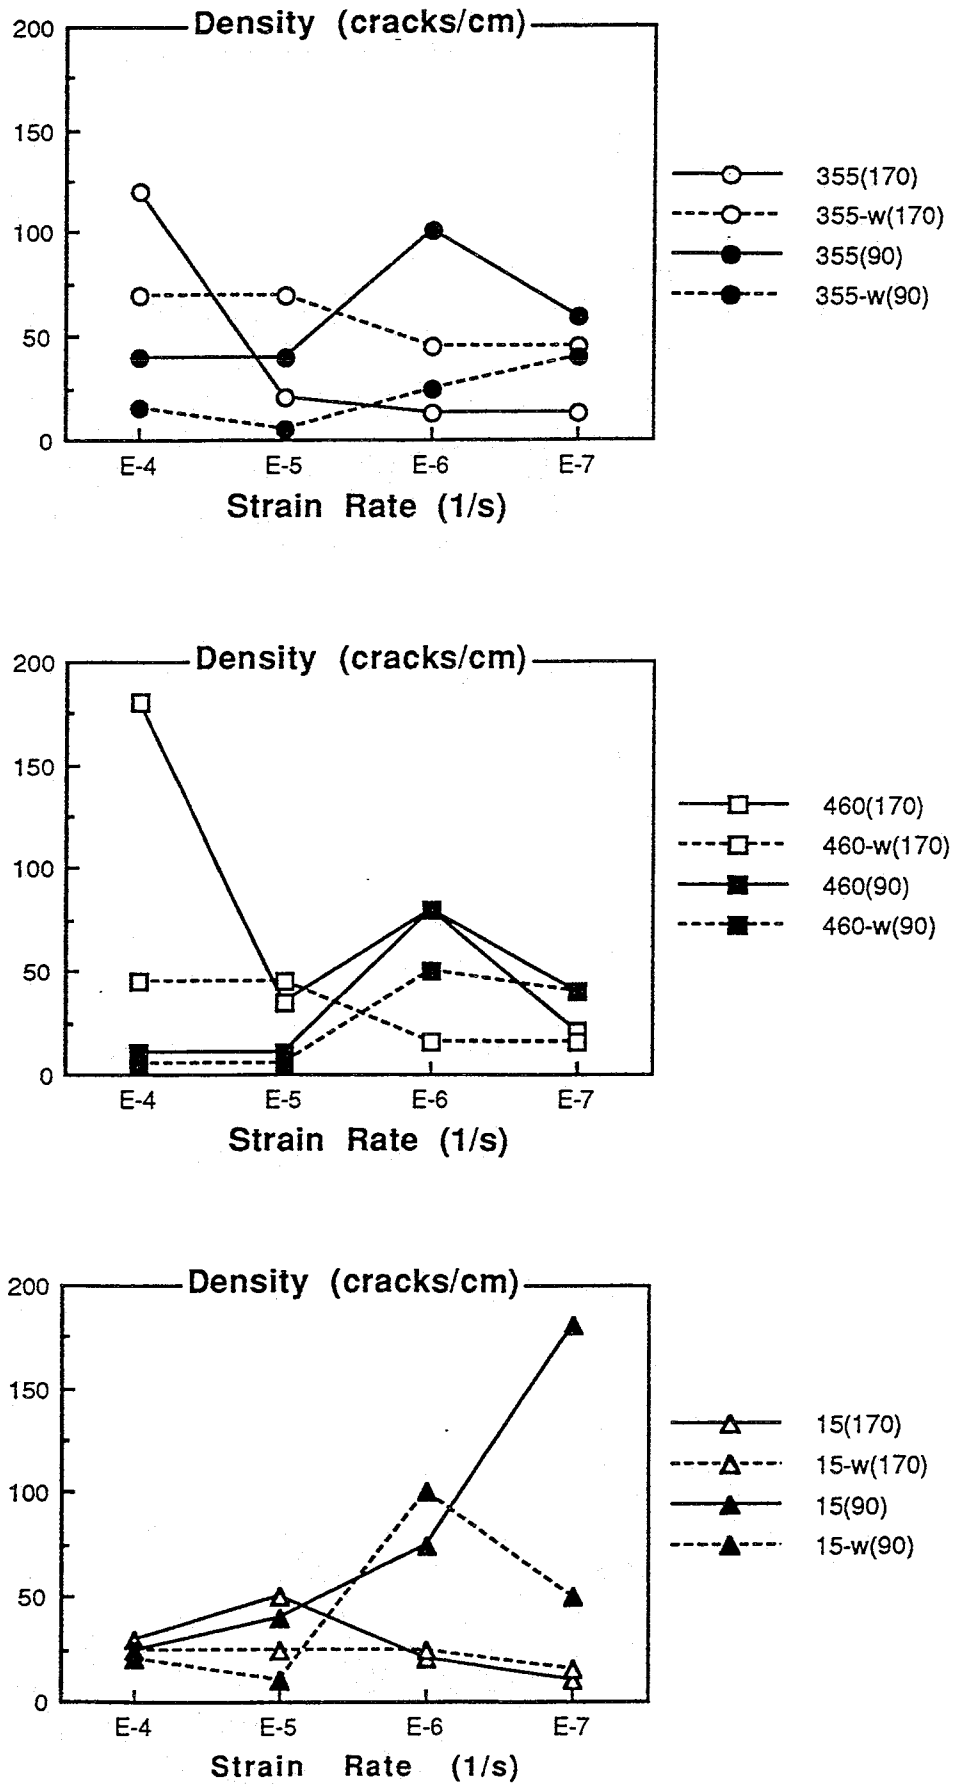
Fig. 22: Crack density obtained for the steels TStE 355, TStE 460 and 15MnNi 6.3 after slow strain rate testing in Q-brine under various conditions ($T = 90^{\circ}\text{C}$, 170°C , $w = \text{welded material}$)

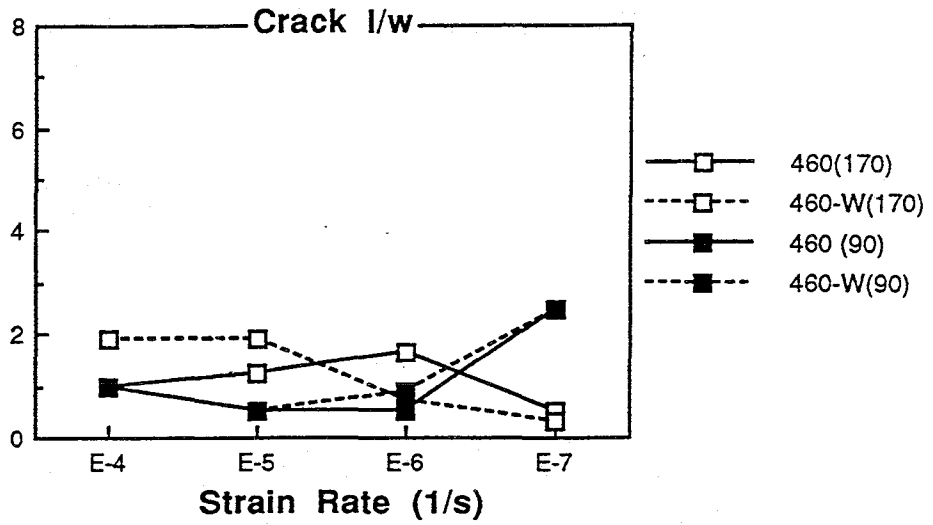
Fig. 24: Crack length to wide ratio obtained for the steels TStE 355, TStE 460 and 15MnNi 6.3 after slow strain rate testing in Q-brine under various conditions ($T = 90^{\circ}\text{C}$, 170°C , $w = \text{welded material}$)
