FORSCHUNGSZENTRUM KARLSRUHE

FZKA 5869

**Gamma Irradiation-Corrosion Studies and Surface
Analytical Investigations of the HLW Container Material
Ti99.8-Pd**

E. Smailos, D. Schild, K. Gompper

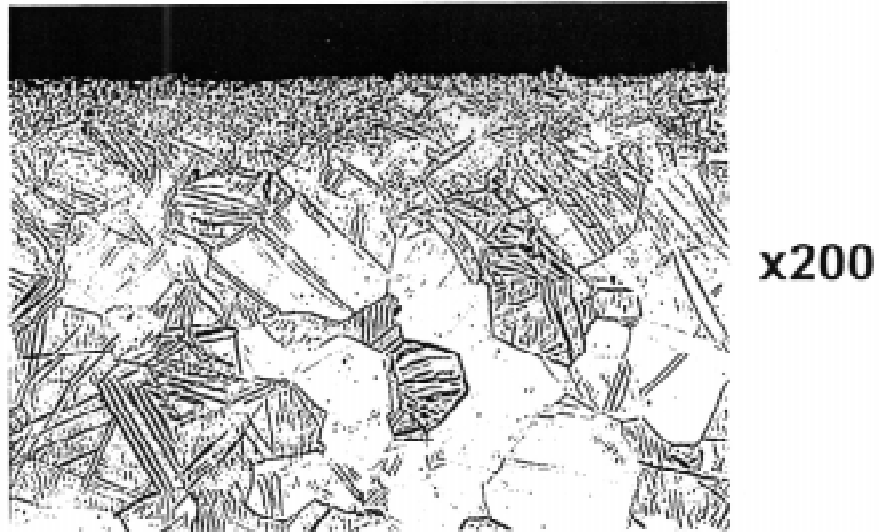
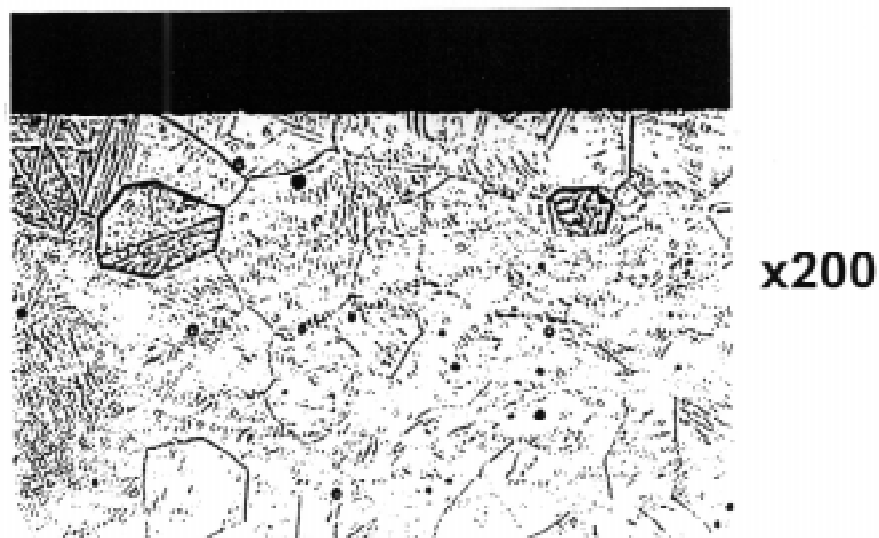
Q-brine/150°C/125d

Q-brine/150°C/10Gy/h/265d

Fig. 2. Optical micrographs of Ti99.8-Pd after corrosion in MgCl₂-rich Q-brine at 150 °C with and without gamma irradiation

It is evident from the metallographic examinations and from the surface profiles of corroded specimens that the alloy Ti99.8-Pd is resistant to pitting corrosion both with and without irradiation. Under the test conditions, a completely uniform corrosion was observed. Characteristic optical micrographs of Ti99.8-Pd specimens after immersion in the brines at 150 °C are shown in Fig. 2.
