Forschungszentrum Karlsruhe

FZKA 6604

Single rod quench tests with Zr-1Nb cladding.
Comparison with Zircaloy-4 cladding tests and
modelling

J. Stuckert, M. Steinbrück, U. Stegmaier

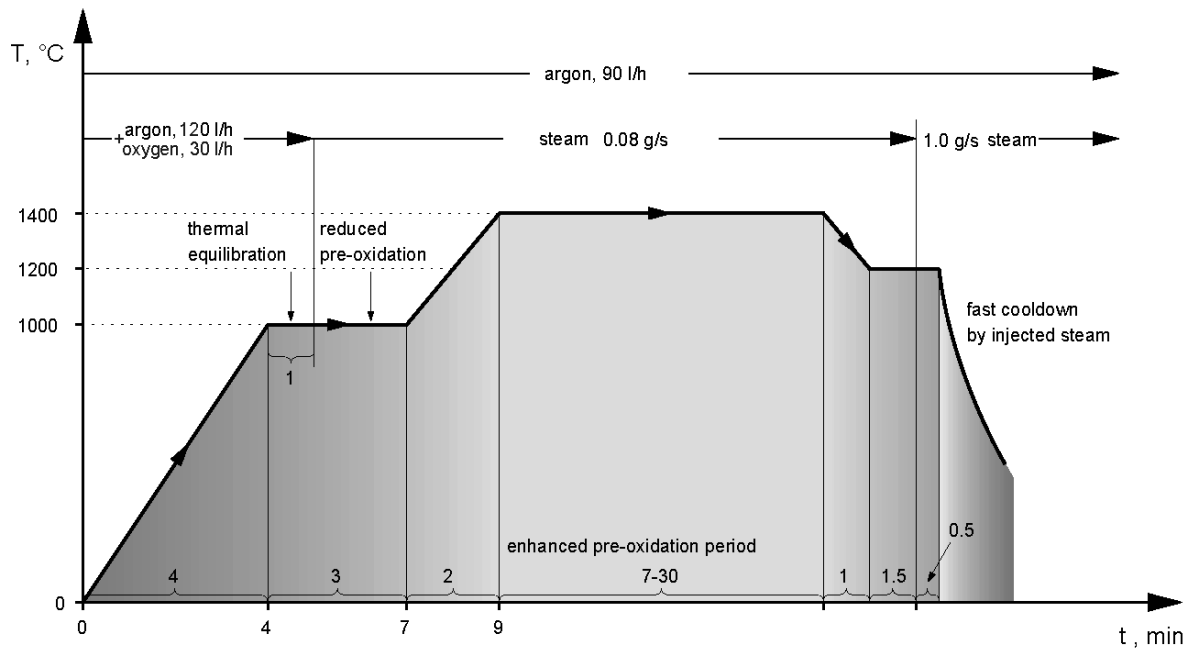
Fig. 2: Test conduct of single rod quench experiments

The scheme of the test conduct is presented in [Fig. 2](#). The following phases for the test sequence can be distinguished. First, an initial phase, during which the facility was prepared for the actual test. The specimen was heated up to 1000°C under constant argon flow with the addition of 20% oxygen to prevent dissolution of the protection oxide layer. After establishing of the thermal equilibrium the steam was injected at a constant rate of 0.08 g/s. Second, during the enhanced pre-oxidation

period, the specimen was heated up to 1400°C under a constant flow of argon and steam through the test section. The specimen was kept at this temperature until the desired oxide layer thickness is reached. Finally, the specimen was heated or cooled to the desired initial temperature at the onset of cooldown. The test was completed by increasing the steam flow rate to 1 g/s (steam temperature about 150°C) and switching off the inductive heating.

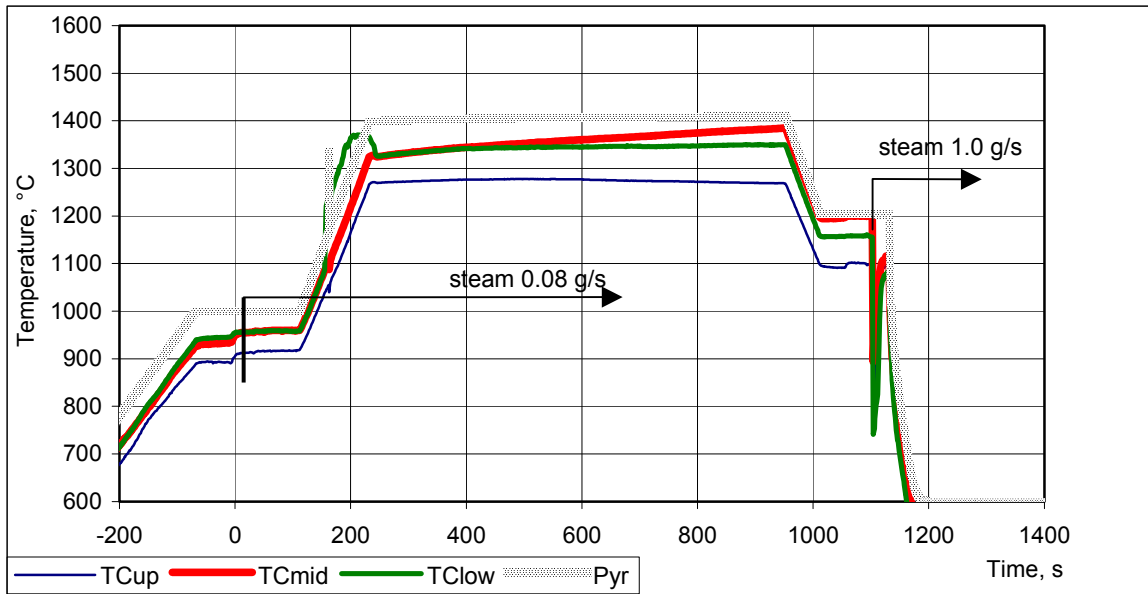
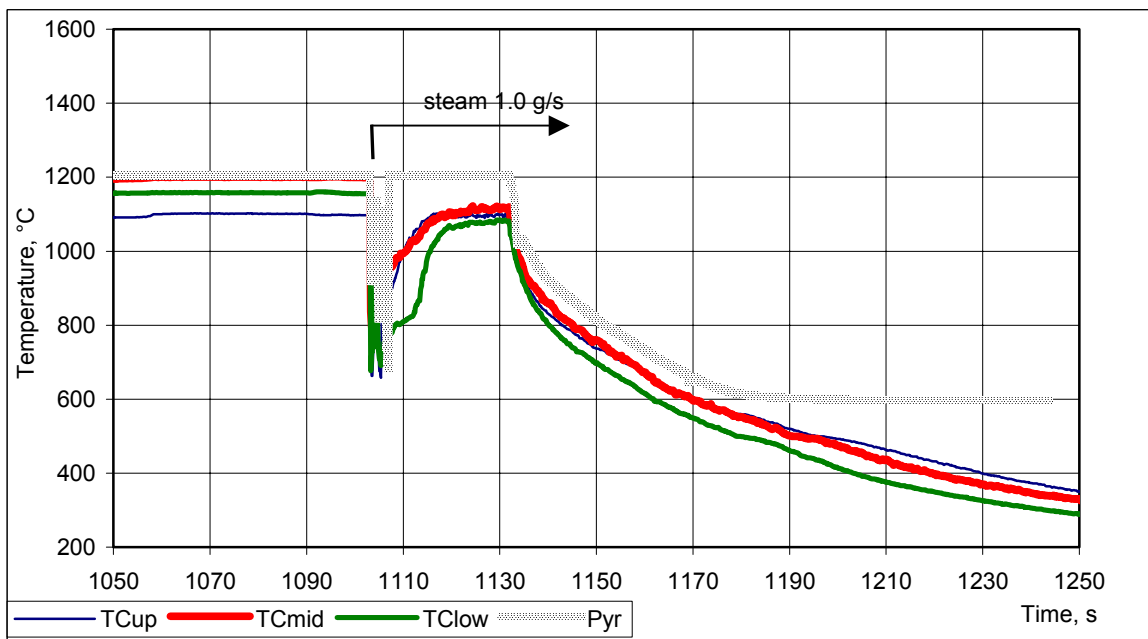
Fig. 6: Temperature history and corresponding hydrogen release for the test No. 3 (20030b). Pre-oxidation 12 minutes, cooldown from 1200°C

The thermocouple readings are depicted in Fig. 4 – Fig. 12. Because of the finite coil dimensions all specimens had non-uniform axial temperature profile with a maximum in the middle of the tube segment. The lowest temperatures were measured at the top of the tube. The difference between thermocouple values was up to 200 K. The injection of 1 g/s steam 30 s before power shut-off causes a temporary decrease of the specimen temperature in all the experiments performed. This temperature drop was soon compensated by automatically increased electrical heating.

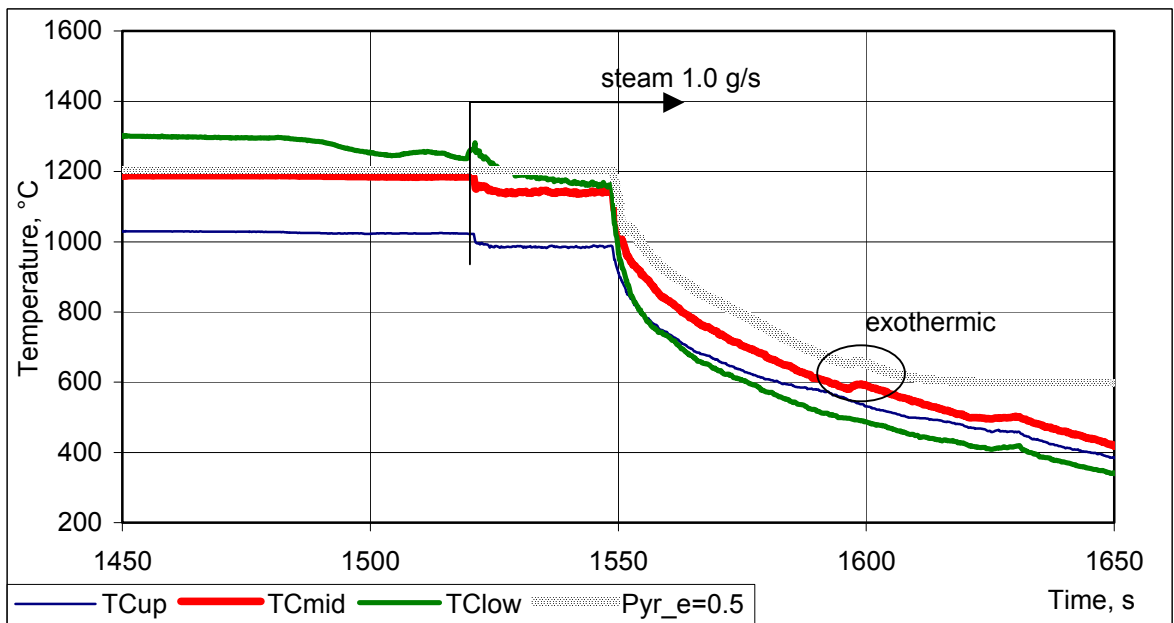
Fig. 7: Temperature history and corresponding hydrogen release for the test No. 6 (27030a). Pre-oxidation 19 minutes, cooldown from 1200°C

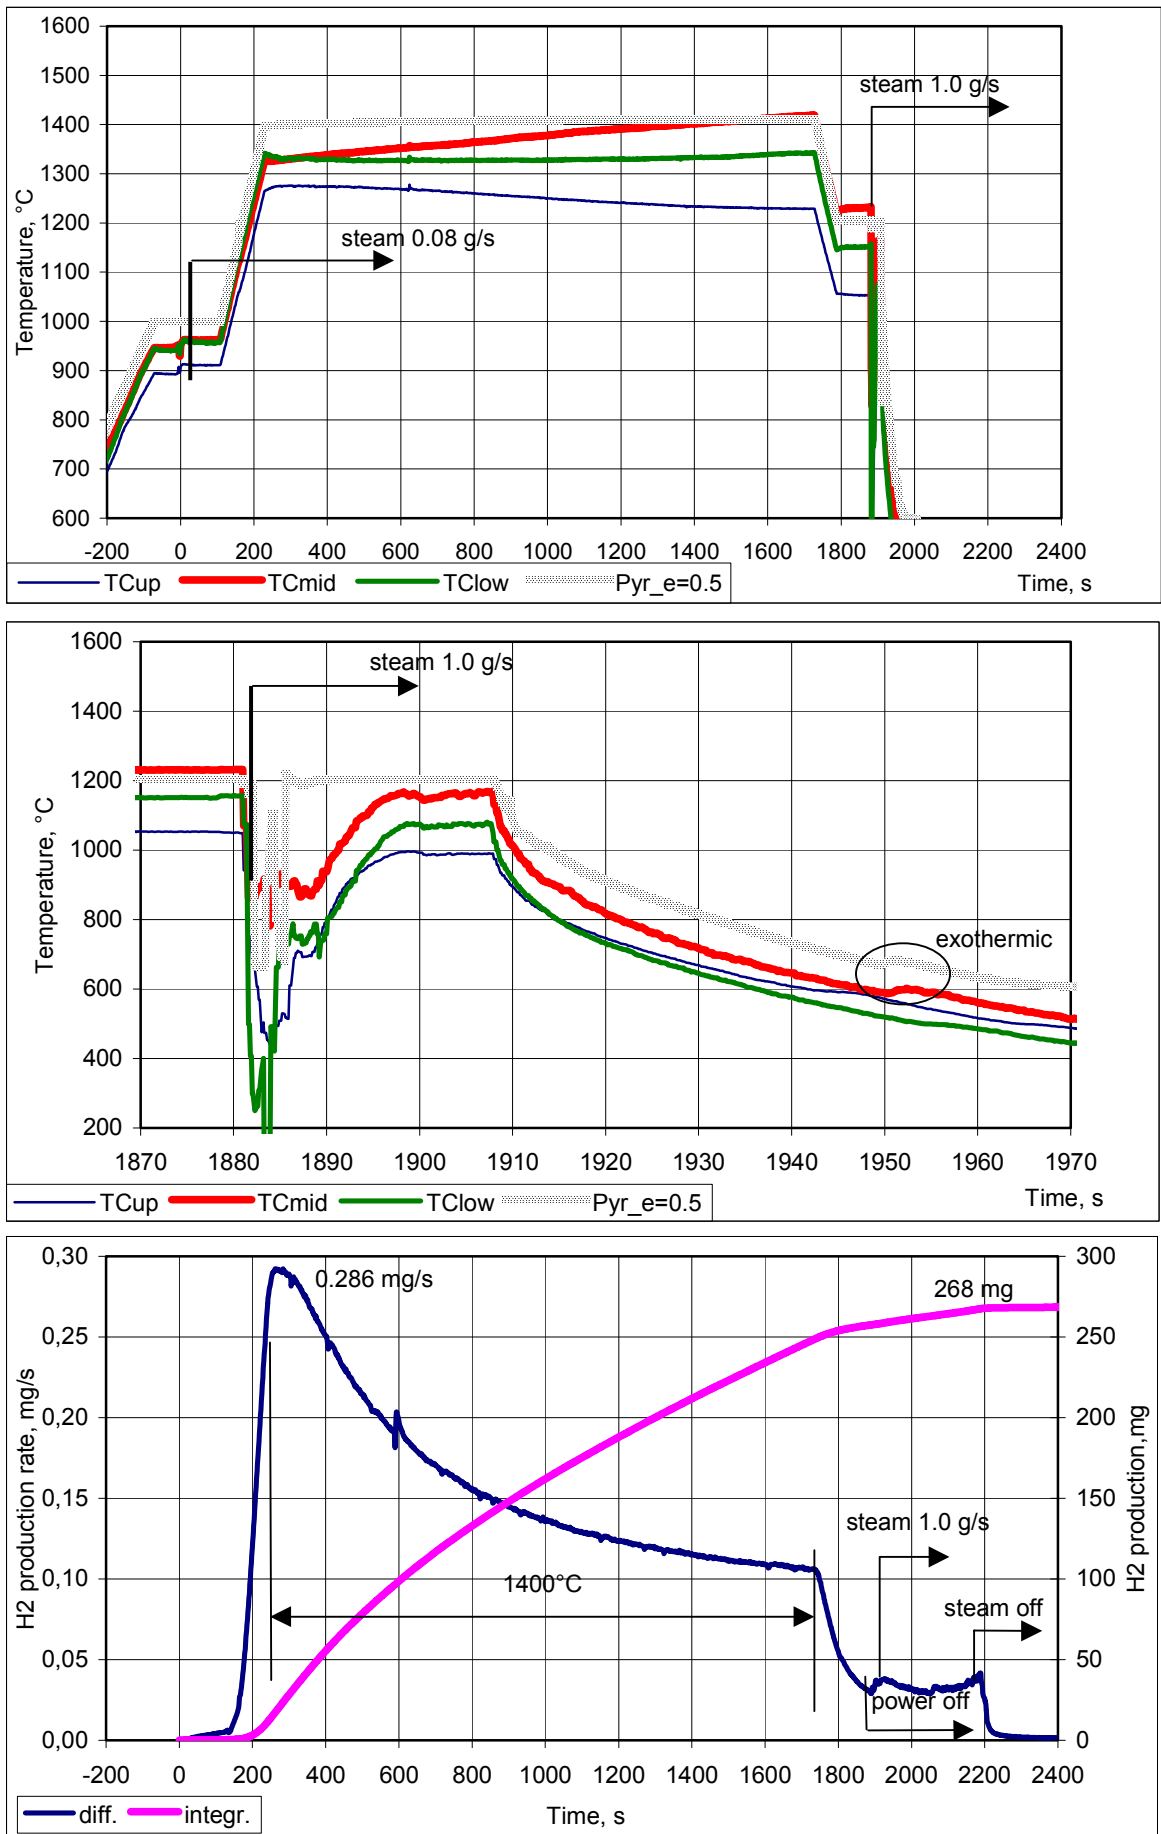
Fig. 8: Temperature history and corresponding hydrogen release for the test No. 2 (20030a). Pre-oxidation 25 minutes, cooldown from 1200°C

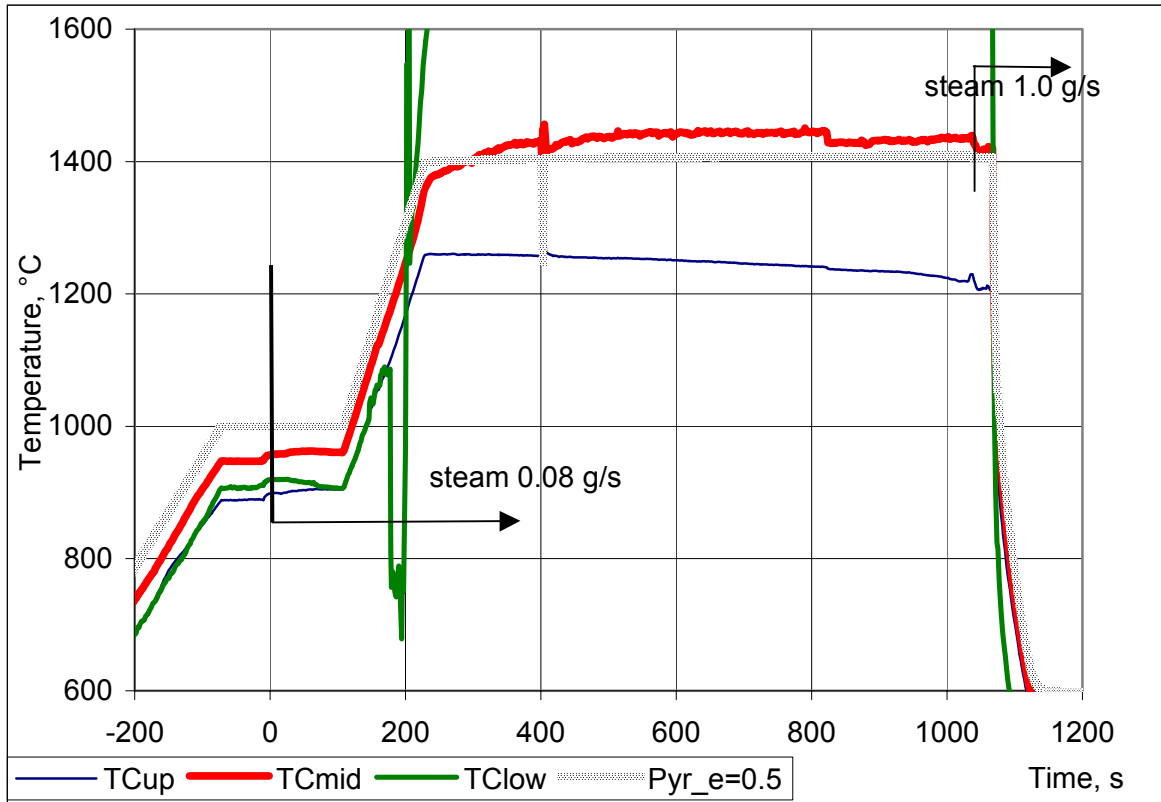
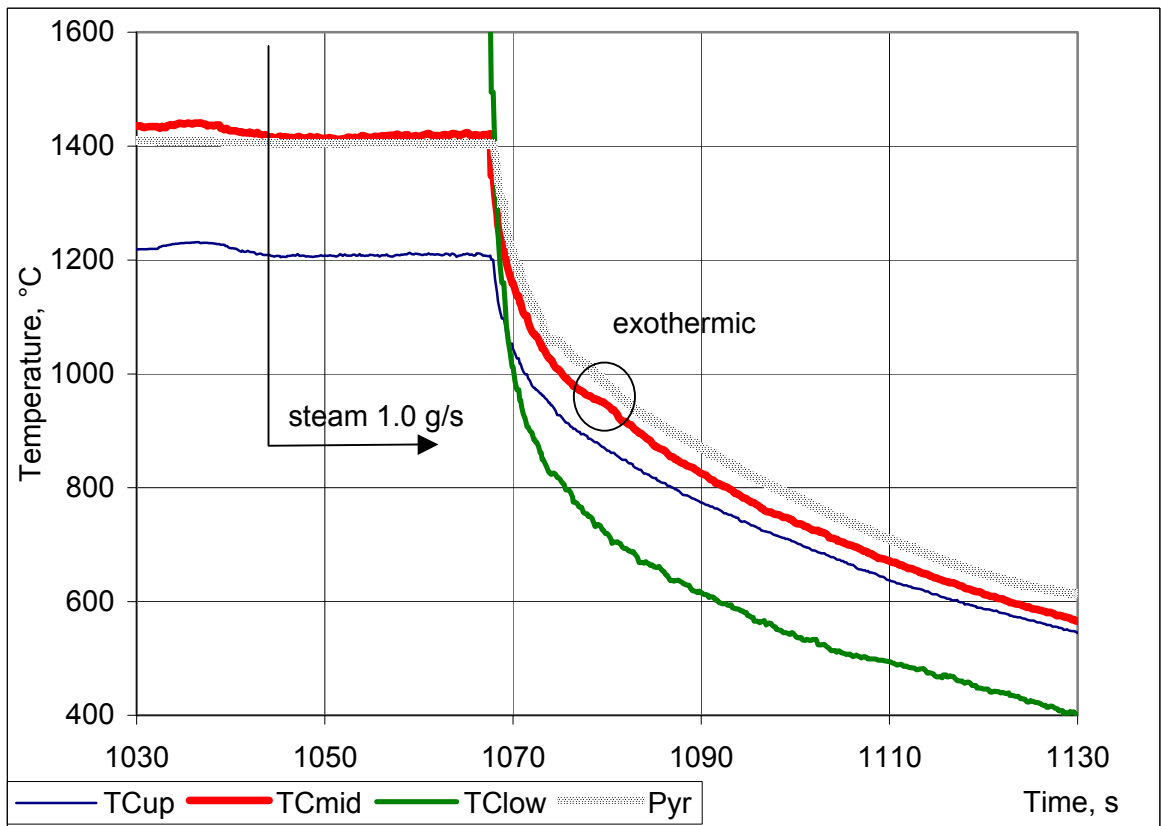
Fig. 9: Temperature history for the test No. 5 (24030). Pre-oxidation 13.5 minutes, cooldown from 1400°C

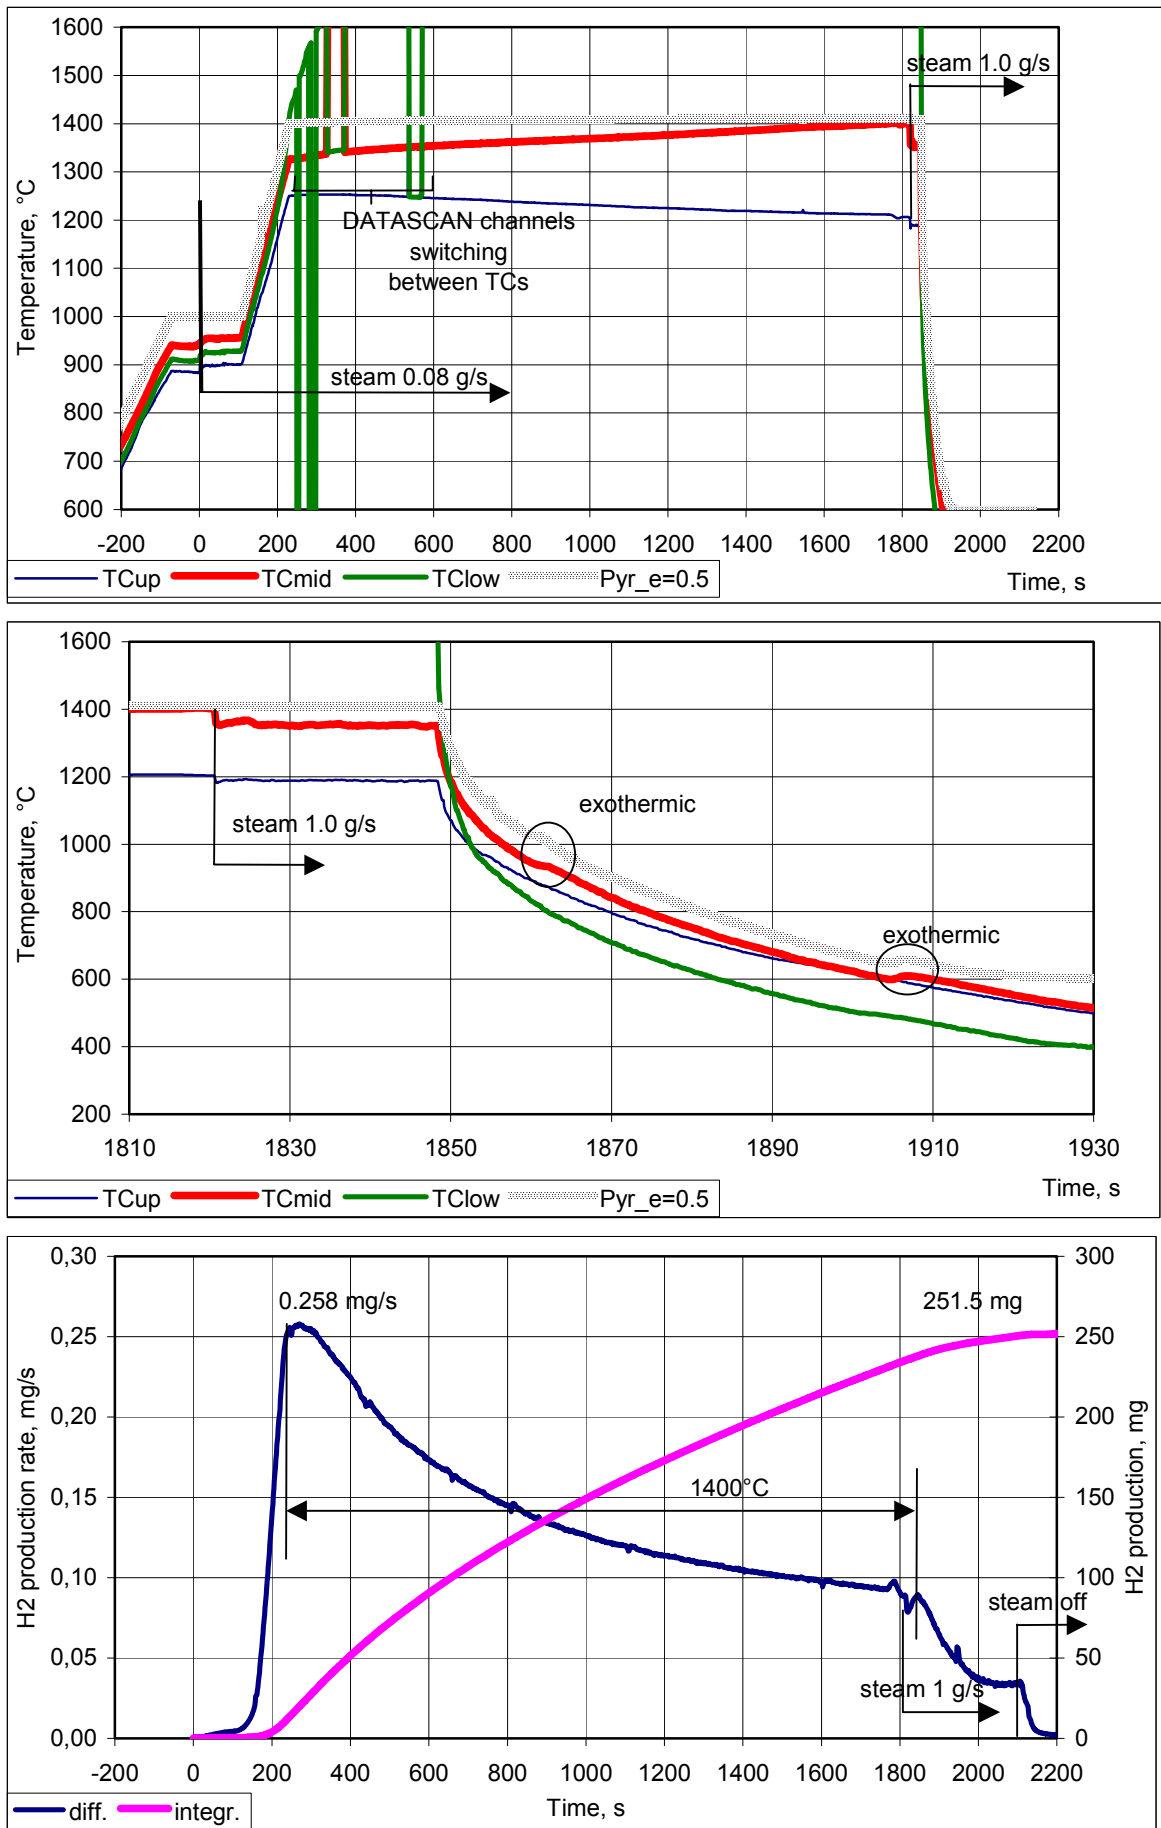
Fig. 11: Temperature history and corresponding hydrogen release for the test No. 8 (28030a). Pre-oxidation 26.5 minutes, cooldown from 1400°C

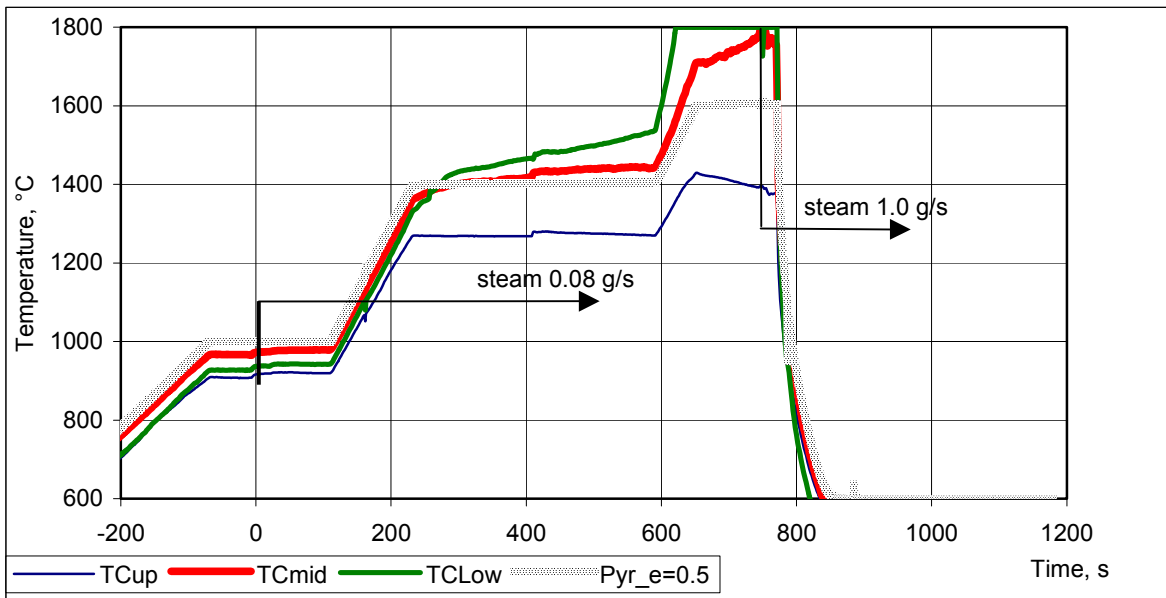
Fig. 12: Temperature history and corresponding hydrogen release for the test No. 4 (21030). Pre-oxidation 6 minutes, cooldown from 1600°C

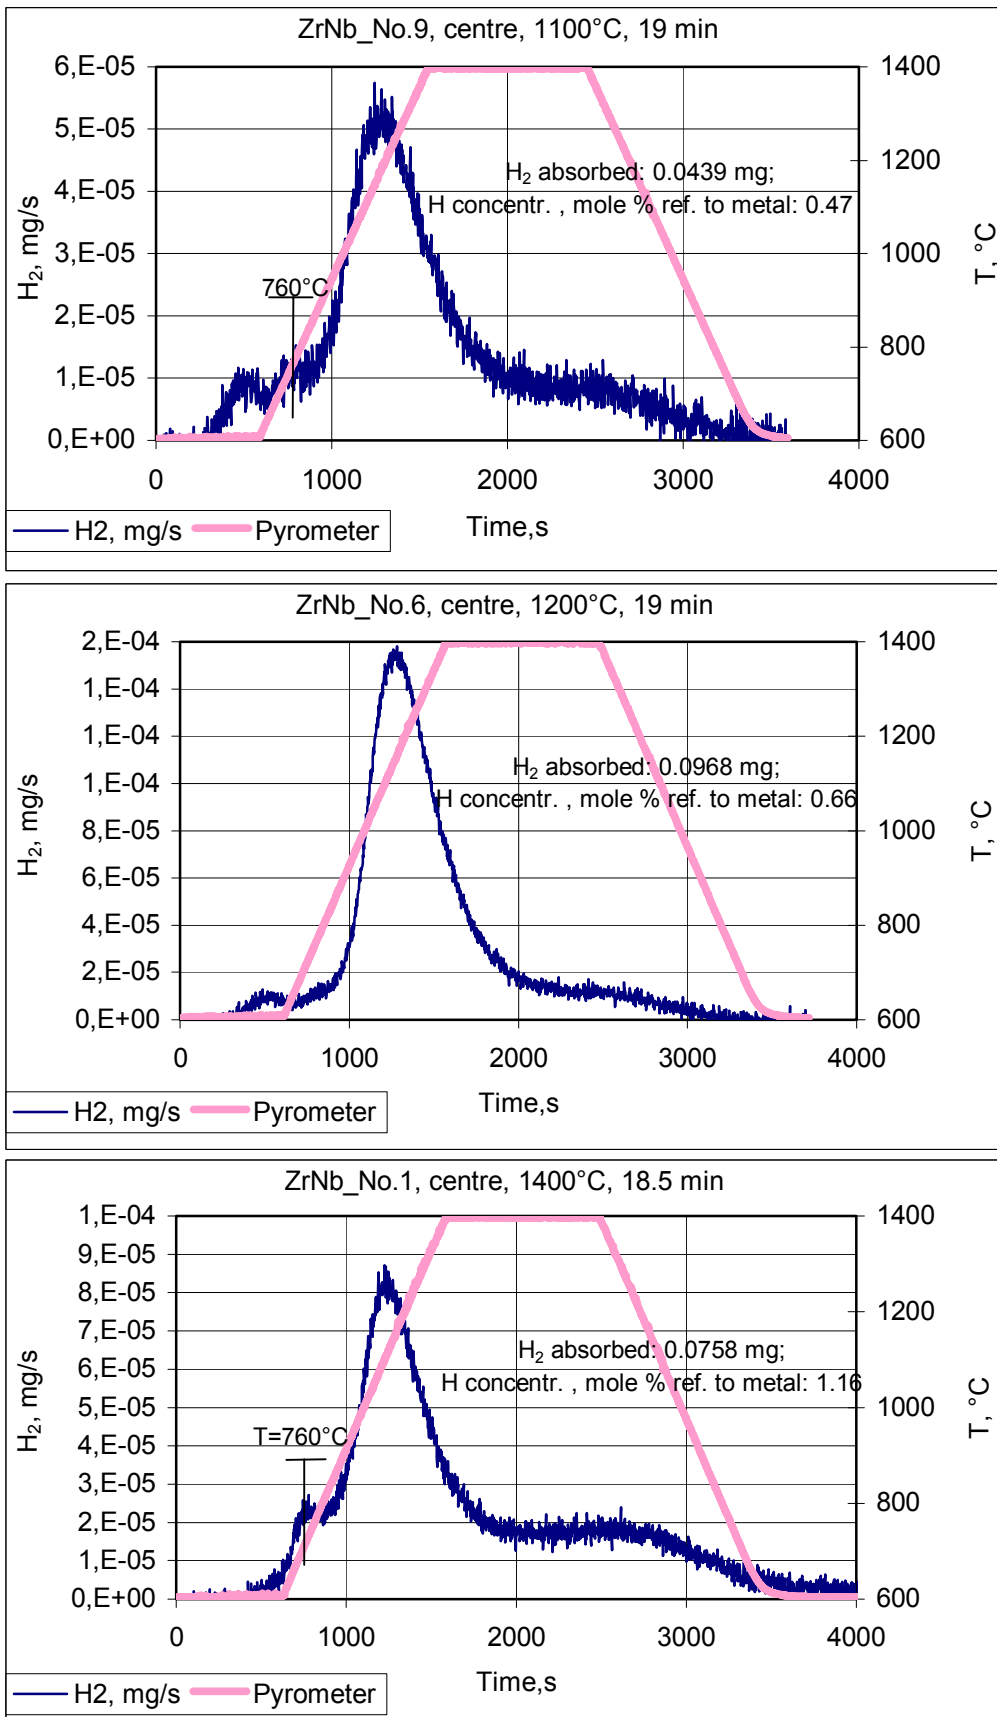
Fig. 13: Analysis of hydrogen absorbed in cladding tube segments at elevation 65-75 mm. Typical curve profiles from LAVA rig

The amount of hydrogen absorbed by the specimens was analysed by hot extraction under flowing argon in the LAVA facility coupled with a mass spectrometer. 1 cm long tube segments from the bottom, centre and top parts of each specimen were analysed. The specimens were kept at 1400°C for ca. 15 min under a well defined argon gas flow. The hydrogen release was analysed by the GAM-300 mass spectrometer. Fig. 13 shows typical temperature curves and MS results for specimens with 19 min pre-oxidation and different cool-down temperatures, as an example.

One of main tasks of these tests was the quantitative description of the hydrogen generation kinetics. Fig. 5 – Fig. 13 show the sharp increase of the hydrogen release during heat-up to 1400°C for all tests. The increase of the hydrogen generation for the test No. 4 (Fig. 13) during heat-up to 1600°C is much more pronounced. There is no noticeable increase of hydrogen generation during the quench phase for all the tests. The results of the hydrogen release measurements during the tests are summarised in Table 4.

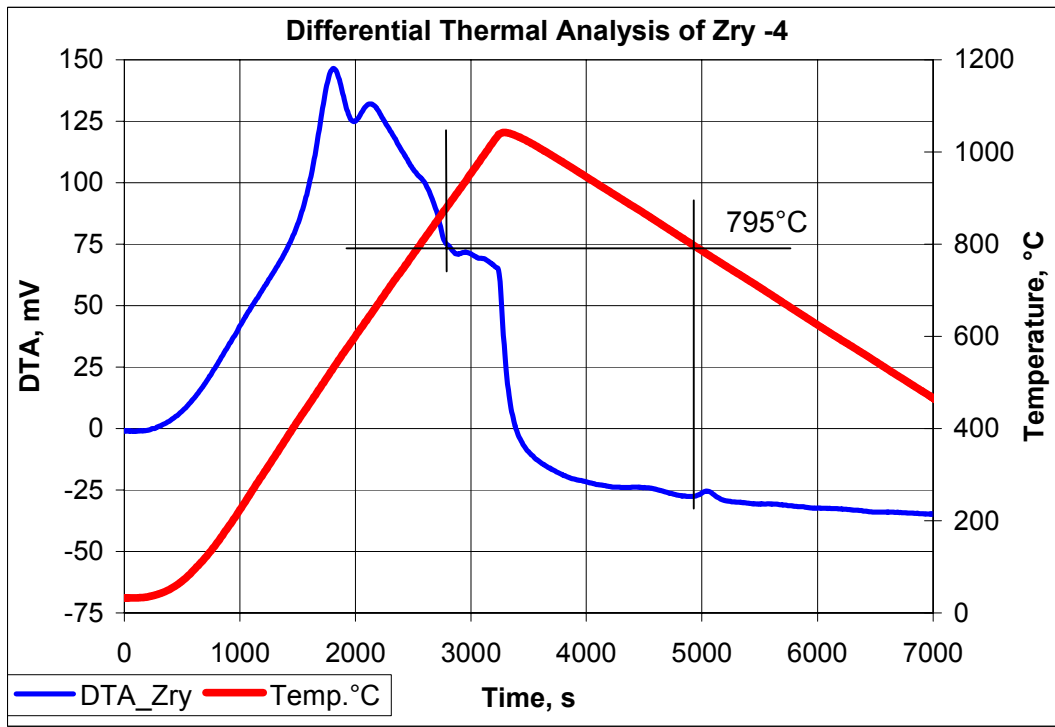
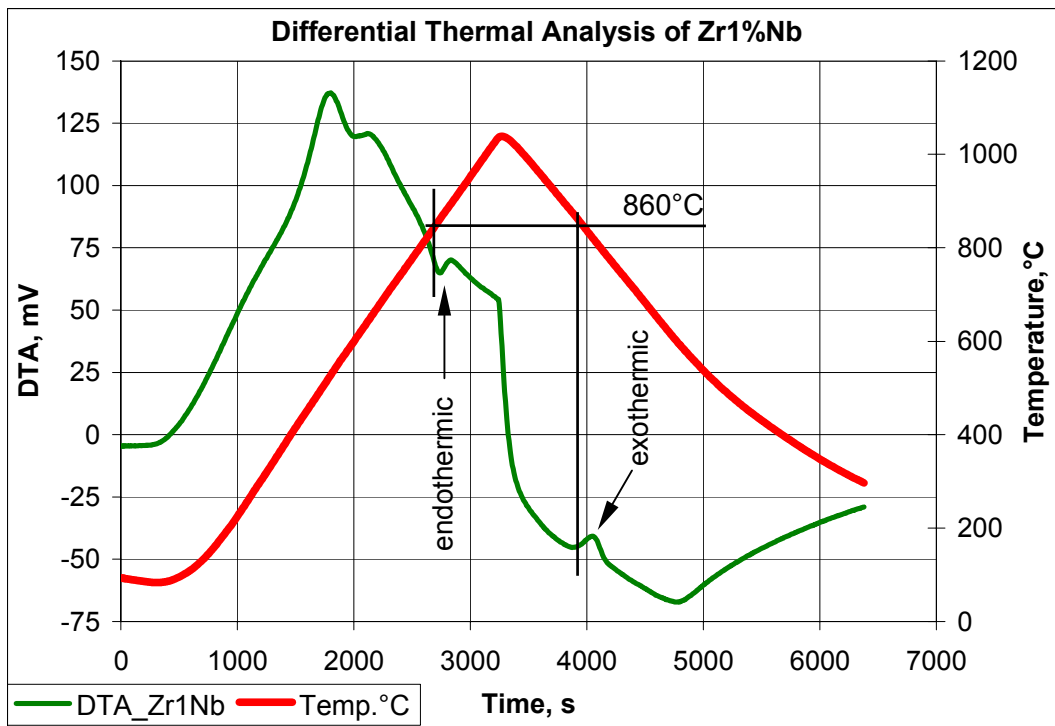
Fig. 14: : Differential thermal analysis performed for two kinds of materials: a) Zircaloy-4; and b)Zr-1Nb. Probe dimensions: disc diameter 9.1 mm, thickness 2 mm

These exothermic deviations from a regular cooldown curve are probably caused by the $\beta \rightarrow \alpha$ phase transition in the base metal. Differential thermal analysis (DTA) tests with Zircaloy-4 and Zr-1Nb samples were performed to check this hypothesis ([Fig. 14](#)). The thermal effect at about 800°C is more pronounced for Zirconium-Niobium. The scattering of the onset of the temperature deviation in [Fig. 7 - Fig. 12](#) can be connected to different phase transition temperatures for the different oxygen and hydrogen contents in the metal phase due to different pre-oxidation times.

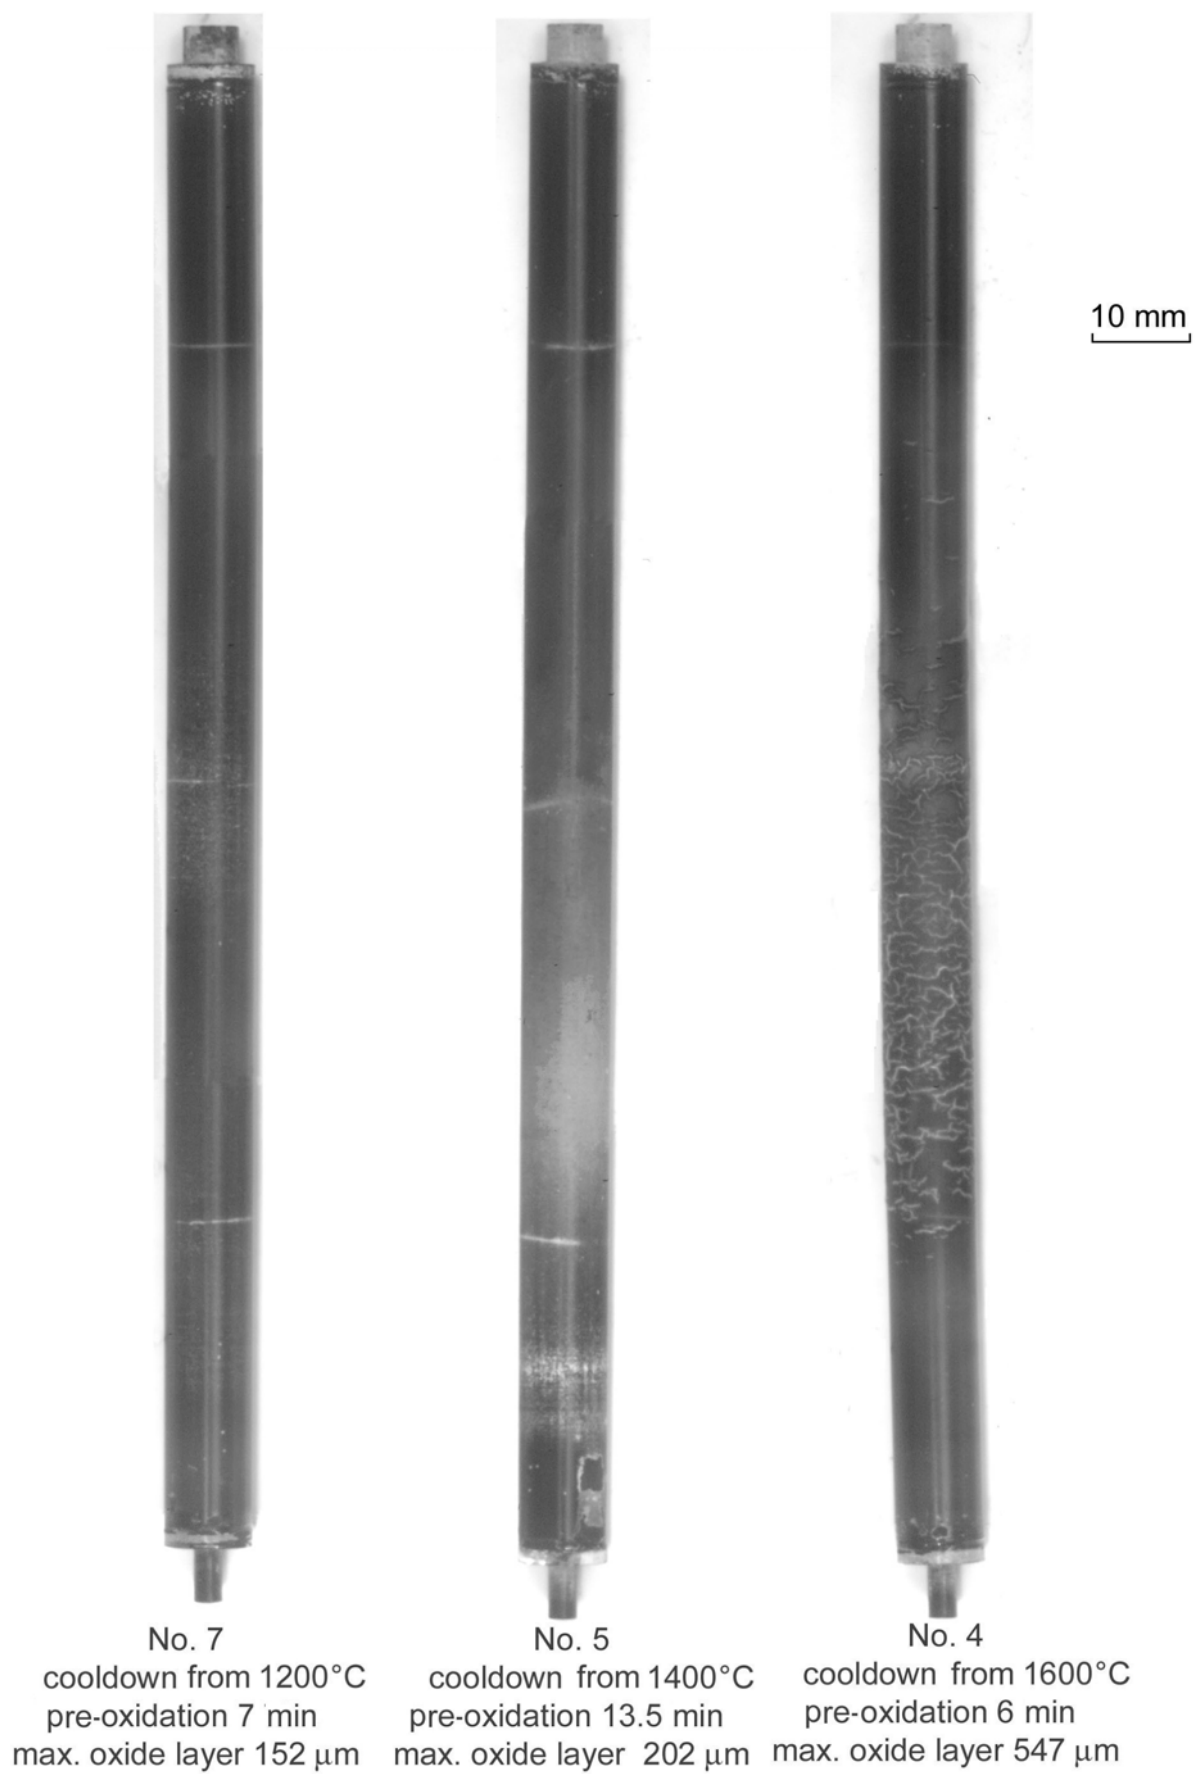
Fig. 15: Macroscopic appearance of stable specimens

[Fig. 15 - Fig. 16](#) show the appearance of specimens after the cooldown from different temperatures. The oxide layer thickness at the onset of the cooldown phase was between 150 and 550 μm . Some specimens were broken during handling. Nevertheless they are quite stable mechanically and show no indications of spalling of the oxide scale. The outer surface of the cladding tubes is mostly dark which can be seen in [Fig. 17](#). Here, the comparison of Zircaloy and Zirconium-Niobium claddings after the cooldown tests under the same conditions shows that at least the optical properties of oxide layers on the Zry and Zirconium-Niobium surfaces are different. It means also that these surfaces have different emissivity coefficients. [Fig. 18](#) illustrates the differences of the optical properties for both materials. The reflectivity of Zircaloy-4 tube surface is higher than reflectivity of Zr-1Nb tube surface at room temperature. The measurements were performed by means of a light spectrometer [6]. Analogous measurements are necessary for the temperatures up to Zirconium melting temperature in the infra-red wavelength range.

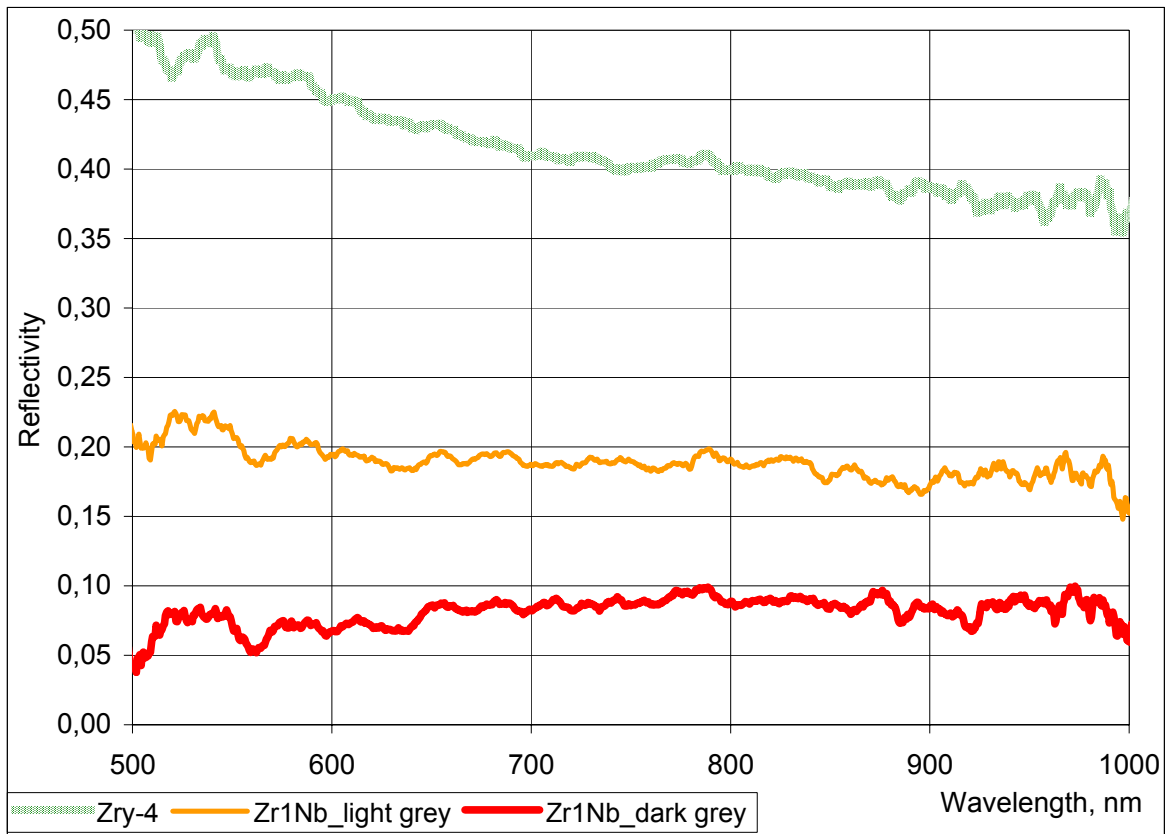
Fig. 18: Reflectivity of oxidised cladding at 20°C, oxide layer thickness ~250µm

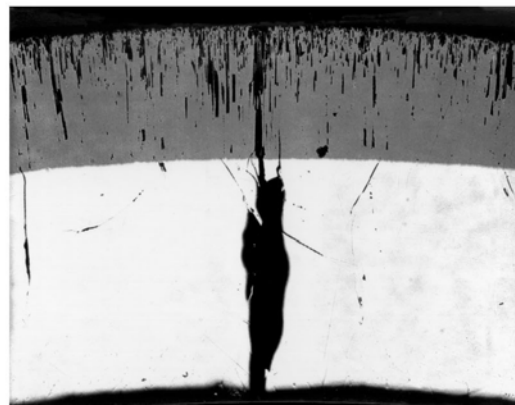
ZrO₂ 118 μm
α-Zr(O) 161 μm
β-Zr 426 μm

ZrO₂ 295 μm
α-Zr(O) 493 μm

**Fig. 21: Test No. 9 (pre-oxidation period 19 min., cooldown from 1100°C).
Cross sections at three TC elevations, as polished.
There are a few non-oxidised through-wall cracks**

After the tests a detailed metallographical analysis of the cladding cross-sections was performed at three elevations for each rod (Fig. 21 – Fig. 31). Three typical layers (oxide layer, brittle α -Zr(O) layer, ductile β -Zr layer) were identified and measured. The results of the thickness measurements are summarised in the Table 3.

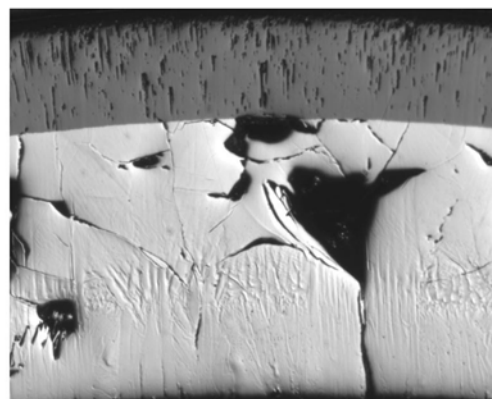
Elevation 30 mm
Max pre-oxidation temperature 1335°C

ZrO₂ 211 μm
α-Zr(O) 305 μm
β-Zr 257 μm

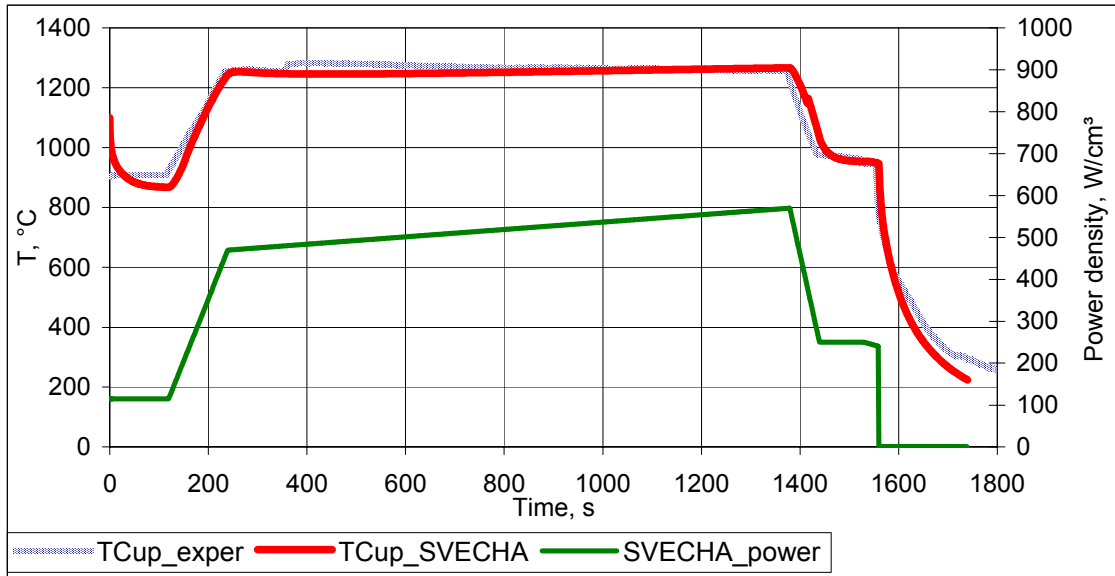
Fig. 43: SVECHA calculations for the upper section (5 cm long) of rod after Test No. 9. The power is fitted according to the test temperature profile

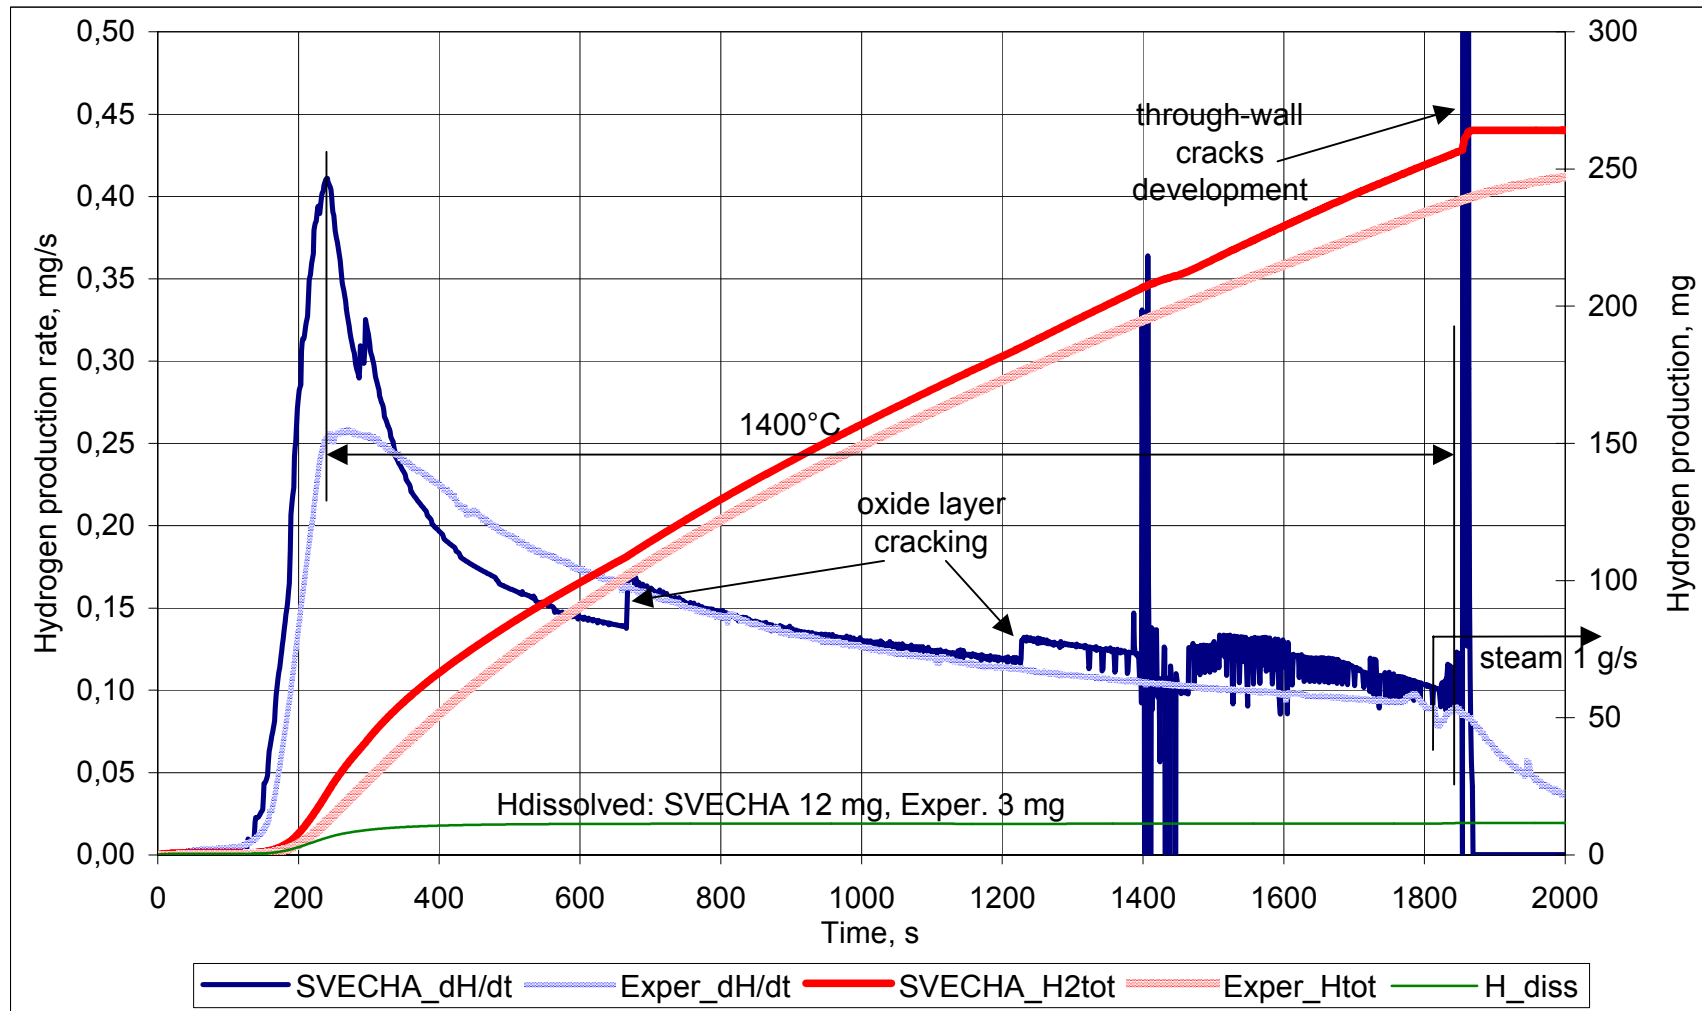
Fig. 48: Comparison of the experimental and SVECHA calculation results of the hydrogen production for the test No. 8. The SVECHA hydrogen is the sum of the three rod segments
